105 Miller St

Heritage Presentation

Investa

May 2025

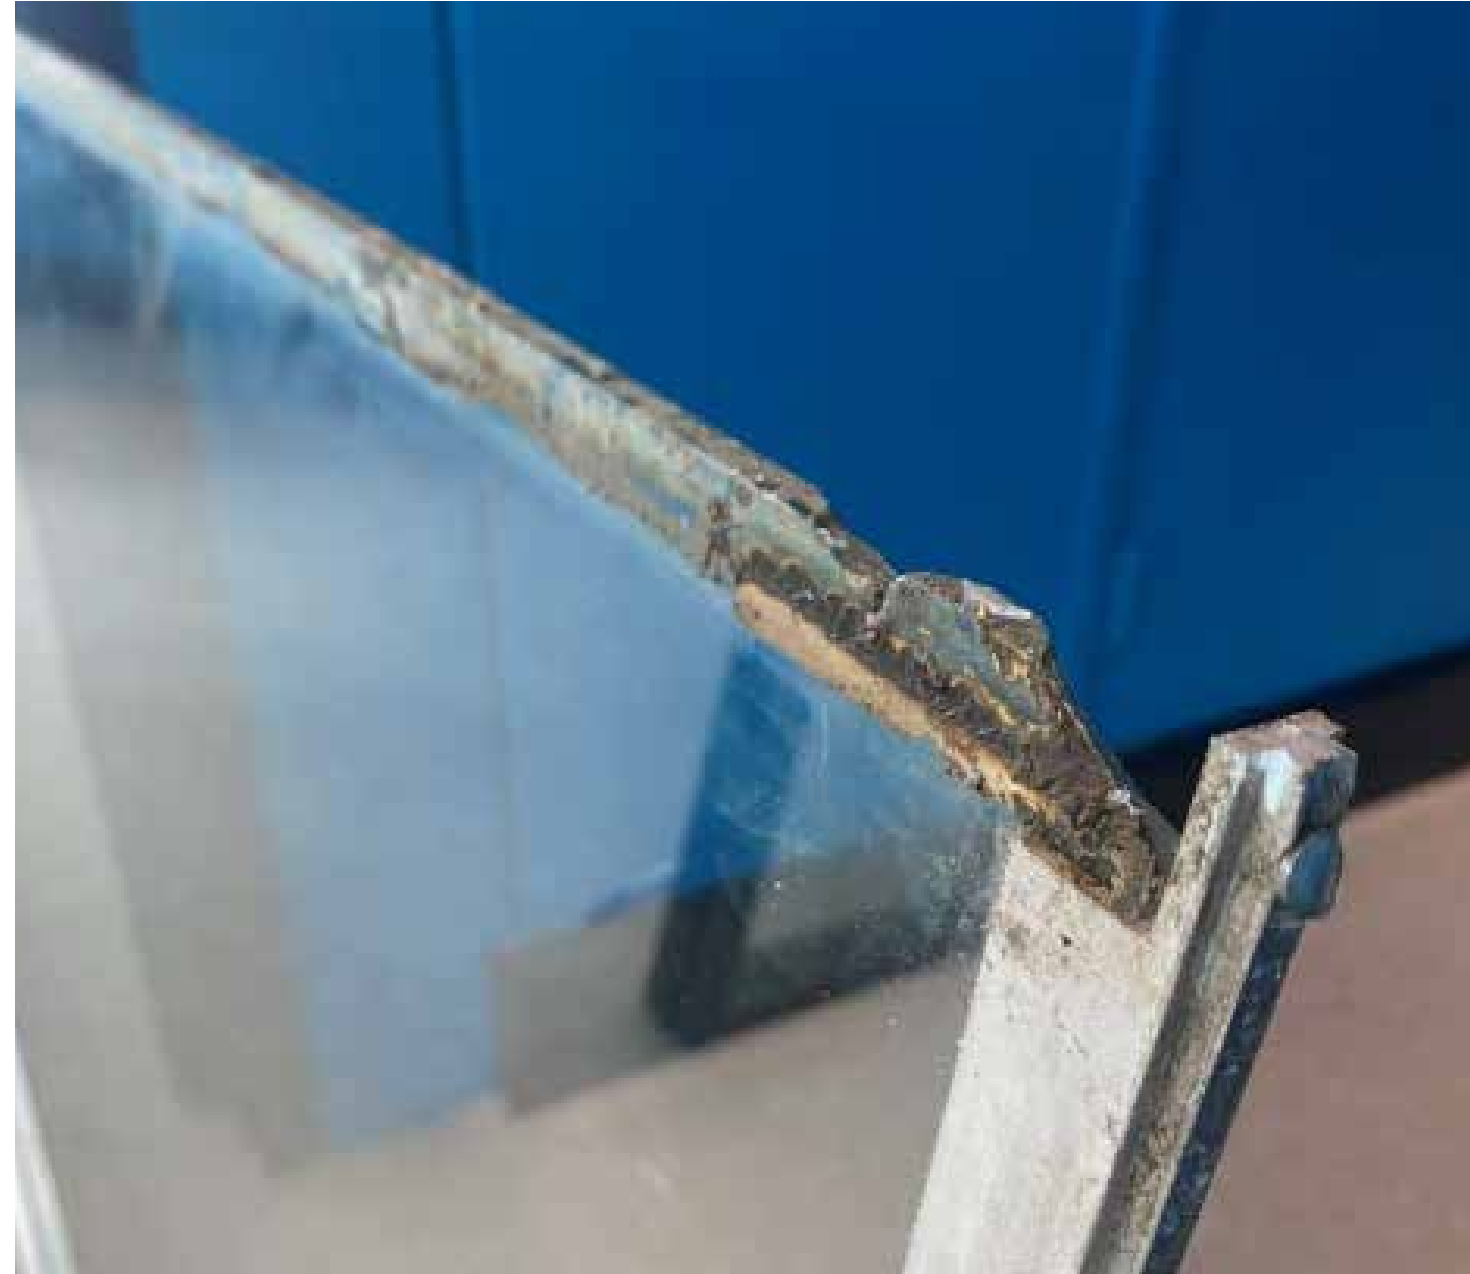
Site Investigations

Glass

- Glass testing has been carried out that indicates that the **solar height gain coefficient (SHGC) for the glass is 0.66**. Inhabit ESD completed an energy assessment, which outlines that the **glass needs to be replaced** to achieve BCA Section J compliance and a GBCA 5 Star rating and 5.5 NABERS Energy Rating
- The glass has been confirmed as **6mm float glass which is a safety hazard** and non-compliant with AS1288

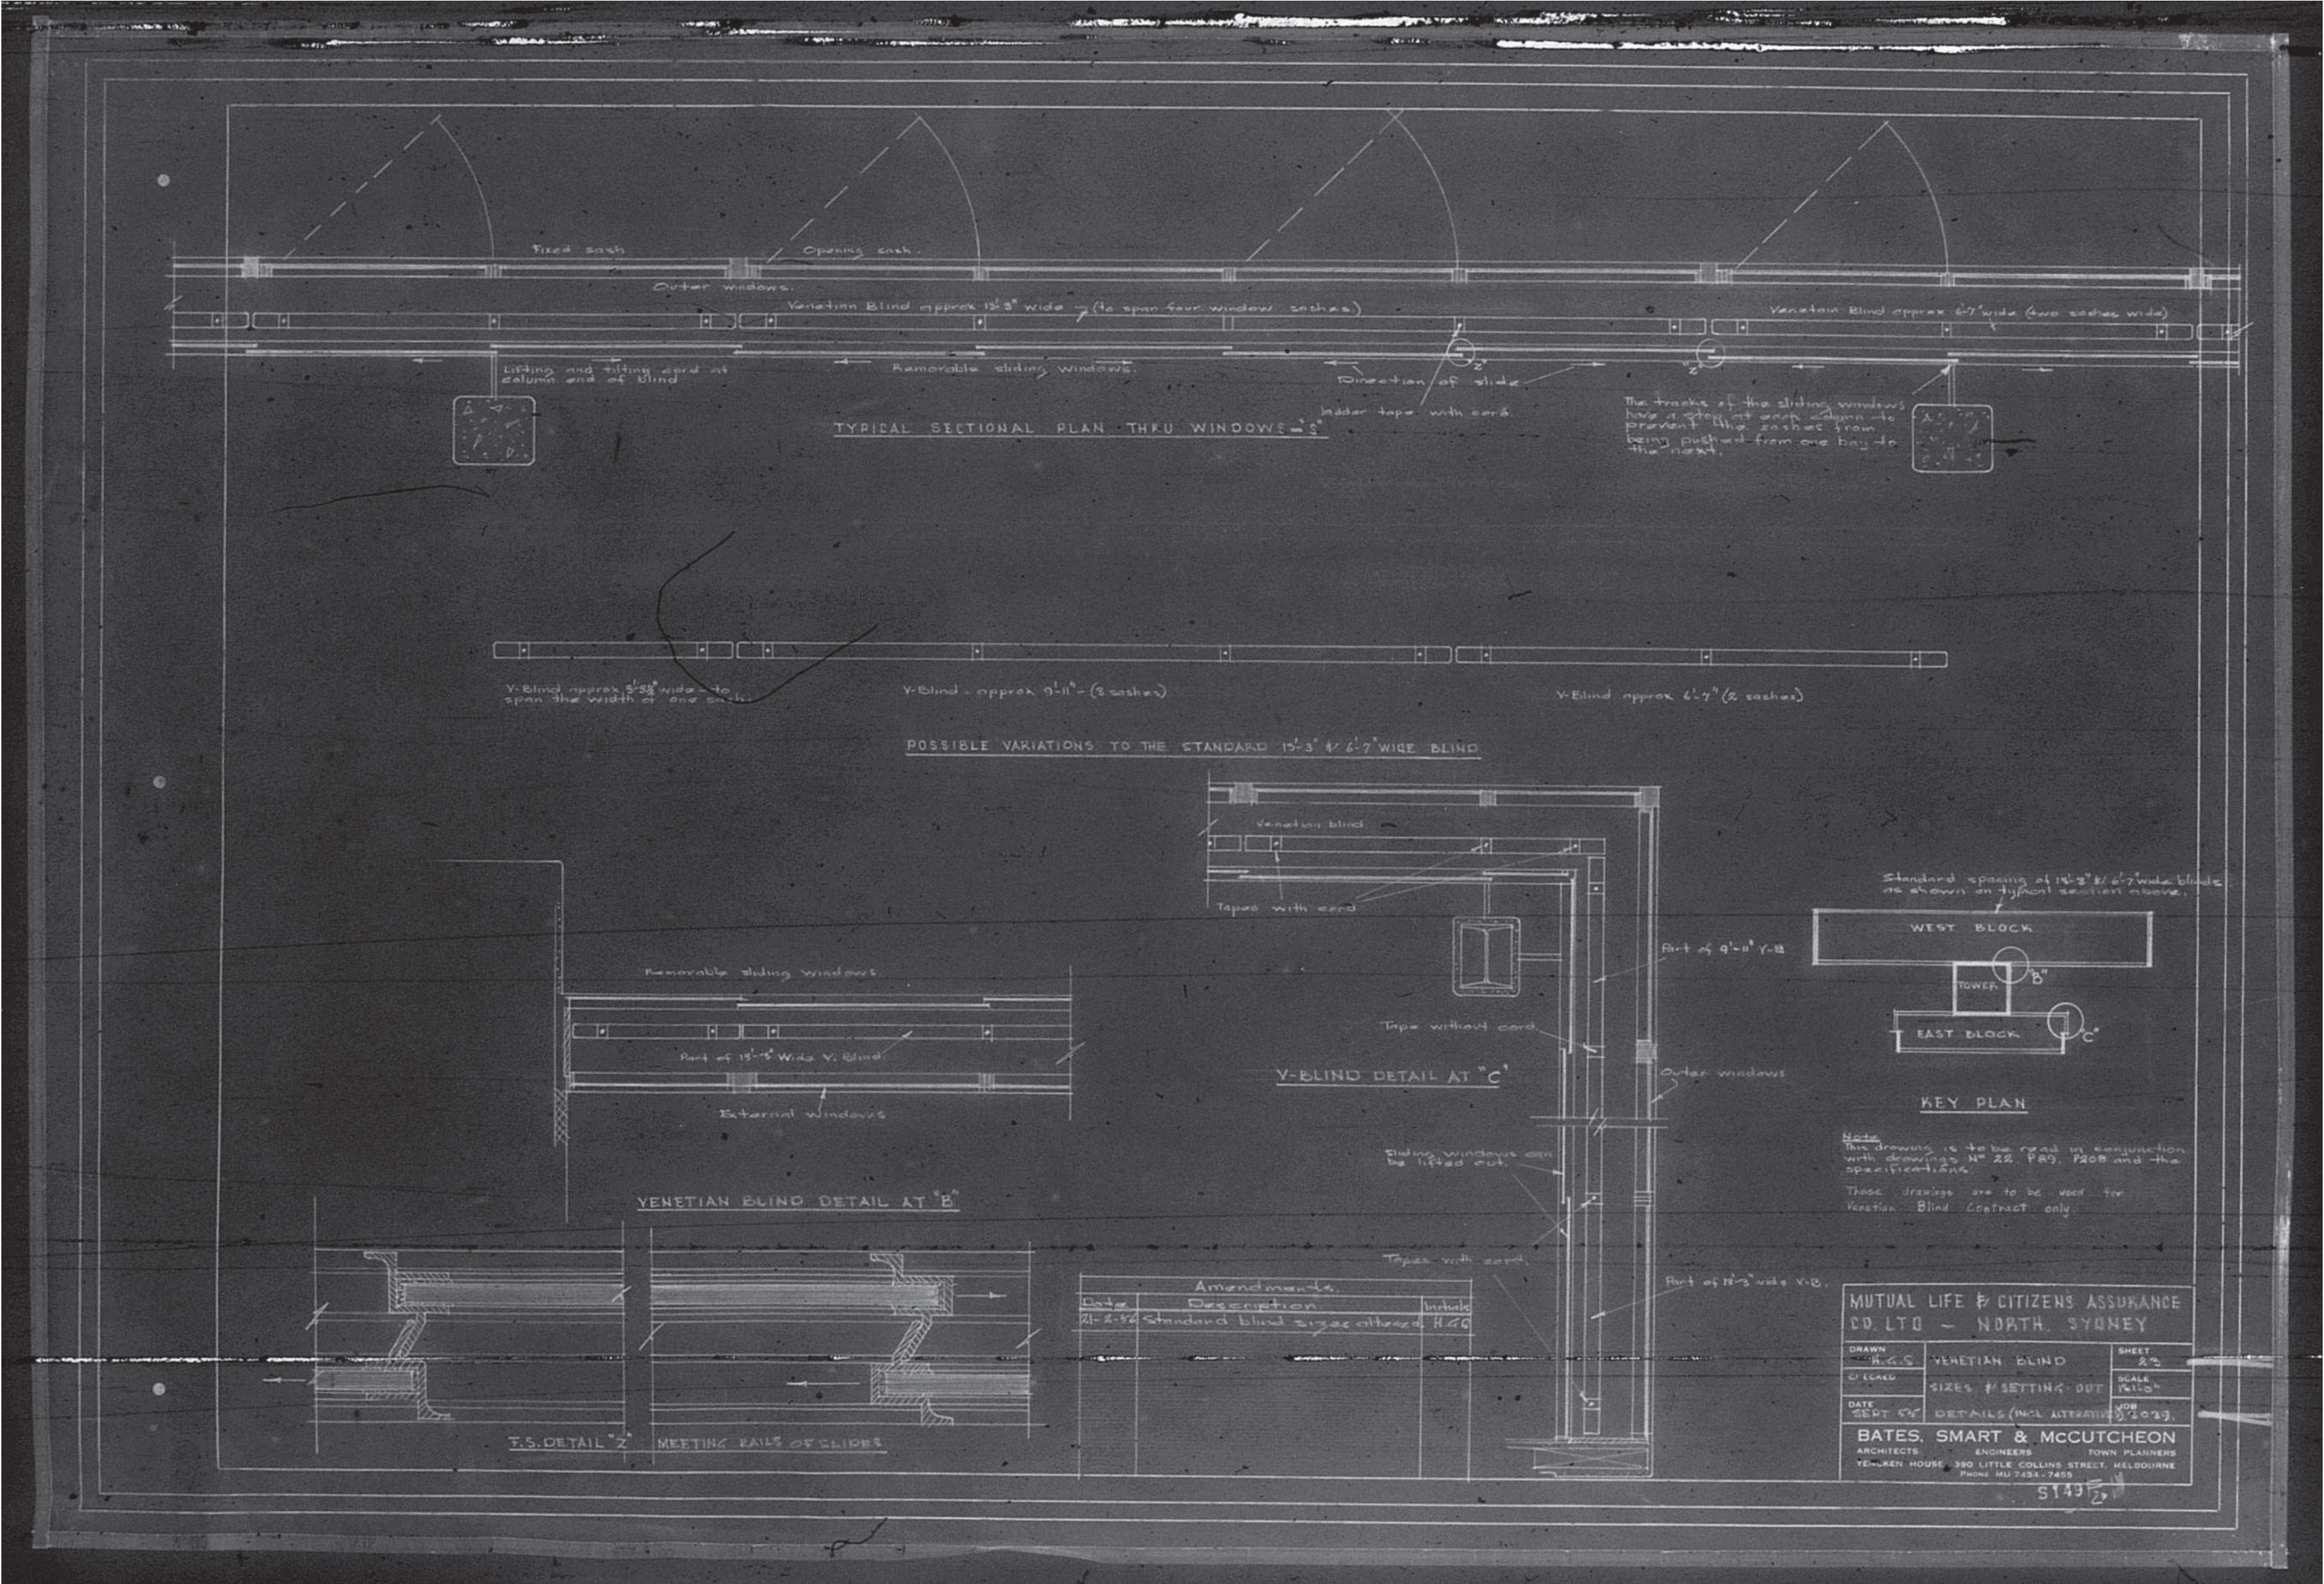
Miller Wing Facade

Original Detail

- Typical details showing window arrangement and blind setout
- Confirms that outer leafs were designed to be operable but were later screwed shut
- No requirement for operability in proposed condition but the capping should resemble the various framing depths

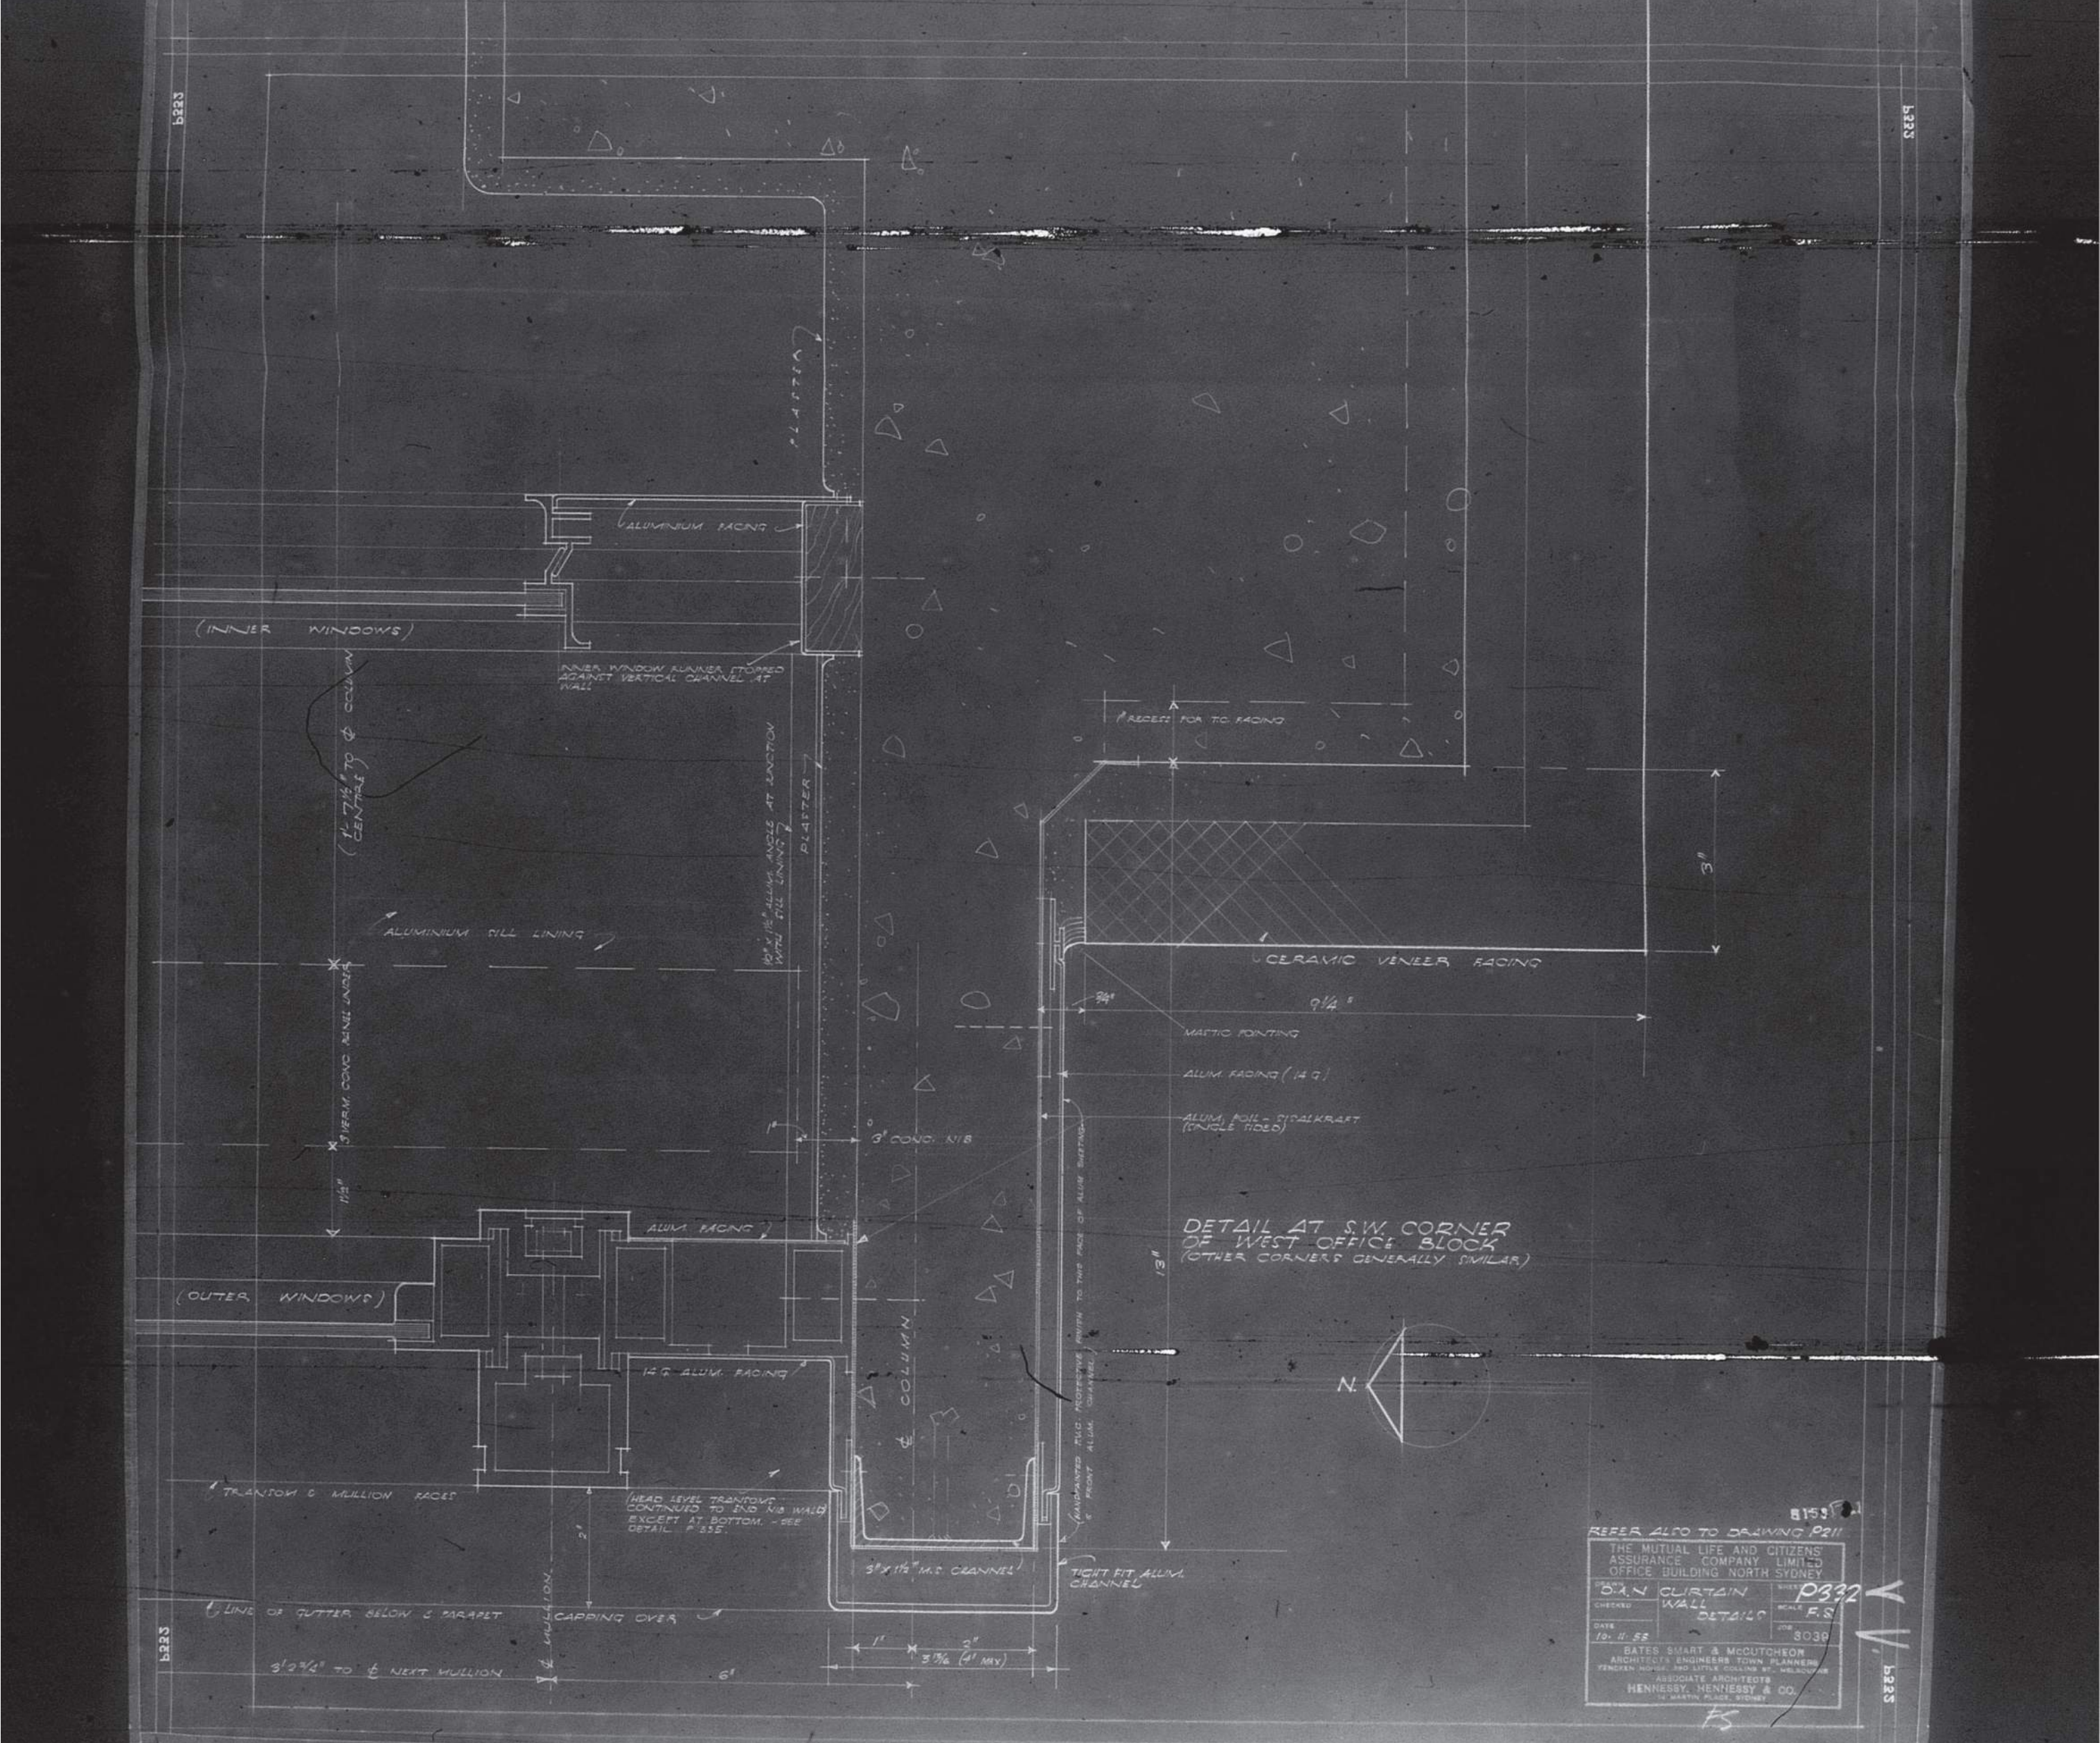
Miller Wing Facade

Original Detail

— Detail at corner of Miller wing

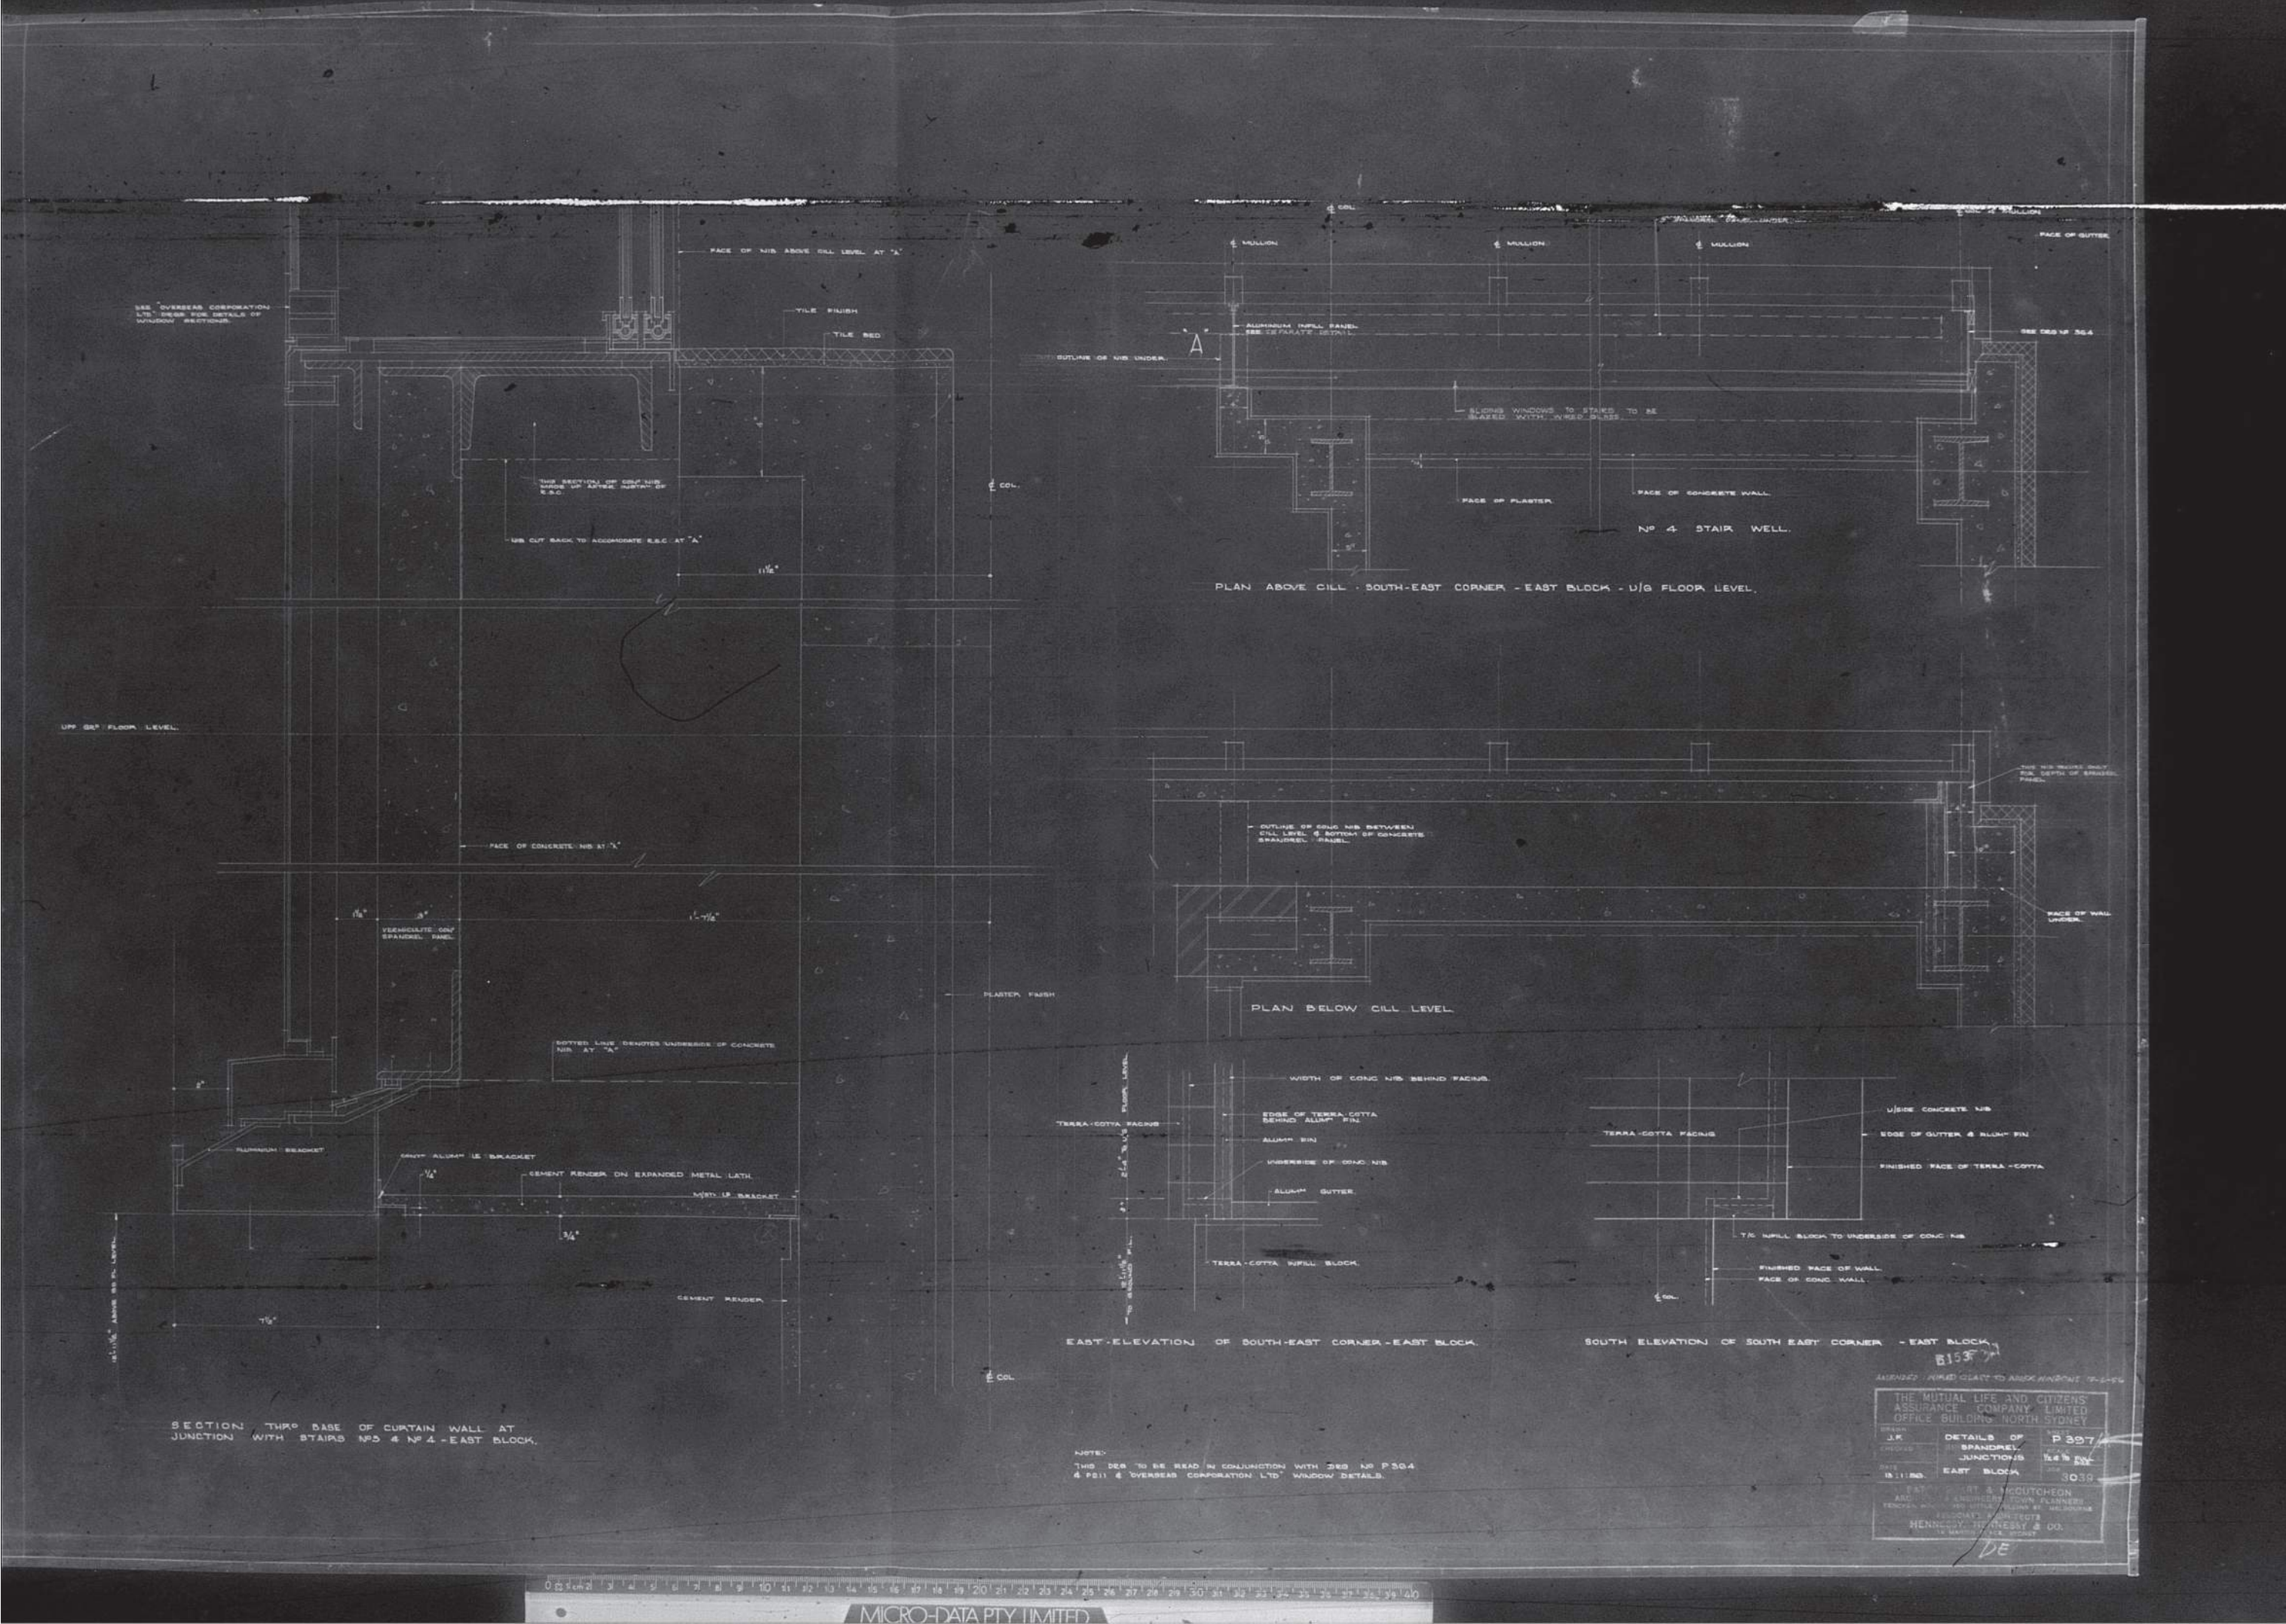
Miller Wing Facade

Original Detail

- Typical section of Denison wing
- It appears that the Denison wing was originally constructed with the smaller cavity and internal sill (as per the existing condition) and the Miller wing had a larger cavity with no internal sill which was later amended to match Denison

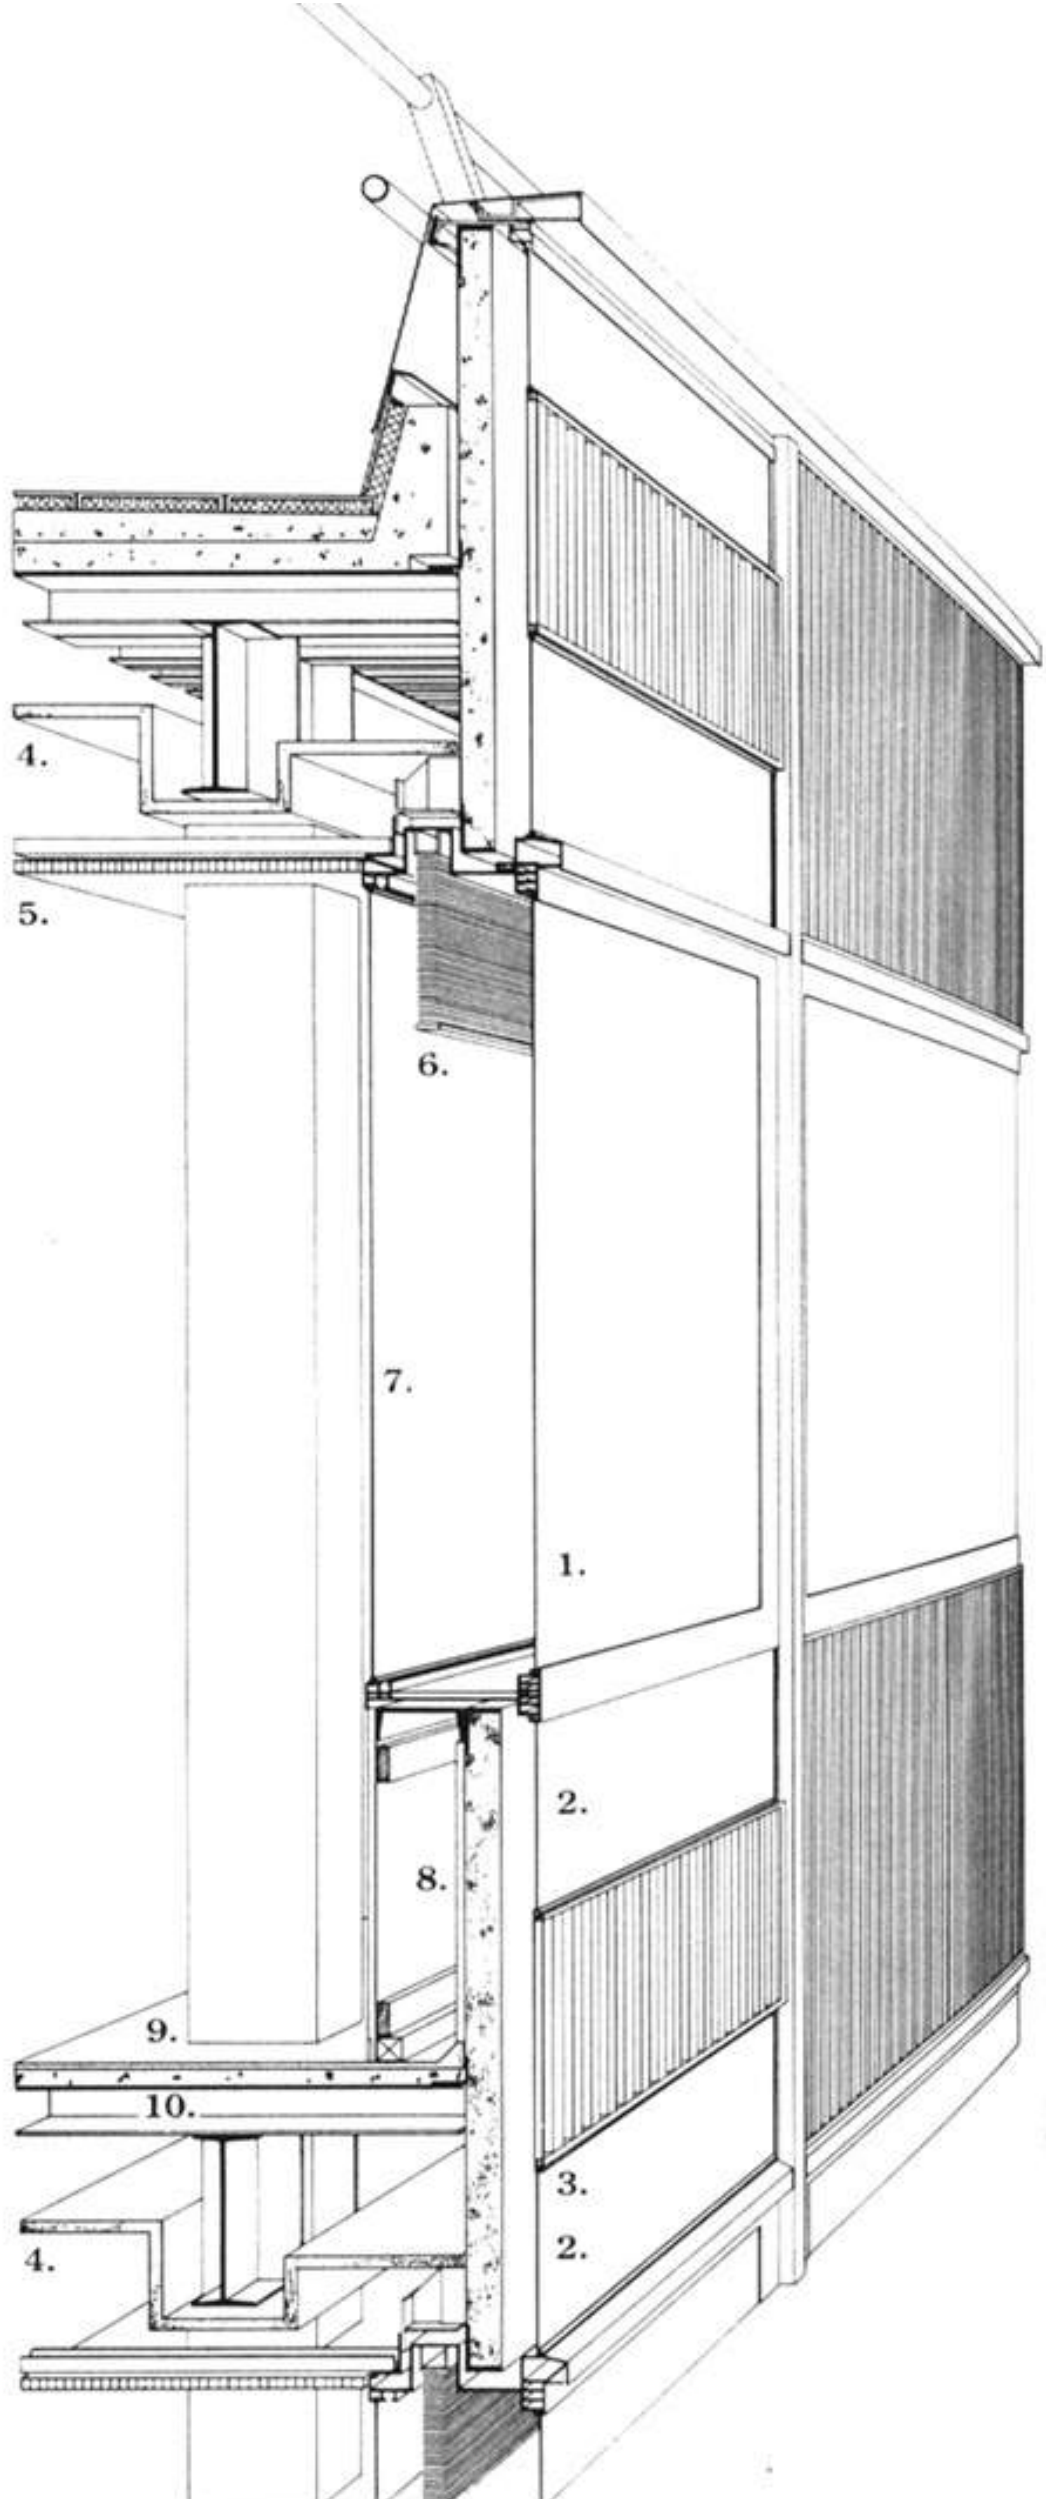
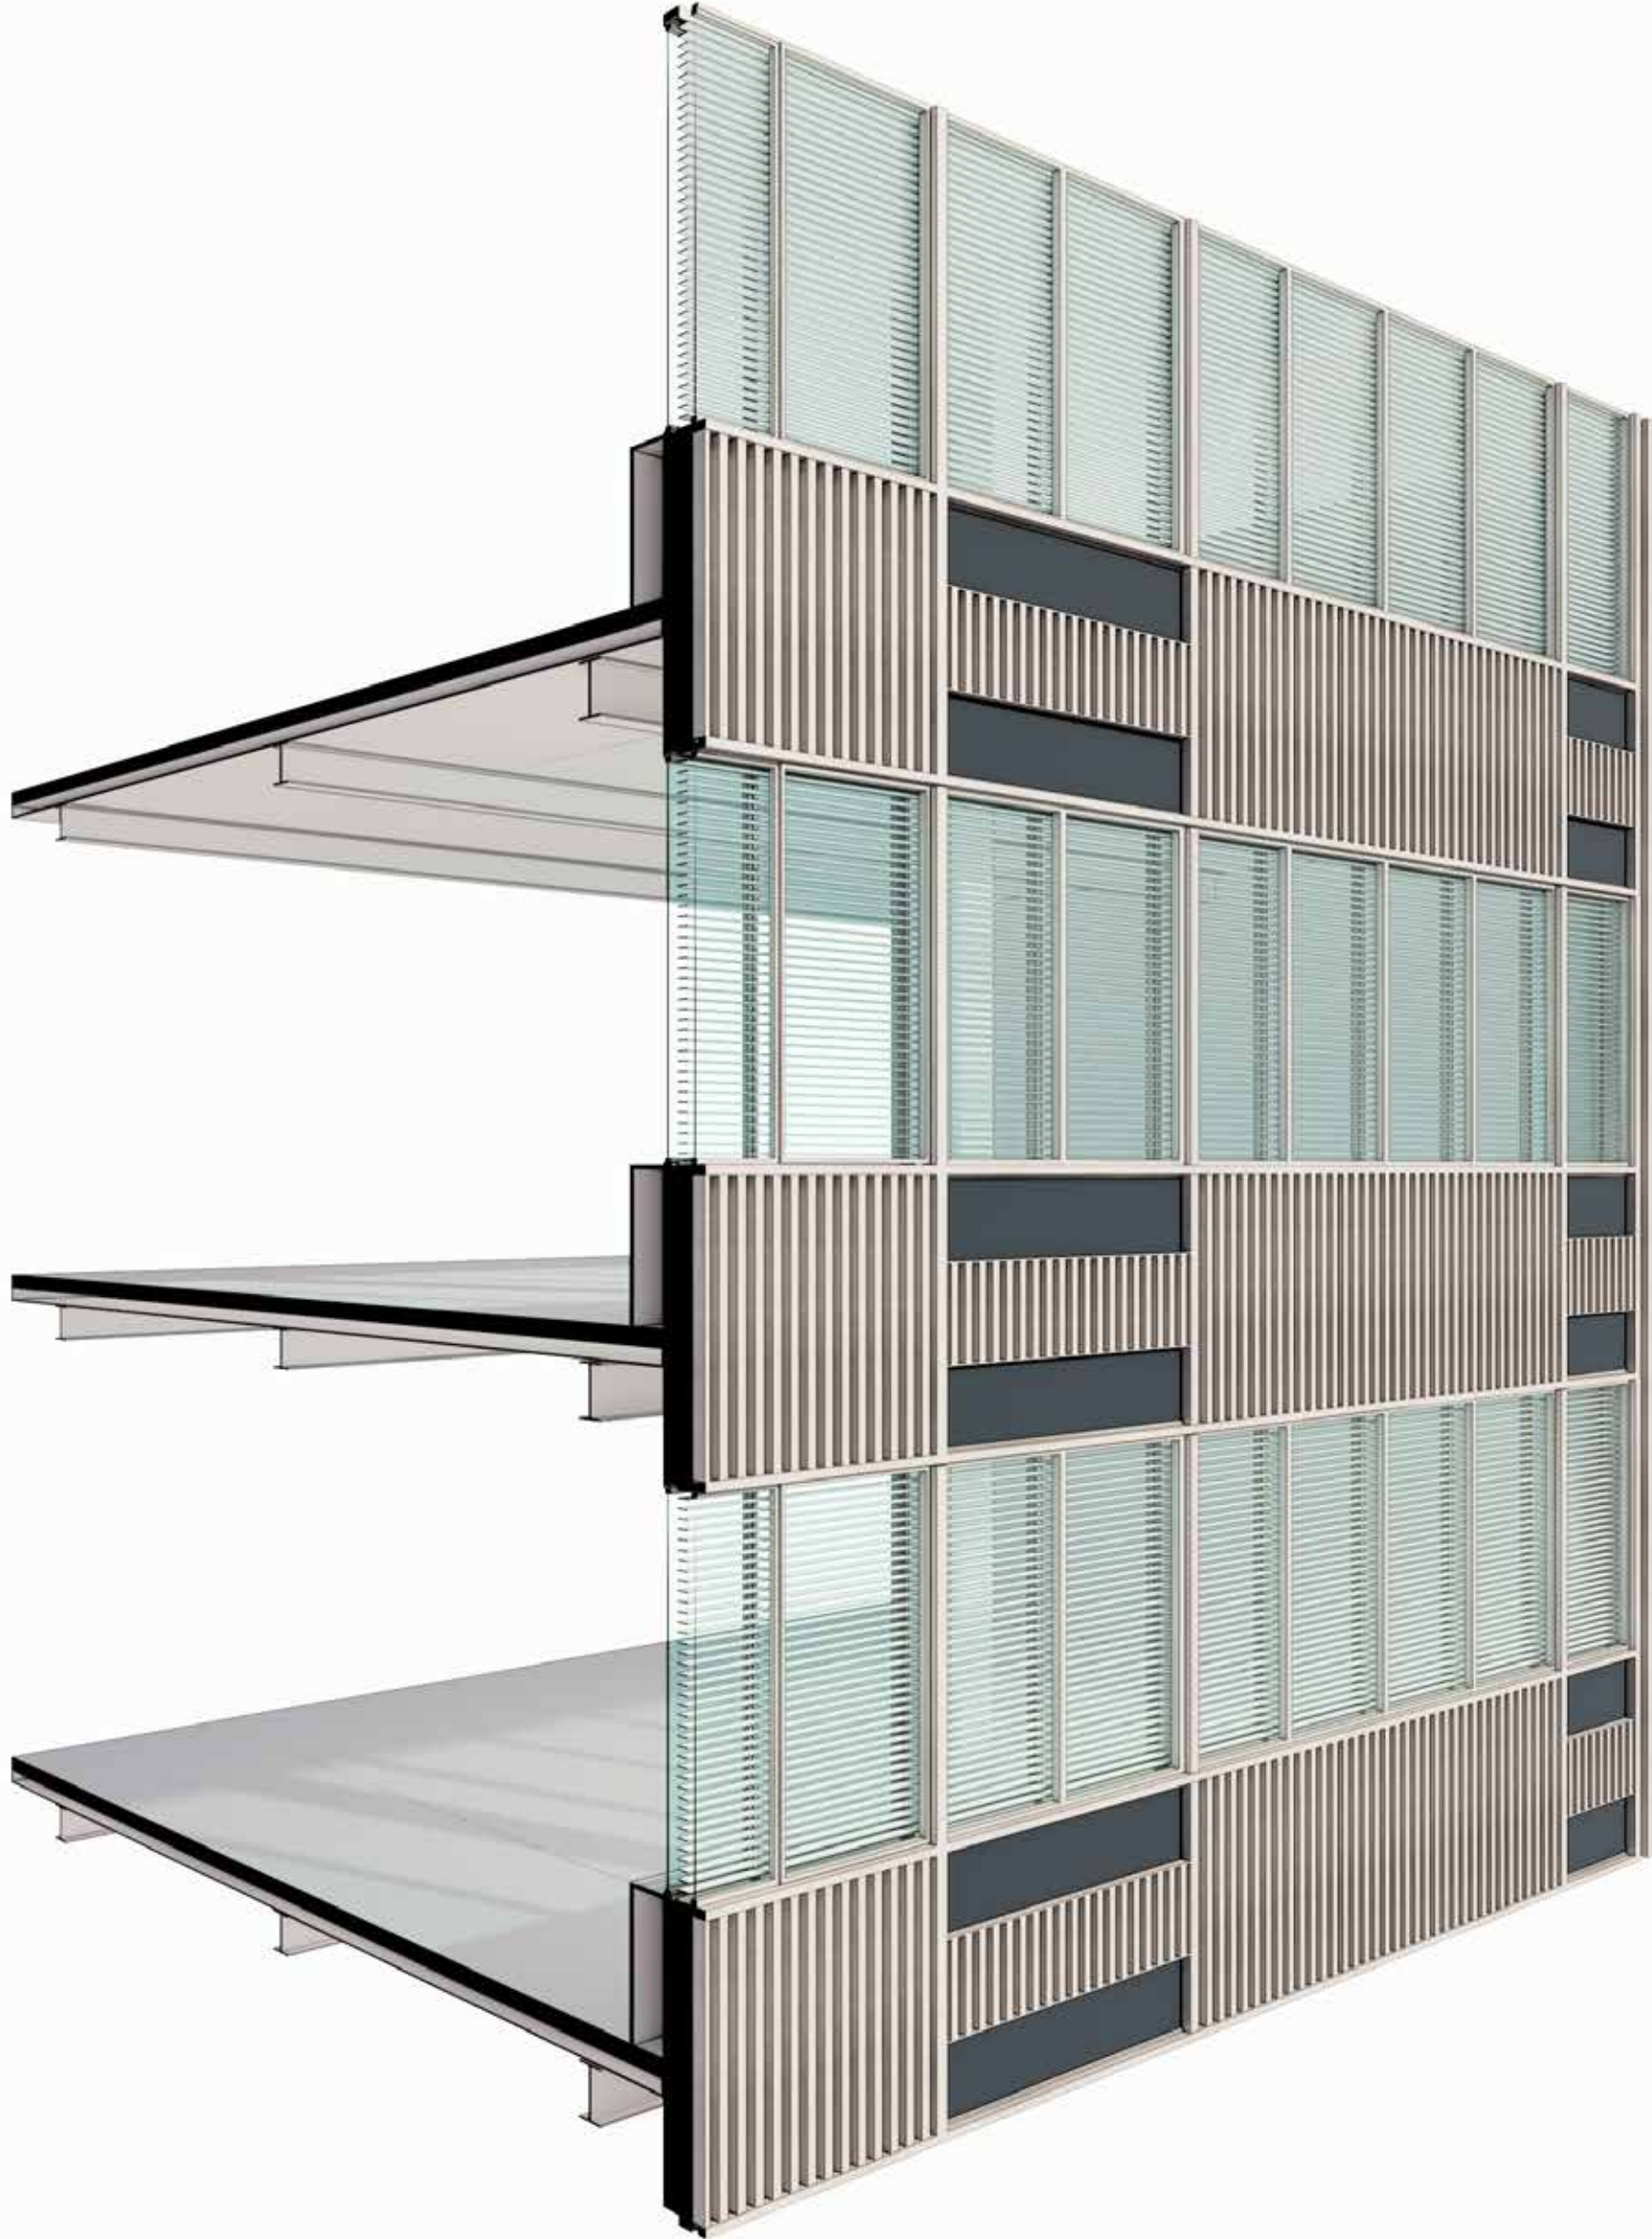
EXISTING FACADE

Heritage Fabric Curtain Wall Facade

Replacement of facade is deemed necessary for the following reasons:

- Asbestos has been detected in mastic joints and seals across the curtain wall facades
- Coatings are damaged and have surpassed their design life of 50 years resulting in widespread corrosion and pitting
- Structural damage to fixings, rivets and framing
- Repairs would require disassembly and reassembly of facade which is not possible without causing damage
