105 Miller St

Heritage Presentation

Investa

May 2025

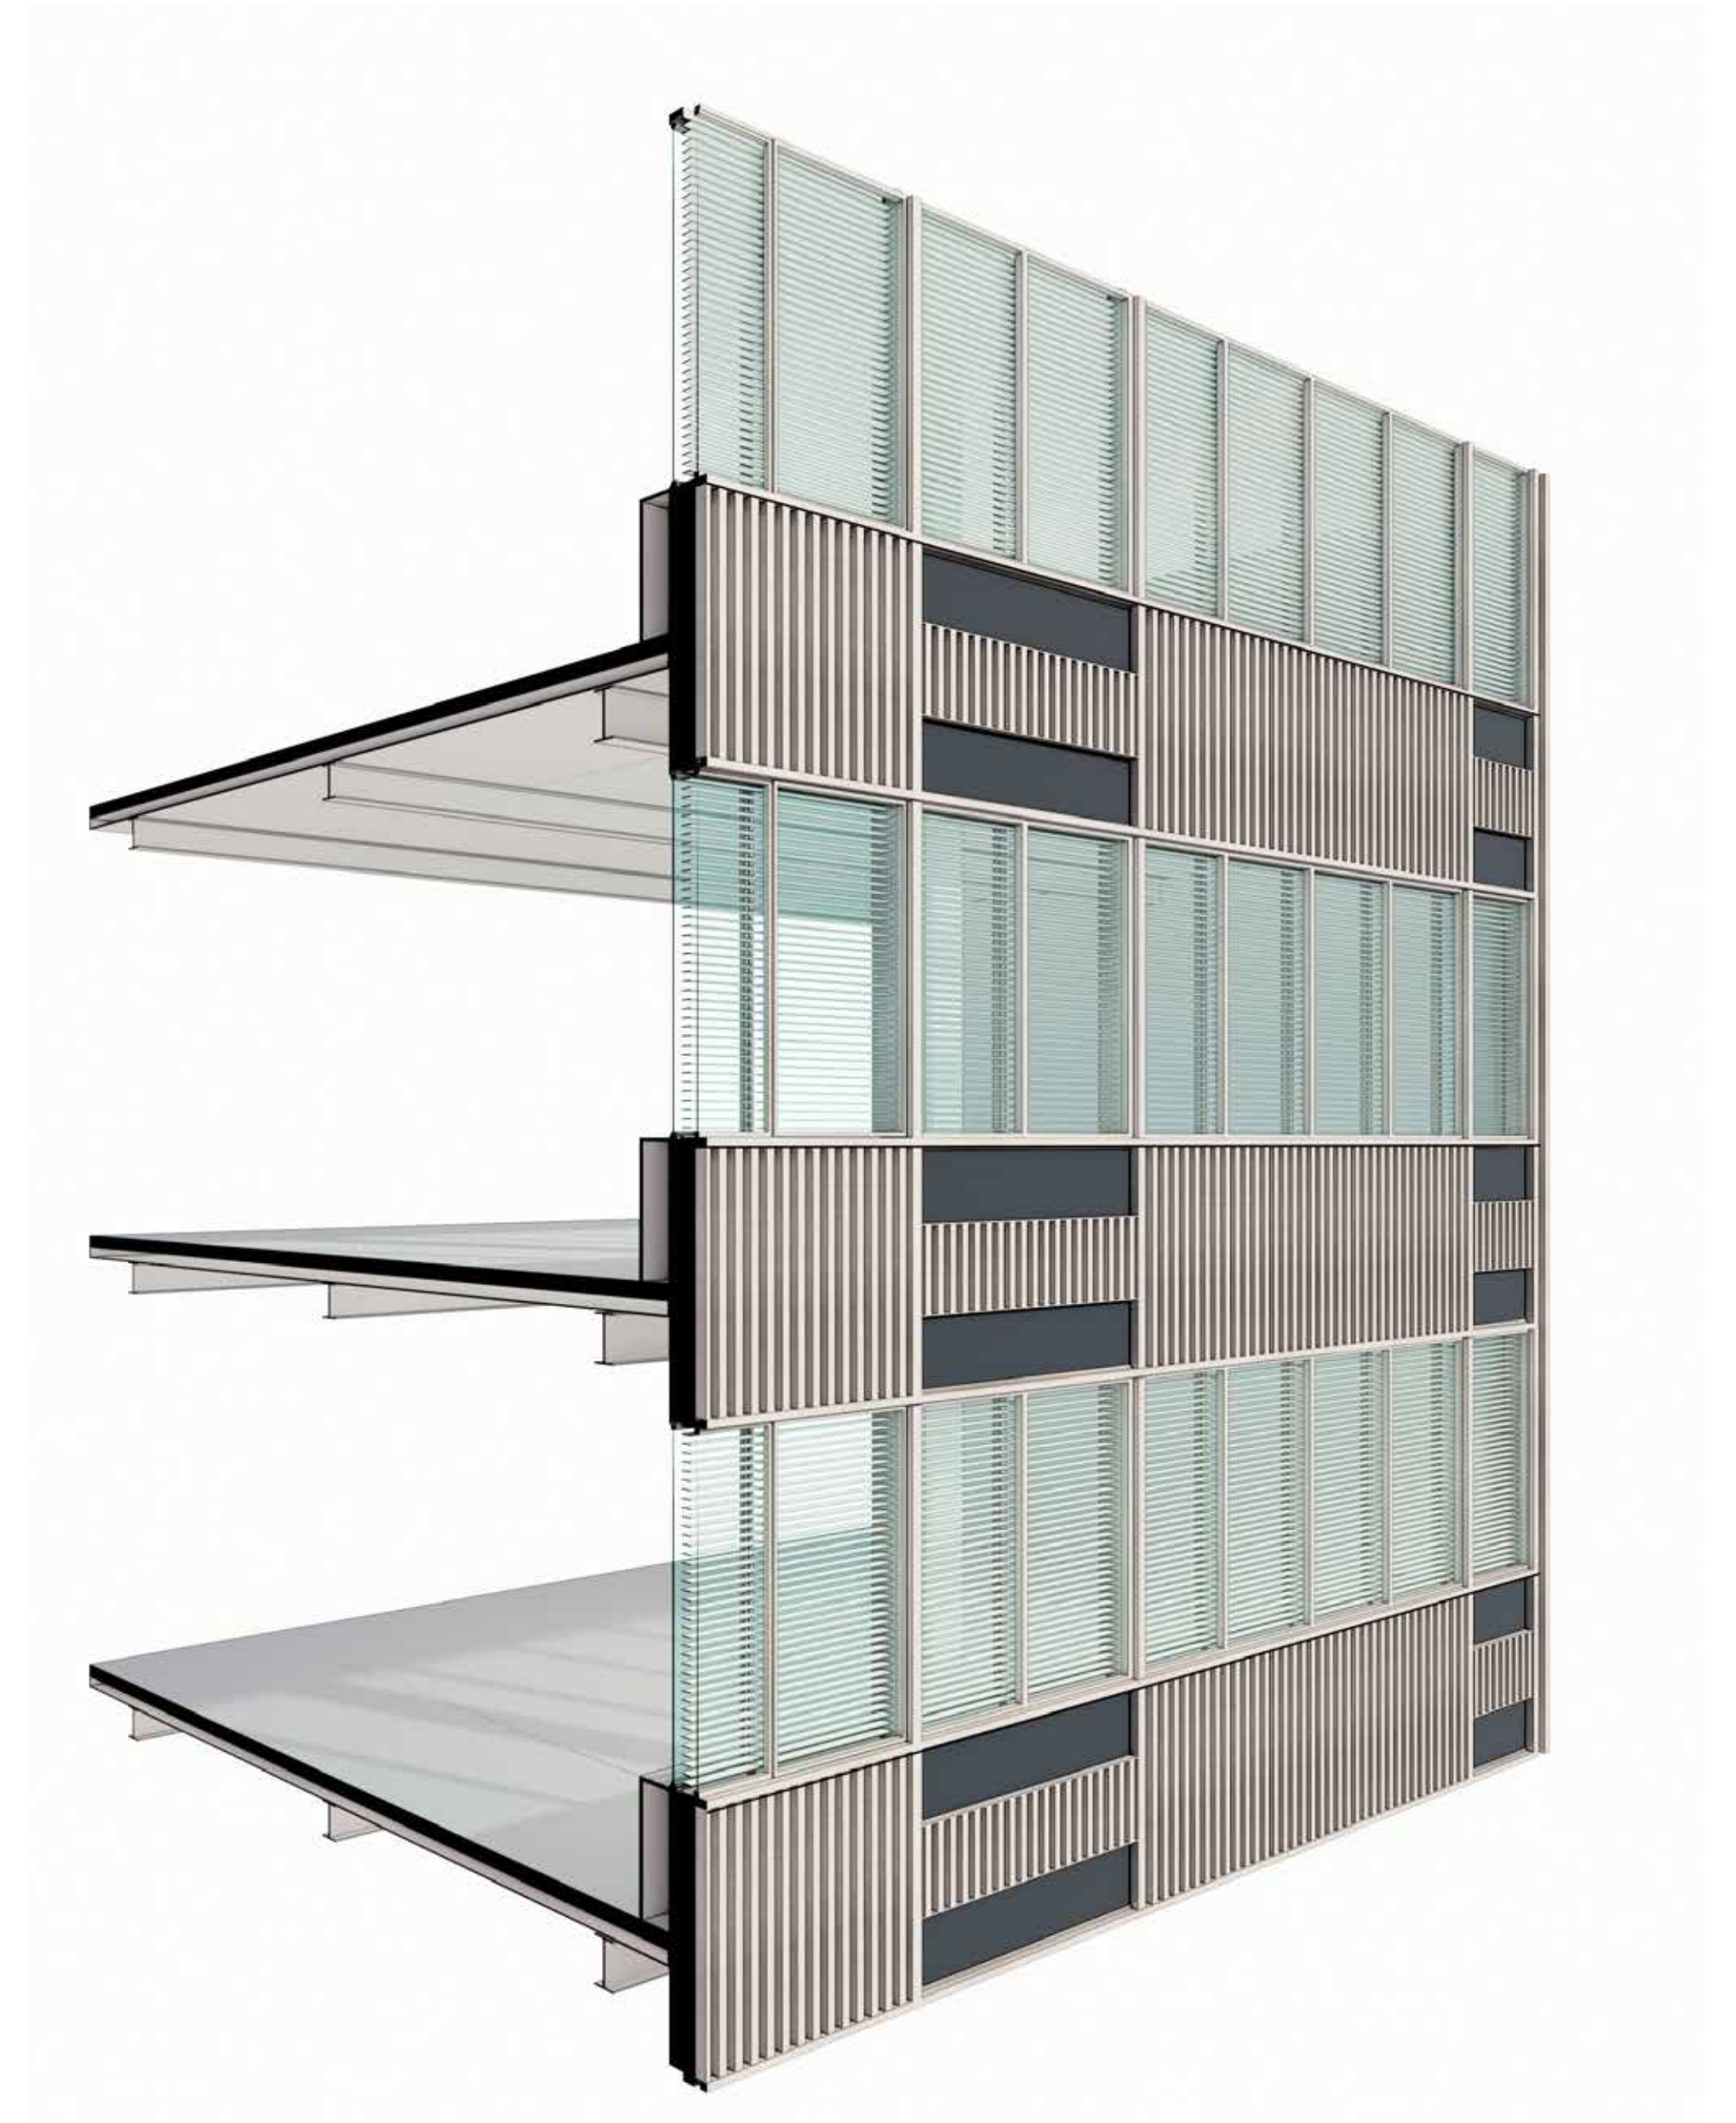
PROPOSED FACADE

Miller St Wing Curtain Wall

Proposed Design

- A replacement facade design has been developed to ensure a like-for-like appearance with two layers of glazing and blinds within the cavity which is **compliant with the CMP**
- Two full-depth mullions proposed per structural bay to allow unitised curtain wall system (panel sizes maximised to emulate original stick system)
- The double-skin facade allows the glass to be equivalent in appearance to the existing with a high visual light transmittance
- The existing glass has been tested for its visual characteristics which will be used in selecting a proposed glass type

- A replacement curtain wall facade with a like-for-like aesthetic
- Performance will be enhanced through contemporary technology and materials to meet current ESD requirements
- Venetian blinds to be replicated between two layers of glazing as existing

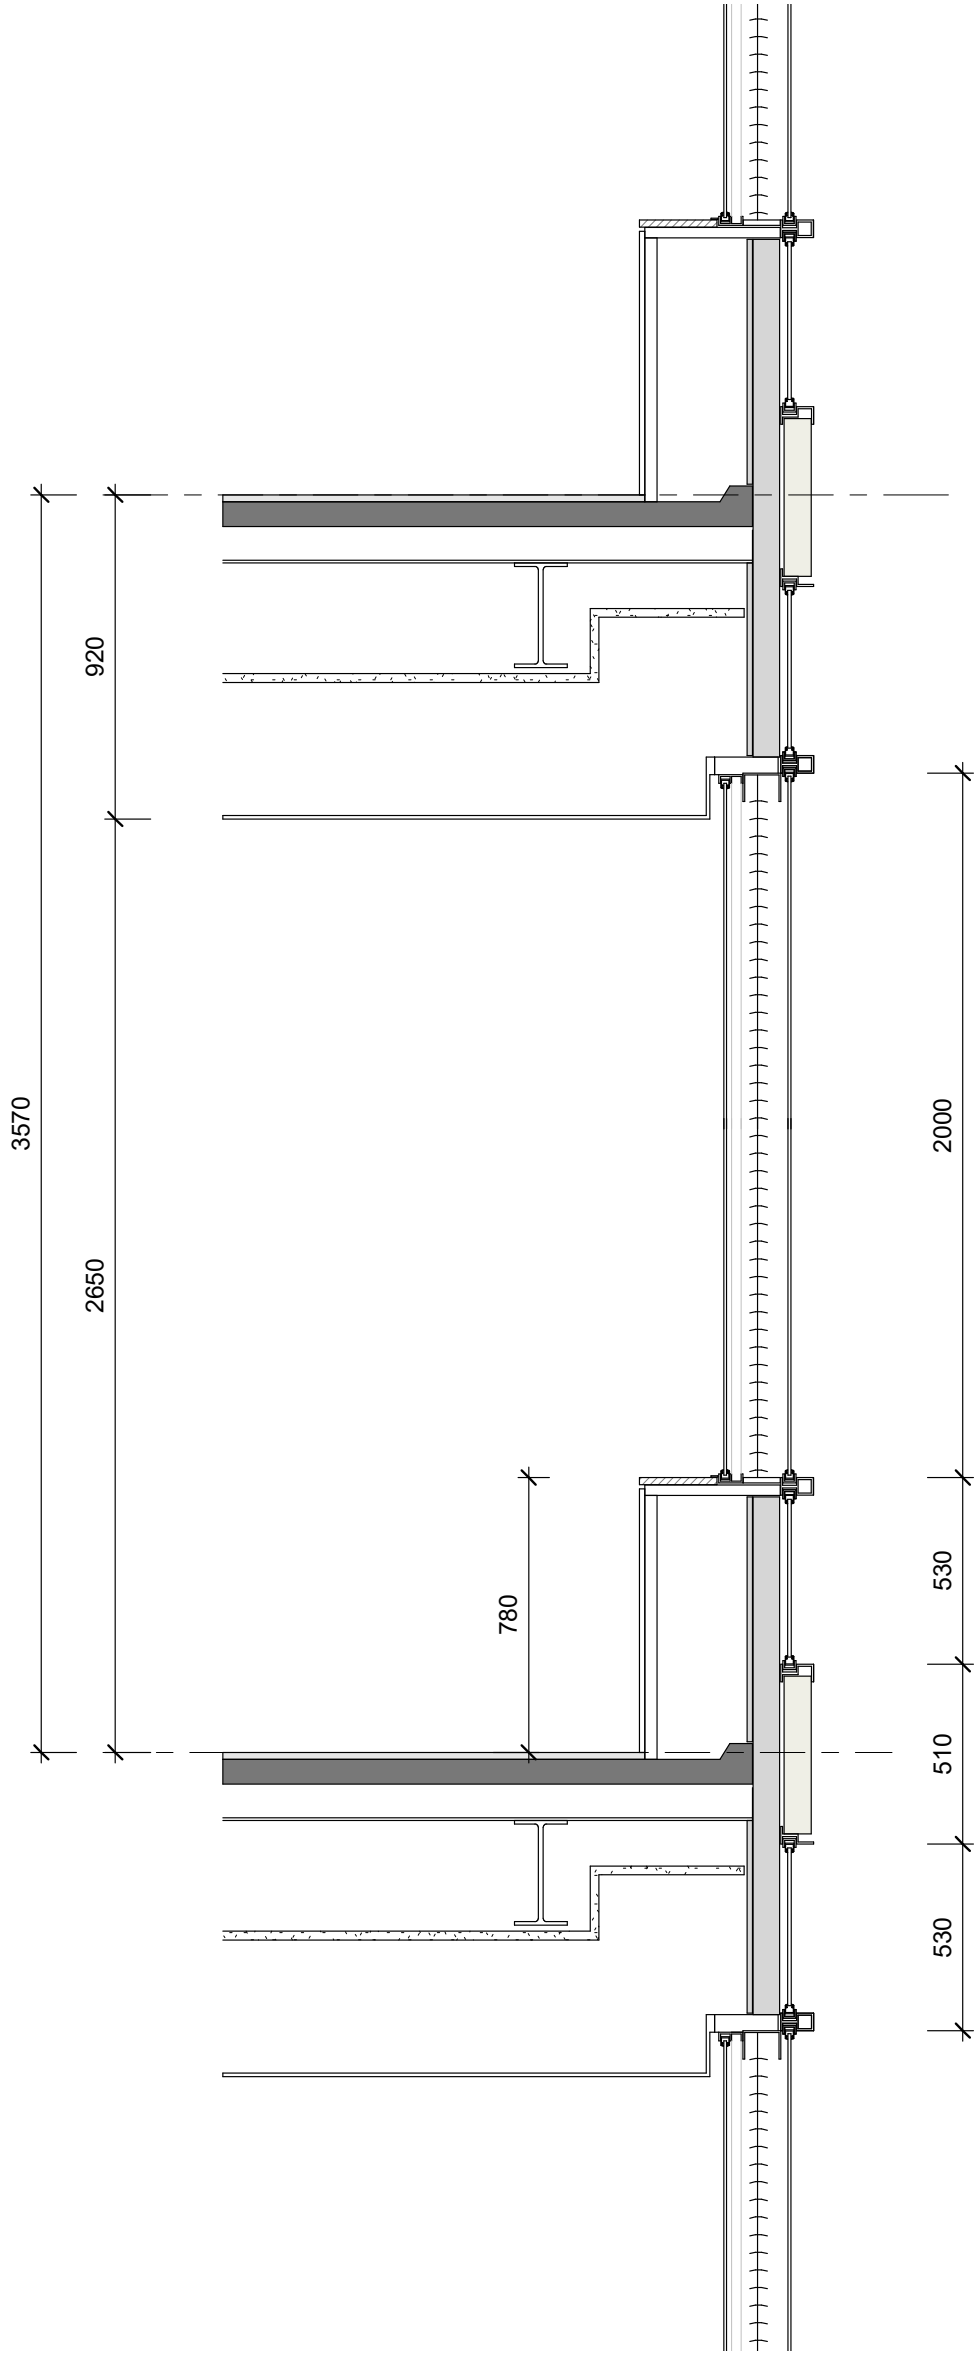
EXISTING SECTION

Miller St Wing Curtain Wall

Existing vs Proposed Design

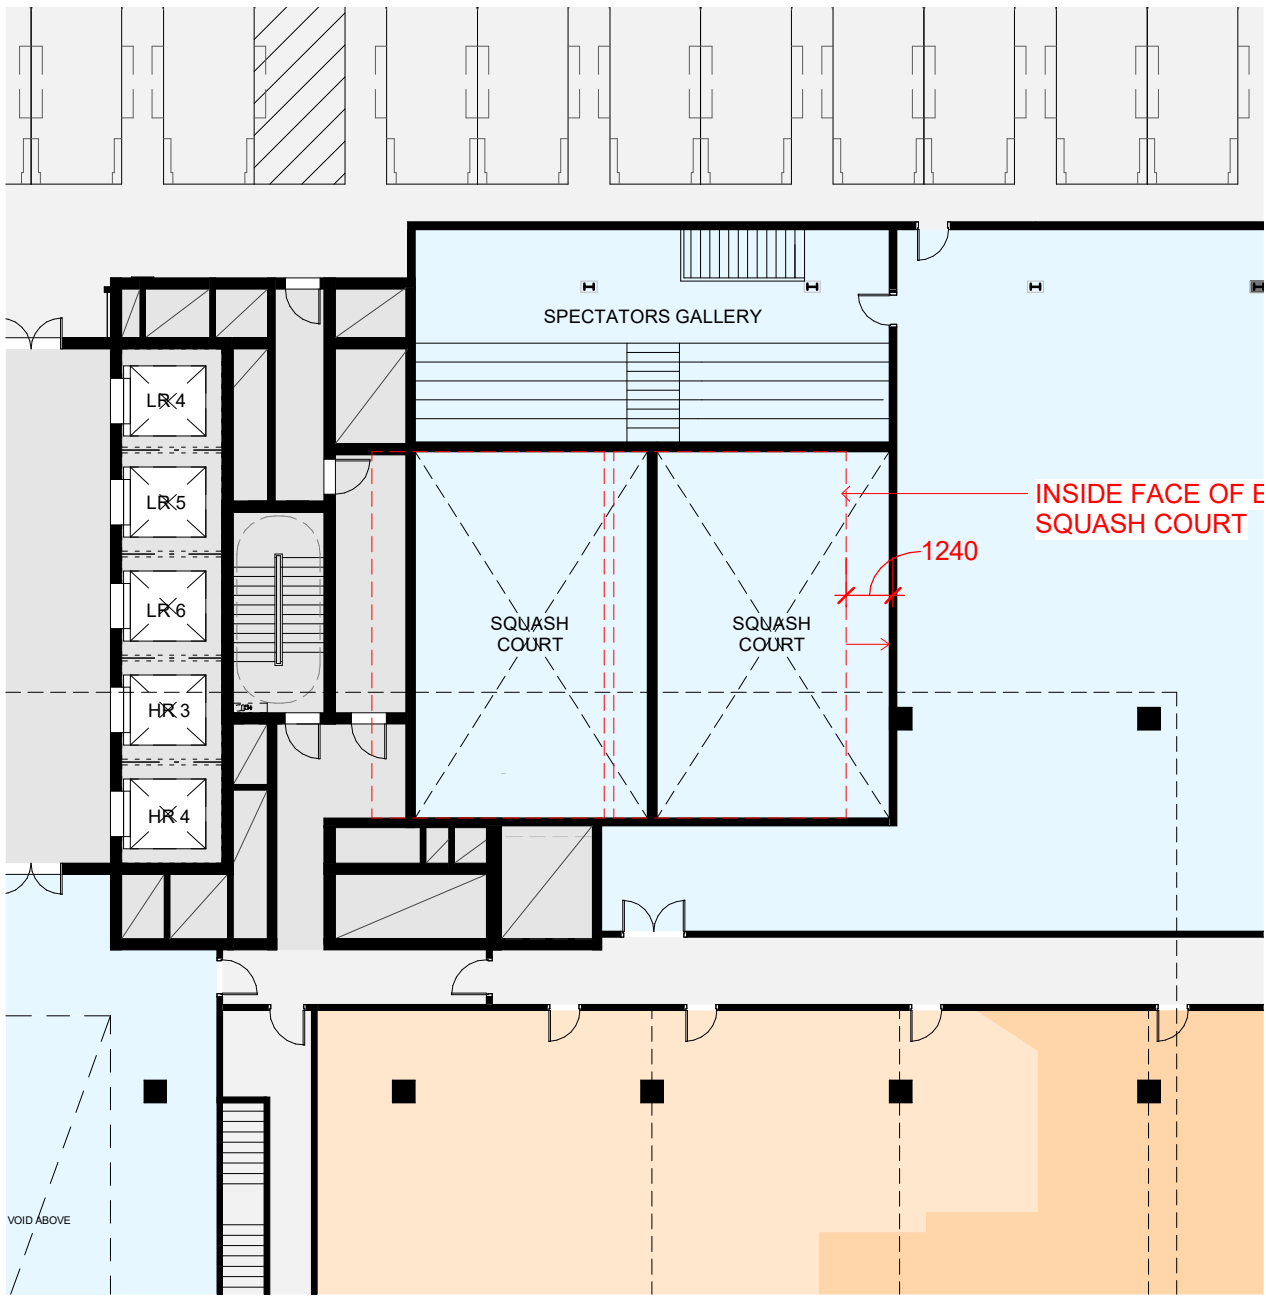
PROPOSED

Proposals:

- Squash courts to be shifted north by approximately 1200mm to suit new core extend and column locations
- Bleacher seating to be refurbished and reinstalled to match existing
- All other heritage fabric to be refurbished and reinstalled where feasible and fit for purpose
- Existing amenities serving squash courts are not original and have no heritage value
- Squash courts will be attached to the new end of trip facility

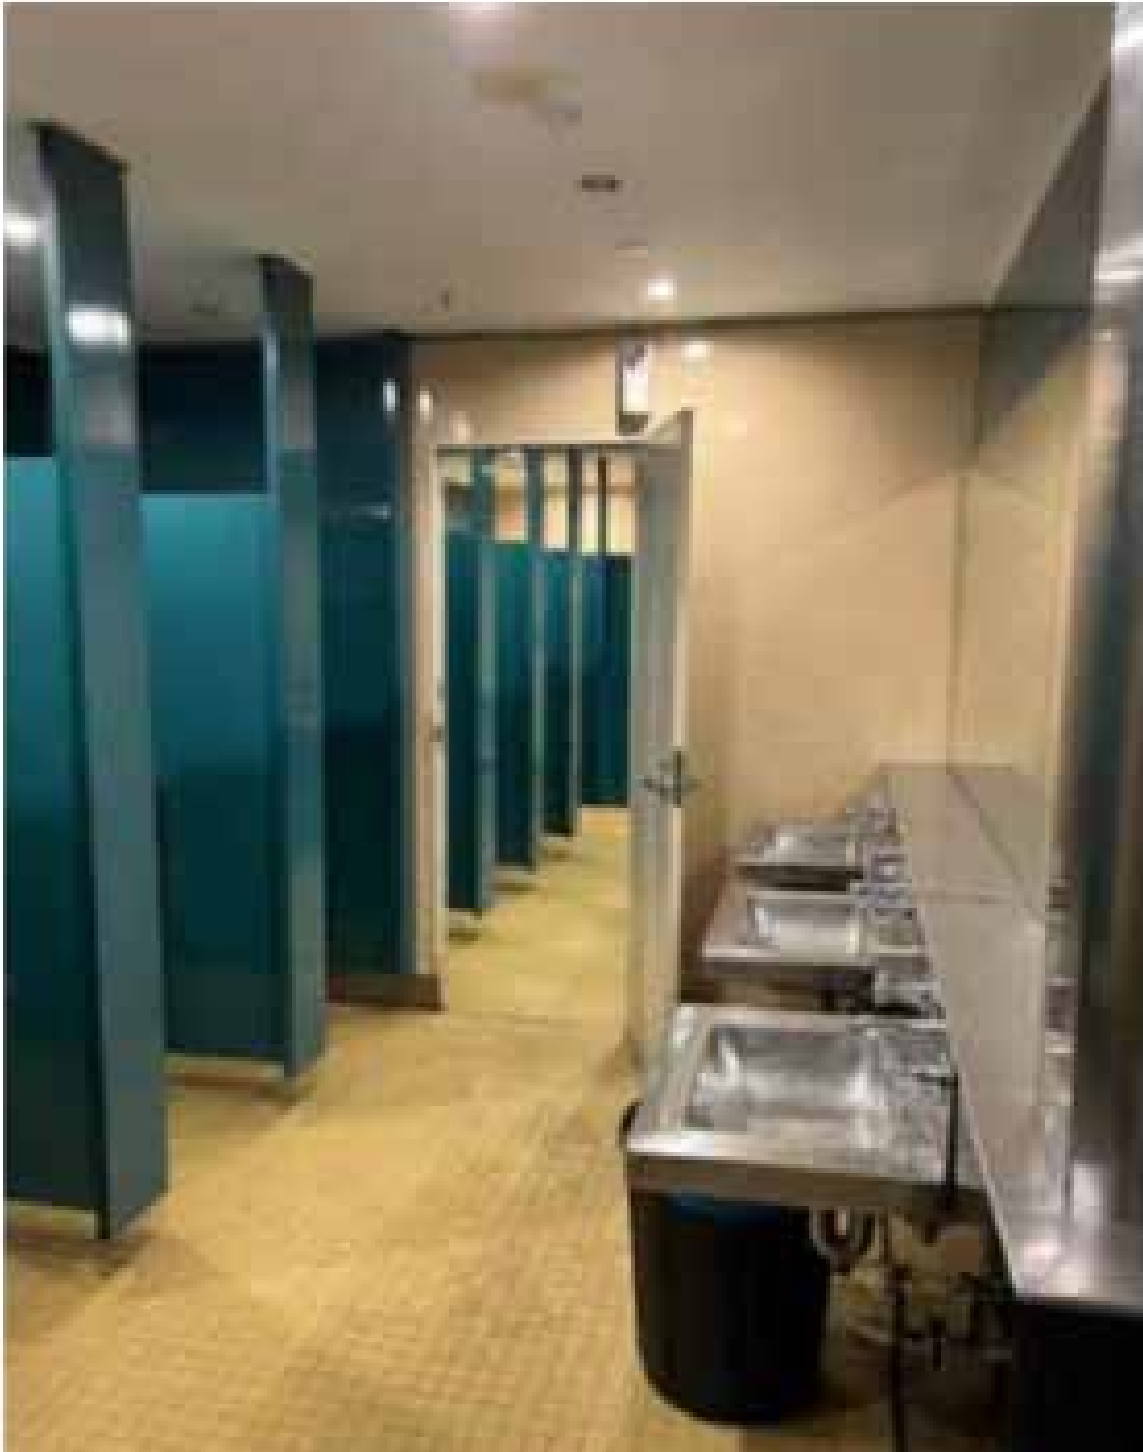
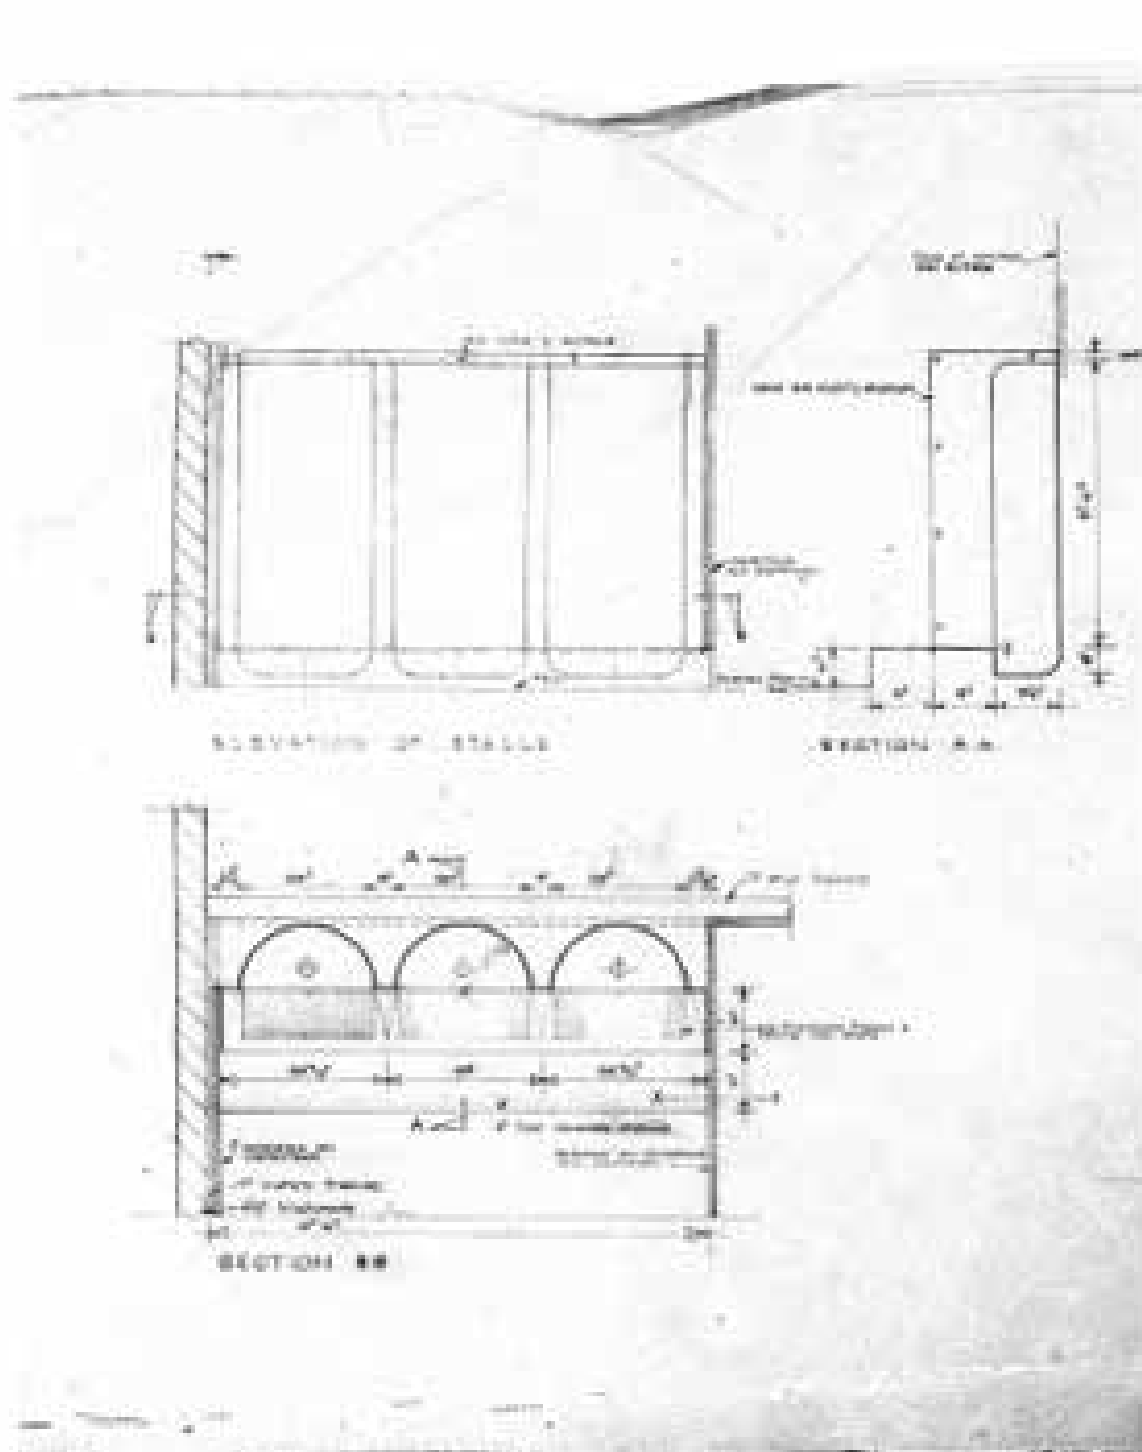
Ground Floor Amenities

Where possible original fabric will be retained and restored. Replacement will be informed by original documentation.

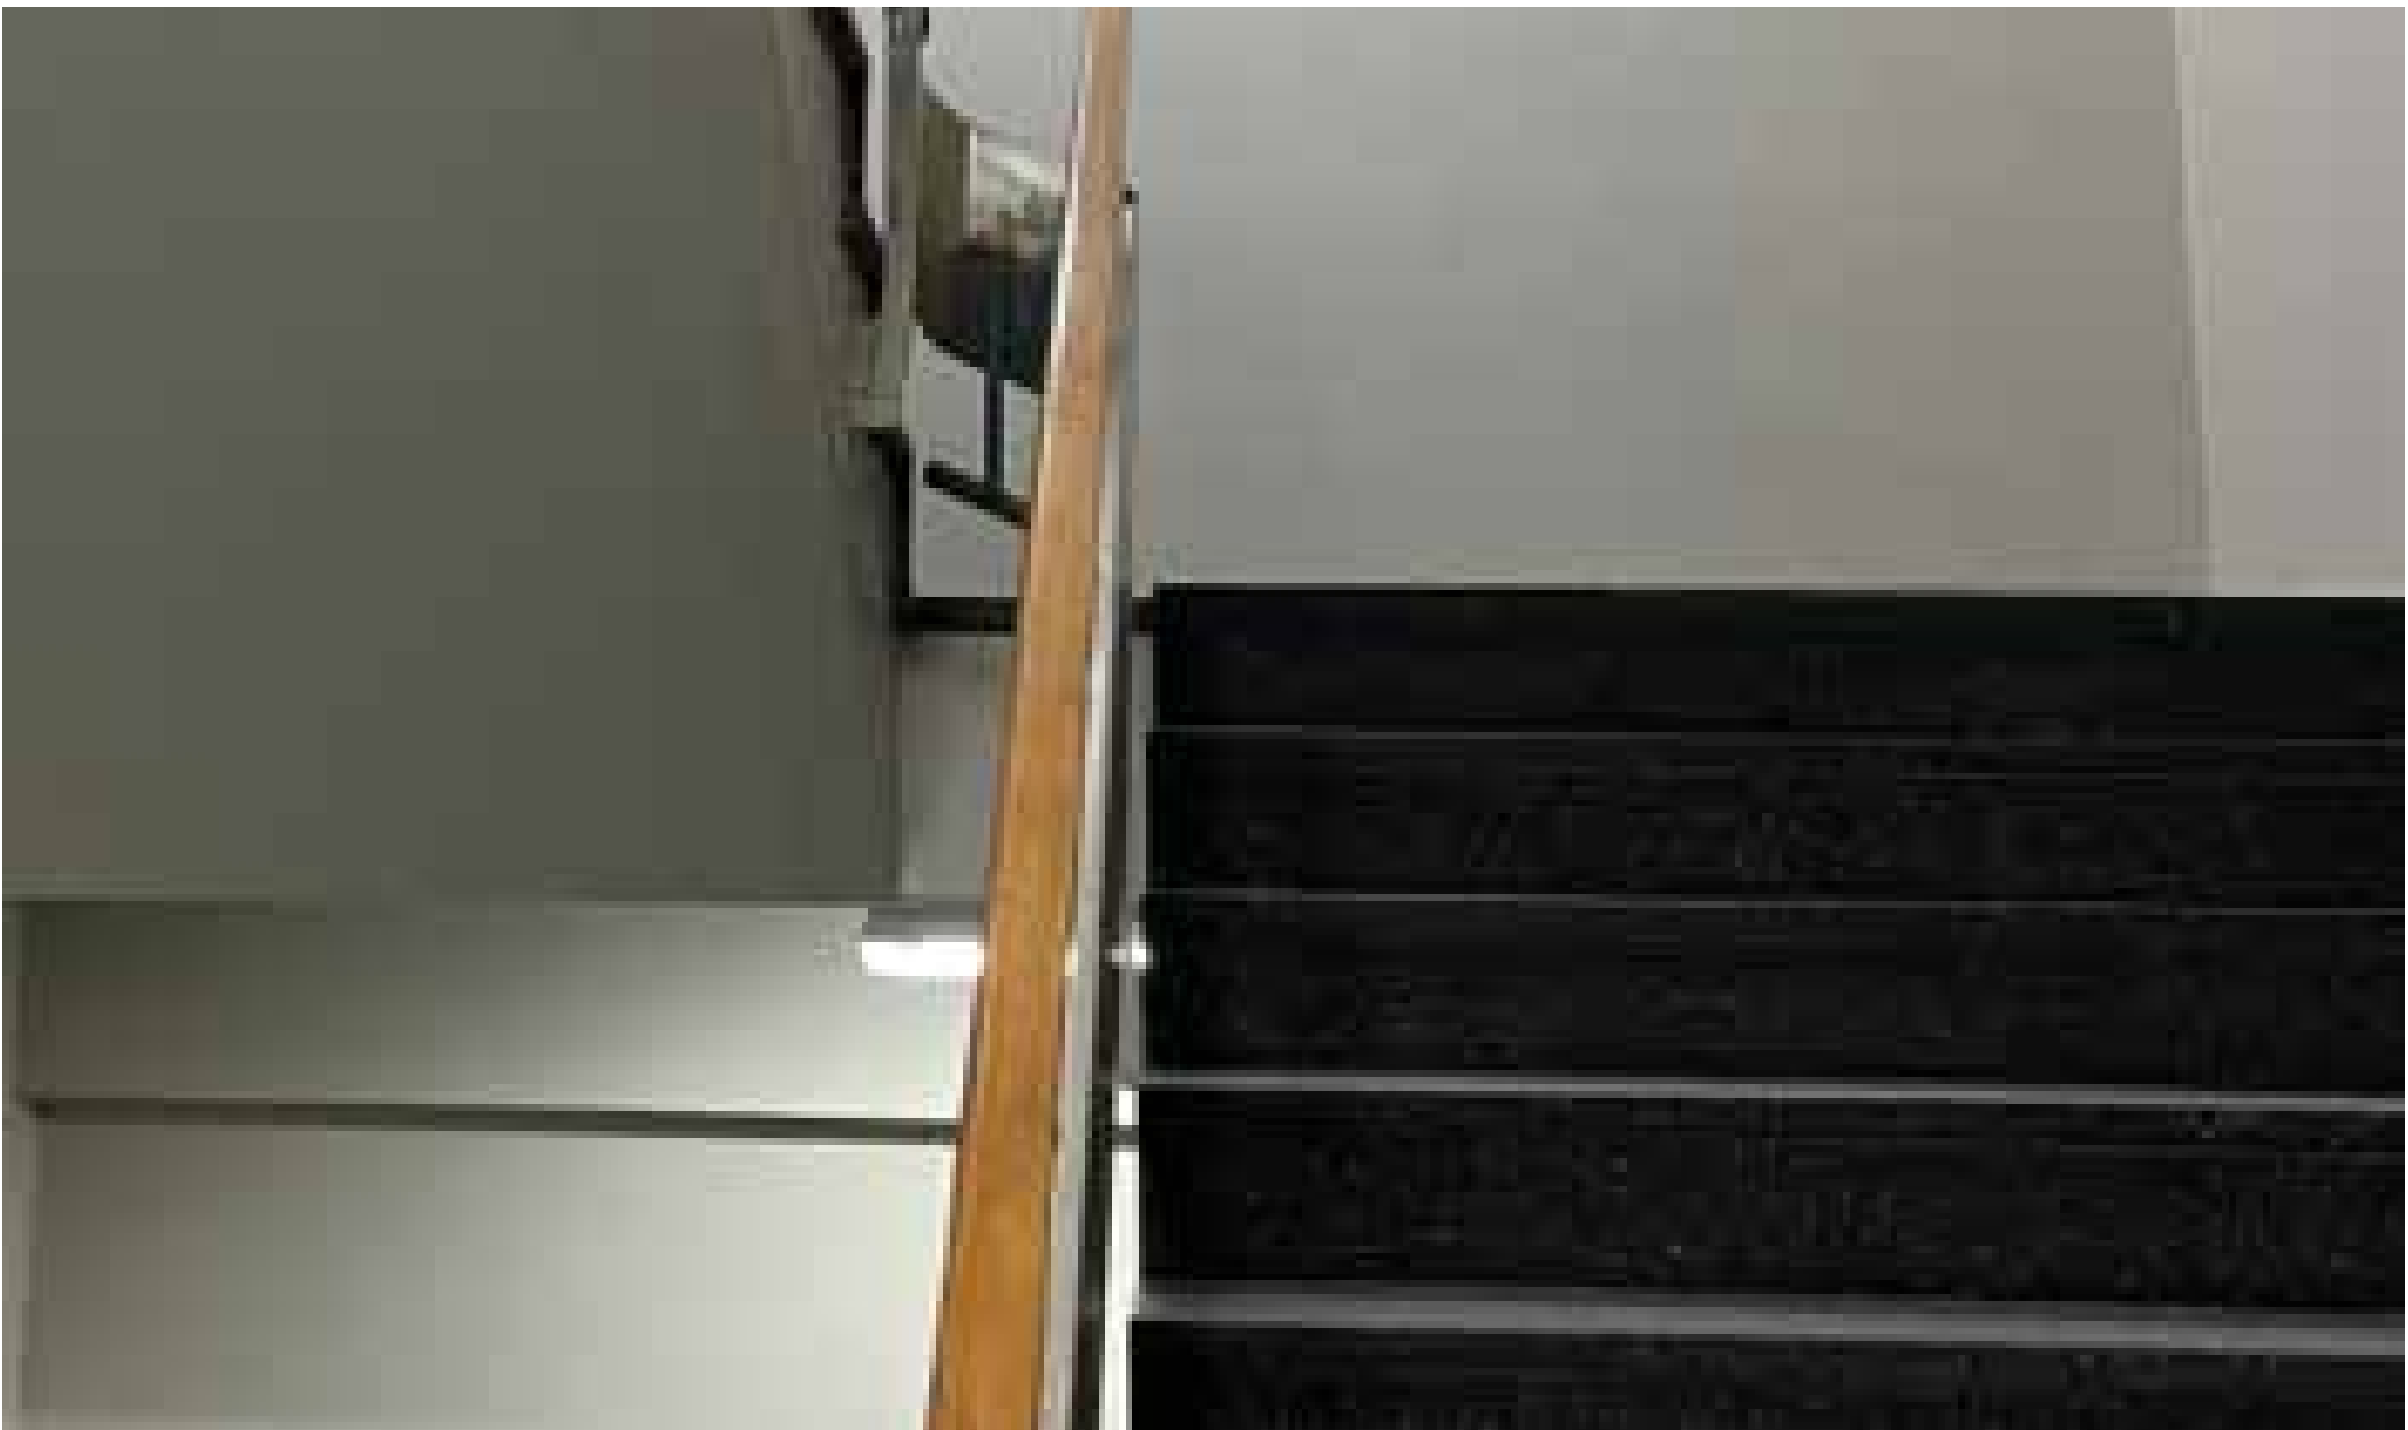
The fire stairs located to the north and south of the Miller Wing are will be retained and refurbished. The fire stair within the central core does not meet the necessary dimensional requirements for stair width and riser/going compliance and is therefore proposed for demolition as part of the core's reconstruction.

- Without the replacement of the core lateral bracing will be required to the north and south fire stairs in the Miller Street wing, significantly impacting the condition of these stairs which are of exceptional Heritage significance

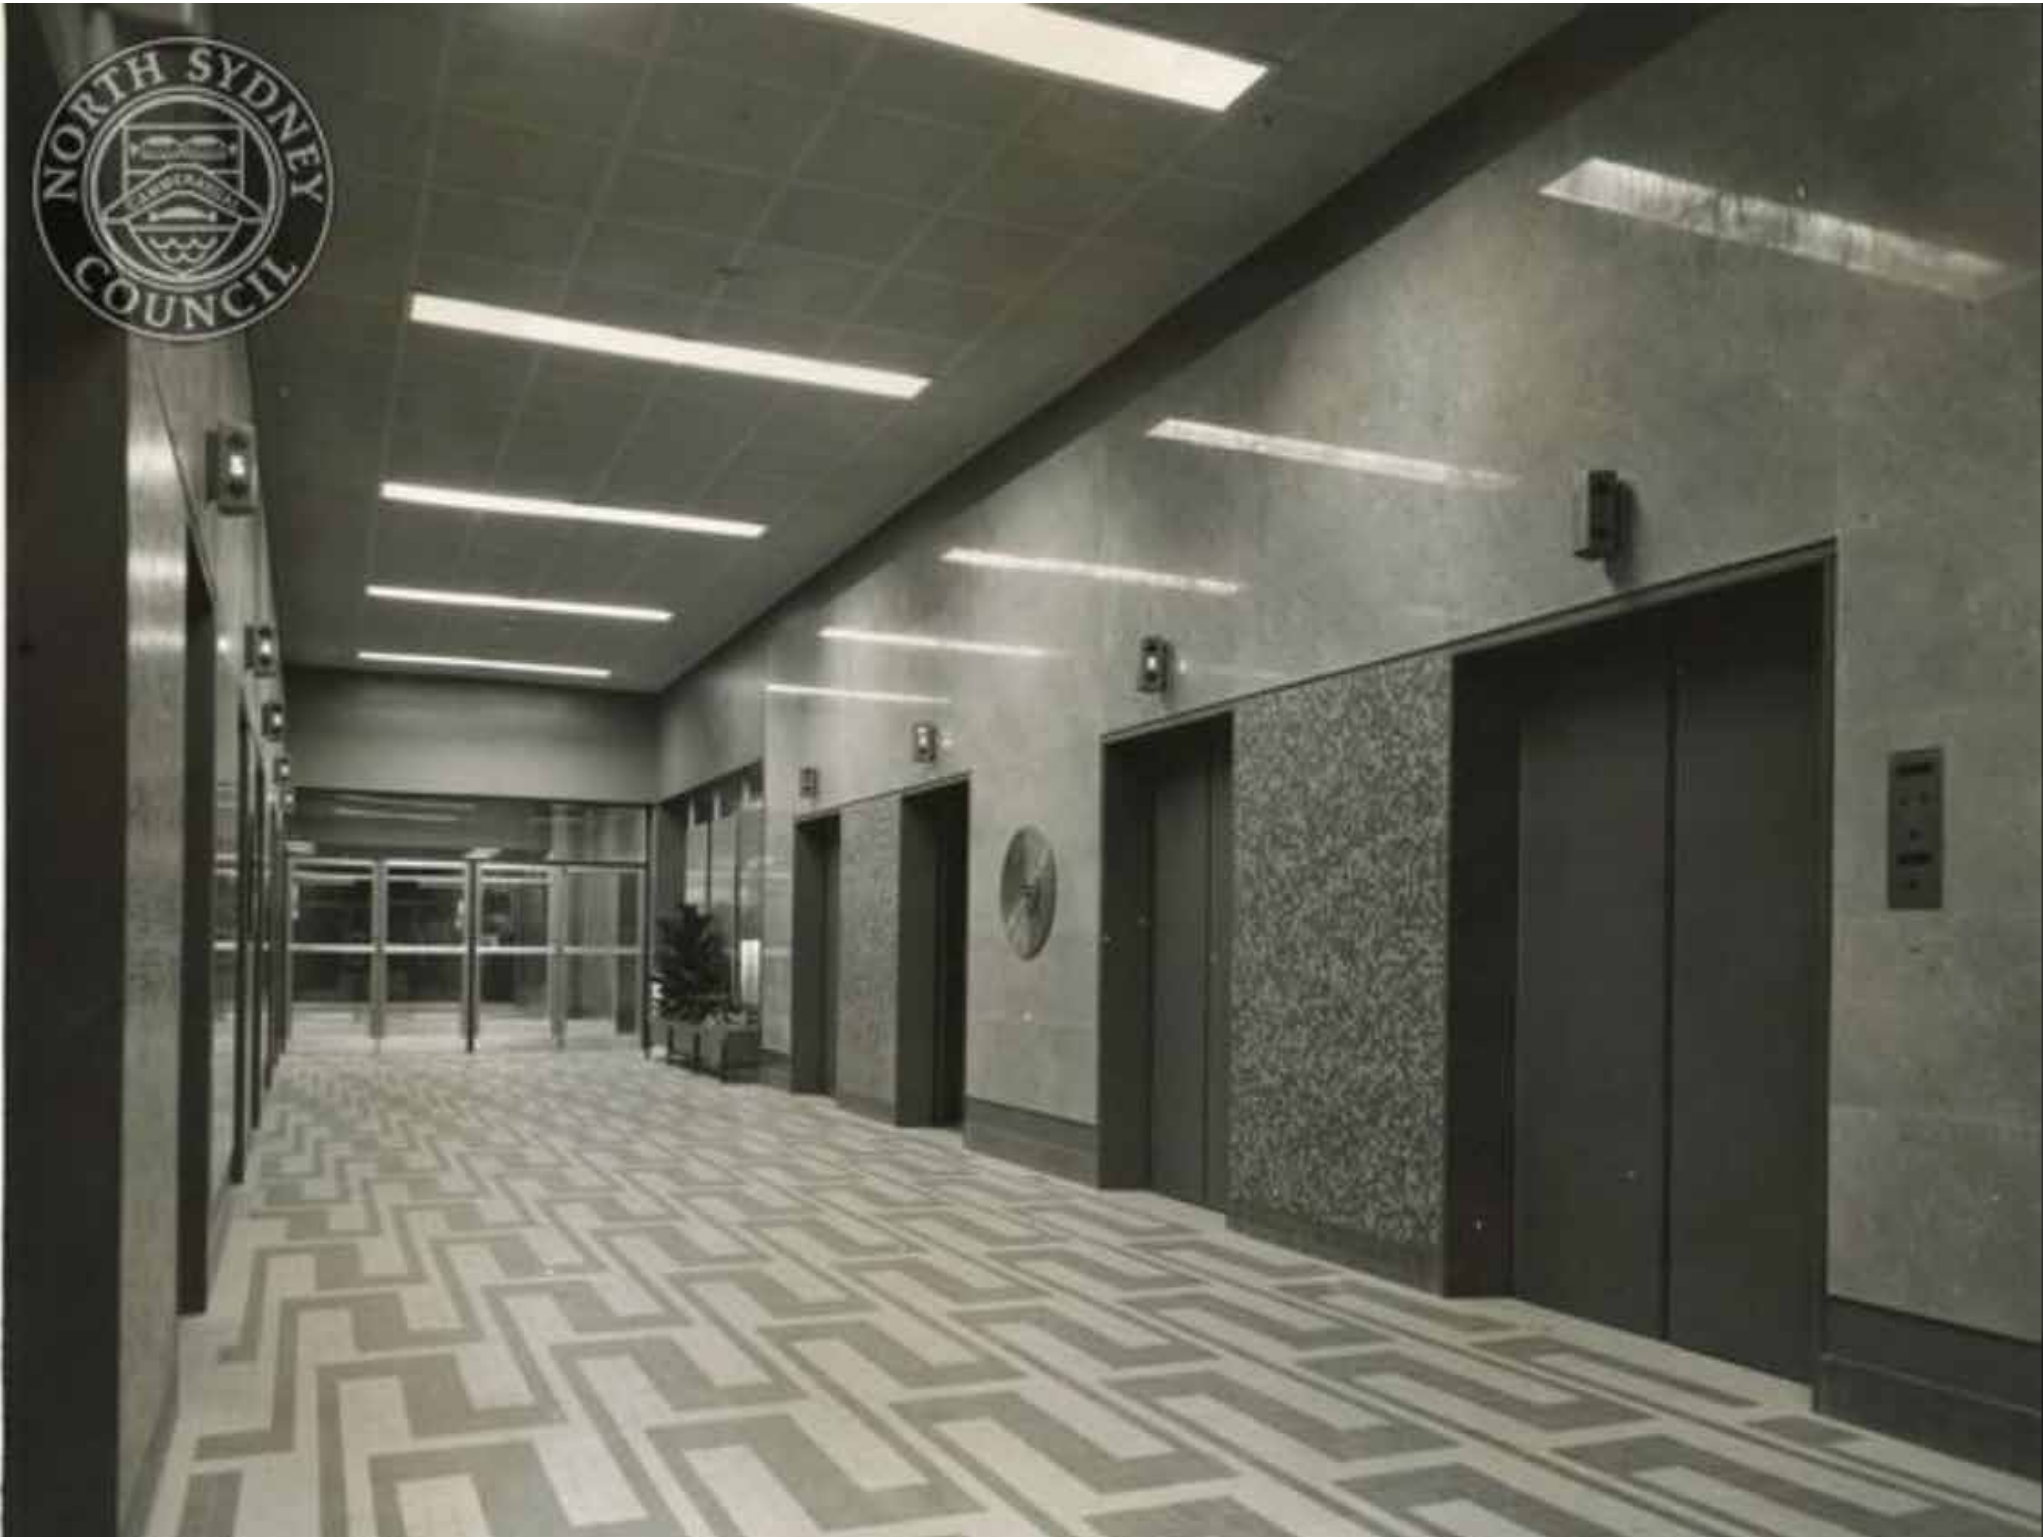
Lift Lobbies

The lift lobbies will be thoughtfully designed to reference the original layouts and details, echoing the heritage design and maintaining a strong connection to the building's historical character.
