**Destructive Hazardous  
Building Materials  
Assessment**

**The Ritz Estate  
203-223 Leura Mall,  
Leura NSW 2780**

**Farrell Coyne Projects  
December 2025**

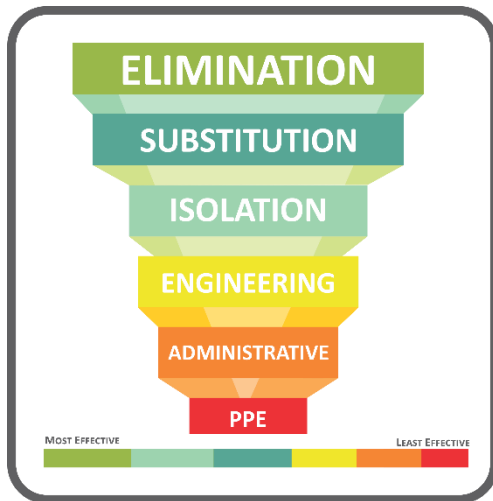
As required by legislation, materials assumed or identified as containing asbestos must be recorded in a register. Furthermore, if the hazardous material is to remain in-situ, a risk assessment must be conducted and appropriate control measures implemented. Prensa adopts a similar approach for the identification, recording and management of hazardous materials. The control measures adopted for each material have been determined based on reducing the risk of exposure, so far as is reasonably practicable. The control measures, which were determined by a competent person and/or hygienist, need to reflect the hierarchy of control measures, as required by legislation, and is as follows:

1. **Elimination / Removal** (most preferred);
2. **Substitution**;
3. **Isolation**, such as erection of permanent enclosures encasing the material;
4. **Engineering** controls, such as negative air pressure enclosures for removal works, HEPA filtration systems;
5. **Administrative** controls – including the incorporation of registers and management plans, the use of signage, personnel training, safe work procedures, regular re-inspections and registers; and
6. The use of **Personal Protective Equipment (PPE)** (least preferred).

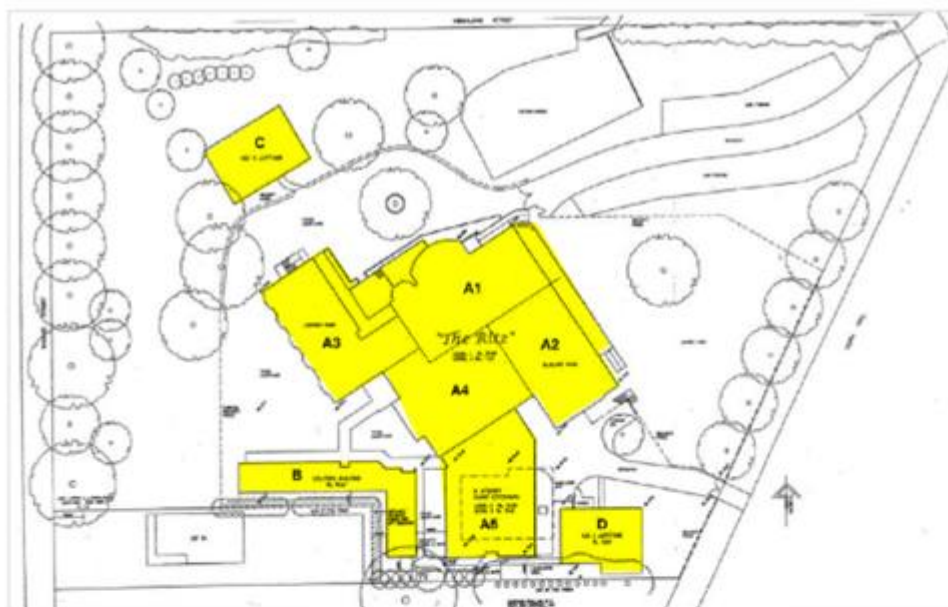
**Figure 10: The Current buildings on site.**  
 Source: HIS 2024, John Oultram

Ref #	Building	Description
A1	The Ritz Hotel Core	The 1892 section of the former hotel.
A2	The Ritz Hotel - South Wing	Early two storey extension (1914)
A3	The Ritz Hotel -West Wing	Early two storey extension (1914)
A4	The existing structure - Infill Wing	Later and modern, two storey extension - Constructed as part of the nursing home in 1970s
A5	The existing structure - Modern Extension	Modern two storey extension constructed in 2004.
B	Laundry	Single storey service building and stores constructed in 1970.
C	Manager's Residence	Single storey, Inter War era house 1914.
D	Education Offices	Single storey weatherboard cottage constructed in 1910

- A1 The Ritz Hotel Core;
- A2 The Ritz Hotel – South Wing;
- A3 The Ritz Hotel – West Wing;
- A4 The existing structure – Infill Wing;
- A5 The existing structure – Modern Extension;
- B Laundry;
- C Manager’s Residence; and
- D Education Offices.
