Snapper Mineral Sands Mine  
ML 1621

Annual Environmental Management Report

1<sup>st</sup> September 2019 – 31<sup>st</sup> August 2020

# Snapper Annual Environmental Management Report September 2019 – August 2020

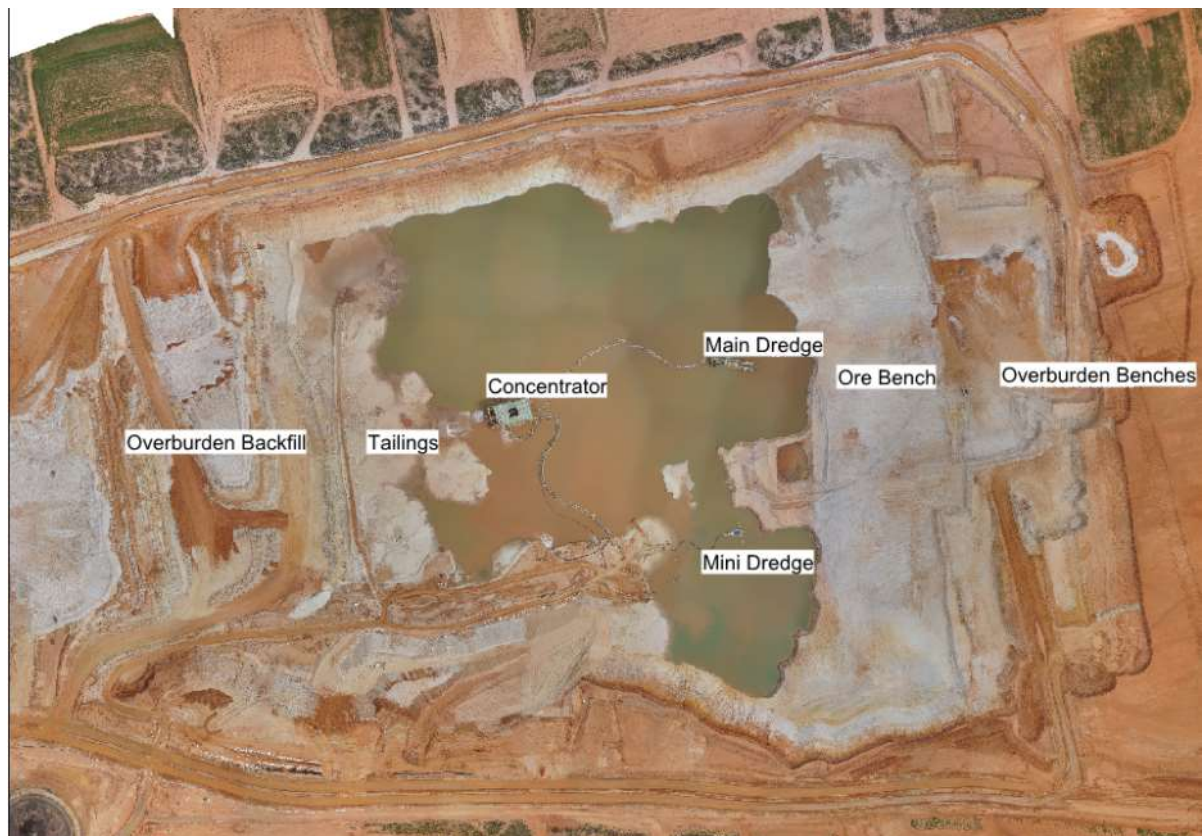
**Figure 3- Snapper mining pit arrangement**

The current methods of mining overburden at Snapper are primarily using a truck and shovel fleet. Overburden is removed from the front of the pit and replaced over tailings at the back of the pit or stockpiled in temporary waste dumps for closing out final voids.

Modification 7 was approved in March 2020, the extension of the Snapper mining pit will result in an additional 12 months of production, with expected cessation in mid-2022.

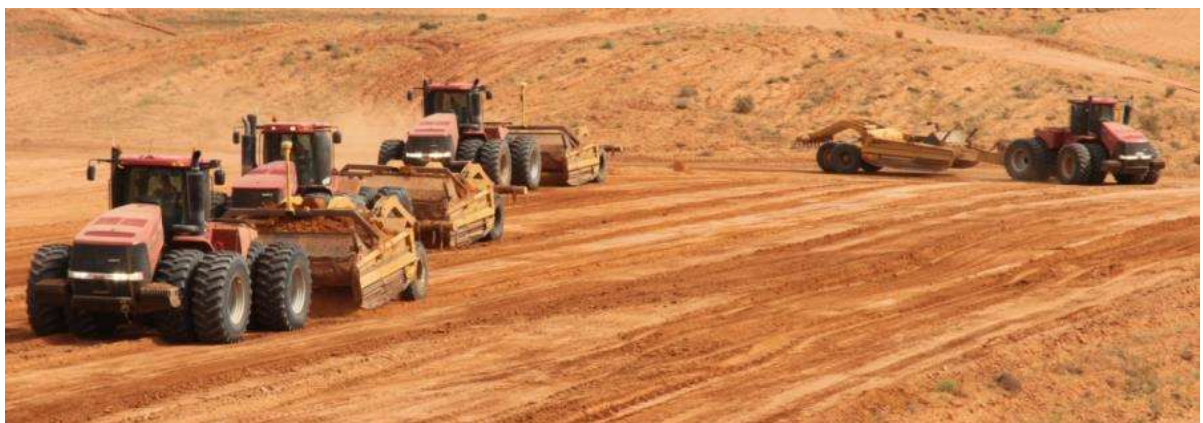
**Tractor and scoops used for topsoil and subsoil stripping and replacement**

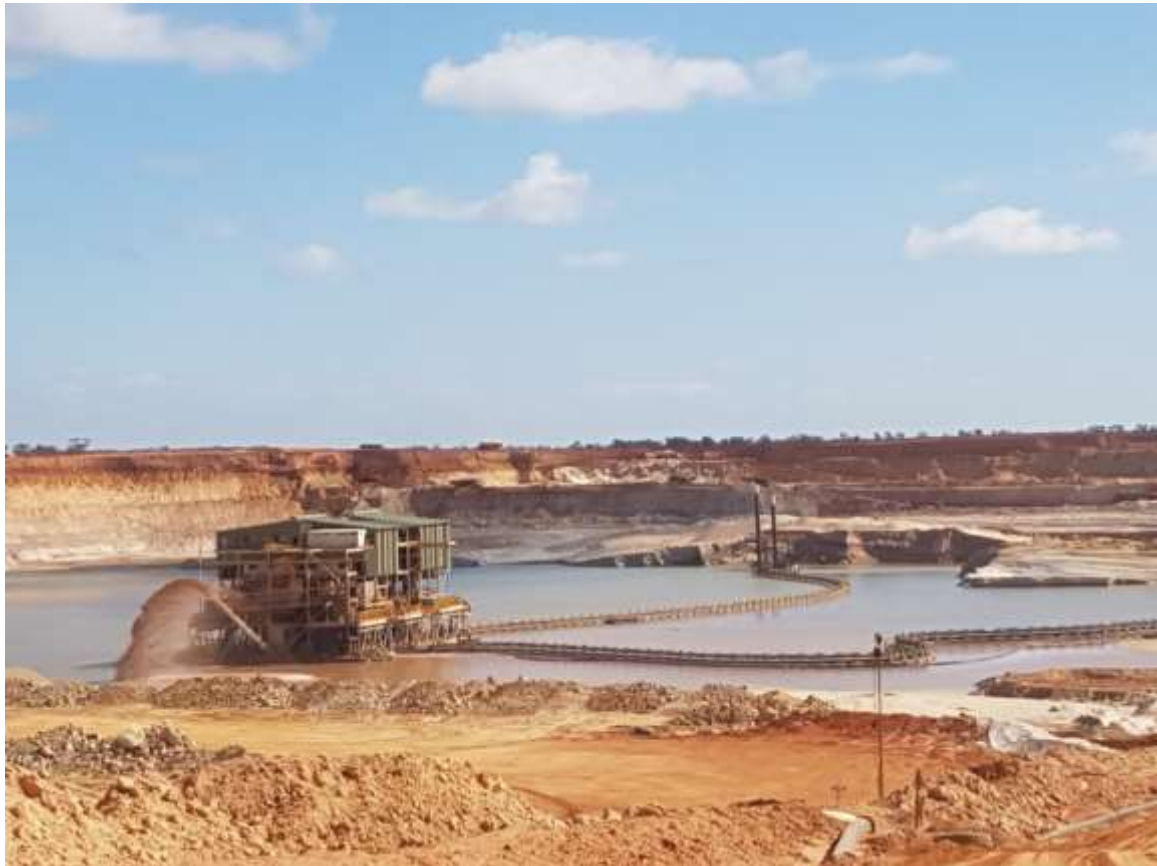
Snapper produced 5.74 Million tonnes of sand residues during the period September 1<sup>st</sup> 2019 to August 31<sup>st</sup> 2020, this was pumped out via the plant boom stacker and the land based cannon to form a beach for the overburden backfill to be dumped over. The Snapper MOP estimates that 10.27 Mt of sand residues will be produced at the period of 78Mt of ore mined.

**Boom stacking tails directly from the concentrator**

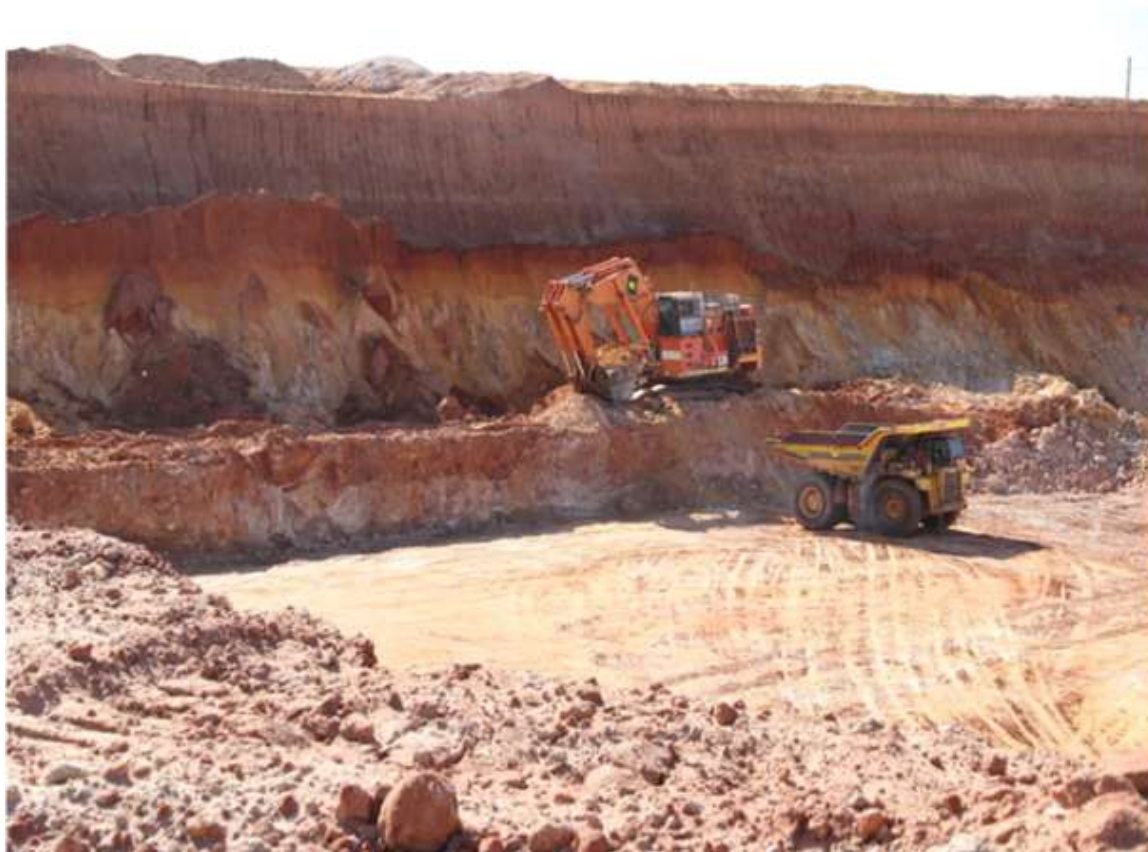
During the period September 1st 2019 to August 31st 2020 a total of 18.479 BCM of overburden had been removed and placed behind the dredge as backfill. Once placed on the backfill the overburden contractor must cap the backfill area with clean clay/sand overburden in preparation for the rehabilitation phase.

**Overburden being removed by truck and shovel**

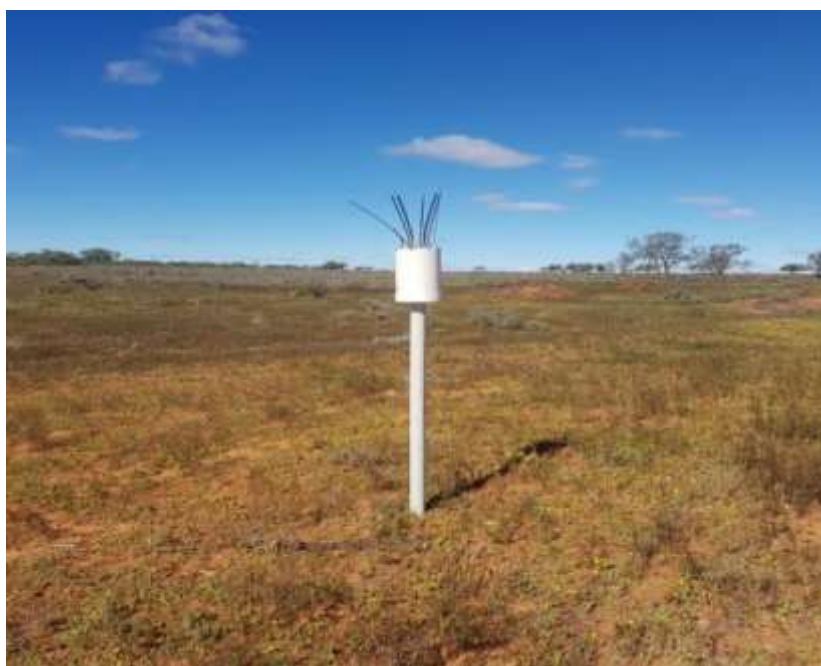
**Dust deposition gauge at Manilla homestead**

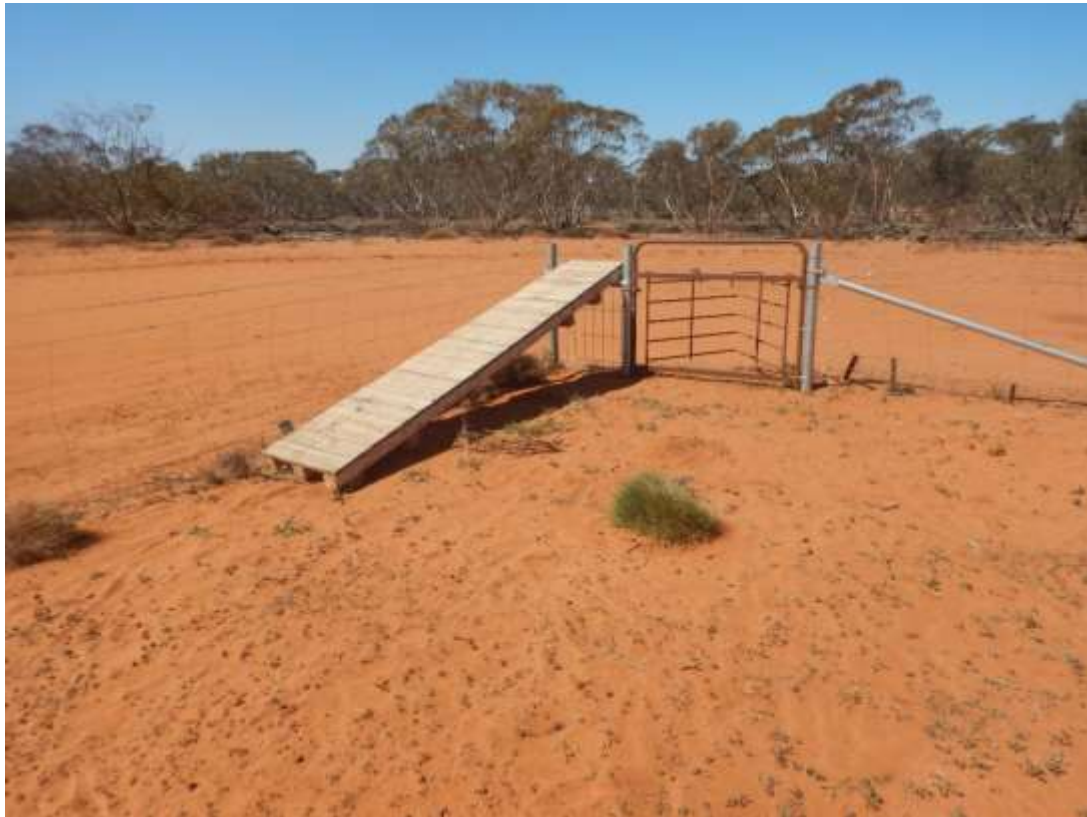
**One-way spring gate and ramp to allow herbivores to exit the lease**

One-way spring gates and ramps are installed in selected corners of the lease with the intention that goats and possibly kangaroos would exit the lease. The gates would also be used during mustering to push both kangaroos and goats off the lease. Animal activity at the base of the spring gates and observations captured by trail cameras confirm that both Kangaroos and Goats are exiting the lease.

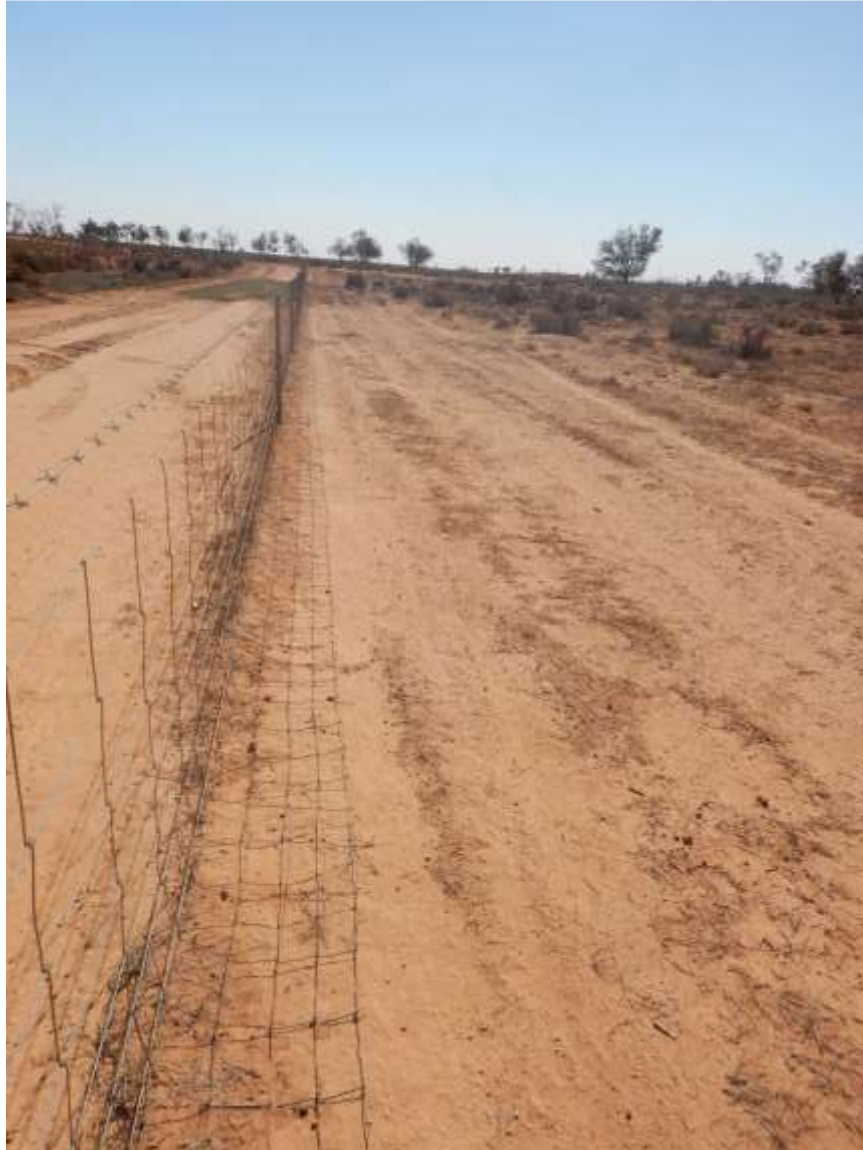
**Apron attached to bottom of fence**

Since the installation of the fence apron, ramps and spring gates it is evident that the number of kangaroos and goats on the lease have decreased substantially.

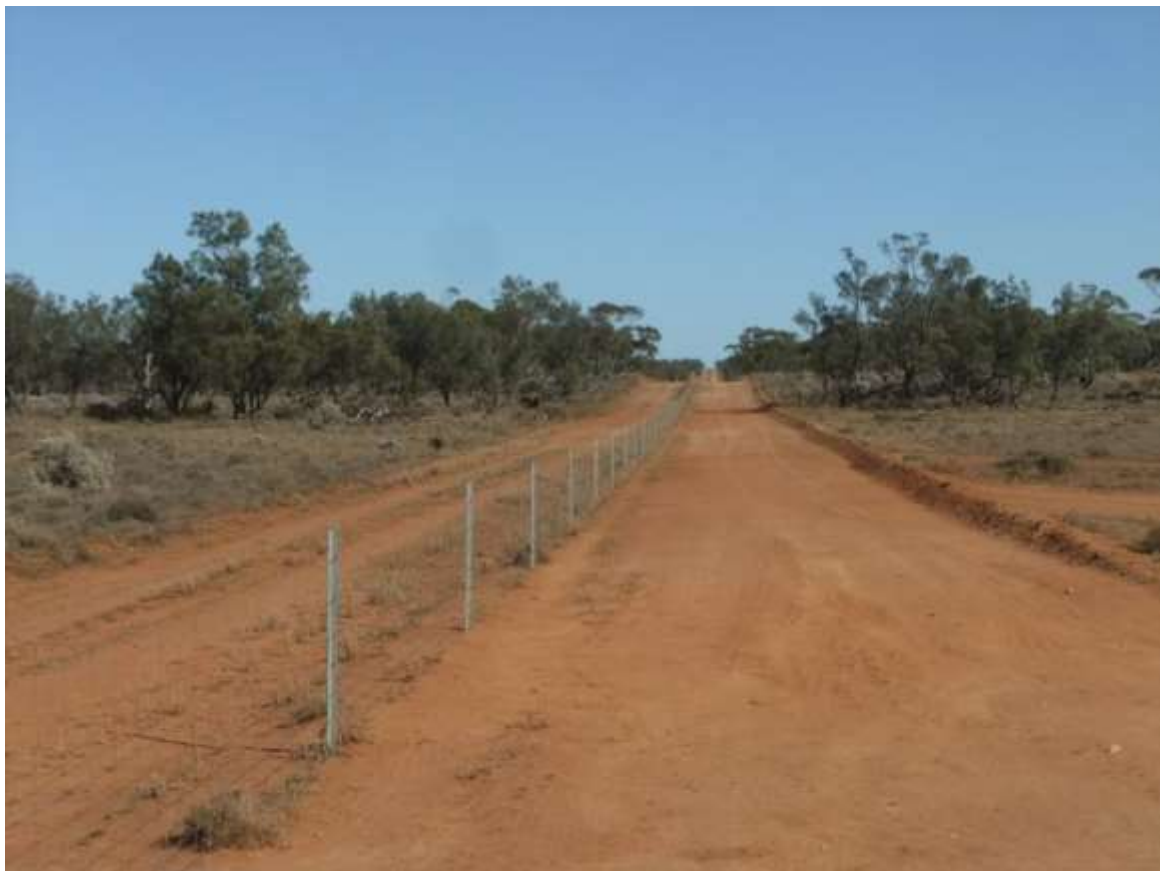
The firebreak is designed to act as control lines for low-intensity fires and assist with safer access and egress for high-intensity fires. Firebreaks have been maintained using a grader.

**Fire break along a boundary fence**

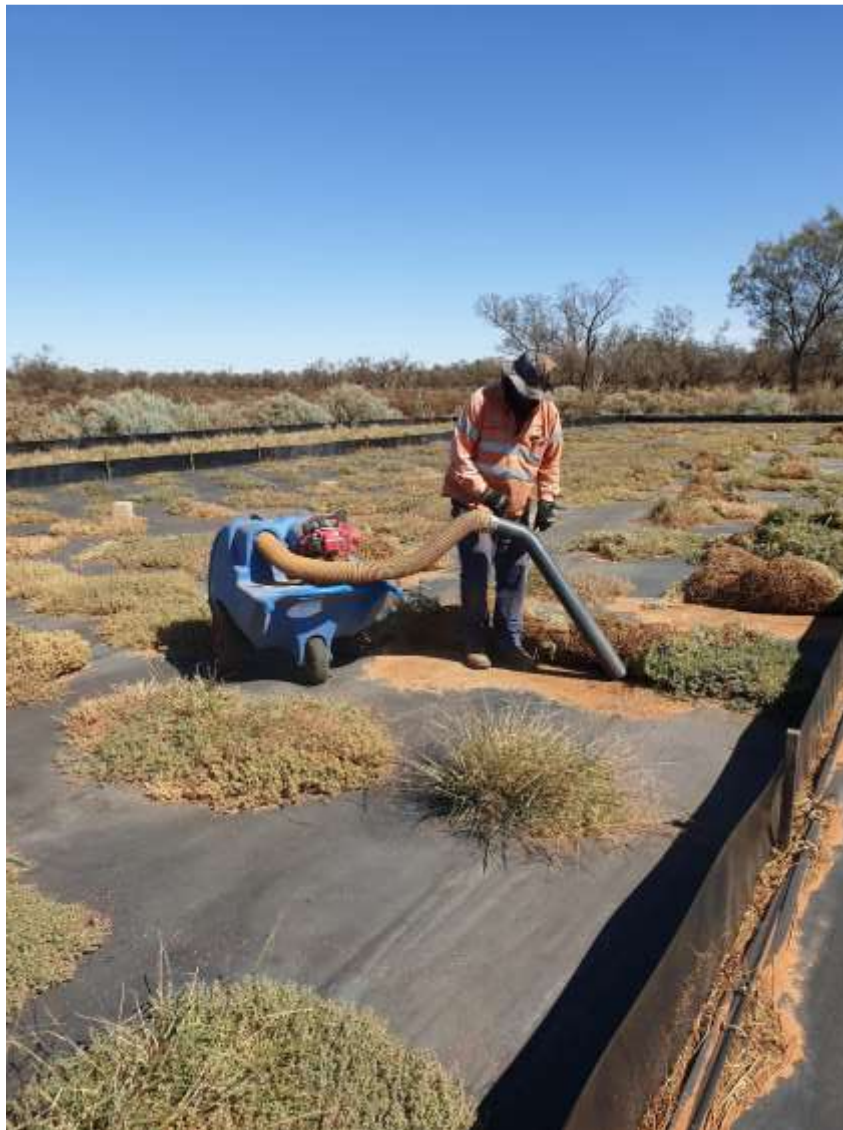
A small portion of the seed used in revegetation is grown at Tronox's seed production area (SPA). Species that are difficult to collect seed from in any significant quantities in remnant areas are grown and seed is harvested and vacuumed up for storage.

**Seed being vacuumed up in the seed production area**

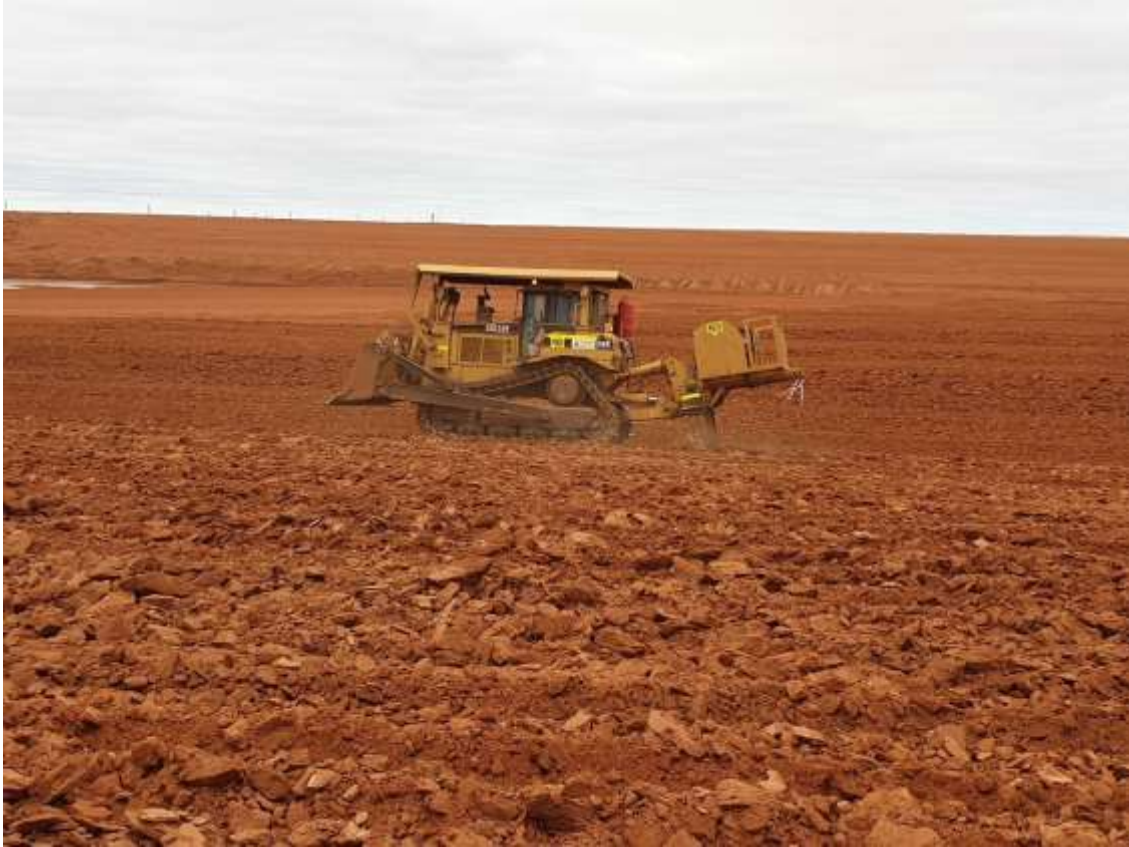
**Dozer seeding of OPTD batters was completed using 3 ripper tines on the batters that did not receive timber trash due to the batter slopes being approximately 10:1VH. Slopes of this nature are considered low risk for erosion when cross ripped to contours.**

**D9 dozer with Gessner drum seeder mounted above 3 rippers.**

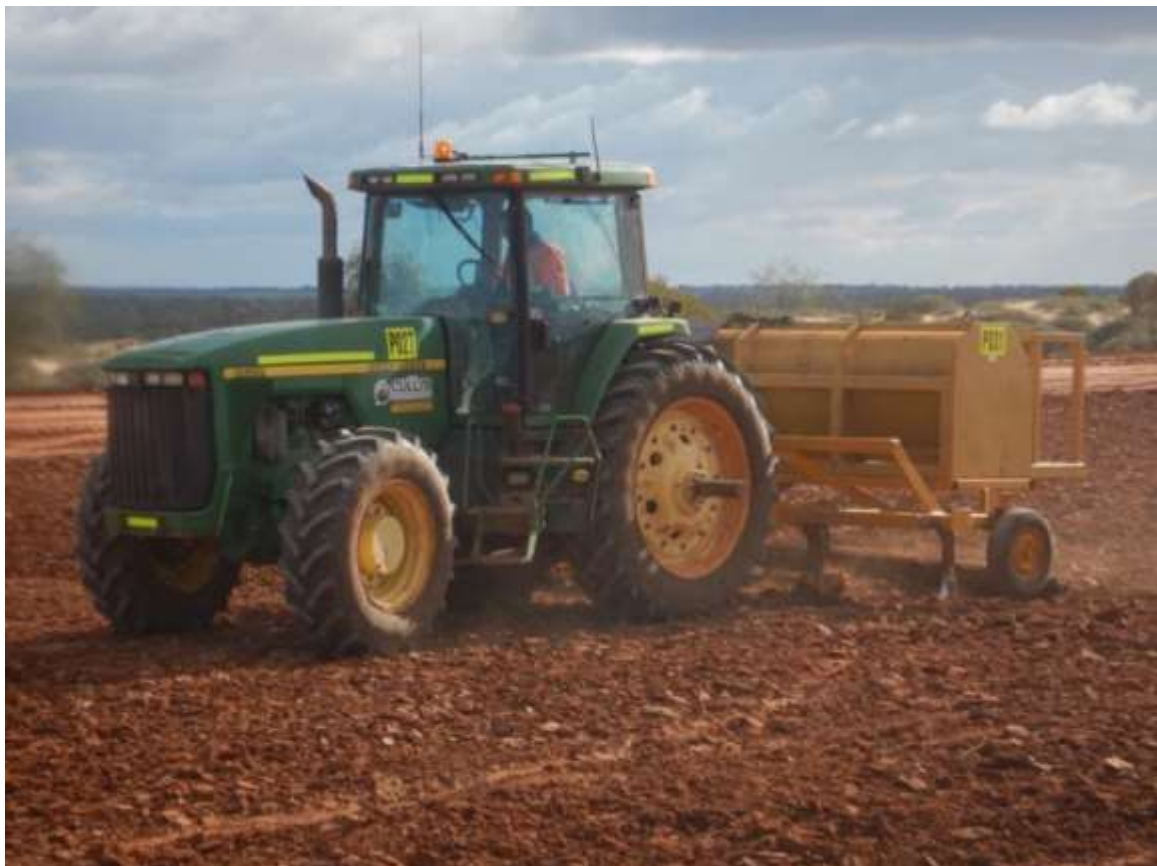
The plough is towed by a wheeled tractor and is limited to flat areas and gentle slopes of less than 1:7. Using this arrangement allows faster seeding times than the dozer and a much better soil surface for seed niches. The use of multiple narrow tines allows compacted soil to be broken up leaving a well prepared surface for seed delivery, and limits the amount of subsoil being brought to the surface where it can contaminate the topsoil horizon. The tines on the plough can be set to the desired ripping depth, in this case approximately 350mm or just below the depth of the topsoil.

**John Deere tractor with 5 tine plough and Gessner drum seeder mounted.**

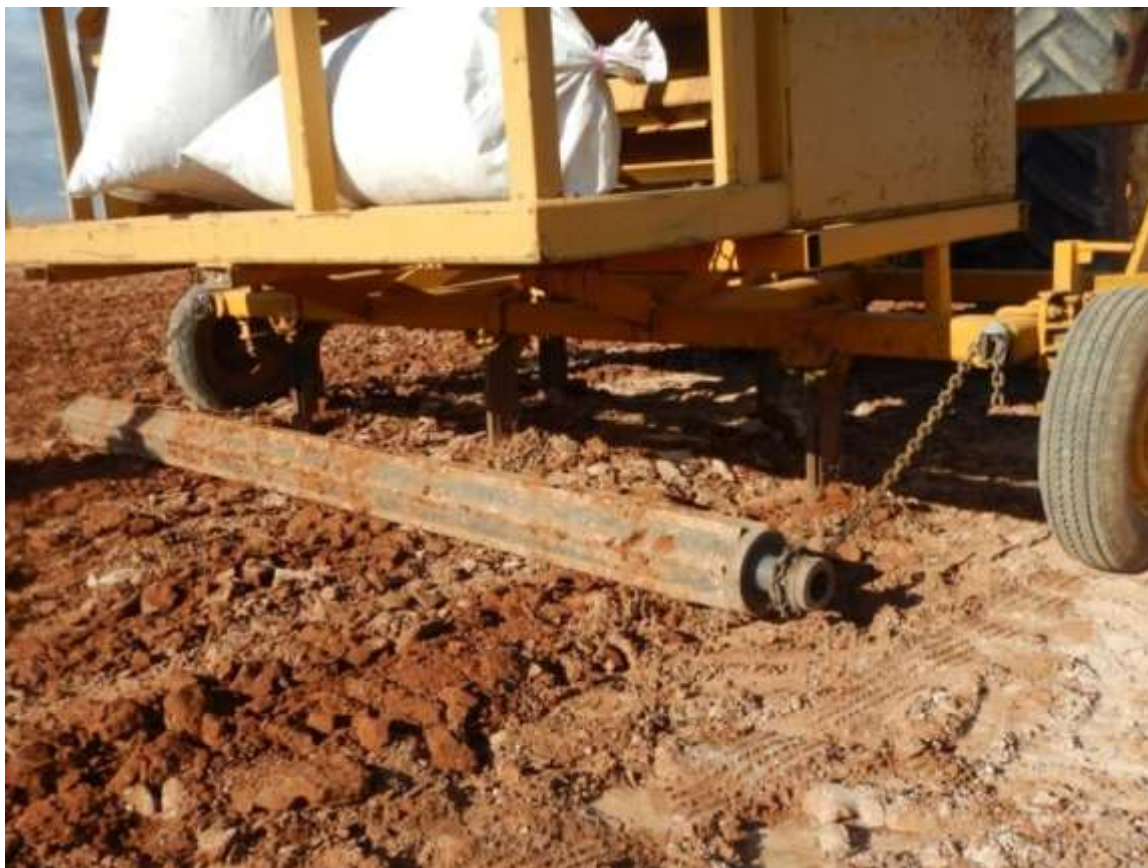
**Crumble roller attached to the rear of the plough.**

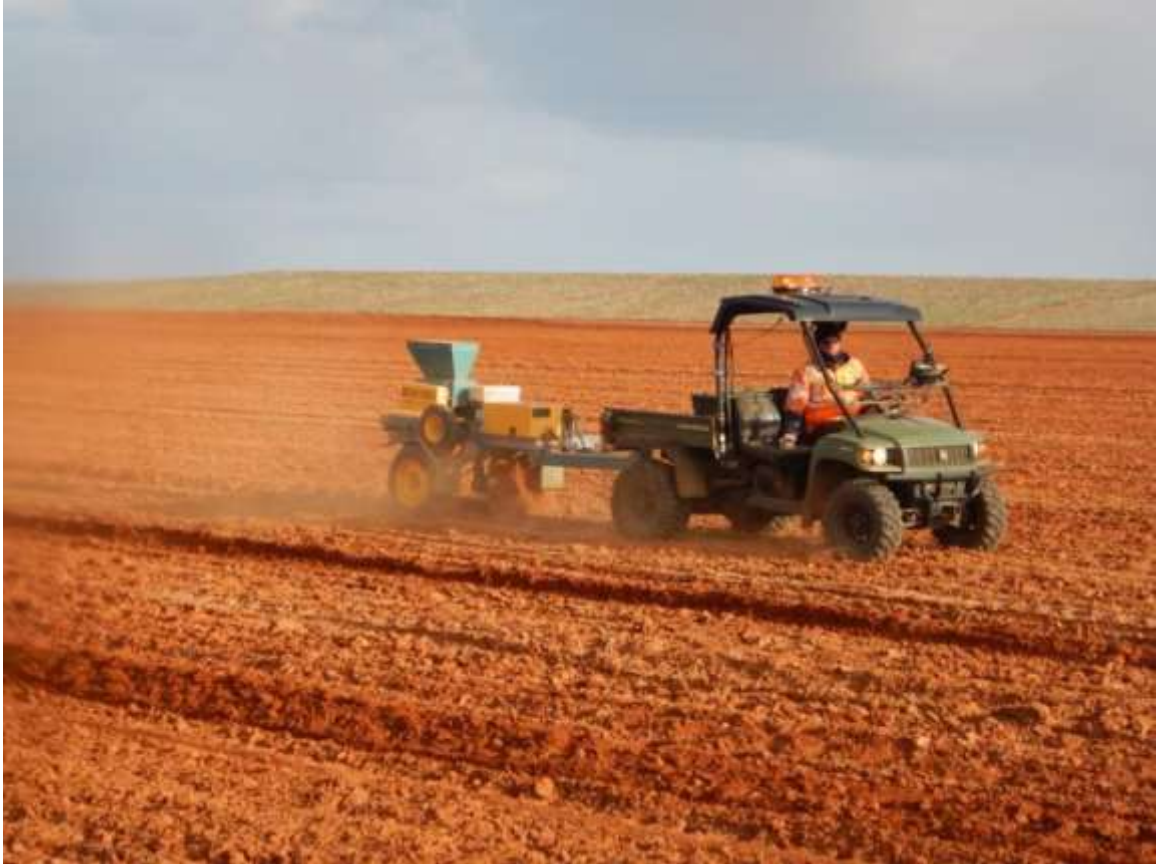
The Burford seeder is towed by a 4x4 utility task vehicle (UTV). The Burford tree seeder is a precision seeder as the seed can be placed accurately at the desired depth where it will receive the best chance of germination and survival. Target species and rates for the tree seeder in 2020 can be seen listed in Table 20. Germination of these small seed species has been improved with this new seeding method due to correct seed placement depth of 5-10mm in the soil. Moisture availability in the seeding lines is harnessed due to a small furrow created by the seeders disc. The combination of the UTV and seeder is limited to flat areas such as mine path, former stockpile areas and over burden dump patties.

**Burford tree seeder being towed by the UTV.**

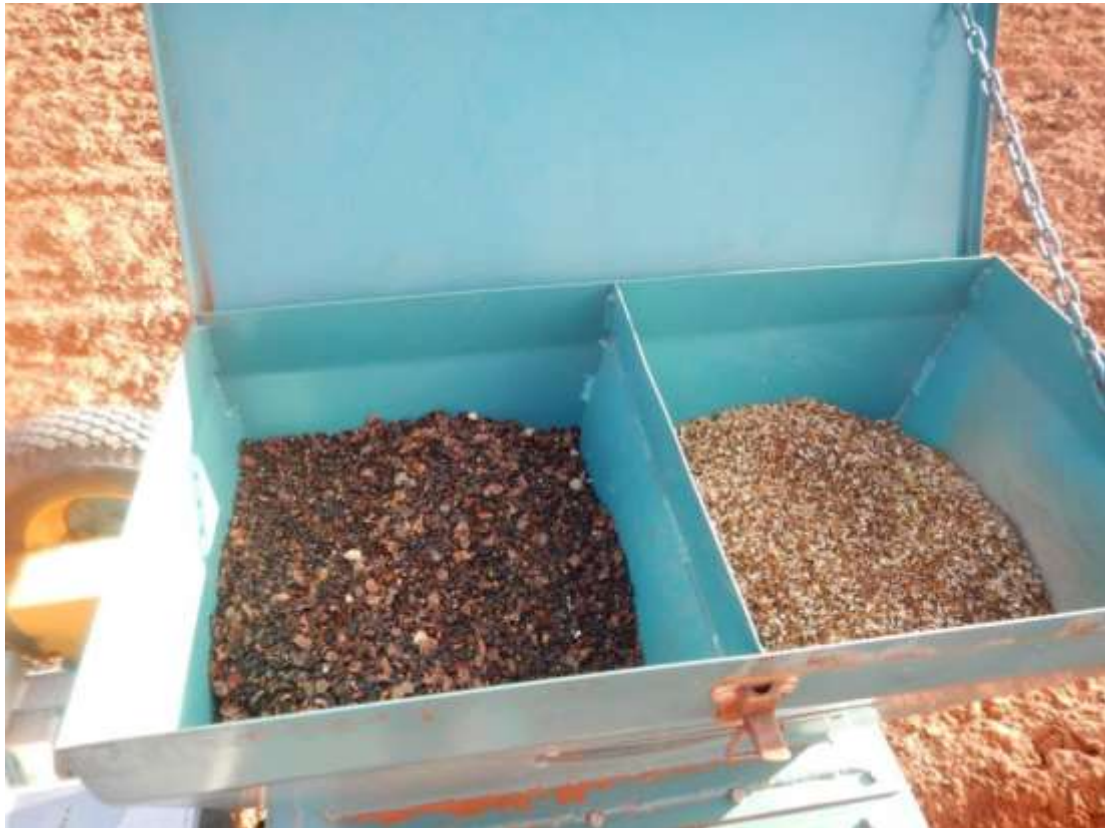
Tree seed separated in hoppers according to relative size.

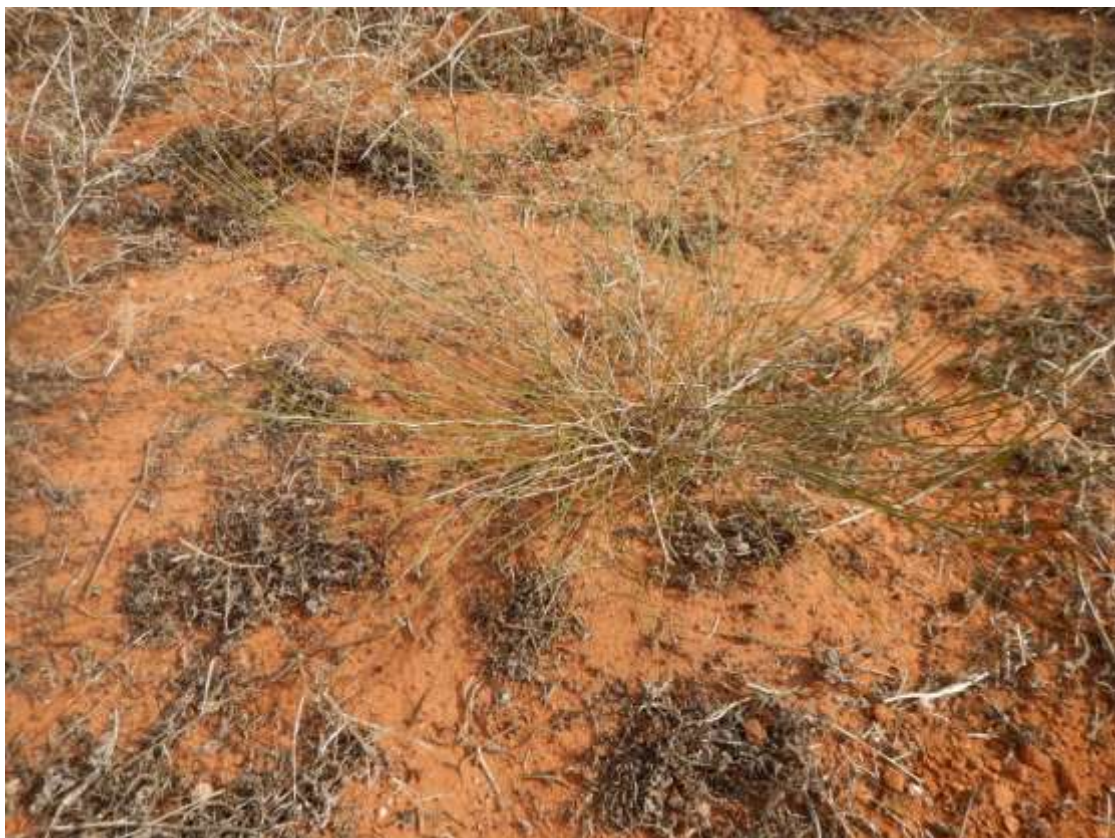
Belah (*Casuarina pauper*) established from 2016 Burford seeding

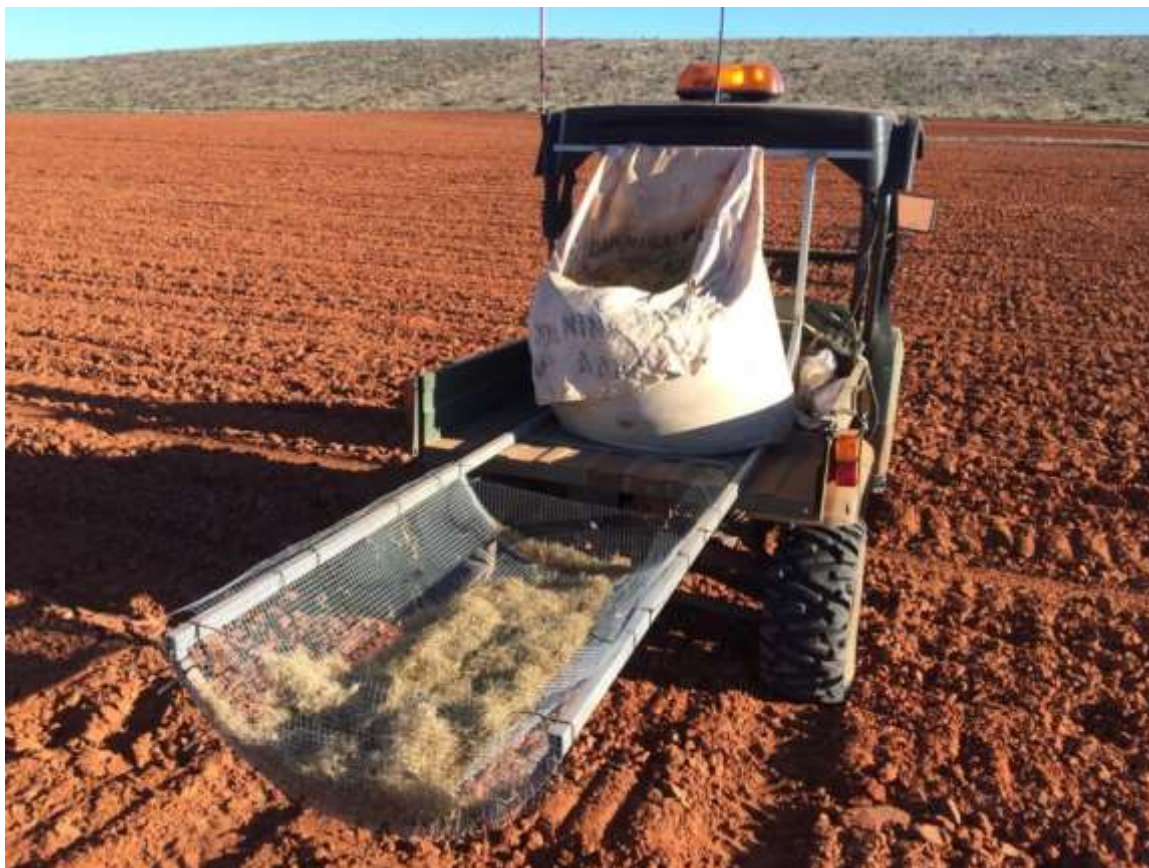
UTV with grass seed broadcaster attached to rear

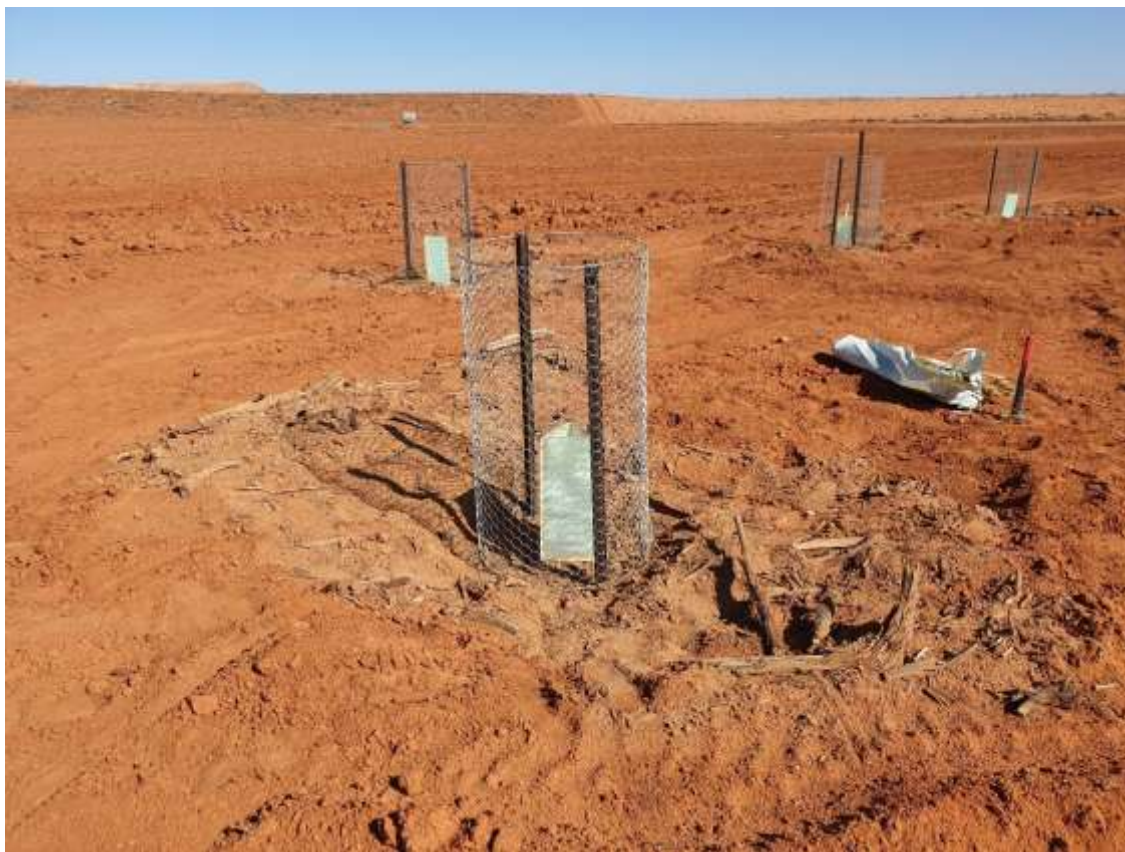
Individual tree plantings consisted of 600 tubestock planted in groups of approximately 20 individuals. Each tree well was excavated to approximately 800mm, subsoil was removed and replaced with rich organic soil recovered from beneath timber stockpiles. Excavating the compacted subsoil allows better root development initially and improved soil condition provides better nutrient availability and water holding capacity. A depression was left for the tree to be planted into for water retention during irrigation and rain events. Trees were guarded with a 1m high wire guard and a temporary plastic fluted guard for initial frost protection.

**Plots of individuals planted and guarded**

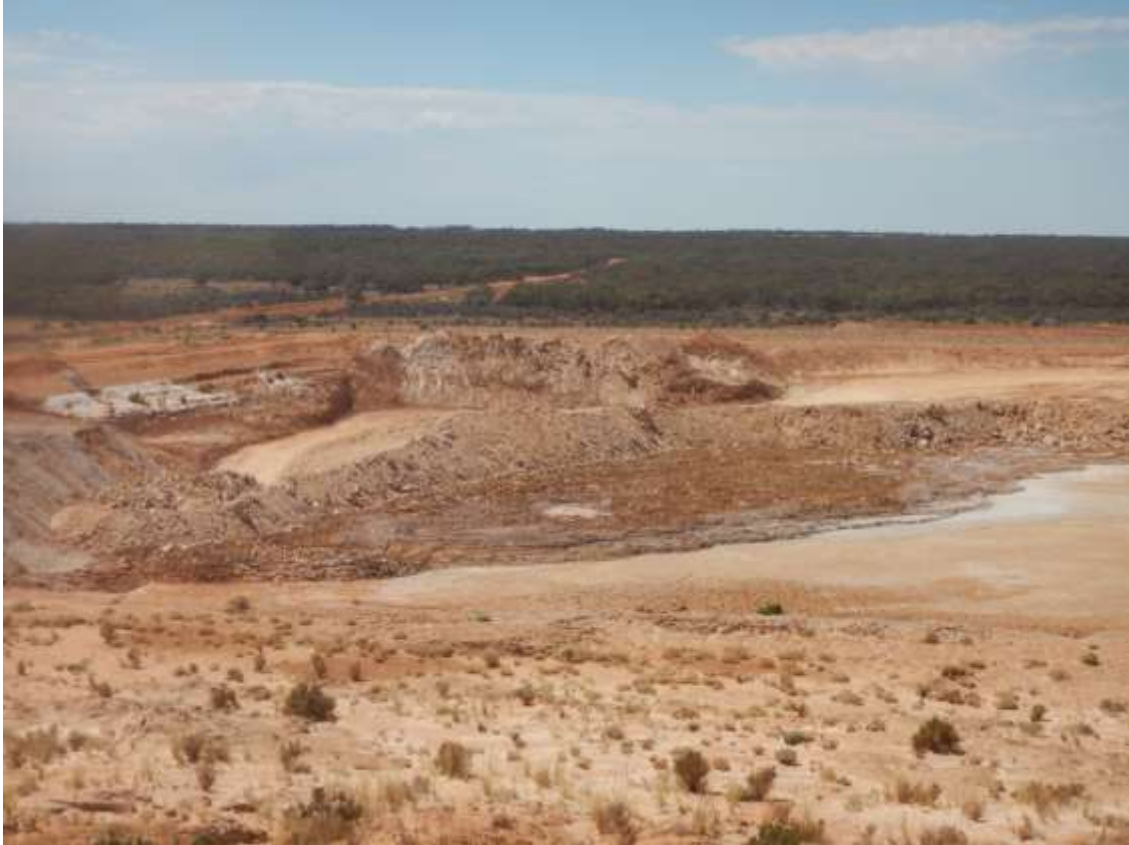
Rehabilitation works on the former start-up water dam have been ongoing during the reporting period. The capping of slimes and shaping of the landform was completed in December 2018. During 2020, subsoil and topsoil was replaced over an area of 100Ha. Timber was placed on all batters with slopes of >7:1VH and spread over the surface. The area is scheduled for seeding in May 2021.

**Capping of slimes with overburden at the former water dam (2018)**

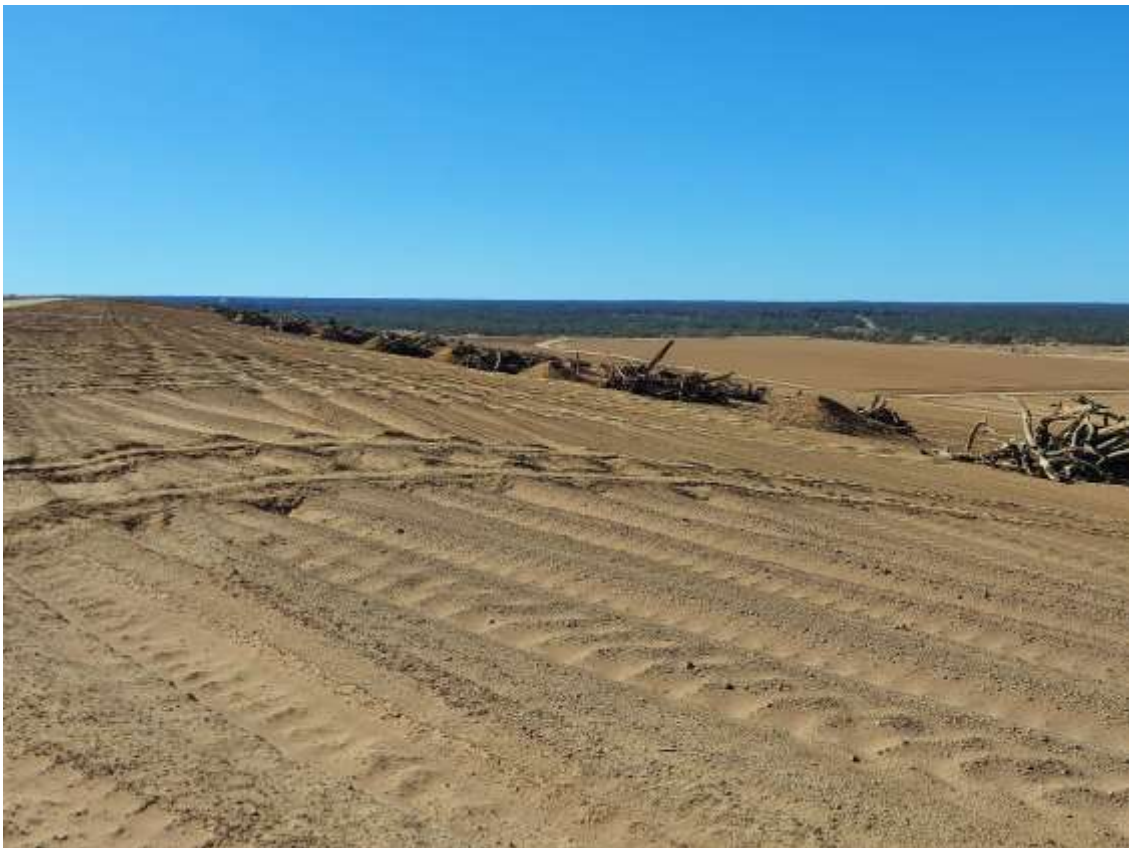
**Final landform topsoiled and timber being placed onto batters. (July 2020)**

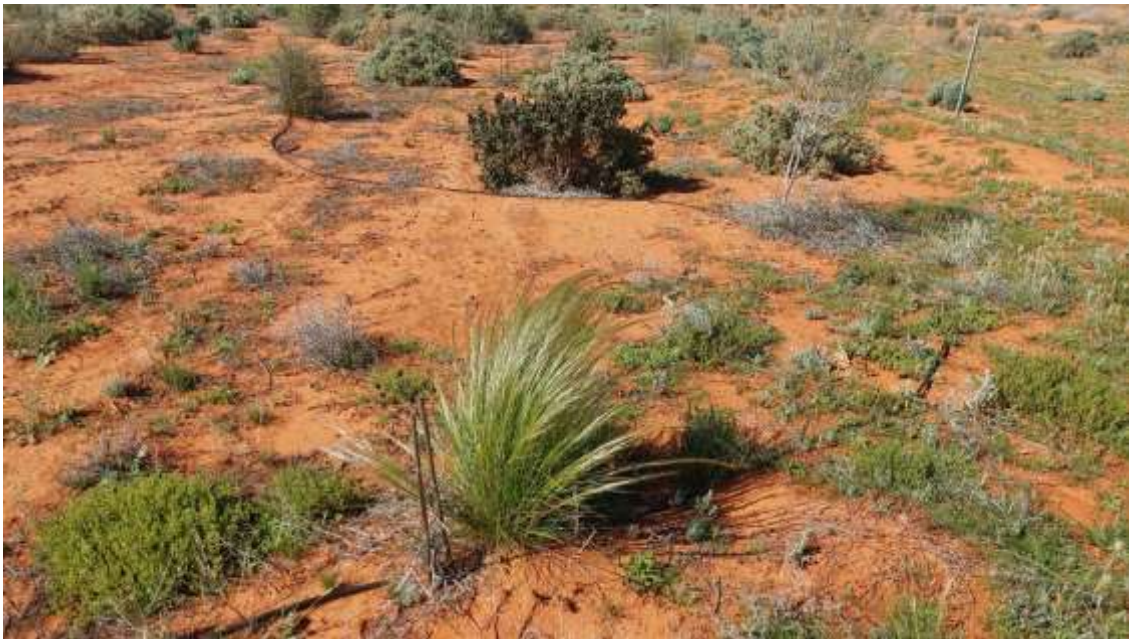
There is a notable difference in groundcover between the fenced plot and the surrounding area due to browsing by herbivores absent in the fenced area. Chenopods and native grasses within the plots are producing good amounts of seed, which can be carried by wind to surrounding areas. The plots could be seen as seed banks and when placed throughout the rehabilitation landscape will provide seed for natural regeneration to the wider area.

**Spear grass within a fenced tree plot (August 2020)**

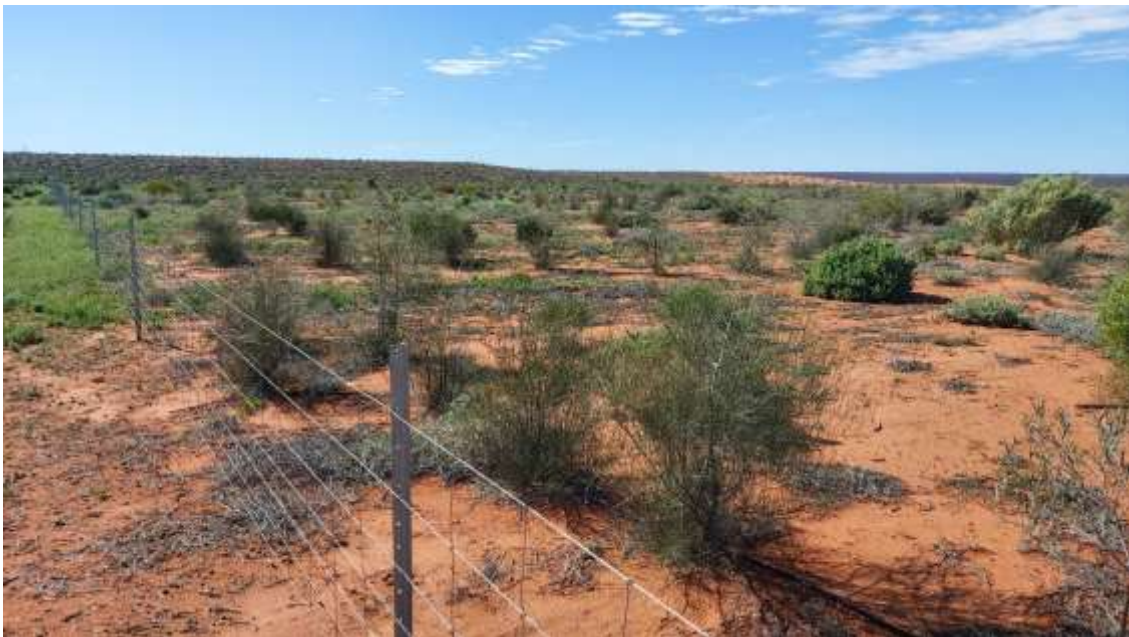
The survival rate of trees within the plots has been outstanding with more than 90% of the trees surviving since being planted in 2016. The exclusion fence has been successful in keeping goats and Kangaroos from browsing on the vegetation.

**A fenced and irrigated tree plot showing good progress (August 2020)**

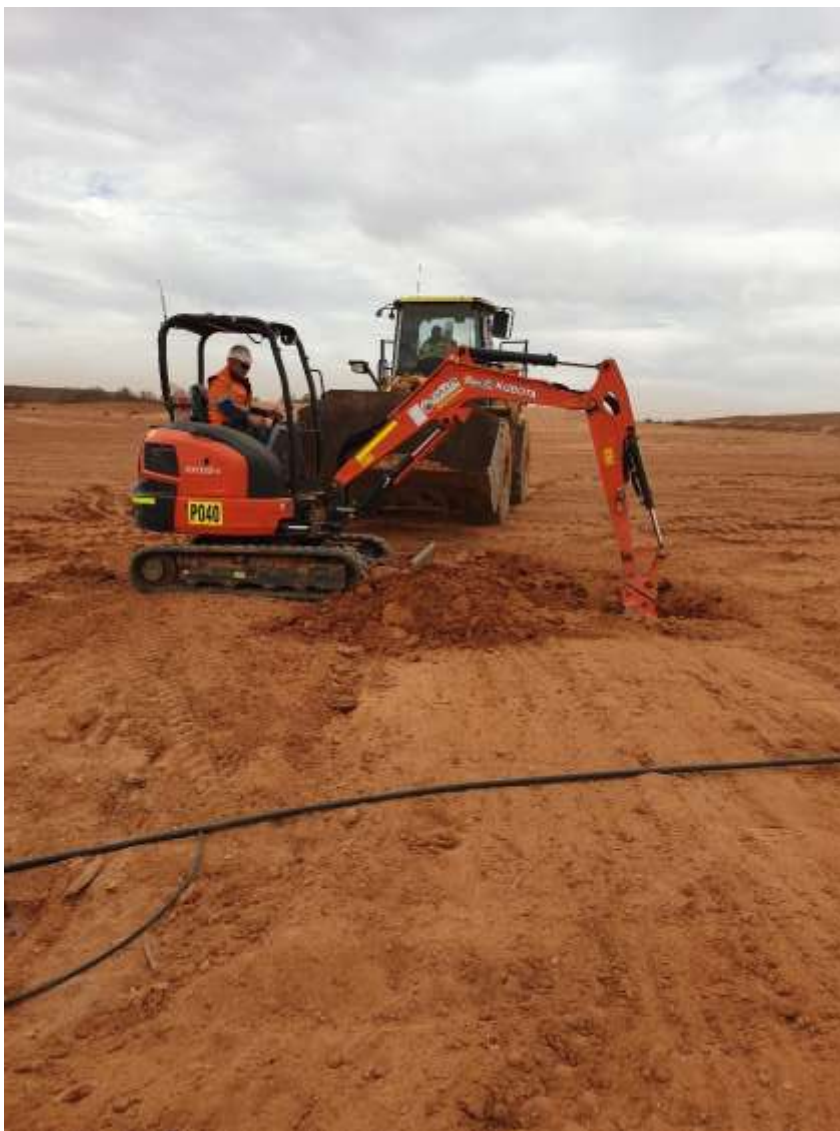
A 3-tonne excavator was used to scrape away approximately 200mm of topsoil and remove approximately 600mm of underlying sub-soil and overburden materials. The hole was backfilled with remaining topsoil and rich organic soils found beneath timber stockpiles. A well was formed below ground level to encourage water harvesting to the primary root zone of the trees.

**Tree wells being excavated with a 3 tonne digger**

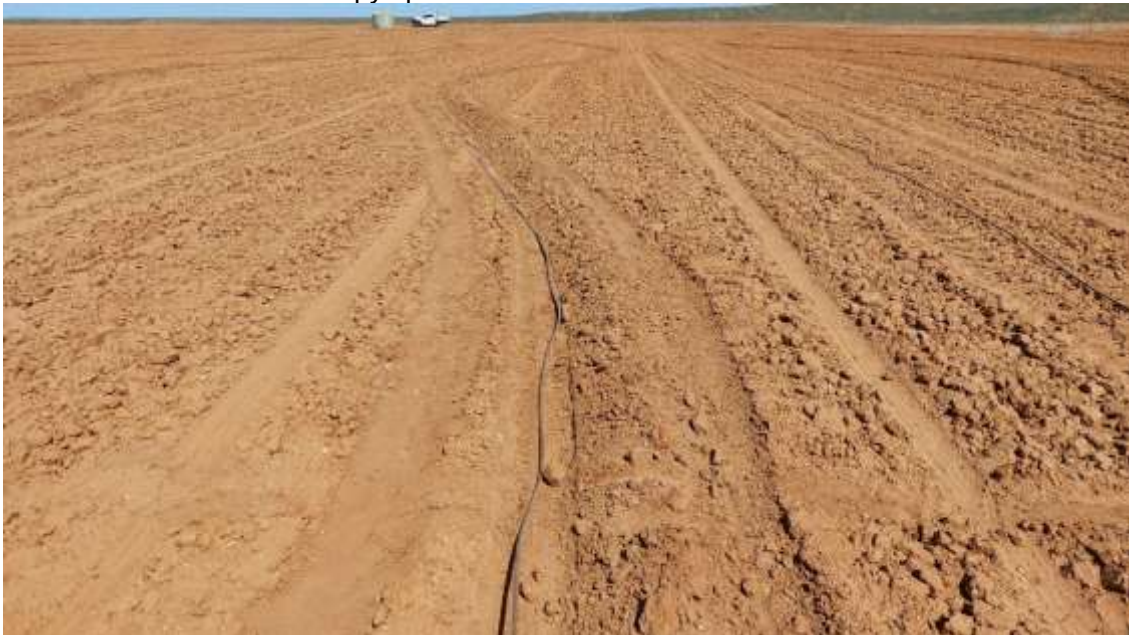
Hand planting tube stock is expensive and labour intensive, therefore Tronox is conducting a trial by direct seeding in fenced 2 ha plots and applying irrigation drip tubing to the seeding lines.

**A lateral irrigation tube placed in direct seeding line**
