Snapper Mineral Sands Mine  
ML 1621

Annual Environmental Management Report

1<sup>st</sup> September 2019 – 31<sup>st</sup> August 2020

# Snapper Annual Environmental Management Report September 2019 – August 2020

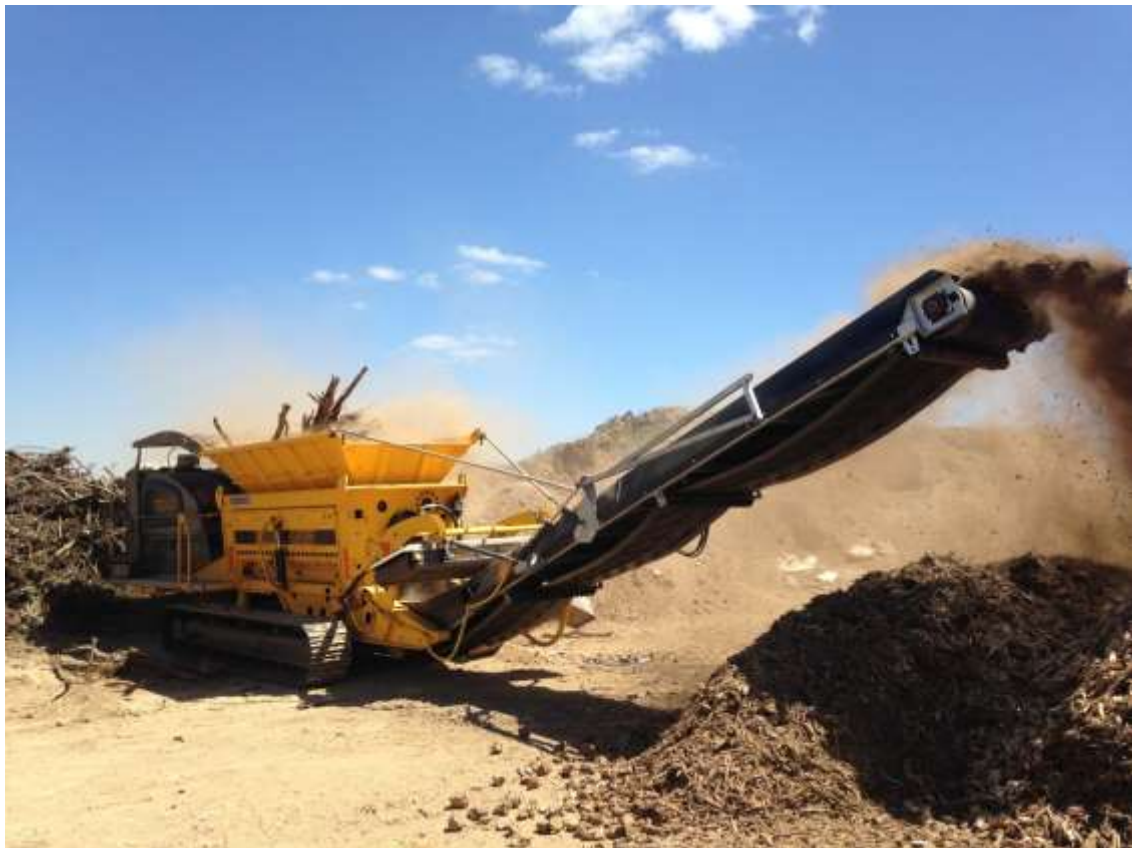
**A Tana Shark Shredder (image not from actual trial)**

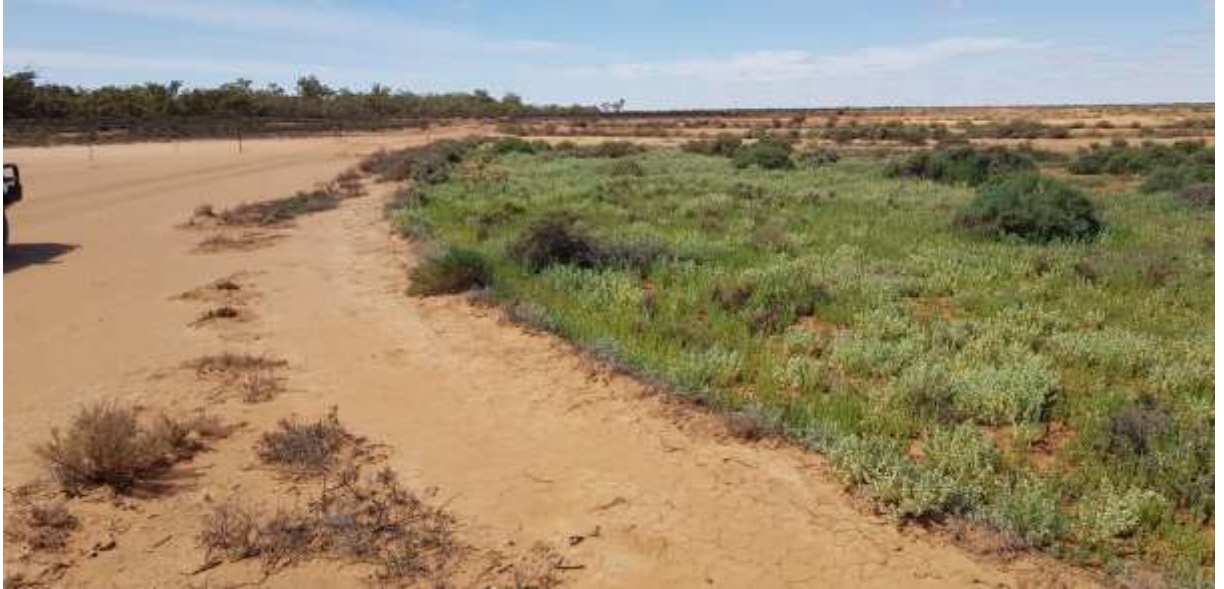
Mini-catchments are an adaption of the “waterponding” technique, which has been successfully used to revegetate scalded duplex soils in western NSW rangelands, for mine rehabilitation. The technique involves the construction of horseshoe or completely circular shaped banks to create small catchments which accumulate runoff and provide niches for plants to establish (Thompson, 2008)

**A 2004 waterponding treatment (mini-catchment) on a scalded flat at Neds Corner Station, 30km from Cullulleraine Victoria.**

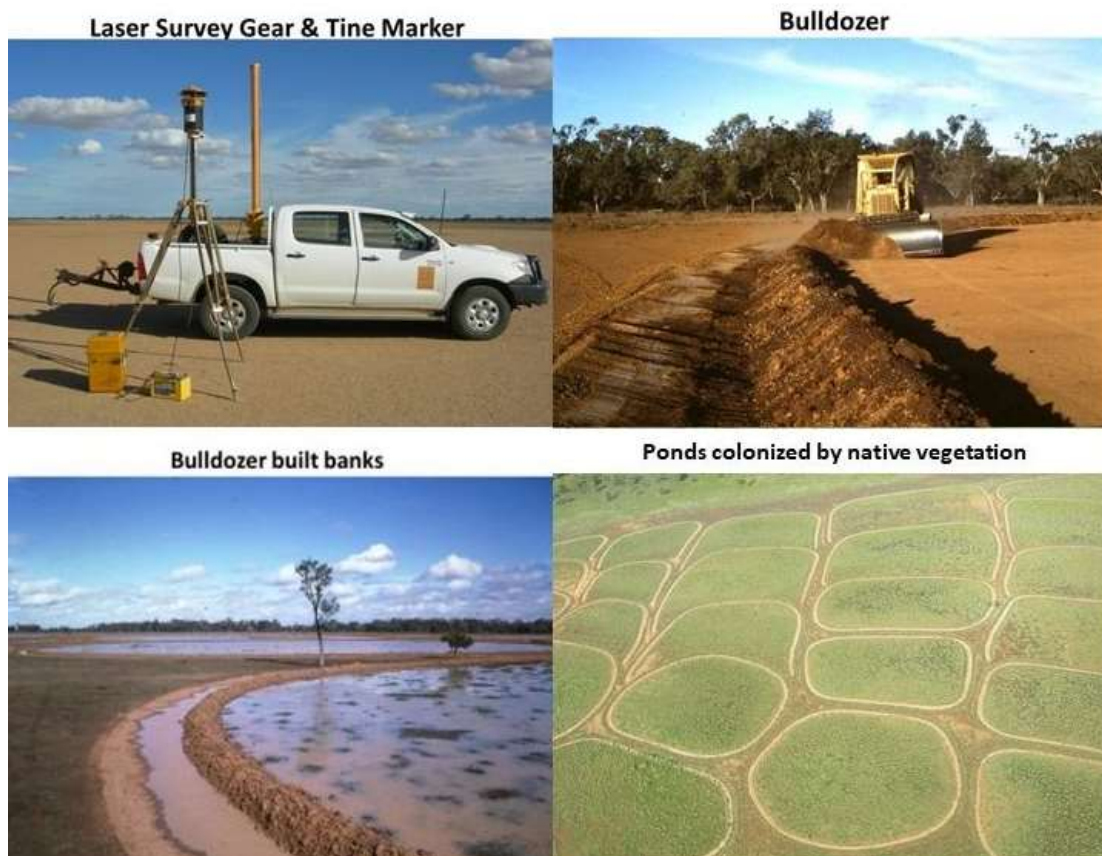
Mini-catchments will be trailed on the final surfaces of the backfilled mine voids. The mini-catchments will be created using horseshoe shaped embankments that are 250m long. The embankments will be constructed with a grader to a minimum height of 45cm and a base width of approximately 1.8m. Each mini-catchment will be approximately 0.4ha in size and the horseshoe embankments will be spaced approximately 5–10 m apart.

The images below depict the process of developing mini-catchments which requires laser levelling to aid in the site-specific design of the mini-catchment and dozing of the embankments to the specifications described above.

Construction of mini catchments by NSW Local Land Services
