# **ORICA BOTANY**

CAR PARK WASTE ENCAPSULATION  
REMEDICATION PROJECT – PROJECT  
APPROVAL 06\_0197  
MODIFICATION 6

10 August 2015

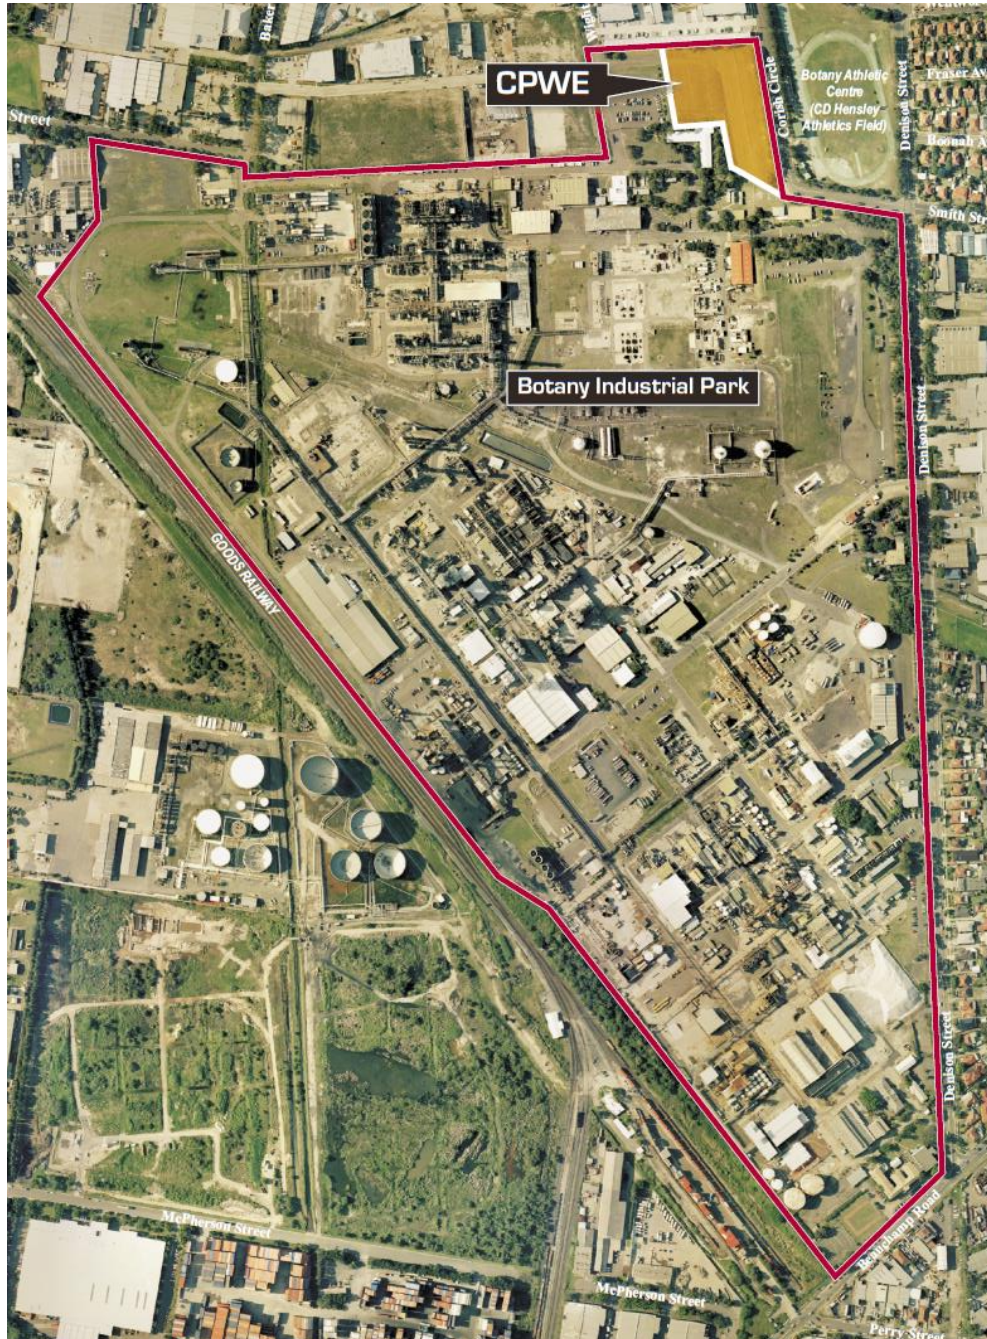
**Figure 1: The Car Park Waste Encapsulation and Botany Industrial Park (HLA, 2007).**

The CPWE and BIP as it existed as at 12 November 2009 are shown in Figure 1 (Project Area).

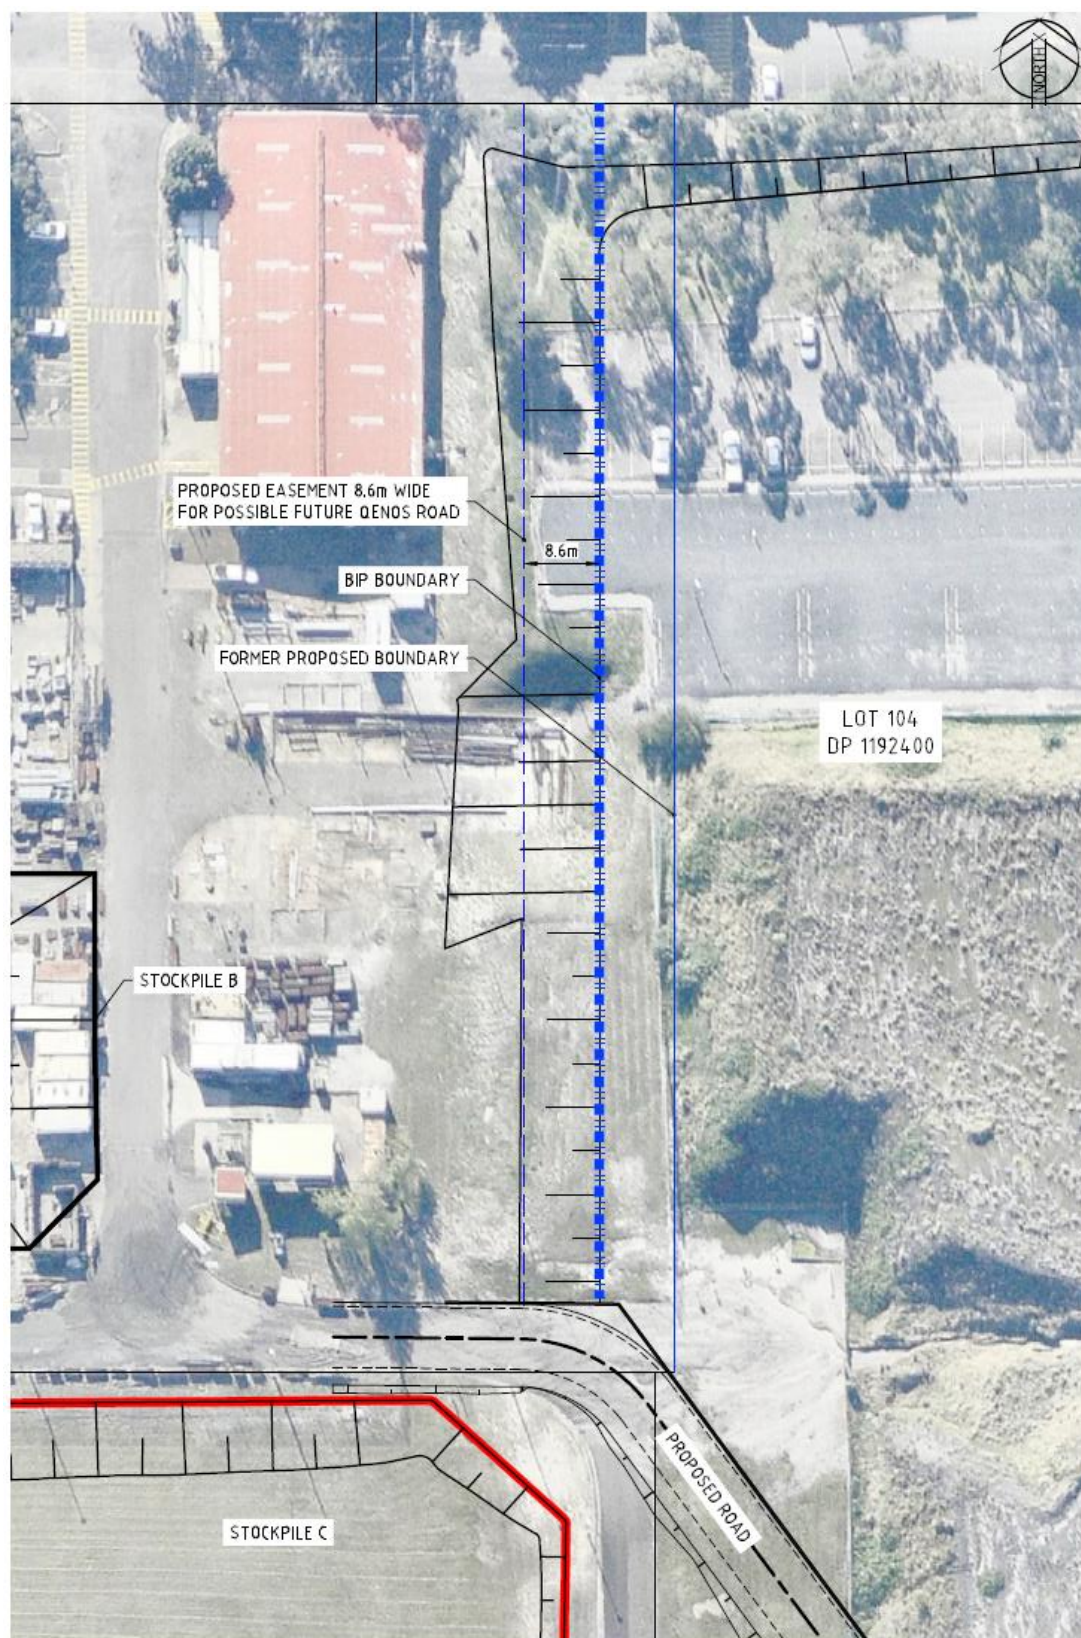
**Figure 5: Proposed adjustment of the northern portion of the western boundary of Lot 104 DP 1192400, to cater for topography.**

Consistent with the topography of the area it is proposed to move the northern portion of the western boundary of Lot 104 DP 1192400, 8.6 metres to the west. This is presented in Figure 6.

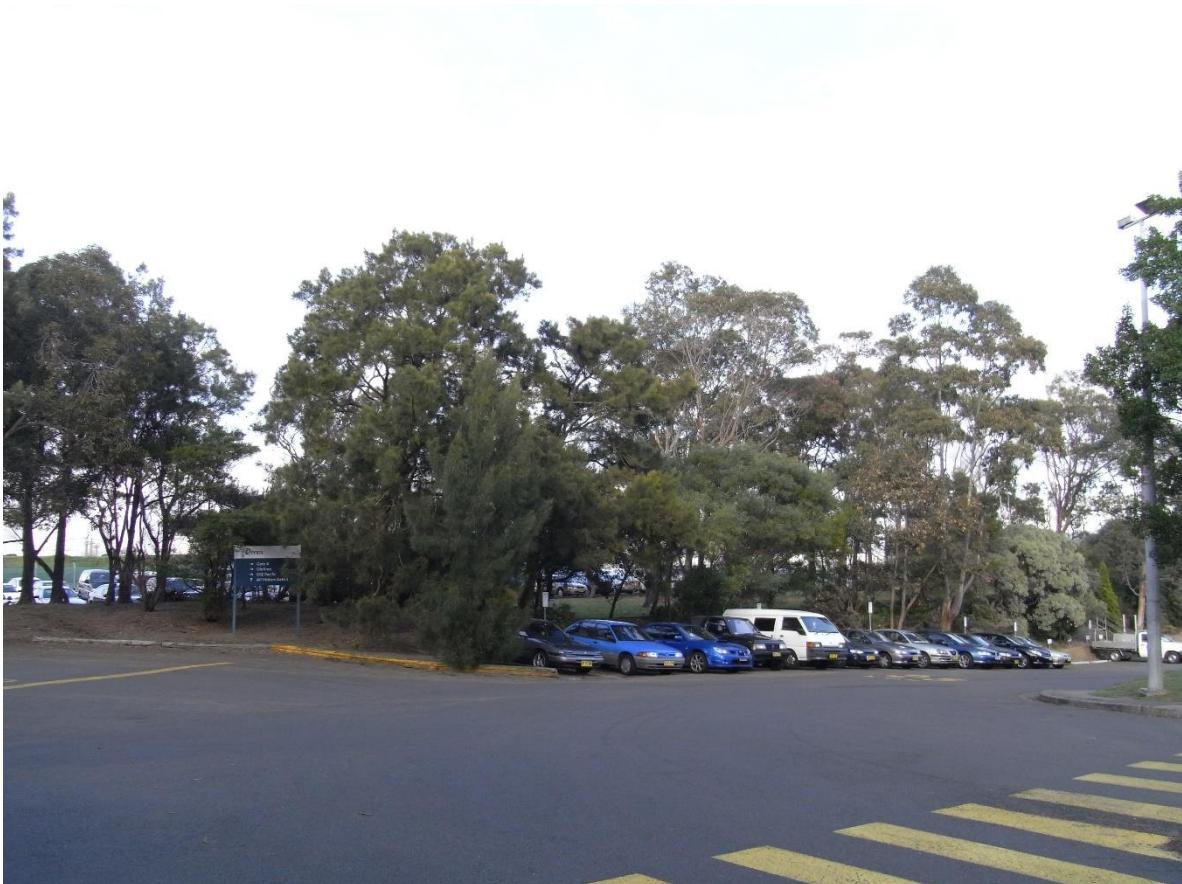
**Figure 3: Illustrating the access roads, carparking and landscape plantings in part of the site.**

- The following observations are made in regard to the site:
- 
- The site is part of the area known as Botany Industrial Park;
- The area of the site affected by the application site is in the vicinity of Corish Circle and Denison Street Banksmeadow
- There appears to have been significant past changes in the majority of the site with extensive industrial development and associated infrastructure;
- The area of the site where the trees are located comprises landscape areas, access roads and carparking areas.
- The trees assessed for the report are a mixture of exotic species and planted Australian species (some of which are representative of species that would have occurred in the locality in the past).
- An illustrative view of the area is shown in Figure 3.

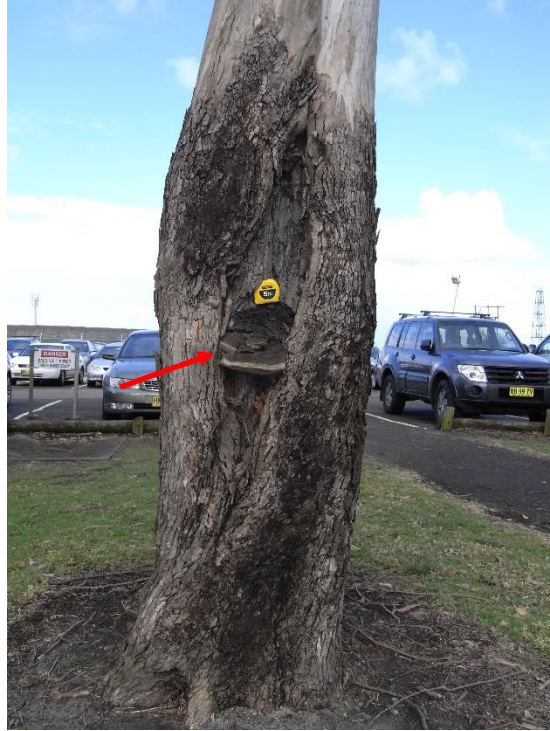
Photograph 1 - Tree # 5 - illustrating the past wounding and evidence of decay (fruiting bodies - *Phellinus* sp.)

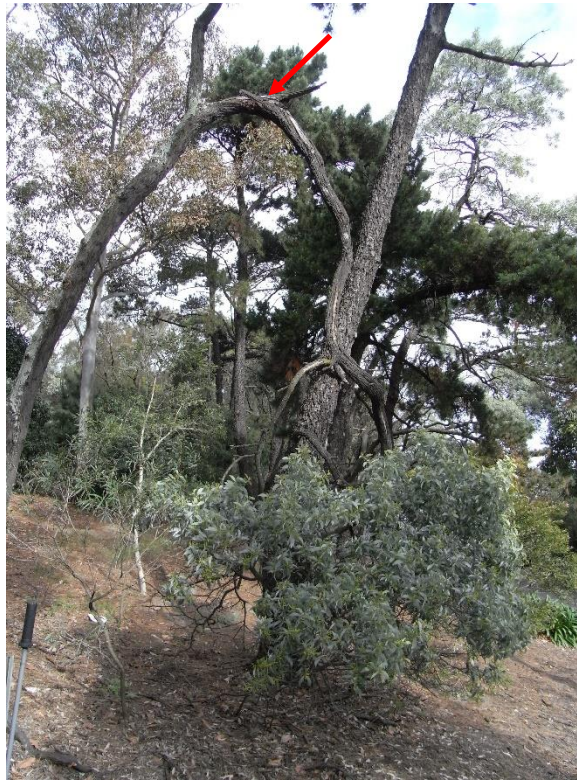
Photograph 3 - Tree # 58 - illustrating the past failure (fracture) of a main leader.

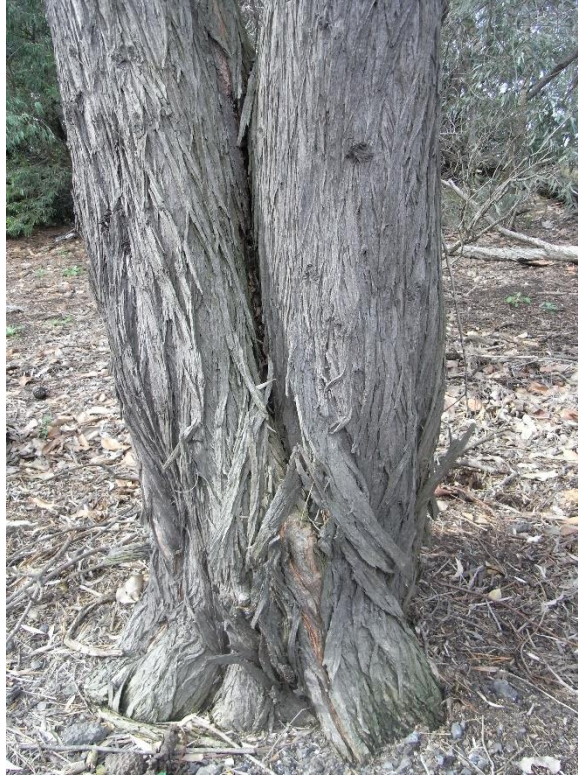
Photograph 4 - Tree # 65 - illustrating the codominant leaders from ground level with evidence of poor attachment at the junction.

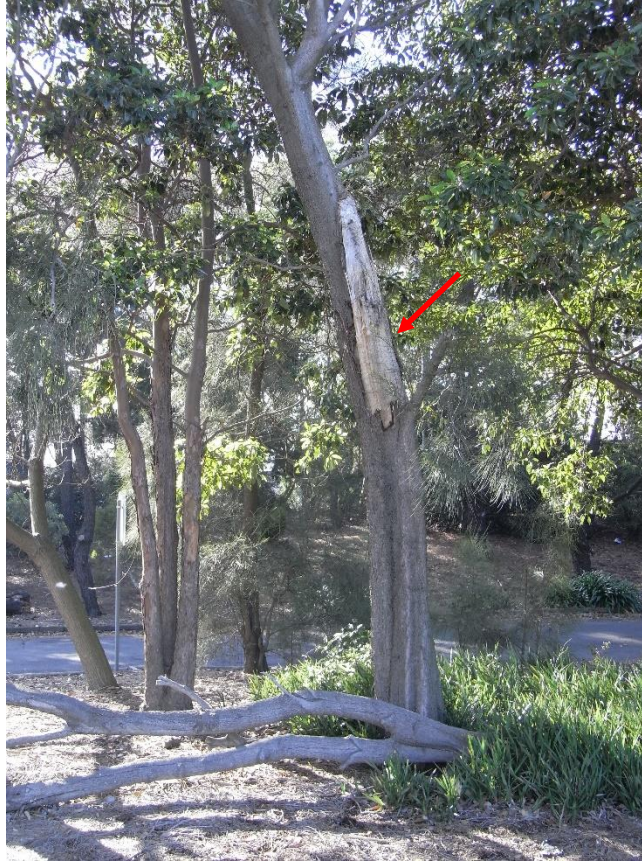
Photograph 5 - Tree # 81 - illustrating the past failure of a codominant leader t t 2 metres.

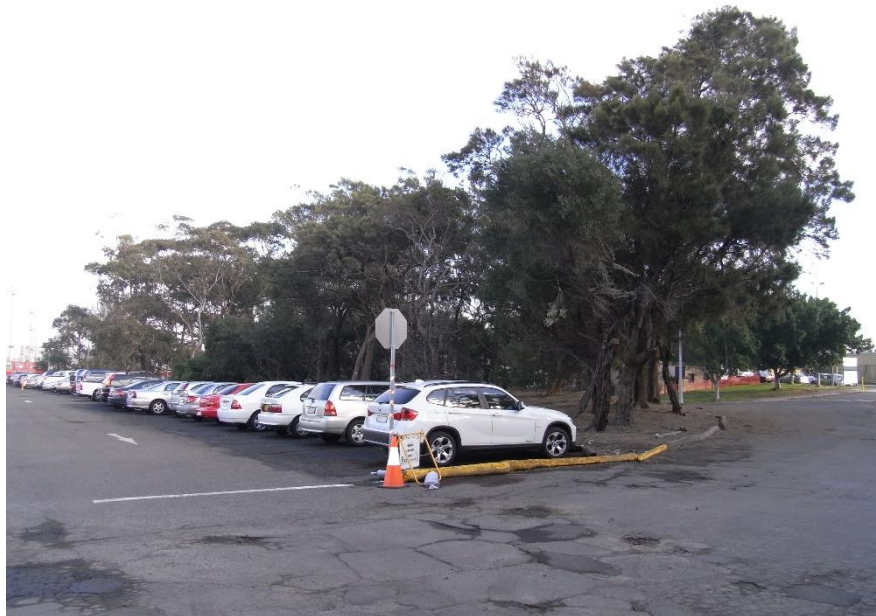
Photograph 6 - Illustrating the layout of carparking and landscape areas.
