# **ORICA BOTANY**

CAR PARK WASTE ENCAPSULATION  
REMEDIATION PROJECT – PROJECT  
APPROVAL 06\_0197  
MODIFICATION 6

Revision 1 - 1 October 2015

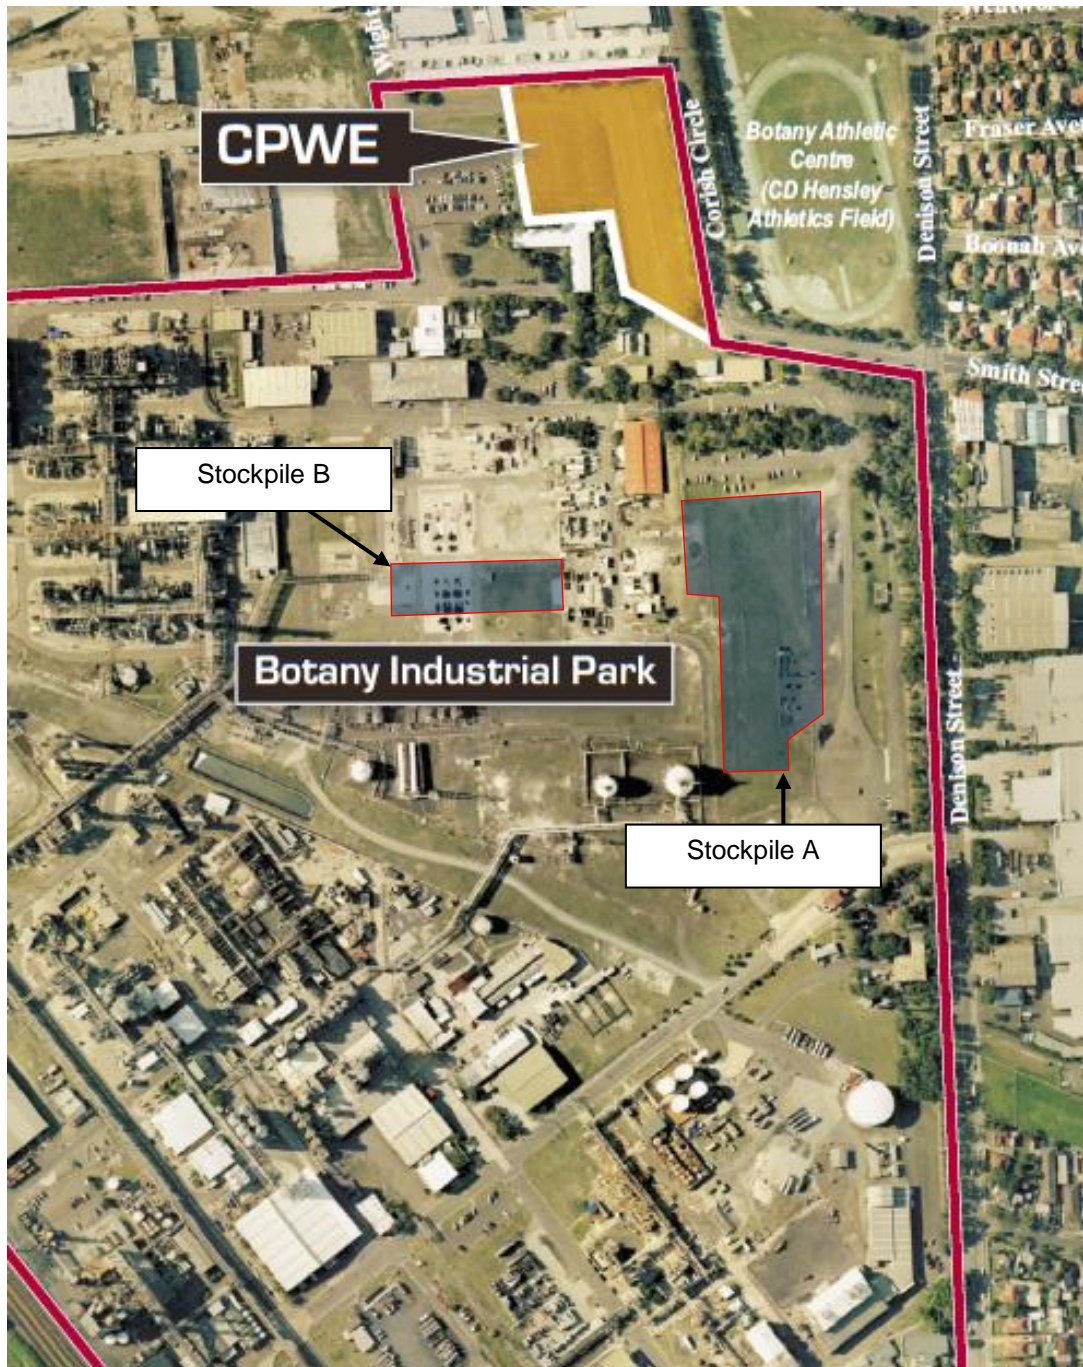
**Figure 2: Current approximate location of existing stockpiles of validated material, referred to as Stockpiles A and B (modified from HLA, 2007).**

The CPWE and BIP as it existed as at 12 November 2009 are shown in Figure 1 (Project Area). The location of the stockpiles of validated material to be reused are presented in Figure 2.

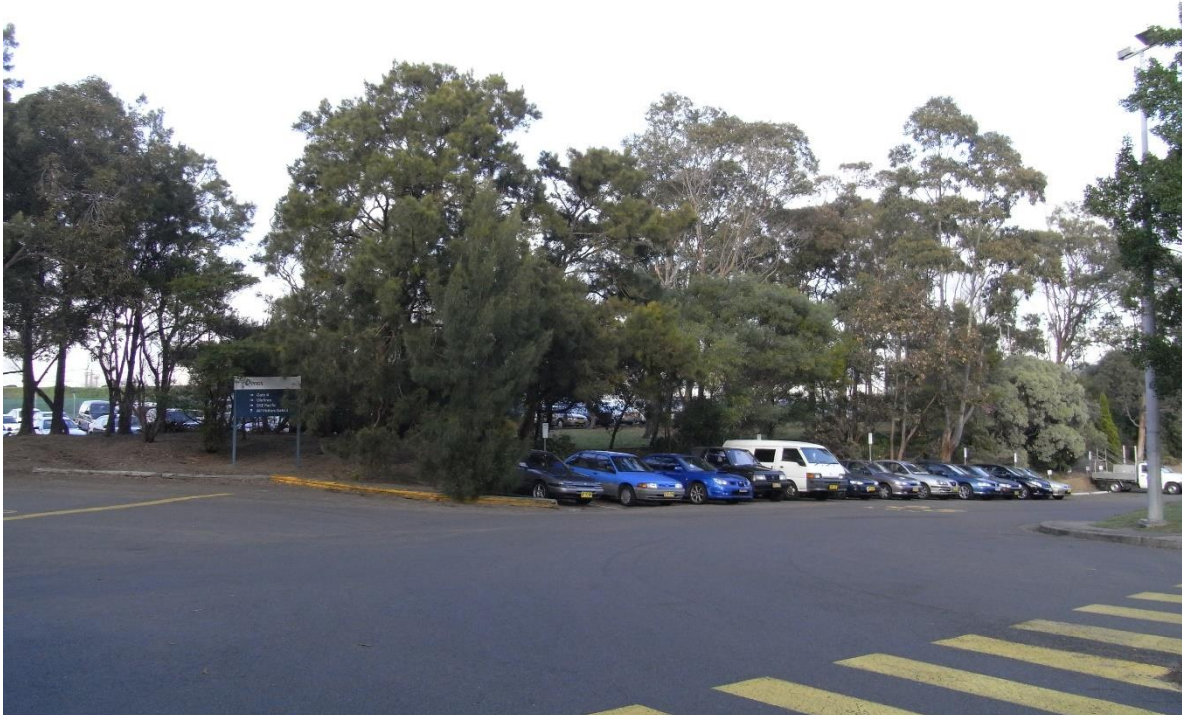
**Figure 3: Illustrating the access roads, carparking and landscape plantings in part of the site.**

- The following observations are made in regard to the site:
- 
- The site is part of the area known as Botany Industrial Park;
- The area of the site affected by the application site is in the vicinity of Corish Circle and Denison Street Banksmeadow
- There appears to have been significant past changes in the majority of the site with extensive industrial development and associated infrastructure;
- The area of the site where the trees are located comprises landscape areas, access roads and carparking areas.
- The trees assessed for the report are a mixture of exotic species and planted Australian species (some of which are representative of species that would have occurred in the locality in the past).
- An illustrative view of the area is shown in Figure 3.

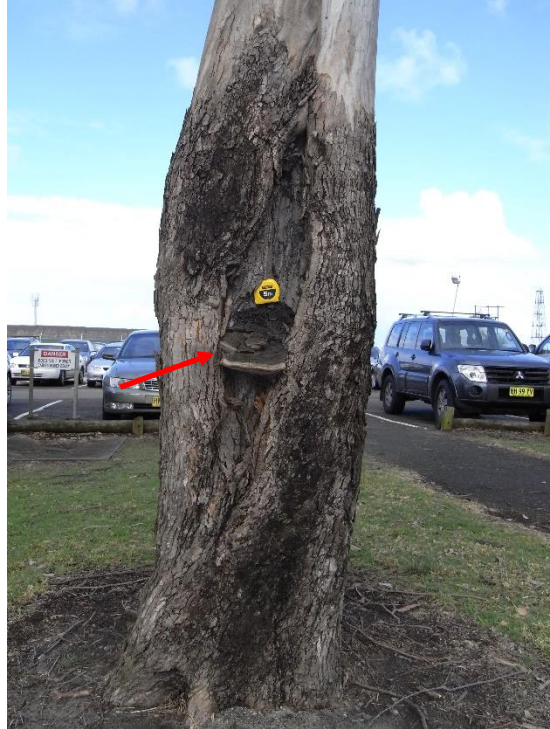
Photograph 1 - Tree # 5 - illustrating the past wounding and evidence of decay (fruiting bodies - *Phellinus* sp.)

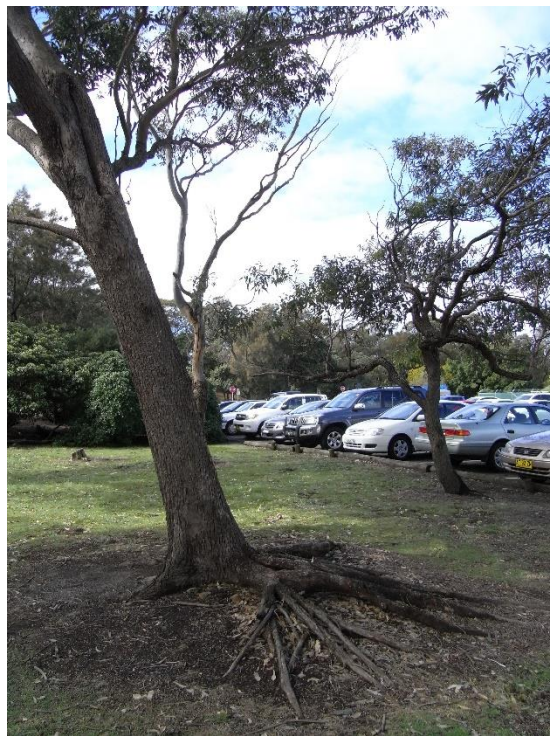
Photograph 2 - Tree # 11 - illustrating the evidence of partial, past failure (wind throw) with exposed structural roots and distinct trunk lean

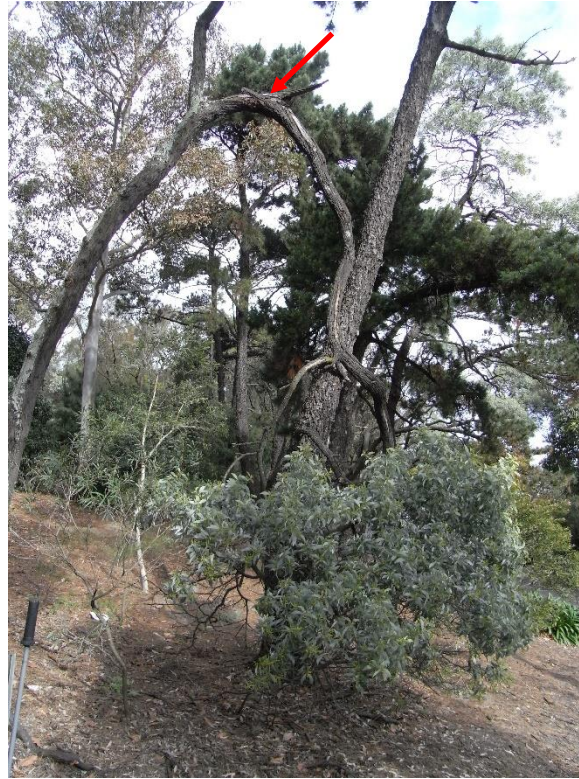
Photograph 3 - Tree # 58 - illustrating the past failure (fracture) of a main leader.

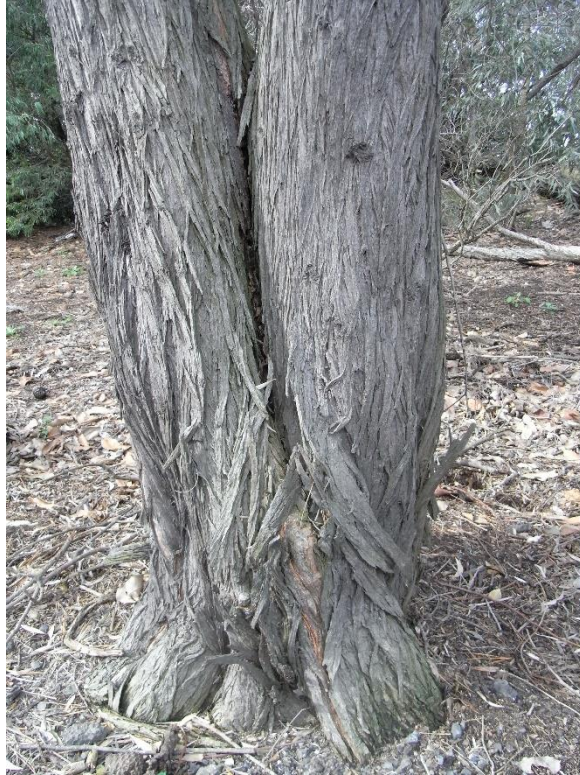
Photograph 4 - Tree # 65 - illustrating the codominant leaders from ground level with evidence of poor attachment at the junction.

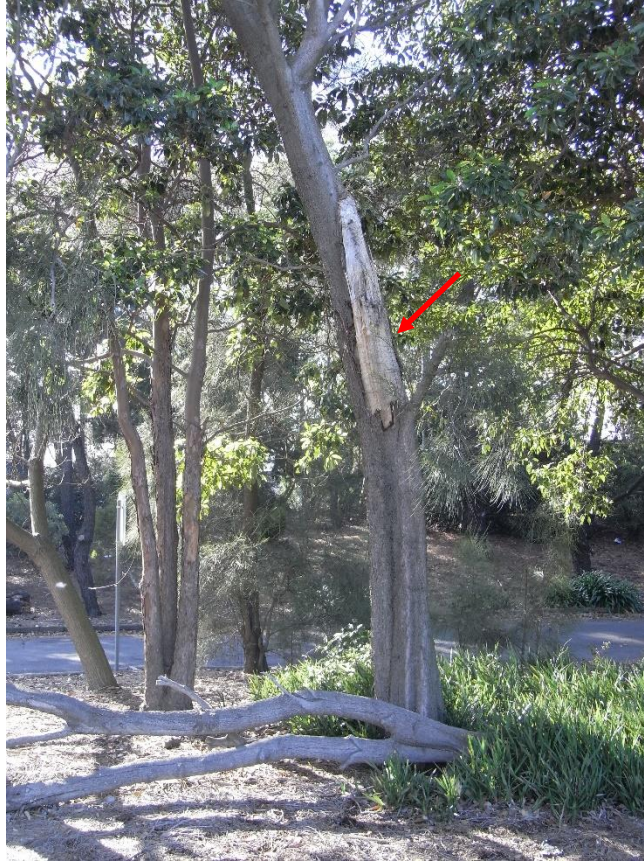
Photograph 5 - Tree # 81 - illustrating the past failure of a codominant leader t 2 metres.

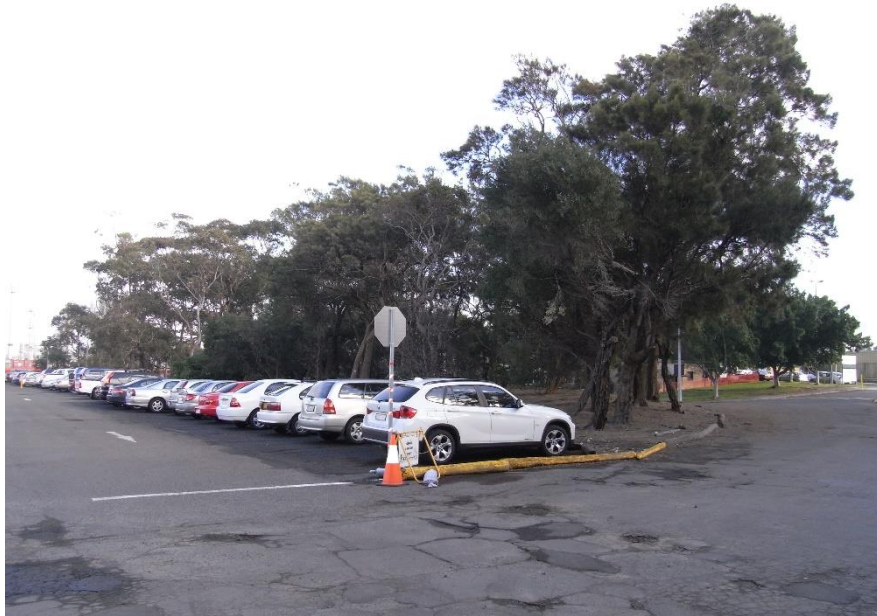
Photograph 6 - Illustrating the layout of carparking and landscape areas.

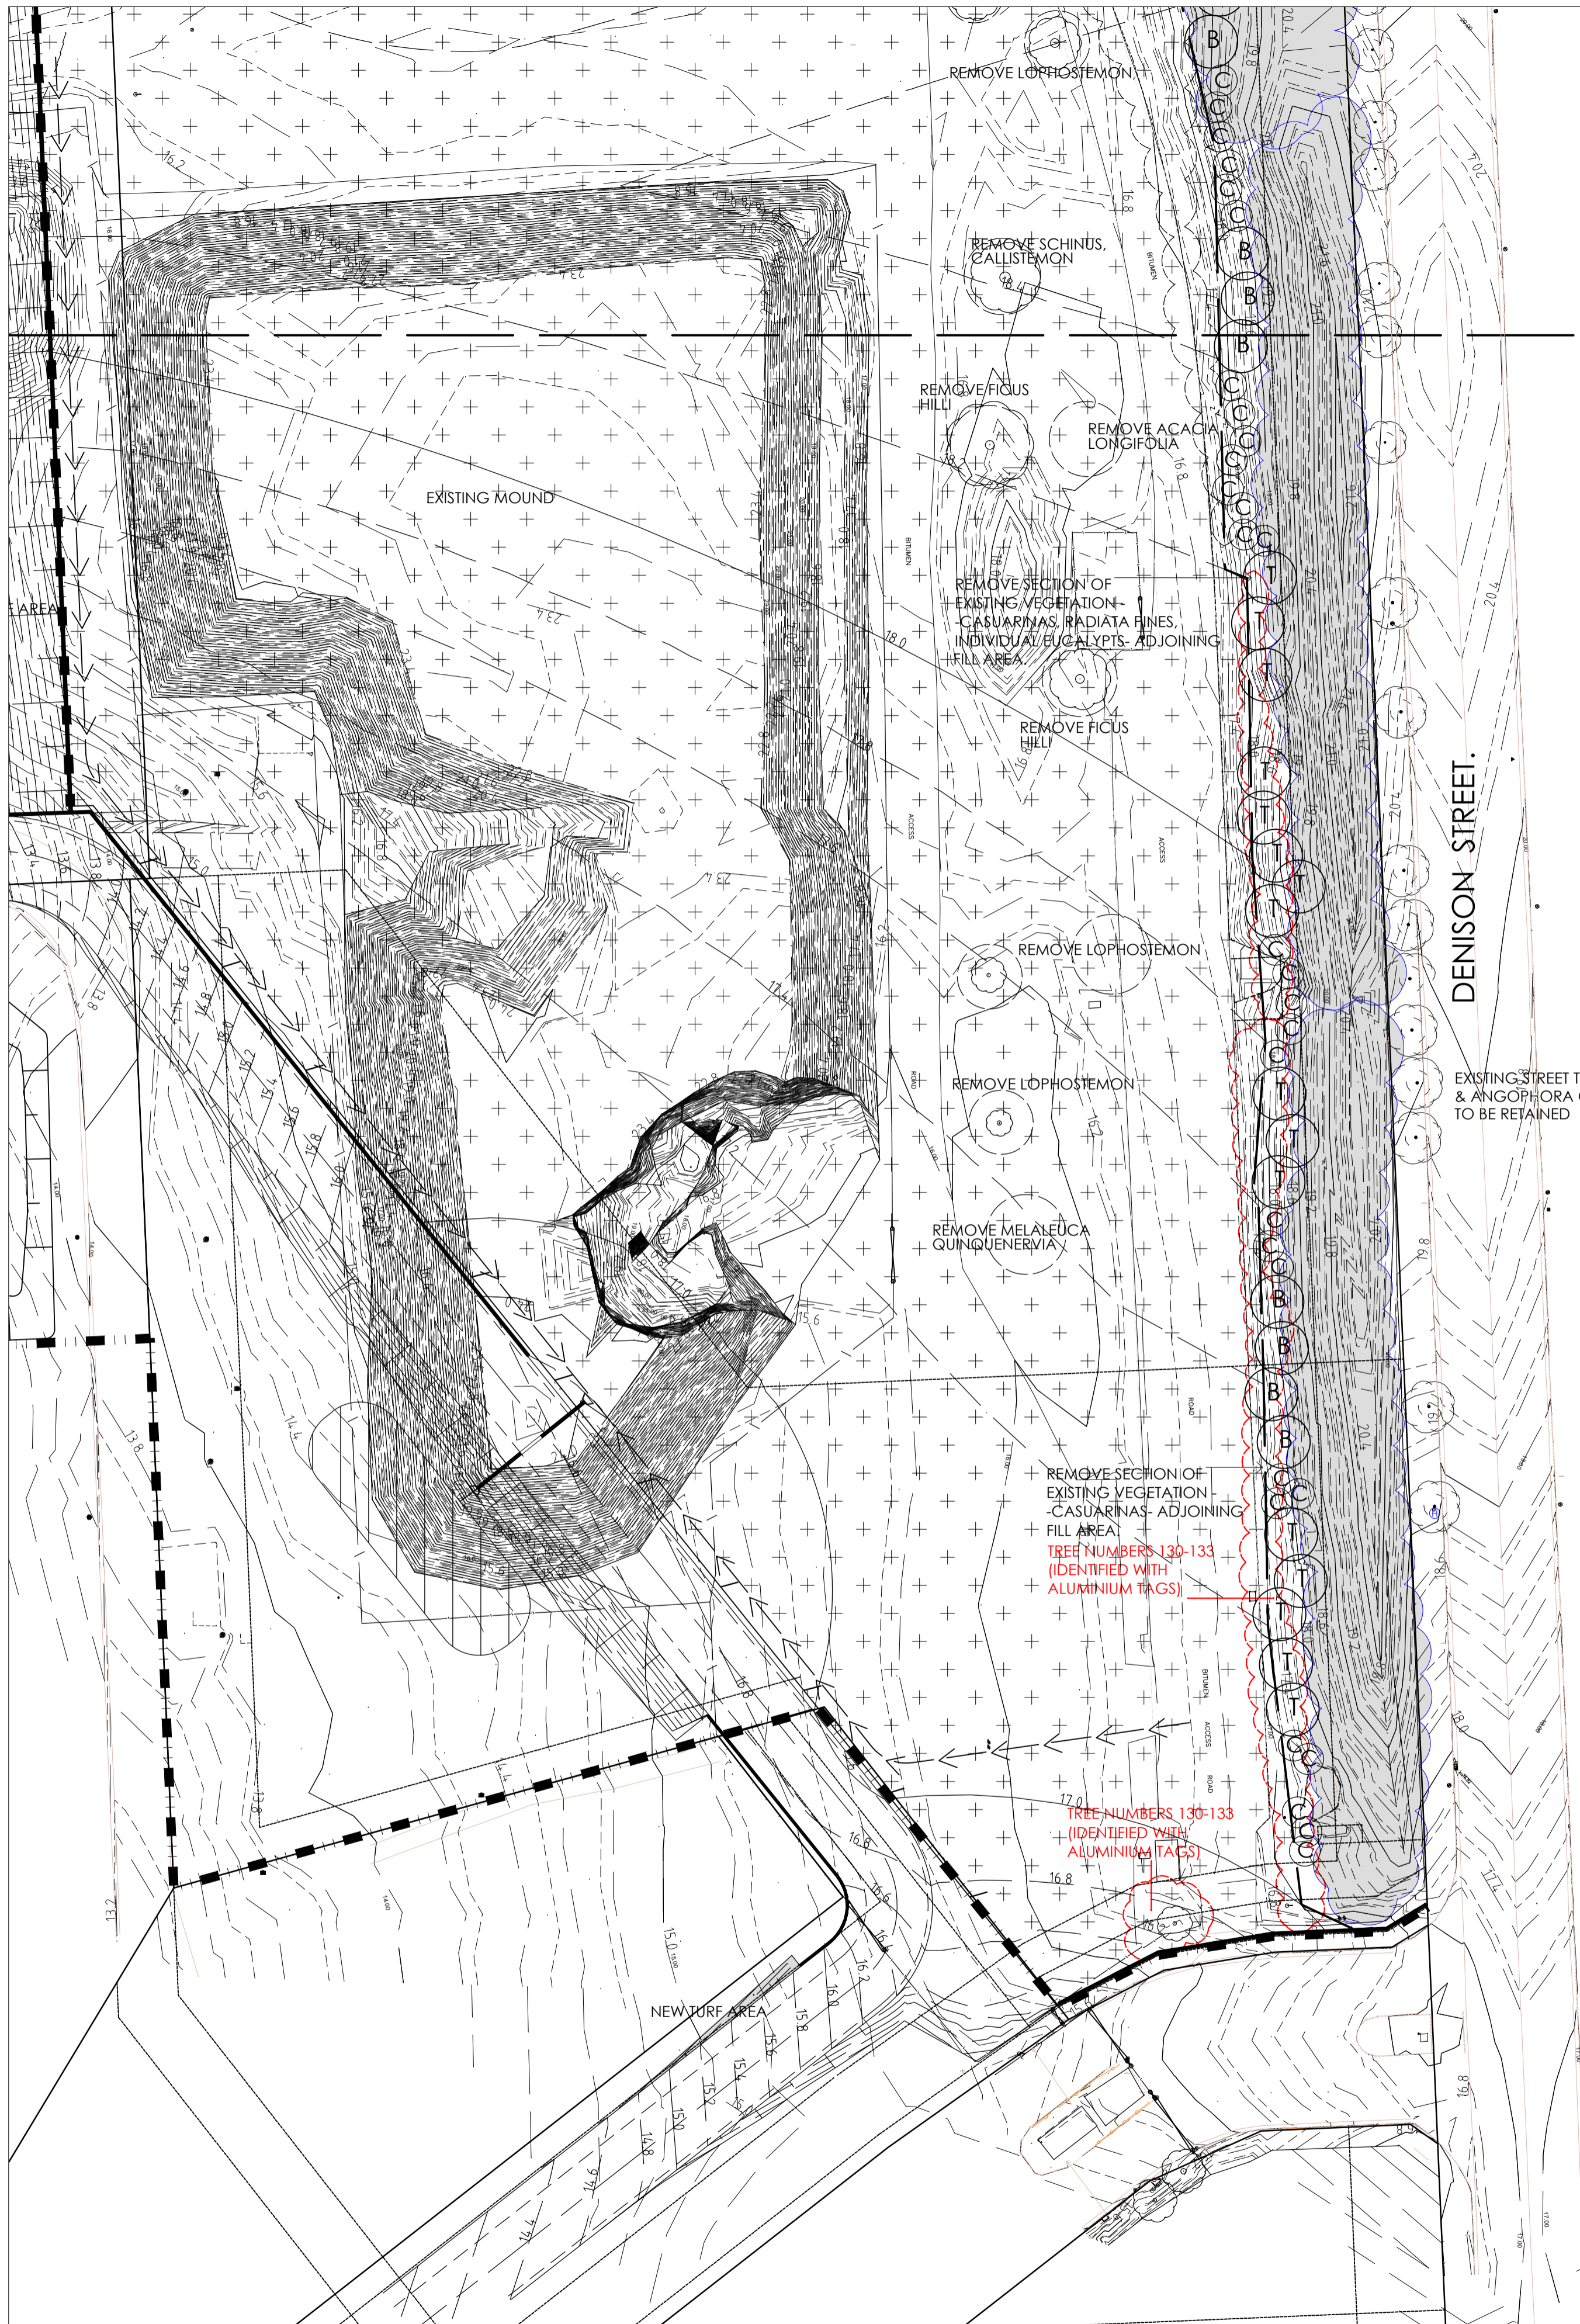
CLIENT: ORICA.	DATE: JULY 2015 DWG. NO. 15-007/L03	SCALE: 1:500 @ A1 NO. IN SET 3
-------------------	--	---

PROJECT: CARPARK NO 3. WASTE ENCAPSULATION PROJECT.	DRAWING: LANDSCAPE PLAN
---	----------------------------
