2021 Annual Environmental Review

Document Number: HVOOC-748212775-6

Owner: Hunter Valley Operations

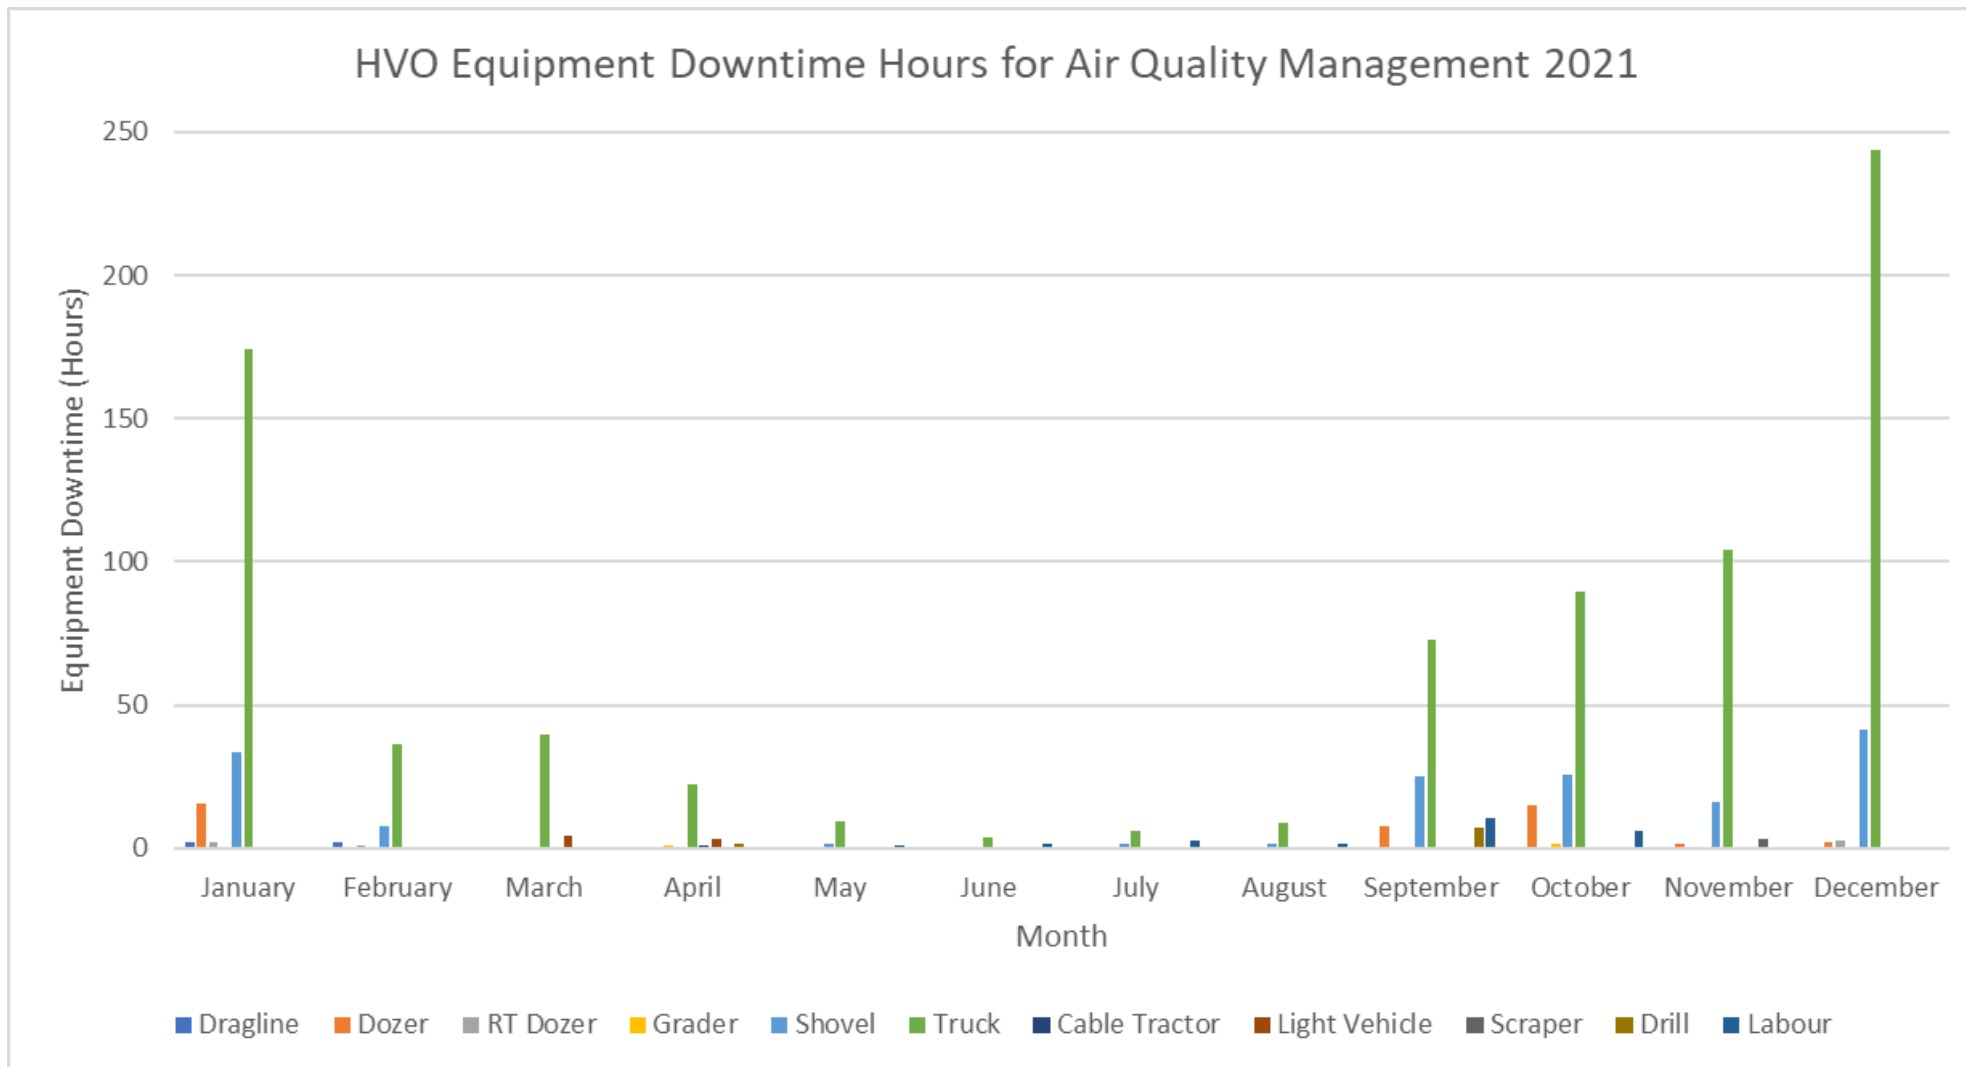
Figure 13 Equipment Downtime Hours for Air Quality Management 2021

In response, 1054 hours of equipment downtime was recorded due to air quality management. A detailed breakdown of air quality related equipment stoppages (per month, per equipment type) presented in **Figure 13**. Note that these delays are instances where operations were completely stopped and does not include occasions where operations were changed/modified but not stopped (e.g., changed from exposed dump to in-pit dump).

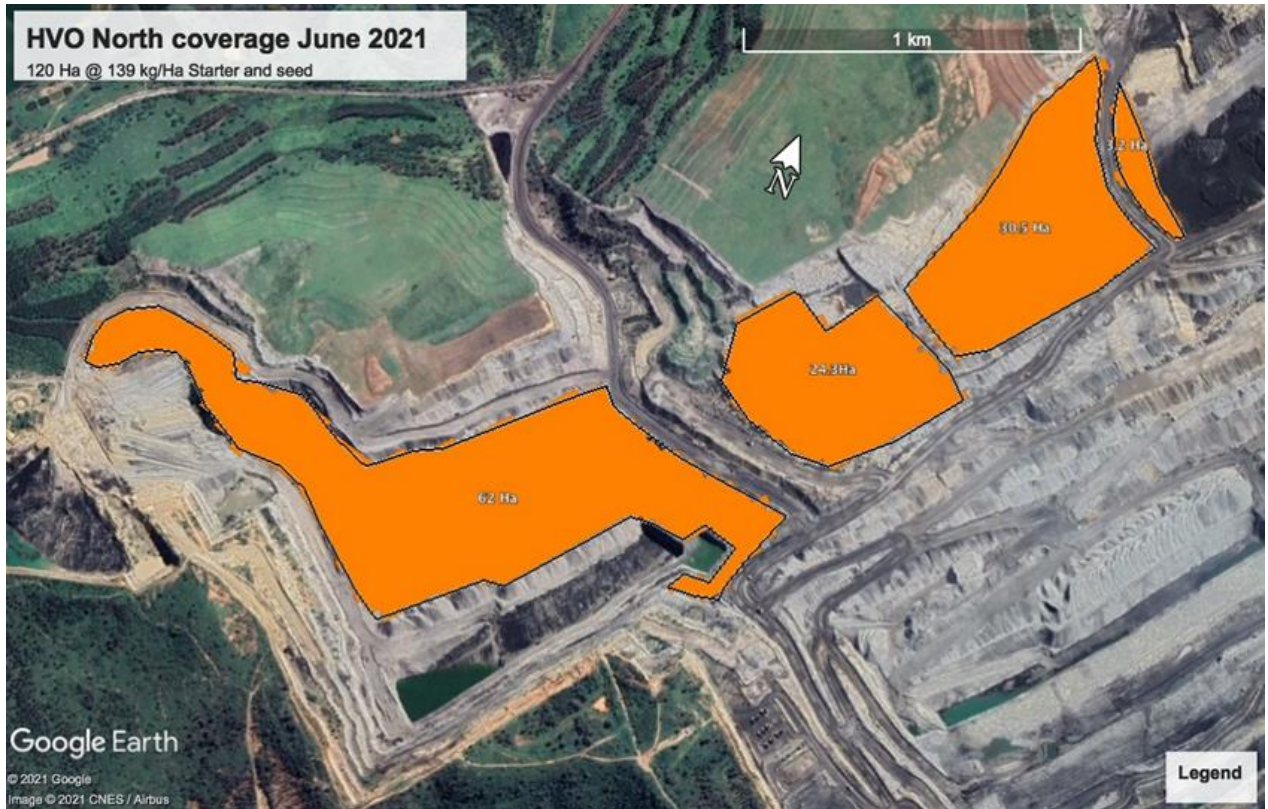
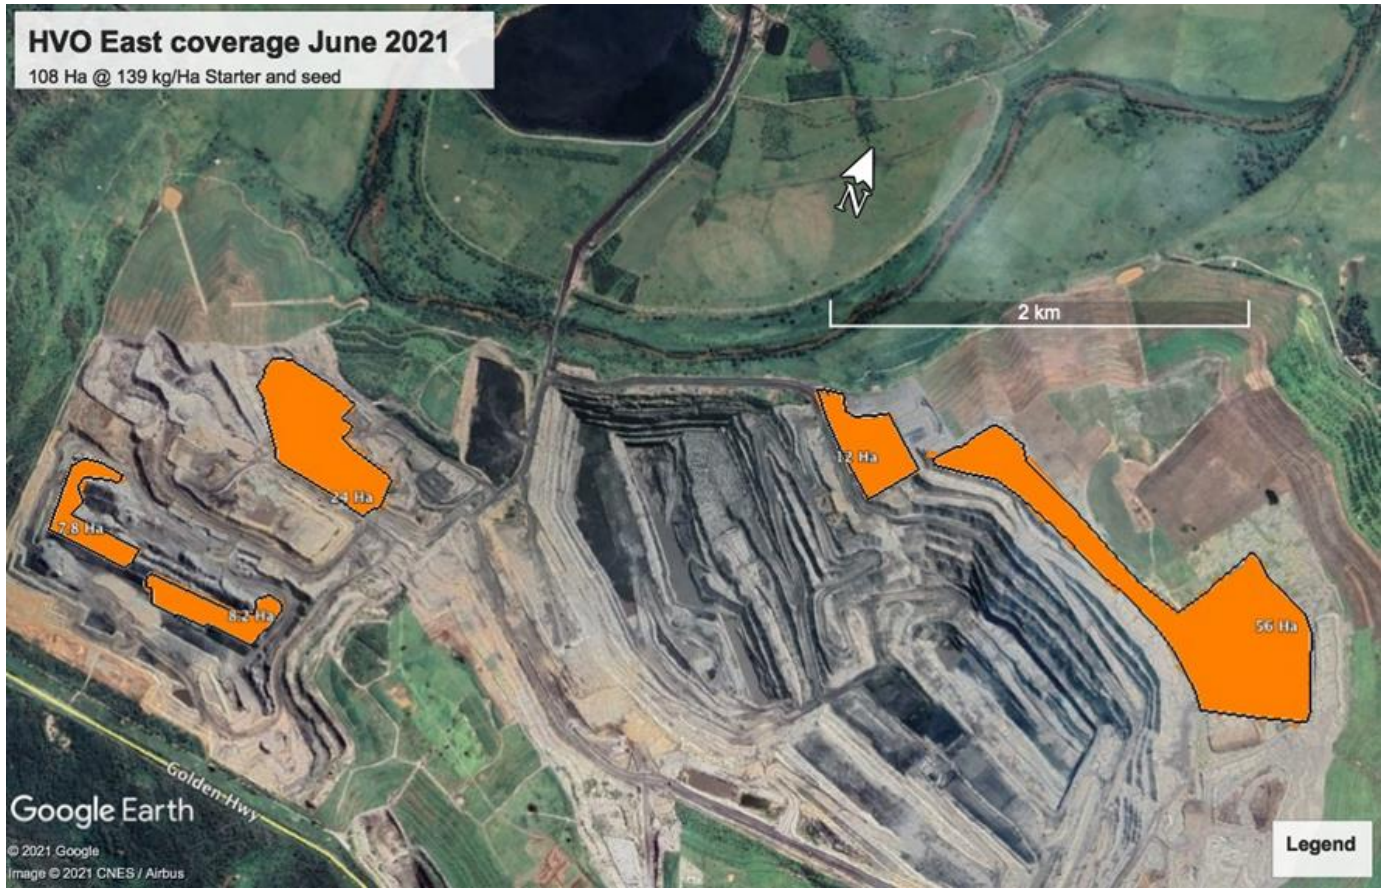
Aerial Seeding was undertaken in June 2021 by fixed wing aircraft to provide temporary cover to areas exposed to wind generated dust and erosion at HVO. Waste dumps and exposed areas were selected for seeding if they were not planned to be disturbed within six months. A total area of 335 ha was seeded which included waste dumps ahead of mining re-disturbance (**Figure 14 to Figure 16**). All areas were seeded using an exotic pasture and legume mix suitable for autumn sowing. A starter fertiliser was mixed with the seed prior to loading to provide sufficient nutrients for plant growth.

Figure 14 Areas Aerial Seeded in 2021 – HVO North (West Pit)

Figure 15 Areas Aerial Seeded in 2021 - HVO North (Carrington Pit)

Figure 16 Areas Aerial Seeded in 2021 - HVO South

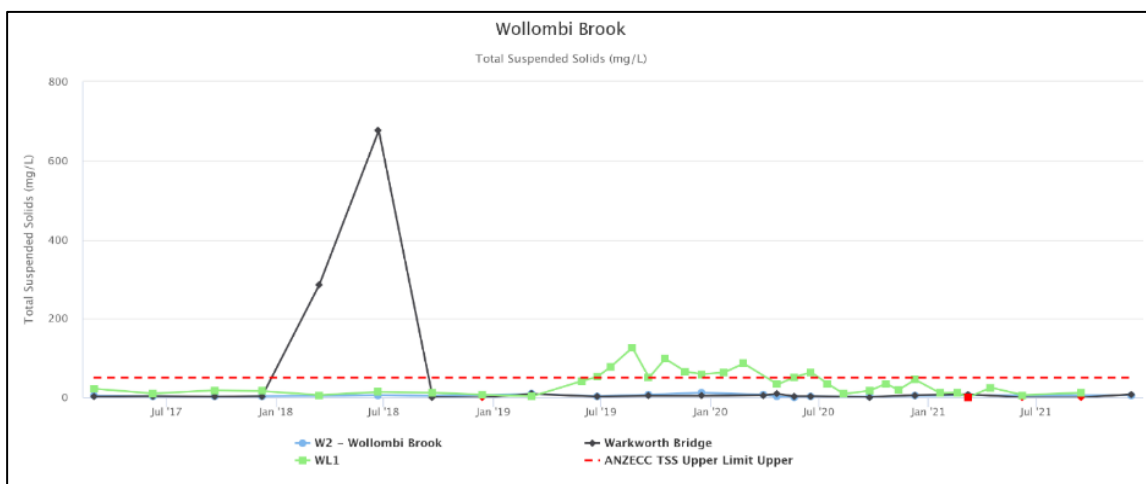
Wollombi Brook was sampled on 15 occasions from three monitoring locations during 2021. Long term trends for pH, EC and TSS from Wollombi Brook are shown in **Figure 30** to **Figure 32**.

Results were generally consistent with historical trends and acceptable ranges.

Figure 30 Wollombi Brook pH Trends 2017 – 2021

Figure 31 Wollombi Brook EC Trends 2017 – 2021

Figure 32 Wollombi Brook TSS Trends 2017 – 2021

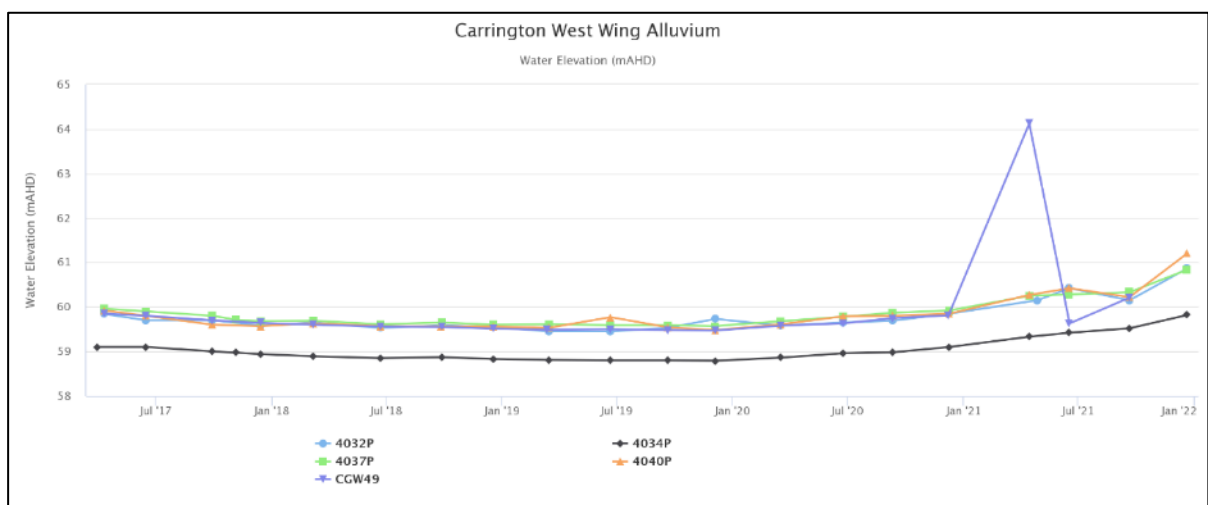
Figure 50 Carrington West Wing Alluvium Groundwater pH Trends 2017 – 2021

Figure 51 Carrington West Wing Alluvium Groundwater EC Trends 2017 – 2021

Figure 52 Carrington West Wing Alluvium Groundwater SWL Trends 2017 – 2021

Results are shown in **Figure 50** to **Figure 52**. Water quality results were generally consistent with historical trends.

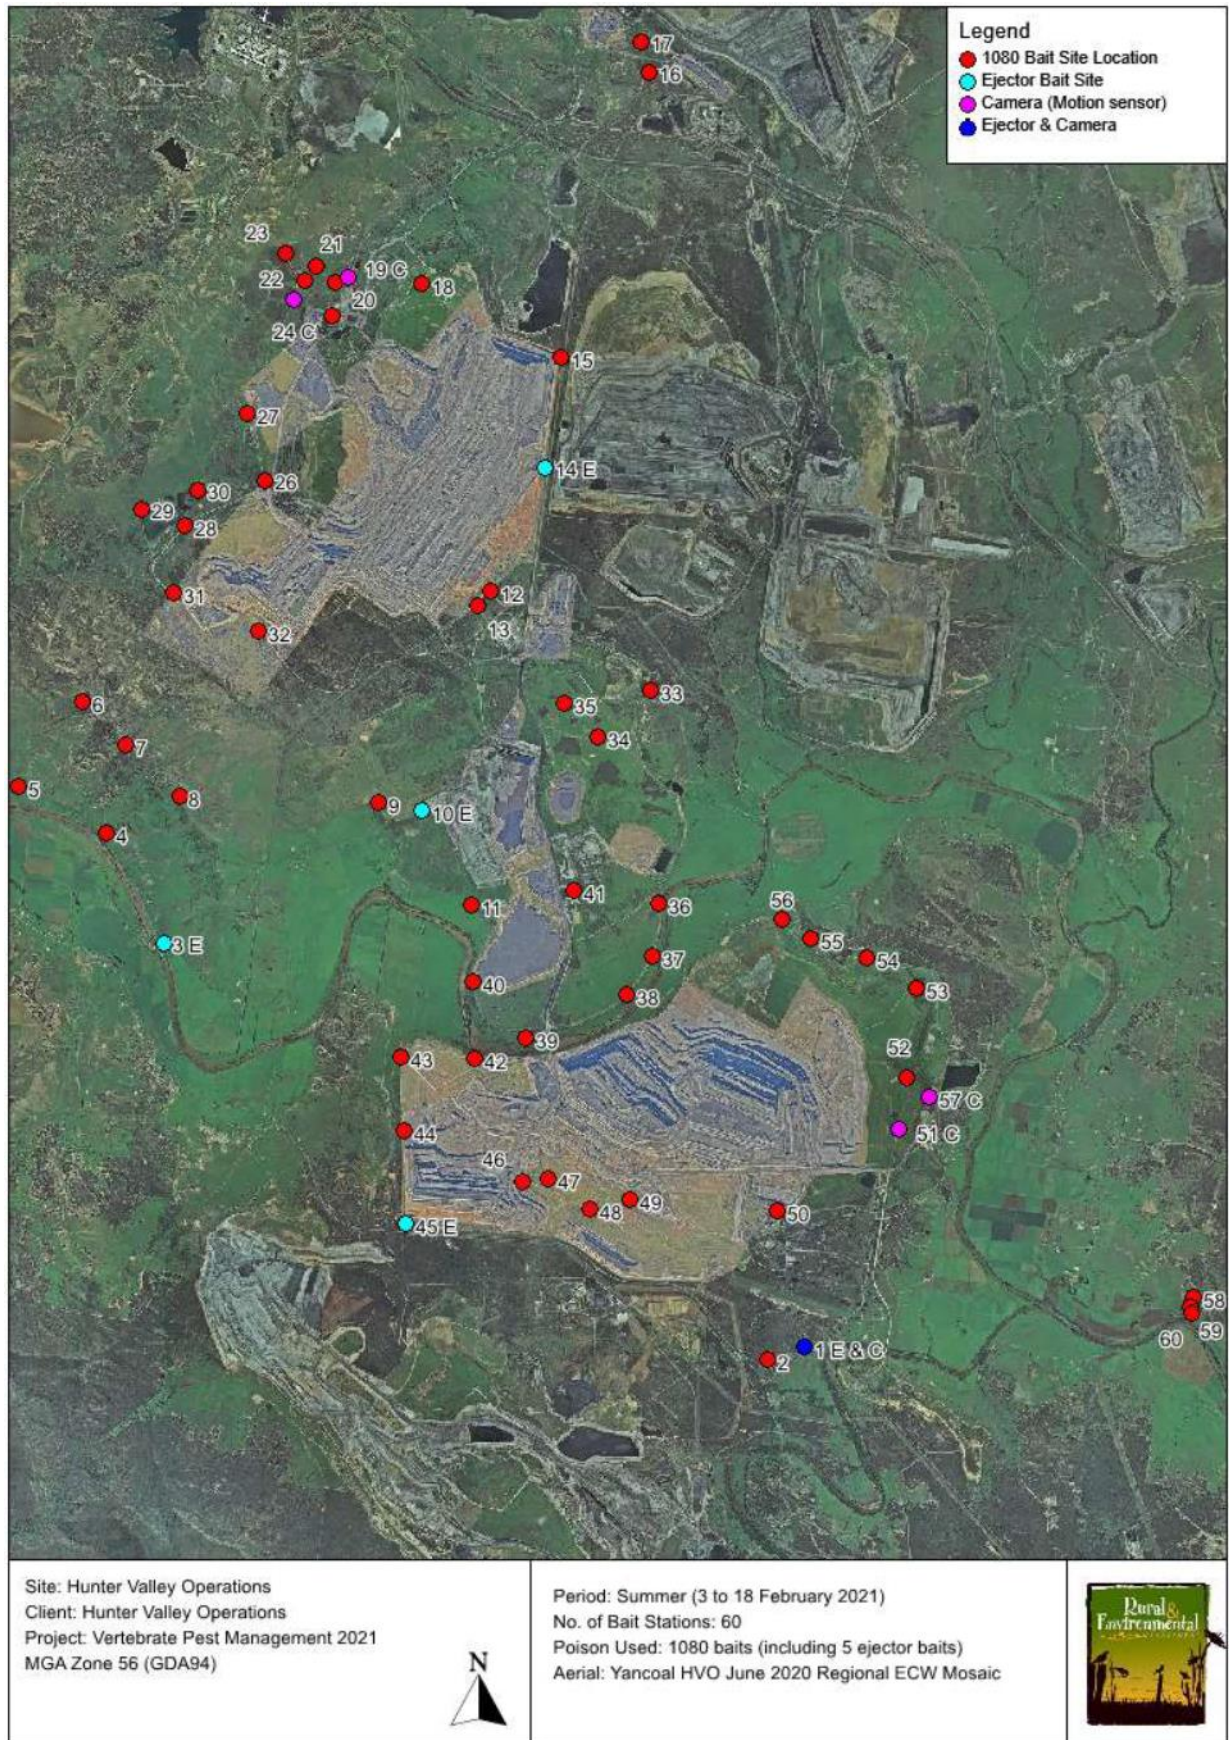
Figure 103 HVO Vertebrate Pest Management Bait Locations – Summer 2021

Table 71 summarises the results from the programmes carried out at HVO during 2021 with wild dog and fox baiting locations and results for the programs illustrated in **Figure 103** to **Figure 105**.

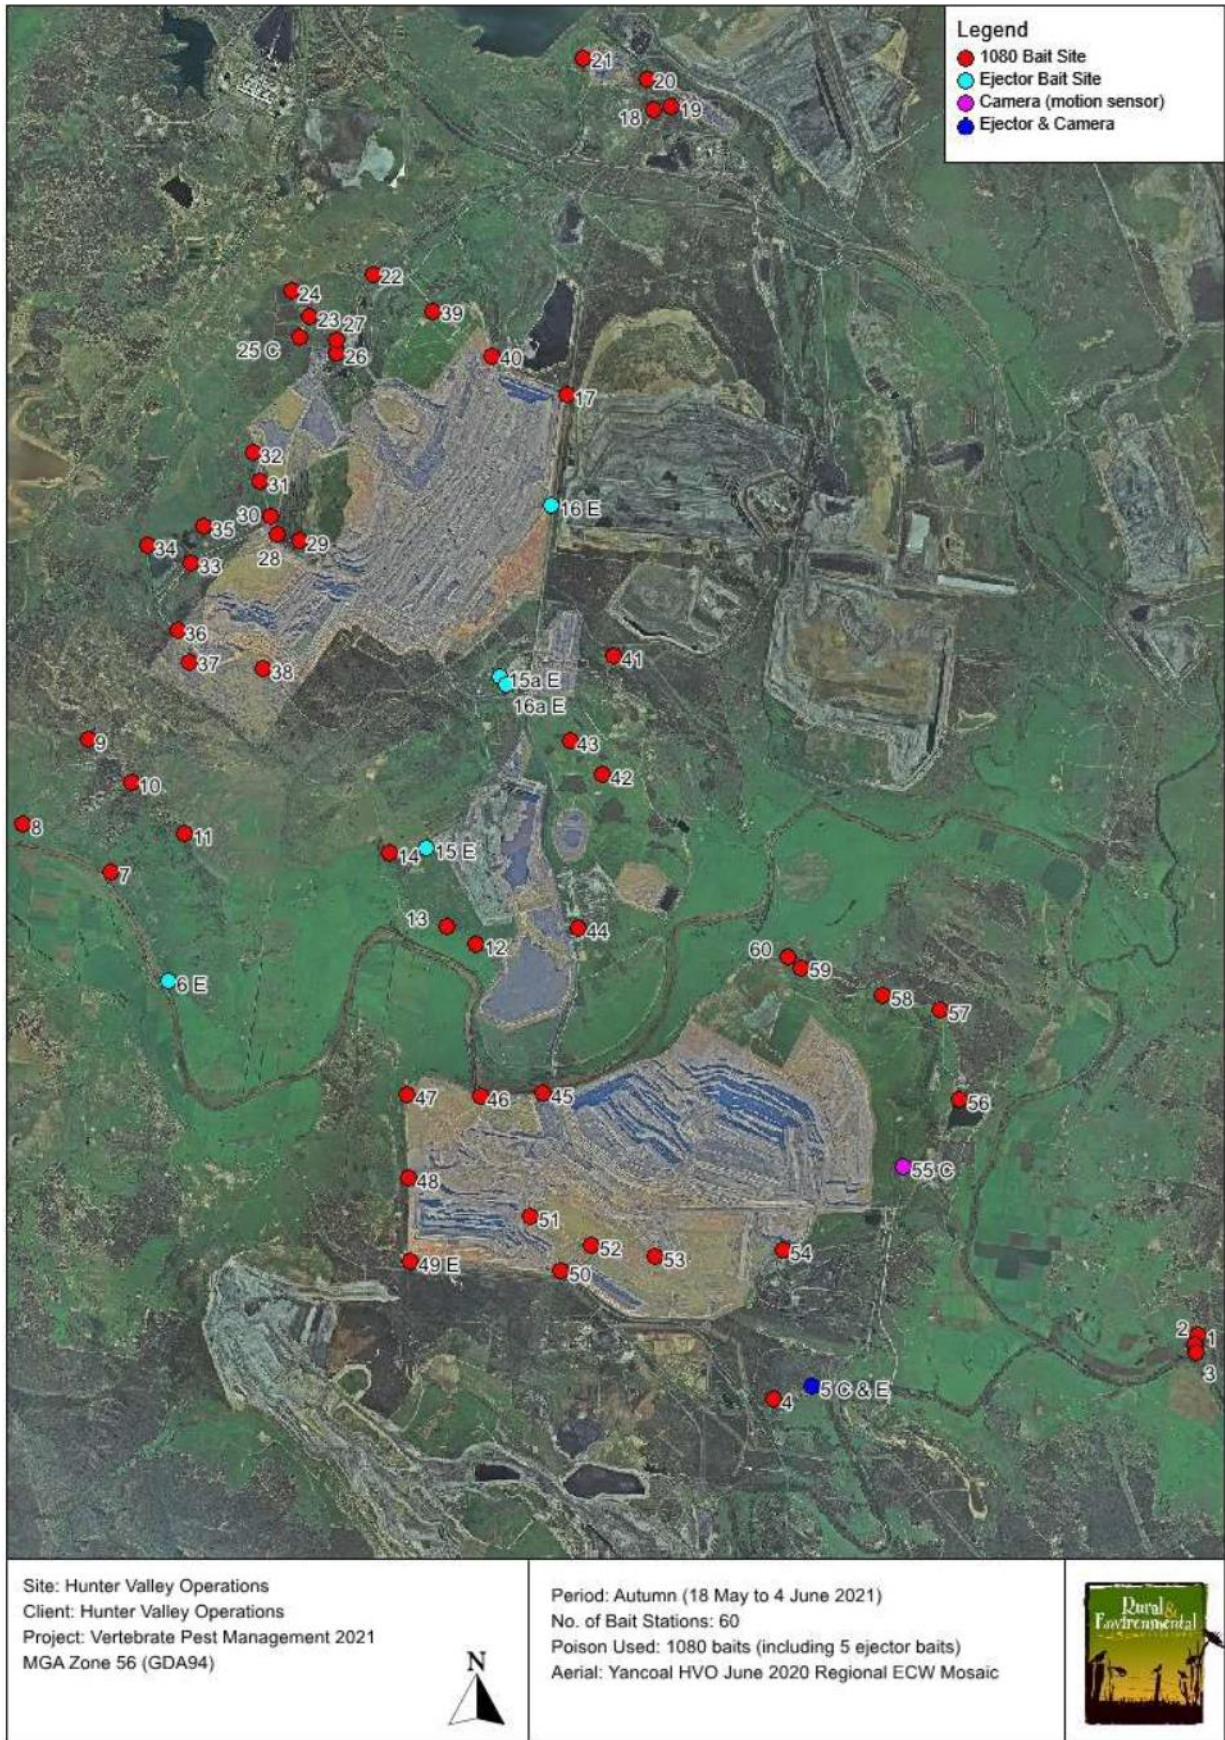
Figure 104 HVO Vertebrate Pest Management Bait Locations – Autumn 2021

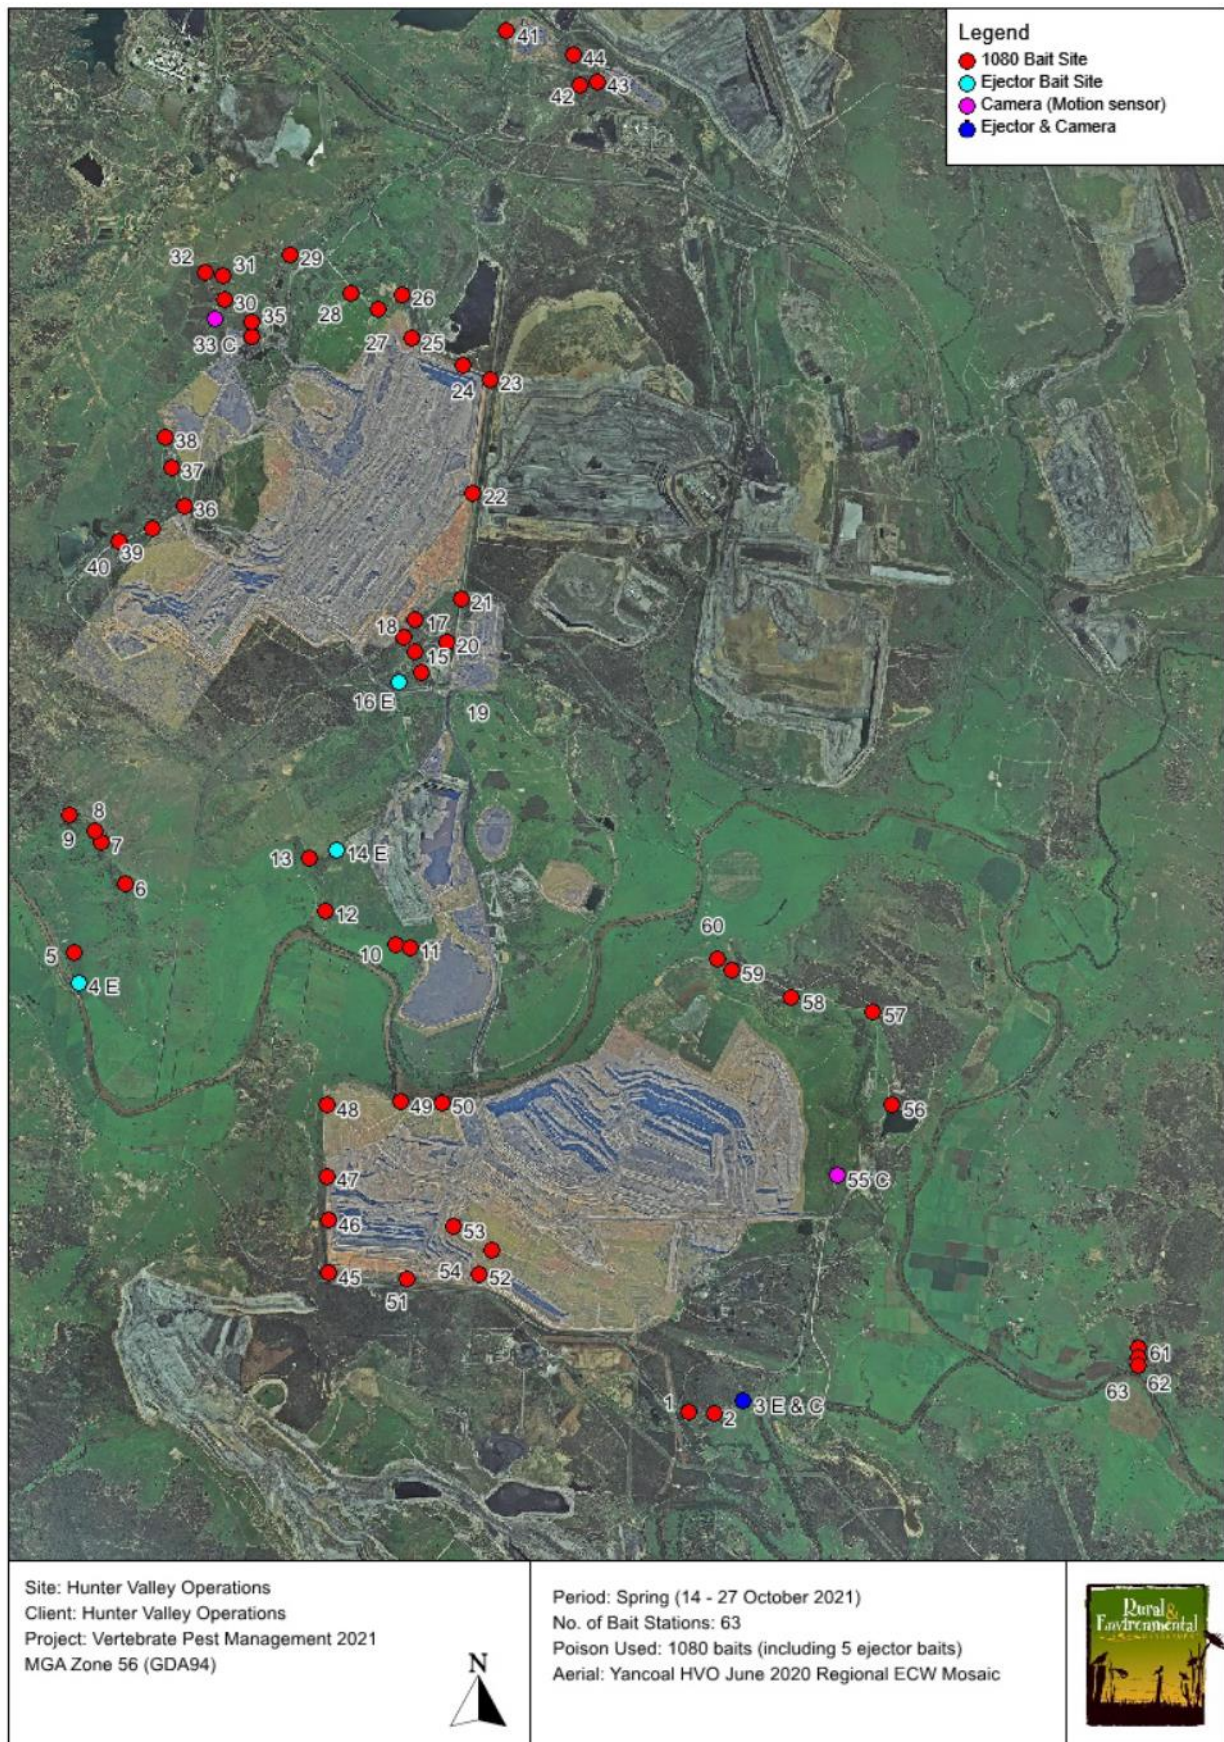
Figure 105 HVO Vertebrate Pest Management Bait Locations – Spring 2021

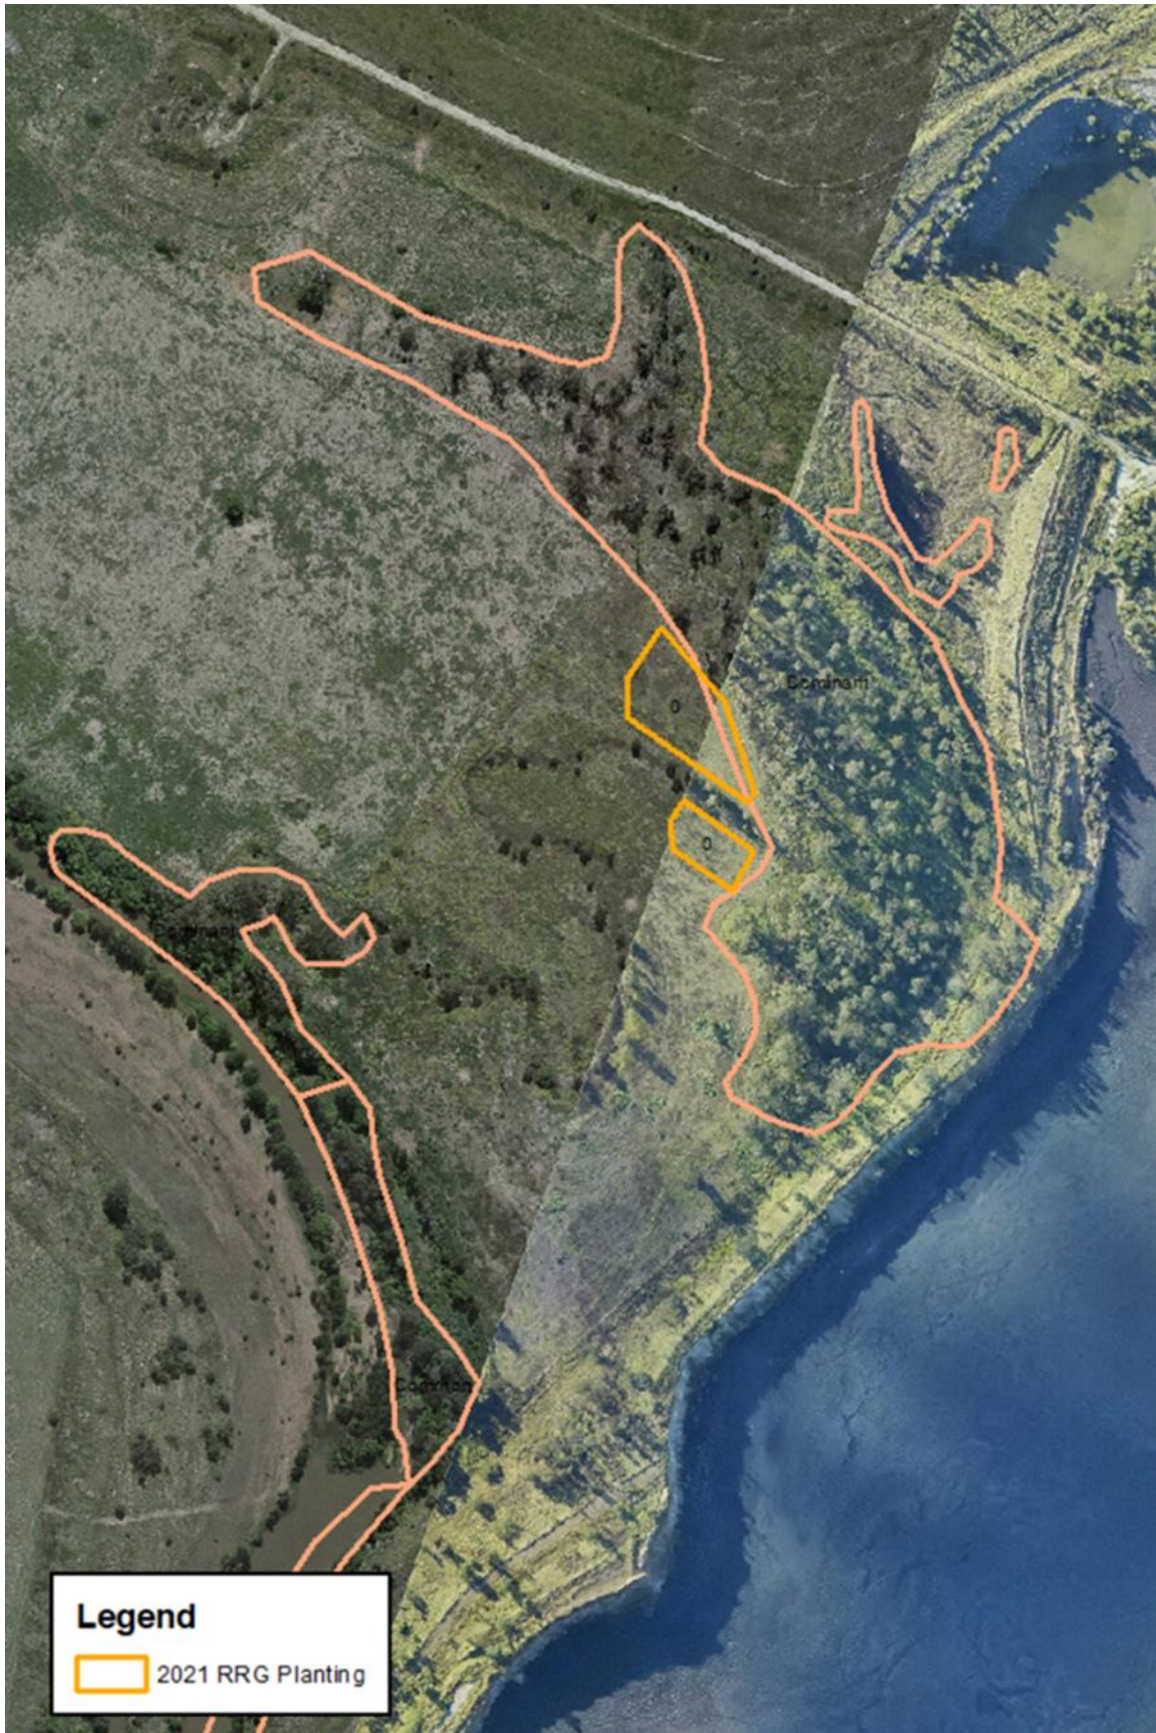
Figure 113 Location of the 2021 tubestock plantings at the Carrington billabong

As discussed previously, to assist to protect the existing stand at Carrington Billabong from future storm and wind damage, HVO planted an additional 200 *E.camaldulensis* tubestock within the Hunter River floodplain adjoining the billabong to broaden the population (Figure 113). These tubestock were watered and hand weeded as needed during 2021 to assist survival and establishment. A clear majority of these tubestock have survived and growth rate has exceeded expectations.

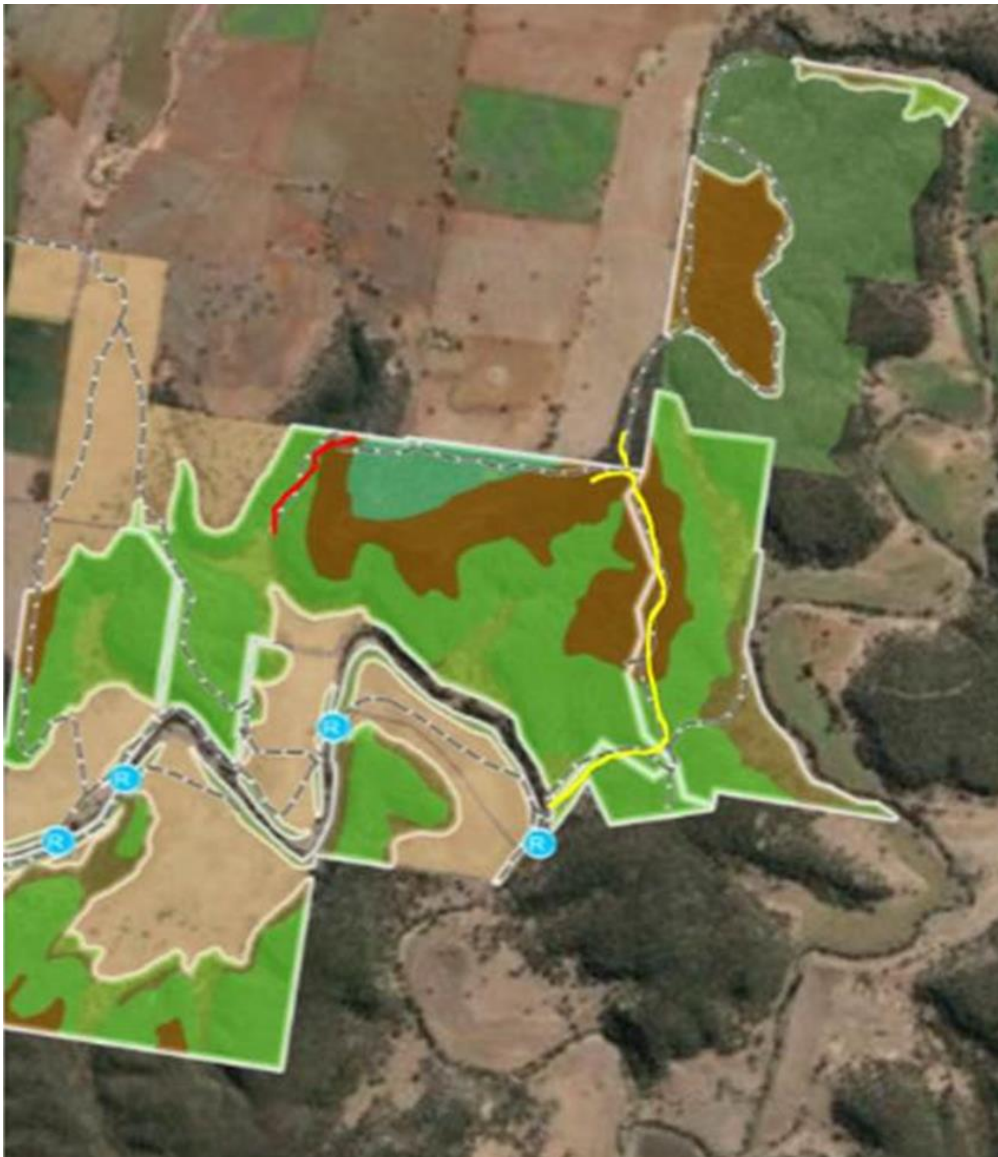
Figure 118 Access locations from the MTW offset to HVO's Goulbourn River Offset

HVO asked the adjoining landholder if access to the offset could occur via his property. Unfortunately, this request was denied on Covid 19 grounds and access to the HVO offset was only possible via the internal tracks. **Figure 118** indicates the current access across the Goulburn River (yellow track) and the alternate walking track (red track) that is currently being upgraded.
