Subject: Queensland Hunter Gas Pipeline Risk Submission
Application Reference No.: 06_0286

Historical Photographs of the 1982 Failure

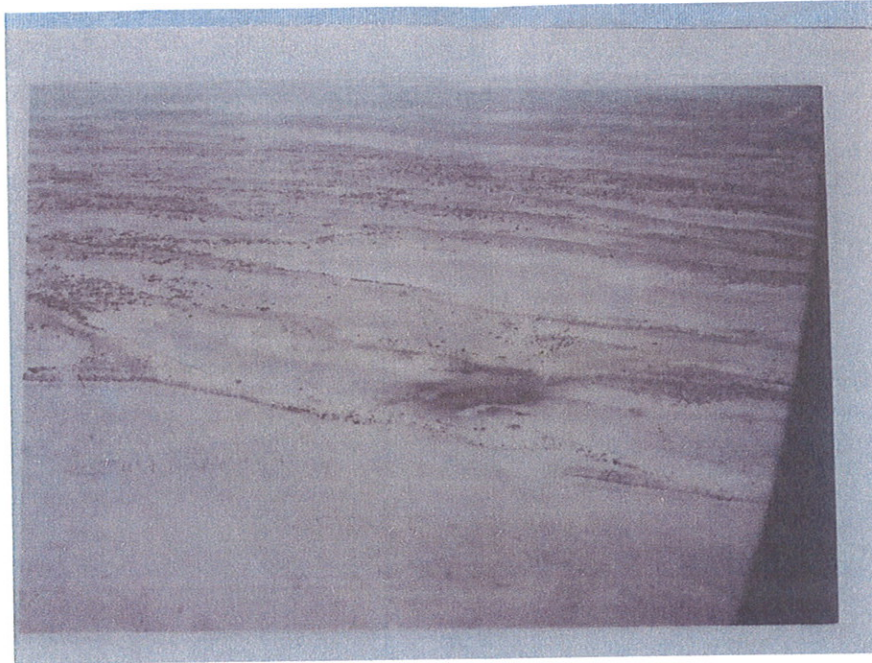
Aerial photograph of the original failure site at MW4.2 at Moomba in 1982 showing scorching of the clay pan and sand dune area for up to a distance of 400 metres from the explosion centre

approximately 4.2 kms from the Santos gas plant at Moomba in north east South Australia. (Refer attached photos of failure site).

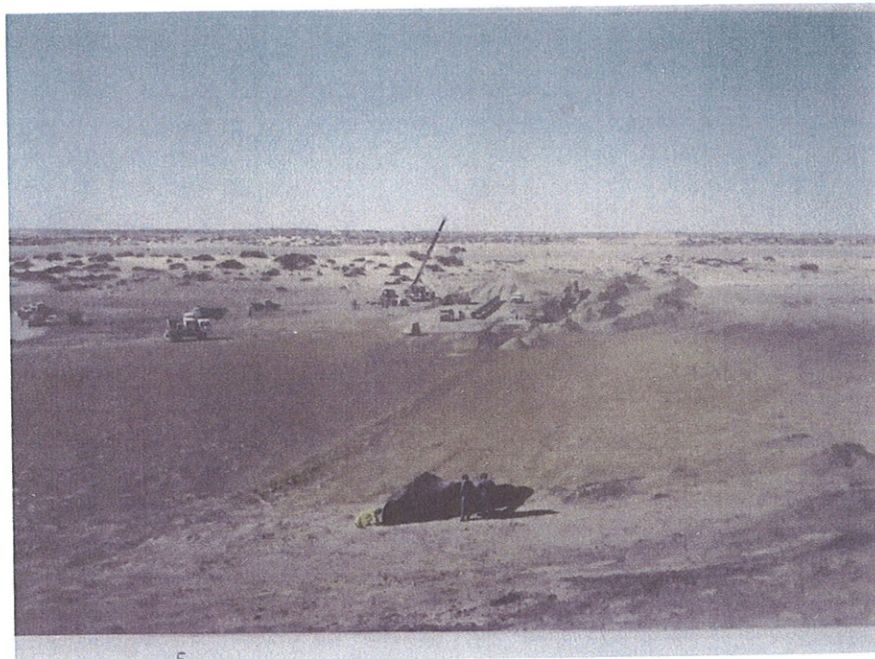
Section of pipe blown from the failure site 400 metres away caused by intergranular stress corrosion cracking (SCC)

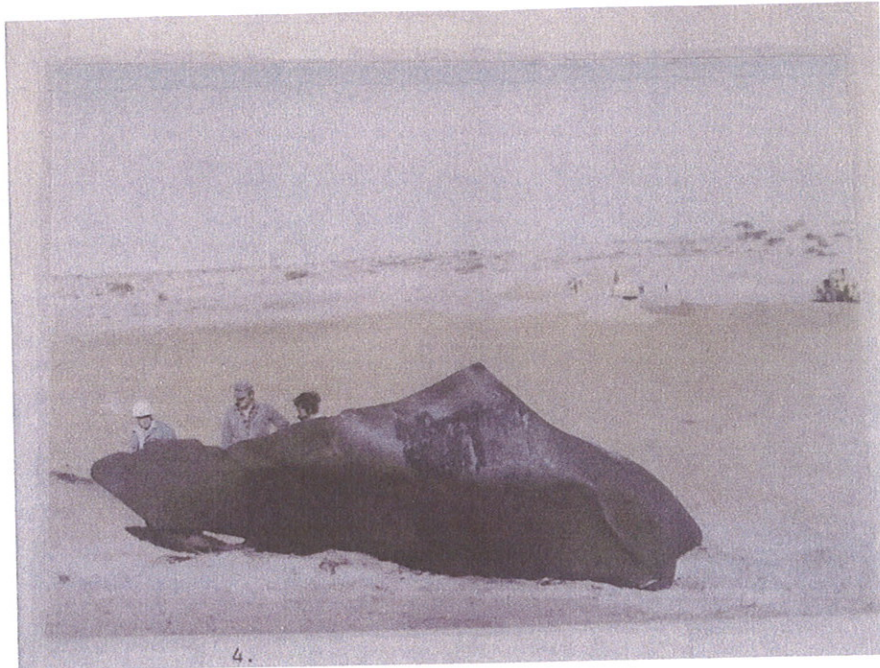
Close up view of the piece of fractured pipe blown out of the ground

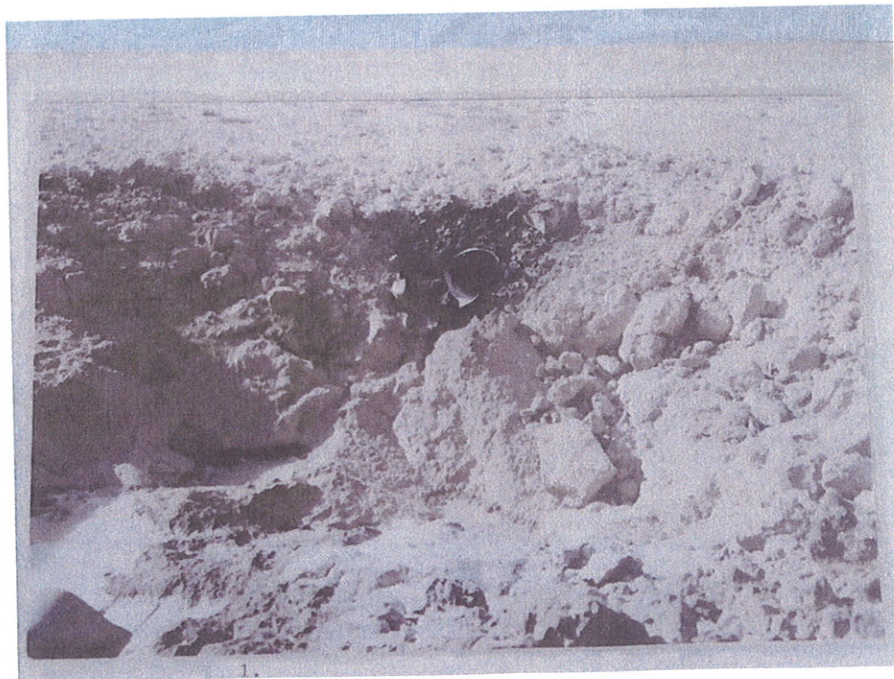
Explosion crater showing the down stream end of the fractured pipe

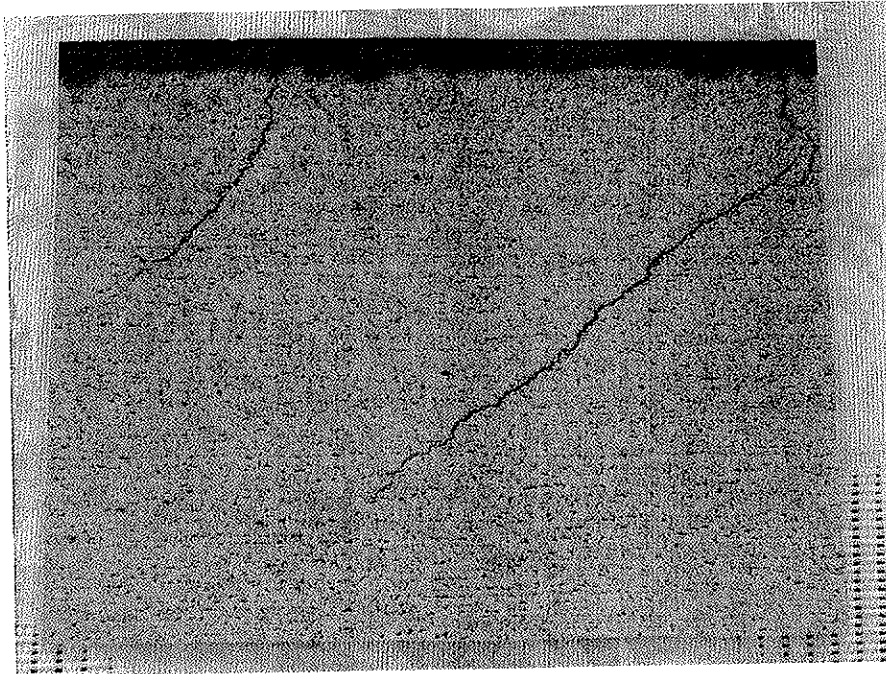
Macro photograph showing the typical 45° orientation of SCC in the X65 material pipe from the Moomba pipeline

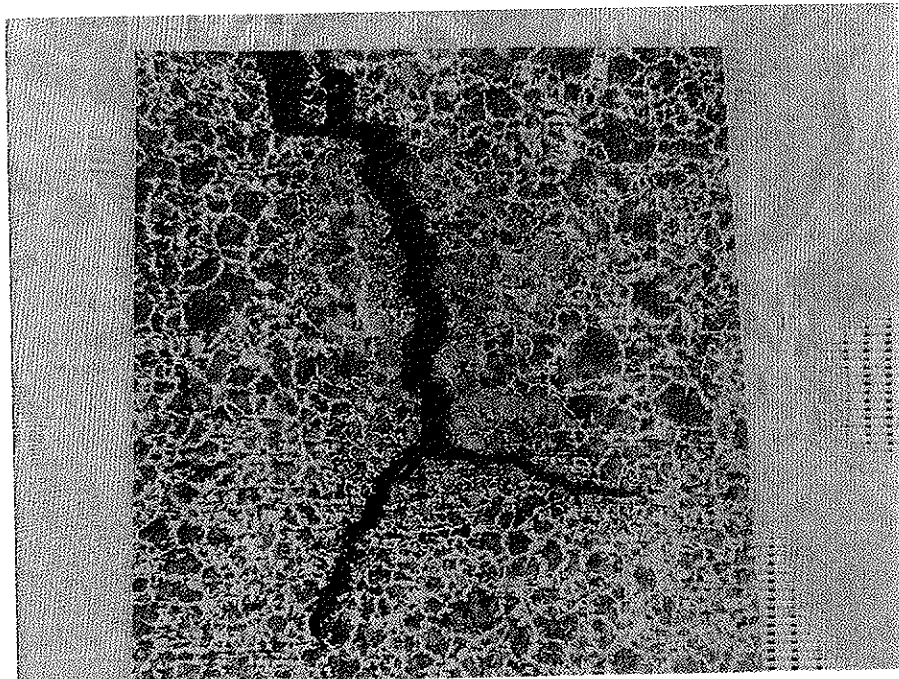
Micro photograph showing root branching of the intergranular SCC

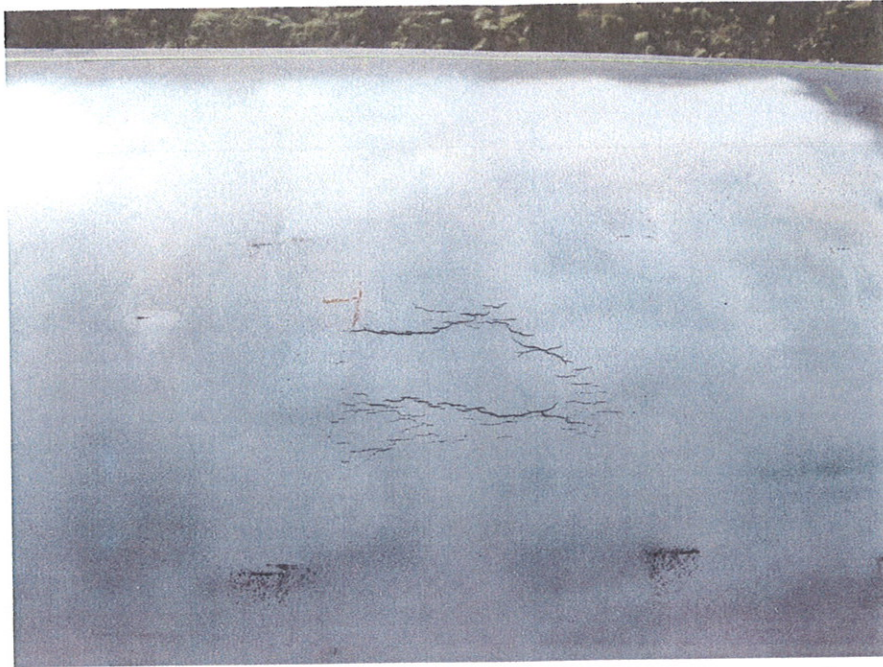
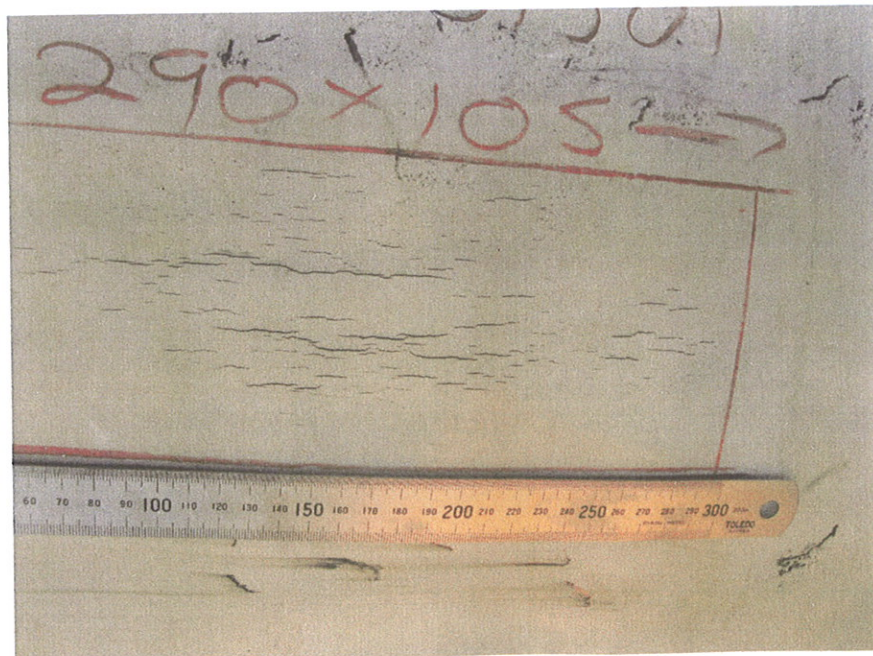
Photographs showing magnetic particle confirmation
of a colony of SCC after detection by ultrasonic examination

- Working on approximately 700 dig ups to date in the Moomba/Sydney gas pipeline from Moomba to Bulla Park (west of Cobar, NSW). This involves magnetic particle examination and ultrasonic depth determination and sentencing of SCC, while the pipe is in the operating and pressurized condition. This work is ongoing.
- Involved with the development of an automated ultrasonic mill inspection system to examine sub-sea gas pipelines constructed between Tasmania and Victoria.
- Involved with development of an automated inline ultrasonic inspection system for a pipe mill on the south coast.
