## ASSESSMENT REPORT

### Cadia East Gold/Copper Project

#### Cadia Hill Pit Tailings Deposition Modification (06\_0295 – MOD 11)

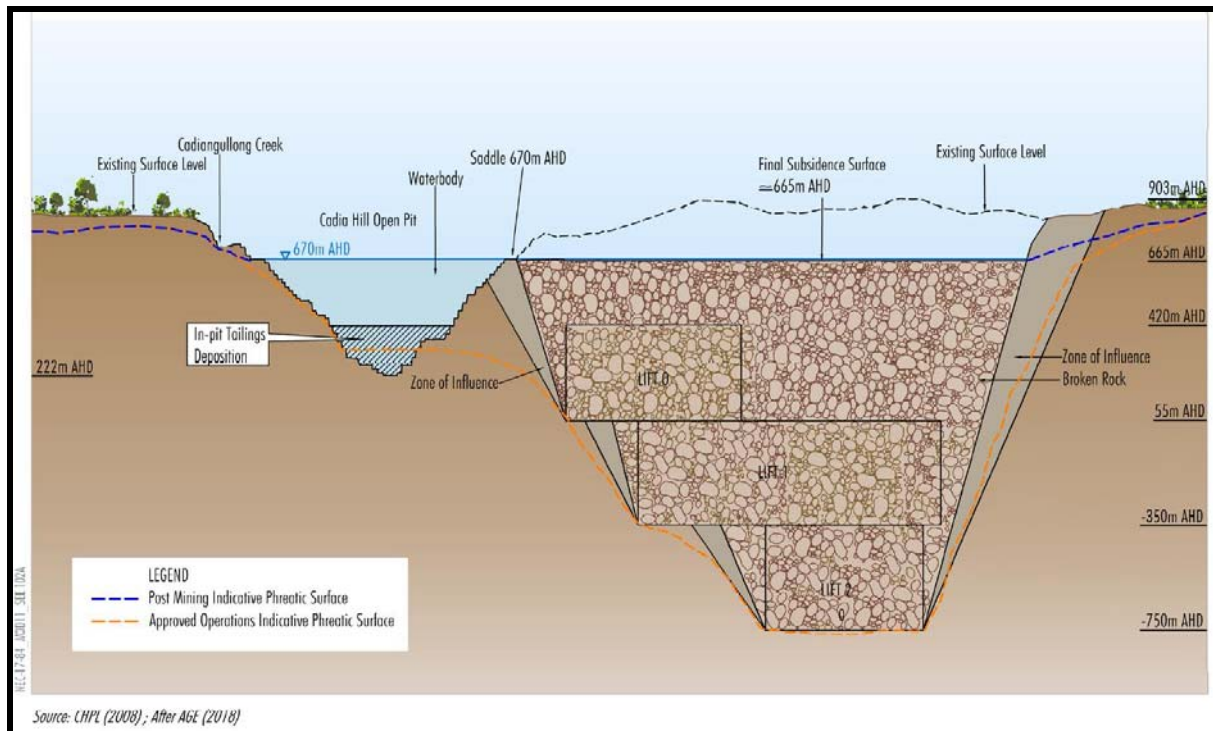
**Figure 3:** Groundwater levels during operations and post mining recovery

This occurs because groundwater from the surrounding rock flows into the open cut, the underground mining panels and the voids/fractures formed from subsidence of the land over the cave mining area. Once mining is completed, groundwater levels are predicted to recover until a new equilibrium is reached and a pit lake would form, with a direct hydraulic connection between the open cut pit and subsidence void (see **Figure 3**).

With the formation of a pit lake, there would be a permanent loss of groundwater from the system due to evaporation from the pit lake surface, with groundwater from the surrounding rock continuing to flow into the void due to the hydraulic gradient.

This means the area is predicted to remain a groundwater and surface water sink such that any leachate released from the tailings would not migrate to adjoining groundwater or surface water resources.

The predicted equilibrium level of 670m AHD for the pit/subsidence lake would also be 51 m below the spill point at 721 AHD into the adjoining surface water system, with the base level of Cadiangullong Creek at 708 m near the pit, 38 m above the pit lake equilibrium level.

This very low permeability is supported by the low groundwater inflow observed seeping into the pit and the high pore water pressure measured close to the pit wall. This is shown in **Figure 3** above where the groundwater or phreatic surface during mining operations is maintained near the void wall. It is estimated from groundwater modelling that there is currently around 0.7 megalitres (ML) of seepage into the pit daily.
