Cadia MOD13 Cadia Hill Tailing Completion Groundwater Assessment

Prepared for
Cadia Holdings Pty Limited

Project No. G1383R August 2019
www.ageconsultants.com.au ABN 64 080 238 642

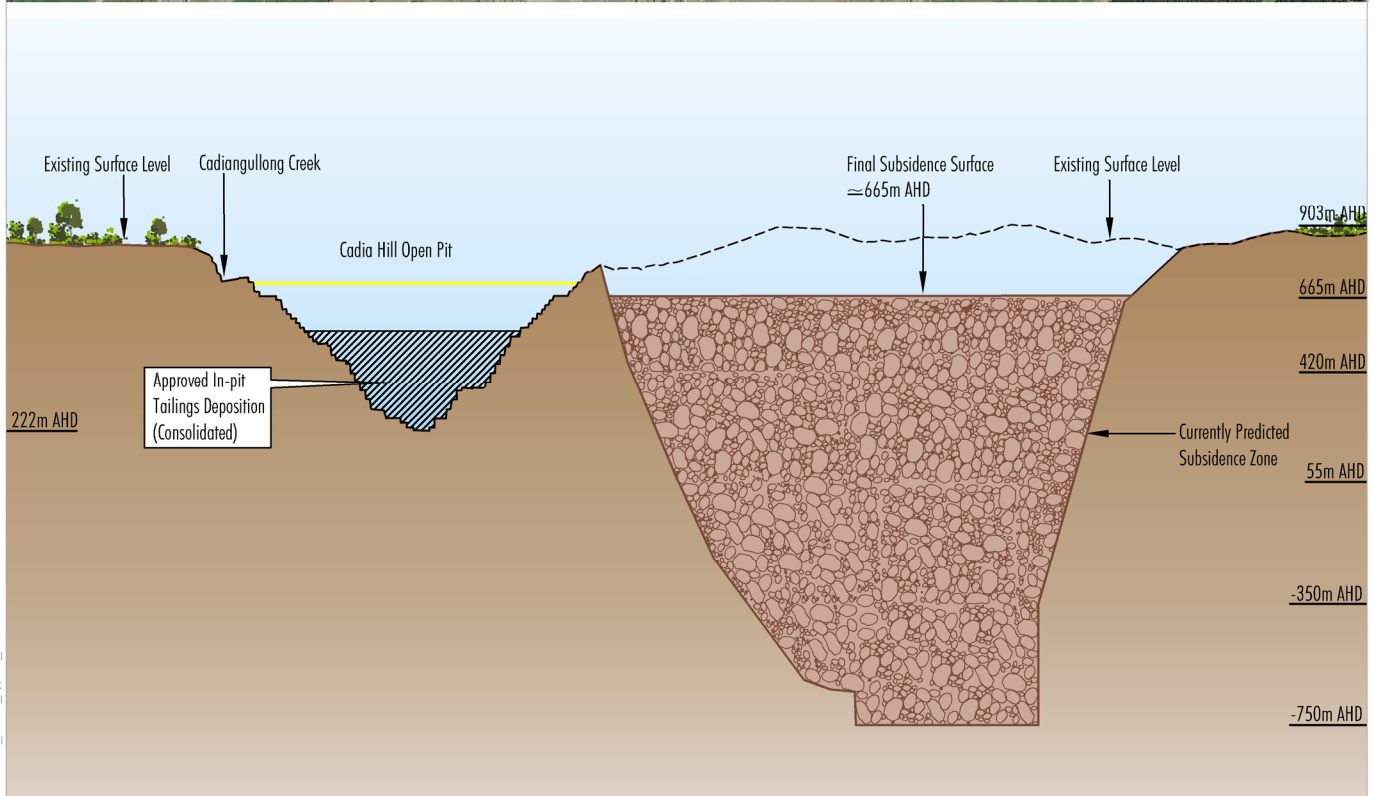
LEGEND
 Proposed Modification In-pit Tailings Deposition (Pre-consolidated)

Figure 1.1 shows the locations of Cadia Hill open pit and the footprint of the proposed tailings emplacement. Figure 1.2 includes a long section through Cadia Hill open pit and Cadia East. Previous subsidence assessments have shown the Cadia East subsidence merging with the Cadia Hill open pit. Revised subsidence assessments now show this will not occur, with Cadia Hill and Cadia East being two separate voids. It also illustrates the relationship of the tailings emplacement with the Cadia East underground mine and the surrounding environmental features including Cadiangullong Creek.

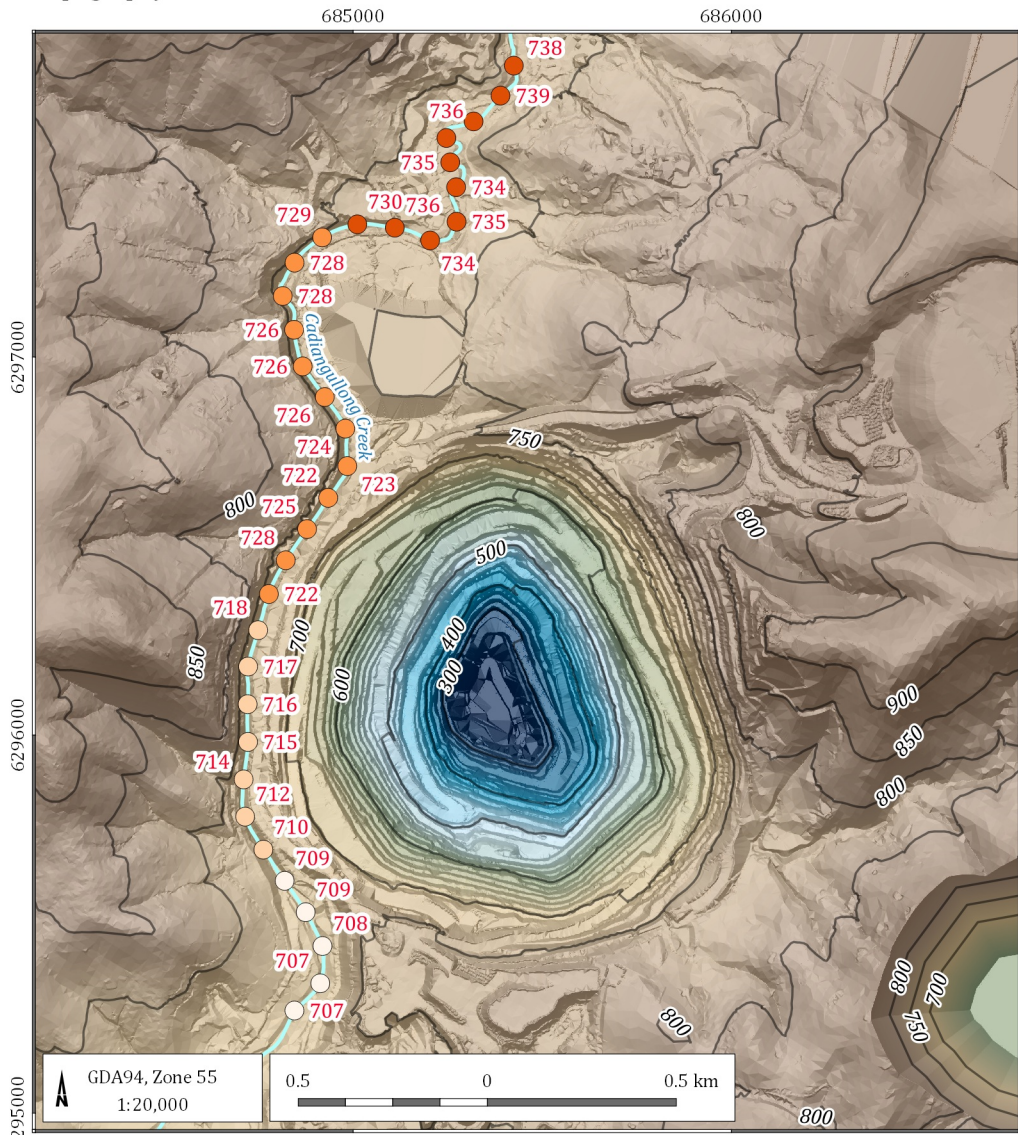
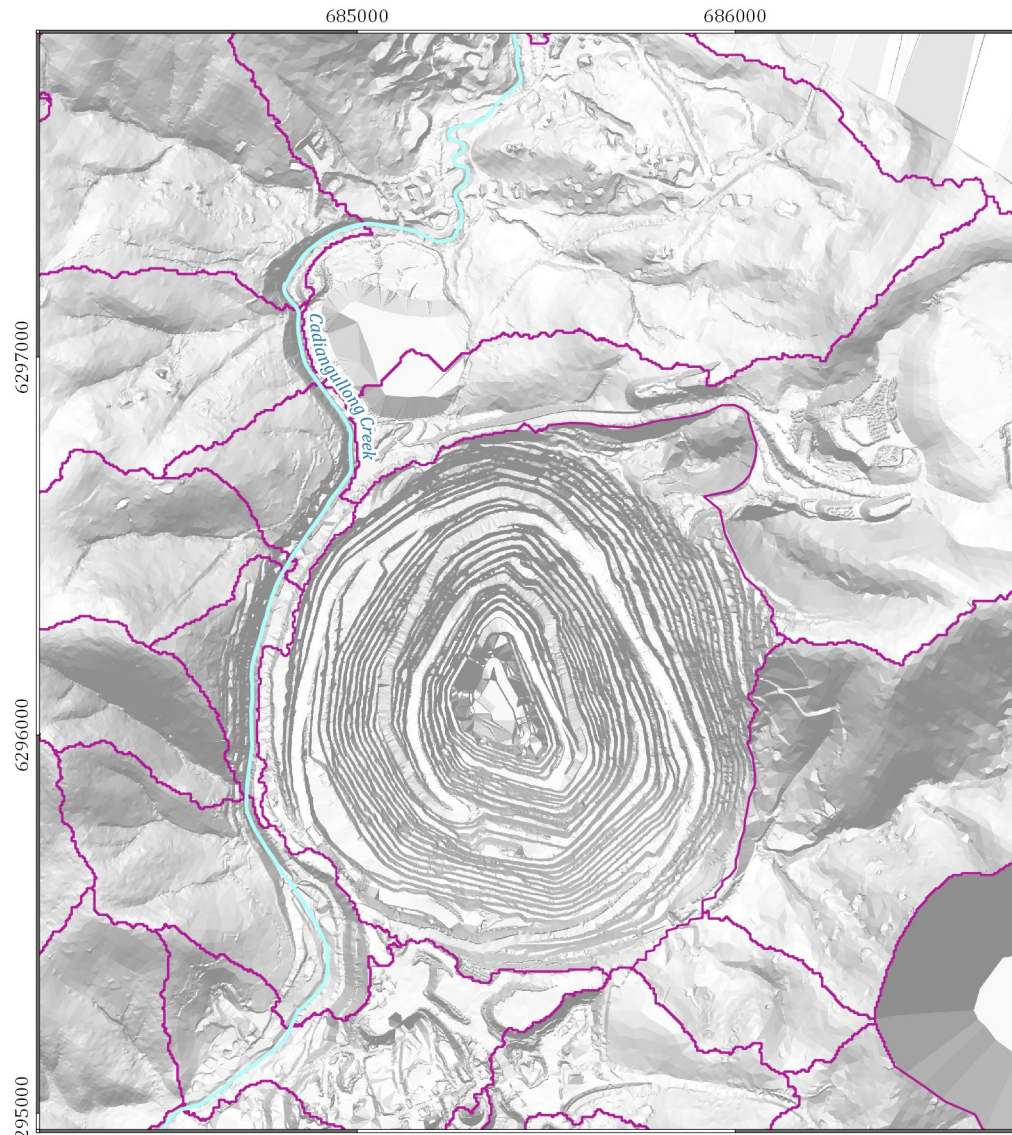
Topography

Creek		Elevation contour
	Catchment

Topography (mAHD)		Cadiangullong Creek invert level (mAHD)	
	200		700 - 710
	300		710 - 720
	400		720 - 730
	500		730 - 740
	600		740 - 750
	700		
	800		
	900

Catchment

Cadiangullong Creek drains from north to south around the western side of the Cadia Hill Pit via a diversion adjacent to the western crest. The elevation of the Cadiangullong Creek Diversion invert ranges from 741 mAHD at the northern side of the pit, to 707 mAHD at its southern side, as shown in Figure 2.1. Flow is maintained in Cadiangullong Creek by releases from the upstream Cadiangullong Dam as required by Project Approval 06_2095.

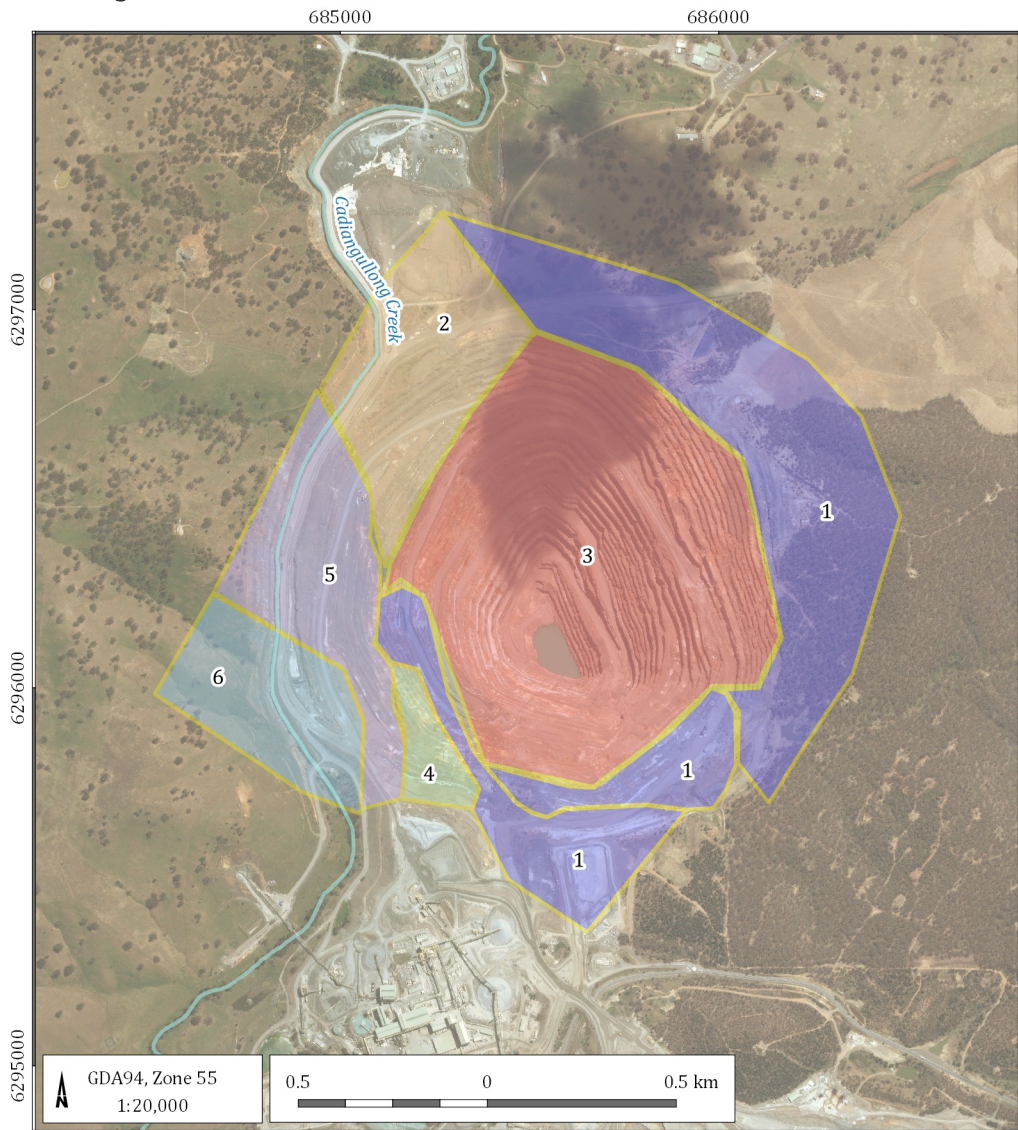
Lithological domain

Hydrogeological domain

- Domain H1 - characterised as being highly fractured and jointed and therefore very permeable. Groundwater levels rise and fall rapidly in response to rainfall and when dry conditions occur. The upper weathered zone is primarily sediments.

- Domain H3 - comprises moderately to highly weathered and fractured volcanics that are typically depressurised with groundwater levels likely to be in excess 50 m from the slope face.

- Domain H7 - located on the footwall of Purple Fault and hanging wall of Cadiangullong Fault. The rock mass is typically fractured but with a low permeability that is probably due to clay infill within structures. Historically, groundwater levels are elevated even with mining development adjacent to the pit wall, and drainholes drilled in this area generally intersect flows.

- Domain H8 - located on the footwall of the Cadiangullong Fault and the hanging wall of the South Footwall Fault, and is also intersected by the Fishtail/Baroness thrust fault. This rock mass comprises large blocks intersected by structures. Depending on slope aspect in relation to the structures, good dewatering can be achieved.

Further data collection would also be undertaken to better understand the local hydrogeological regime in the southern and western areas of the Cadia Hill pit. To achieve this, additional groundwater monitoring bores suitable for measuring groundwater levels and water quality would be installed outside the pit shell and along Cadiangullong Creek. Drilling and testing would incorporate in-situ packer tests to measure fracture network permeability. In-pit mapping of faulting and fractures (if safe access is available) would focus on hydrogeological domains H1, H3, H5 and H6 (Figure 2.2).

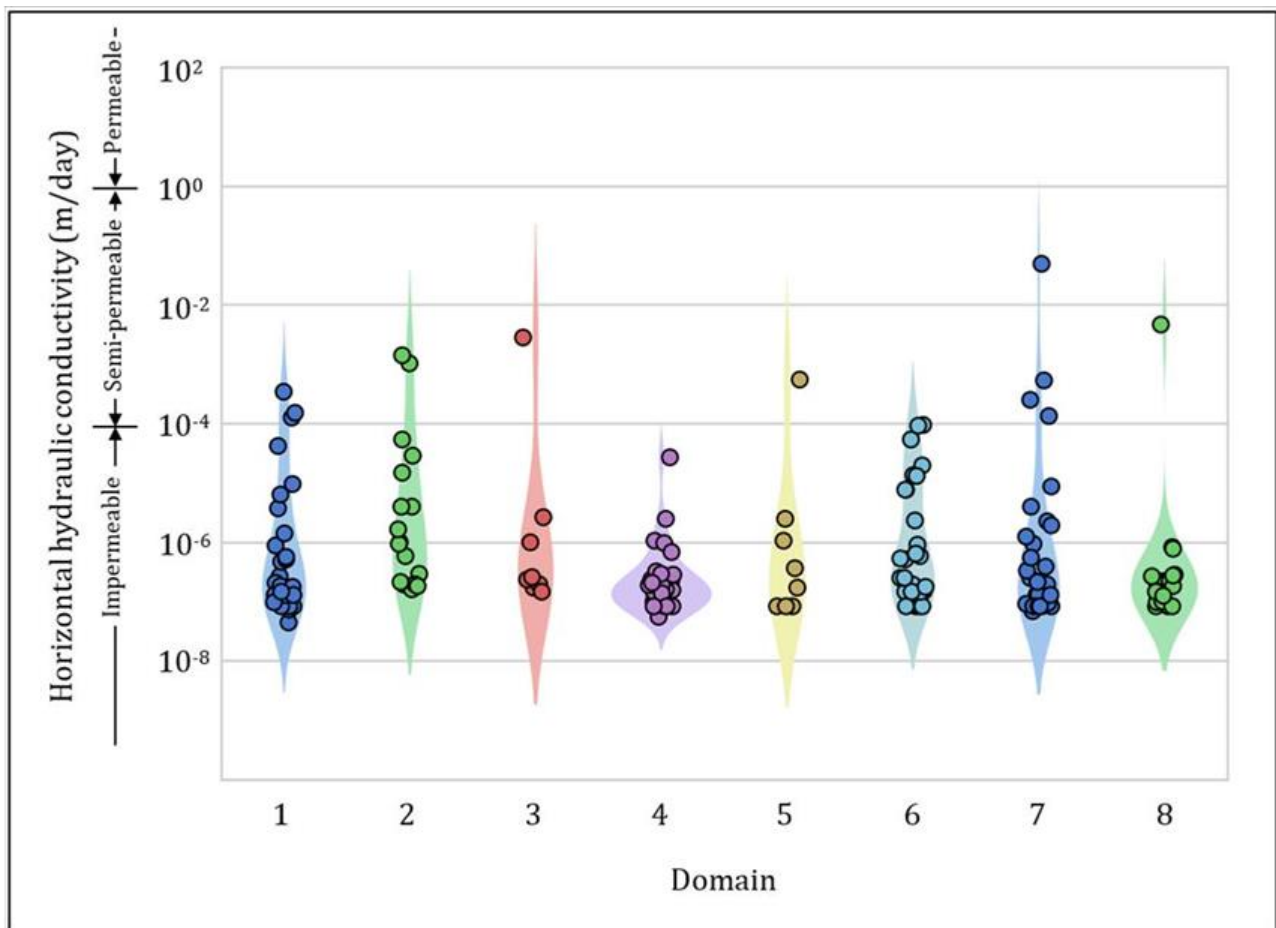
Figure 3.1 Drill core primary permeability testing results for Cadia Hill Pit

CHPL has recently completed laboratory testing of primary permeability in 195 drill core samples collected from the eight hydrogeological domains around the Cadia Hill Pit shell. Figure 3.1 shows the results of this testing graphically, and categorises the results as either impermeable, semi-permeable or permeable. The permeability values for the lithologies tested for each hydrogeological domain are typically between 10^{-4} m/day and 10^{-8} m/day with a median of 1.1×10^{-7} m/day. This is equivalent to a range of 10^{-9} m/sec to 10^{-13} m/sec with a median of 10^{-12} m/sec. The testing data therefore indicates that the rock matrix in which the Cadia Hill pit is constructed, has a very low permeability and is, in some areas, essentially impermeable. This means groundwater flow occurs largely via defects such as fractures and joints.

The permeability test data makes reference to those core samples with hydraulic conductivity values greater than 10^{-4} m/day being fractured. This indicates that where small fractures occur, and the lab methodology allowed testing, the rock mass becomes semi-permeable, potentially allowing the transmission of groundwater. The descriptions provided by Newcrest (2015) for each of the hydrogeological domains indicates that defects can vary from widely spaced to closely spaced and are associated with faults. The extents of the major structural features mapped by Newcrest (2015) in the Cadia Hill Pit walls are shown in Figure 3.2.

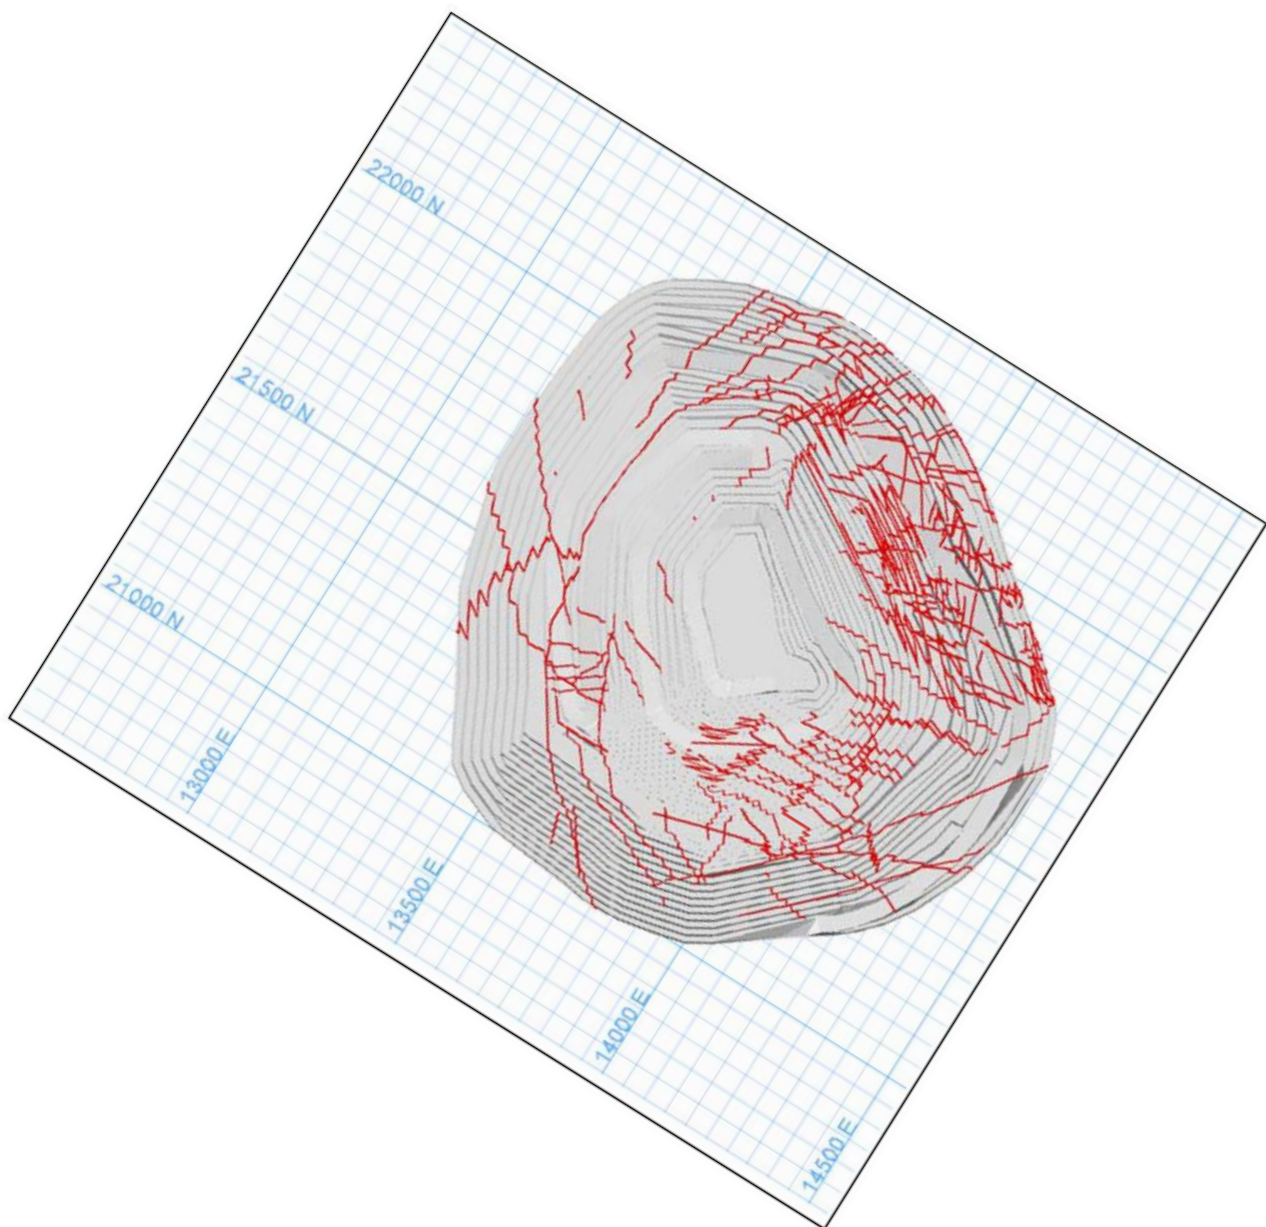
Figure 3.2 Cadia Hill Pit shell and large-scale structural features (faults) (Newcrest 2015)

This shows that major structural features are mostly located within the eastern walls of the pit, and to a lesser extent along the western and southern walls. It should be noted that the image is based on the local mine grid, and has been rotated 32 degrees anticlockwise to return it to true north. Given the generally impermeable nature of the rock matrix, groundwater movement is expected to largely occur through the structural features (where these are permeable).

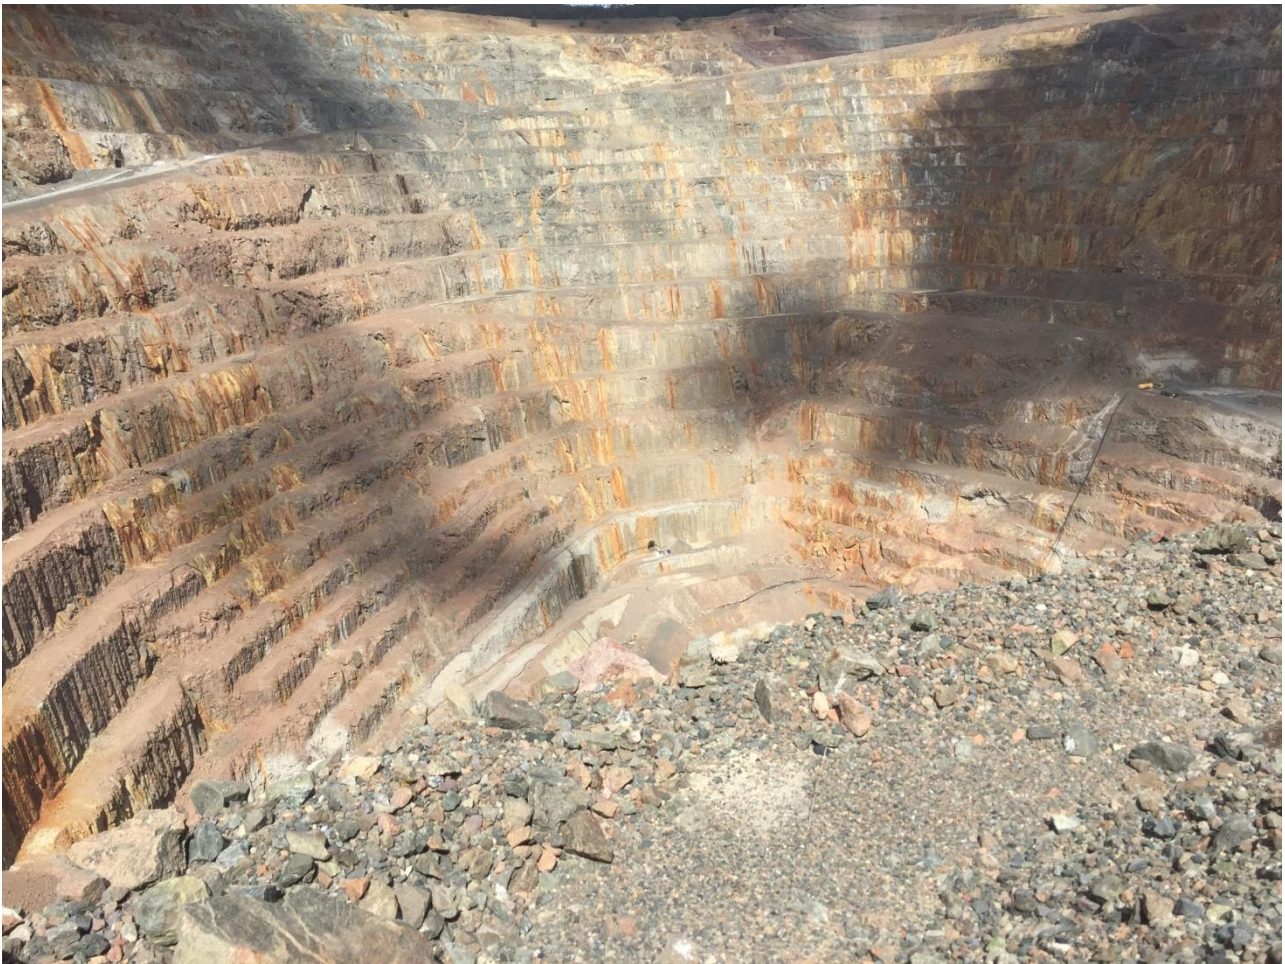
Figure 3.3 Photo within Cadia Hill Pit showing limited and isolated seep zones (2018)

During operations, groundwater inflow into Cadia Hill open pit could not be directly measured as it occurred as slow seepages across the pit walls that mixed with runoff, or was readily evaporated, or bound by capillary action to the excavated ore and waste rock. Figure 3.3 below illustrates the rock mass exposed within the Cadia Hill open pit and the localised seepage zones evident as zones of iron staining on the walls. Whilst this photograph shows minor visible seepage, the extent of the iron staining provides an indication of historic seepage from the pit walls.

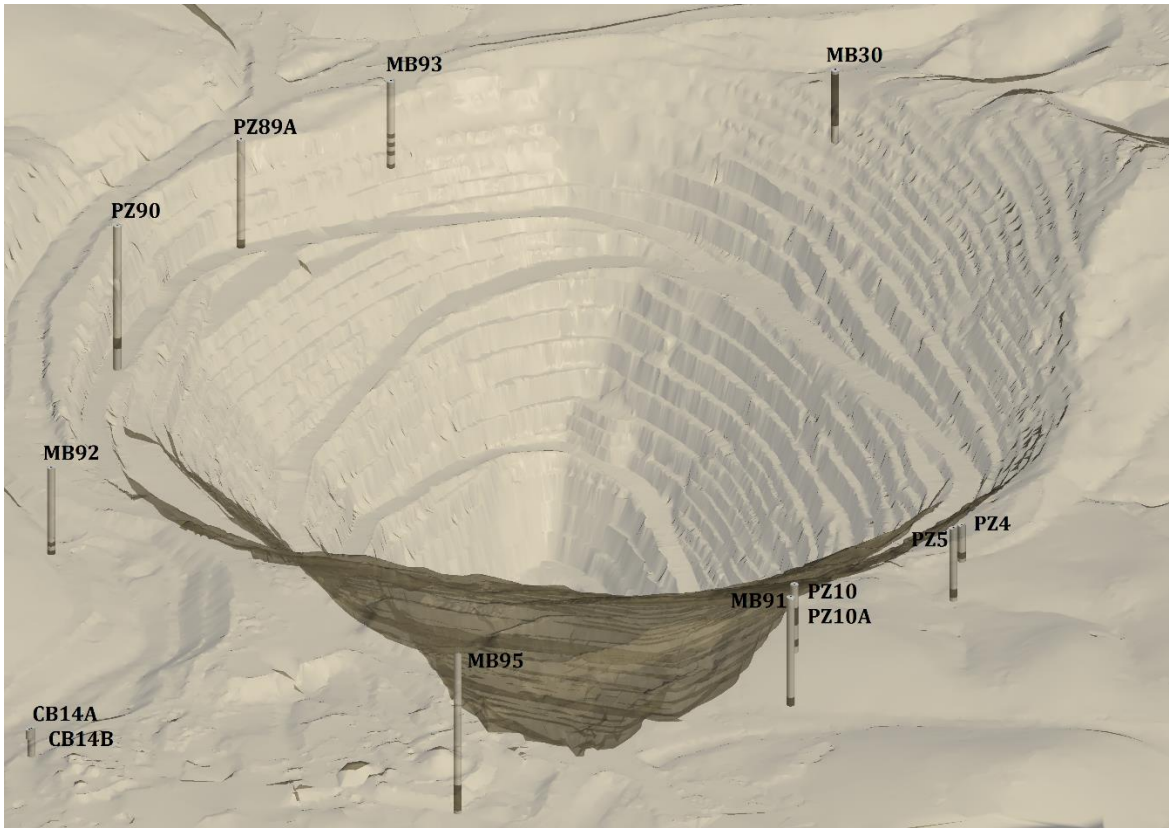
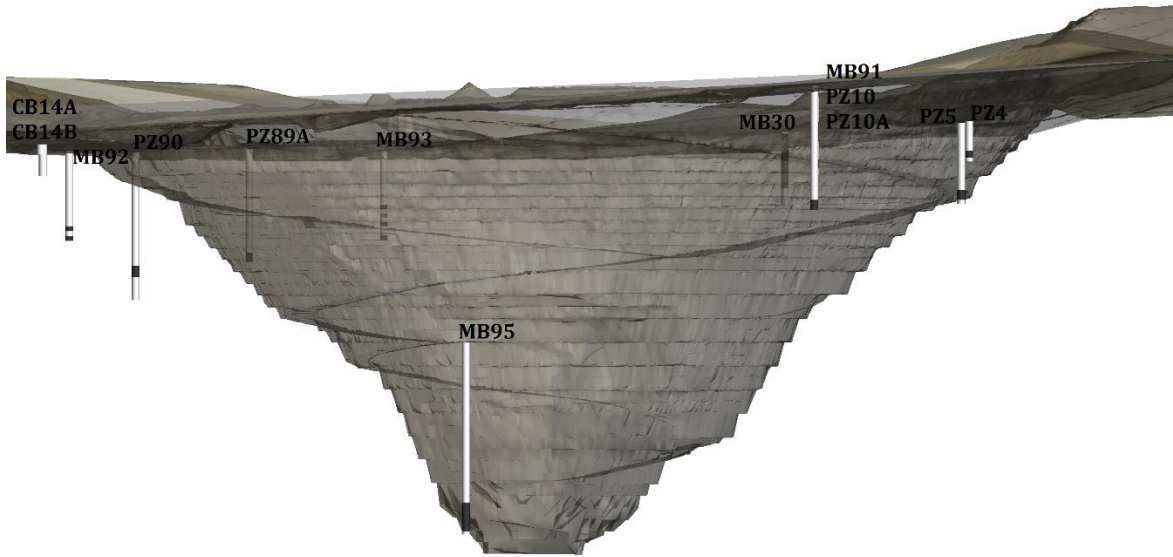
Figure 3.5 Isometric views of monitoring bore network looking north

Isometric views of the monitoring bores in relation to the pit shell are shown in Figure 3.5.

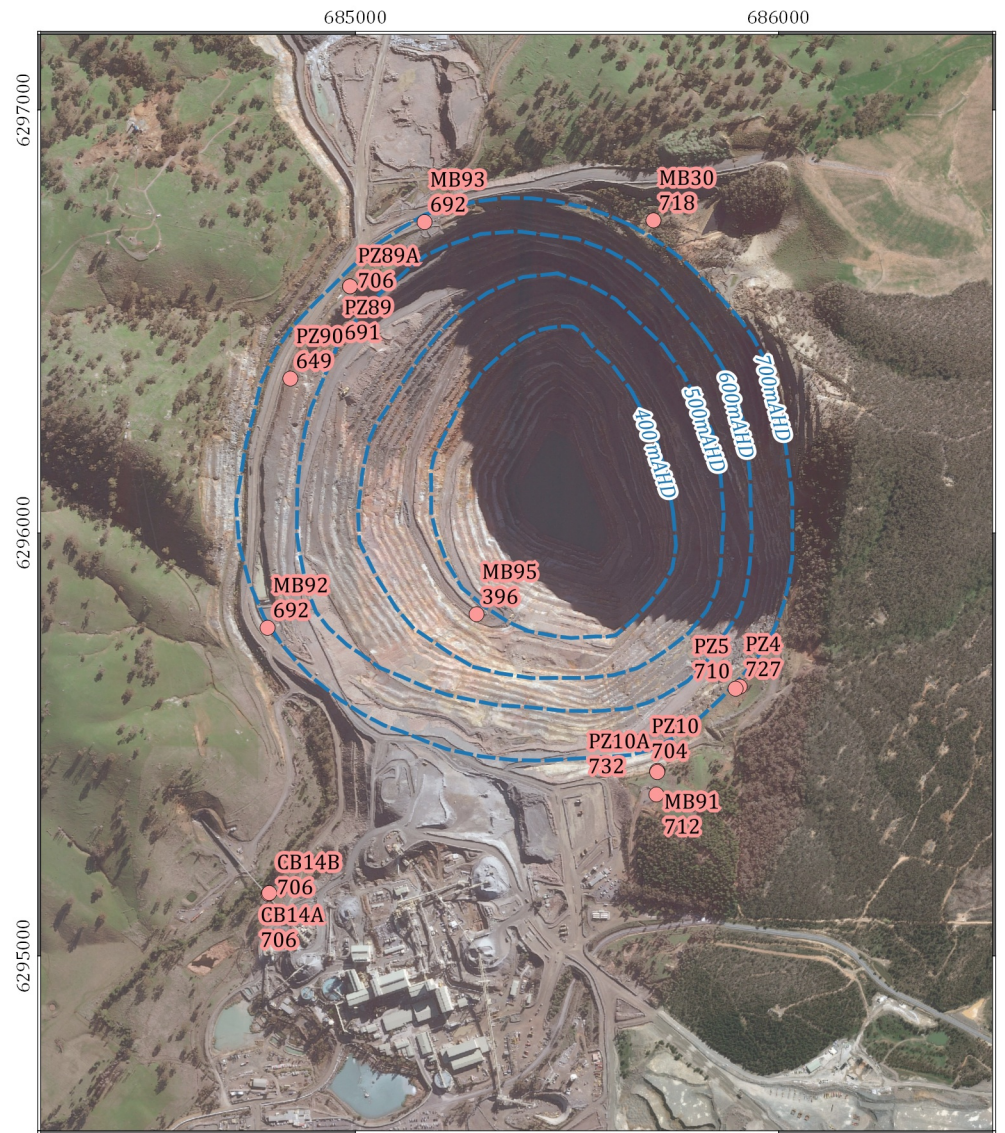
FIGURE No:
3.6

Water level - September 2012

Water level - December 2018 to February 2019

- LEGEND**
- Monitoring bore ID and water level - mAH (September 2012)
 - Monitoring bore ID and water level - mAH (December 2018 - February 2019)
 - Inferred groundwater contours (mAH)

Prior to mining commencing at Cadia Hill, groundwater levels measured in 1997 ranged from 705 mAHD south and 726 mAHD north of the open pit footprint (AGE, 2009). During mining of Cadia Hill, CVO measured pore pressure within the pit walls using a series of geotechnical piezometers. The observations from Newcrest (2015) within each of the hydrogeological zones indicate variable and localised groundwater drainage from the pit wall. However, the piezometer data after the commencement of mining indicates that a very steep hydraulic gradient remains in place within the rock mass and does not extend far from the pit shell. This is consistent with the description of the hydrogeological regime in Sections 3.1 and 3.2 (i.e. a very low permeability rock mass). Groundwater levels measured from monitoring bores in 2012 (when mining ceased) are presented in Figure 3.6. This figure also displays additional groundwater level data measured between December 2018 and February 2019, which indicates that water levels have only varied a matter of metres over the last 6 to 7 years. Some have increased whilst others have decreased, showing it is clear steep hydraulic gradients driving groundwater towards the pit have remained in place.

Figure 3.6 shows that groundwater levels measured within the existing monitoring network are above 699 mAHD in the monitoring bores installed on the eastern edge of the Cadia Hill pit. This indicates groundwater will flow into, not out of, the pit in this area. Along the western and south-west walls of the Cadia Hill pit current measurements of groundwater level are commonly less than 699 mAHD. The lower groundwater levels are either a result of depressurisation and resultant lowering of water levels from mining activities or are representative of equilibrium conditions at the point of the bore. To determine the potential for 'source' or a 'sink' to occur in the southern and western areas of the pit shell additional water level measurement points are required further from the pit shell. Whilst there are few bores in these areas to measure groundwater levels it is likely that groundwater levels rise outside the pit shell and would create an inward hydraulic gradient into the pit. This is indicated by the catchment mapping for the Cadia Hill Pit and surrounds, that shows the topography surrounding the southern, eastern and western sides of the pit are higher than the pit crest. Groundwater levels in poorly transmissive fractured rock are commonly a subdued reflection of the terrain which would indicate that groundwater levels rise above 699 mAHD to the west of the pit. Higher groundwater levels in these areas were predicted by groundwater modelling undertaken for the Cadia East Project which is reproduced in Figure 4.1. The modelling shows post-mining groundwater levels in excess of 730 mAHD to 750 mAHD to the north-east to west of the Cadia Hill open pit. The lowest groundwater levels are predicted to be in a small zone at the southern wall of the pit where the Cadiangullong Creek is located. In this area the previous numerical modelling indicates groundwater levels are between 700 mAHD and 710 mAHD.

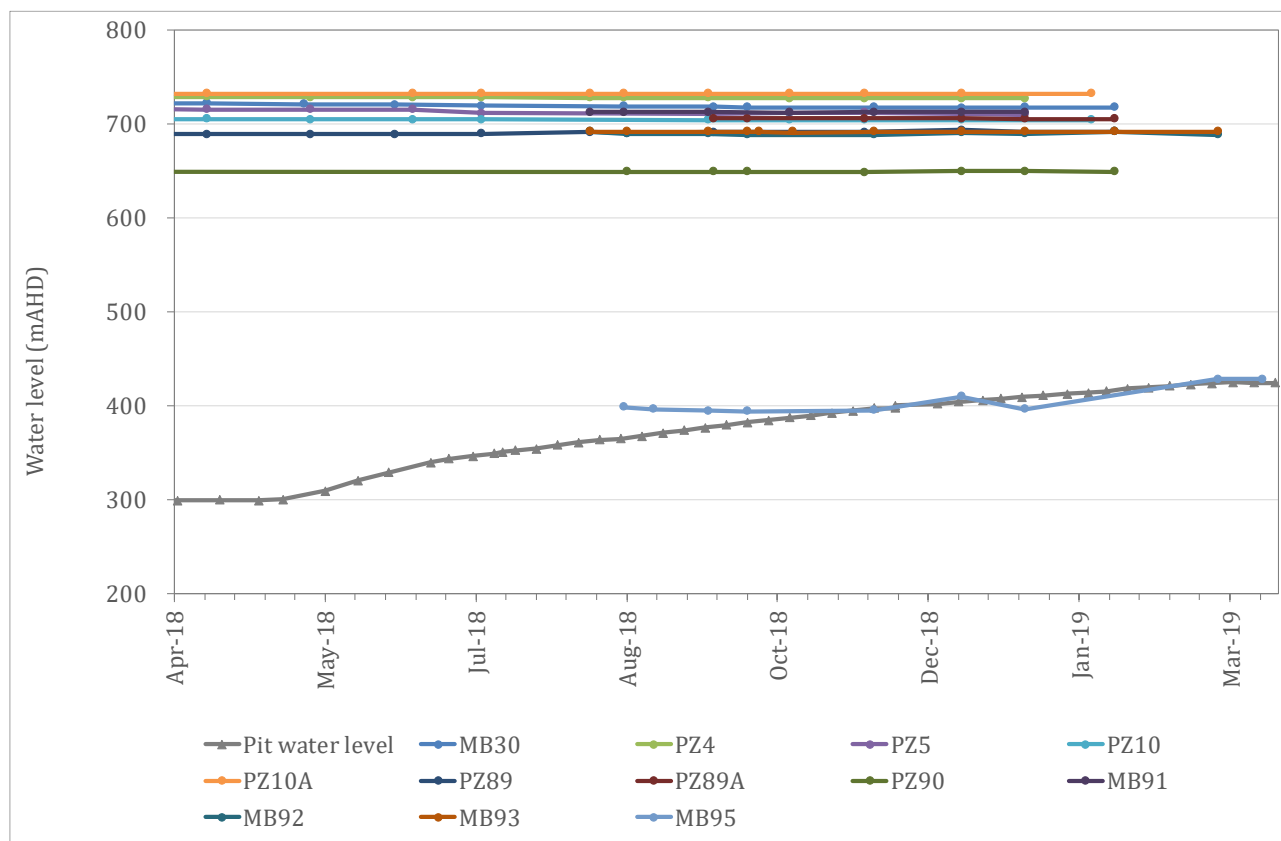
Figure 3.7 Hydrograph showing groundwater response to Cadia Pit water levels

Figure 3.7 below shows groundwater levels recorded from the monitoring bores surrounding Cadia Hill open pit since deposition of tailings commenced. Groundwater levels in the more elevated bores around the crest of the Cadia Hill open pit have generally remained static since tailings emplacement commenced. Monitoring bore MB95 which is installed towards the base of the Cadia Hill open pit and has recorded a gradually rising water level since the tailings level reached the groundwater level in this bore in November 2018. Thereafter, the groundwater level has risen at a similar rate to the pit water level. This indicates a localised hydraulic connection along fractures within the pit wall between the pit water level and the nearby surrounding groundwater level at depth.

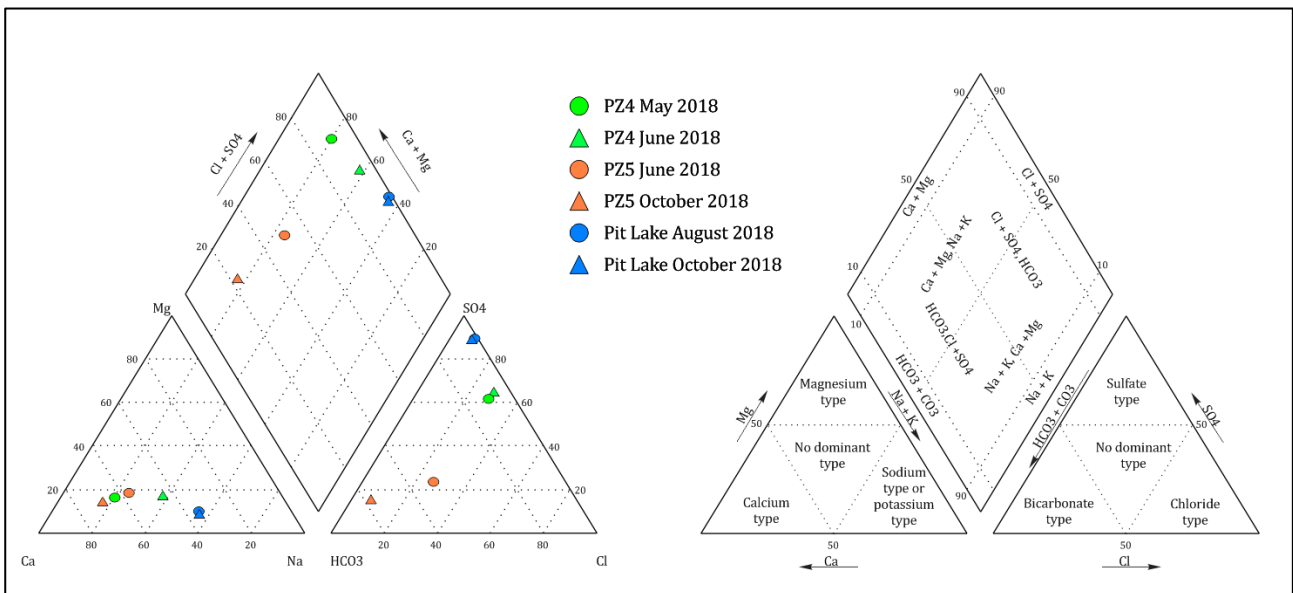
Figure 3.8 Piper diagram – Pit Lake and surrounding groundwater quality

The relative proportions of the major ions in the six water samples are presented graphically in the Piper diagram in Figure 3.8.

The Piper diagram identifies three different water types as follows:

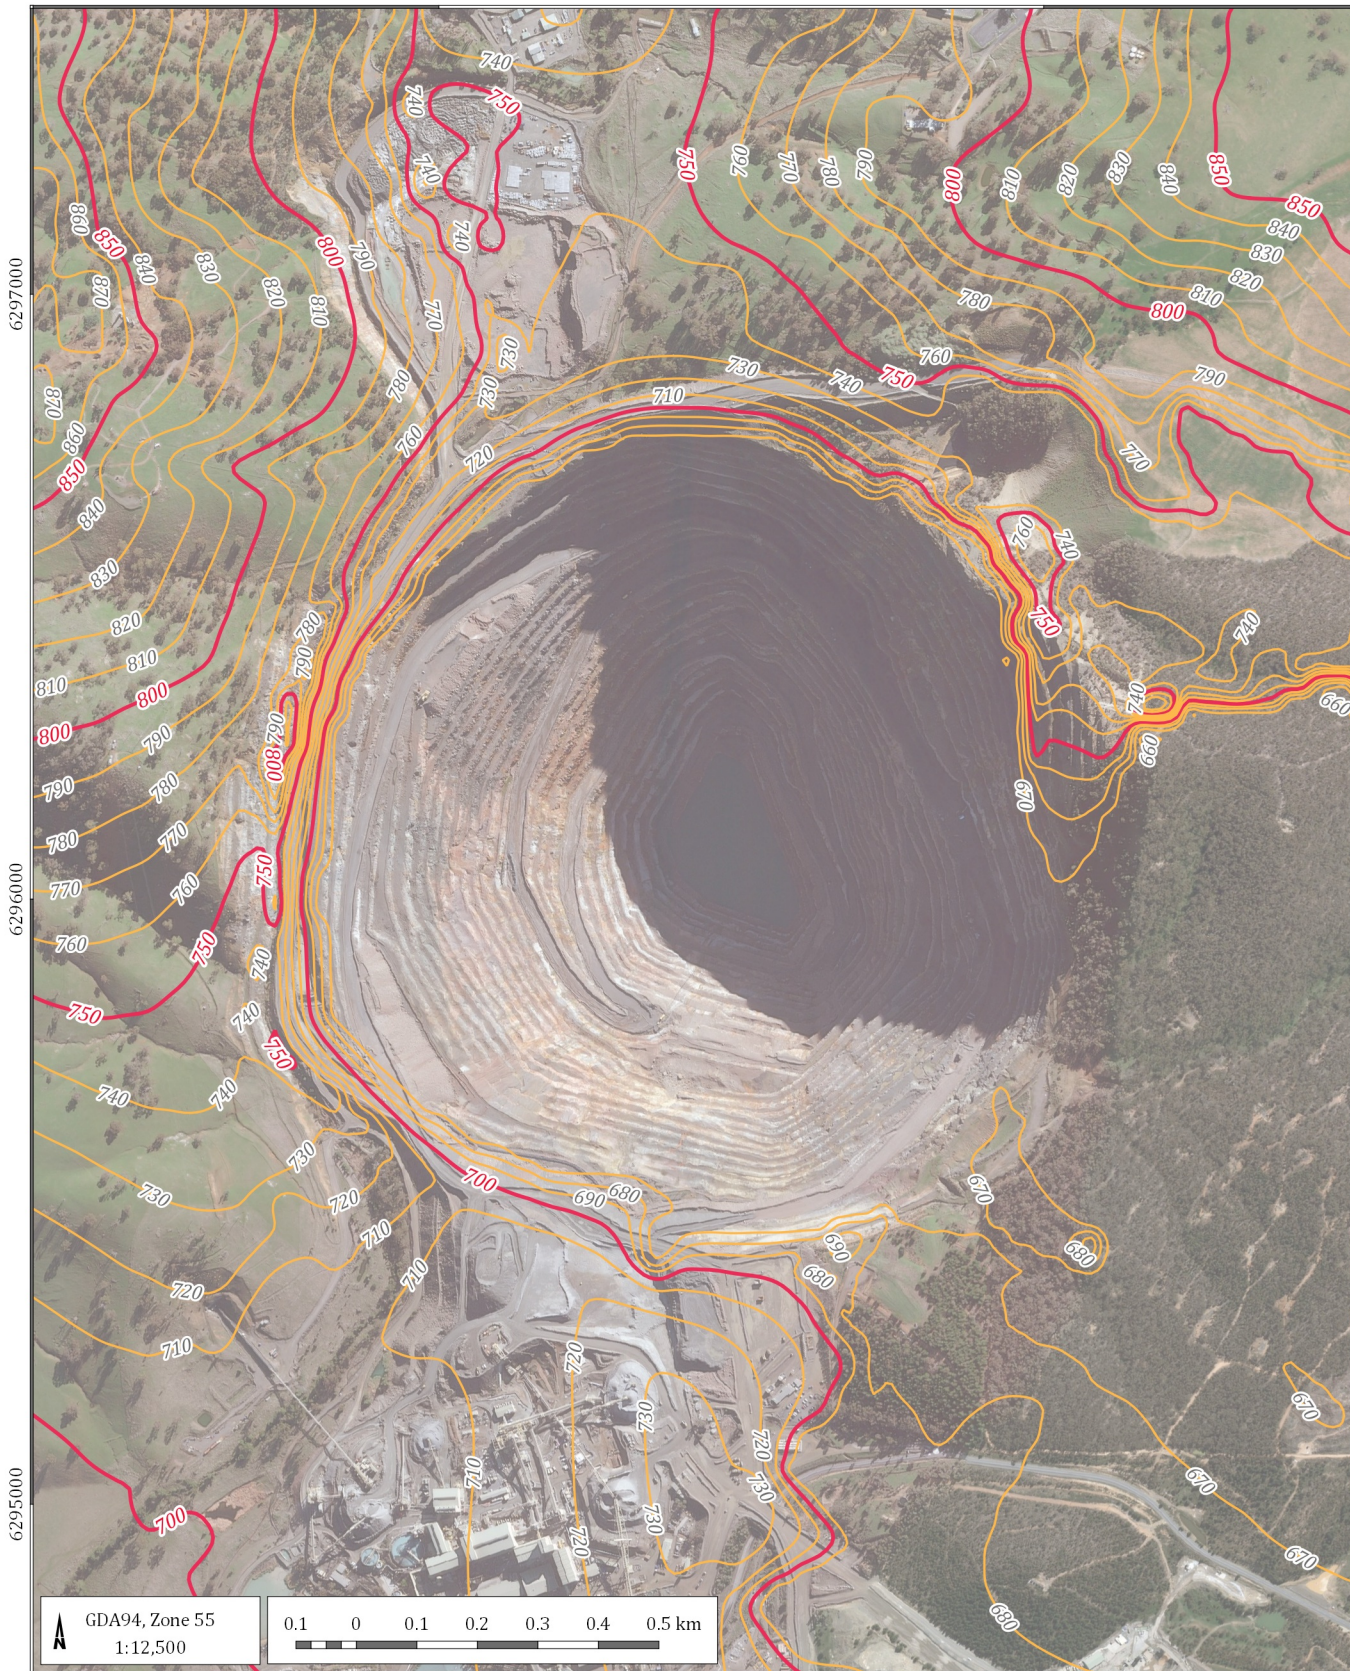
FIGURE No:
4.1

Groundwater level contours:

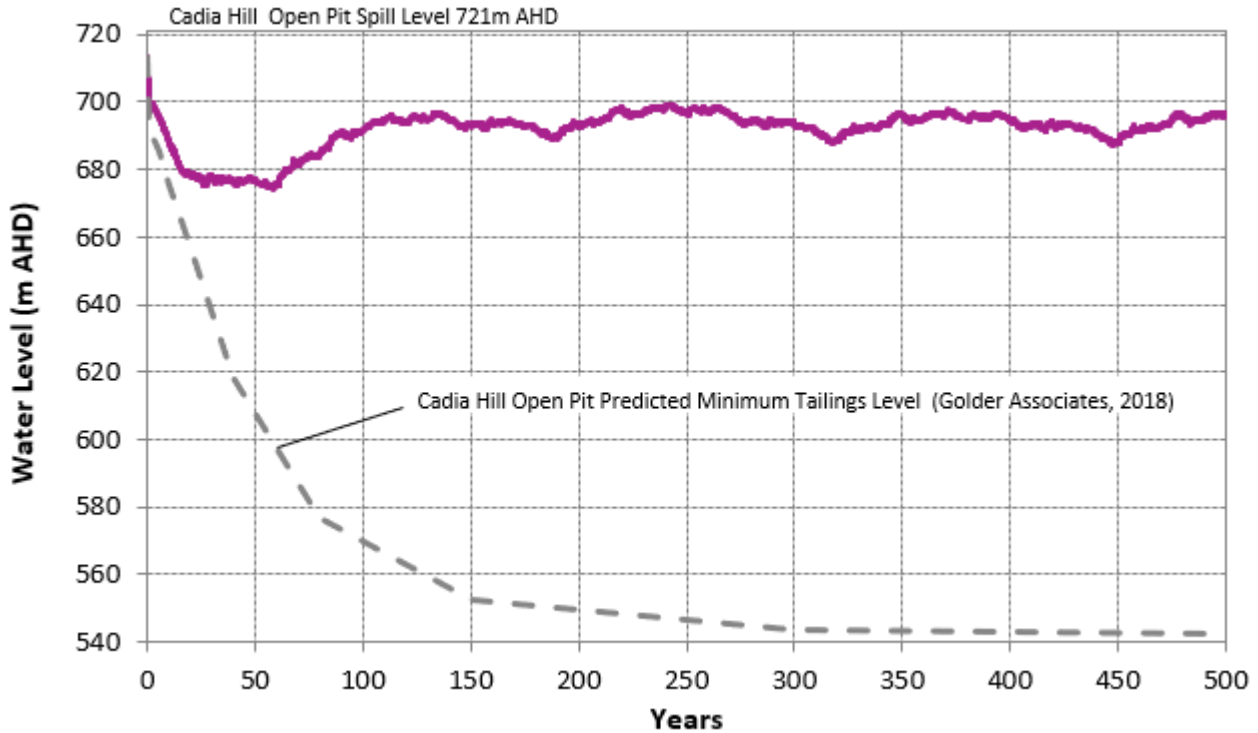
Figure 4.2 Predicted Cadia Hill Water Level (HEC 2019)

Geotechnical assessments have now indicated that the Cadia East subsidence zone will not extend to the Cadia Hill open pit. This means that instead of a single pit lake forming across the two mining areas, the two pits will remain separated. HEC (2019) updated the water balance model to reflect the changes in the Cadia Hill pit and predicted the water level will rise some 30 m higher than if it was connected with the Cadia East subsidence zone. The modelling indicates the water level will stabilise and fluctuate between 687 mAHD and 699 mAHD, averaging about 694 mAHD as shown in Figure 4.2 below.

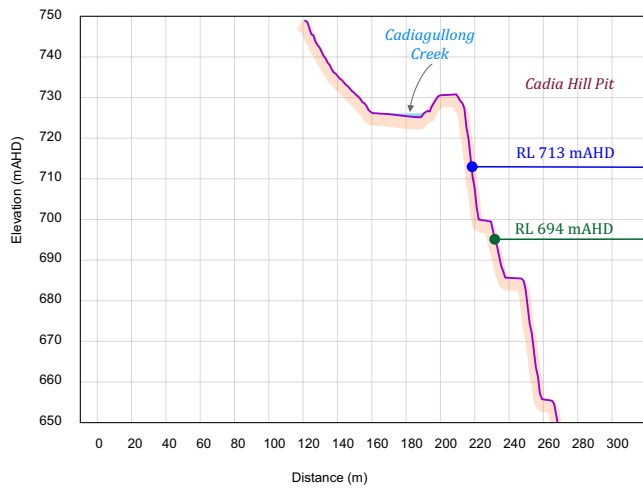
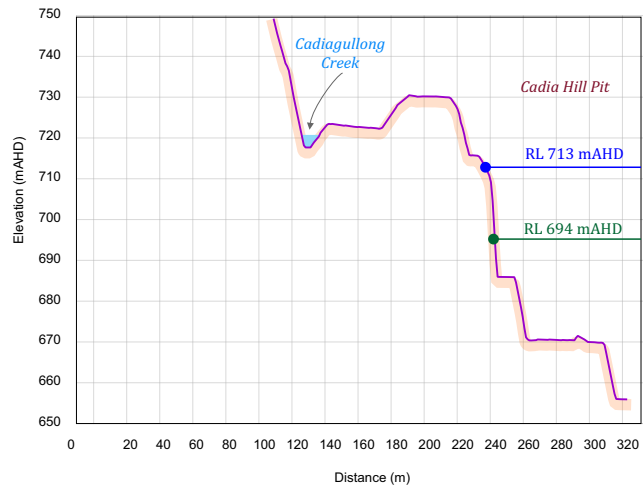
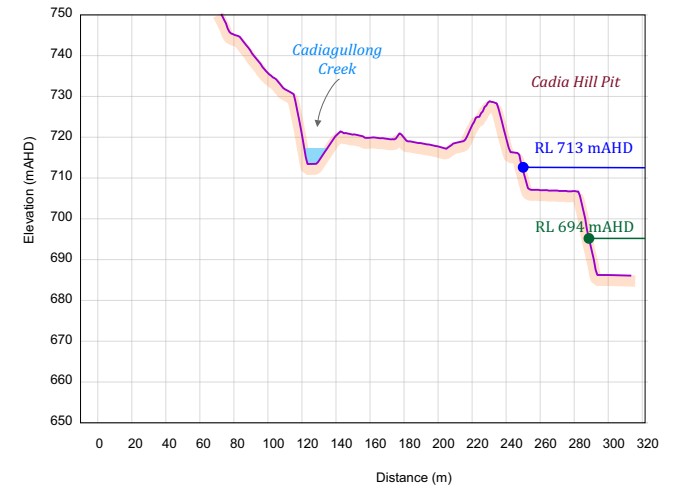
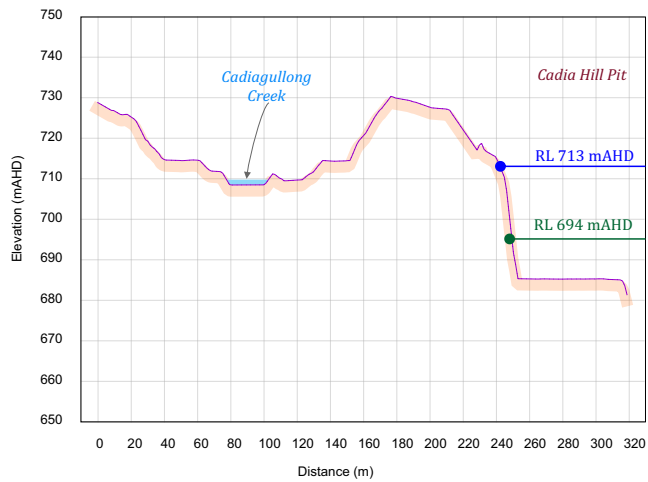
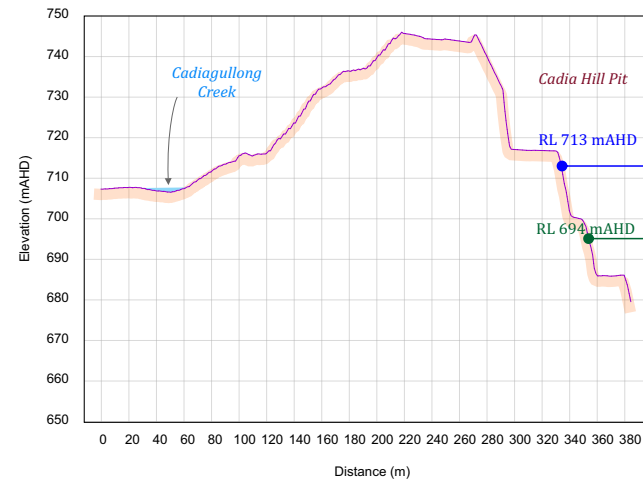
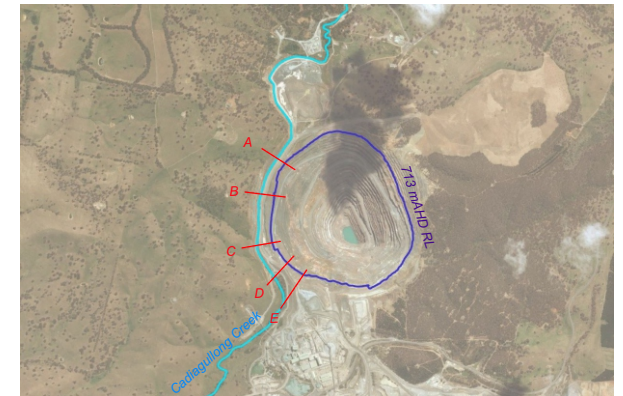
Figure - 5.1

— Operational phase pit water level — Post closure pit water level

Figure 5.1 presents cross-sections across the Cadiangullong Creek Diversion showing the relationship between the short-term (713 mAHD) and long-term (694 mAHD) pit water levels and the adjacent diversion creek invert levels. The sections show that during operations, the water level within Cadia Hill Pit will rise above the base of Cadiangullong Creek, indicating the potential for transport of pit water into the creek in the short-term during operations. The potential for an outward hydraulic gradient occurs in the southern section of the pit shell where the creek elevation is around 708 mAHD, and is in close proximity (i.e. within 200 m) to the pit shell. In this case the Cadia Hill Pit would form a 'source'.

Figure 5.1 shows the average post-mining pit water levels of 694 mAHD compared to the elevation of the nearby Cadiangullong Creek. This figure indicates that, post-closure, as the pit water level falls and equilibrates, the potential for direct seepage to Cadiangullong Creek will reduce to zero. A post-mining groundwater elevation between 700 mAHD and 710 mAHD in the vicinity of Cadiangullong Creek, indicates there will be an inward hydraulic gradient established south-west of the pit wall resulting in the pit forming a 'sink' long-term.
