## **Woodlawn Mine Copper Zinc Project**

### **Annual Environmental Management Review (AEMR)**

**1 July 2022 – 30 June 2023**

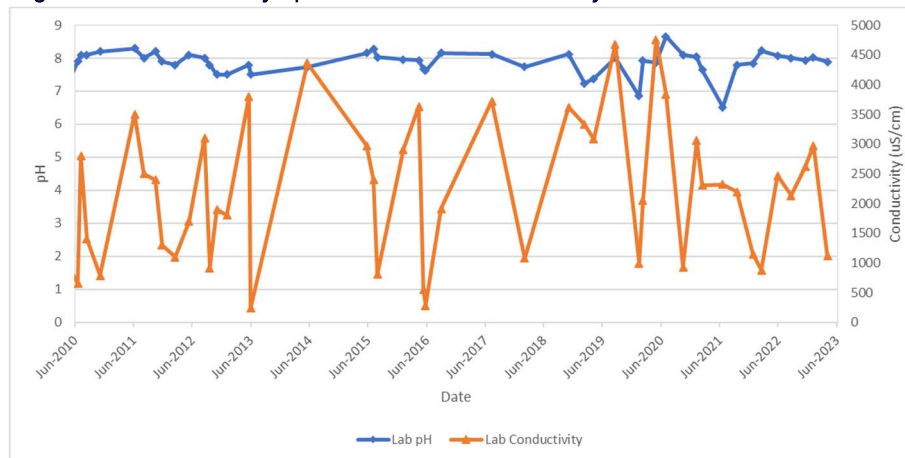
Figure 7-7. Water quality - pH and conductivity - Site 115

Water quality results for site 115 are shown in **Figure 7-7** and **Figure 7-8**. The results show the pH is typically slightly above neutral, whilst conductivity fluctuates considerably most likely due to seasonal wetting and drying cycles. Sulphate and metals concentrations at site 115 are relatively low in overall terms. Since the spike in lead concentration in 2020 the concentration has returned to background values. The cause of the spike is uncertain, but could be associated with either the wet conditions following years of drought or a sampling error.

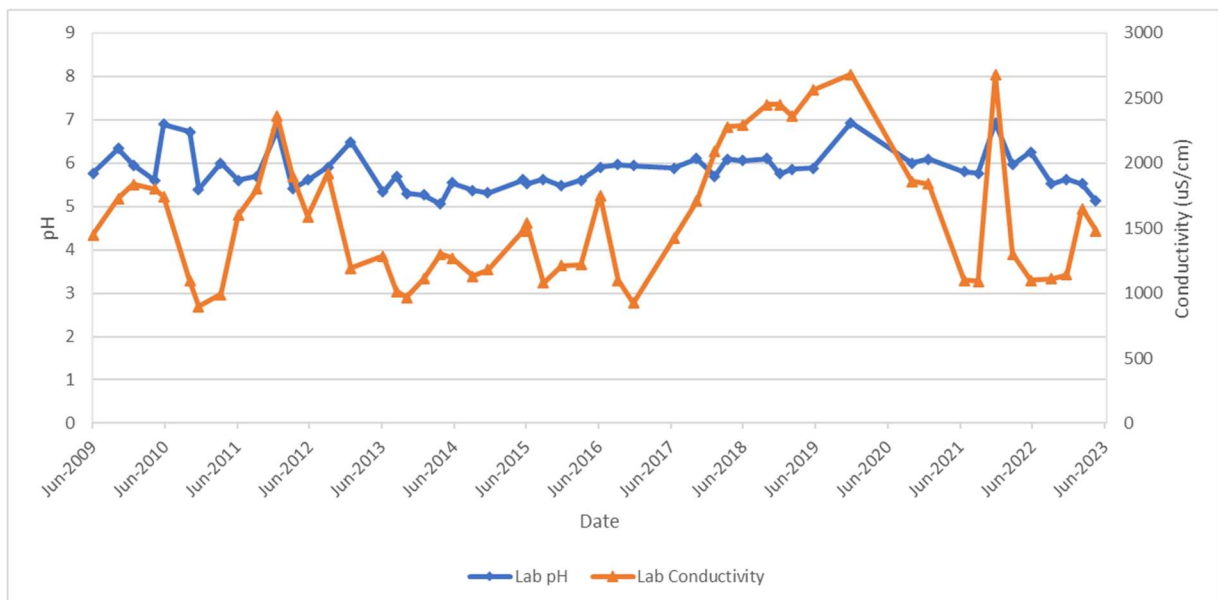
Water quality results in MB22 (Figure 7-48 and Figure 7-49) are consistent with the previous reporting period which indicates slightly acidic water. Conductivity remains consistent with the historical trends. Although sulphate and metal concentrations appear to fluctuate significantly, the absolute values are very low and the variability is considered natural and in response to rainfall, particularly noting the trend for conductivity, sulphate and zinc has been notably downward since high rainfall experienced across site since 2020. MB22 has similar levels of pH, conductivity, sulphate, copper, lead and zinc to background groundwater quality recorded in MB3 (Figure 7-16).

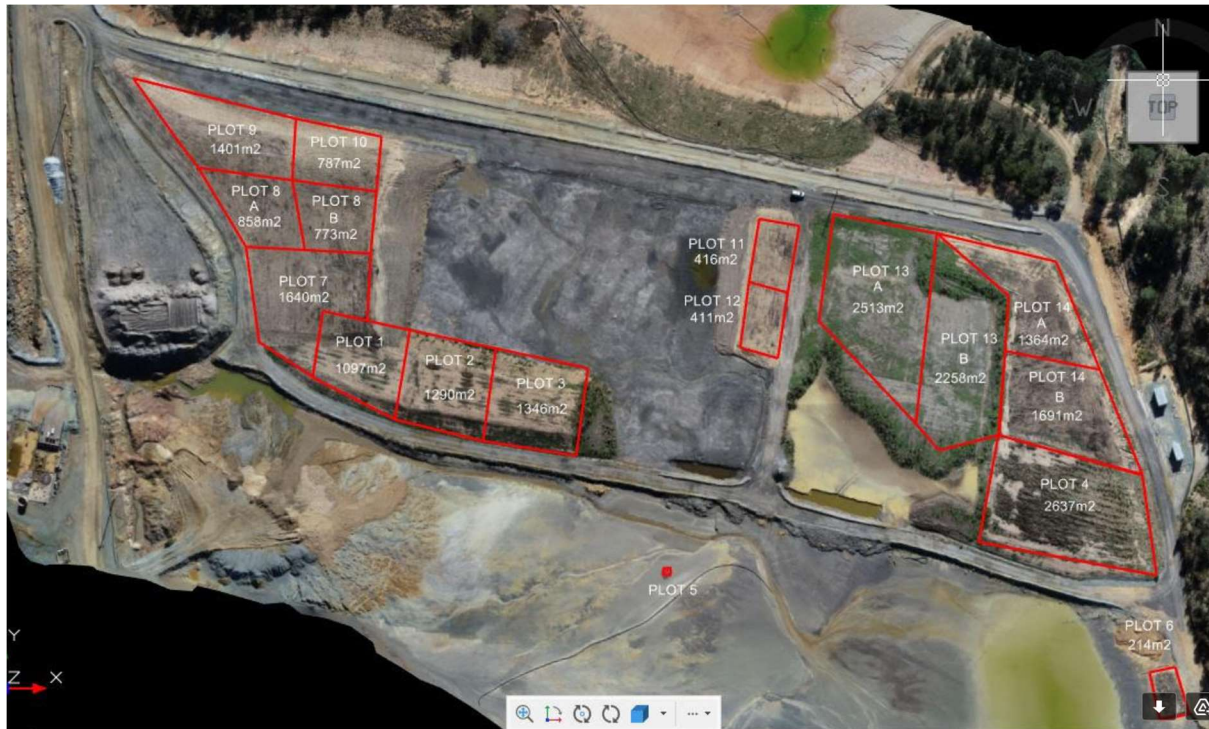
Figure 8-2. TDN field trial plot layout

Figure 8-2 shows the location of the progressive cover and study plots across the 4.5ha trial area. The remainder of the area will be progressively capped and subject to ongoing vegetation, stability and sustainability trials.

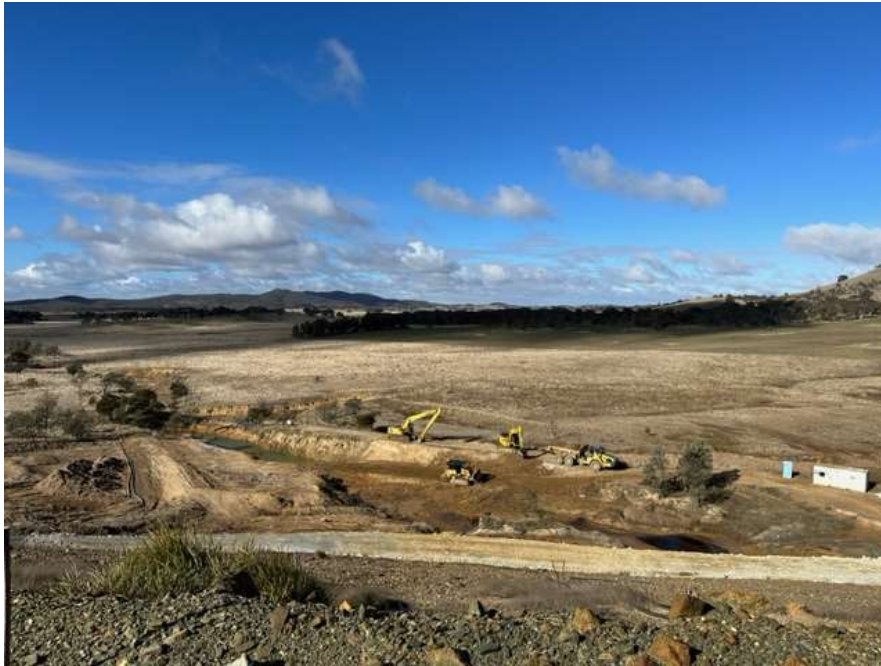
Works to improve the TDS seepage return dam and drains commenced during the reporting period. The works were initiated to fulfil a requirement of Resources Regulator S240 Notice Section 240 Notice NTCE0009097 and NTCE0011671 and address Project Approval Schedule 3, Condition 1a. The works entail improvement to the existing return dam by lining it with HDPE lining, automation of the pumping system, installation of flow monitoring instrumentation and v-notch weirs, diversion of stormwater away from the collection system, repair to the access track and rehabilitation of eroded areas. The purpose of the flow monitoring instrumentation and v-notch weirs is to allow a better understanding and estimation of the actual seepage volume from the drainage blanket.

Shows the progress of the return dam improvement works at the time of this report.
