**Heron Resources Limited**

Woodlawn Zinc – Copper Project

# Woodlawn Mine SML20 Annual Review

1 July 2020 to 30 June 2021

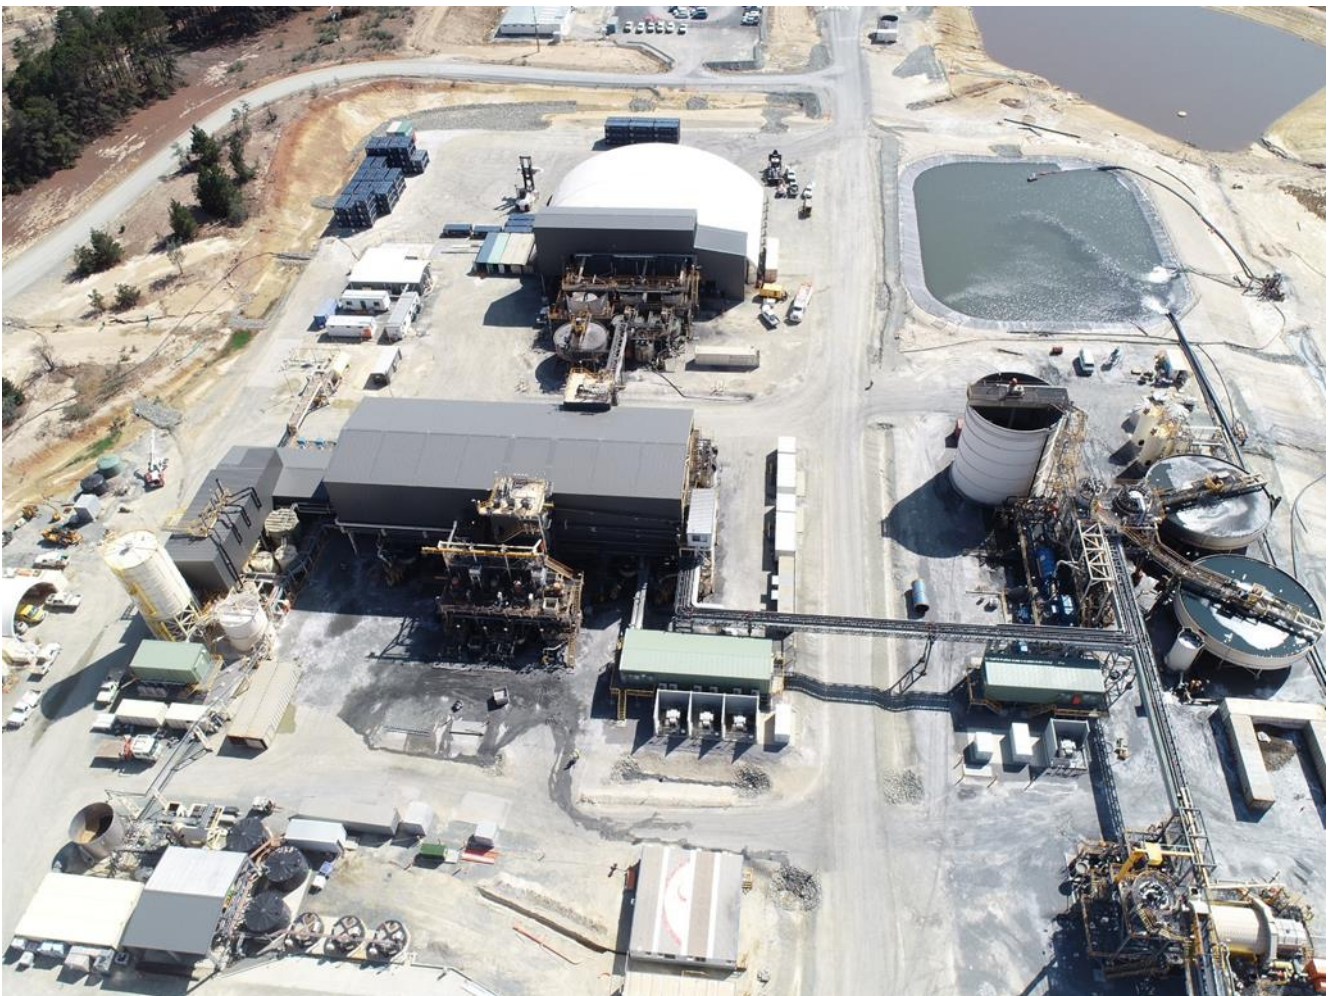
Figure 1. Overview of the completed processing plant - January 2020

An overview of the processing plant site is provided in **Error! Reference source not found.** below.

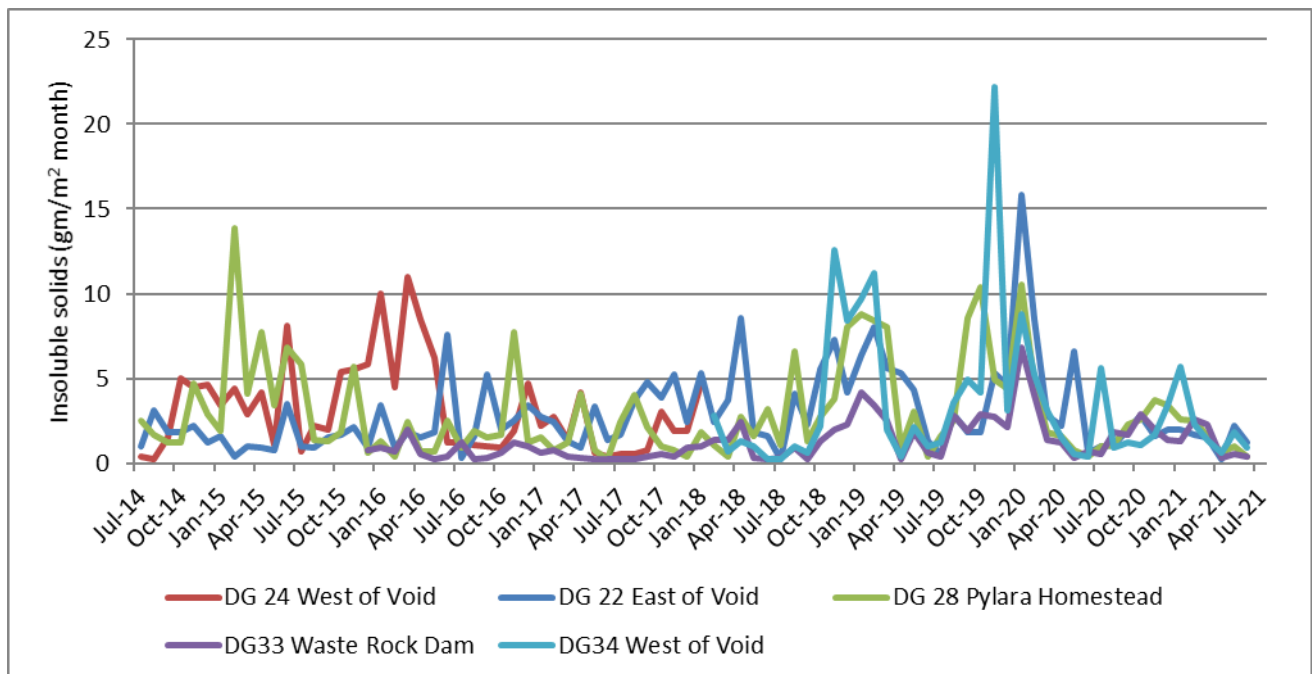
Figure 3. Raw monthly dust deposition results (g/m<sup>2</sup>/month)

The relationship between the dust deposition gauges is shown Figure 3. The results for DG24 (decommissioned end of Jan 2018) have been retained in the chart to provide a historical context for results read by DG34 that was installed to replace DG24 in Feb 2018. The data shows that on most individual months, dust levels at Pylara (DG28) correlate generally with DG34. Where there is a correlation, the potential impact from the mining operation and bioreactor combined is considered to be very low with an estimated contribution of <1 g/m<sup>2</sup>/month. Due to the above average rainfall received and the associated good ground cover, regional atmospheric dust has not been an issue throughout the reporting period. Further, due to there being no operations carried out at Woodlawn Mine there has been no operationally generated dust.

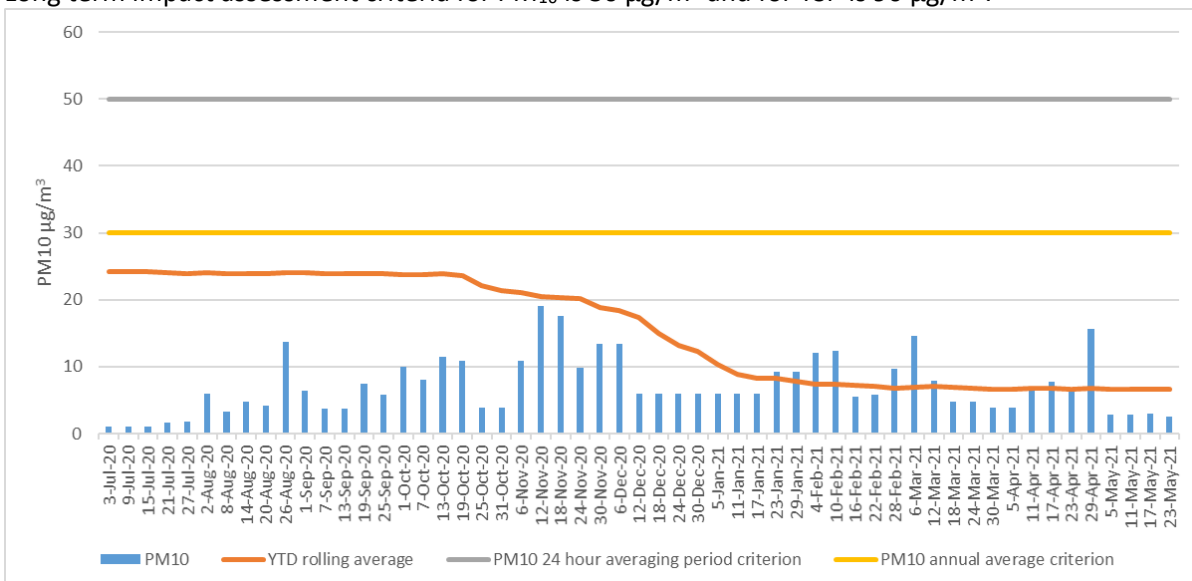
Figure 5. PM10 monitoring results (raw data and rolling average)

A High Volume Air Sampler was installed by Heron in October 2017. High volume air sampler (HVAS) results for PM<sub>10</sub> are provided in Figure 5. TSP results for the current reporting period are shown in Figure 6. Compared with the previous reporting period the above average rainfall experienced during this reporting period has led to a considerable reduction in high dust days, and there have been no exceedances recorded.

Long term impact assessment criteria for PM<sub>10</sub> is 30 µg/m<sup>3</sup> and for TSP is 90 µg/m<sup>3</sup>.

The PM<sub>10</sub> results recorded at the Pylara HVAS station correlated with results recorded by the NSW Department of Planning, Industry and Environment Air Quality Monitoring Network; principally from the Goulburn station which can be monitored regularly to provide advice to employees of air quality forecasts and PPE requirements.

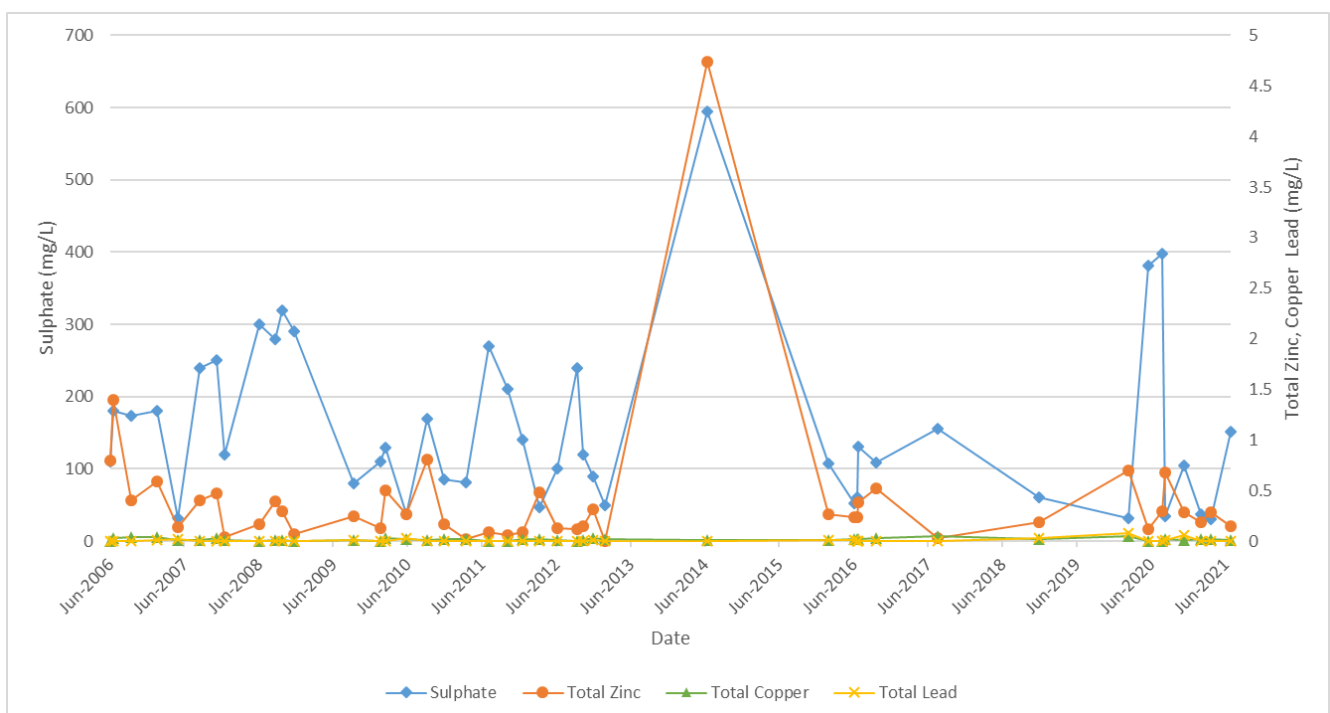
Figure 10. Water quality - Sulphate and metals - Site 105

Figure 10 below show sulphate and metal concentrations of Crisps Creek. Although the graph appears to show elevated sulphate and zinc in June 2014 and again in 2020, the actual values are low. The remaining data are at trace levels. The peak of 600 mg/L sulphate occurred during very low flow but is still below ANZECC stock drinking guidelines.

As indicated in the long term results provided in Figure 9 and Figure 10, the water quality in Crisps Creek is generally very good, with spikes in EC typically associated with dry cycles. When flowing, conductivity levels are between 1,000 and 3,500  $\mu\text{S}/\text{cm}$  while sulphate and metals concentrations are very low. The creek is consistently neutral to slightly alkaline with an average pH of 7.4 during the reporting period. Sulphate and conductivity spiked in May 2020 but the results are still relatively low and no greater than previous spikes. The probable cause being the drought conditions at the time. Subsequent rainfall has seen the conductivity retreat to a low concentration.

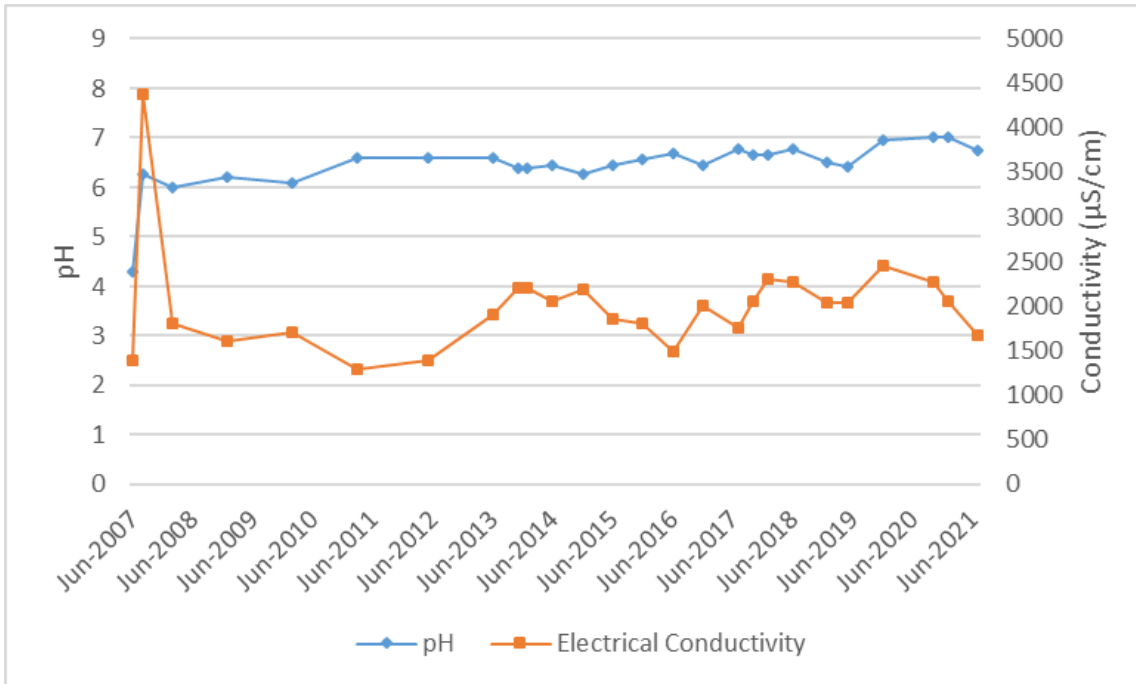
ETP8 and SP11B are located downstream of the eastern embankment of TDN. Results for ETP8 (Figure 41 and Figure 42) show recent pH and conductivity levels were comparable with background levels. Sulphate fluctuates but the absolute concentration is well within background levels. The recent average zinc concentration has been 1.2 mg/L, which is less than the long term average level of 6.84 mg/L, since 2007. Copper and lead were measured with trace levels detected at both ETP8 and SP11B.

Figure 41.ETP8 pH and conductivity

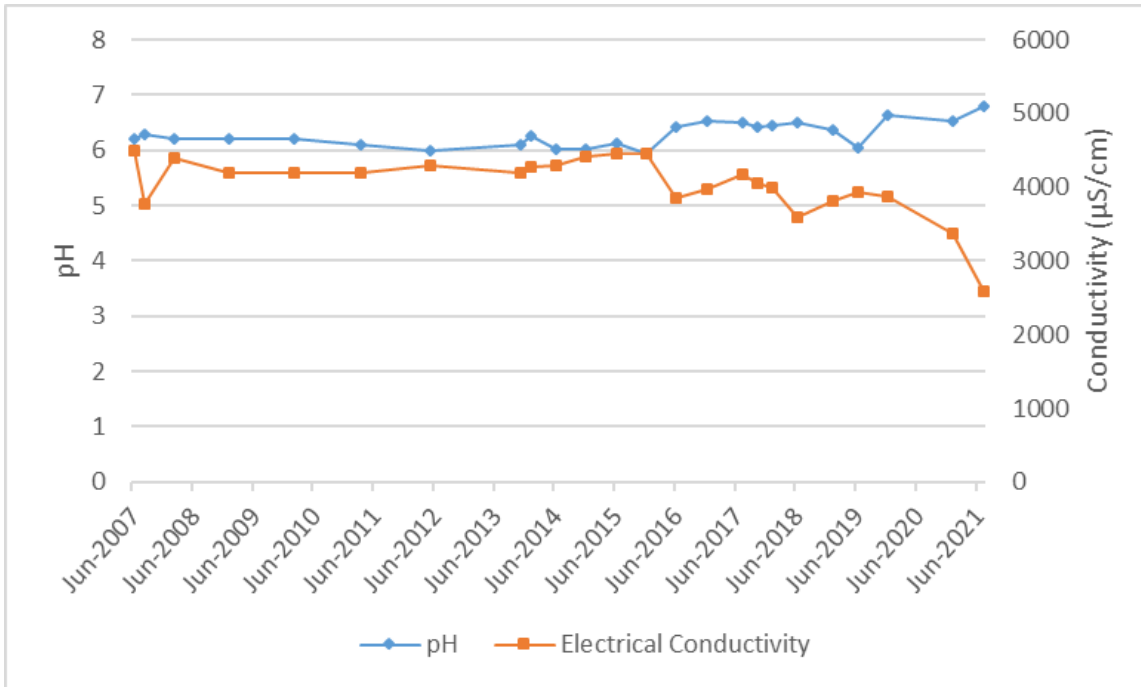
Water quality results in SP11B (Figure 43 and Figure 44) are consistent with background groundwater quality. The fluctuation of results particularly sulphate and zinc is not of concern as the absolute values are low. The data confirms that there is no leakage from the eastern embankment of TDN.

Figure 43. SP11B pH and conductivity

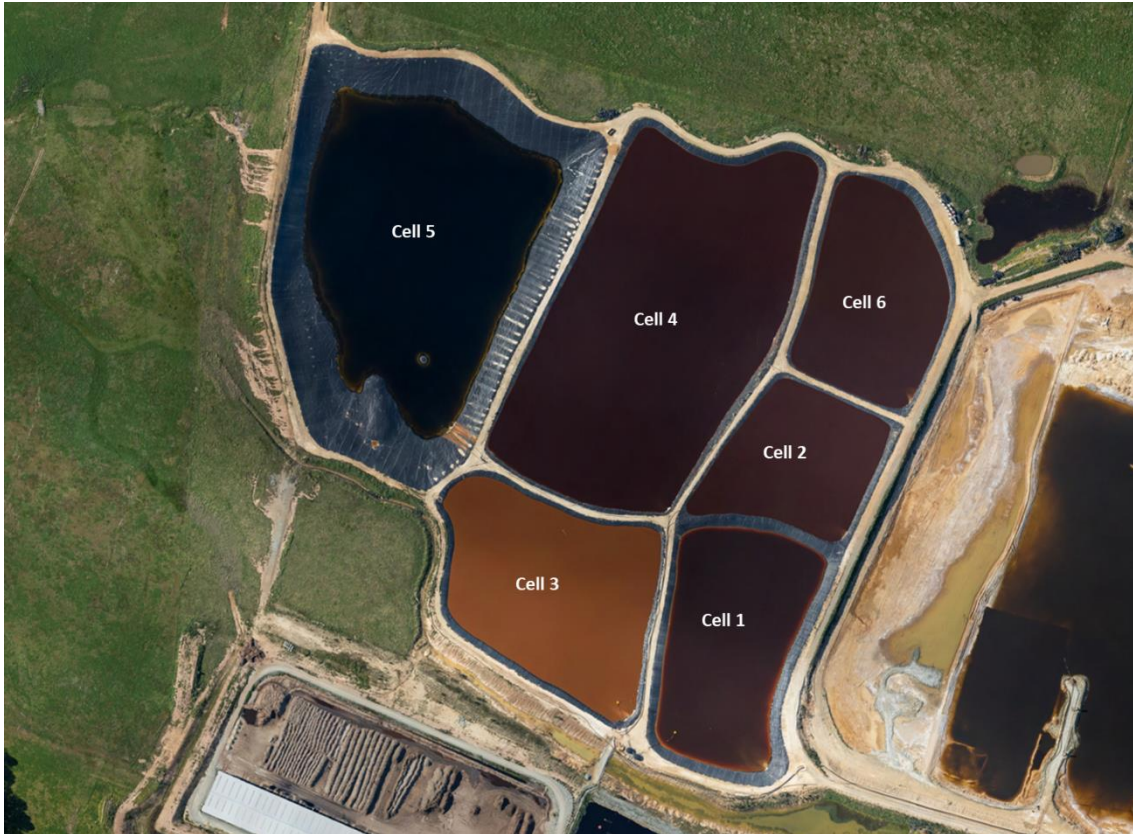
**Figure 64. Evaporation Dam 2 - cell layout**

The location and designation of the cells in ED2 is shown in Figure 64 below. Water pumped from the underground workings is stored in individual cells within ED2 for evaporation. The quality of the water held within the workings is anticipated to vary according to extraction depth and may fluctuate significantly during dewatering. The EPA have therefore required a staged approach coupled with ongoing monitoring and reporting. To date, Heron has provided eight progress reports detailing water quality and management options. Additional environmental assessment was also required during dewatering stages 1 and 2 to include odour modelling, potential treatment options and attenuation over time. Reporting will resume after dewatering recommences.

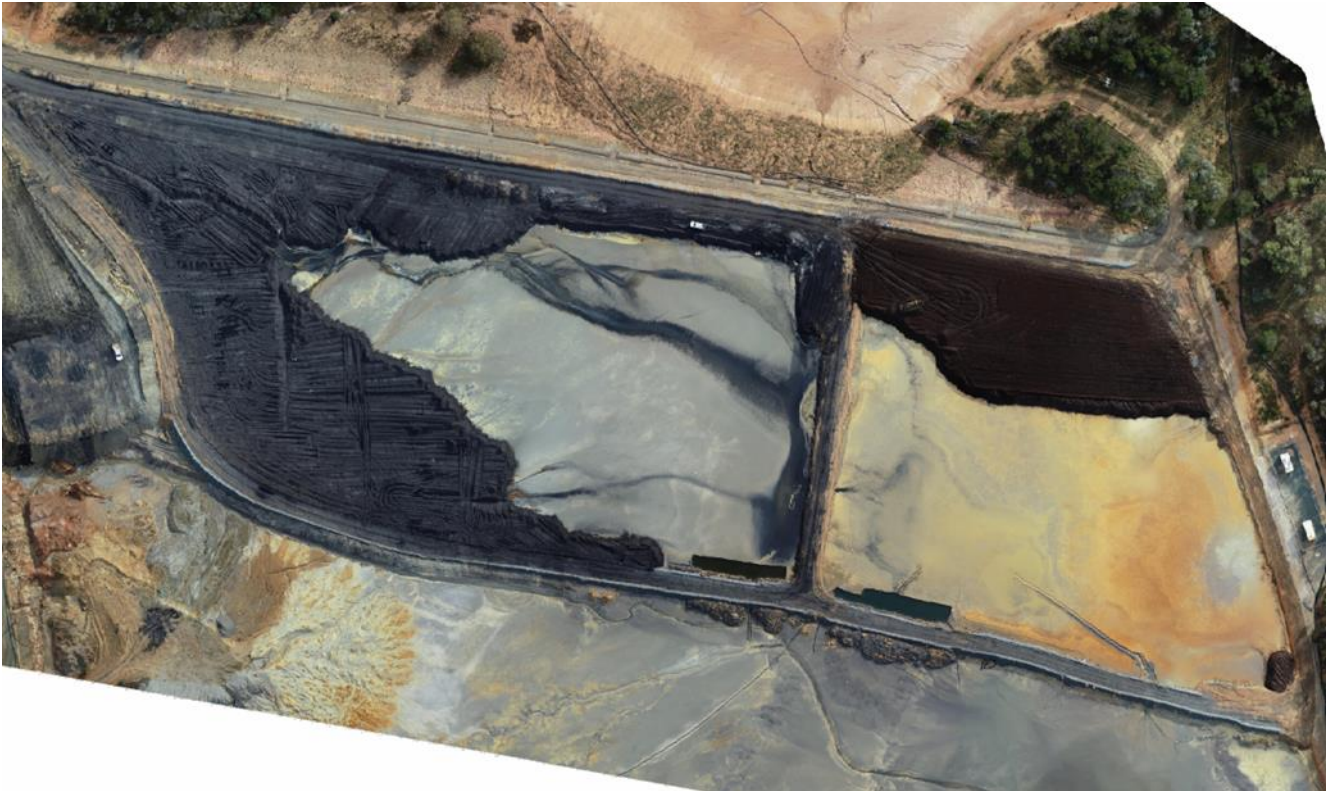
At the time of this Annual Report, approximately 5,000 tonnes of WOO had been applied to plot 4, and approximately 10,000 tonnes of alkaline product across much of plots 1-3 (Figure 68). The key learnings to date are associated with the techniques, attributes and constraints of the materials during the placement. There have been considerable delays associated with rainfall and saturation of the materials during this phase.

Figure 68. Aerial photo showing progress in spreading WOO (right of picture) and Alkaline product (left of picture)
