# METROPOLITAN COAL    LONGWALLS 305-307

## BUILT FEATURES MANAGEMENT PLAN

#### **GARRAWARRA CENTRE COMPLEX**

ME-TSE-MNP-0086

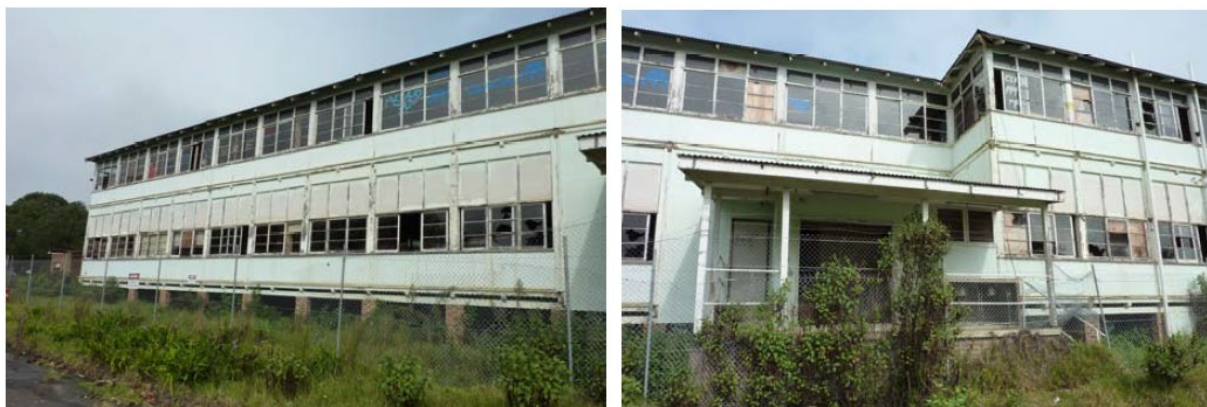
**Plates 1 & 2 – Abandoned Hospital Buildings [A01a] {Former Male Wards}**  
(Source: MSEC, 2016)

No abandoned hospital buildings will be directly undermined by Longwalls 301-307. The abandoned hospital buildings are located more than 375 m away from the nearest longwall. No hospital buildings (including Former Male Wards [i.e. Wards 1 to 8 and Dining Room], Former Female Wards [i.e. Wards 1 to 9 and Library/Canteen], Laundry/Boilerhouse or Workshops nor the Gatehouse and Gate Piers are within the predicted 20 mm subsidence contour for Longwalls 301-303, Longwall 304 or Longwalls 305-307.

Photographs of the abandoned hospital building structures are shown on Plates 1 to 4.

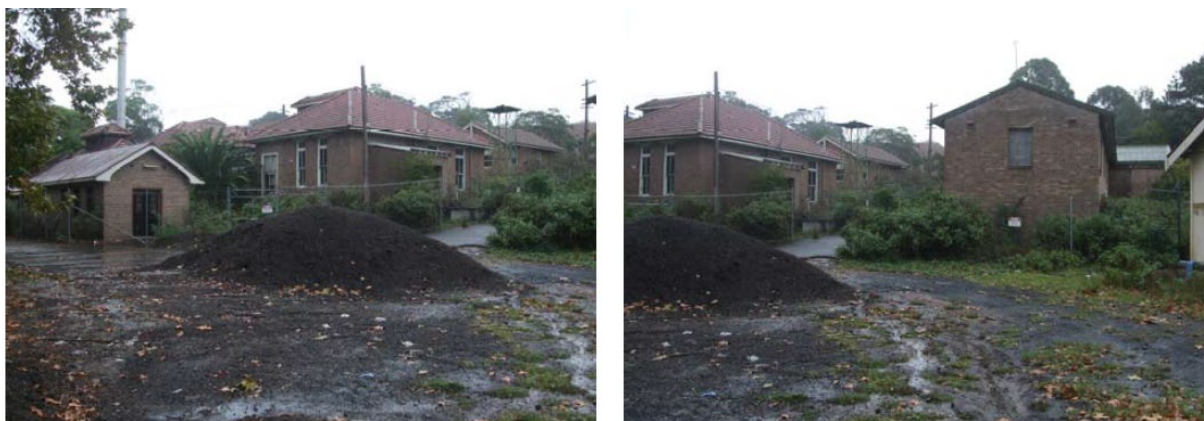
**Plates 3 & 4 – Abandoned Hospital Buildings [B03a] {Laundry / Boilerhouse}**  
(Source: MSEC, 2016)

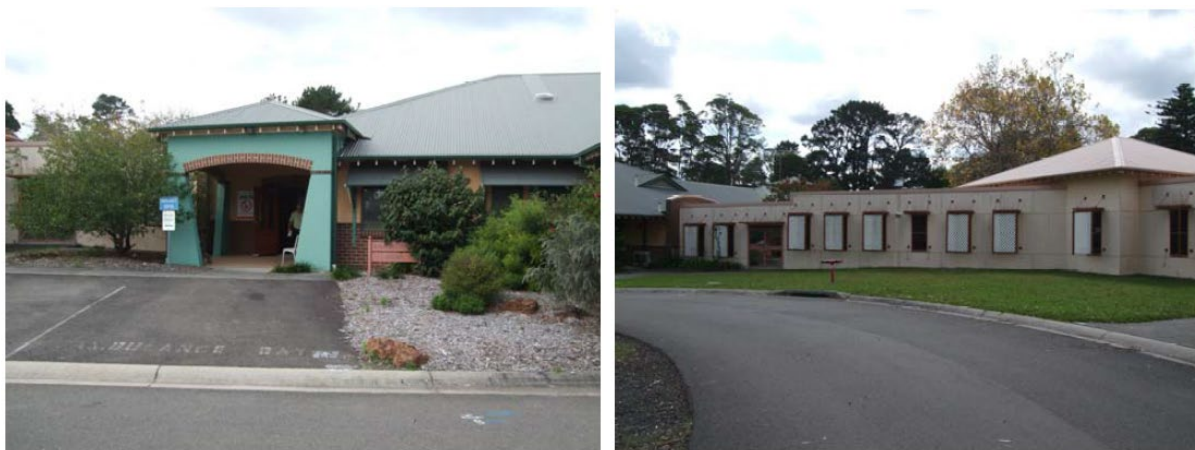
**Plates 5 & 6 – Aged Care Building Structures [B01a-B01d] {Administration}**  
(Source: MSEC, 2016)

No aged care building structures will be directly undermined by Longwalls 301-307. The aged care buildings are located more than 250 m away from the nearest longwall. No aged care buildings (including the Nurses Quarters and Administration/Kitchen Group) are within the predicted 20 mm subsidence contour for Longwalls 301-303, Longwall 304 or Longwalls 305-307.

Photographs of the aged care building structures are shown on Plates 5 to 10.

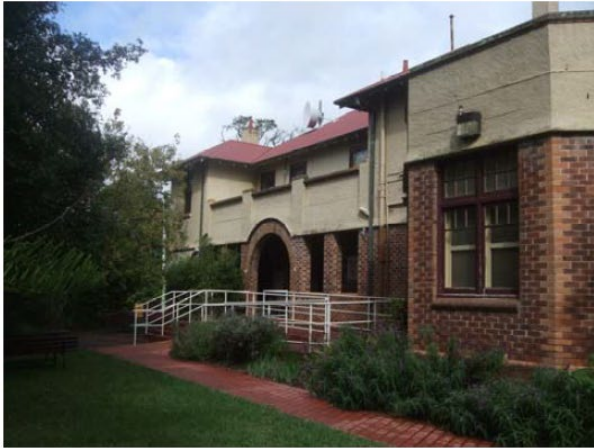
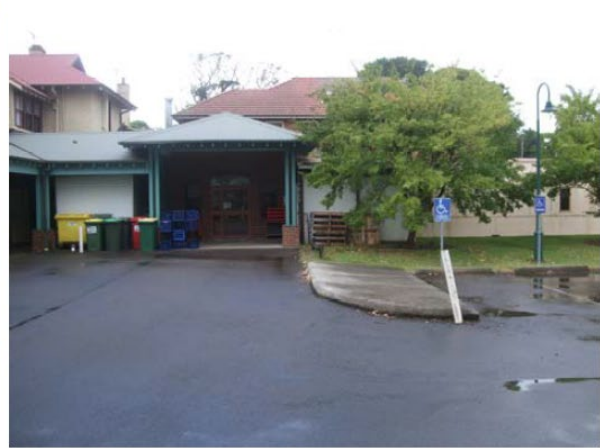
**Plates 7 & 8 – Aged Care Building Structures [B01e] {Nurses Quarters} (Source: MSEC, 2016)**

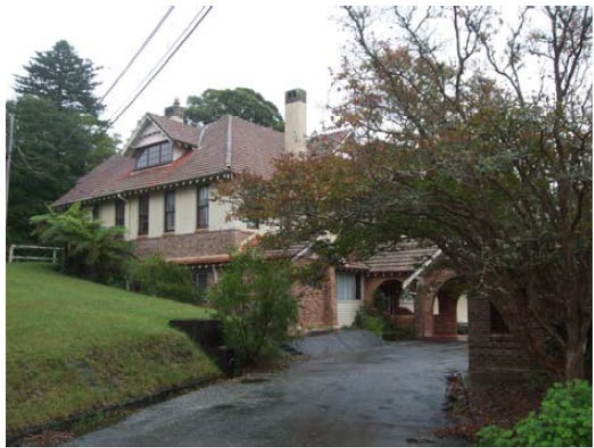
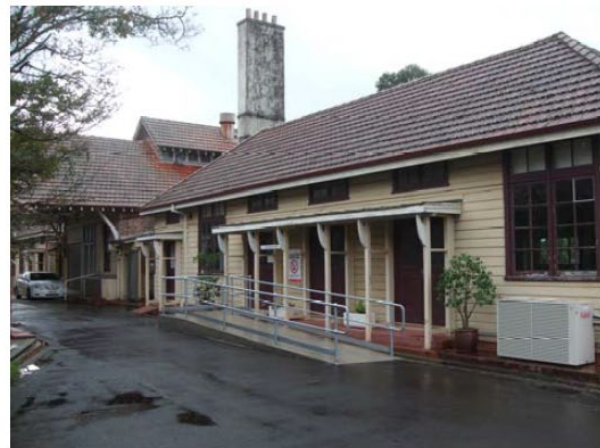
**Plates 9 & 10 – Aged Care Building Structures [B02a & B02b] {Administration/Kitchen Group} (Source: MSEC, 2016)**

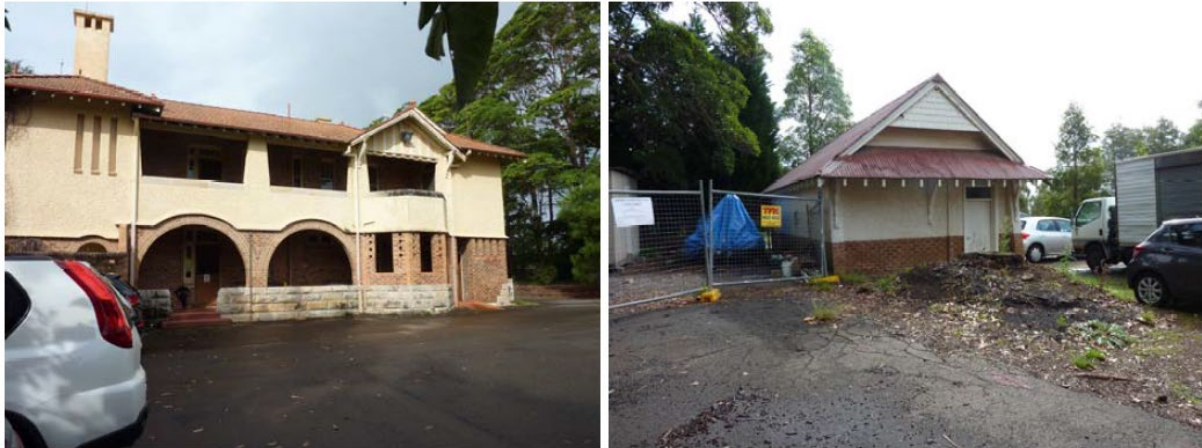
**Plates 11 & 12 – Houses [A09a & A09b] {Palmer House and Adjacent Garage/Stable}**  
(Source: MSEC, 2016)

Houses A01m and A02a-A08a are located outside the Study area for Longwalls 301-303, Longwall 304 (more than 600 m from the nearest longwalls) and Longwalls 305-307. House A09a & A09b {Palmer House and adjacent garage/stable} is located outside the predicted 20 mm subsidence contour for Longwalls 301-303, Longwall 304 and Longwalls 305-307.

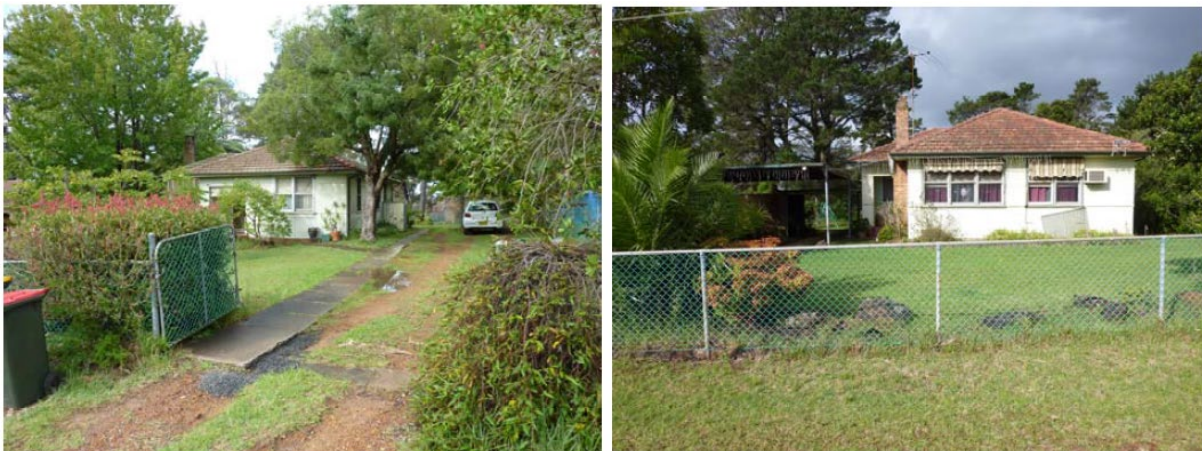
**Plates 13 & 14 – Houses [B06a & B08a] {Staff Residences}** (Source: MSEC, 2016)

Houses B04a-B09a are within the predicted 20 mm subsidence contour for Longwalls 301-303, Longwall 304 and Longwalls 305-307. Subsequent to the Longwalls 301-303 risk assessment, an agreement was reached between South Eastern Sydney Local Health District and Metropolitan Coal to remove cottages B04a-B09a as part of risk mitigation process. The Memorandum of Understanding – signed 31 August 2017 details the structures to be removed subject to Wollongong City Council development approval. These abandoned house structures will be fenced until development approval is granted.

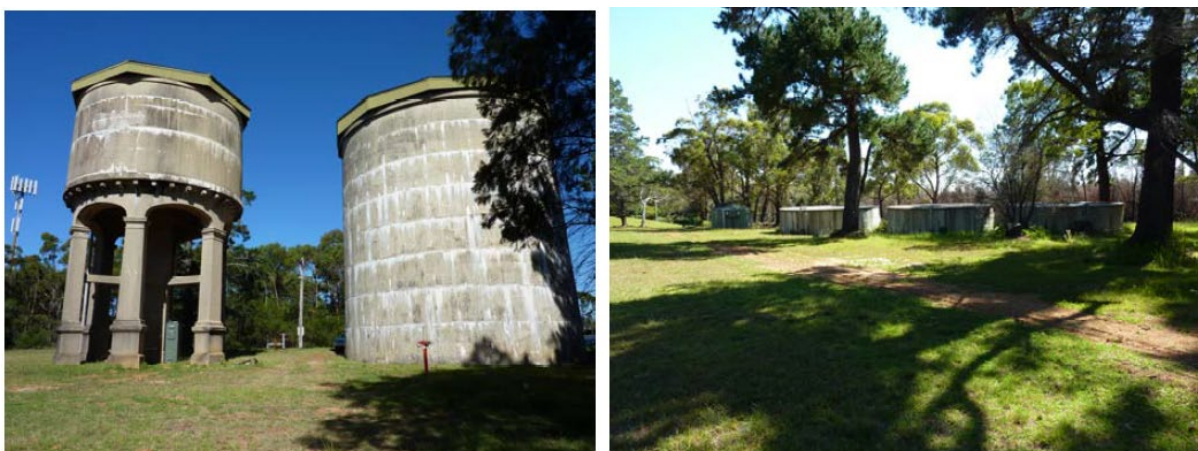
The two large water storage tanks (B14t01 and B14t02) and the below ground water storage tanks (B16t01-B16t03) are shown on Plates 15 and 16. It is noted that no water is currently stored in the elevated tank structure (Plate 15 - reservoir on the left).

**Plates 15 & 16 – Large Water Storage Tanks (Source: MSEC, 2016)**

Subsequent to the Longwalls 301-303 risk assessment, an agreement was reached between South Eastern Sydney Local Health District and Metropolitan Coal to remove derelict water tank B14t02 as part of risk mitigation process. The Memorandum of Understanding – signed 31 August 2017 details the structures to be removed subject to Wollongong City Council development approval. This derelict structure will be fenced during active subsidence effect periods or until removed.

Temporary fencing was erected around the large water storage tanks (B14t01 and B14t02) and the Kiln chimney (F01b) during the active extraction period of Longwalls 302, 303 and 304. This fencing was kept in place when there was a potential for measurable subsidence movements to occur. This fencing will be removed for Longwall 305 as predicted subsidence parameters do not change after Longwall 304 given increasing distance away from mining.

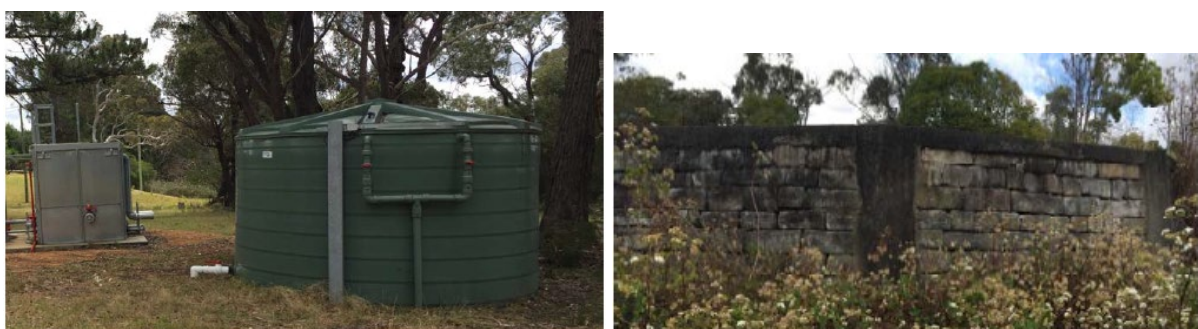
The fire water tank and steel tank adjacent the pump house (B17t01 and B18t01), and the trickle filter tank (B15t01) are shown on Plates 17 and 18.

**Plates 17 & 18 – Fire Water Tank and Steel Tank Adjacent Pump House, and Trickle Filter Tank (Source: MSEC, 2016)**

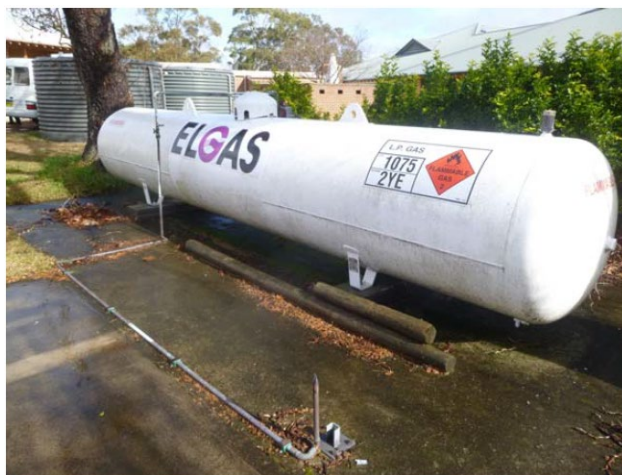
The gas storage tank is shown on Plate 19.

**Plate 19 – Gas Storage Tank (Source: MSEC, 2016)**

The gas storage tank will not be directly undermined by Longwalls 301-307. The gas storage tank is located more than 310 m away from the nearest longwall. The gas storage tank is not within the predicted 20 mm subsidence contour for Longwalls 301-303, Longwall 304 or Longwalls 305-307.

A baseline audit has been conducted to confirm the system of connection between gas storage tank and associated pipeline(s) at the Garrawarra Centre Complex is a flexible connection.

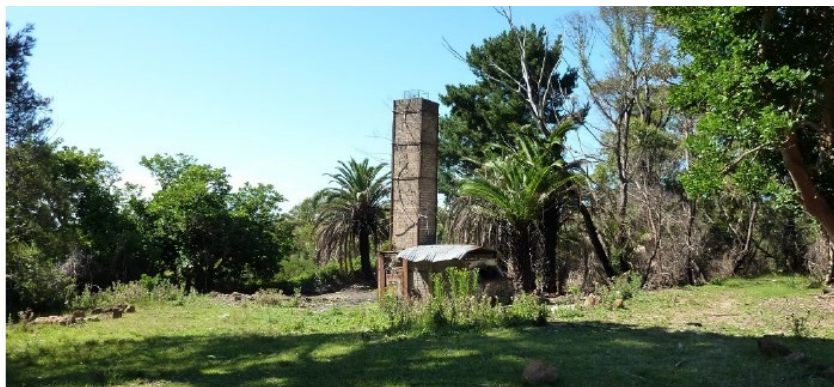
The kiln is shown on Plate 20.

**Plate 20 – Kiln (Source: JMA, 2016)**

| Building<br>(MSEC, 2016, JMA, 2016<br>and Howard Tanner &<br>Associates, 1993) | | Predictions and Exceedance Probabilities (MSEC, 2016 and JMA, 2016) | | | |
|---|---|---|---|---|---|
| F01b | Kiln | Tilt mav add to pre-existing tilt – barrier fence recommended | | | |

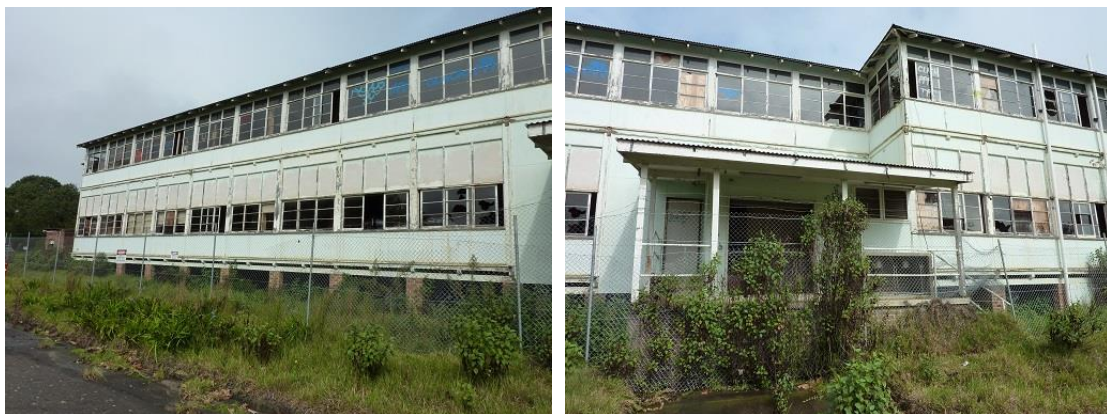
The *hospital* building structures are Refs. A01a to A01k and B03a to B03l. These structures are located outside the extents of the longwalls at a minimum distance of 440 m from Longwall 305. The buildings are not currently in use and have been fenced off. Photographs of the main hospital building structures are provided in Figure 1 and Figure 2.

**Figure 1 Hospital Building Structure (Ref. A01a)**

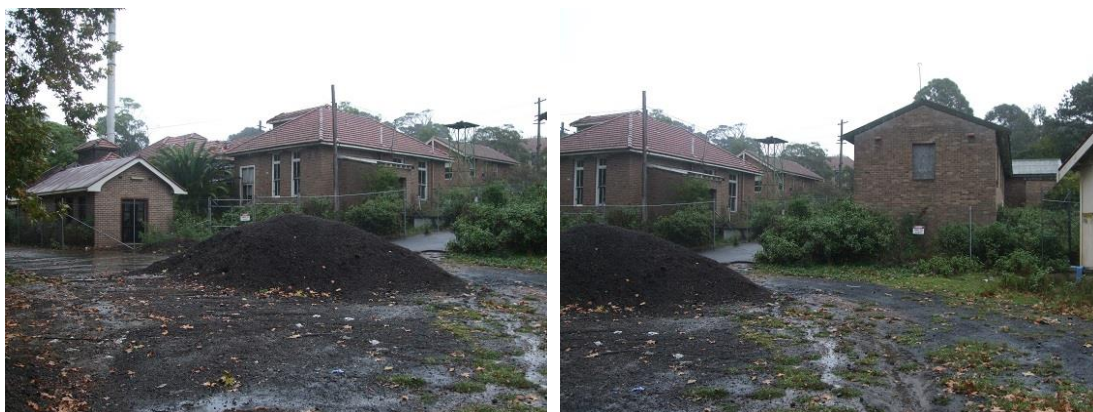
**Figure 2 Hospital Building Structure (Ref. B03a)**

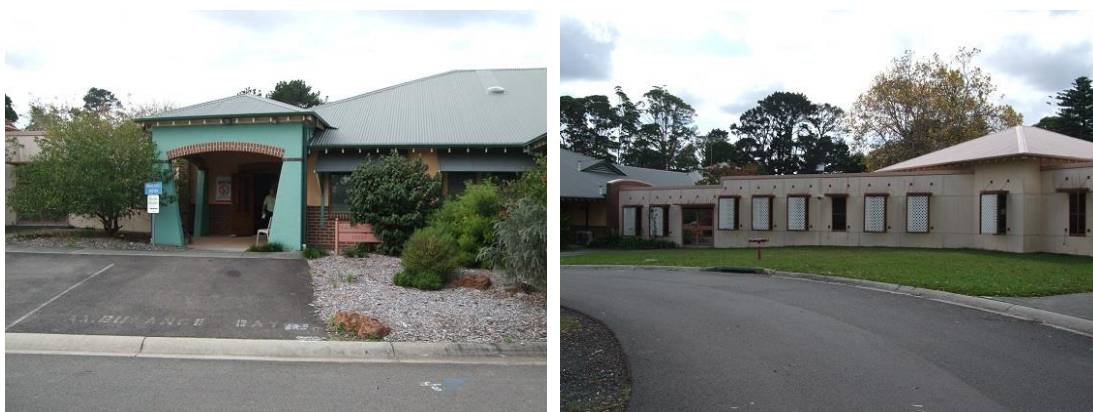
Structure Refs. B01a to B01d are located over 240 m to the north-east of Longwall 305. These buildings comprise single storey structures founded on a combination of ground slabs, strip footings and pad footings. The external walls are brick-veneer and the internal walls are of lightweight construction. The roofs are steel framed with metal sheeting. Photographs of these structures are provided in Figure 3.

**Figure 3 Aged Care Building Structure Refs. B01a to B01d**

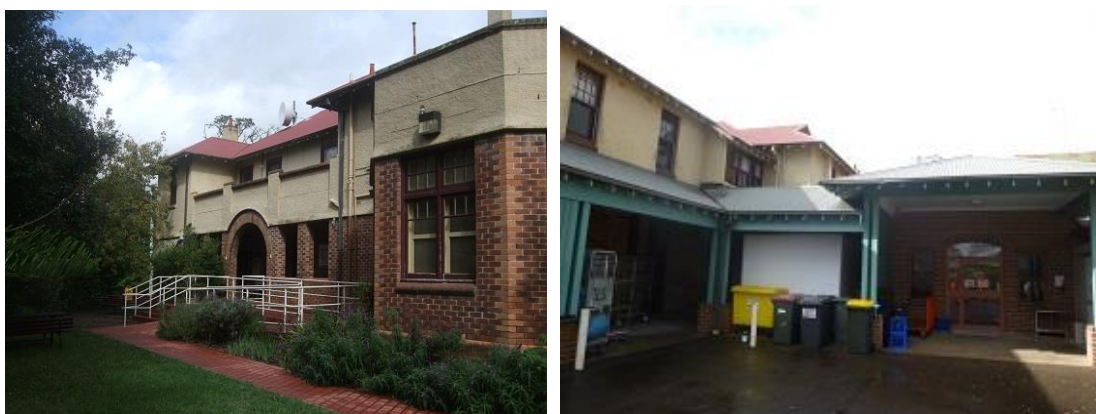
Structure Ref. B01e is located 350 m to the north-east of Longwall 305. This building is a double storey brick structure founded on a ground slab with a tiled roof. Photographs of this structure are provided in Figure 4.

**Figure 4 Aged Care Building Structure Ref. B01e**

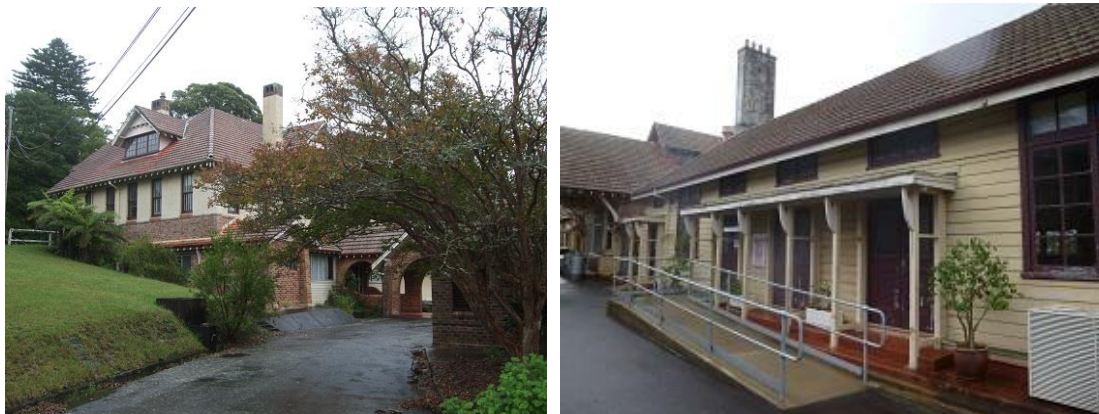
Structure Refs. B02a to B02h are located outside the Study Area. These buildings comprise one and two storey structures founded on strip footings and ground slabs. The perimeter walls are double brick, but in some cases the upper levels have timber framed walls. The suspended floors are timber framed and in some cases are supported on steel frames. The tiled roofs are supported by timber frames. Photographs of two of these structures are provided in Figure 5.

**Figure 5 Aged Care Building Structure Refs. B02a and B02b**

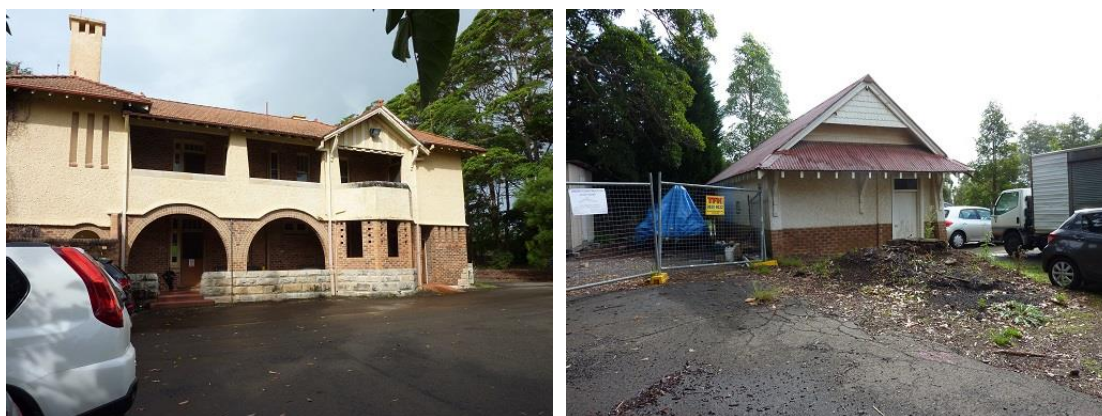
Structure Refs. A01m, A02a to A06a are located outside the Study Area. Structure Refs. A07a and A08a are partially located within the Study Area boundary, and Structure Ref. A09a is located within the Study Area. This building is a two storey double brick structure on strip footings with timber floor and a tiled roof. Photographs of this house and the associated structure A09b are provided in Figure 6.

**Figure 6 House Structure Ref. A09a (left side) and A09b (right side)**

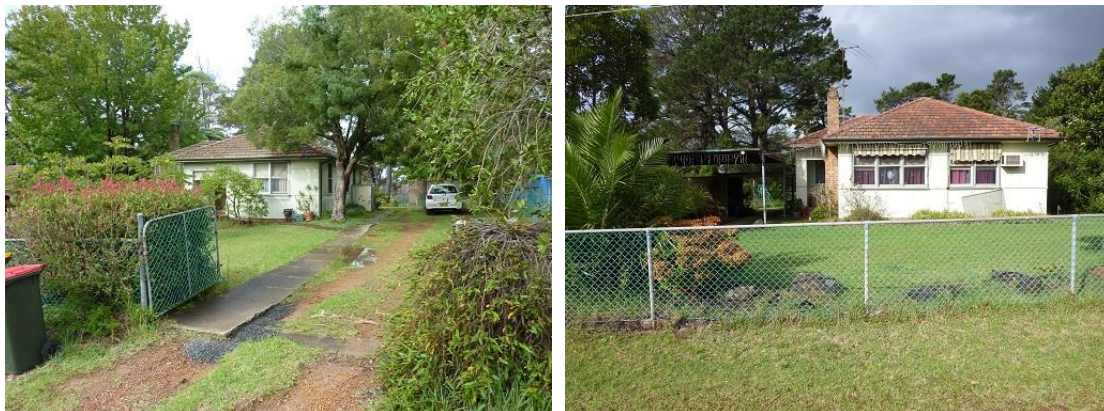
Structure Refs. B04a to B09a are located 360 m to 400 m to the east of Longwall 305. These houses are one storey structures founded on brick piers and low-level perimeter brick walls with timber floors, fibro walls and tiled roofs. Photographs of two of these houses are provided in Figure 7. The houses are currently vacant and have been fenced off in preparation for demolition.

**Figure 7 Houses Structure Refs. B06a (left side) and B08a (right side)**

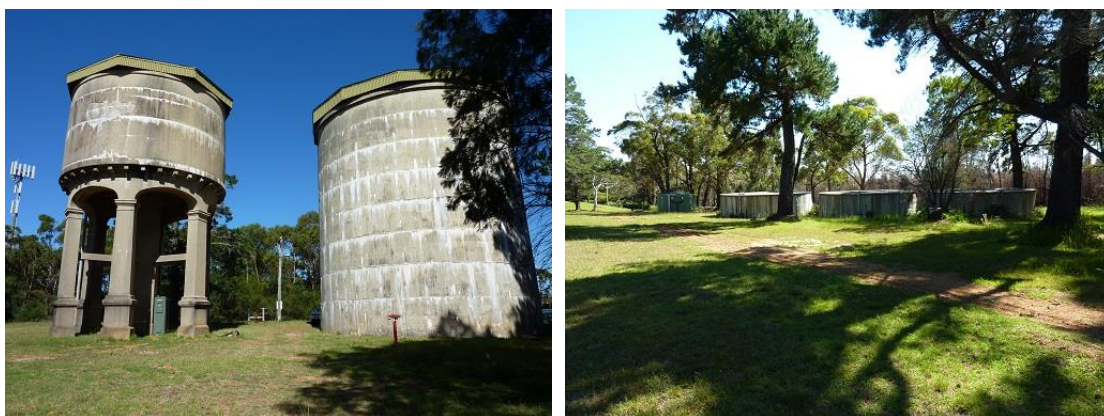
The other main structures on the complex include water storage tanks (Refs. B14t01, B14t02, B15t01 to B15t03, B17t01, and B18t01), above ground gas storage tank (Ref. B01t03), and trickle filter tank B16t01. Photographs of these features are provided in Figure 8 to Figure 11.

**Figure 8 Water Storage Tanks Refs. B14t01 and B14t02 (left side) and Refs. B15t01 to B15t03 (right side)**

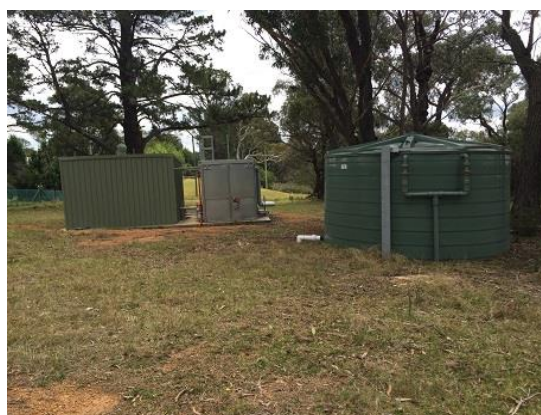
**Figure 9 Water Storage Tanks Refs. B17t01 (poly tank) and B18t01 (steel tank)**

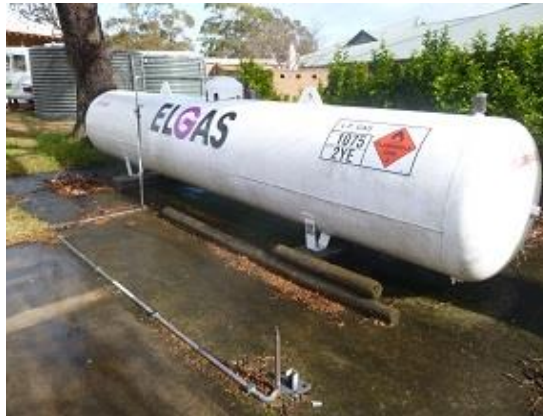
**Figure 10 Gas Storage Tank B01t03**

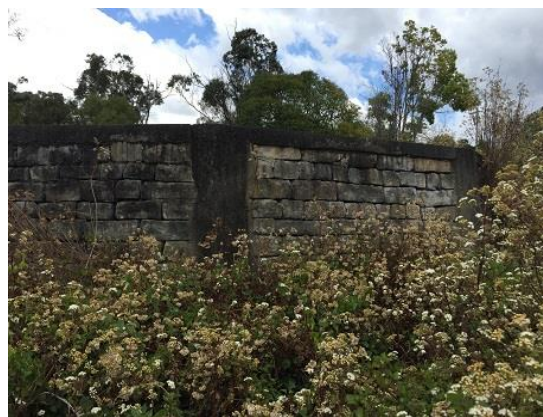
**Figure 11 Trickle Filter Tank B16t01**
