# Appin Mine Heritage Management Plan

# CONSERVATION MANAGEMENT PLAN

Mountbatten Group, Menangle Road, Douglas Park NSW

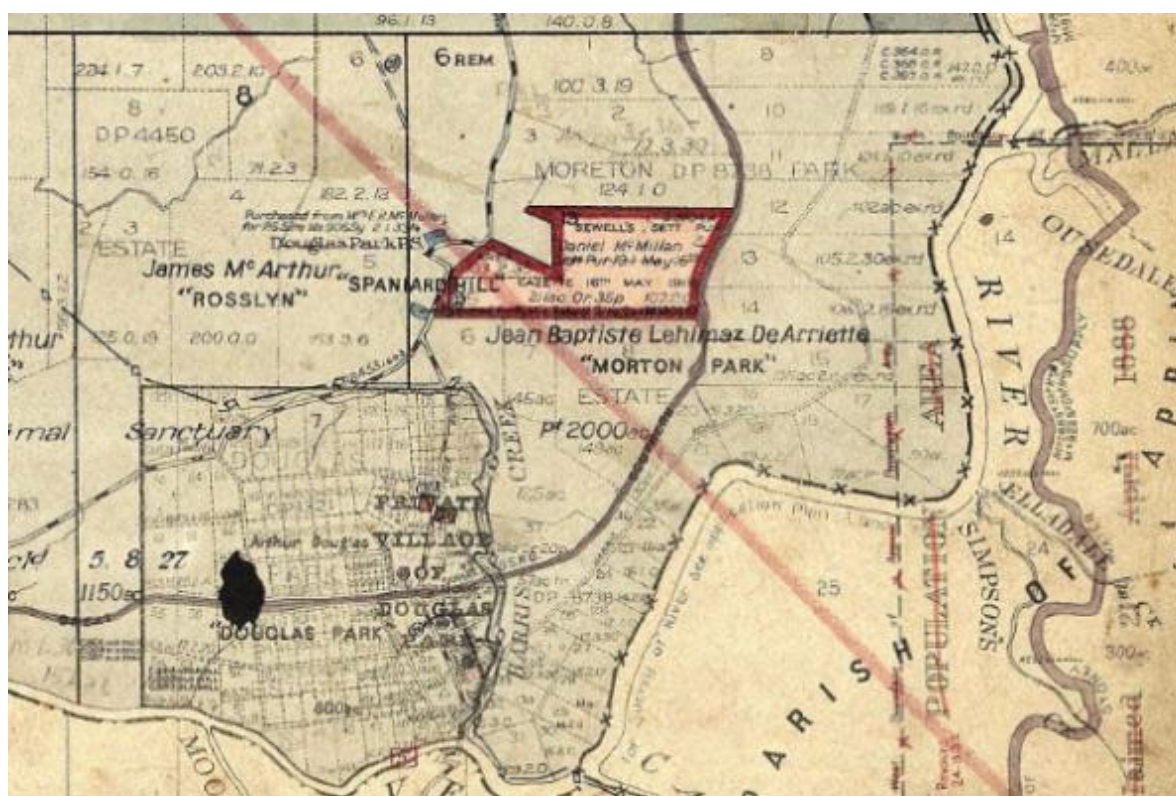
Figure 11. A 1922 subdivided plan of Morton Park Estate, with the 38 Lots possibly denoting former tenant farm boundaries (Source: HLRV)

| Figure 11. A 1922 subdivided plan of Morton Park Estate, with the 38 Lots possibly denoting former tenant farm boundaries (Source: HLRV)..... | 28 |

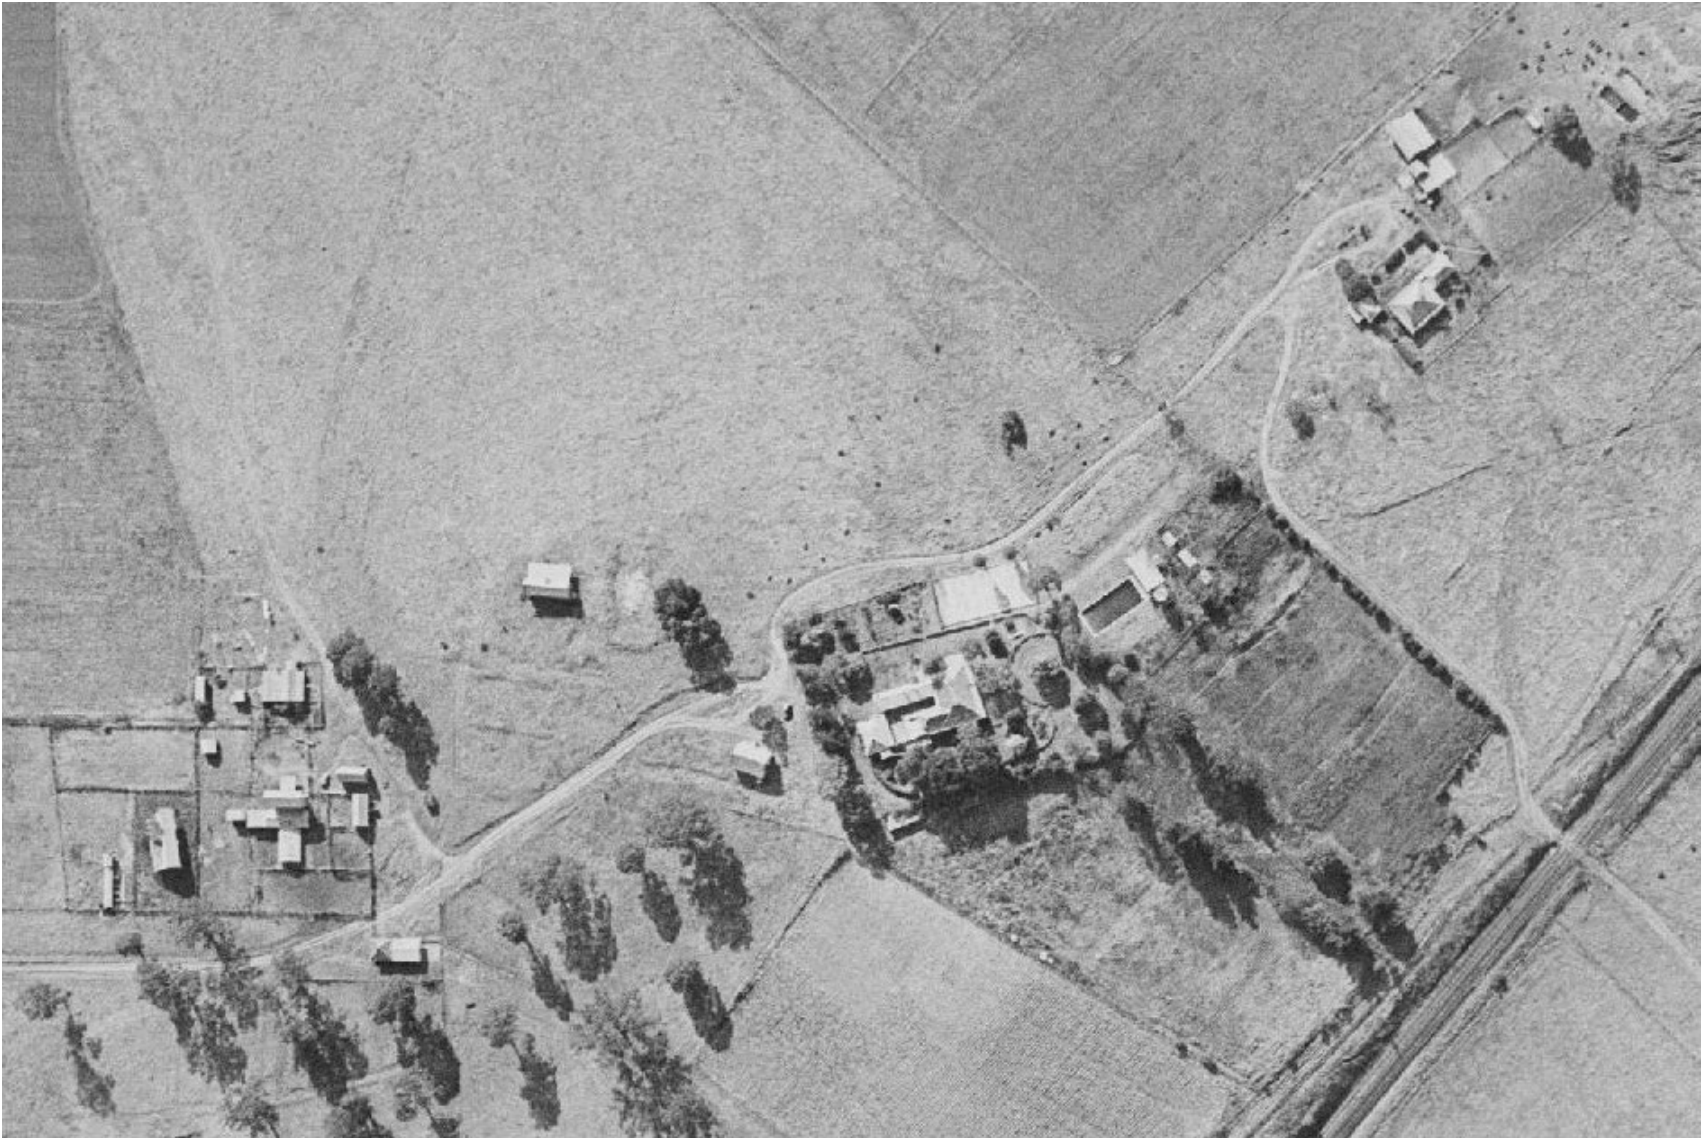
*Figure 13. 1950 aerial photograph of the Terpening's 'Mountbatten' (Morton Park) guesthouse showing the extent of buildings at that time (Source: Spatial Services NSW)*

| Figure 13. 1950 aerial photograph of the Terpening's 'Mountbatten' (Morton Park) guesthouse showing the extent of buildings at that time (Source: Spatial Services NSW)..... | 30 |

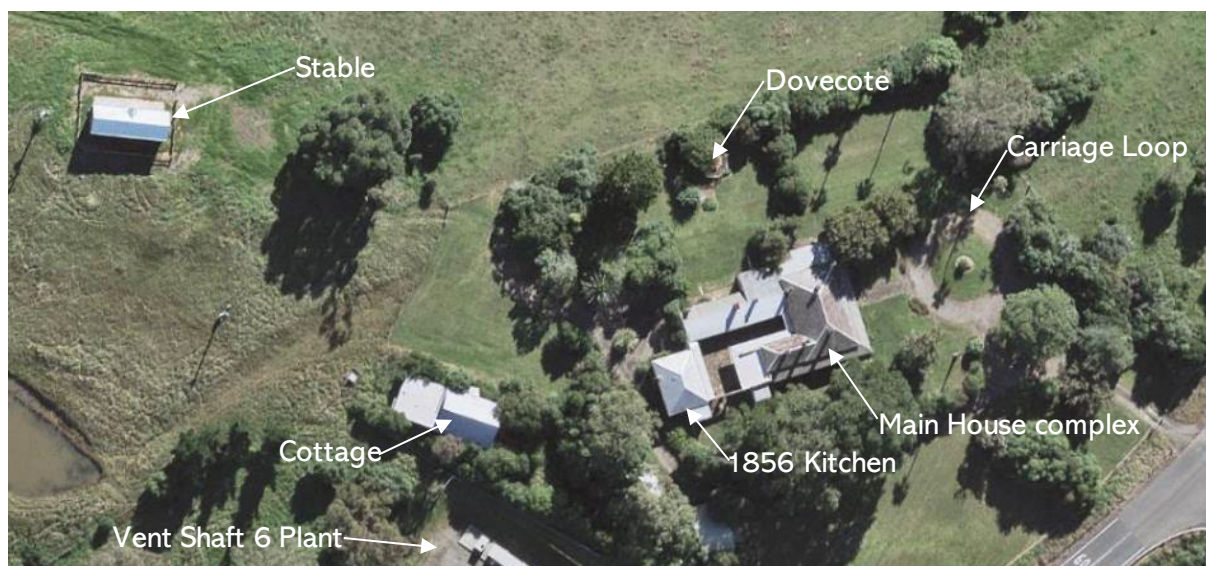
Figure 14. Overview of key elements of the present Mountbatten Group (north to top) (Source: Sixmaps with Archive markup).

| Figure 14. Overview of key elements of the present Mountbatten Group (north to top) (Source: Sixmaps with Archive markup)..... | 35 |

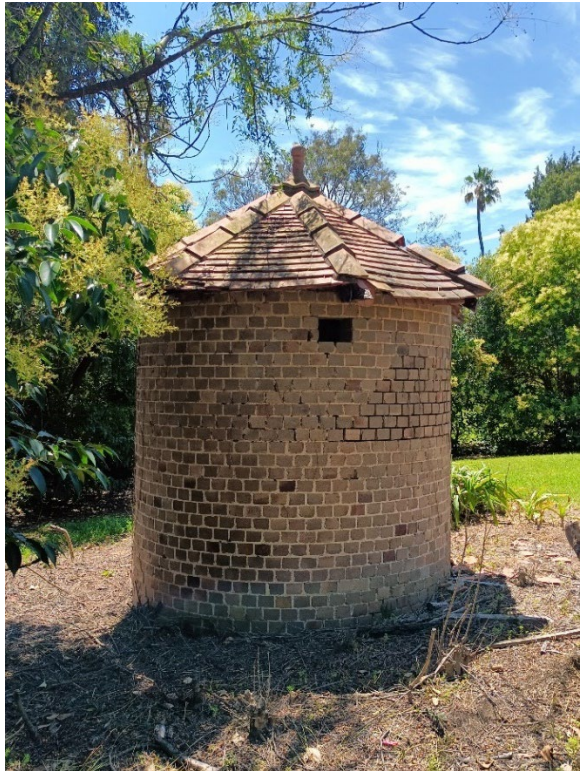
Plate 9. 20<sup>th</sup> century dovecote (Source: Archive Heritage)

The dovecote is the structure referred to elsewhere as the aviary<sup>52</sup> and 'garden building'.<sup>53</sup> Dovecotes of this style were features of aristocratic homes from the earliest phases of colonial Australia and the roof tiles of this example are handmade and consistent with others in use during the first half of the 19<sup>th</sup> century.<sup>54</sup> However, the masonry of this example is of a later date, being made of mass-produced bricks and a cement render and likely built during Phase 3.

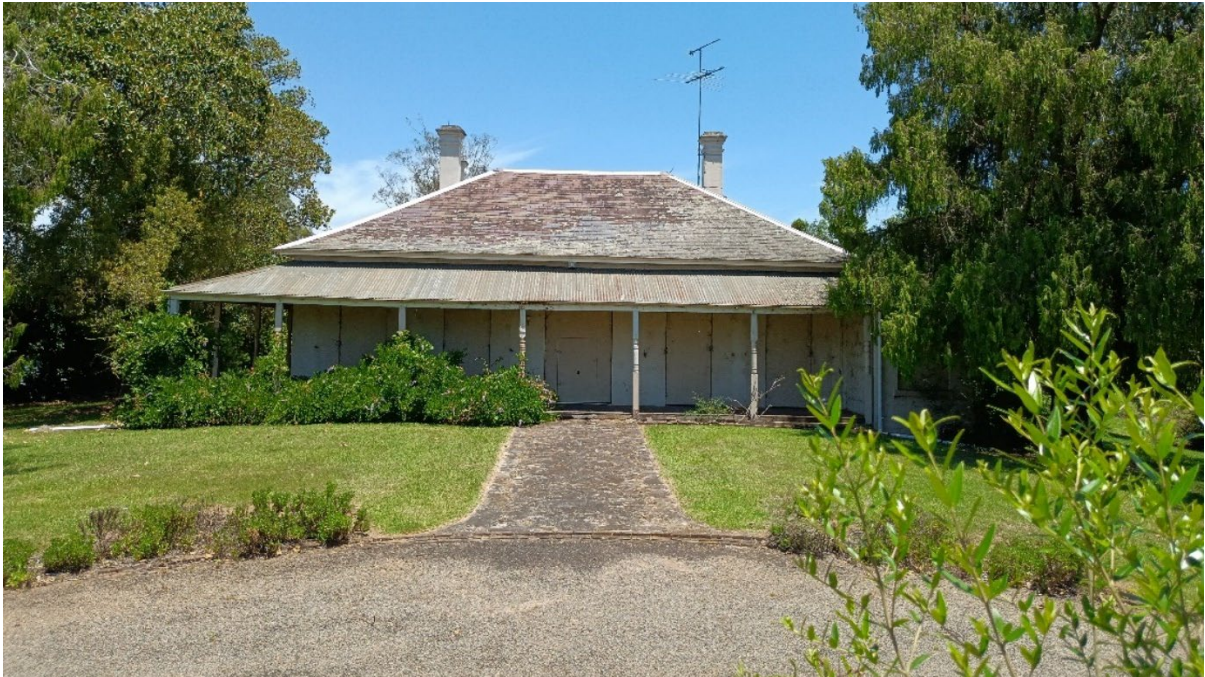
*Plate 10. Front entrance façade of the Main House (Source Archive Heritage)*

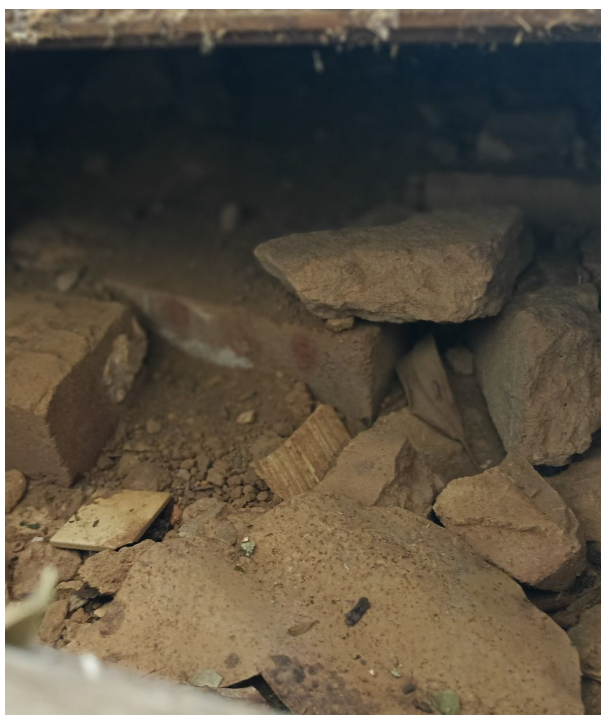
*Plate 12. Disused timber support pad materials from previous phases of decking (Source: Archive Heritage)*

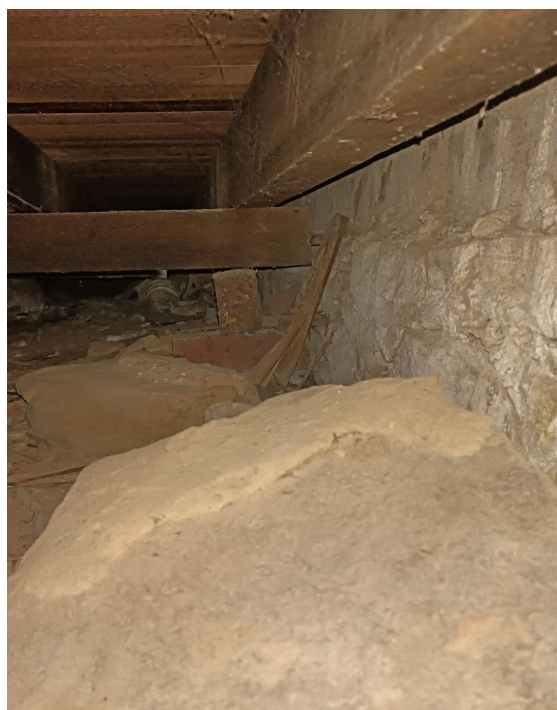
*Plate 13. View of well-formed sandstone footings beneath interior floor (Source: Archive Heritage)*

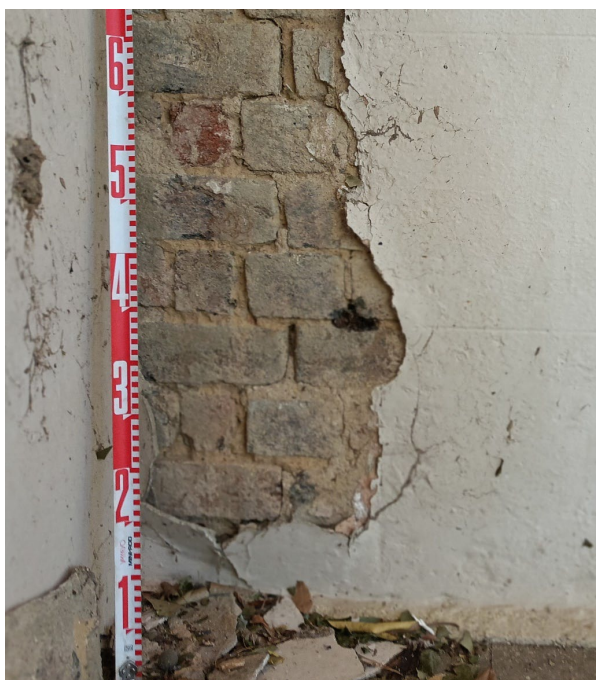
Plate 14. Fallen render and exposed masonry (Source: Archive Heritage)

entirely re-applied using traditional techniques during major restoration works carried out during the 1980s.<sup>60</sup> However, well-made and applied lime render may last for centuries, requiring only repeated limewash 'set' finishes. The render of the front façade is considered no older than the Phase 3 extensions at either end of the verandah which underlie the present render.

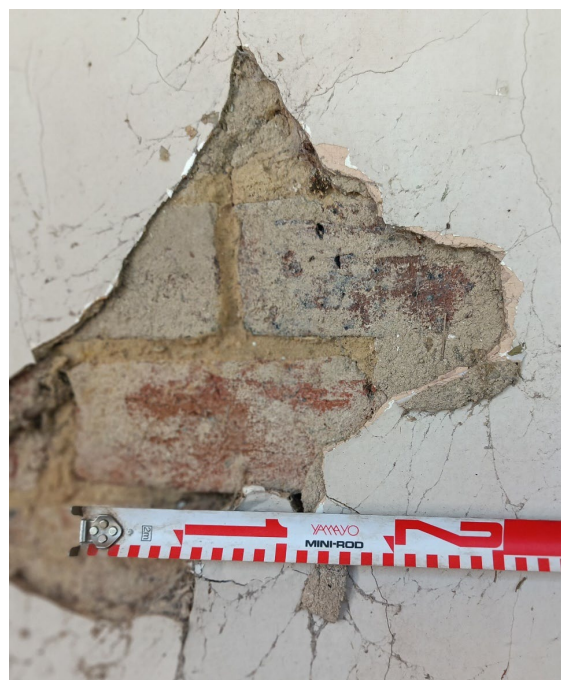
Plate 15. Detail of render and mortar (Source: Archive Heritage)

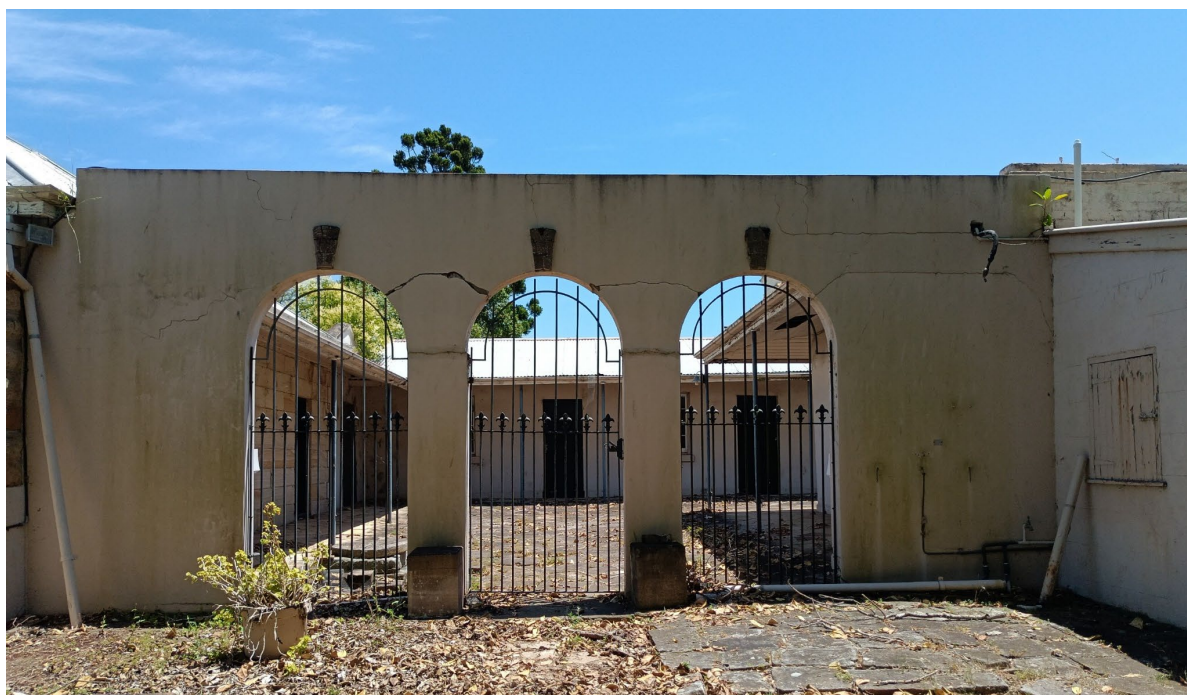
*Plate 16. Phase 3 masonry arch wall exterior with the 20<sup>th</sup> century laundry addition at right (Source: Archive Heritage)*

The wall at the southern end of the verandah forms one side of the Phase 2b (1860-1914) Bathroom 4 extension. This bathroom forms an en-suite to one of three adjoining rooms of a southern wing accessed from an internal Courtyard. Bathroom 4 has also had a small, one-room laundry with a concrete floor tacked on to its southern wall that is likely to have been built for this purpose, or as a storeroom during Phase 3 (1914-c.1960) or Phase 4 (c.1960-Present) (**Plate 16**).

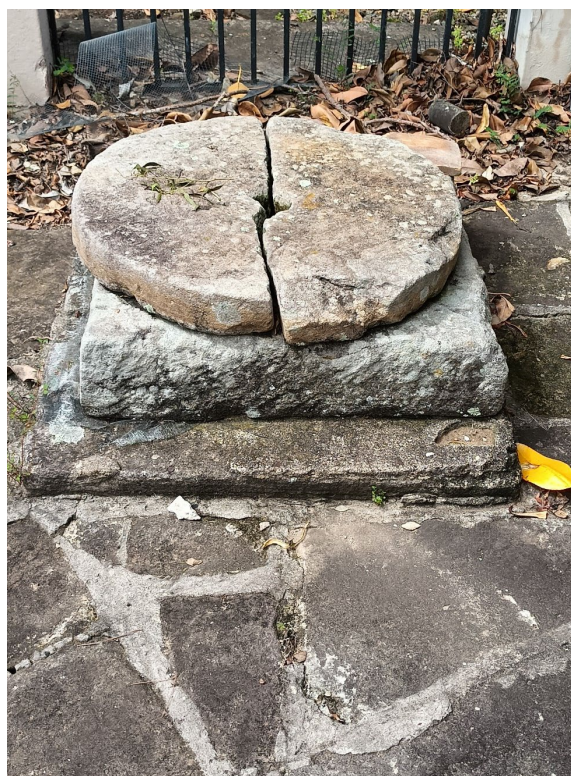
Plate 17. Sandstone framed cistern opening set into the Courtyard and former millstone (Source: Archive Heritage)

The large, approximately 20,000 litre capacity cement rendered cistern was likely built during Phase 2b (c.1860-1914) and later modified under Stanley Haddin's Phase 3 ownership, as he is recorded as sourcing pumped water from the Nepean in 1933.<sup>55</sup>

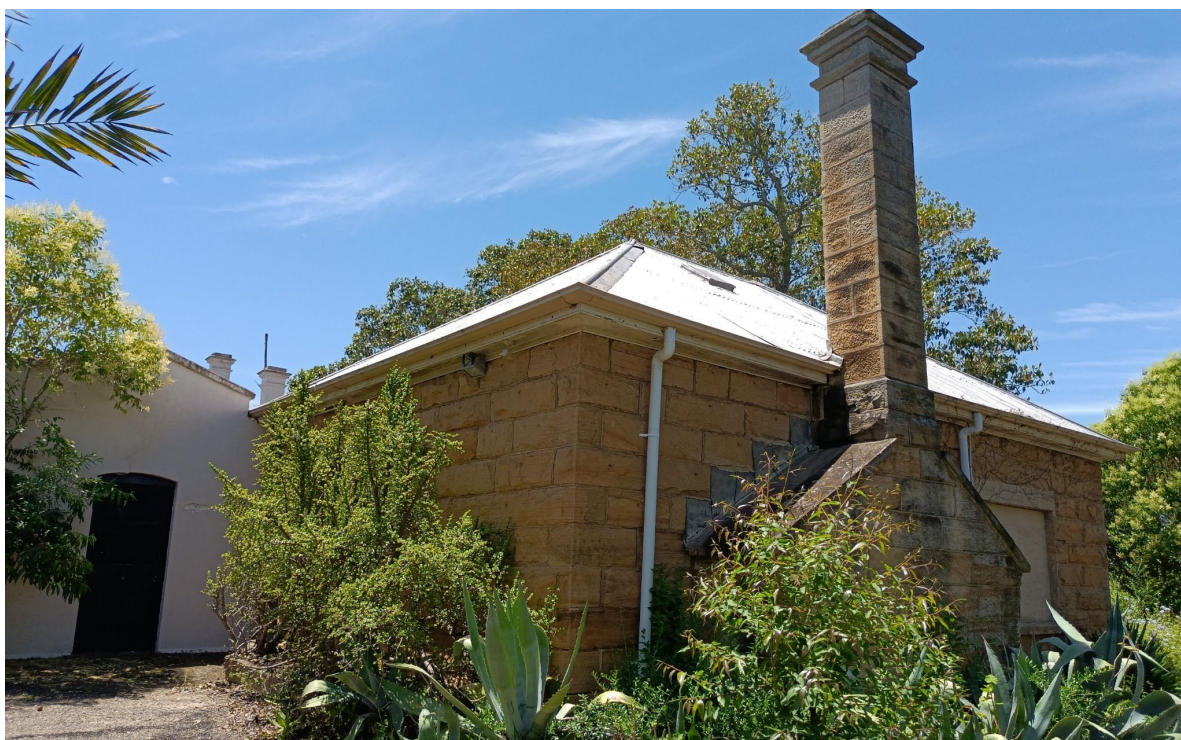
*Plate 19. View south-east toward the western elevation of the Kitchen and attached Courtyard wall (Source: Archive Heritage)*

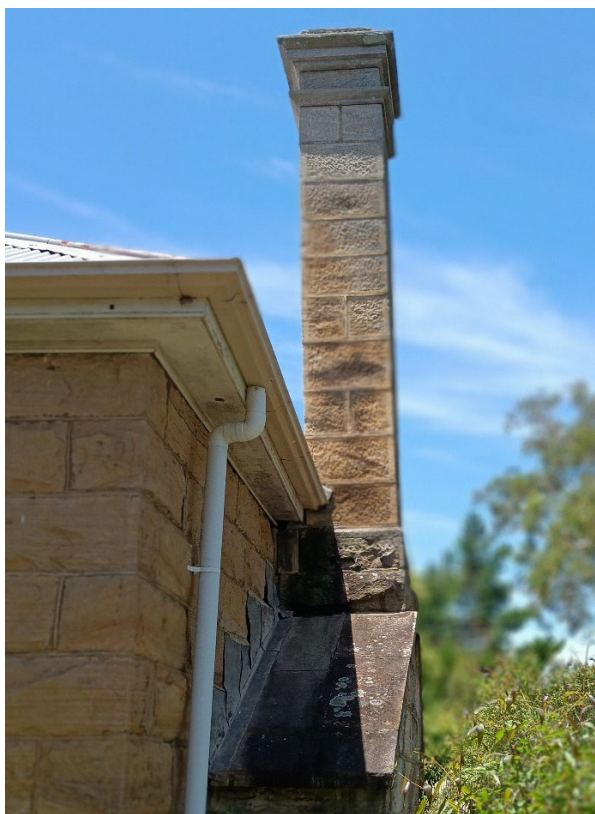
*Plate 20. Tilted chimney seen from the north (Source: Archive Heritage)*

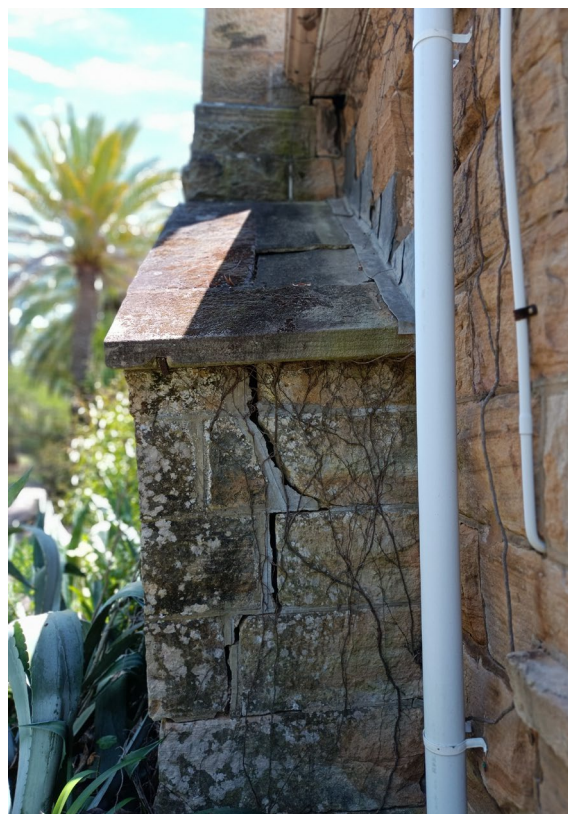
*Plate 21. Cracking on the chimney seen from the south (Source: Archive Heritage)*

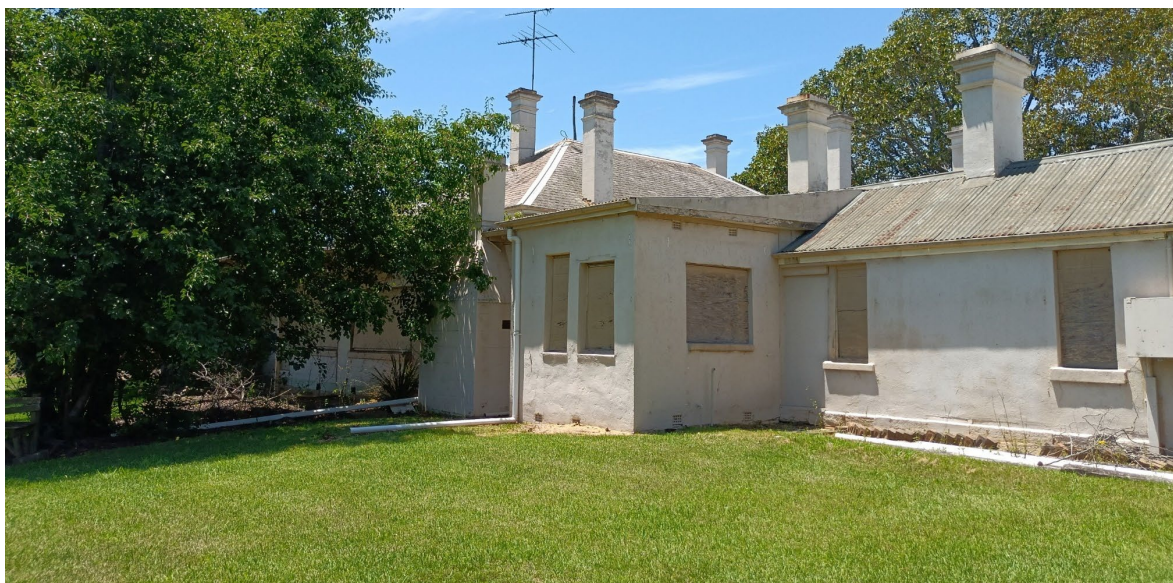
*Plate 22. View southeast toward the northern elevation (Source: Archive Heritage).*

To the east the elevation becomes irregular in profile; a result of substantial, piecemeal Phase 3 extension of the interior spaces (**Plate 22**). A former Phase 4 timber deck in this area has been removed. At its eastern end, the extension wraps around to meet the front verandah of the house as described at the start of this Section.

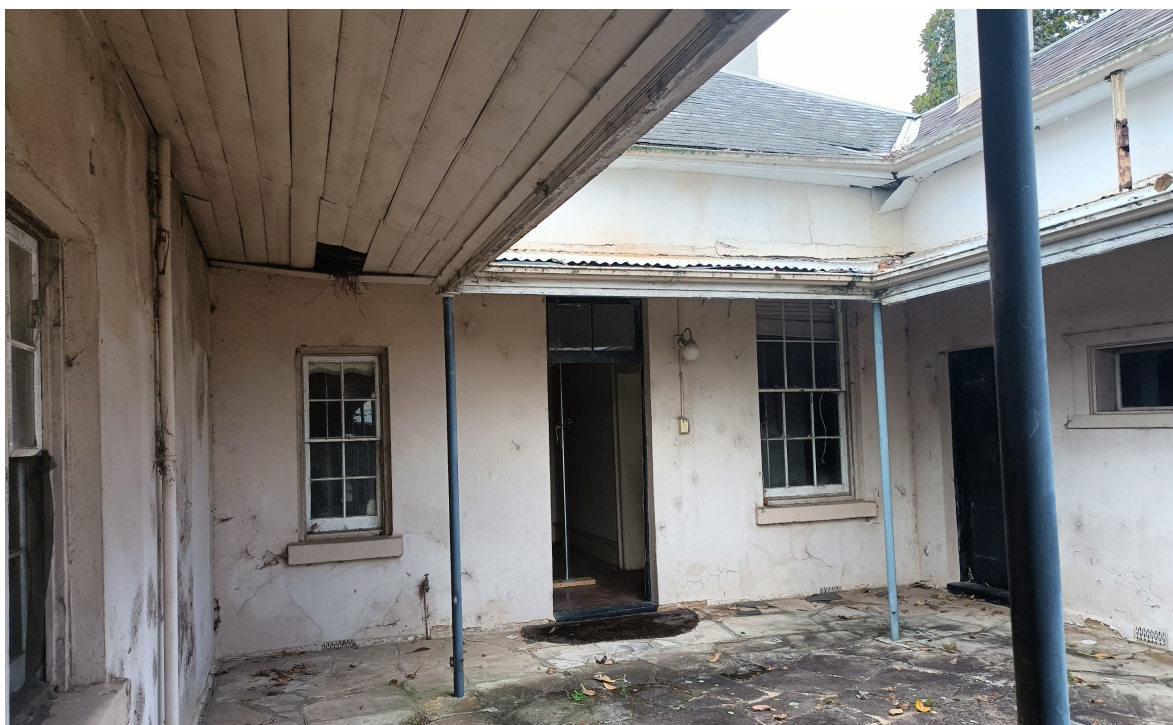
*Plate 23. Courtyard doorway and altered window reveals at the back of the Main House. Failing flashing and eaves are visible (Source: Archive Heritage)*

The 1858 building has a long history of alterations, culminating in a series of restoration works carried out in the late 1980s.<sup>66</sup> These works were in keeping with the original style, however the result is that the house features eclectic signs of past development (**Plate 22** and **Plate 23**) and many original internal finishes have been replaced, affecting the architectural character of the interiors and function of many rooms. The present function of rooms within the Main House are illustrated in **Figure 16**.

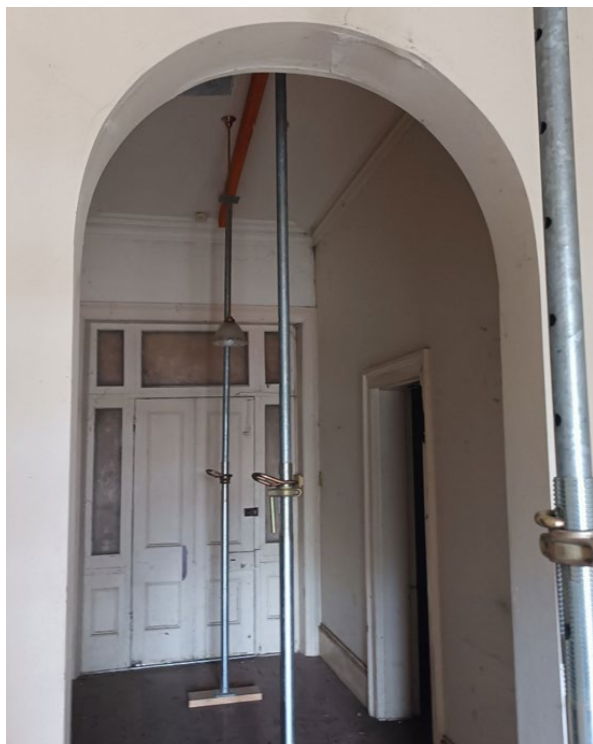
*Plate 24. Centre of the Entrance Hall showing arch, front door and glazing (Source: Archive Heritage)*

The full-length Entrance Hall (**Plate 24**) is centrally divided by a simplified Georgian hall arch and displays the original 12-foot ceiling heights. Wall surface fabrics were seen to be a mix of painted and concealed render and later plasterboard and tiles introduced during Phase 4 renovations,<sup>67</sup> Ceilings appear to also be a mixture of older plaster and recent plasterboard additions (**Plate 25**). Where sections of these have been removed, recent timber members are seen supporting lath and plaster impressed original ceiling joists,

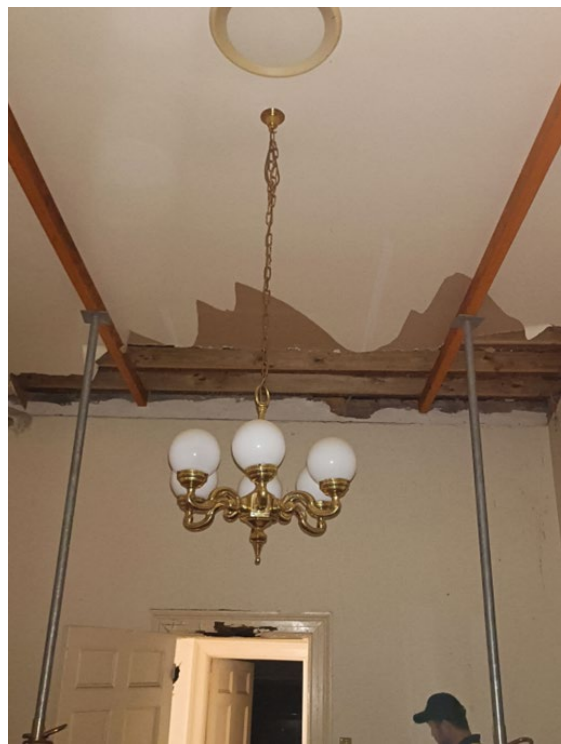
*Plate 25. 20<sup>th</sup> View north of the Dining Room showing ceiling damage (Source: Archive Heritage)*

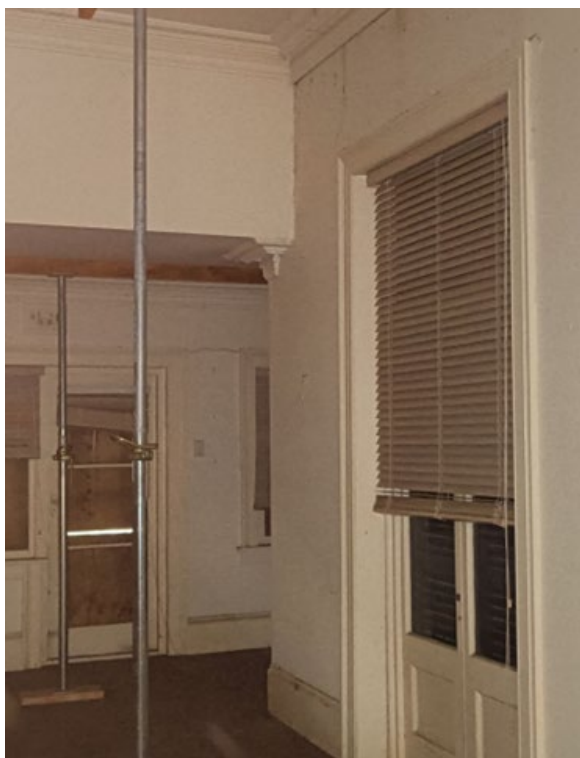
Plate 26. View north through the living room showing bulkhead of northern extension (Source: Archive Heritage)

Plasterboard cornice mouldings used are consistent with traditional wide profile 'run' plasterwork. No original plaster corning appeared to remain. These would have come away with the original ceiling and all current cornices are likely to have been added since the 1940s northern extension (**Plate 26**).

To the right of the front door is a heavily modified 'Lounge Room' (probably originally the 'Drawing Room') (**Figure 16**), the northern wall of which has been removed and replaced with the Phase 3 extension that sits beneath a broad, bulkhead ceiling (**Plate 26**). A large conifer grows close to the north-east of this extension. The interior of this part of the house does not show evidence of foundational movement from this tree. However, substantial cracking is evident elsewhere throughout the interior, including at the eastern end of this Phase 3 extension beneath an area of missing chimney flashing over Bedroom 1. Water infiltration is considered the most likely source of masonry cracking, with foundational movement a secondary contributing factor.

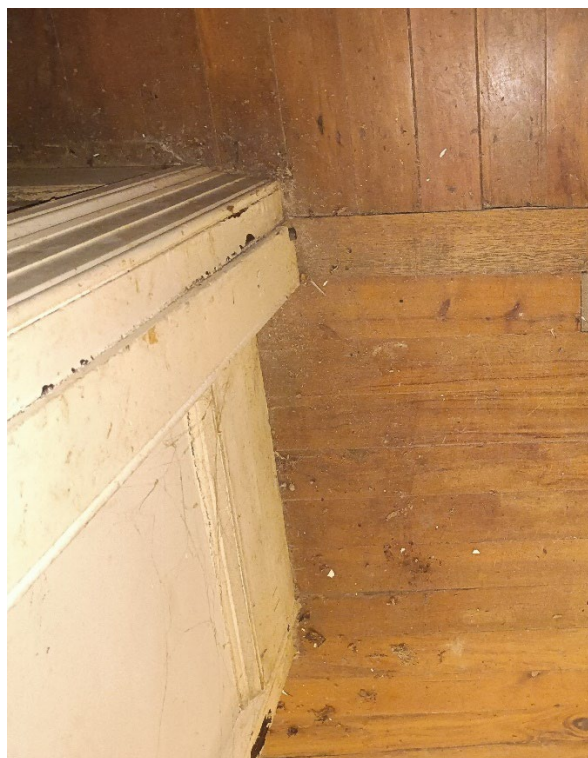
Plate 27. Transition between flooring at entrance to Bedroom 1 (Source: Archive Heritage)

Floors are constructed of a mix of older, hardwood tongue and groove boards fixed with rectangular headed nails or brads and later boards introduced after 1940 (**Plate 27**). All floorboards and the

On the opposite side of the hall the 'Dining Room' (probably originally the reception room or 'Parlour') fireplace had also been covered over, and no fireplace surrounds within the house are original.<sup>68</sup> Doors within this room may retain some of their original surrounds and architraves. In contrast, the main Bedroom has been completely altered through removal of the original doorway and entire northern external wall and the addition of a 20th Century ensuite bathroom, new arched entry and new partition wall and door. At the modified entrance to the Bedroom the transition between the older pre-extension floor and post extension flooring is evident (**Plate 27**).

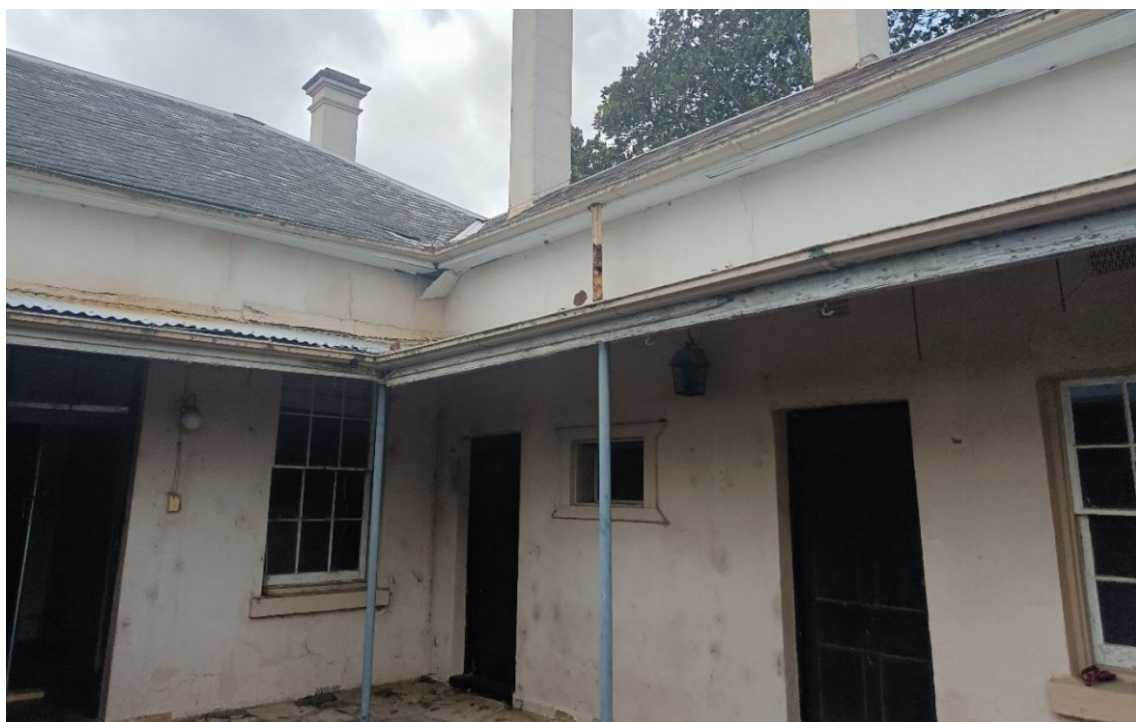
*Plate 28. View south-east of the start of the South Wing. Failed roof plumbing is seen at junction (Source: Archive Heritage)*

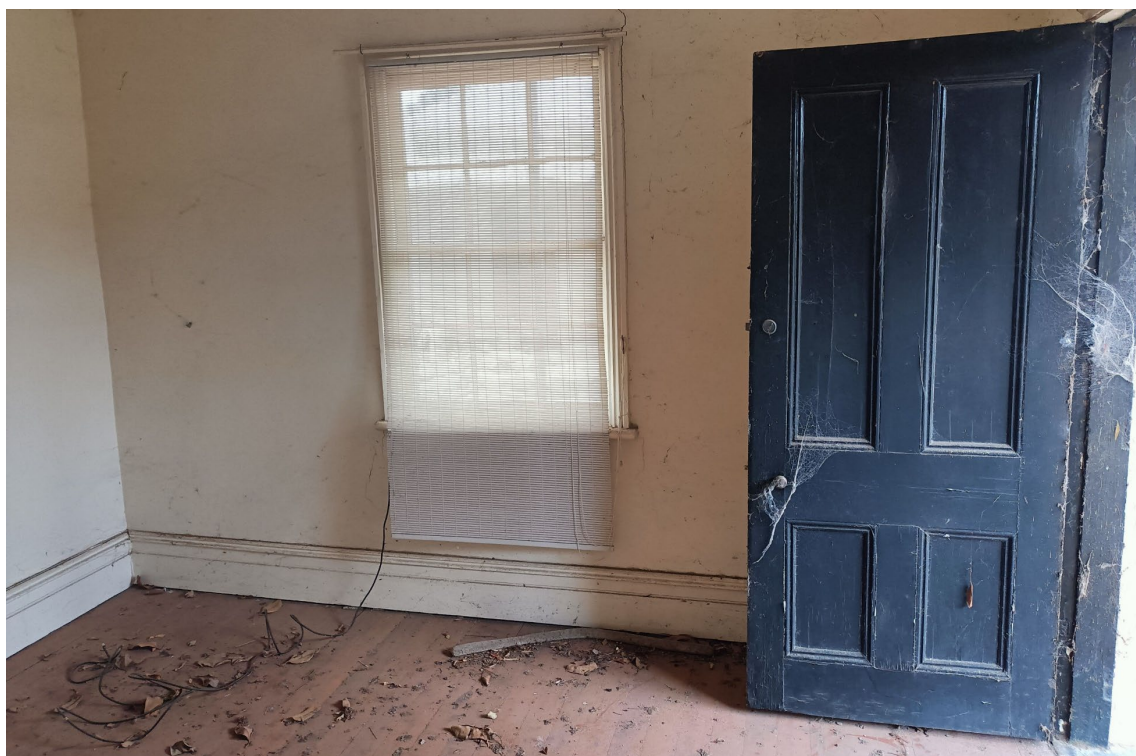
*Plate 30. Interior of the Bedroom 5 western extension of the South Wing with original window (Source: Archive Heritage)*

The final rooms to the west appear to be a later 19<sup>th</sup> century extension. The tacked-on skillion roof of Bedroom 5 and Bathroom 4 is framed by masonry parapet walls – a typical convention of the slightly later Victorian Regency period.<sup>70</sup> These rooms feature original sash windows and timber doors (**Plate 29 and Plate 30**). An internal door connects the two rooms and both have been altered from their original conditions. A timber floor has been fitted to Bedroom 5 and a vitrified clay greywater riser has been

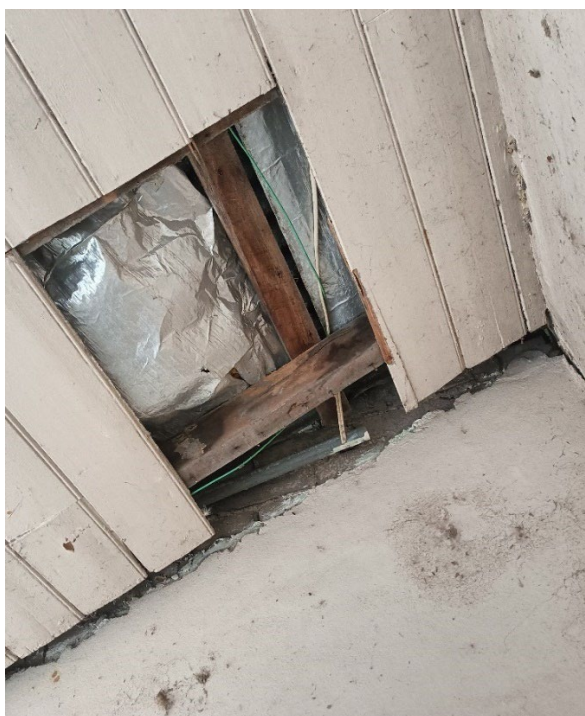
*Plate 33. Timber board ceiling in Bedroom 4 (Source: Archive Heritage)*

The Bedrooms are set under a pitched roof with raked ceilings along the northern edge. Timber boarded ceilings consistent with those seen in Bathroom 4 in the South Wing have been sheeted over during concurrent changes during the 1940s (**Plate 33**).

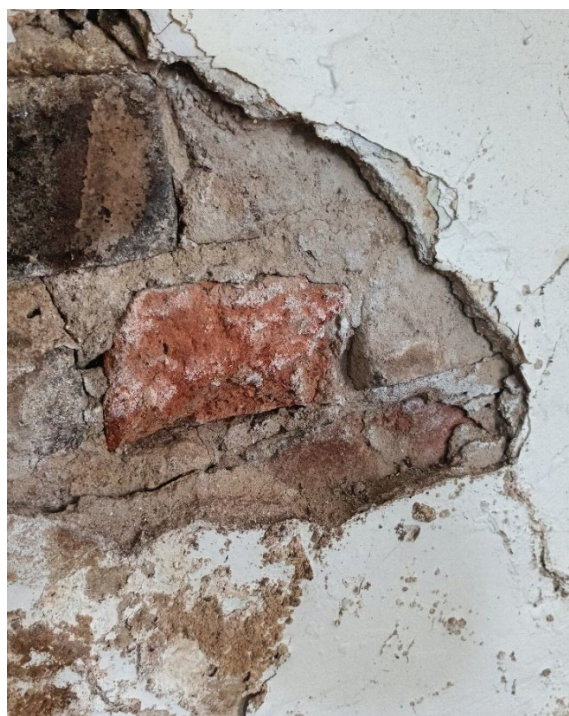
*Plate 34. Early bricks and mortar beneath painted render in Bedroom 4. (Source: Archive Heritage)*

Fallen render in the westernmost room has revealed early bricks bonded with a dark, soft shell lime mortar (**Plate 34**). A reasonable case has been made for the argument that the masonry of this building may predate the Main House,<sup>71</sup> however due to the separate roofline it is more likely that the North Wing was added on to the Main House soon after its construction during Phase 2b. Confirmation of this is prevented by the fact that the entire wing is rendered and painted and the rooms have undergone various alterations including the removal or concealment of some of the original fireplaces (**Plate 35**) though each chimney remains on the roof.

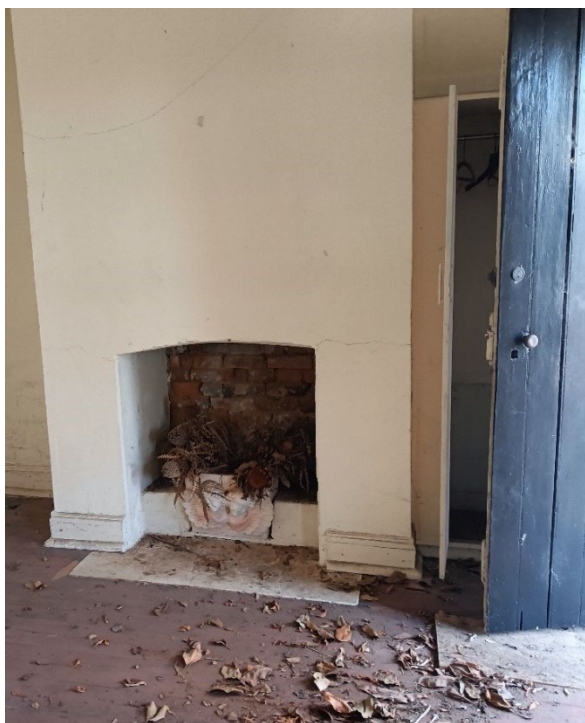
*Plate 35. Original fireplace bricks in Bedroom 3*

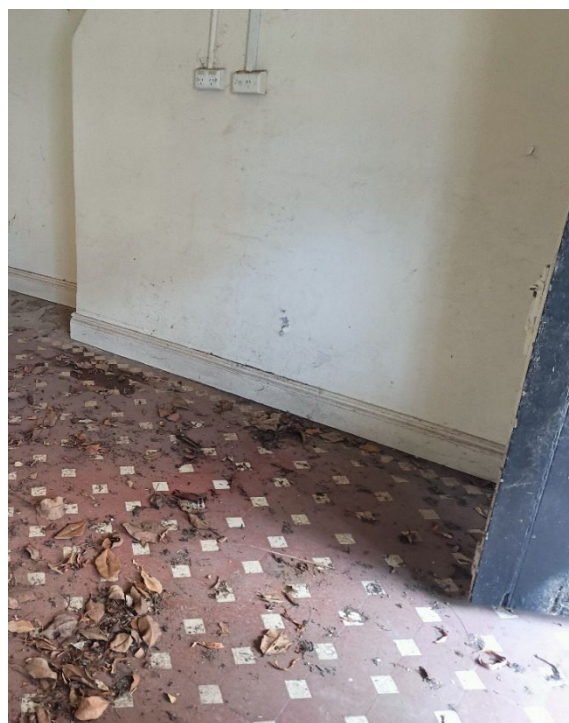
*Plate 36. Concealed fireplace and 20<sup>th</sup> century floor in the laundry (Source: Archive Heritage)*

East of the two end Bedrooms a third has been converted into a laundry (**Plate 36**) and a large Phase 3 bathroom forms the junction with the former master Bedroom of the Main House (**Plate 38**). A variety of

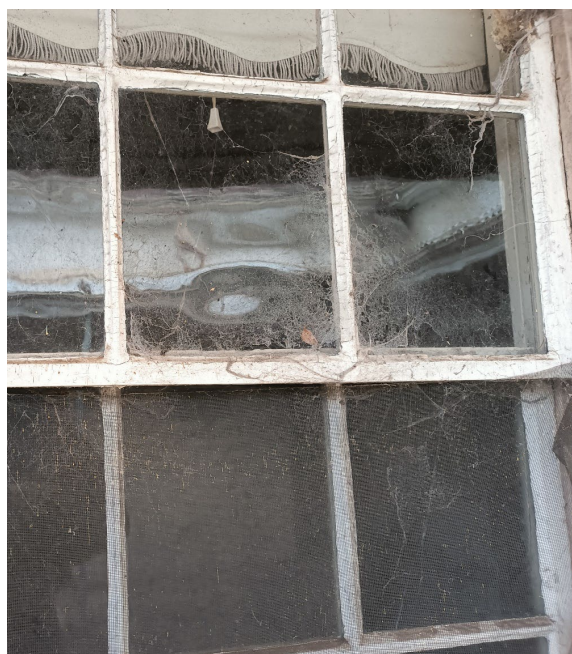
Plate 37. Warped, mid-19<sup>th</sup> century cylinder glass in an original Bedroom 3 window (Source: Archive Heritage)

sash windows are present, with original, early cylinder glass examples lining the Courtyard wall (Plate 37).

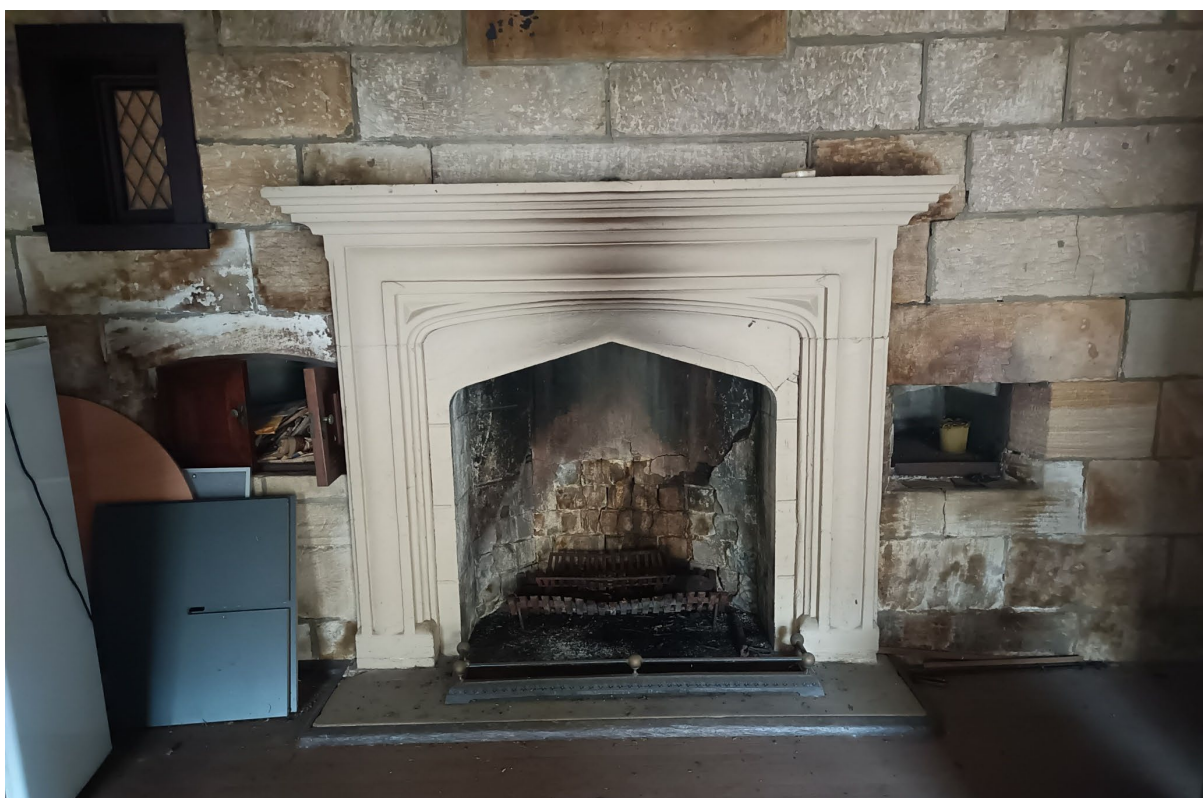
*Plate 40. Replica York stone gothic revival fireplace surround and side ovens, now wood boxes. The inscribed 1865 panel can just be seen above (Source: Archive Heritage)*

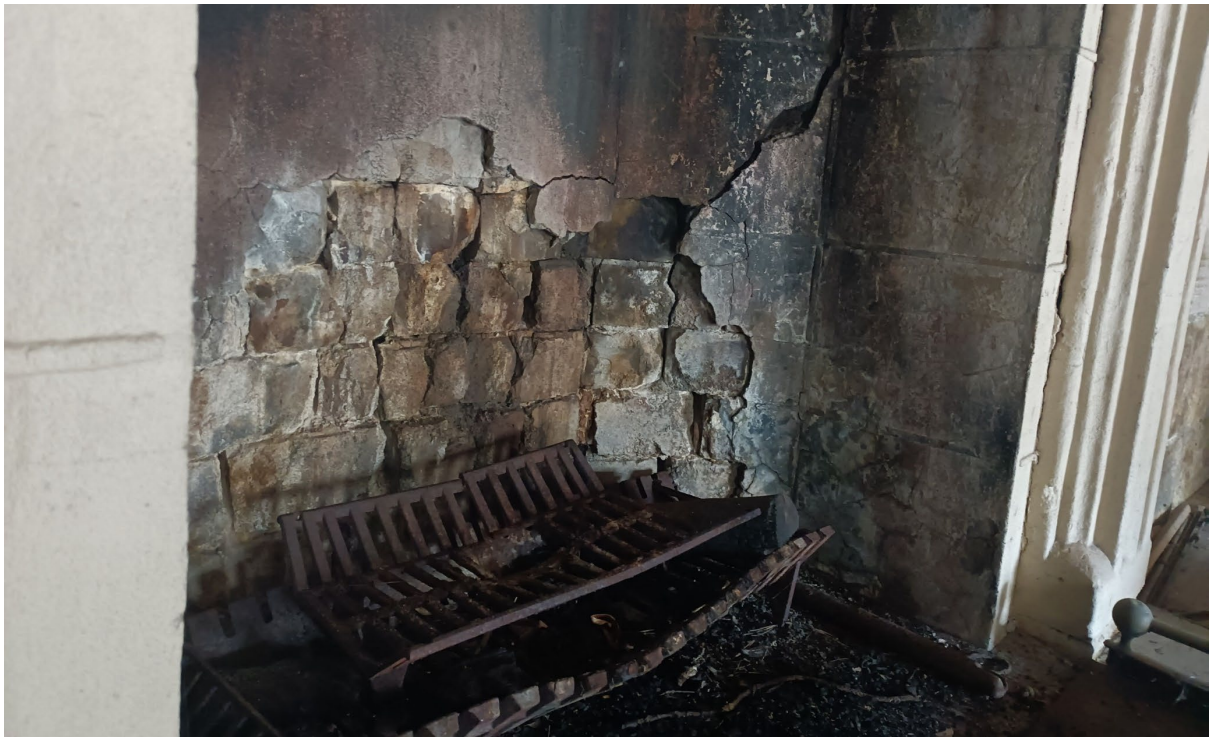
*Plate 41. Detail of the fire bricks used beneath the cracked render (Source: Archive Heritage)*

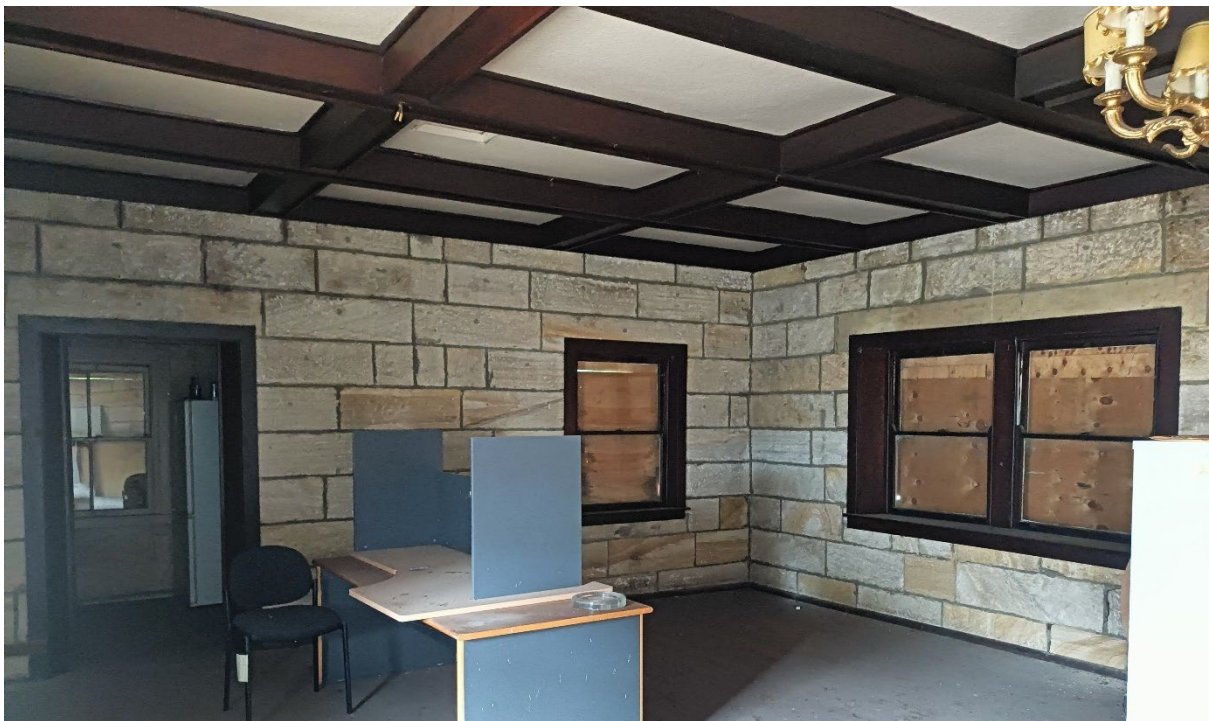
*Plate 42. Phase 3 windows and coffered ceilings, with the meat curing addition at left (Source: Archive Heritage)*
