# Appin Mine Heritage Management Plan

# CONSERVATION MANAGEMENT PLAN

Mountbatten Group, Menangle Road, Douglas Park NSW

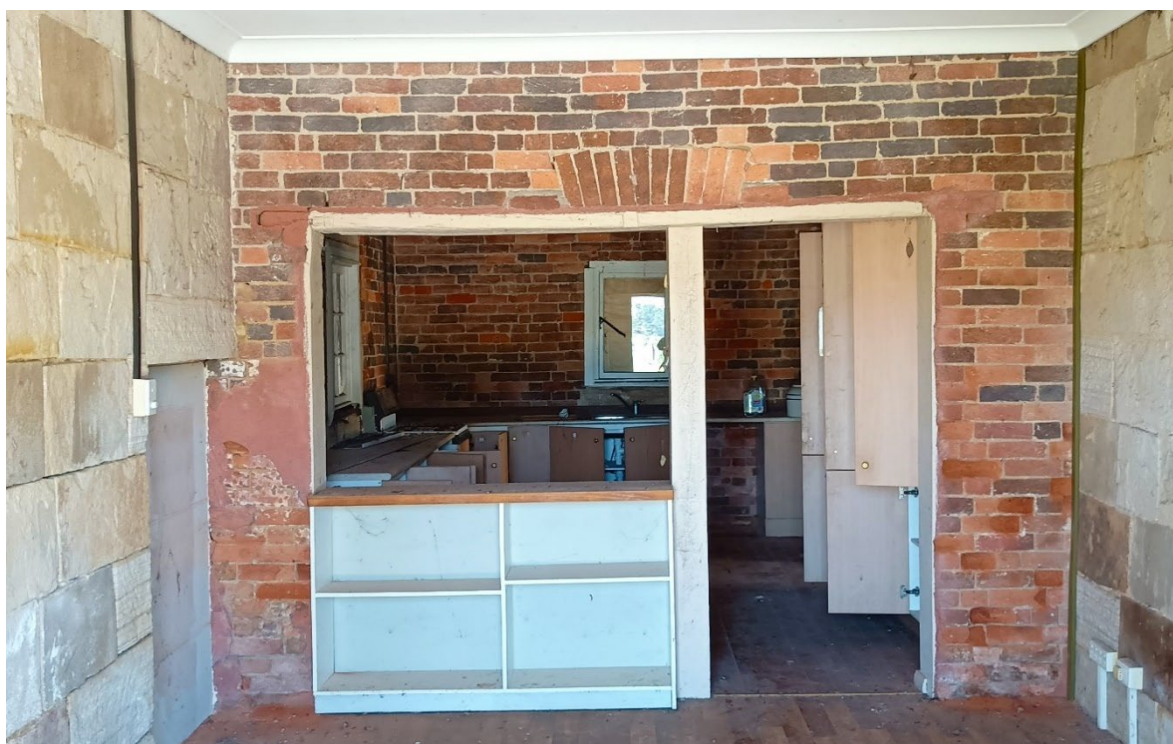
*Plate 45. View east from within the sandstone extension into the earlier brick structure (Source: Archive Heritage)*

The room originally had two centrally placed entrances in the north and west walls. Both have been removed by later changes but are recognizable by their 70 cm-wide brick lintels in the straight fan Colonial Georgian style (**Plate 45** and **Plate 46**). These lintels sit at 2.70 m above the current floor level, a height that is 1 m taller than the average 19<sup>th</sup> colonial cottage doorway. This anomaly is explained by the fact that a 1 m high cellar space exists beneath the modern floor, indicating that the original floor would have sat at a higher level appropriate to both the doorways and a taller cellar space. No evidence of this original floor is evident along the masonry walls. Rather than slotted into the soft masonry, the floor bearers may have been supported by brick or timber pillars spaced across the cellar floor, as the current Phase 4 floor is.

Subsequent 20<sup>th</sup> century change within the building includes a large opening cut into the western brick wall that was then braced by painted, unsquared timber members (**Plate 45**). A further aperture had been opened at the site of the southern door as well and at each join of these openings the damaged brickwork has been pasted over with a rigid, red-tinted cement mortar that detracts from the historical character of the structure.

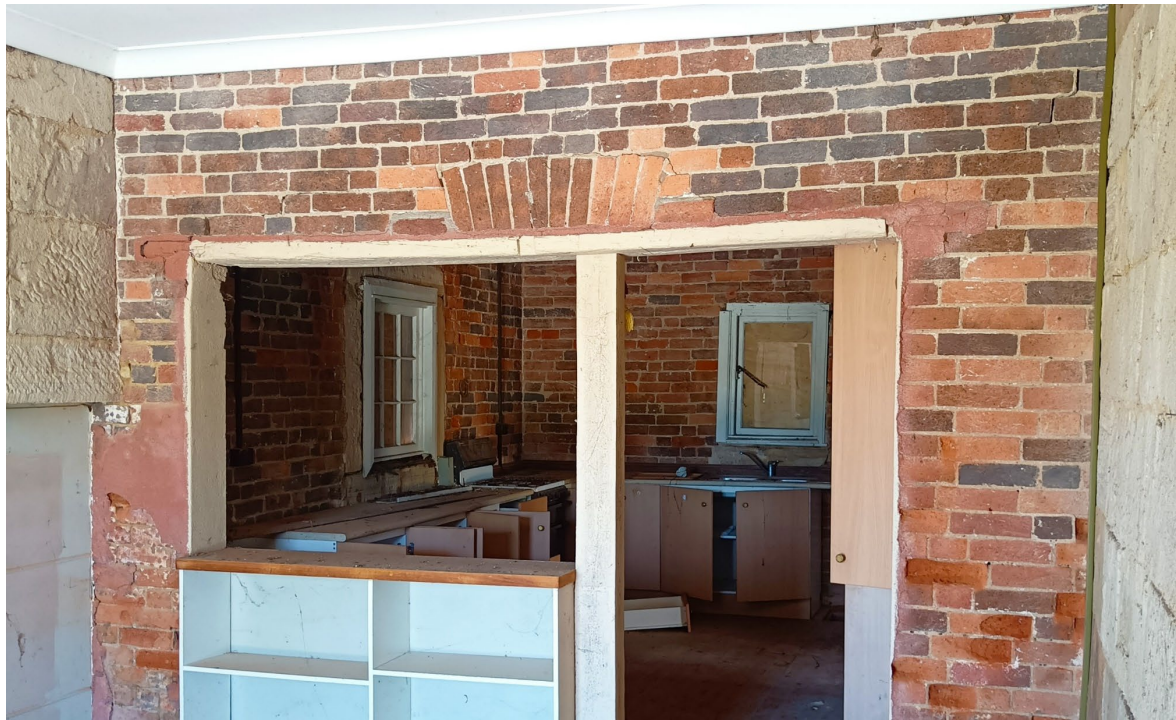
*Plate 46. The splicing of the sandstone masonry into the brickwork can be seen at left (Source: Archive Heritage)*

In taking advantage of the well-constructed brick structure to form a larger one, the sandstone addition has effectively conserved the earlier building (**Plate 46**).

The interior sandstone face blocks are hand-picked, well fitted and free of surface alteration. Windows set into the sandstone reveals, including where inserted into the brick walls, are Mid to Late 19<sup>th</sup> century nine pane and single pane casement windows. The quicklime clay/sand mortar with traditional aggregate inclusions is of an ideal texture, porosity and colour and is likely to be original (**Plate 50**). Mortar is missing from many of the tight joins. The original keying-in of the sandstone addition into the brick walls is clearly visible (**Plate 46**).

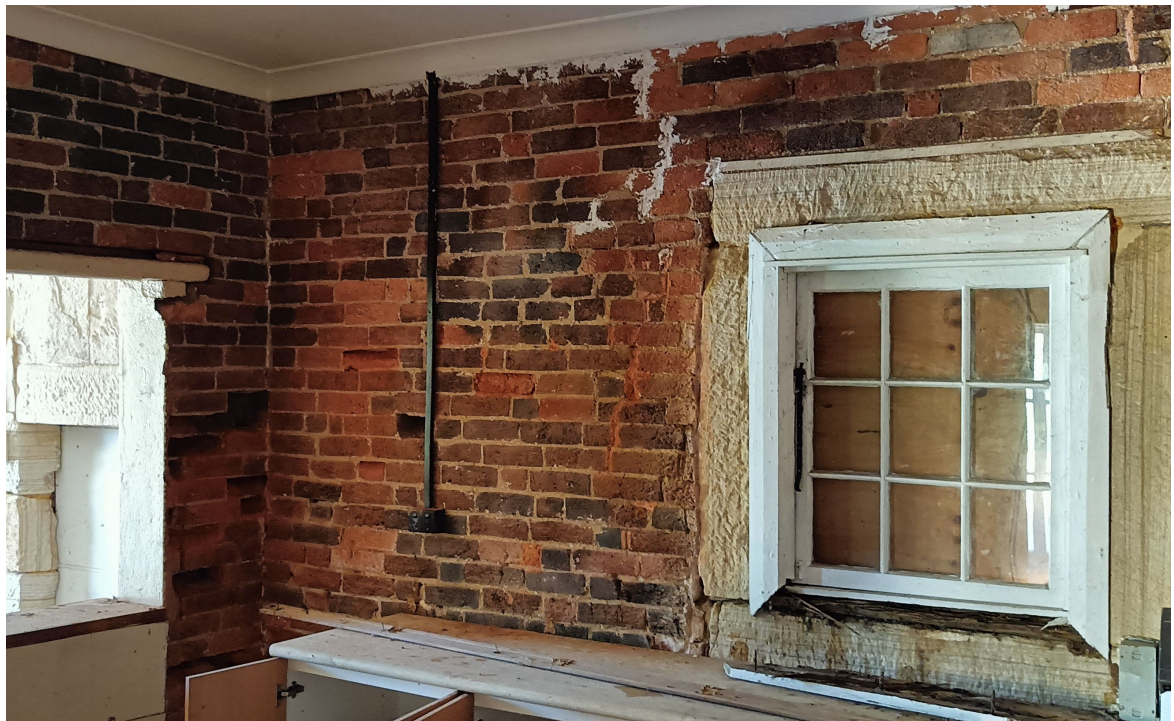
*Plate 47. North-east corner of the brick structure. Various materials can be seen to have patched damaged areas (Source: Archive Heritage)*

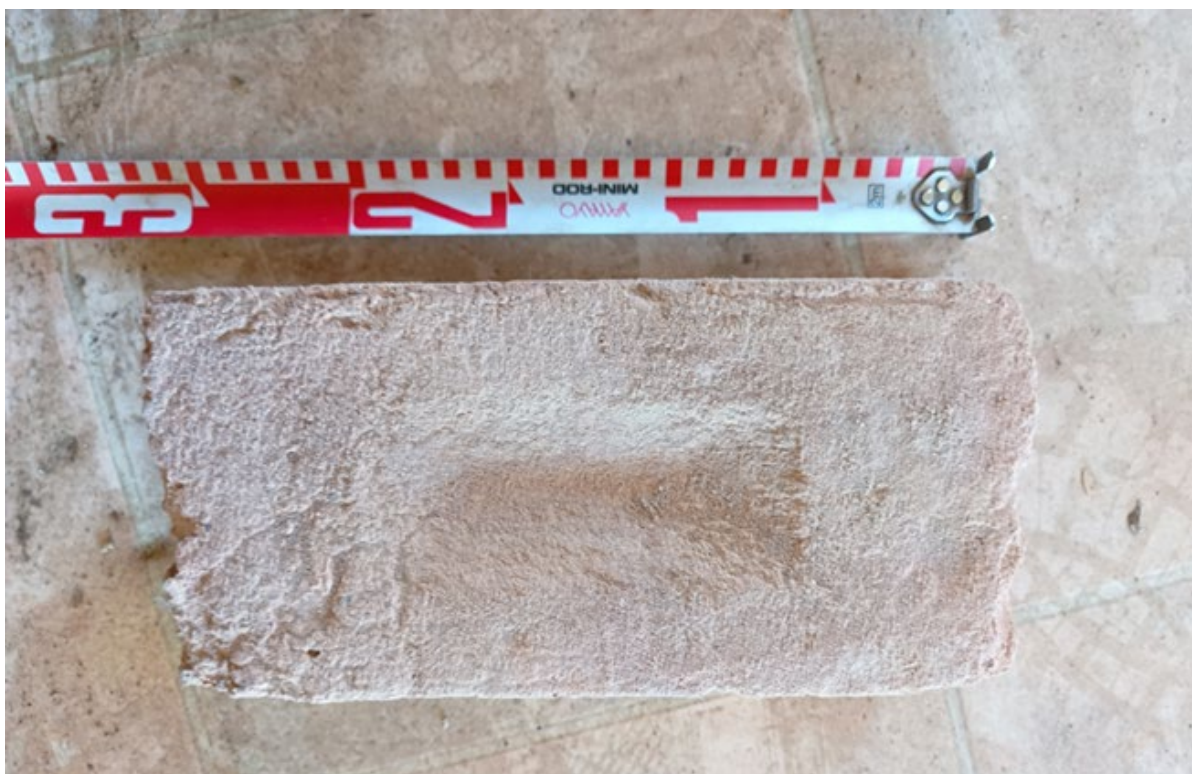
*Plate 48. Size and form of the sandstock bricks, including shallow, irregular frog, poor facing andarris edge. A probable partial thumb print in the handmade fabric is seen at lower right (Source: Archive Heritage)*

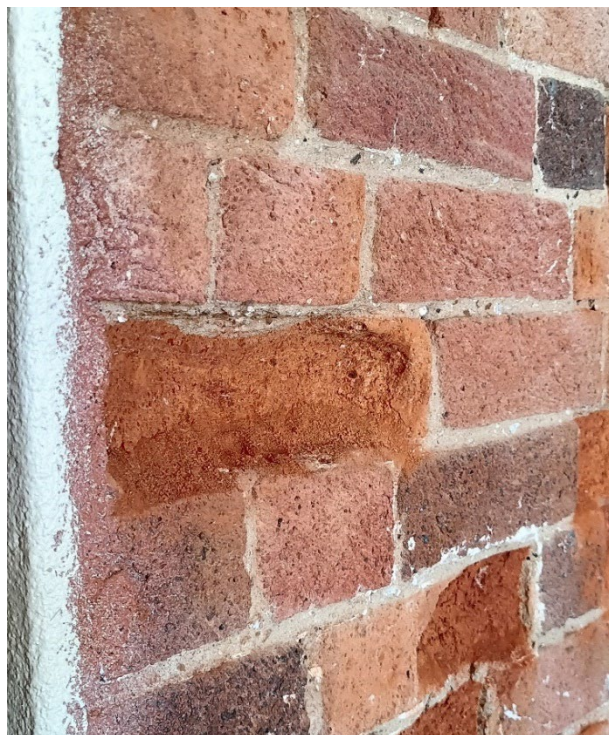
*Plate 49. Detail of mortar and spalling brickwork (Source: Archive Heritage)*

'spalling' - disintegrating and accumulating on the floor as a brick-earth powder, a common problem with early handmade, low-fired bricks, particularly in damp or poorly roofed buildings (**Plate 49**).

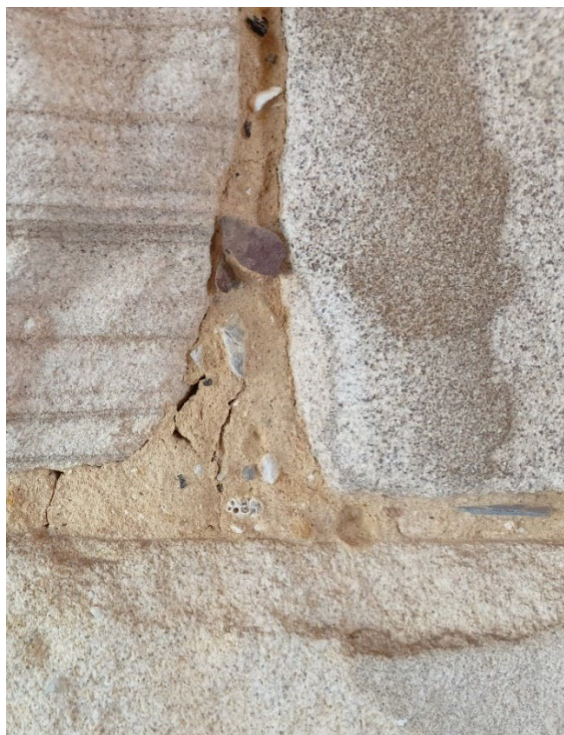
*Plate 50. Detail of the mortar of the later stone masonry (Source: Archive Heritage)*

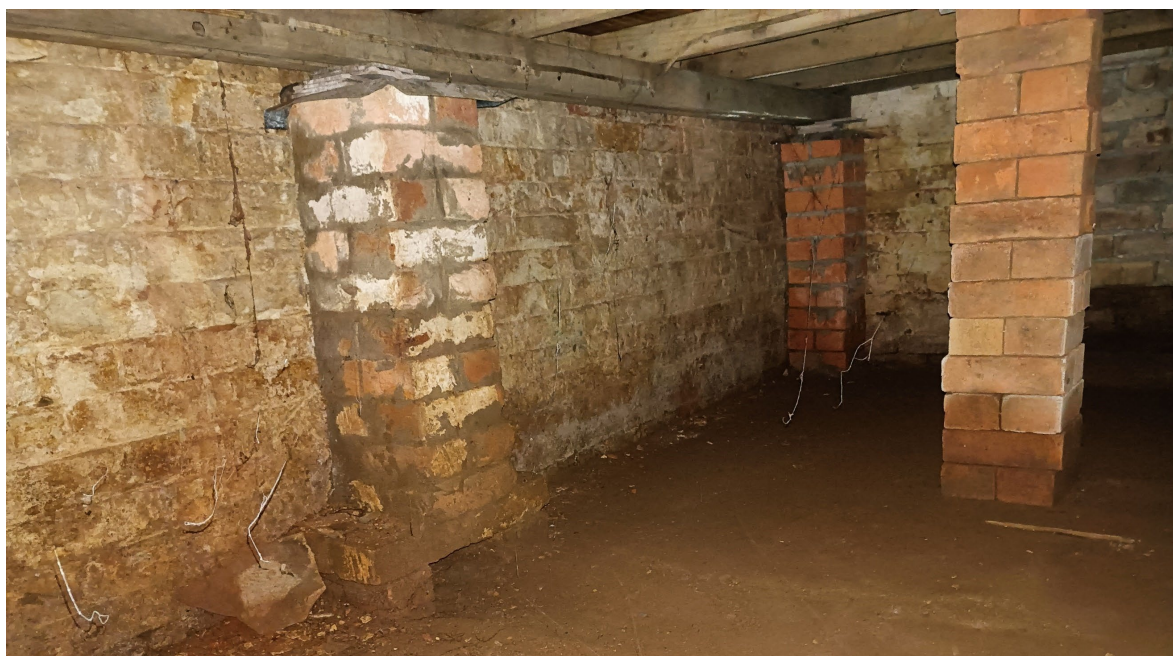
*Plate 51. View south-west into the cellar subfloor area showing later brick piers supporting the Phase 3 floor (Source: Archive Heritage)*

The cellar space, accessible through a trap in the timber floor, once had whitewashed walls (still evident) and likely a rendered and washed floor (**Plate 51** and **Plate 52**). No further details could be made out regarding this floor, as it was covered in a slurry and fine powder of brick-earth and accumulated dust. The space currently supports a number of cement bonded brick pillars supporting the timber floor above, of which the central one rests on a stout, square, brick or sandstone masonry block. This central block has a number of rusted, threaded rods embedded in it that once anchored an iron brace plate or similar, likely for a substantial upright member (**Plate 53**). Such base blocks were required in agricultural settings for mechanical hoists and simple Post Mill mechanisms that were turned by animal or human power to grind flour.<sup>78</sup> It is notable that a relict millstone is present within the Courtyard of the Main House.

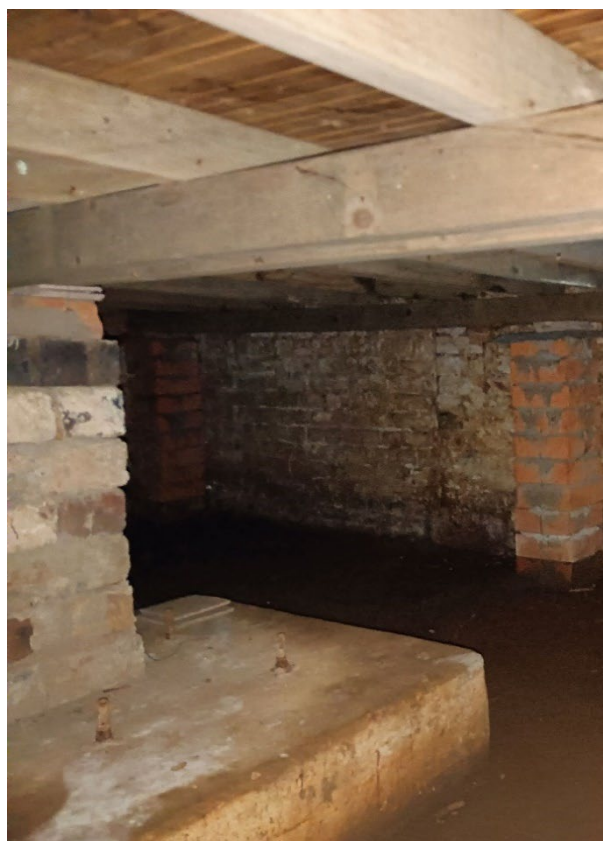
*Plate 53. View north-west into the cellar showing large, central masonry base block with threaded iron fixing rods*

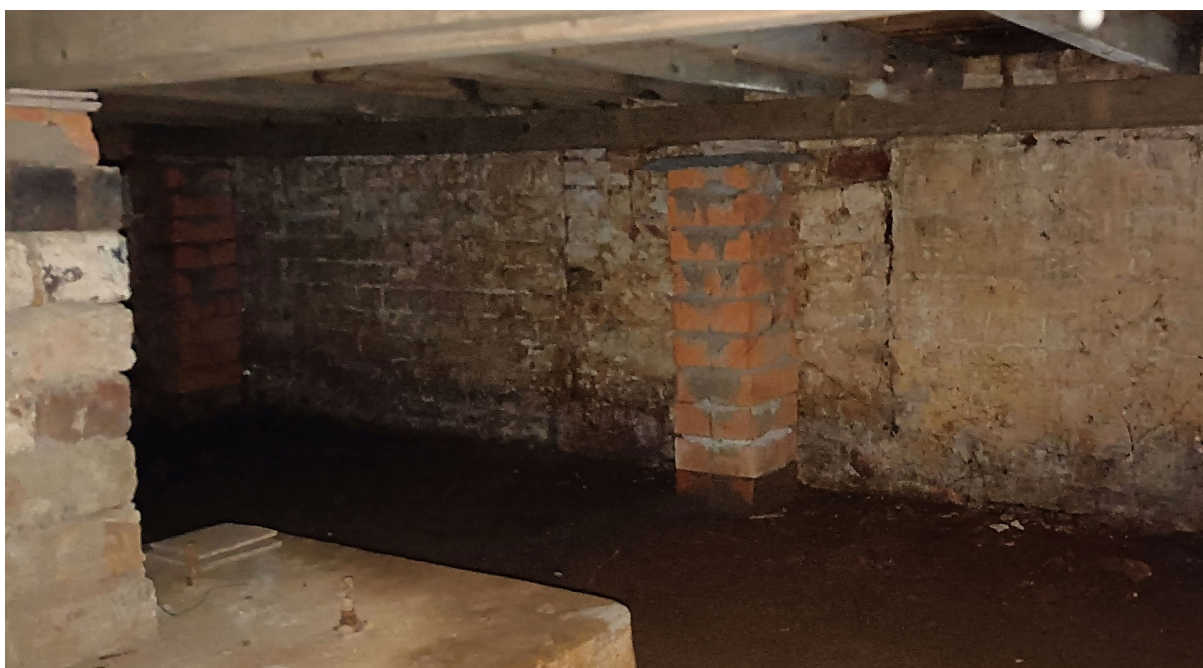
*Plate 54. Possible original, in-filled entry to the Phase 1 brick building's cellar, seen behind the modern brick floor support pillar (Source: Archive Heritage)*

A further detail of the original configuration is seen in an apparent infilled area of brickwork in the northern cellar wall (**Plate 54**). This infilled area may denote a former entry similar to the existing doorway of the exterior northern wall, possibly for a barrel ramp. This strongly suggests that a small, semi-basement/half cellar existed prior to extension of the building into a twin cellar space. It is likely these spaces were accessed via the door seen in **Plate 43-Plate 45** following that extension. Alternatively, the space may have originally formed a specific function such as a kitchen, benefitting from below ground thermal insulation and above ground window light. Removal of the interior floor of the adjacent sandstone extension (discussed below) would further inform the development of the overall structure.

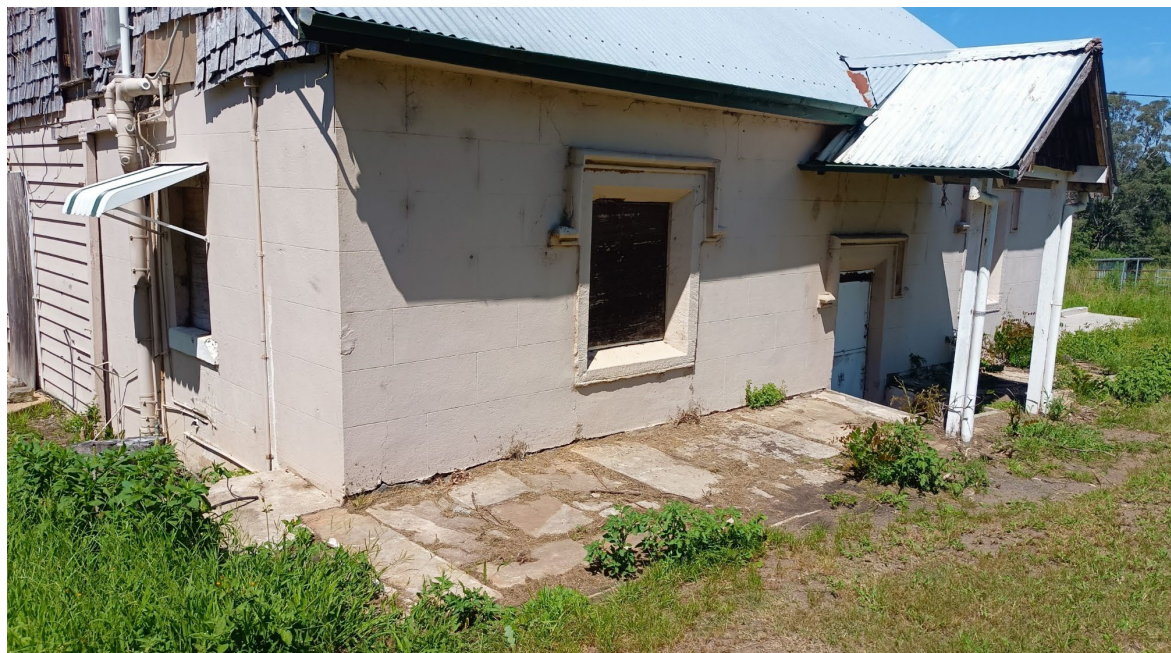
*Plate 55. View south-west toward the cottage. 20<sup>th</sup> century first floor additions are visible at left. The area of the possible former cellar entry (infilled) is below the window (Source: Archive Heritage)*

The central doorway is accessed via a short flight of steep sandstone steps that set the door below the adjacent ground level, as though entering a subfloor space (**Plate 55**). Internally this doorway is set outside the western cellar wall and one third of the doorway is set below the current floor level (**Plate 45**). It is likely that this redundant entrance once accessed a further cellar space west of the load-bearing brick wall via a trap and timber steps set into the interior floor.

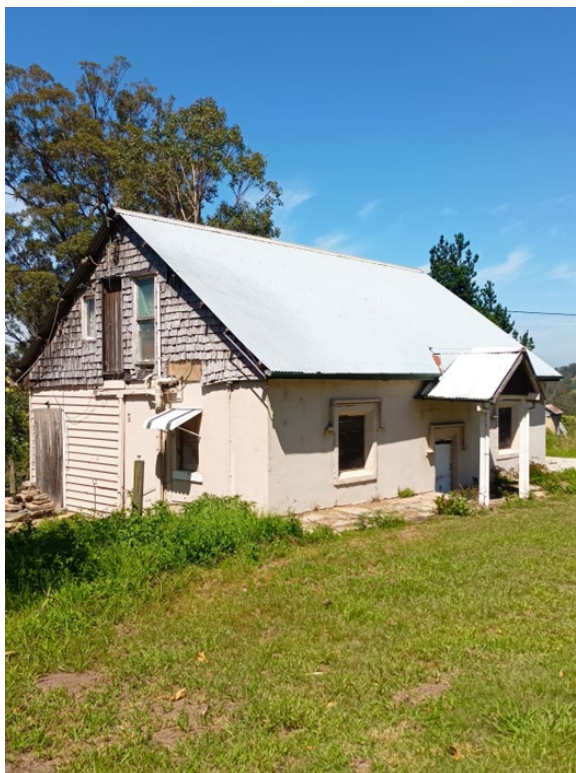
*Plate 56. View to the southwest showing the 20<sup>th</sup> century first floor addition (Source: Archive Heritage)*

20th century change has been extensive, This has entailed the Phase 3 or Phase 4 removal of preexisting roofing, the Phase 4 extension of the building to the west on a concrete slab and the addition of an eccentric and ramshackle first floor loft bedroom and bathroom (**Plate 56**). Further 20<sup>th</sup> century changes include installation of a prefabricated fireplace, large windows and an ad-hoc kitchen within the original brick building (**Plate 46**). A narrow timber verandah has been added to the south elevation of the 20th century addition and a further western fibro extension set on a concrete slab has been removed. The phasing of these changes is outlined in plan in **Figure 17**.

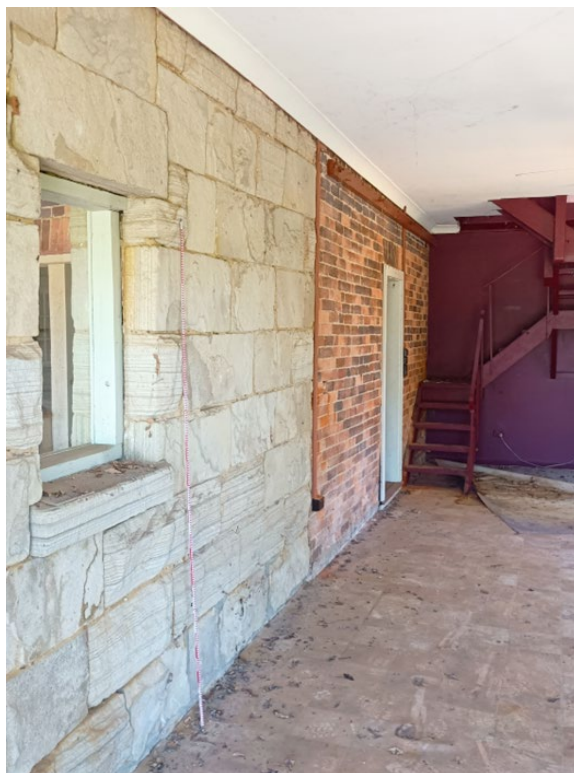
*Plate 57. Interior view of the former exterior junction of brick and sandstone and the 20<sup>th</sup> century addition with first floor stairs in background (Source: Archive Heritage)*

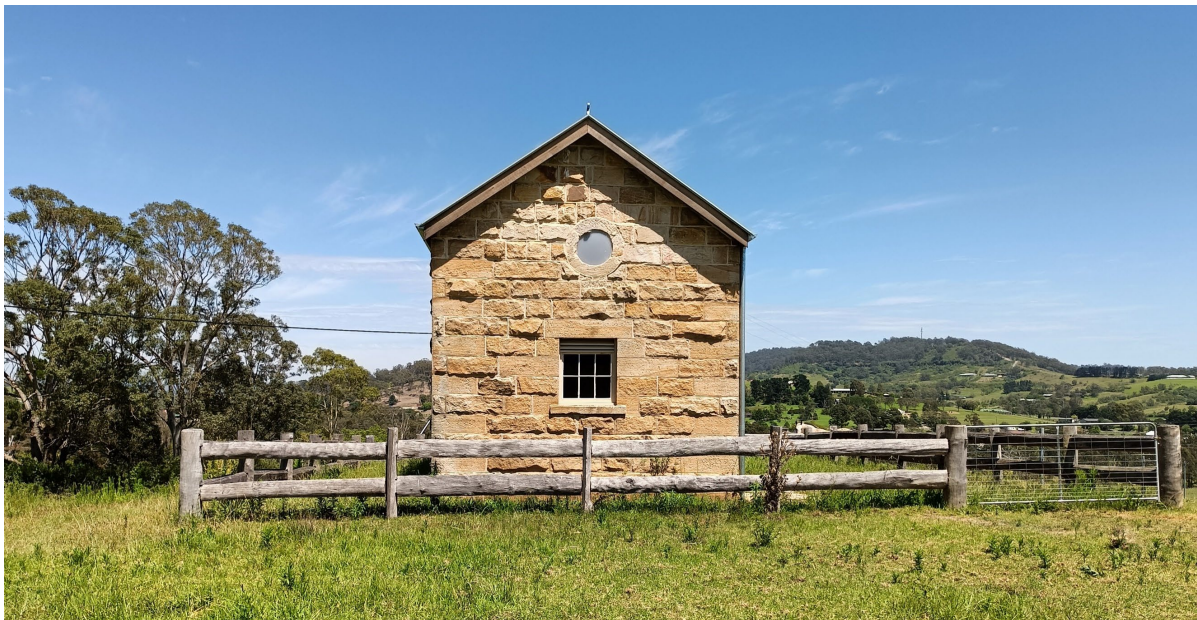
*Plate 59. View west toward the Stable showing restored upper masonry and casement and porthole windows (Source: Archive Heritage)*

The east and west walls contain a single, slightly off centre porthole window in the centre of each gable glazed with etched glass (**Plate 59**, **Plate 63** and **Plate 64**). A dressed border surrounds the porthole windows. The building also features a total of four six pane casement windows. In the southern façade there are four small porthole apertures providing light and ventilation that are bored through the masonry. The masonry has recently been repointed during extensive specialist restoration and repairs in 2021 that have completely restored a failing, derelict building to near-original condition and integrity.

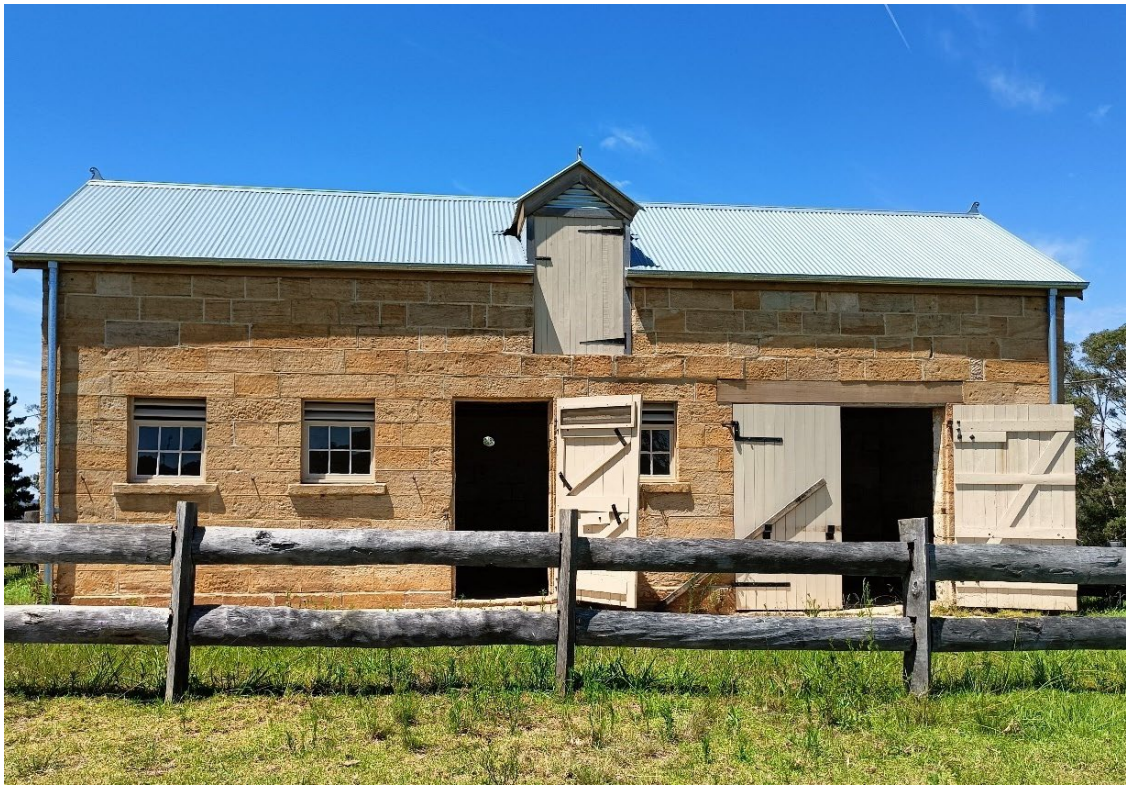
*Plate 60. View south toward main northern elevation (Source: Archive Heritage)*

The northern façade at ground level contains two openings- a single door and a double, outward opening set of doors. Both feature heavy traditional hardwood doors braced with strap iron cleats on riveted strap, pintle hinges (**Plate 60**). The building features dressed openings for windows and doors

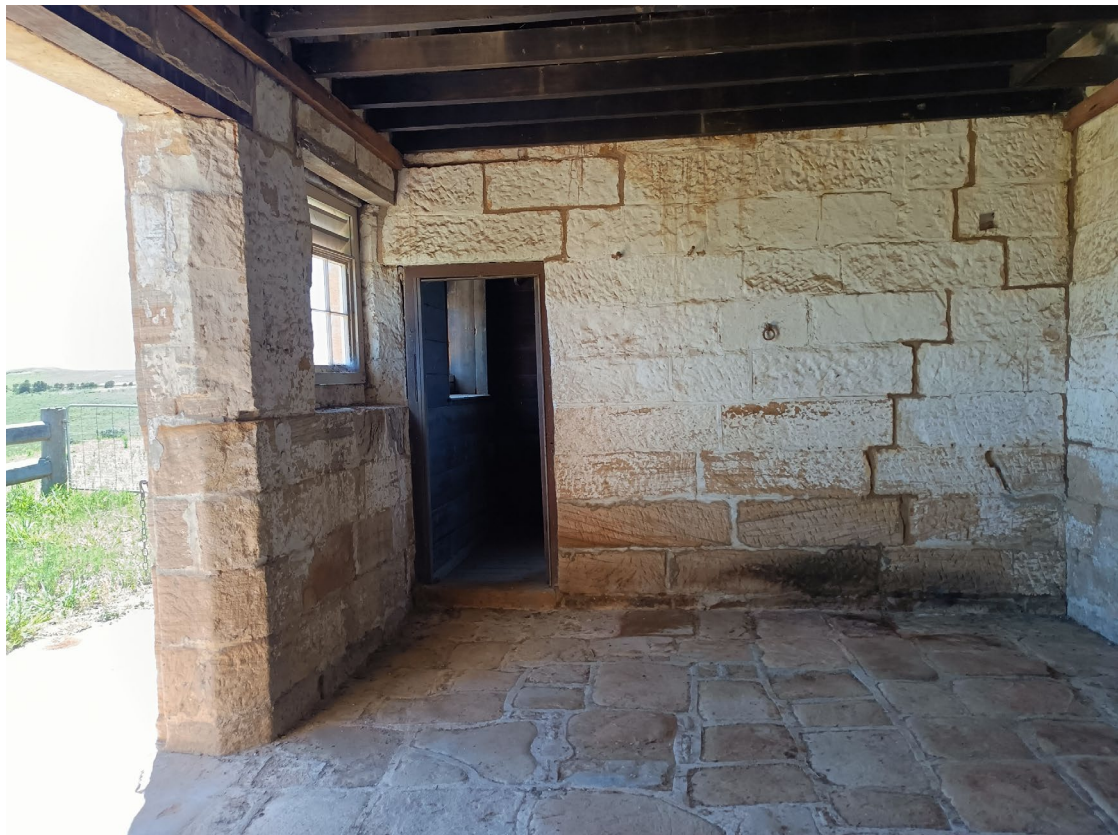
*Plate 61. Interior of Room 1 showing restored stone walls and floor setts. Entry to the tack room (Room 2) is seen (Source: Archive Heritage)*

The rectangular enclosed space of the building is divided at ground floor into three spaces, each of different sizes. The larger spaces: the western-most space (Room 3), and the central space (Room 1) (**Plate 61**), are similarly sized, and have stone sett floors and stone walls which have previously been limewashed. A timber ladder provides access to the roof space from room 1. The small room on the eastern side of the building (Room 2) is fully lined with dark stained timber boards and fittings. The timber floor lining appears to sit on top of a stone floor below and there is a second ladder providing access to the roof space. Rows of timber hooks and shelves on the walls suggest that the space was use as a tack room.

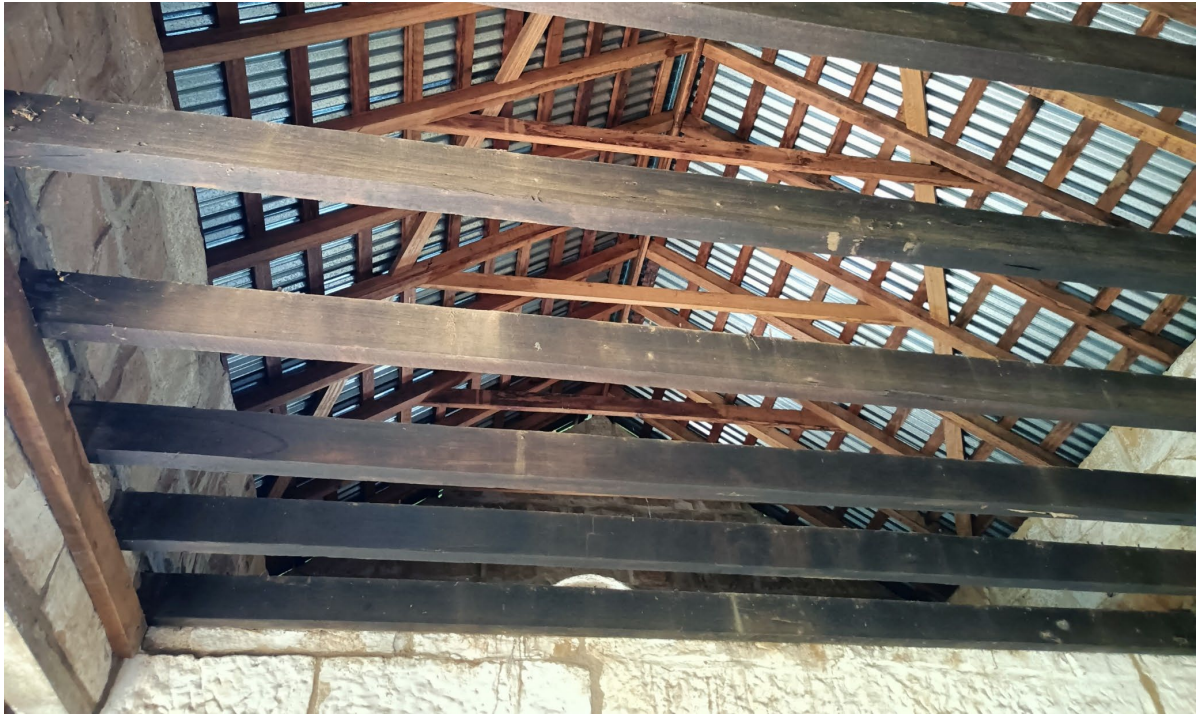
*Plate 62. Restored roof over conserved loft floor joists as seen from Room 1 (Source Archive Heritage)*

A dormer hay door is located at the centre of the northern roof and is likely to have once supported a pulley and hoist system providing access to the substantial timber floored hay loft roof space (**Plate 62**).

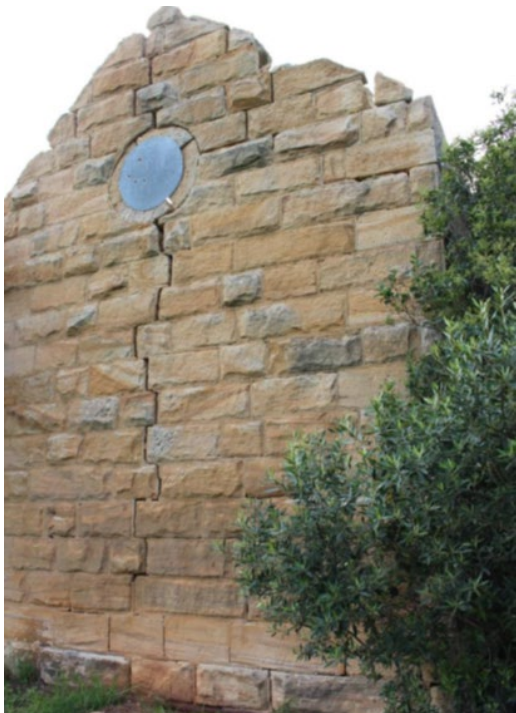
*Plate 63. Western elevation as seen prior to restoration works in 2021 (Source: Niche 2019: p.14)*

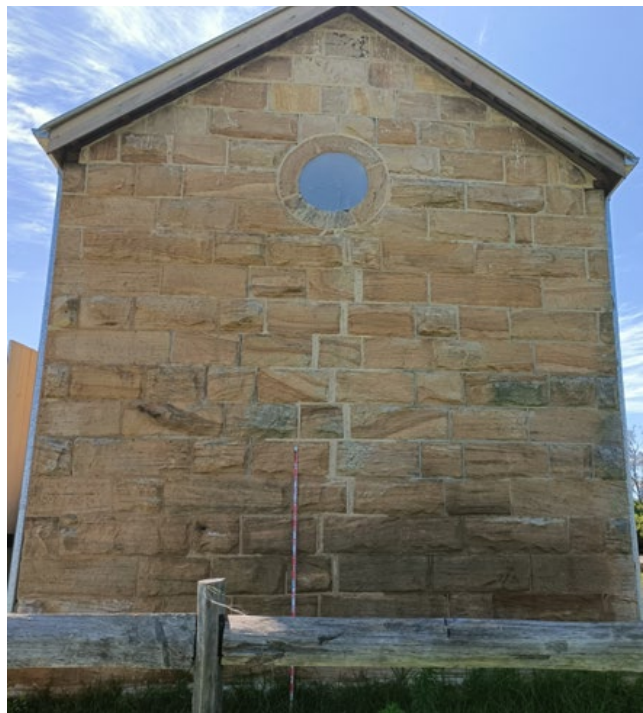
*Plate 64. Current view of restored and conserved masonry and porthole (Source: Archive Heritage)*
