# Engineering Log - Borehole

Project: **ROYAL NORTH SHORE HOSPITAL REDEVELOPMENT**

Borehole No. **BH202**

Sheet 2 of 5  
Project No: **GEOTLCOV23589AA**

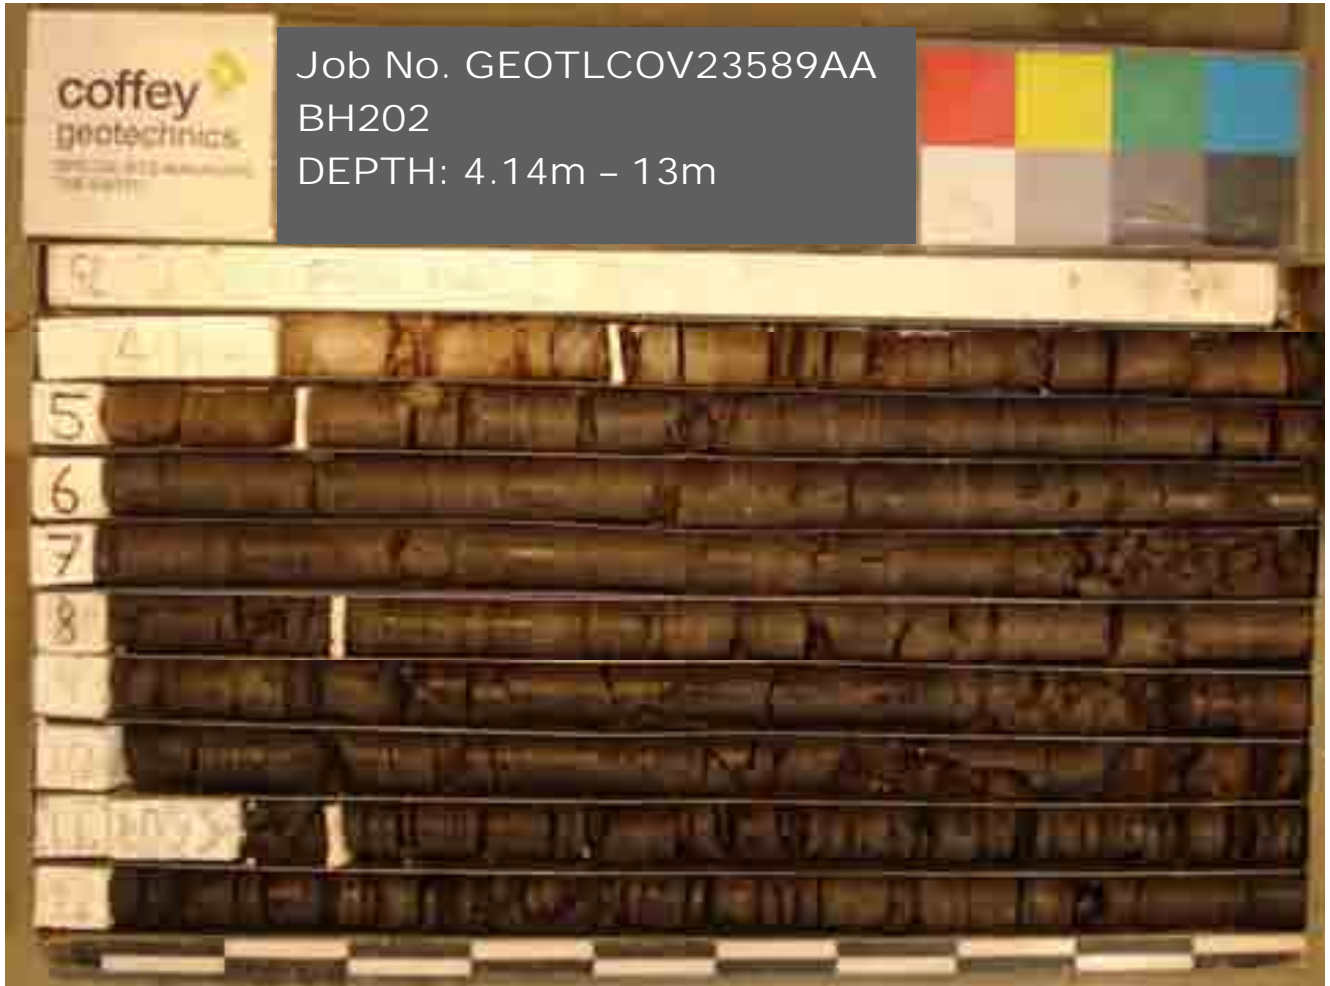
drawn	MT	  SPECIALISTS MANAGING THE EARTH	client: <b>THIESS PTY LTD</b>	
approved	DS		project: <b>ROYAL NORTH SHORE HOSPITAL REDEVELOPMENT, ST LEONARDS</b>	
date	09/09/2008		title: <b>ROCK CORE PHOTOGRAPH – BH202</b>	
scale	Not to scale		project no: <b>GEOTLCOV23589AA</b>	
original size	A4		Photo no: <b>BH202</b> 1 of 3

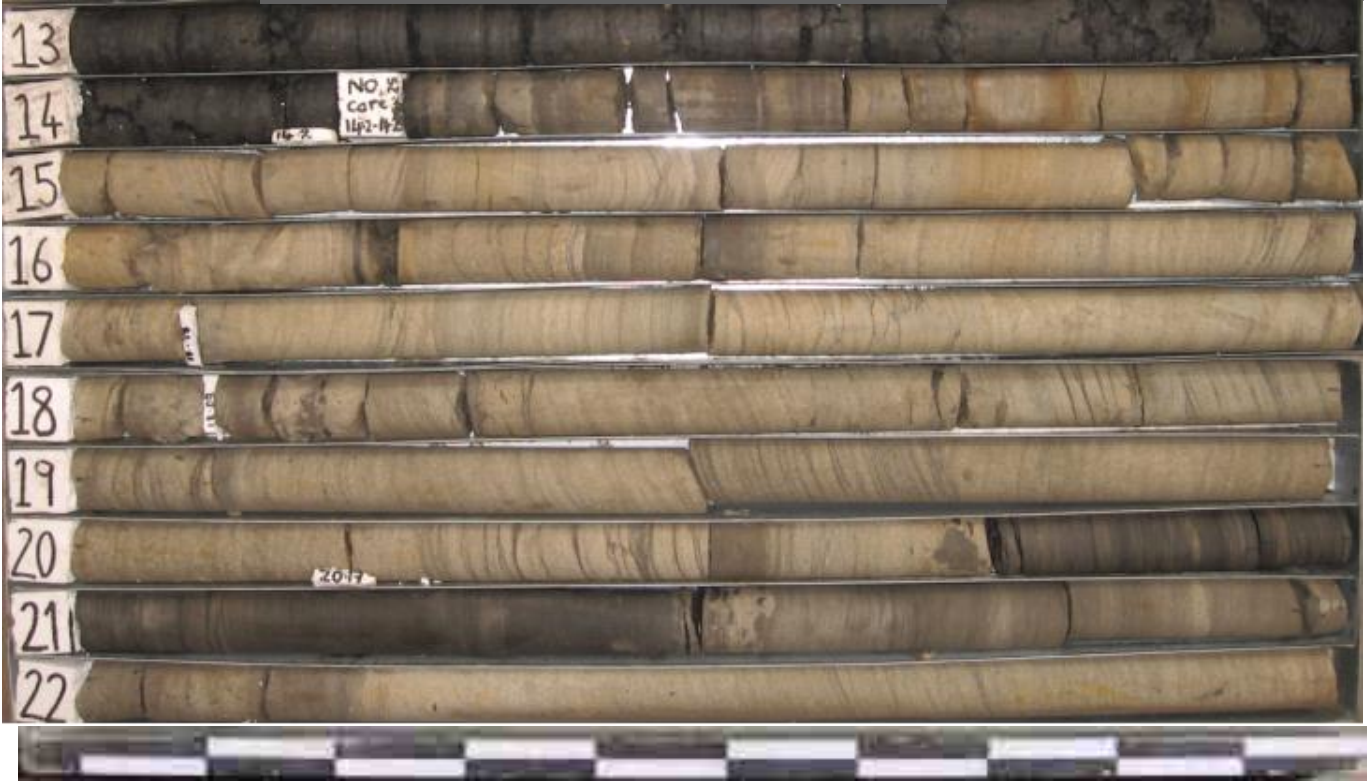
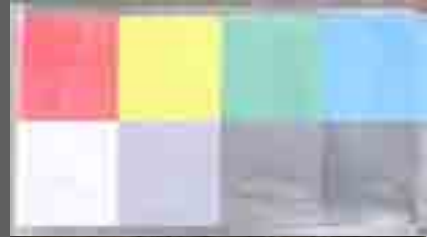
Job No. GEOTLCOV23589AA  
 BH202  
 DEPTH: 13m - 23m

drawn	MT	 	client: <b>THIESS PTY LTD</b>	
approved	DS		project: <b>ROYAL NORTH SHORE HOSPITAL REDEVELOPMENT, ST LEONARDS</b>	
date	09/09/2008		title: <b>ROCK CORE PHOTOGRAPH - BH202</b>	
scale	Not to scale		project no: <b>GEOTLCOV23589AA</b>	
original size	A4		Photo no: <b>BH202 2 of 3</b>

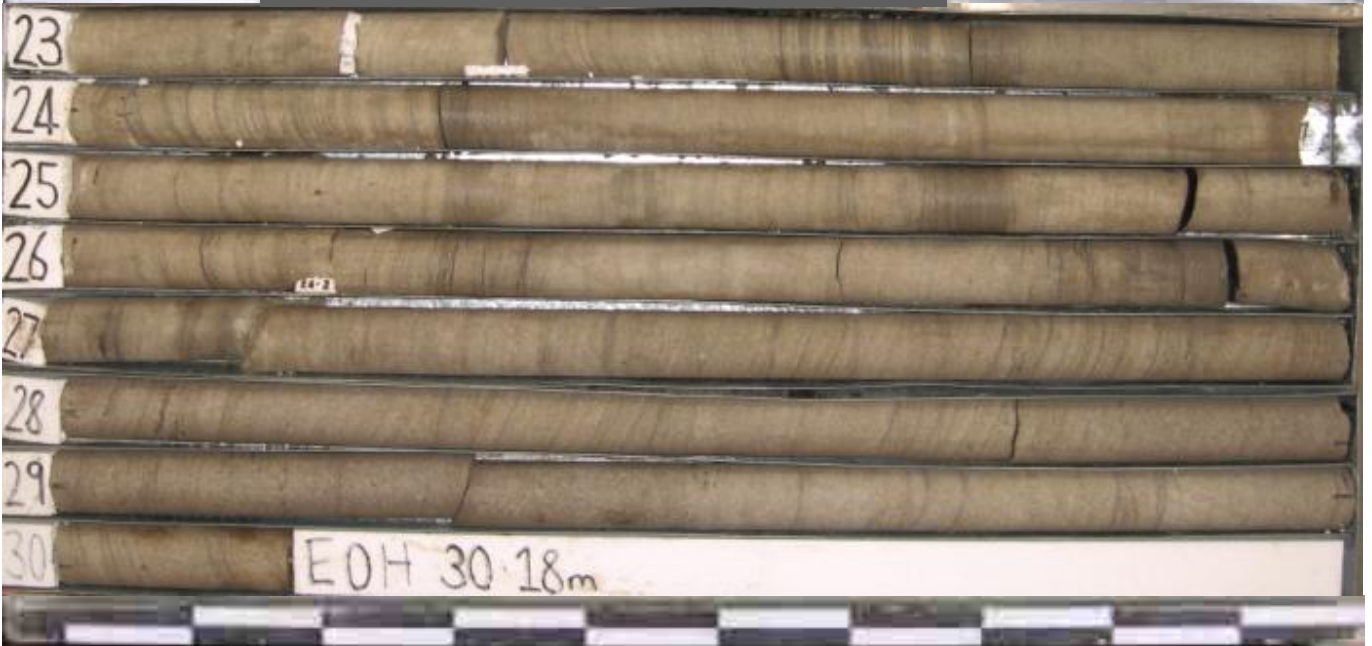
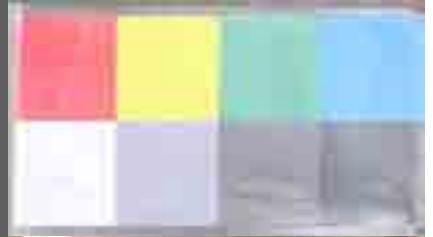
Job No. GEOTLCOV23589AA  
BH202  
DEPTH: 23m – 30.18m

drawn	MT		client: <b>THIESS PTY LTD</b>	
approved	DS		project: <b>ROYAL NORTH SHORE HOSPITAL REDEVELOPMENT, ST LEONARDS</b>	
date	09/09/2008		title: <b>ROCK CORE PHOTOGRAPH – BH202</b>	
scale	Not to scale		project no: <b>GEOTLCOV23589AA</b>	Photo no: <b>BH202 3 of 3</b>
original size	A4

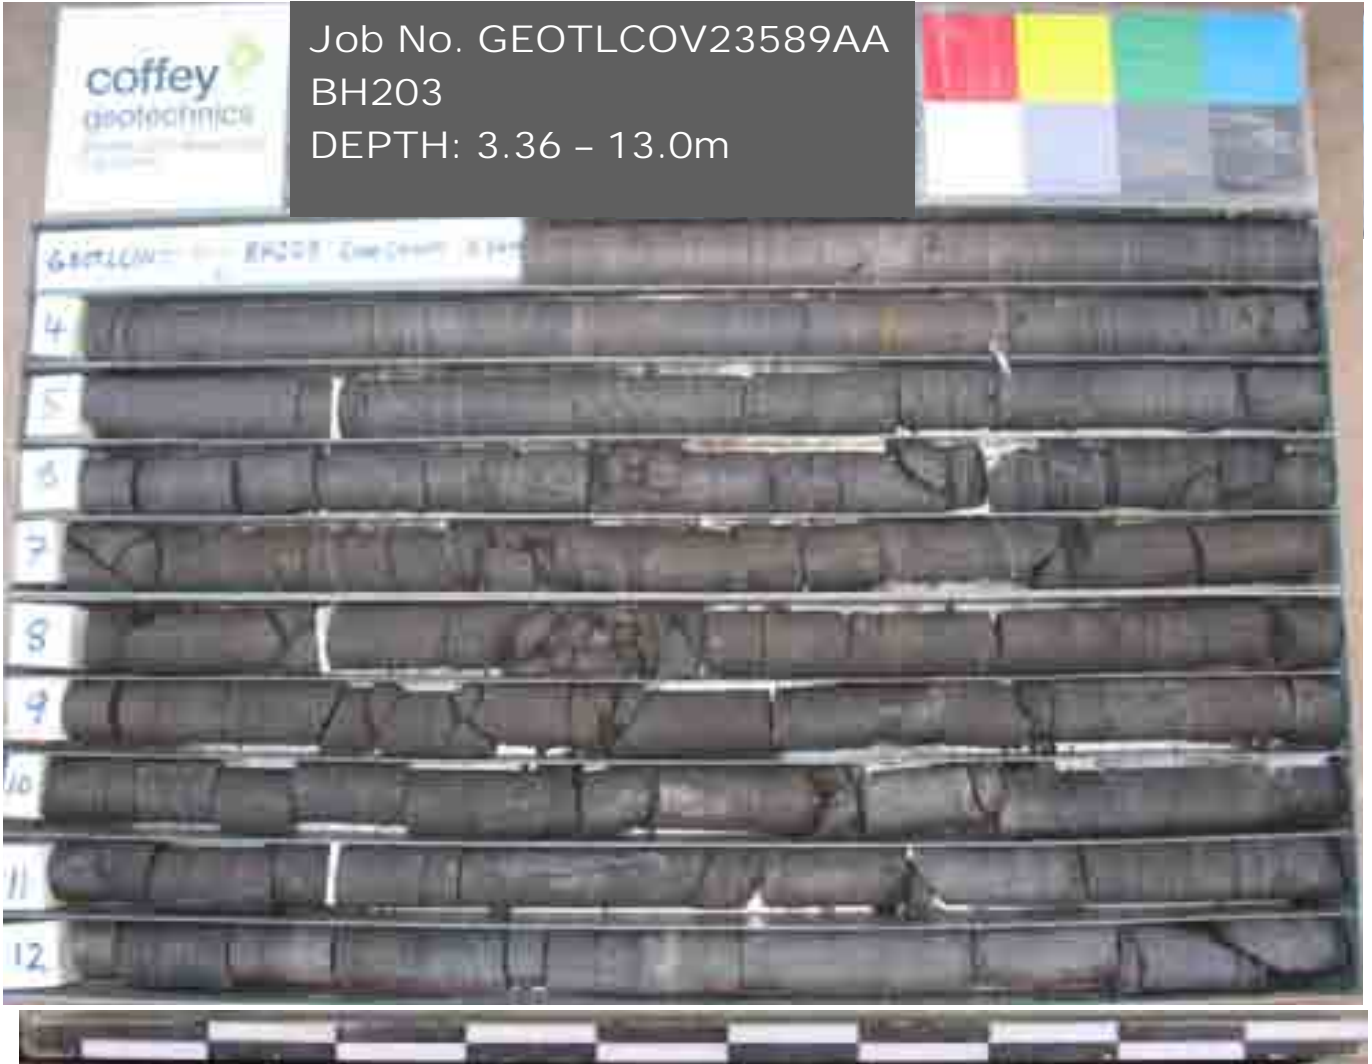
Job No. GEOTLCOV23589AA  
 BH203  
 DEPTH: 3.36 – 13.0m

drawn	MT	  <p><b>coffey</b> geotechnics SPECIALISTS MANAGING THE EARTH</p>	client: <b>THIESS PTY LTD</b>	
approved	DS		project: <b>ROYAL NORTH SHORE HOSPITAL REDEVELOPMENT, ST LEONARDS</b>	
date	09/09/2008		title: <b>ROCK CORE PHOTOGRAPH – BH203</b>	
scale	Not to scale		project no: <b>GEOTLCOV23589AA</b>	
original size	A4		Photo no: <b>BH203 1 of 2</b>

drilling information				material substance				rock mass defects								
method	core-lift	water	RL	depth metres	graphic log core recovery	material rock type; grain characteristics, colour, structure, minor components	weathering alteration	estimated strength				defect spacing mm	defect description type, inclination, planarity, roughness, coating, thickness			
								VL	L	M	H			VH	EH	IS <sub>(50)</sub> MPa
NMLC			73			<b>SANDSTONE:</b> Medium grained pale grey to yellow, indistinctly bedded at 20-30°, with dark grey shale (<10%) laminations (1mm). Rare carbonaceous laminae and shale clasts. <i>(continued)</i> 16.60 - 16.73m: Shale bed with fine to medium grained pale grey sandstone.	FR									
			72	17												
			71	18												
			70	19												
			69	20												
			68	21												
			67	22		BH203 terminated at 21.95m										
			66	23												
			65	24

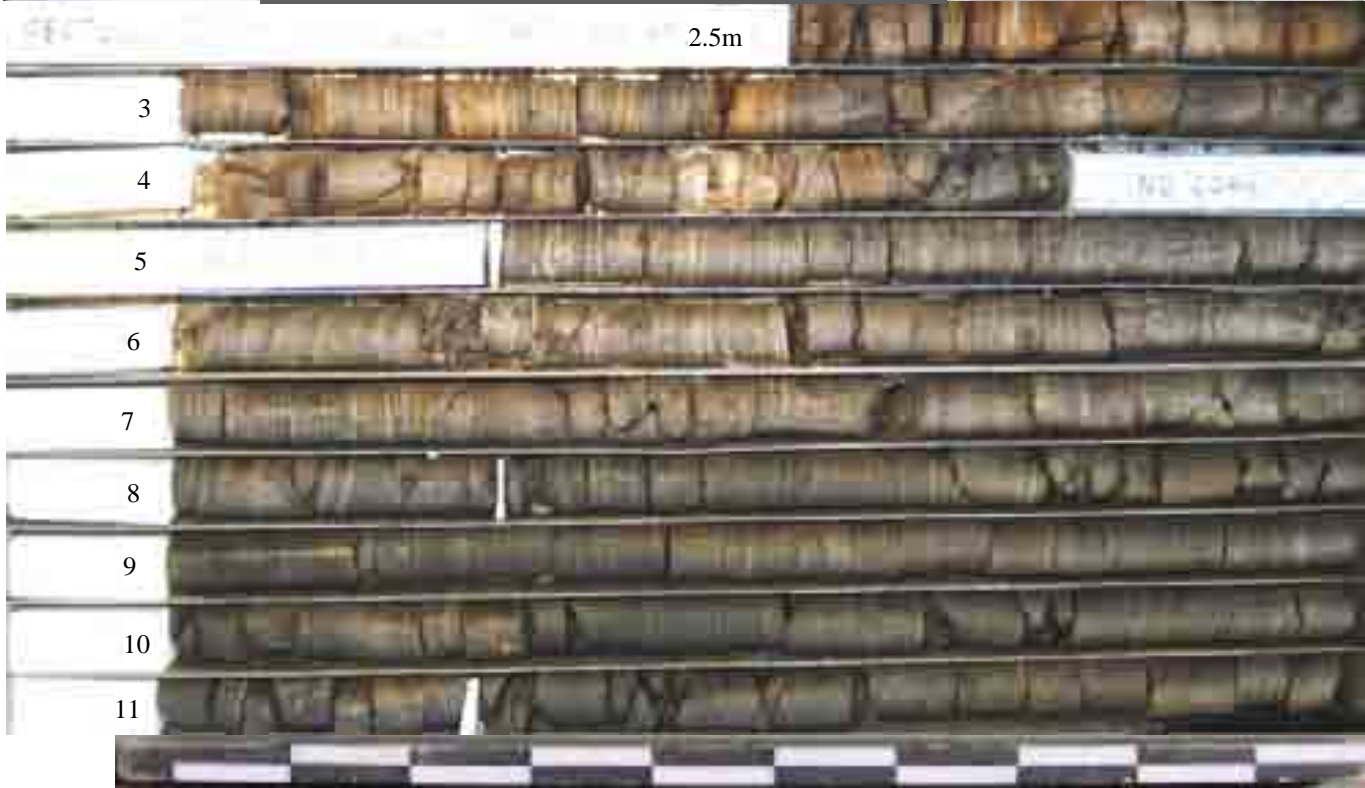
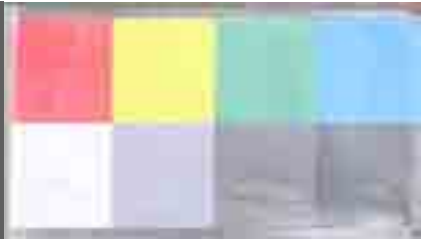
Job No. GEOTLCOV23589AA  
 BH204  
 DEPTH: 2.5m – 12m

drawn	MT		client: <b>THIESS PTY LTD</b>	
approved	DS		project: <b>ROYAL NORTH SHORE HOSPITAL REDEVELOPMENT, ST LEONARDS</b>	
date	09/09/2008		title: <b>ROCK CORE PHOTOGRAPH – BH204</b>	
scale	Not to scale		project no: <b>GEOTLCOV23589AA</b>	
original size	A4		Photo no: <b>BH204</b> 1 of 2

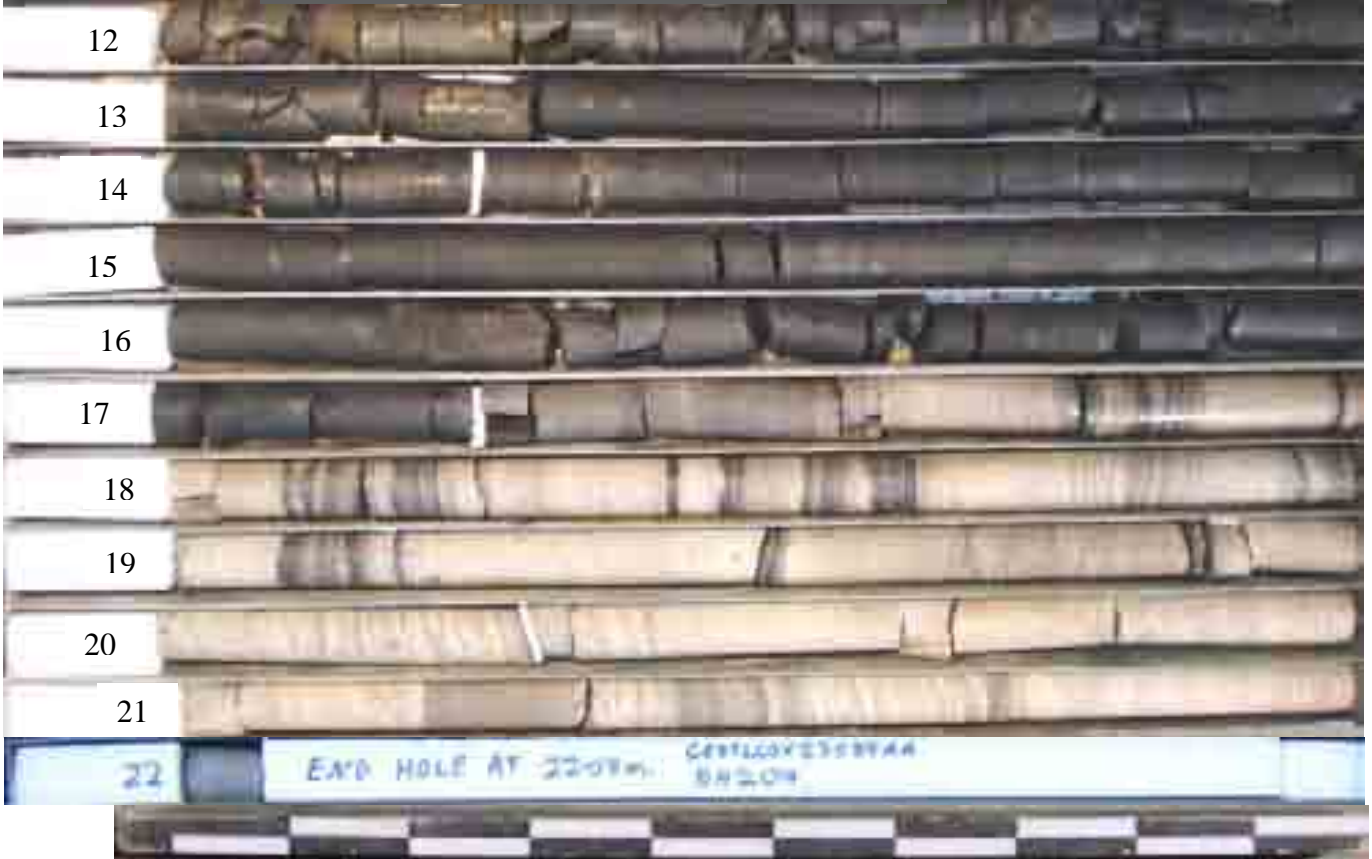
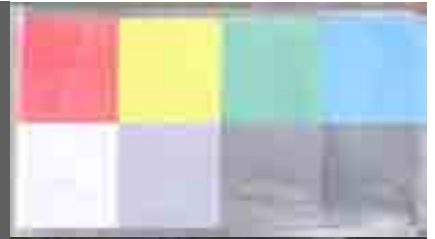
Job No. GEOTLCOV23589AA  
 BH204  
 DEPTH: 12m - 22.07m

drawn	MT		client: <b>THIESS PTY LTD</b>	
approved	DS		project: <b>ROYAL NORTH SHORE HOSPITAL REDEVELOPMENT, ST LEONARDS</b>	
date	09/09/2008		title: <b>ROCK CORE PHOTOGRAPH - BH204</b>	
scale	Not to scale		project no: <b>GEOTLCOV23589AA</b>	
original size	A4		Photo no: <b>BH204 2 of 2</b>

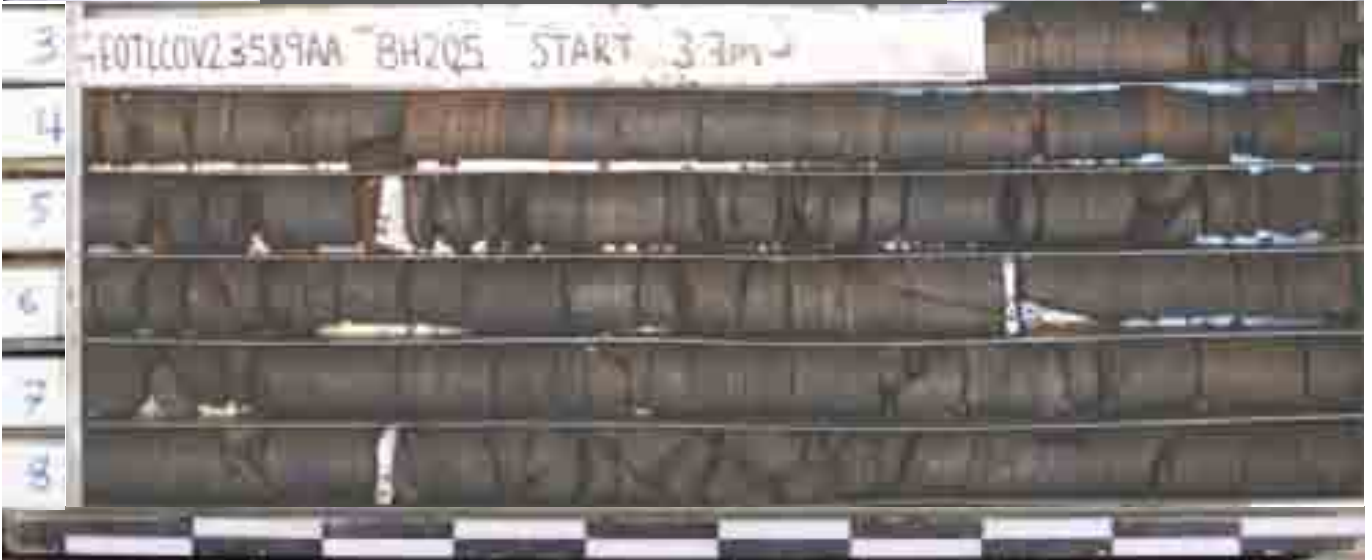
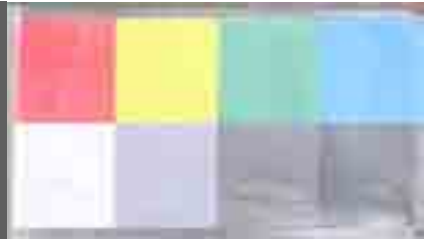
Job No. GEOTLCOV23589AA  
 BH205  
 DEPTH: 3.7m – 9m

drawn	MT		client: THIESS PTY LTD	
approved	DS		project: ROYAL NORTH SHORE HOSPITAL REDEVELOPMENT, ST LEONARDS	
date	09/09/2008		title: ROCK CORE PHOTOGRAPH – BH205	
scale	Not to scale		project no: GEOTLCOV23589AA	
original size	A4		Photo no: BH205 1 of 3

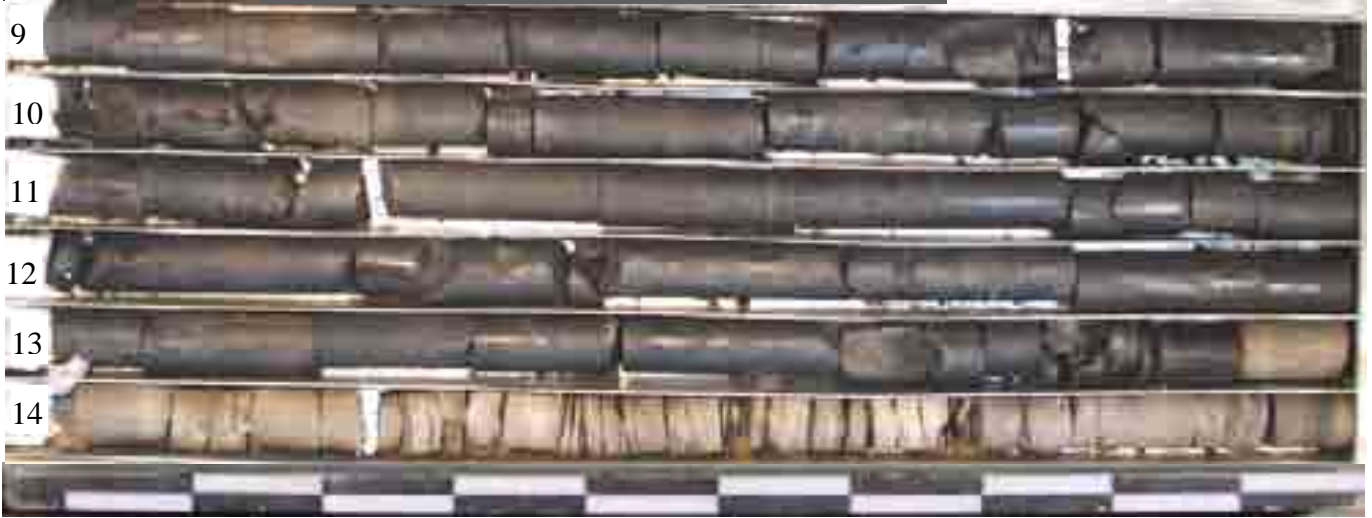
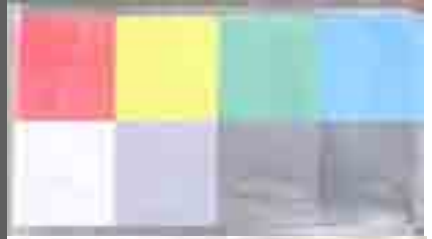
Job No. GEOTLCOV23589AA  
 BH205  
 DEPTH: 9m – 15m

drawn	MT	 	client: <b>THIESS PTY LTD</b>	
approved	DS		project: <b>ROYAL NORTH SHORE HOSPITAL REDEVELOPMENT, ST LEONARDS</b>	
date	09/09/2008		title: <b>ROCK CORE PHOTOGRAPH – BH205</b>	
scale	Not to scale		project no: <b>GEOTLCOV23589AA</b>	
original size	A4		Photo no: <b>BH205 2 of 3</b>

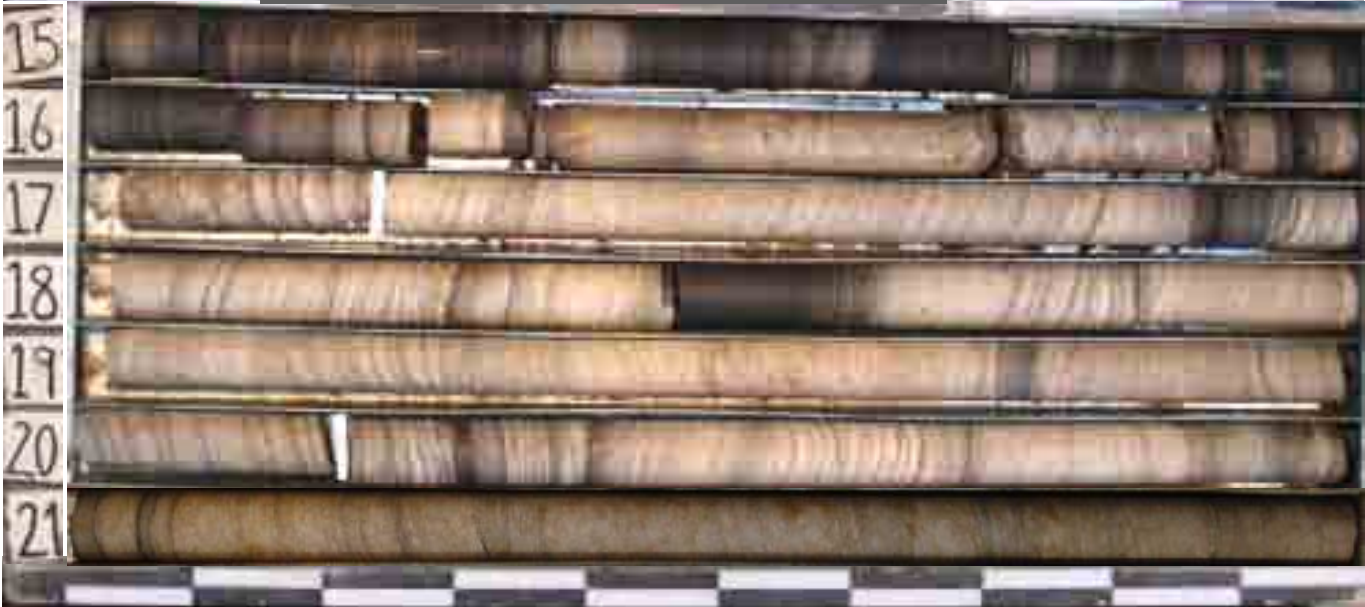
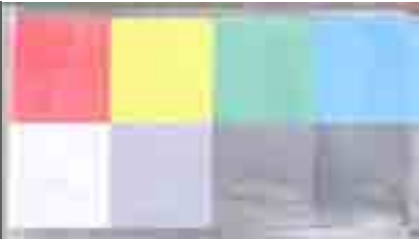
Job No. GEOTLCOV23589AA  
 BH205  
 DEPTH: 15m - 22m

drawn	MT		client: <b>THIESS PTY LTD</b>	
approved	DS		project: <b>ROYAL NORTH SHORE HOSPITAL REDEVELOPMENT, ST LEONARDS</b>	
date	09/09/2008		title: <b>ROCK CORE PHOTOGRAPH - BH205</b>	
scale	Not to scale		project no: <b>GEOTLCOV23589AA</b>	
original size	A4		Photo no: <b>BH205 3 of 3</b>
