drawn	MT		client: THIESS PTY LTD	
approved	DS		project: ROYAL NORTH SHORE HOSPITAL REDEVELOPMENT, ST LEONARDS	
date	09/09/2008		title: ROCK CORE PHOTOGRAPH – BH206	
scale	Not to scale		project no: GEOTLCOV23589AA	
original size	A4		Photo no: BH206 1 of 1

Project: **ROYAL NORTH SHORE HOSPITAL REDEVELOPMENT**

Appendix B

Uniaxial Compressive Strength Test Results

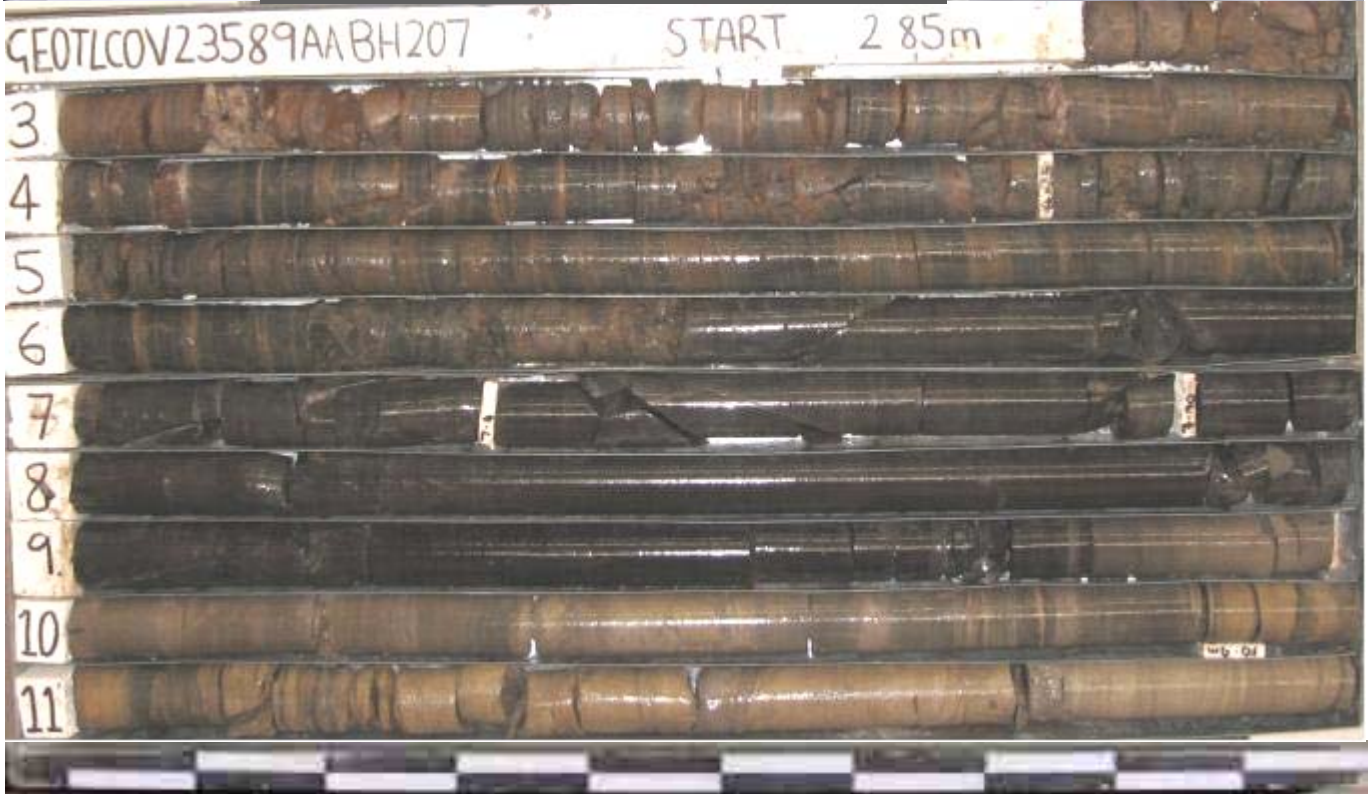
Job No. GEOTLCOV23589AA
 BH207
 DEPTH: 2.85m – 12m

drawn	MT	 	client: THIESS PTY LTD	
approved	DS		project: ROYAL NORTH SHORE HOSPITAL REDEVELOPMENT, ST LEONARDS	
date	09/09/2008		title: ROCK CORE PHOTOGRAPH – BH207	
scale	Not to scale		project no: GEOTLCOV23589AA	
original size	A4		Photo no: BH207 1 of 1

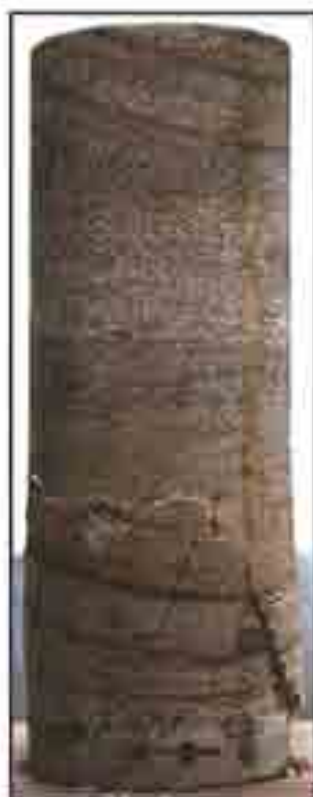
QESTLAB work order ID	depth	date tested	height average diameter	uniaxial compressive strength MPa	wet density moisture content	sample description bedding/foliation	comments failure mechanism
LCOV08W00713 BH202 15.28 to 15.43 m LCOV08S-03004		11 Sep 08 9.83 min	154 mm 51.5 mm 2.98:1	4.73	2.4 t/m ³ 6.6 %	sandstone Cross-bedded	shear
LCOV08W00711 BH202 21.07 to 21.22 m LCOV08S-03005		12 Sep 08 5.02 min	150 mm 51.6 mm 2.91:1	26.1	2.6 t/m ³ 2.1 %	sandstone/siltstone Bedding planes are at an angle of 60° to the axis of loading	axial and cone

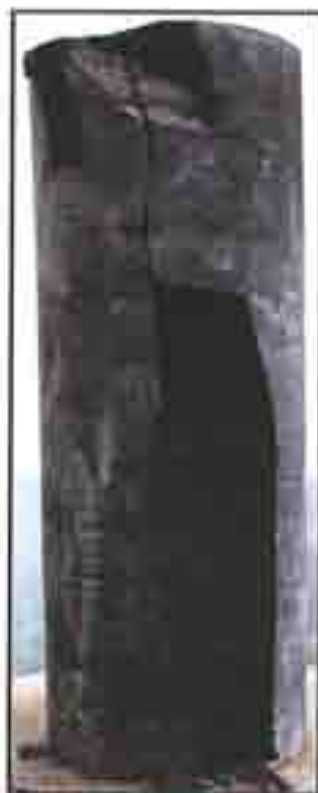
QESTLAB work order ID	depth	date tested	height average diameter	uniaxial compressive strength MPa	wet density moisture content	sample description bedding/foliation	comments failure mechanism
LCOV08W00719			145 mm	10.6	2.6 t/m ³	siltstone	
BH203 16.81 to 18.00 m	11 Sep 08	51.5 mm	3.0 %		Flat bedded		
LCOV08S-03005	13.62 min	2.81:1				shear

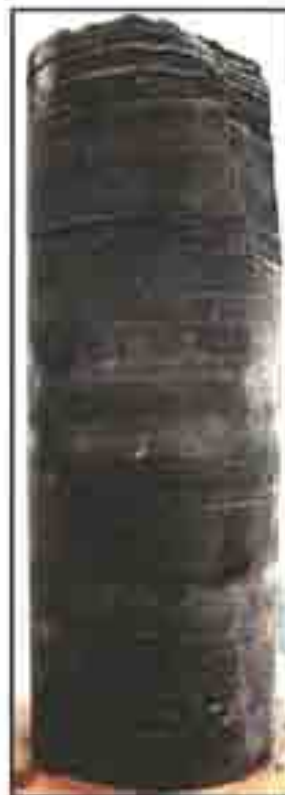
QESTLAB work order ID	height	uniaxial compressive strength	wet density	sample description	comments
depth	average diameter	MPa	moisture content	bedding/foliation	failure mechanism
date tested	height ratio				
QESTLab sample ID	test duration				
LCOV08W00719 BFBH 9.00 to 9.17 m LCOV08S-03007	11 Sep 08 7.15 min	2.29	2.8 t/m ³ 5.0 %	sandstone/siltstone Bedding planes are at an angle of 80° to the axis of loading	end failure

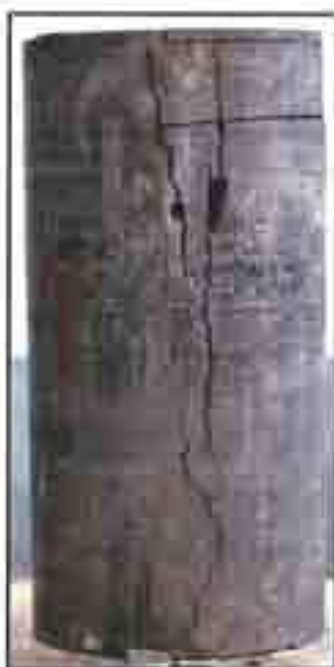
We received the samples on the 10th September, 2008. They were in galvanised coreboxes and had been covered with wet newspaper. The samples were tested in an "as received" condition. The test specimen was shorter than the requirement specified in the standard.

GESTLAB work order ID	depth	date tested	height average diameter	uniaxial compressive strength MPa	wet density moisture content	sample description bedding/foliation	comments failure mechanism	
LCOV08W00719			124 mm	14.5	2.5 t/m³ 2.5 %	siltstone flat-bedded		
INFOV 13.21 to 13.33 m	12 Sep 08	51.5 mm						
LCOV08S-03008	14.67 m	2.40:1						axial

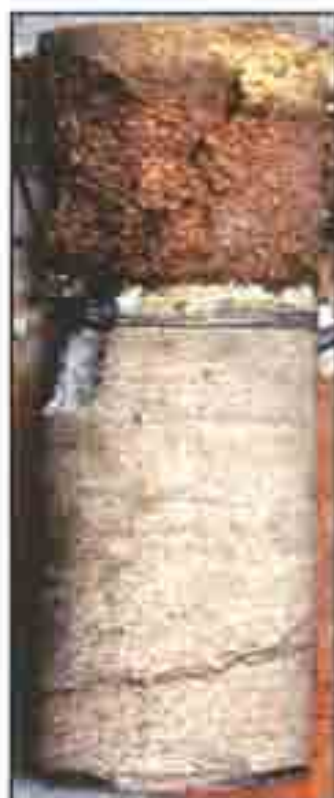
We received the samples on the 10th September, 2008. They were in galvanised corbboxes and had been covered with wet newspaper. The samples were tested in an 'as received' condition. The test specimen was selected from outside the original requested depth in order to comply with the size requirements specified in the standard.

GESTLAB work order ID	depth	date tested	height	average diameter	uniaxial compressive strength	wet density	sample description	comments
GESTLab sample ID	test duration	height/dia	MPa	moisture content	bedding/foation	failure mechanism		
LCOV08IW00719		139 mm	11.8	2.4 %	sandstone	sheared at top end		
BH205 7.21 to 7.48 m	15 Sep 08	51.5 mm		7.8 %			Wavy bedding	
LCOV08IS-03009	5.80 min	270.1

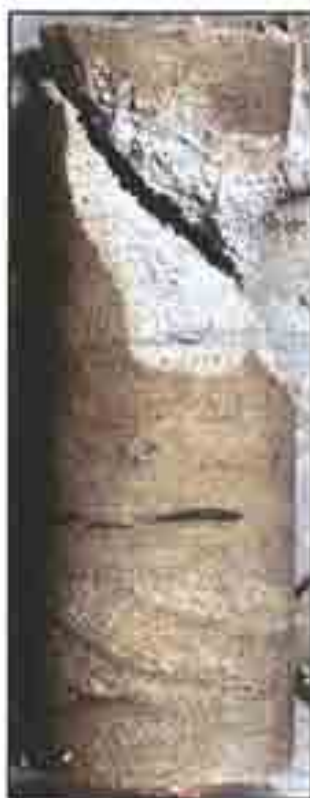
GESTLAB work order ID	depth	date tested	height average diameter	uniaxial compressive strength MPa	wet density moisture content	sample description bedding/foliation	comments
GESTLab sample ID	test duration	height ratio					failure mechanism
LCOV08W00719 08207 11.57 to 11.71 m LCOV08S-03010	15 Sep 08 6.20 min	145 mm 51.5 mm 2.82:1	16.6	2.4 t/m ³ 7.6 %	sandstone shale	sheared at one end
