***Ivanhoe Coal Pty Limited***

***Lidsdale Siding  
Water Management Plan***

***January 2021***

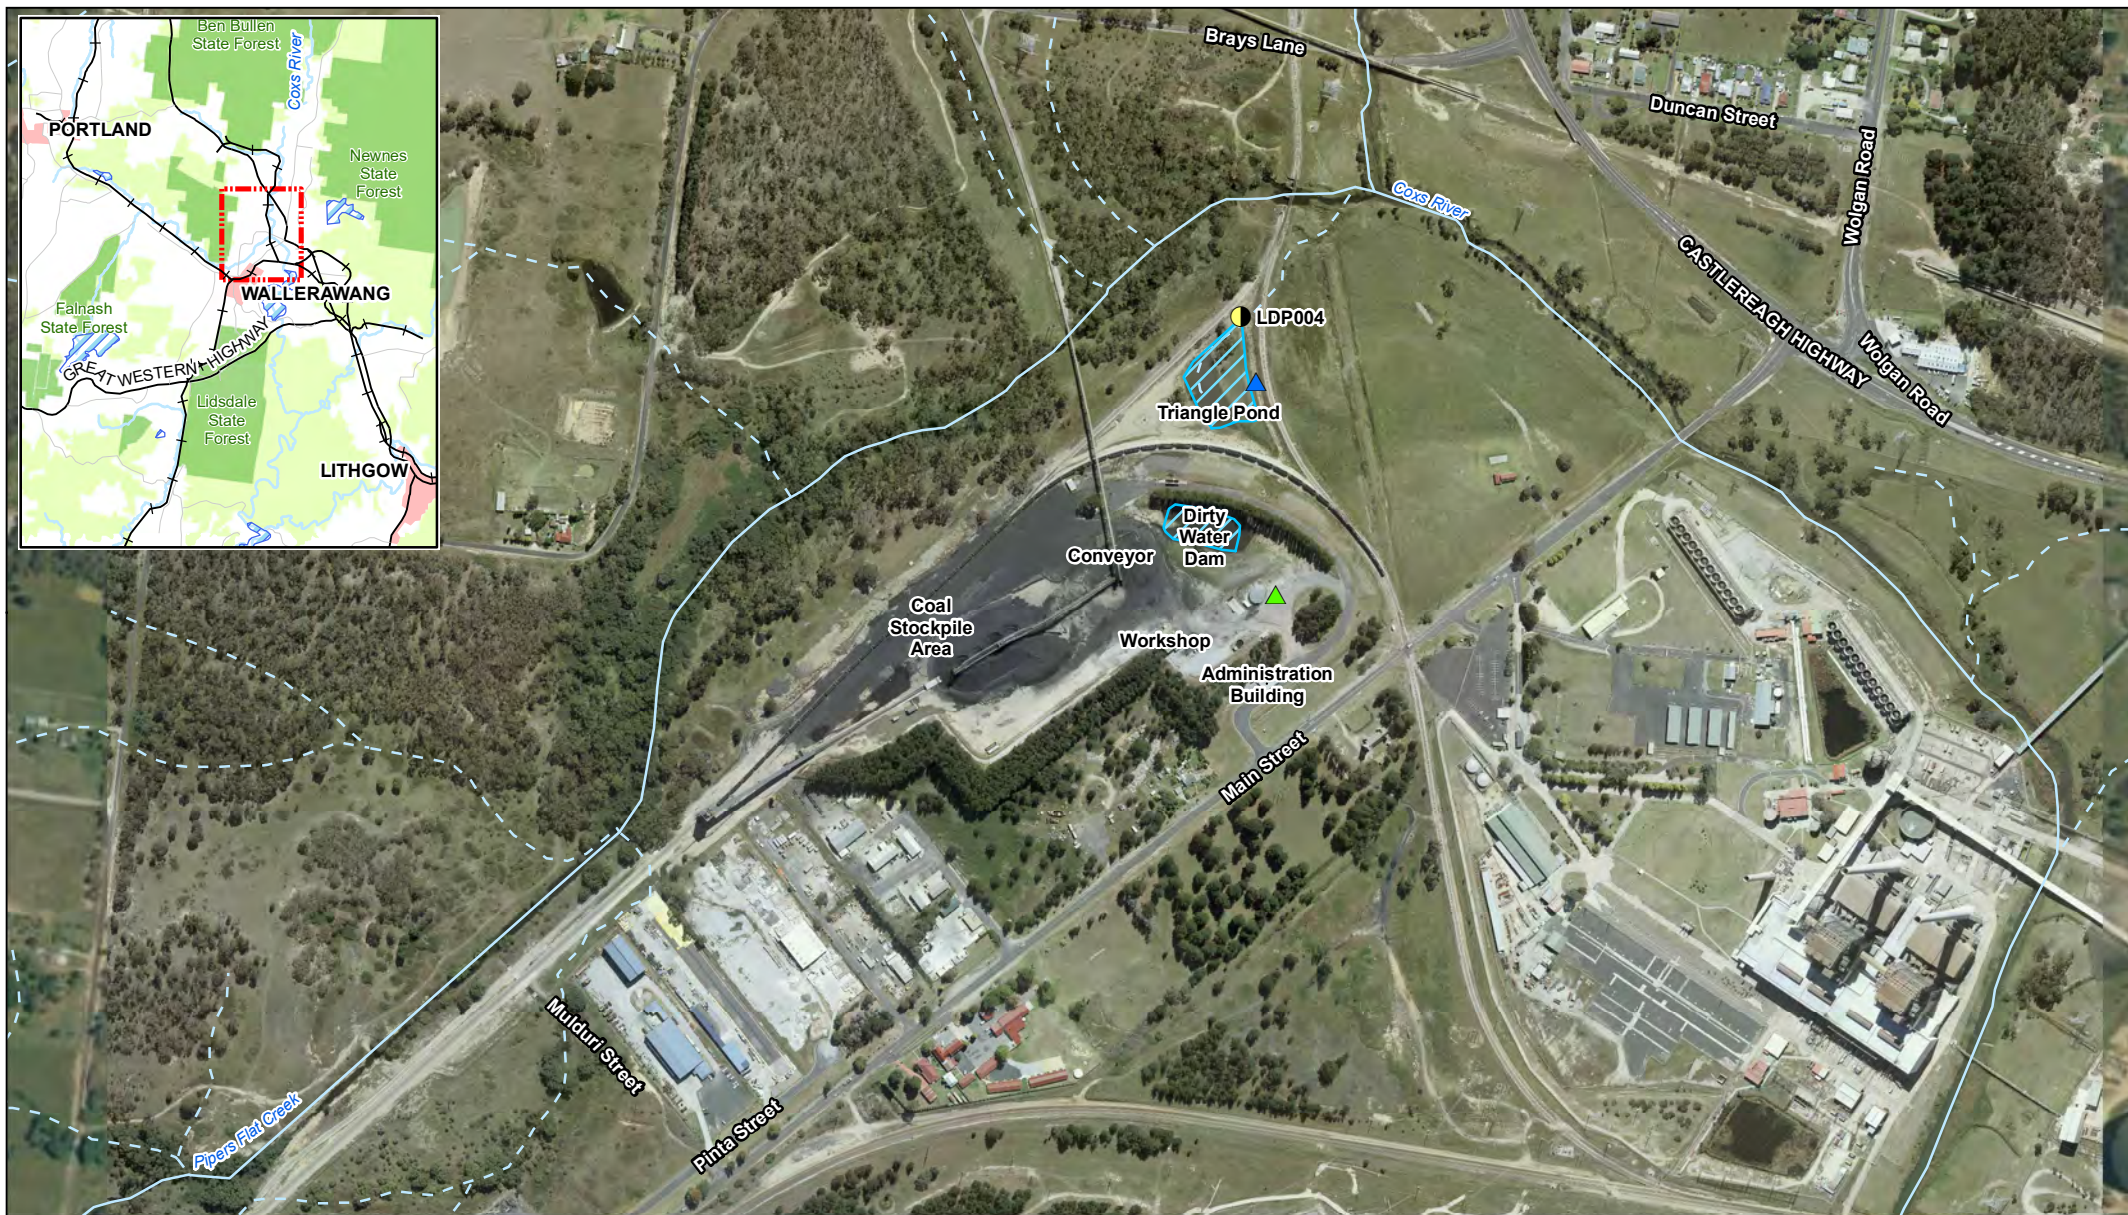
Figure 1-1

The assessment extent for flooding around the Lidsdale Siding site considered hydraulic conditions in both Cocks River and Pipers Flat within an area shown in Figure 1-1. The modelled extent allowed for the consideration of boundary conditions that influence creek hydraulics adjacent to the Lidsdale Siding operations.

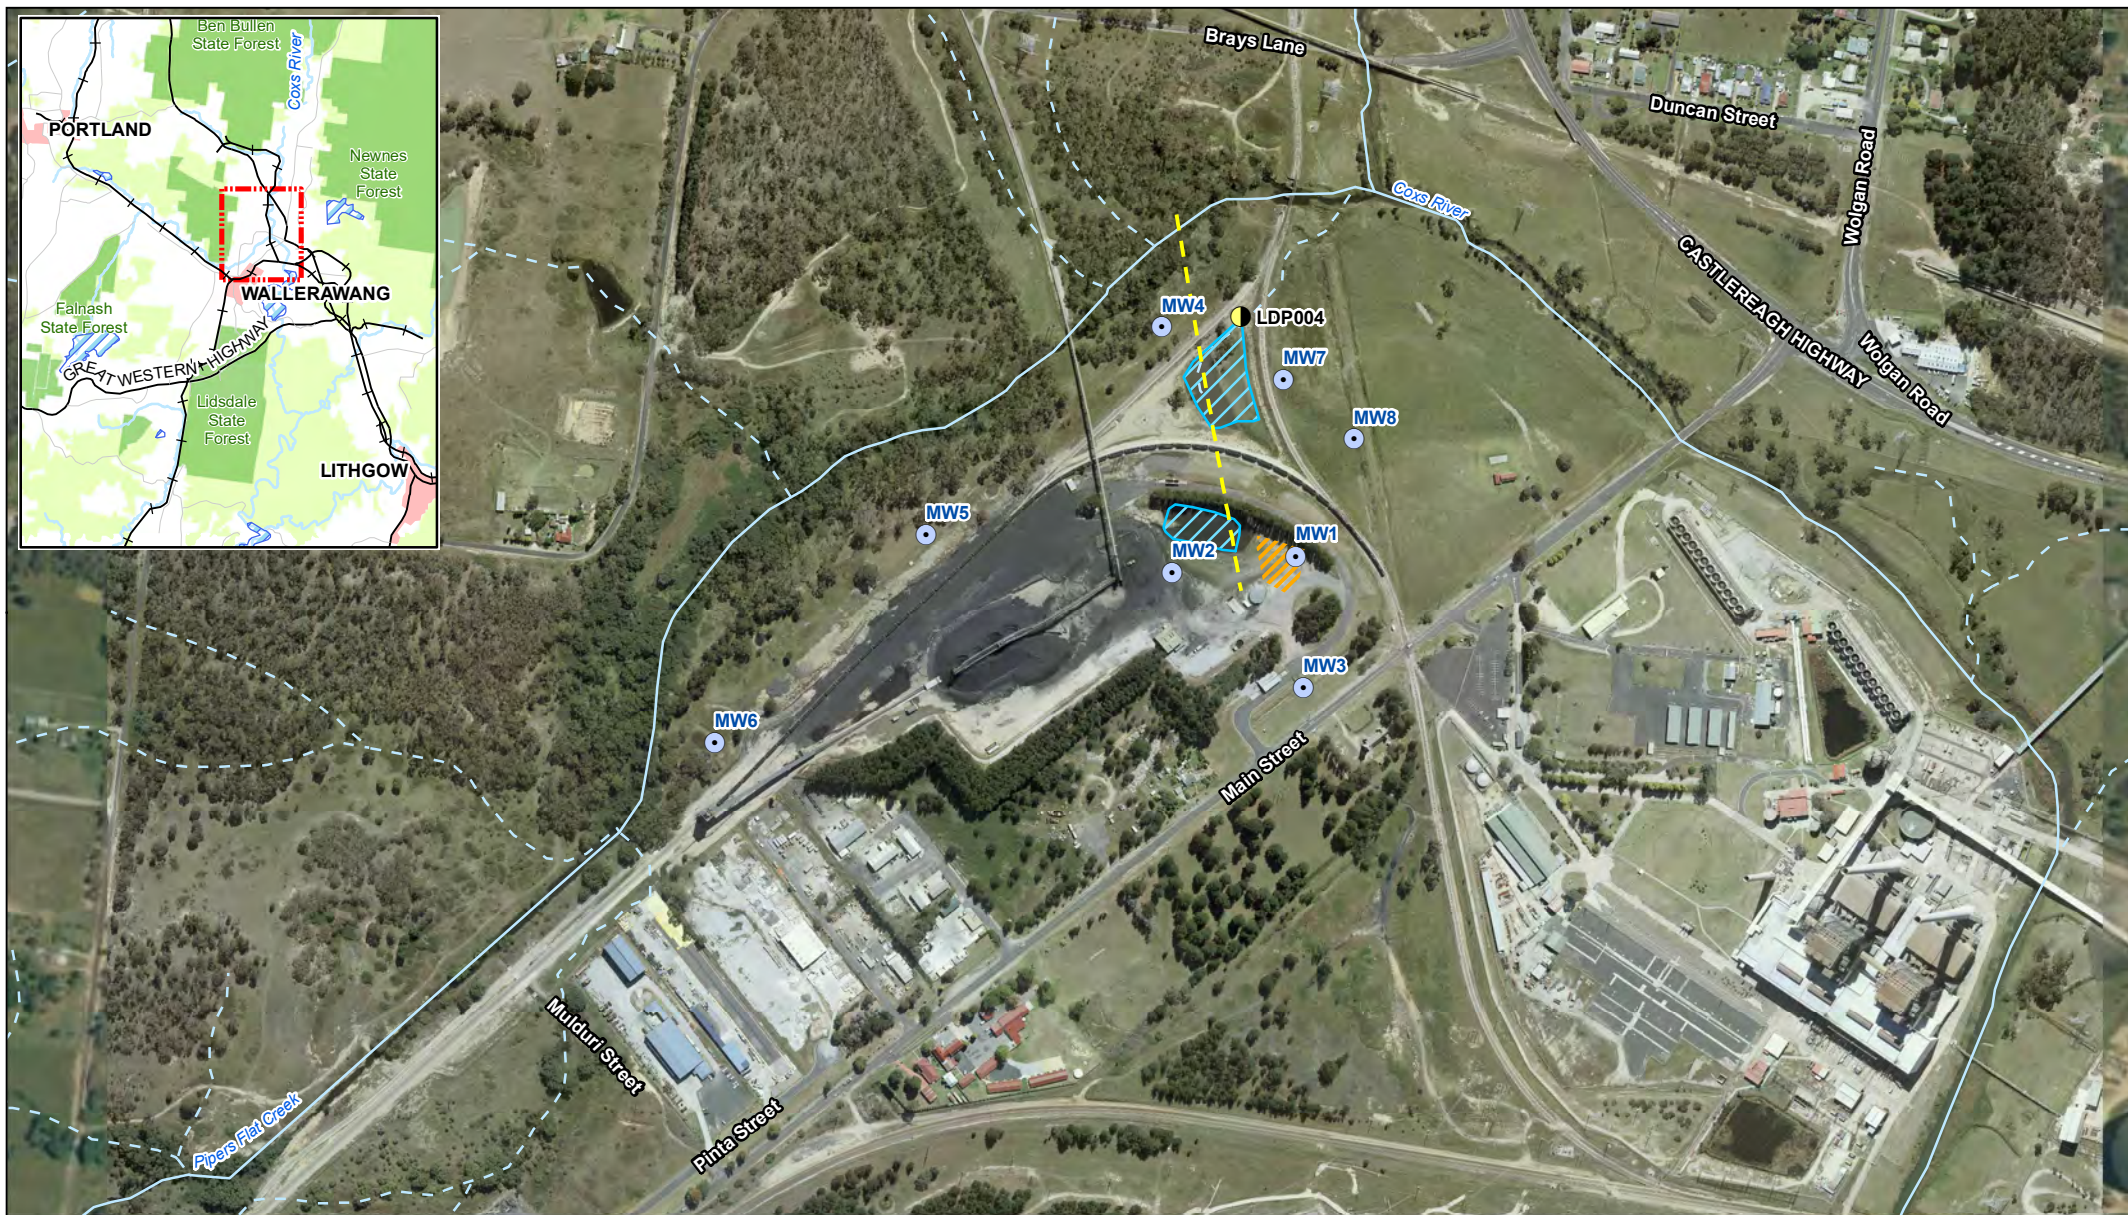
Figure 3-1

Groundwater monitoring of the hydrocarbon contamination has been undertaken biannually since 2009 for monitoring bores MW1 to MW8, as shown on Figure 3-1. Monitoring has tracked attenuation of hydrocarbon contamination. The development of a Trigger Action Response Plan indicated that if a positive result for total recoverable hydrocarbons (TRH) in any down gradient bore occurs (i.e MW4, MW7 and MW8) a full suite of TPH and BTEX sampling will be undertaken.

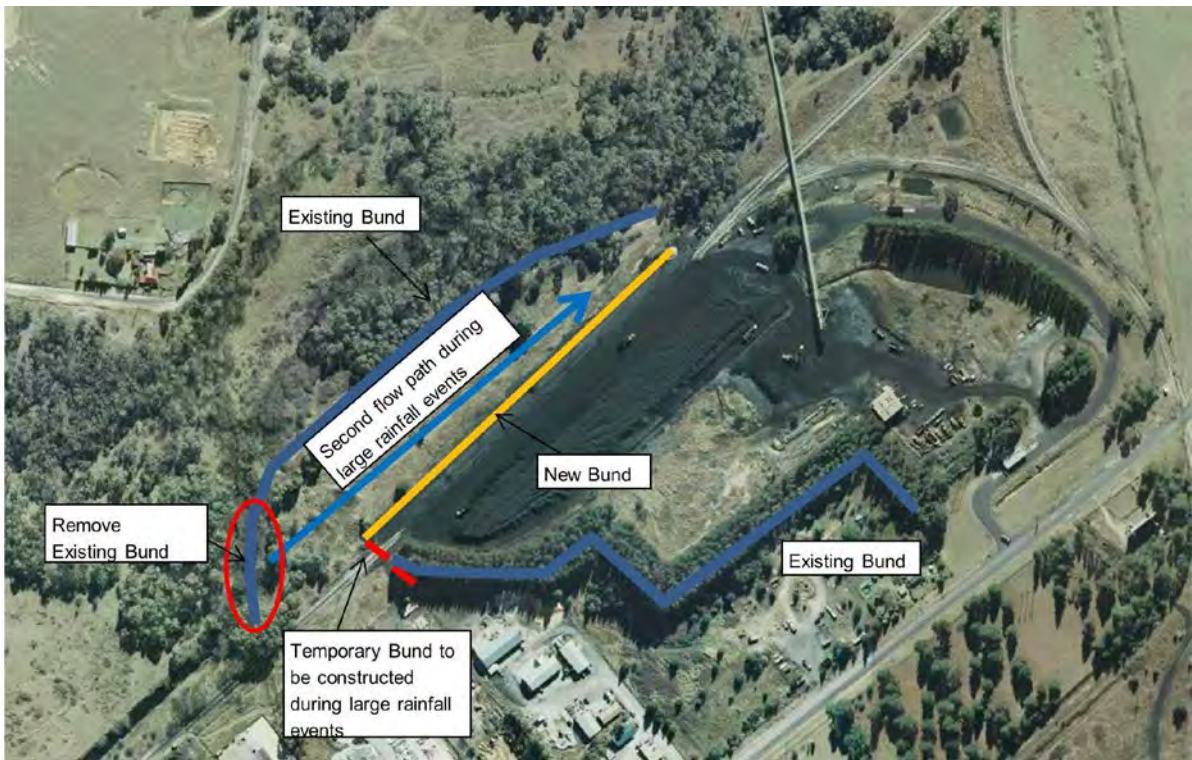
Figure 5 | Mitigation option 2

A substantial bund runs parallel to the siding on the western side downstream of the culvert crossing and it is assumed that this was put in place to help alleviate previous flooding. However, this bund constricts the floodplain and elevates water levels at the rail siding during flood events. In order to provide additional flow capacity, it is proposed to remove a section of the existing bund near the existing culvert and to construct a new bund parallel to the rail line to protect the rail and the site from flooding from Pipers Flat Creek. The area between the new bund and the existing bund provides a second flow path during flood events. During significant rainfall events, the rail line will need to be closed and a small temporary bund will need to be constructed over the rail line to connect the new bund with the existing bund on the southern side of the rail to prevent runoff entering the site along the rail line. This temporary bund has been constructed during past rainfall events as shown in Figure 6. Strict safety and operations procedures and a Safety in Design process during detailed design need to be in place to ensure that the rail line remains closed while the temporary bund is in place. It is proposed to construct the new bund to a level of 880.50, which is approximately 500 mm above the 100 year ARI level. Figure 5 shows the schematics of Option 2.

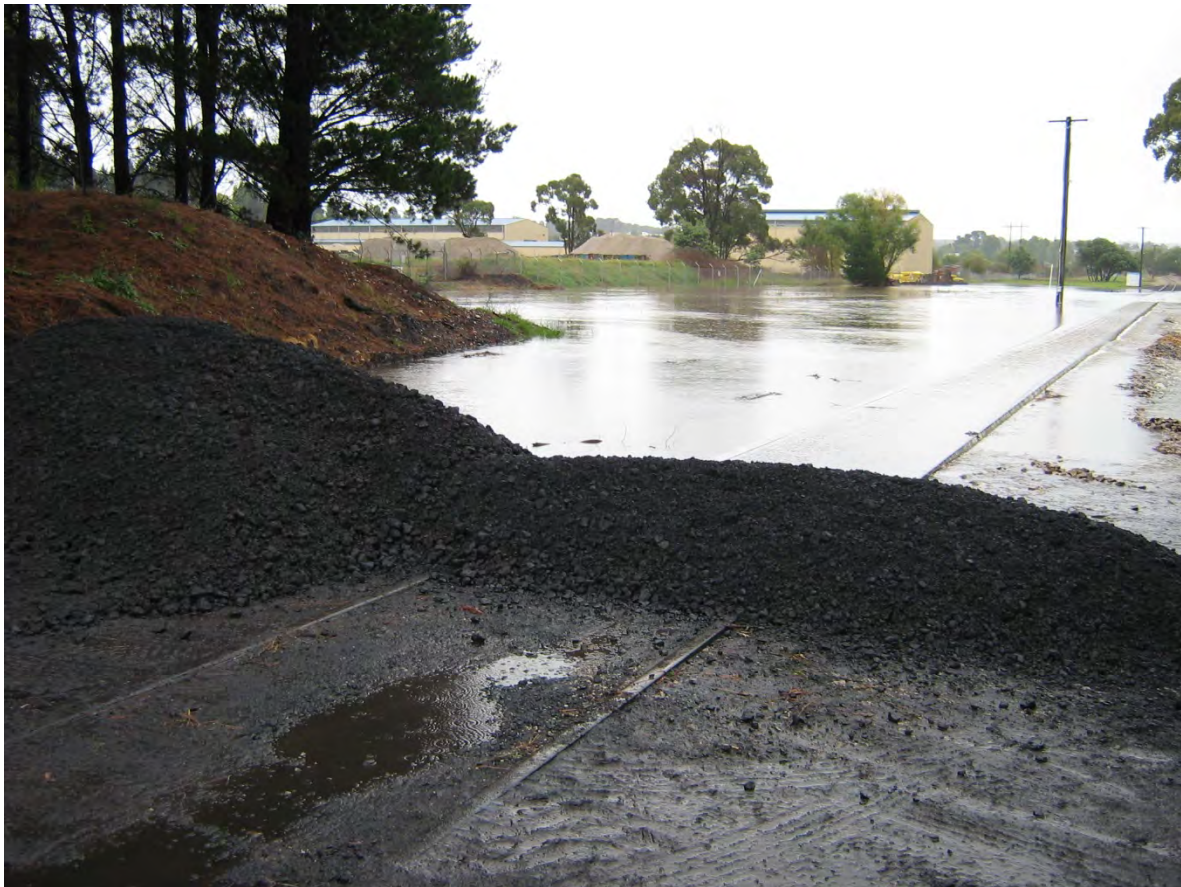
Figure 6 | Temporary bund across rail line
