**REMEDIATION ACTION PLAN
MANILLA HOSPITAL COMBINED MPS
HEALTH ONE CENTRE
COURT ST, MANILLA NSW**

Report Date: 25 September 2009
Project Ref: ENVIWARA00401AB-R02a

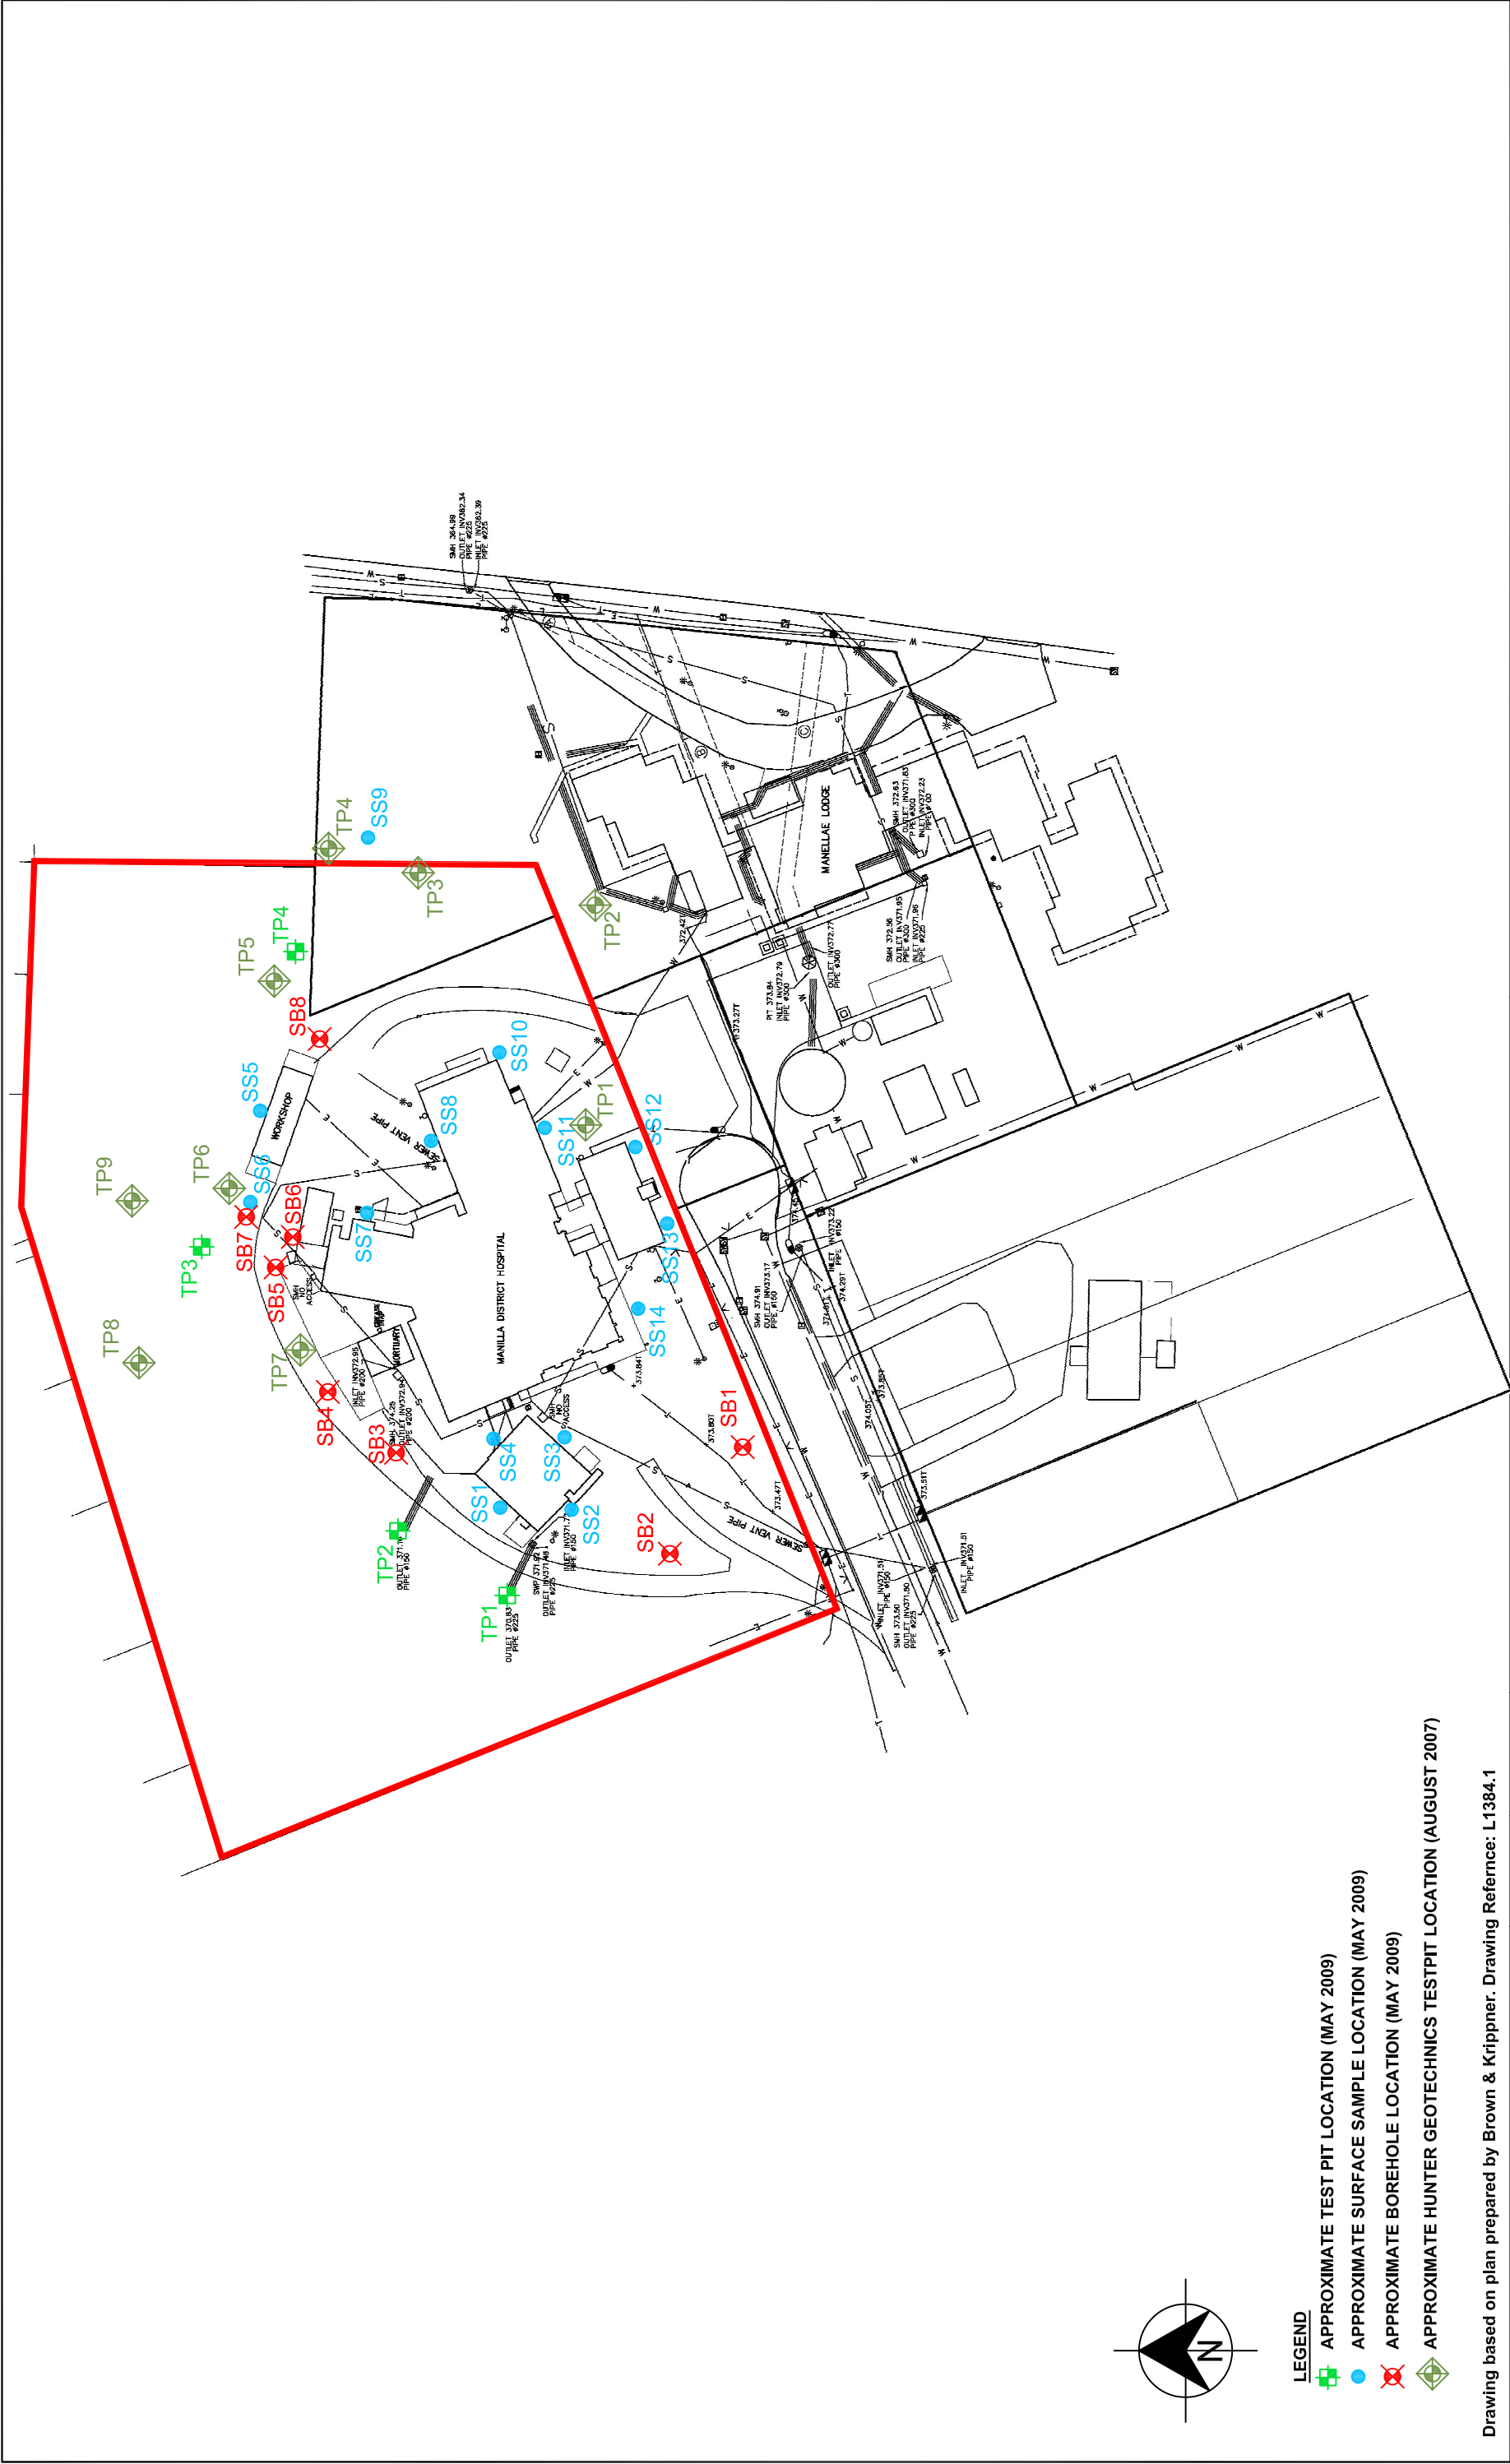
LEGEND
 APPROXIMATE TEST PIT LOCATION (MAY 2009)
 APPROXIMATE SURFACE SAMPLE LOCATION (MAY 2009)
 APPROXIMATE BOREHOLE LOCATION (MAY 2009)
 APPROXIMATE HUNTER GEOTECHNICS TESTPIT LOCATION (AUGUST 2007)

Drawing based on plan prepared by Brown & Krippner. Drawing Reference: L1384.1
