**Engineering Submission  
to**

**Mining Subsidence Board**

**PROPOSED HMRI BUILDINGS  
Rankin Park, John Hunter Hospital**

Compiled by Arup  
Job No. 206014-00

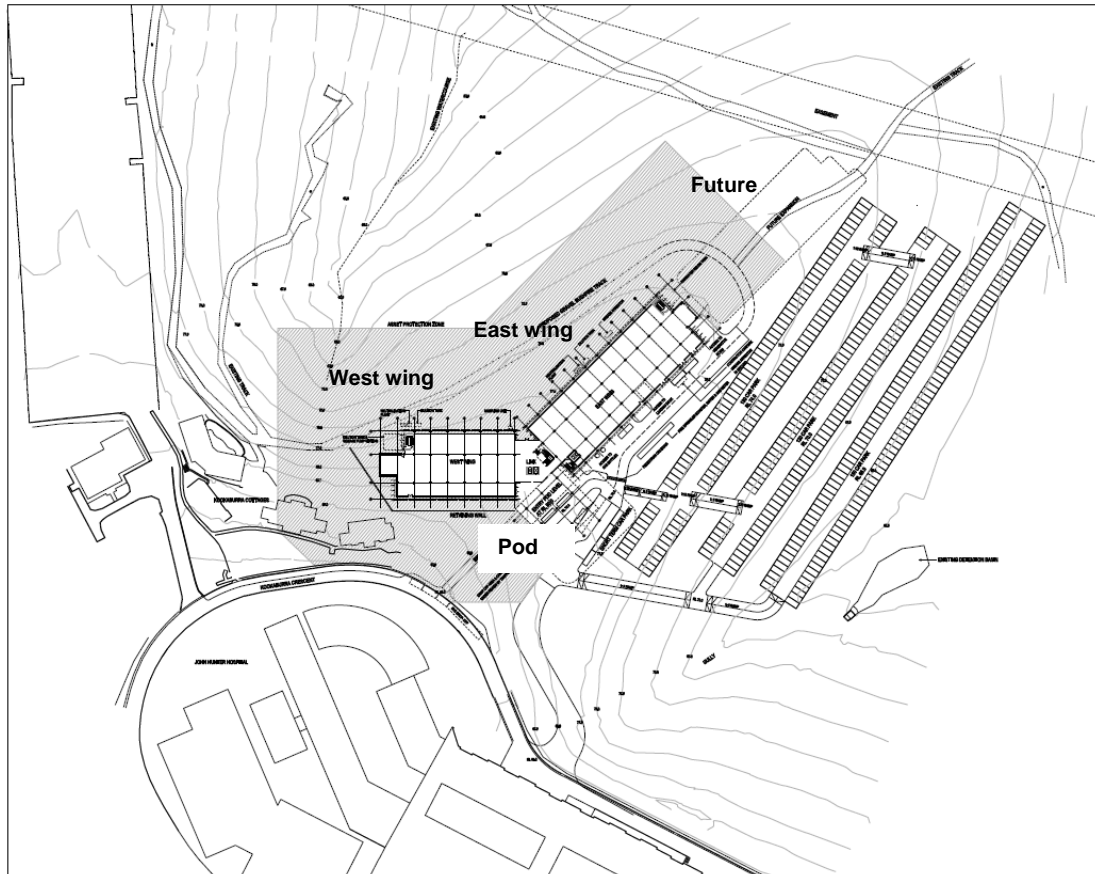
The proposed HMRI facility comprises of three linked buildings – the West Wing & Atria, East Wing and Pod buildings. Figure 1 also shows a potential future extension beyond the East Wing.

Figure 1 – Site Layout Plan of proposed HMRI buildings at Rankin Park Campus

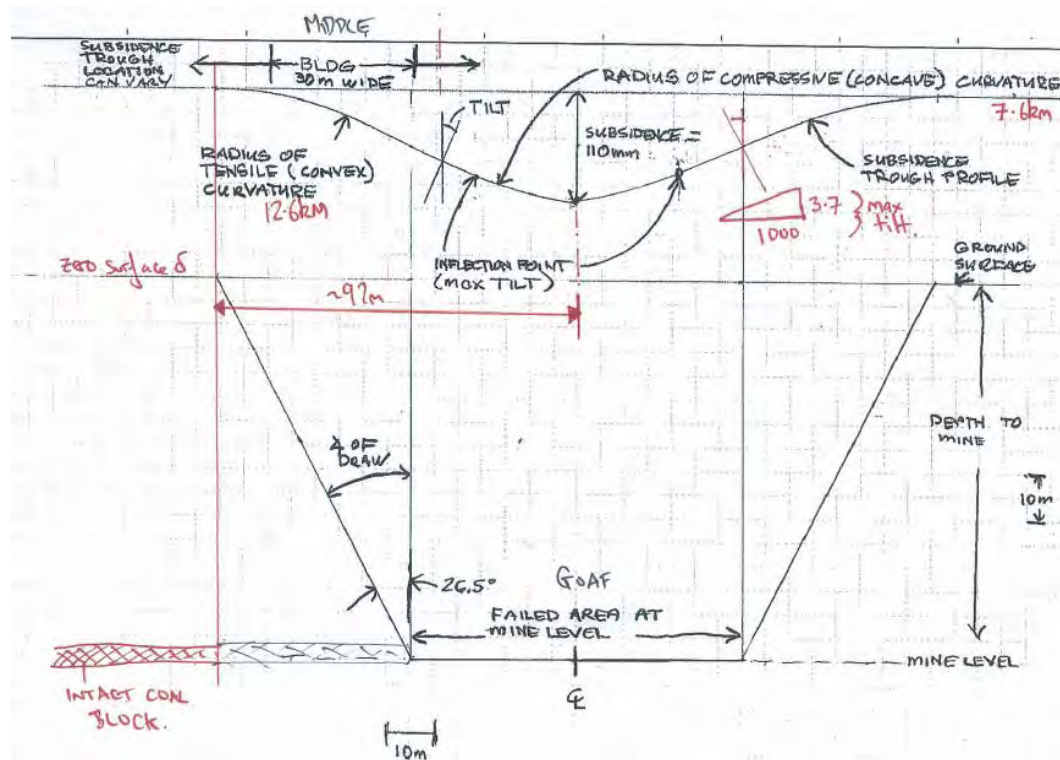
Conceptual Subsidence Profile – Coffey's original sketch in black (overlain by Arup notes in red)

Coffey's have clarified that the future (northern-most) wing of the building is most likely to see the most severe tilt. The relative displacements of the West and East wings are likely to be less in reality though the same principles/solutions will apply. It is likely that there will be some longitudinal subsidence effects. The building wings are expected to physically lie on the convex portion of the subsidence curve and in the region of maximum tilt. This suggests that surface strains could be expected to be mainly tensile (i.e. a tendency for the ground surface to open up rather than compress). Further to discussions with the MSB and Coffey on 1<sup>st</sup> July 2009, the development must assume that the concave compression surface strains could also occur. These profiles are shown on the simplified sketches below.

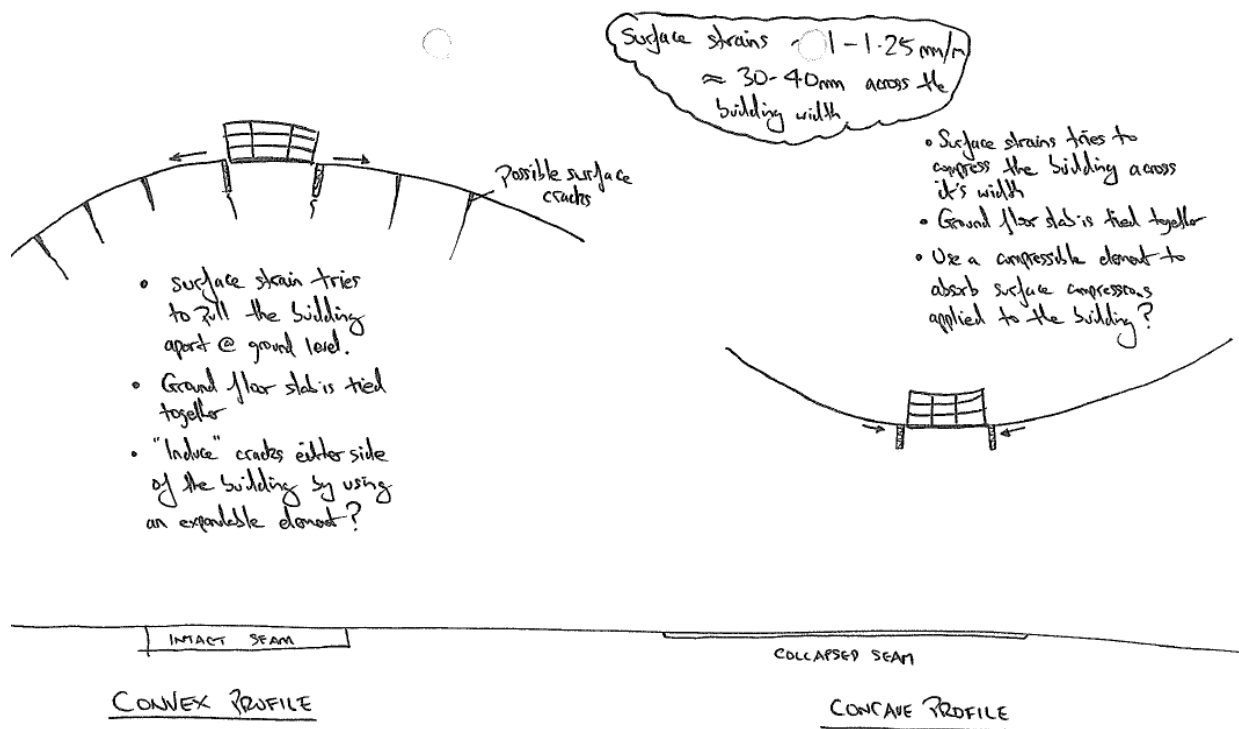
Arup sketches of convex and concave profiles

Due to the inherent inaccuracies in both the location of the proposed building relative to the existing coal features and the assumptions in the analyses, the recommendation of the meeting was to initially assume that the building cross-section could exist at any part of the proposed profile – i.e. both the concave and convex portions of the profile.

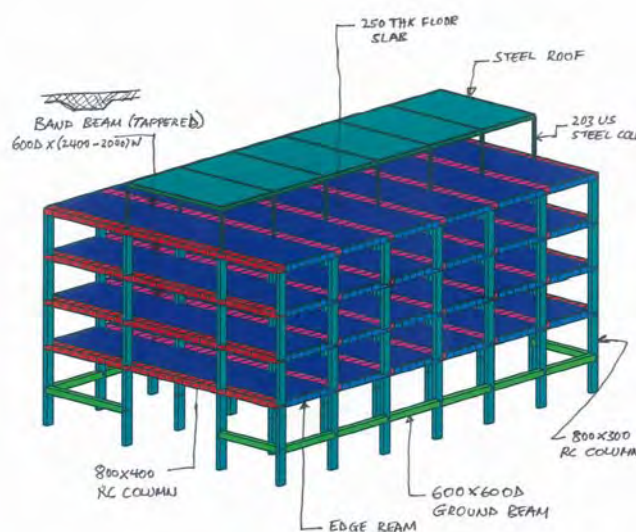
> The entire structure will be founded within very hard sandstone. The sandstone outcrops above the West Wing (requiring bulk excavation), but falls away to be 3m under the far end of the East Wing (Grid 25). So the opportunity exists from Grids 18-25 to create an undercroft.

> Stability walls are 250thk around stairwells, lift cores and shear walls

Arup Isometrics

Main wings

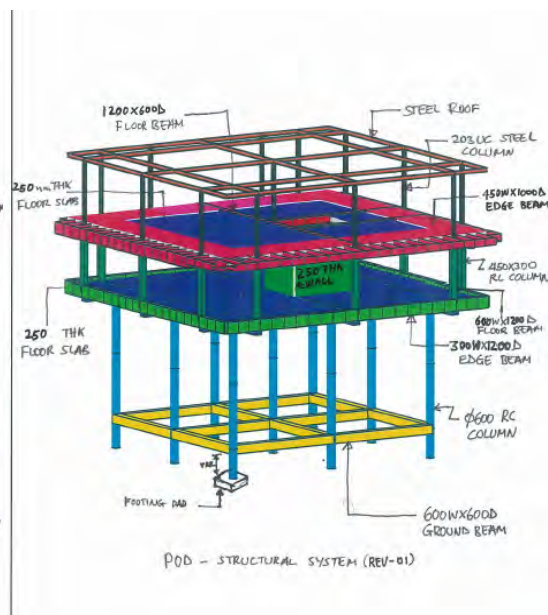
> The Pod has two upper floor levels (L3 and L4) which sit on 9No. 600sq double height columns. The exposed soffit of L3 has 1200dp x 700w beams running over the column and cantilevering out to pick up a 1200dp x 400w perimeter beam, with 250thk infill slab. The 9No. columns pad footings will be founded into the sandstone, and tied together with ground beams under the road level.

Pod building

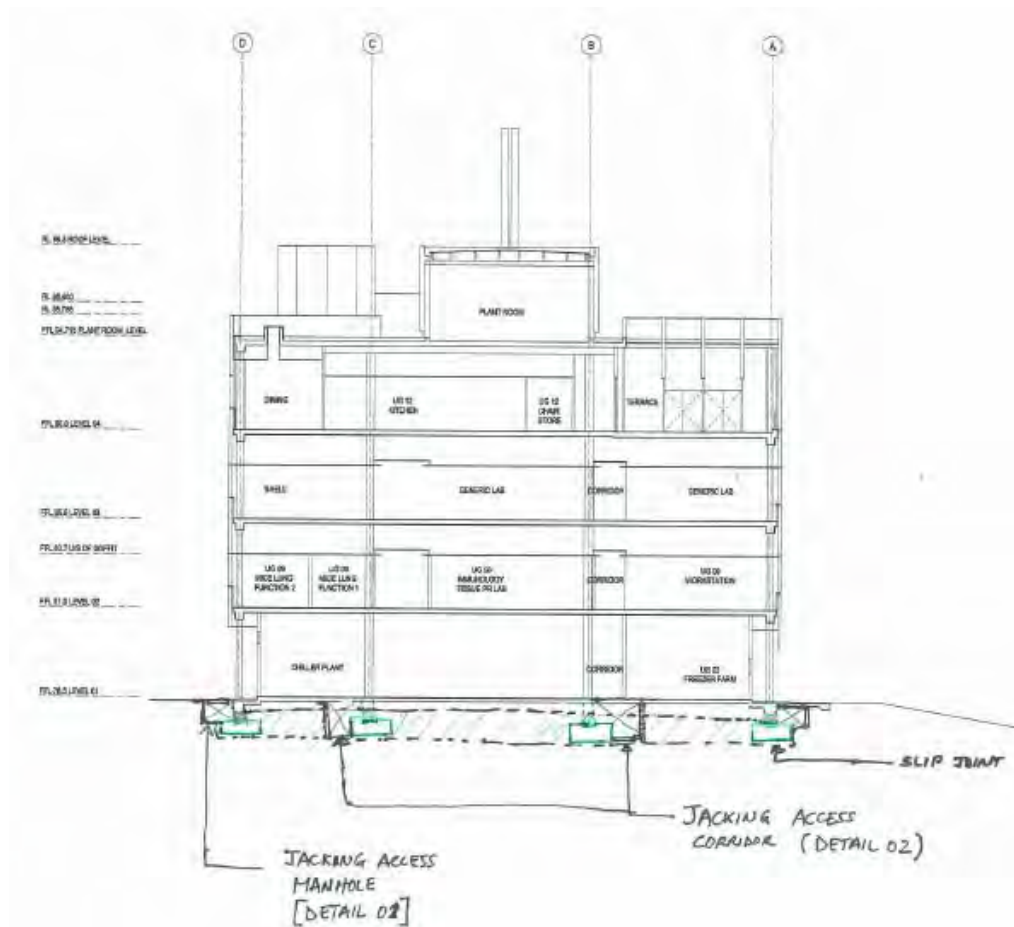
Conceptual sketches of the proposed jacking scheme are included overleaf:

**Jacking Access – via manholes to external columns & corridors internally**

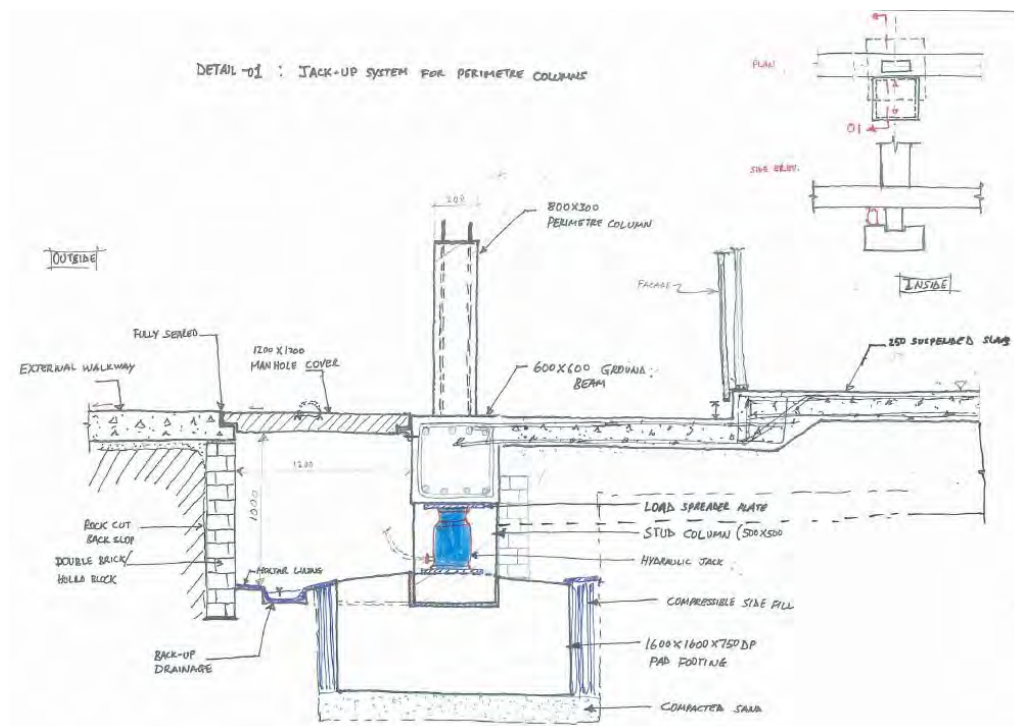
**Proposed Manhole access detail – to all external columns along Grids A & D.**

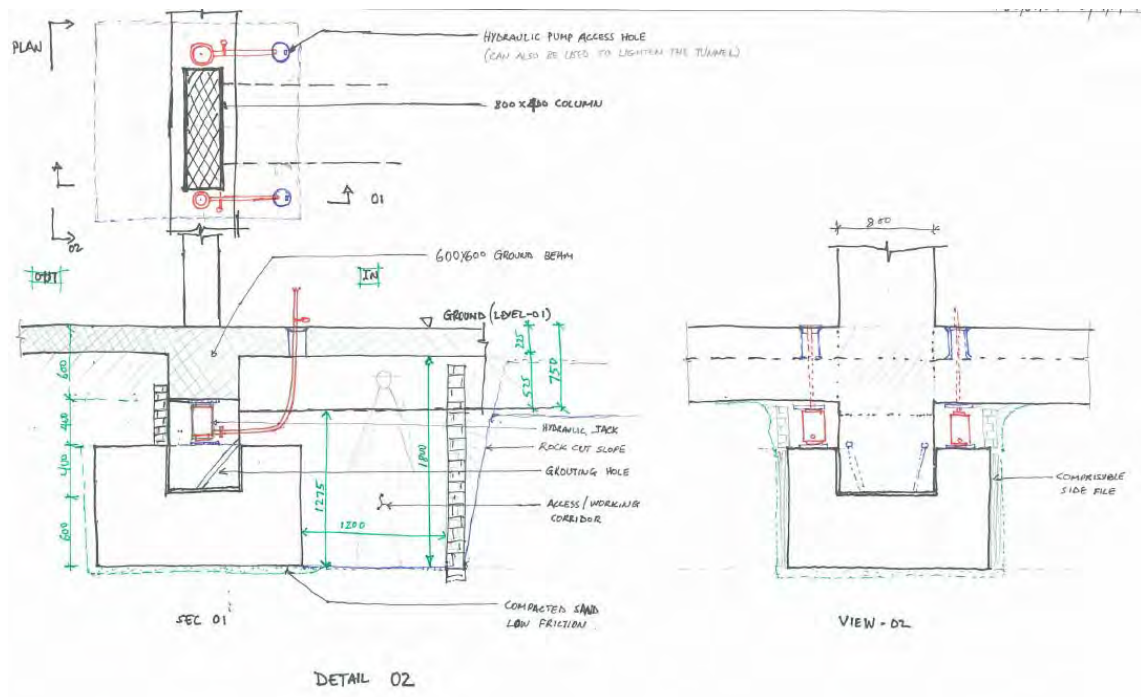
Column jacking via access trench - to internal columns along Grids B & C

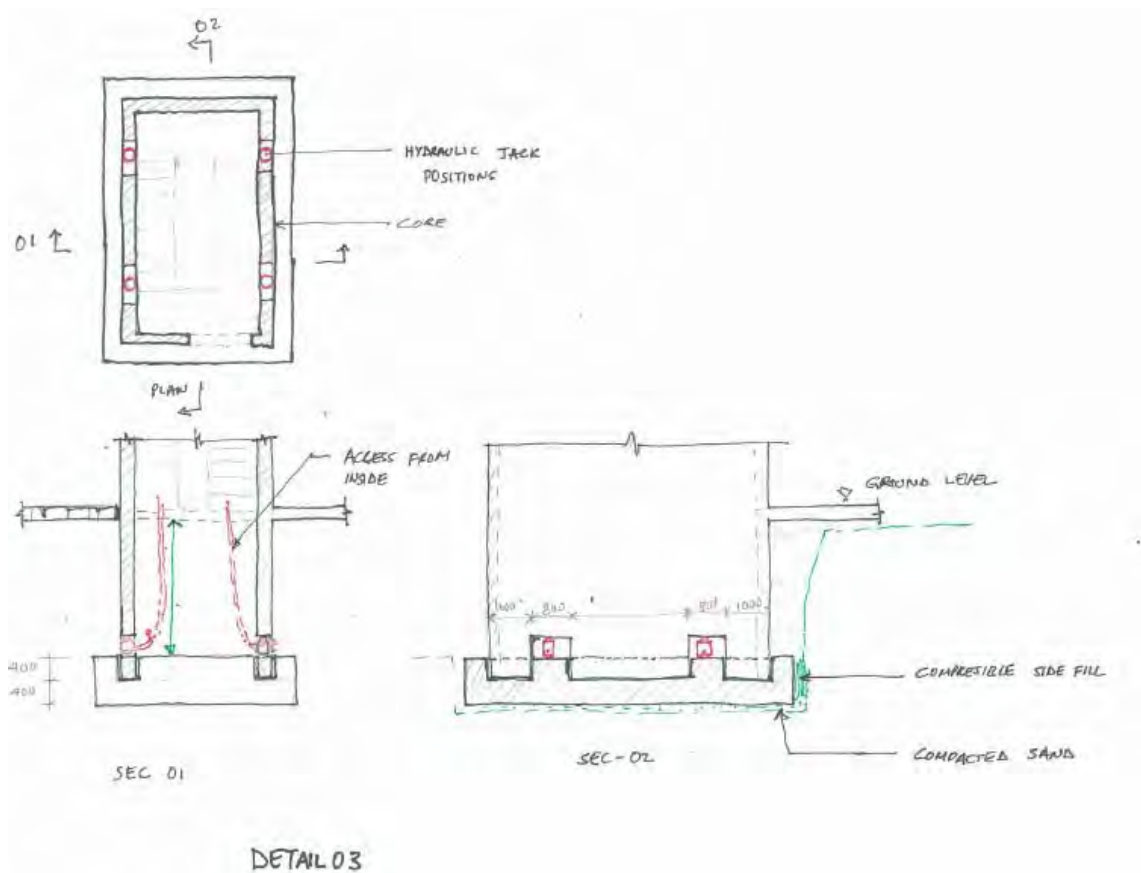
Core - jacking points provided in each corner.

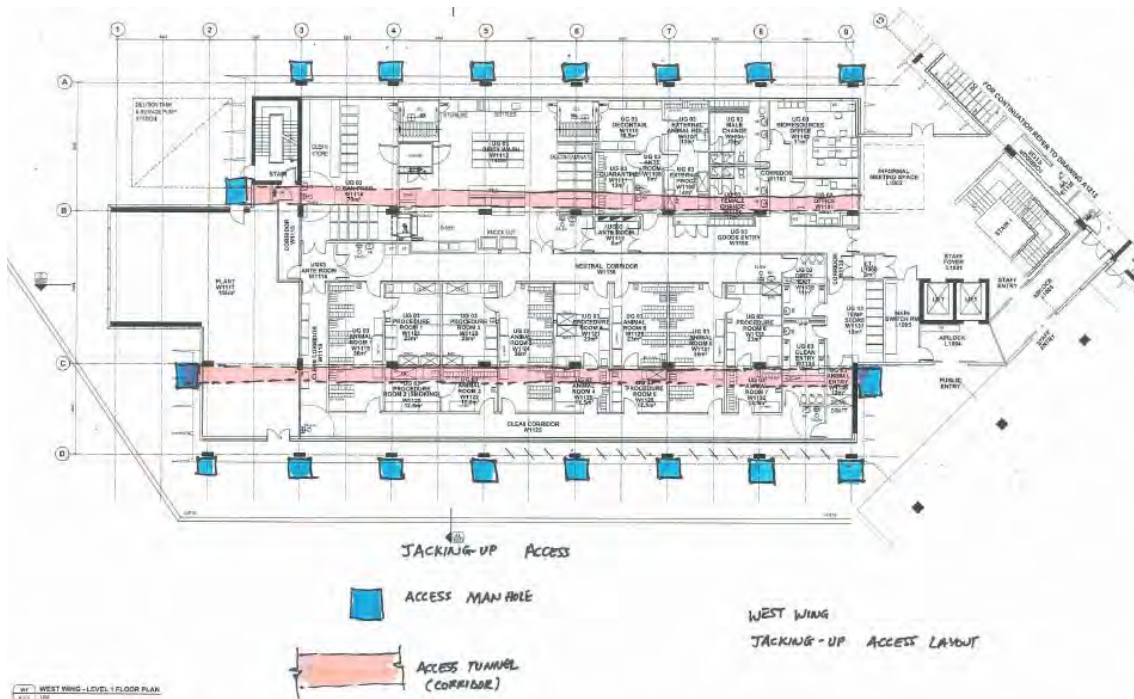
West Wing – jacking access. Blue = manhole, Pink = sub-floor access corridor

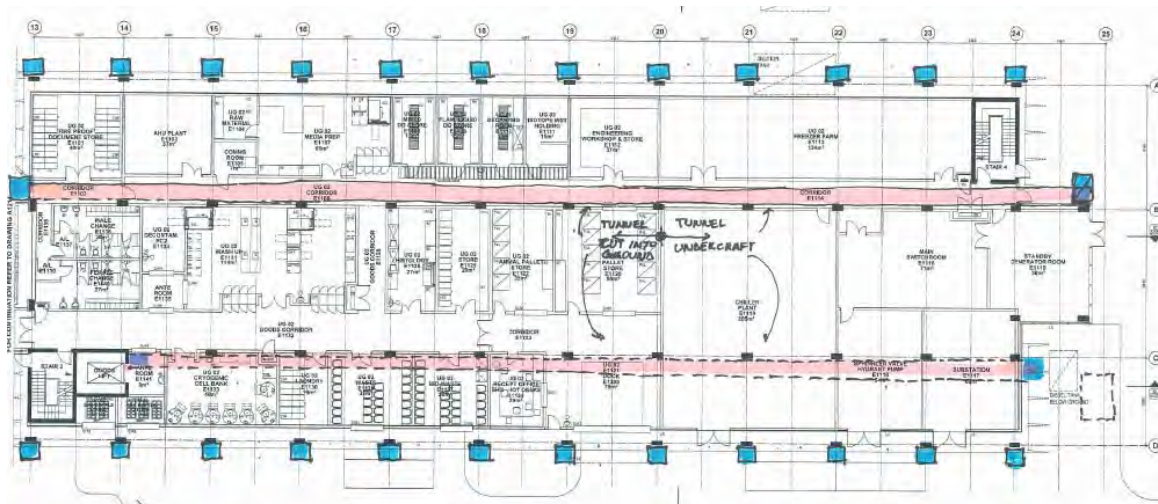
East Wing – jacking access. Blue = manhole, Pink = sub-floor access corridor

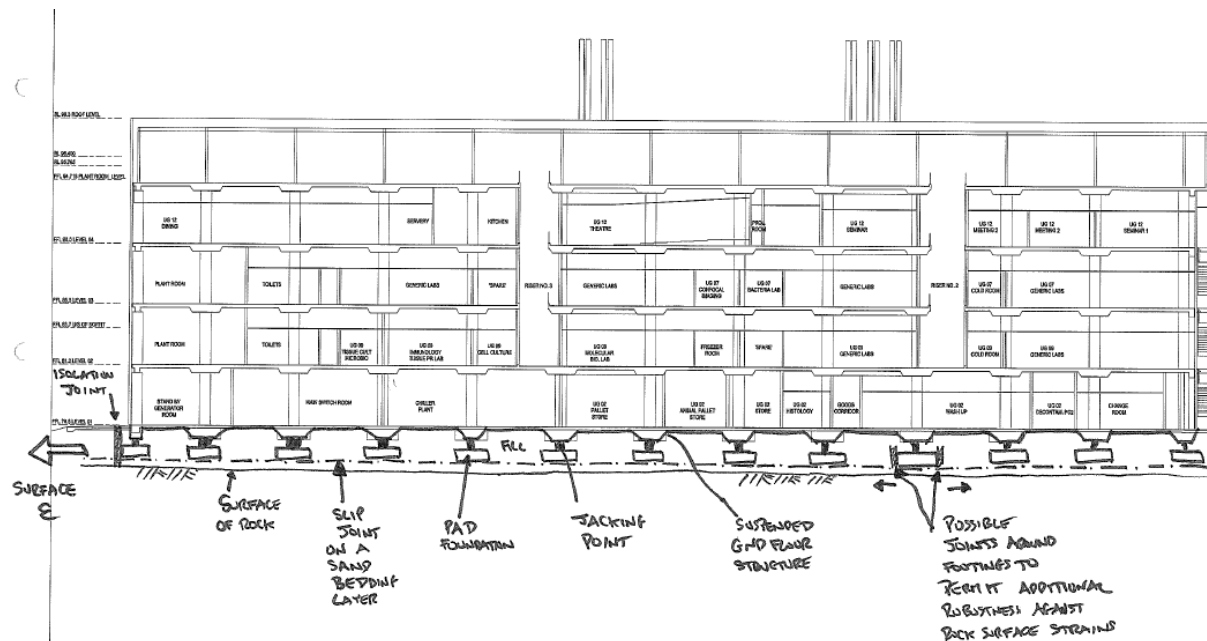
Thus a slip layer will be formed on the plane under the pad footings. This slip layer is intended to reduce friction between the building and the ground, and thus allow the ground to slip under the building. This slip layer will comprise a sand base, and possibly also a bituminous or plastic membrane between the pads and sand base.

Furthermore, compressible material will isolate each pad footing from the surrounding soil and any compressive or tensile strains that are present. A compressible material like void former will be used for this purpose. An alternative and/or supplementary solution to be investigated is cutting a trench all around the buildings to a depth just below the pad footings, which could take out the surface strains before they even affect the pad footings. A cost analysis will determine the final detail.

Sketch showing isolated pad footings & slip layer under

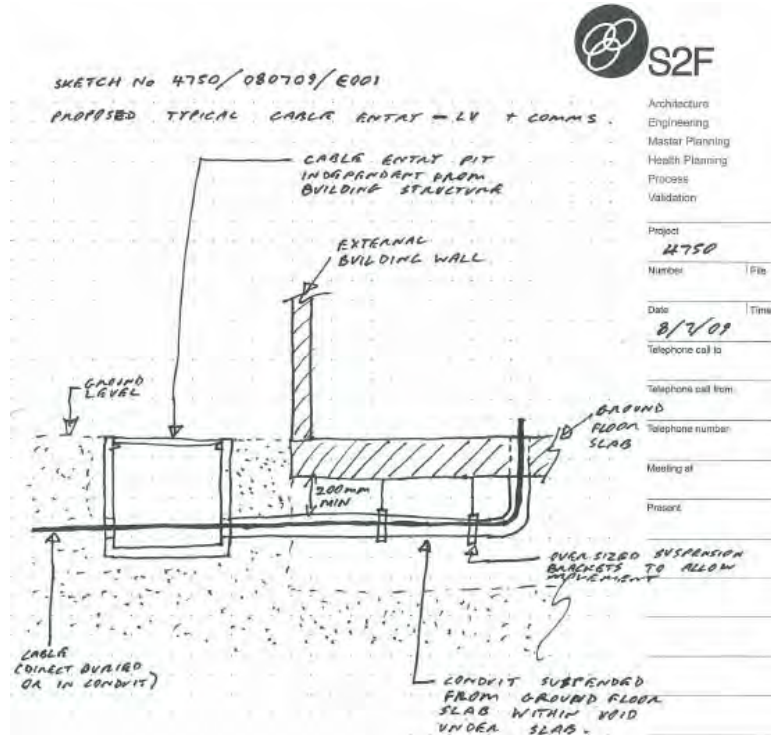
High voltage, low voltage and communication electrical conduits will service the proposed HMRI facility. In each case, the incoming electrical conduit will go from being embedded in the ground, to entering the building. To accommodate any future differential movements due to settlement and subsequent jacking of the building, the conduits will be fixed to the L1 ground slab with oversize suspension brackets, as is illustrated in the sketches below.

Section – LV and communication conduit coming into HMRI buildings

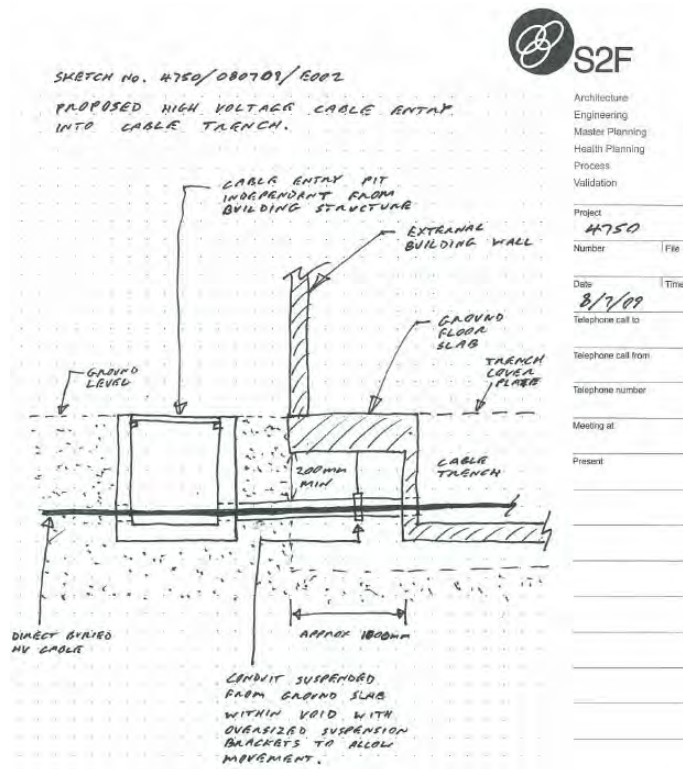
Section - HV conduit coming into HMRI buildings

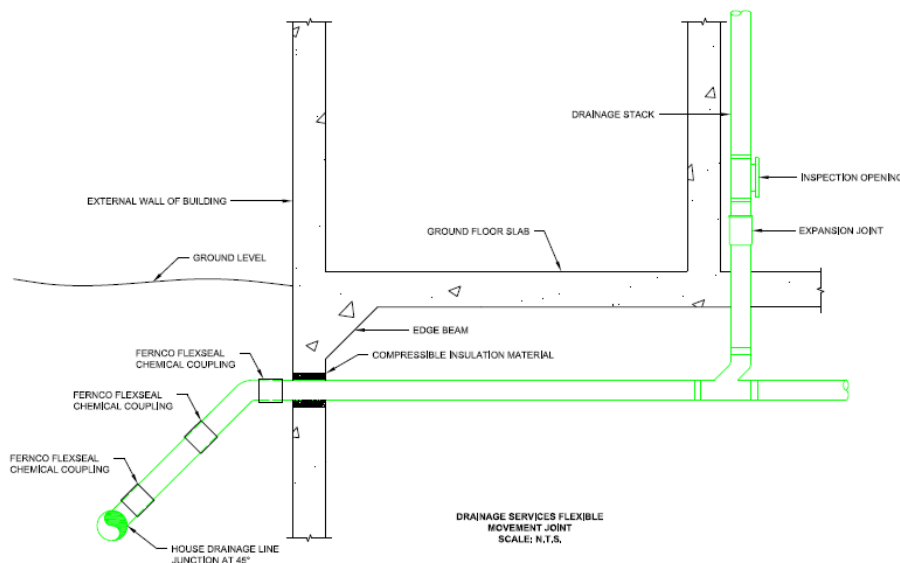
The sketch below illustrates the preliminary detail of how the drainage pipes will accommodate differential movements between the re-levelled building and subsiding ground of up to 110mm.

**Drainage Pipes - Flexible Movement Detail**

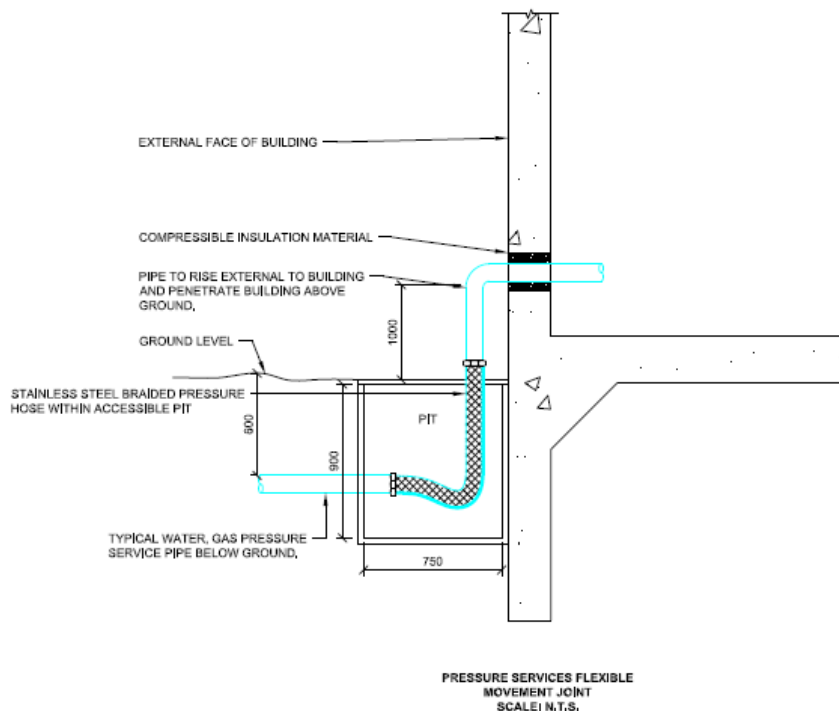
**Pressure Services - Flexible Movement Detail**

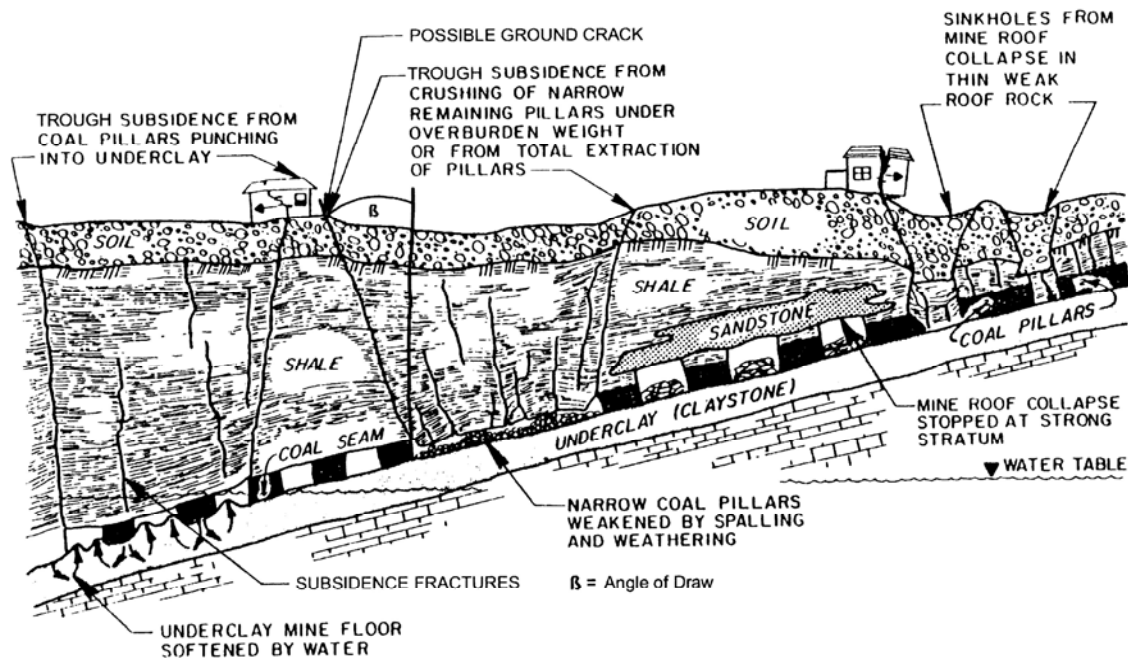
Mine subsidence refers to the downward movement of the ground surface due to the failure of support at mine level. Subsidence can take the form of sinkholes or troughs as shown on Figure 1. Sinkholes (Potholes) are usually circular collapse depressions with sides that can be steep and abrupt or gently sloping towards the center. Sinkhole formation is controlled by the thickness of the rock overburden, jointing of the rock, mining conditions, and bulking of the roof fall material. Sinkholes are not expected at the site due to the conglomerate above the mine workings and overburden depth.

Troughs are broad, shallow depressions that result from the failure of one or more pillars. Pillars can fail by crushing or punching into the roof or the floor. The trough size and deformations depend on the mined width, mined height, thickness and hardness of overburden rocks, and pillar stability.

Deformations from trough subsidence can extent beyond the limits of mining. The zone beyond the limit of mining that is impacted by trough subsidence is determined by the angle of draw. (Angle  $\beta$  in Figure 1). Within the Newcastle Coal Measures an angle of draw of 26.5° to the vertical is generally adopted. This angle translates to one horizontal for every two vertical. That is, should workings at a depth of 66m, collapse beyond 33m from the site, significant surface subsidence at the site would not be expected.

Figure 1 - Types of subsidence (Knott, 2006, modified from Bruhn, et al., 1978).
