APPENDIX D

**XSTRATA COAL NSW
BAAL BONE COLLIERY**

**LONGWALL MINING
SUBSIDENCE RISK ASSESSMENT**

**FINAL REPORT
DECEMBER 2006
HMS622**

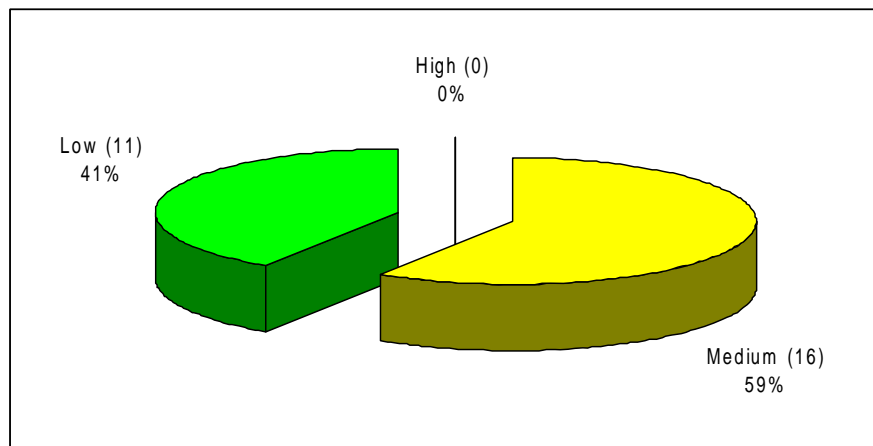
Chart 1 - Risk Distribution by Risk Rating

Risk Rating	No.	%
High	nil	0%
Medium	16	59%
Low	11	41%
Total	27	100%

Table 1 - Summary of Risks by Risk Rating

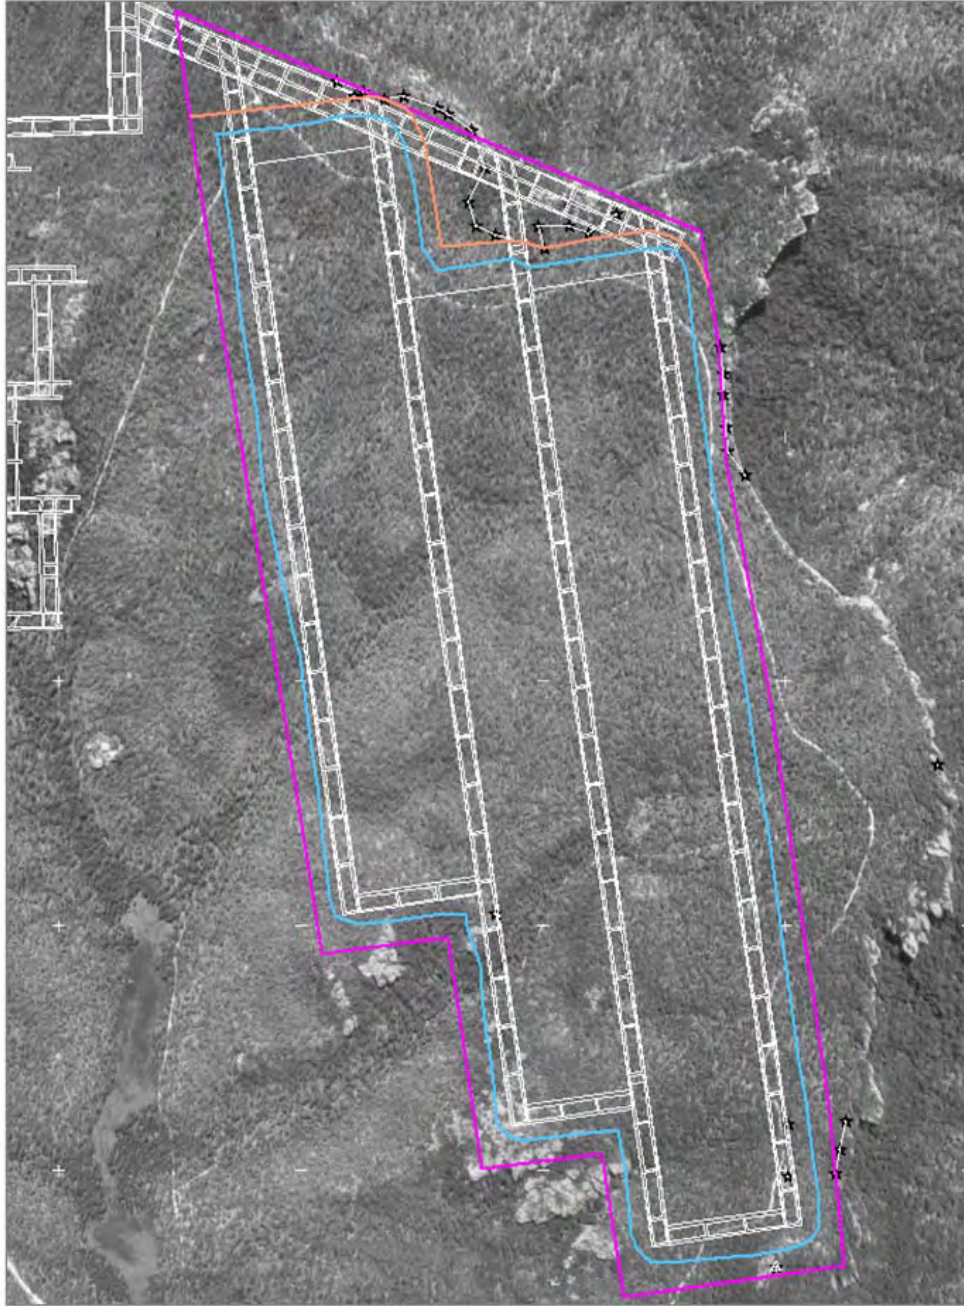
The SMP Application Area, as well as the 17 and 26.5 degree angle of draw zones are shown in *Diagram 3 – Location of SMP Application Area*, following;

- **SMP Application Area**
- **26.5 Degree Angle of Draw**
- **17 Degree Angle of Draw**

Diagram 3 – Location of SMP Application Area
