# BAAL BONE UNDERGROUND

GLENCORE

10 December 2020

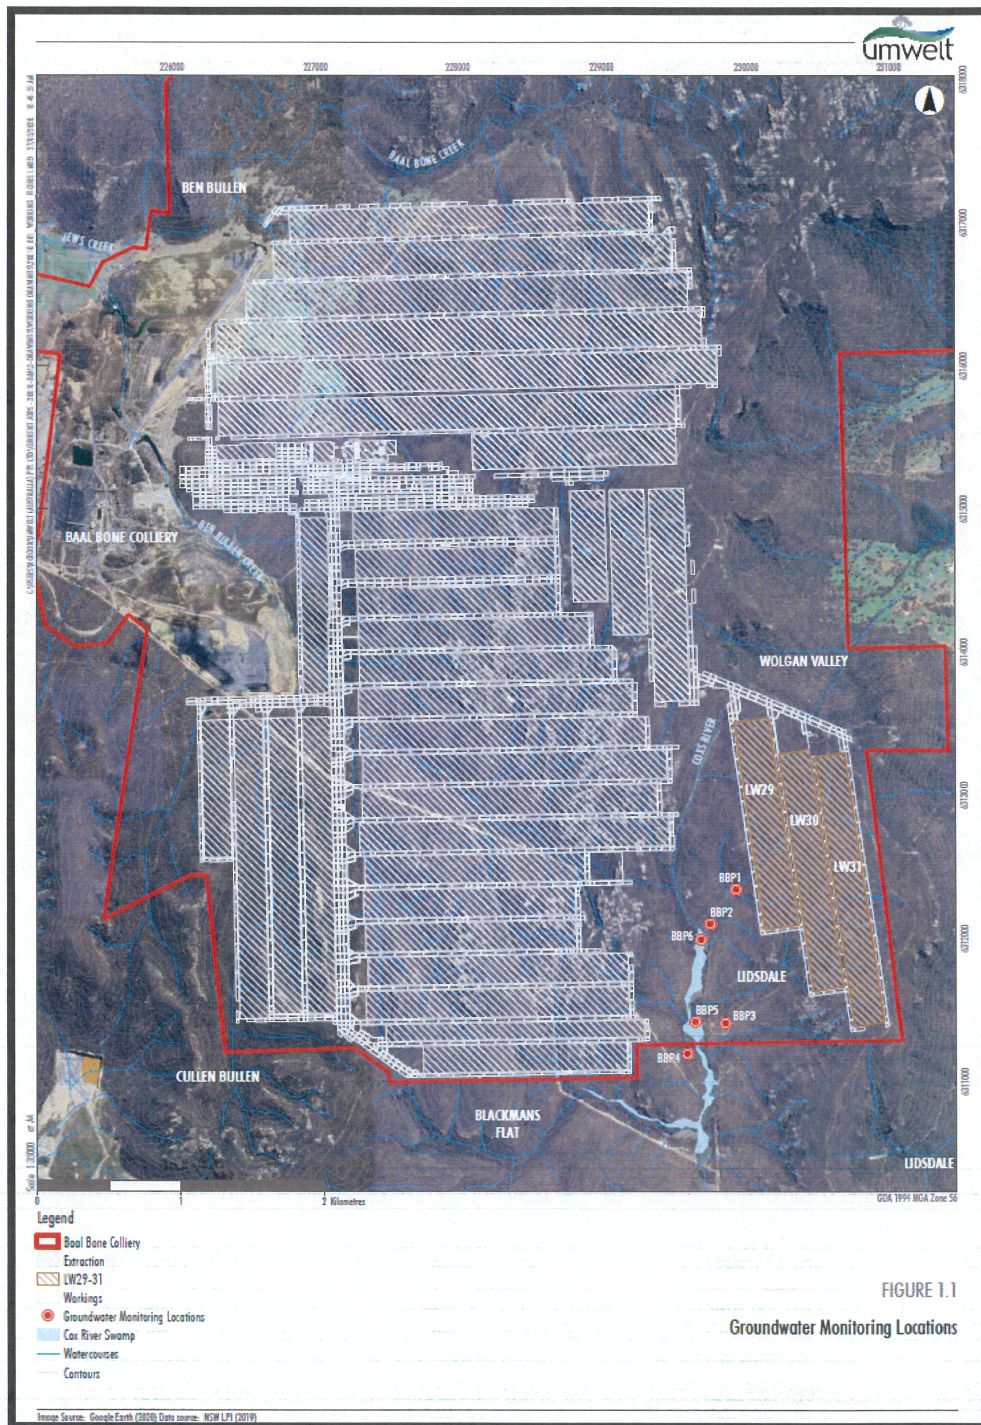
Figure 3 - Groundwater Monitoring Locations

Groundwater in and around Cocks River Swamp has been monitored for the purpose of identifying any potential impacts associated with the mining of Longwalls 29-31. Monitoring has occurred on a monthly basis, since 2007 for groundwater level and since 2008 for groundwater quality. The monitoring network consists of six (6) monitoring bores which includes one background monitoring bore (BBP4). Figure 3 below shows the locations of these bores. Mining ceased in this area in 2011.

The location registering the exceedance, known as BBP3, has had previous exceedances for zinc trigger levels. Increases in trace metals in 2011 resulted in Baal Bone engaging Aurecon to conduct an investigation. Their report identified that zinc exceedances were a result of natural variability and that the largest increase corresponded with the peak in rainfall recovery.
