## 5.0 VISUAL IMPACT

### 5.1 VISUAL IMPACT ANALYSIS

## 5.2 VISUAL IMPACT ASSESSMENT

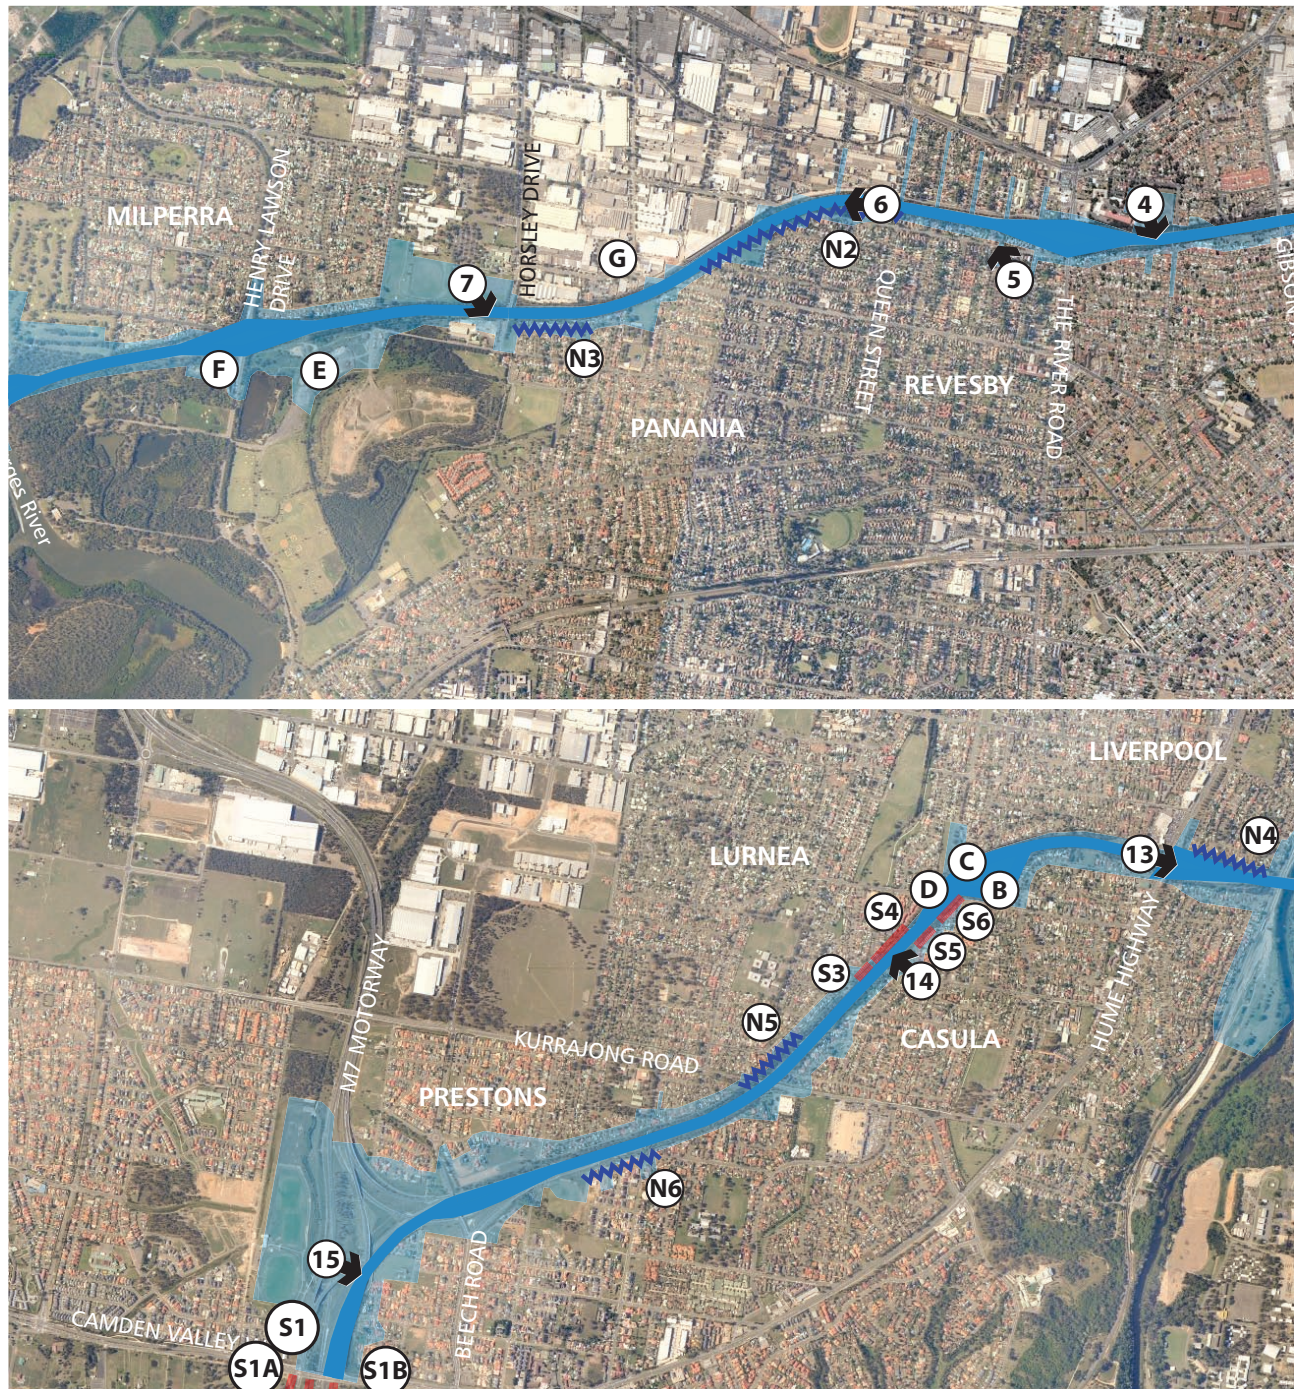
Illustration 64: Approximation of the visual catchment of the existing Motorway, representing a conservative area from where the Motorway is able to be seen. The darker area is the extent of the visibility of the proposed works
