Dargues Reef Gold Project (10_0054)
Submission to the Exhibition of Environmental Assessment

Review of Dargues Reef Gold Mine EA

For Eurobodalla Shire Council

By Water Futures & Atom Consulting

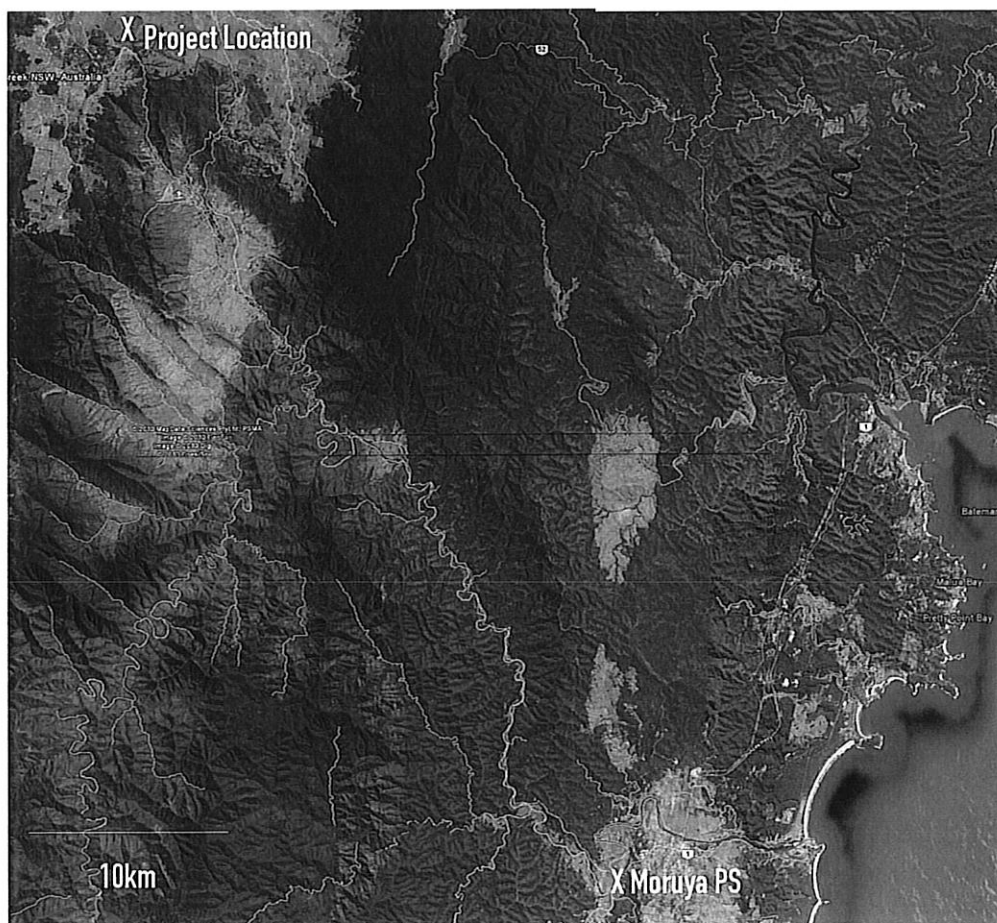
FIGURE 1. AERIAL PHOTOGRAPH SHOWING THE LOCATION OF THE MINE AND THE HEADWATERS OF THE MORUYA DRINKING WATER CATCHMENT (ADAPTED FROM GOOGLE MAPS15/10/2010)

Big Island Mining Pty Ltd ("the Proponent") propose to develop an underground gold mine on the Dargues Reef orebody which is located approximately 2.5 km north of the village of Majors Creek in south-eastern New South Wales. The mine is situated in the headwaters of the Moruya Catchment, one of three drinking water catchments which supply Eurobodalla Shire.
