**Redevelopment of Sydney Fish Market**  
56-60 Pyrmont Bridge Road, Pyrmont NSW  
Environmental Assessment  
**Volume 1 of 3**

Prepared for Sydney Fish Market Authority

September 2010

Conybeare Morrison International  
52 - 58 William Street  
East Sydney, NSW 2011  
T. 8244 8888 F. 8244 8877  
E. mail@cmplus.com.au  
10073

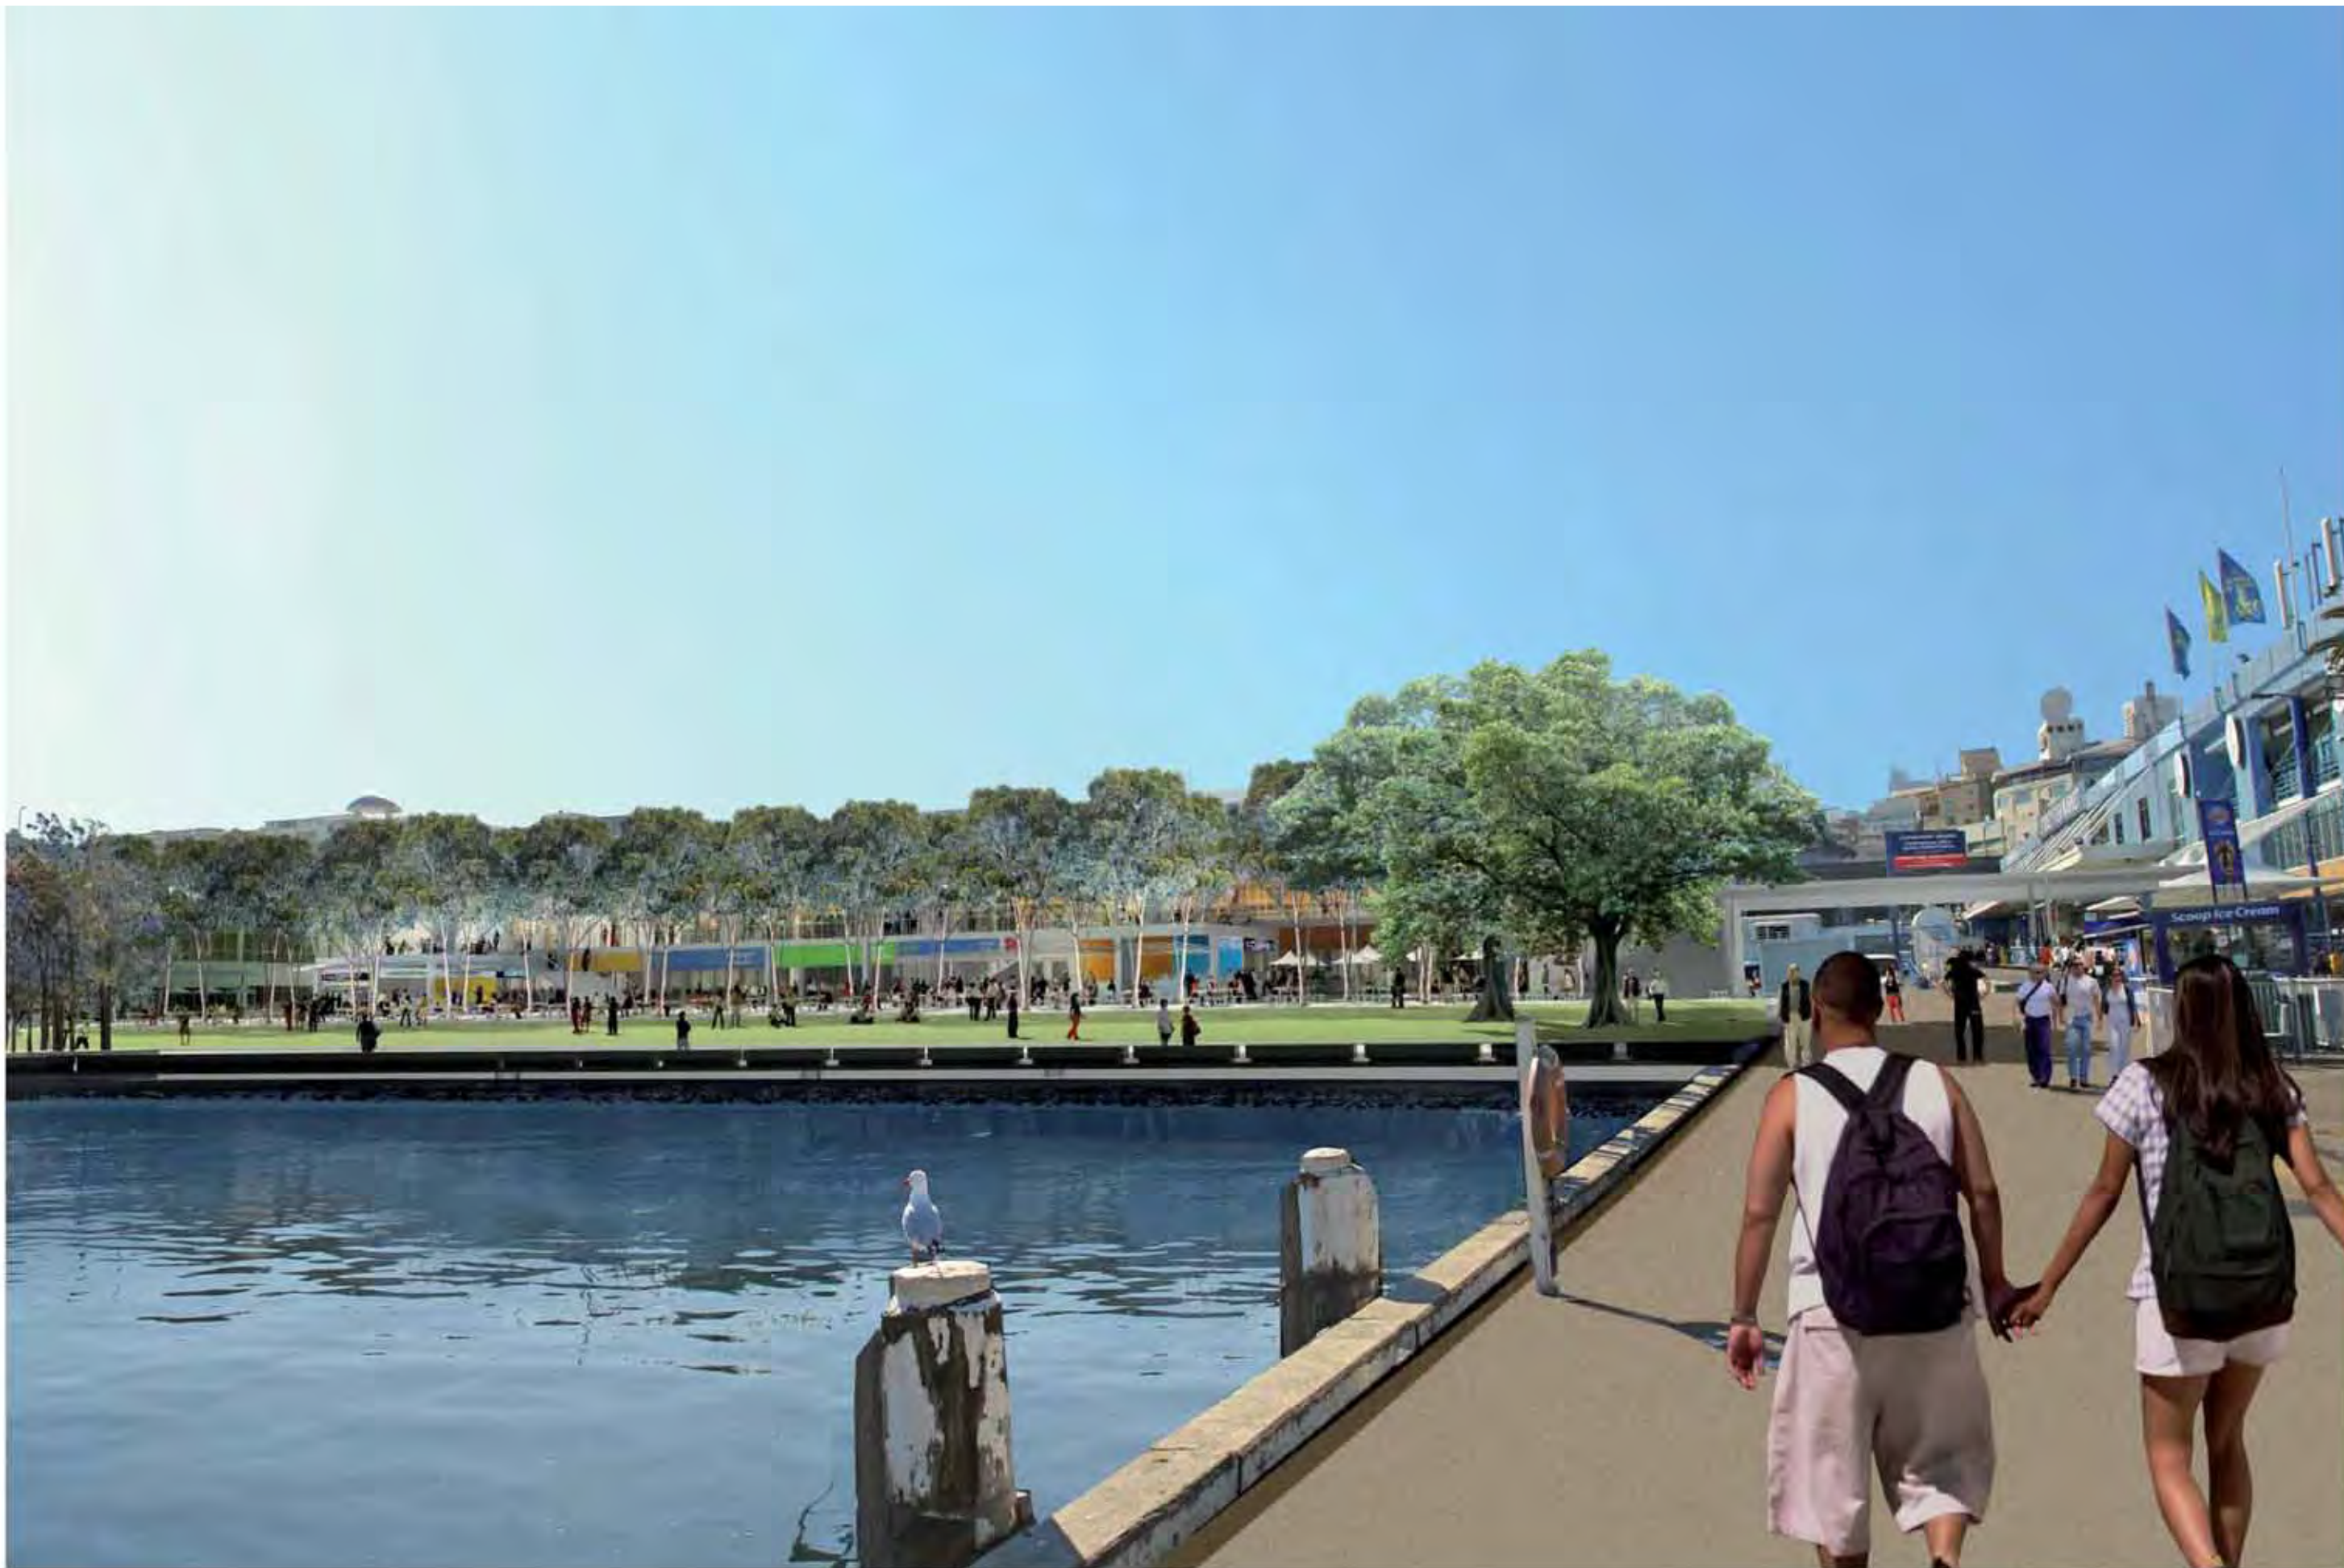
Client: Sydney Fish Market Authority  
September 2010 | 10034 - SK25

3D View From Existing Wharf Looking East

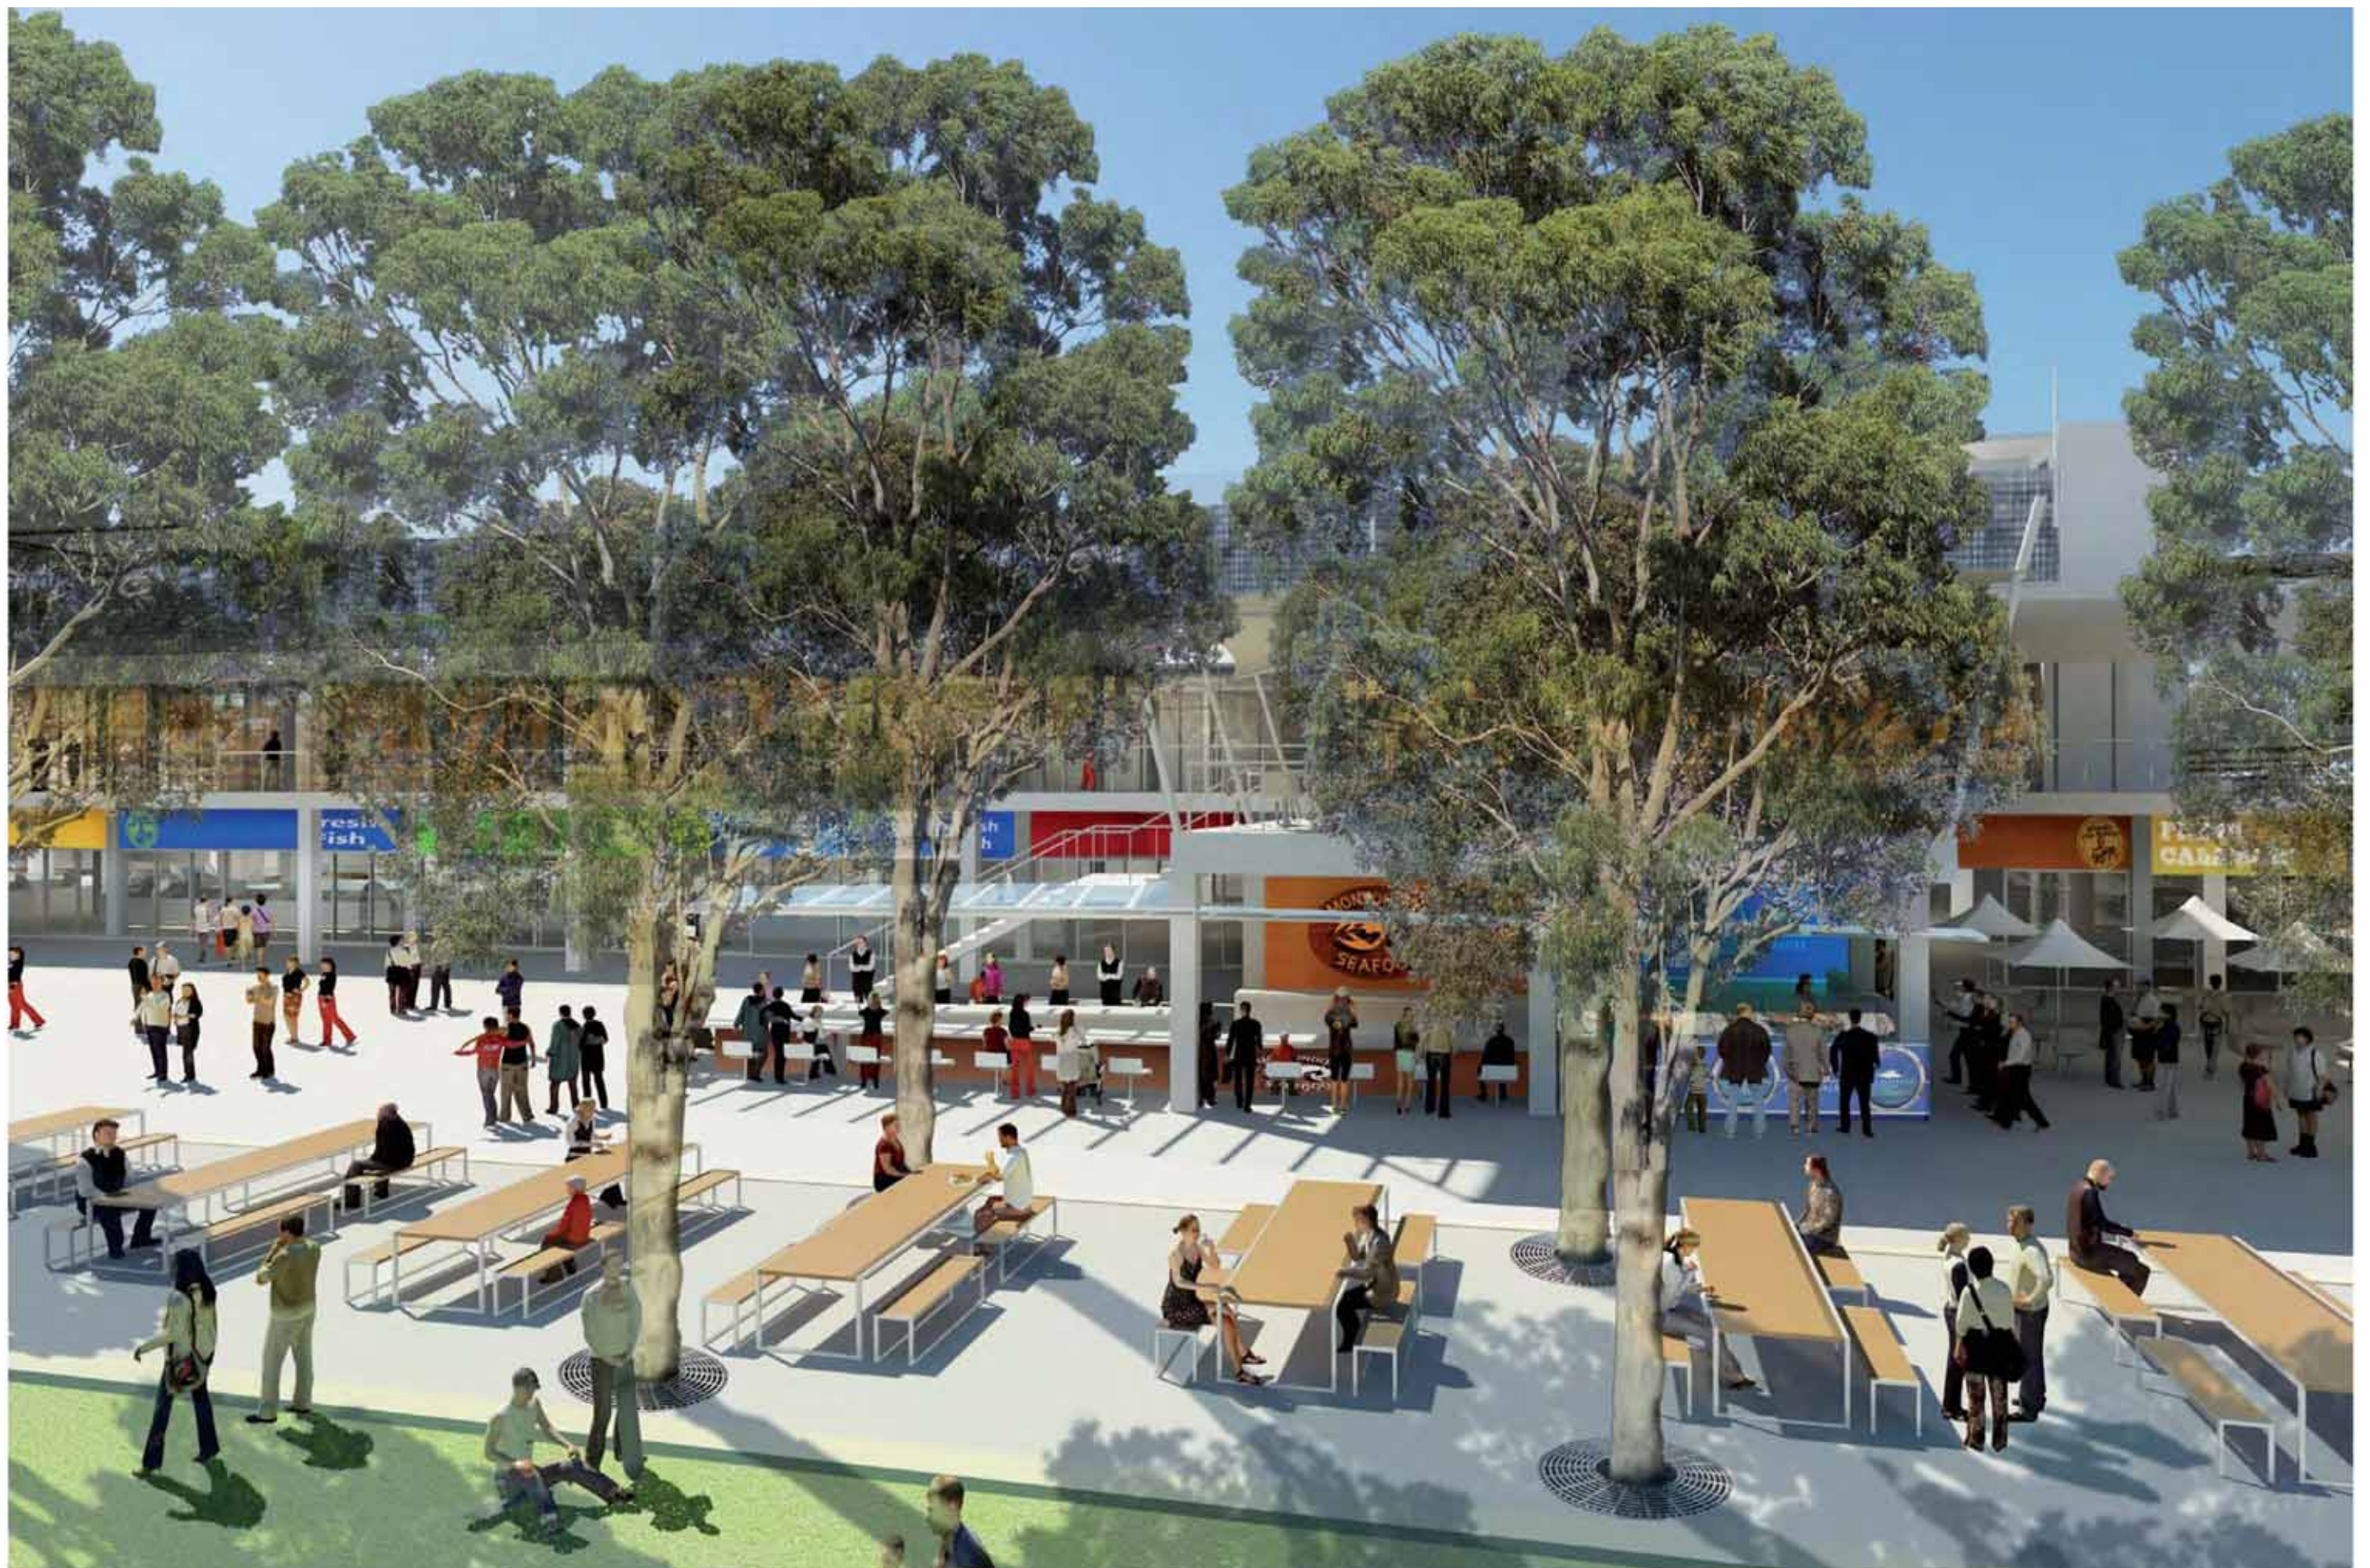
Client: Sydney Fish Market Authority  
September 2010 | 10034 - SK26

3D View to North East

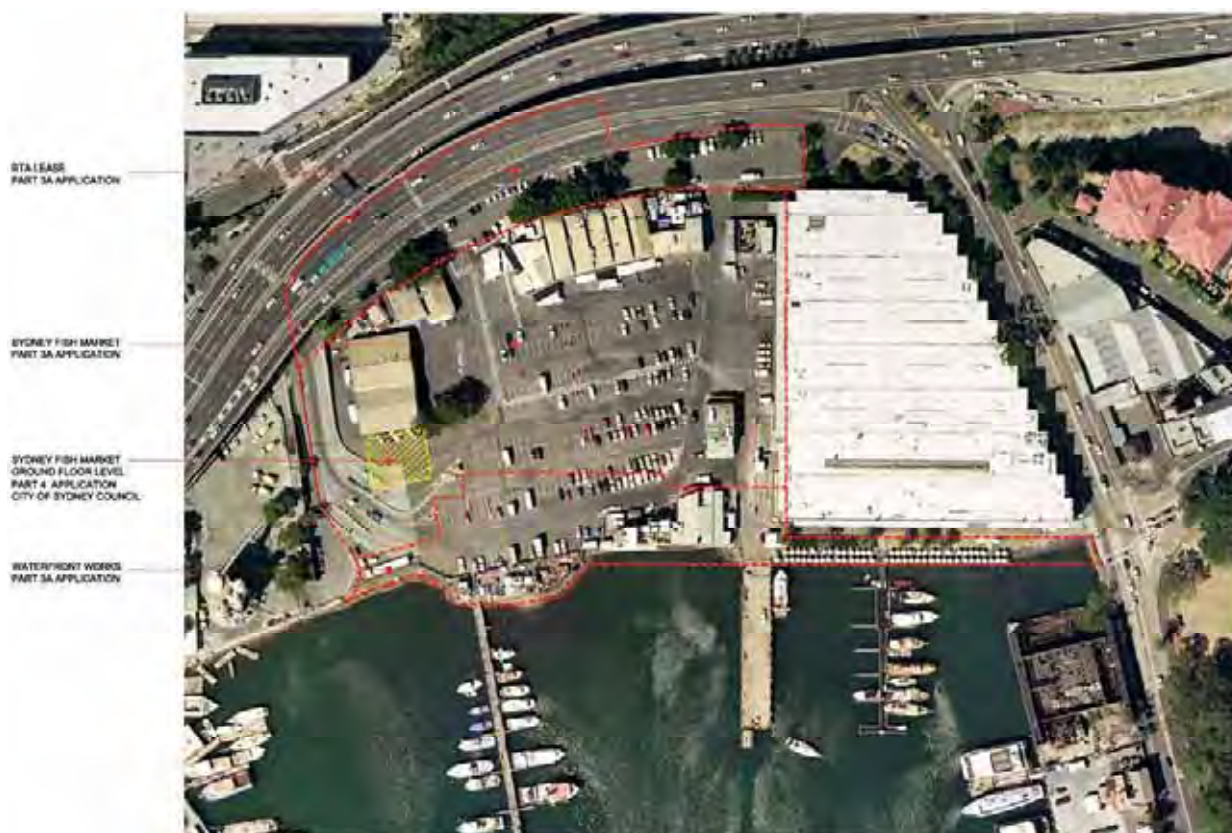
Figure 4: Site aerial

Adjacent to Blackwattle Bay the foreshore is supported by a dilapidated sea wall constructed of sandstone masonry, concrete and timber. The wall ranges in height from 0.9m to 1.5m and is in poor condition in some sections.

Protruding into Blackwattle Bay are:

- a floating pontoon opposite the Main Fish Market Building;
- a concrete wharf which is the main wharf for Fish Market operations; and
- a timber jetty towards the northern end of the site.

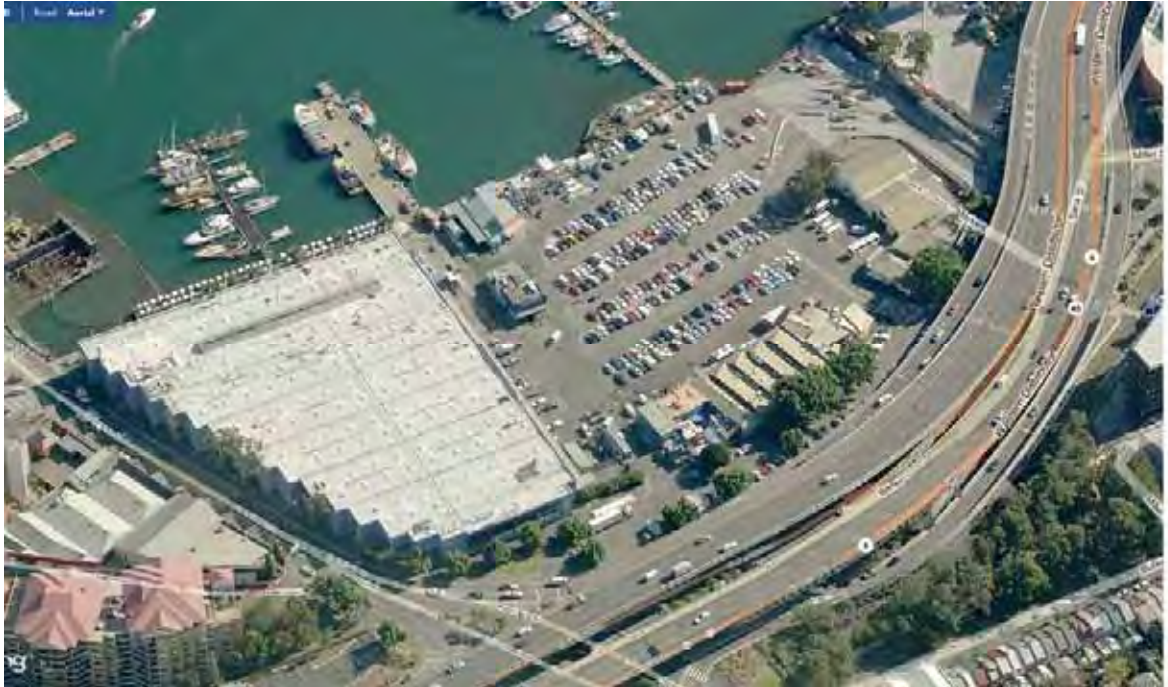
Figure 5: Sydney Fish Market – Existing built form

The majority of the remainder of the site is occupied by an open car park associated vehicular circulation space and loading areas.

Two fixed wharfs and one pontoon extend from the site into Blackwattle Bay, used by both recreational vessels and commercial fishing boats.

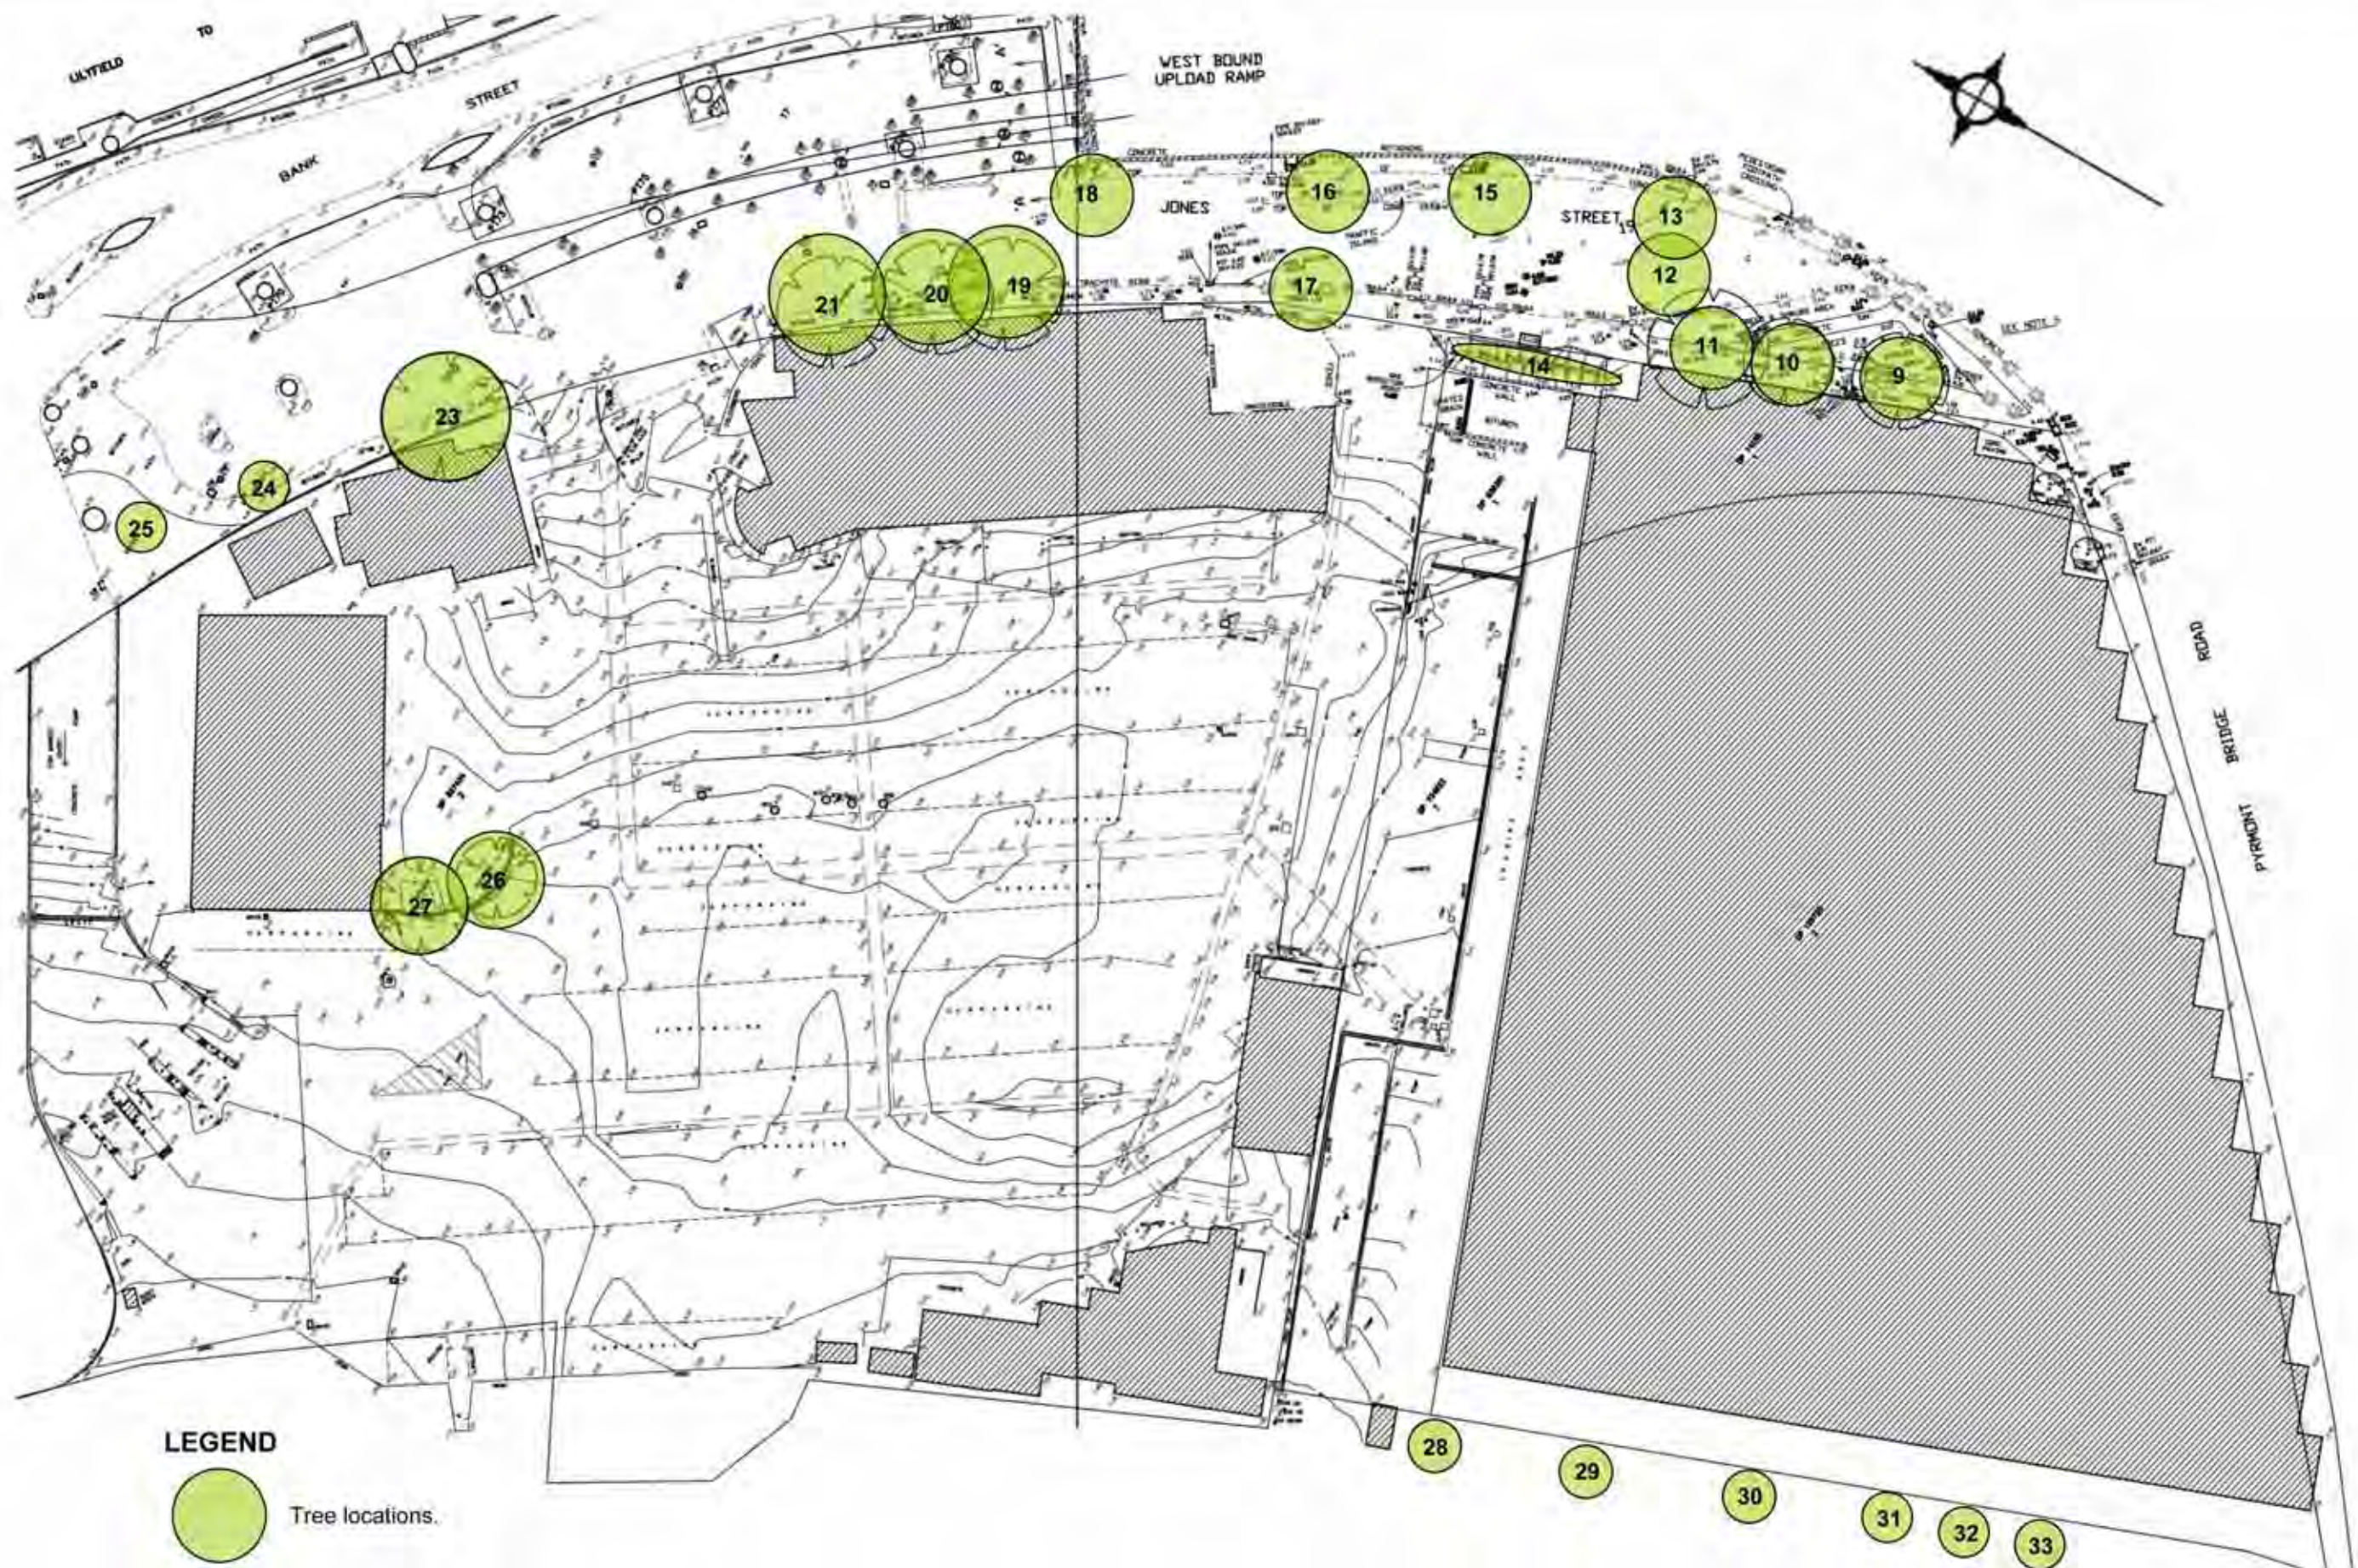
Figure 1 – Tree Location Plan

Six hybrid eucalypts (*Eucalyptus botryoides* x *saligna*) located along the Pyrmont Bridge Road frontage, which are in poor and declining condition (Tree Nos. 1-5 and 7). These trees do not form part of the current proposed development.

Located adjacent to Pyrmont Bridge Road and Bank Street are small Hill's Weeping Figs (*Ficus macrocarpa* var. *hillii*), (Tree Nos. 6 and 8-13) planted at various periods from the mid 1960s to 1990s. Most of these trees exhibit good vigour, some have defects and some have significant structural defects.

Small Hill's Weeping Figs (*Ficus macrocarpa* var. *hillii*) are located along the south-eastern portion of the site at the Bank Street car park (Trees Nos. 6 and 8-18). Most of these trees are in good condition and exhibit good vigour. Most have defects and some have significant structural defects.

Hill's Weeping Figs at the north-eastern portion of the site (Tree Nos. 19-25) are also in similar condition.

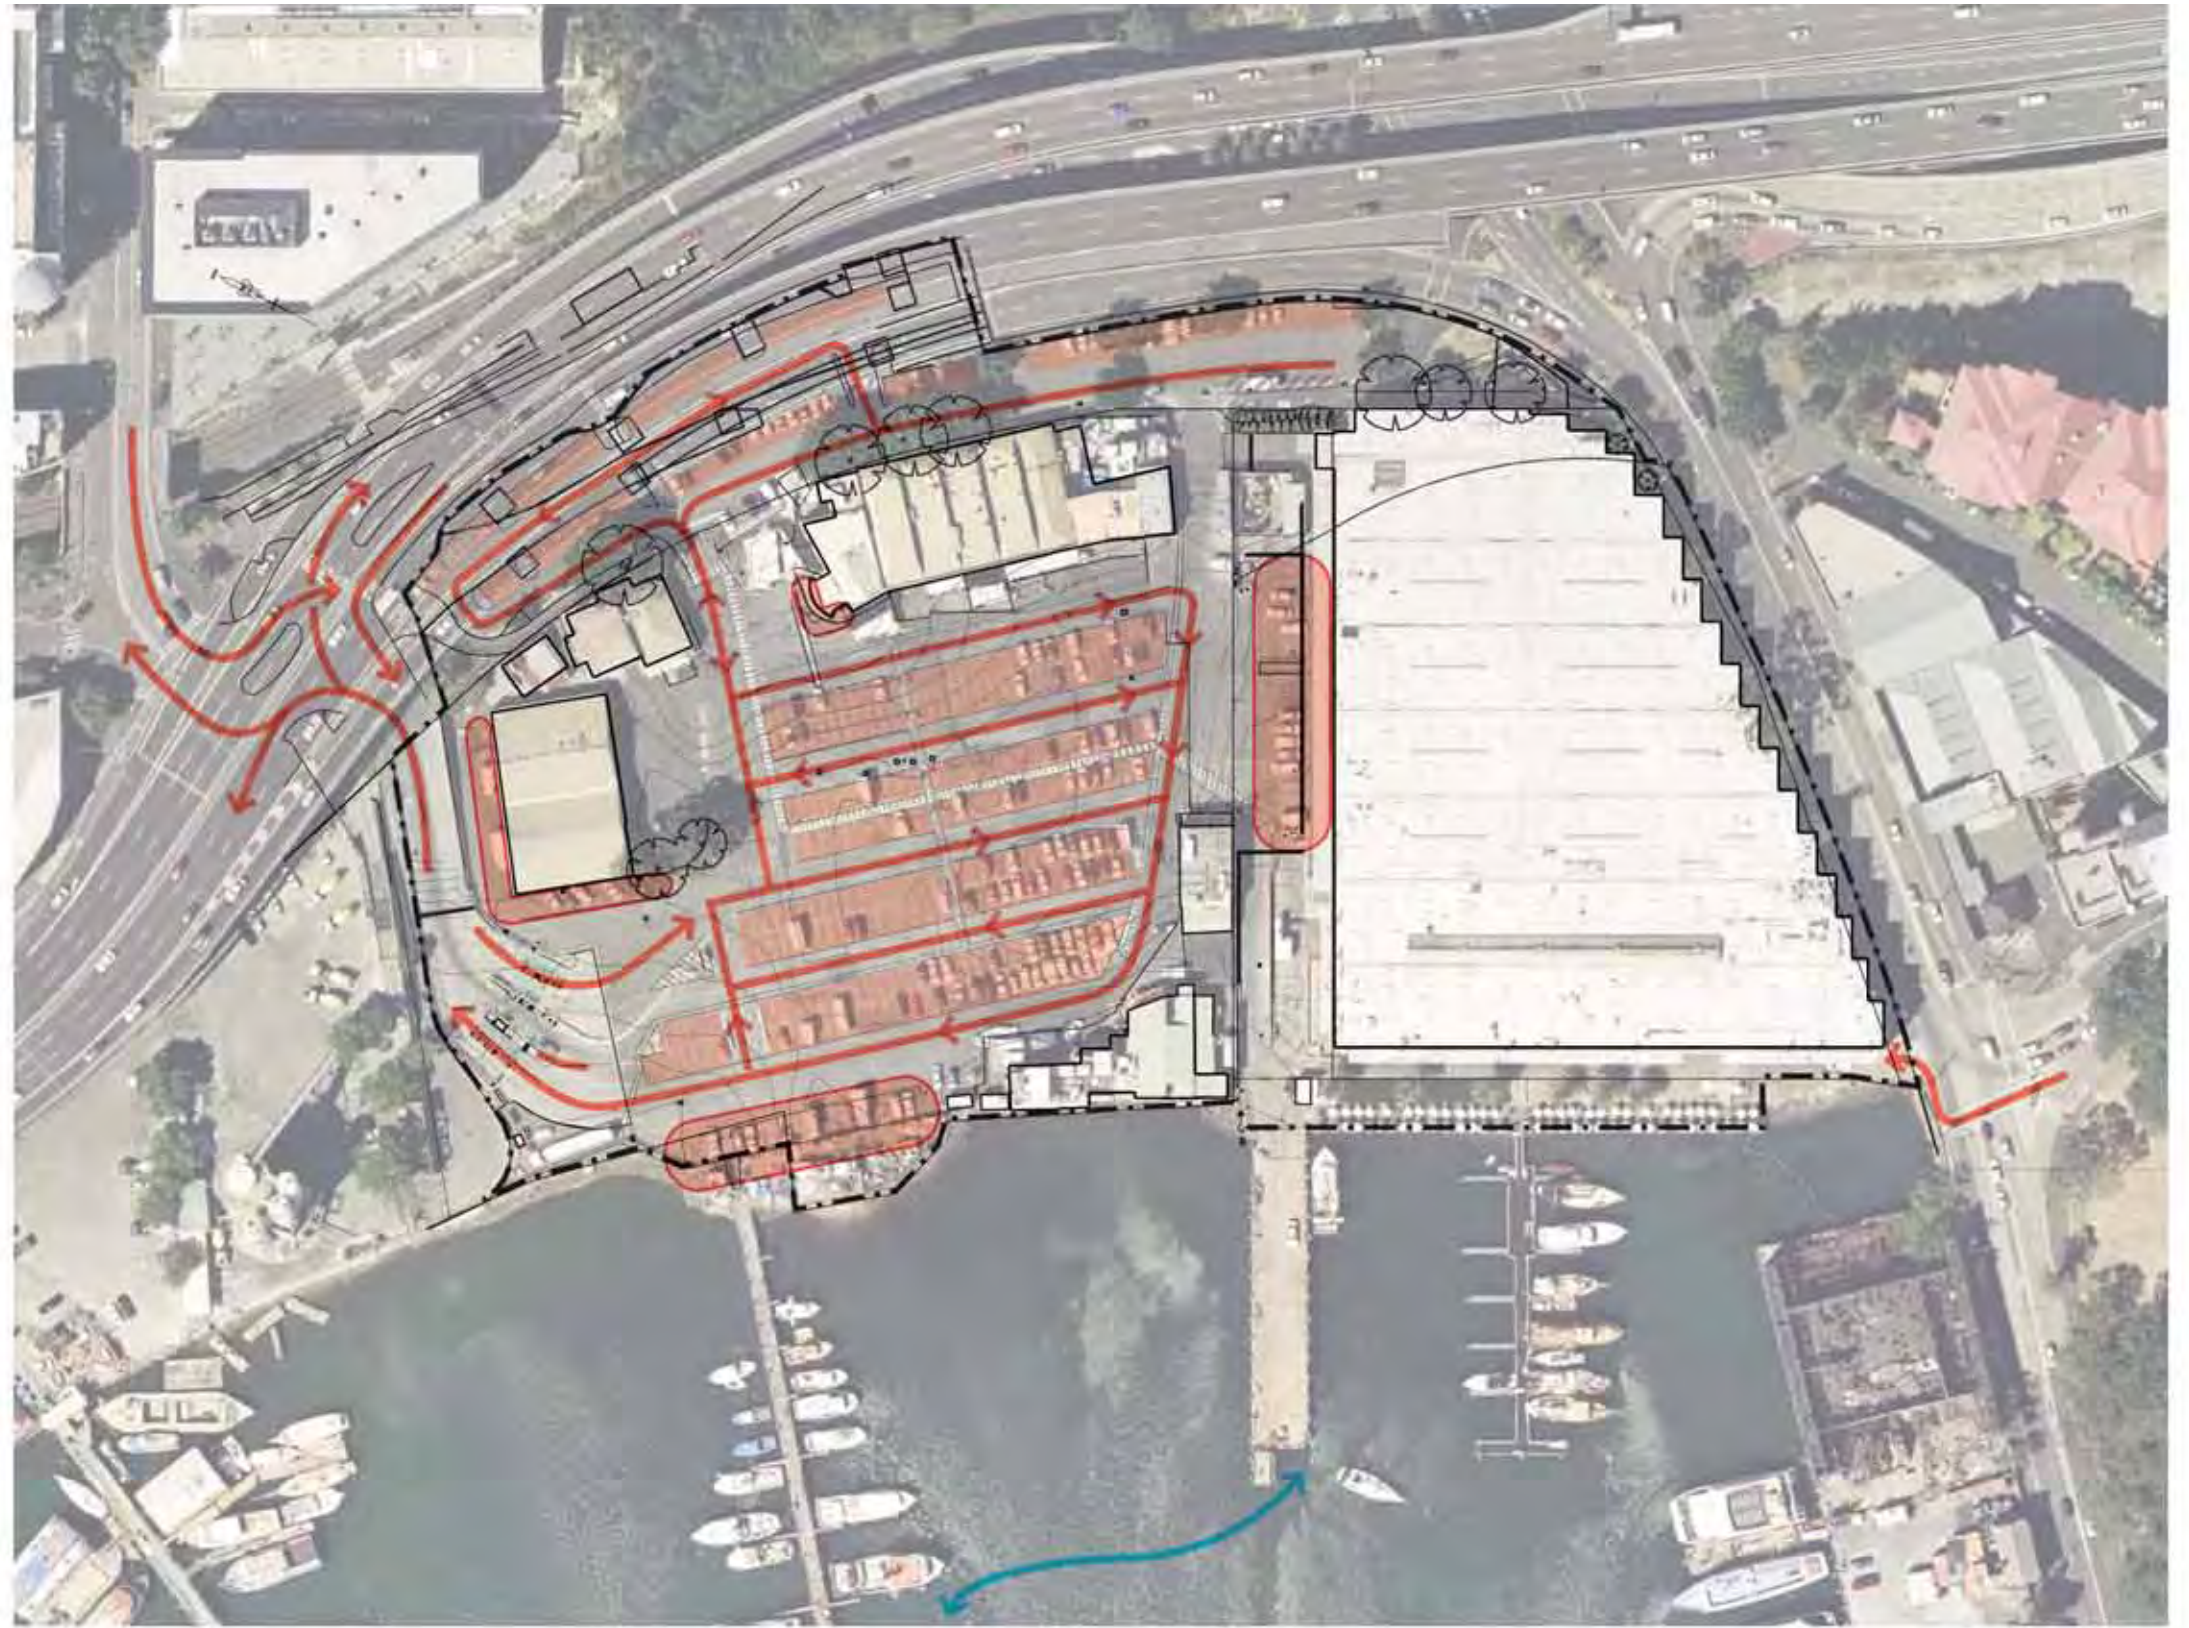
Refer to Figure 10: Existing vehicular movement.

- Vehicular Movement
- Parking
- Service Parking
- Water Access

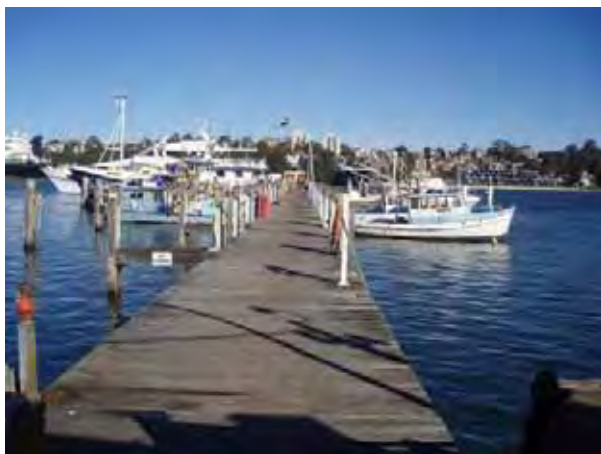
The timber wharf at the northern end of the foreshore is supported on steel piles. It appears that little or no maintenance has been undertaken to this wharf and that the steel piles above the low tide water level have suffered significant corrosion. Remedial works are required to this structure if it is to be maintained in the medium term (5 to 10 years).

Wooden deck wharf servicing the Harbour Fleet

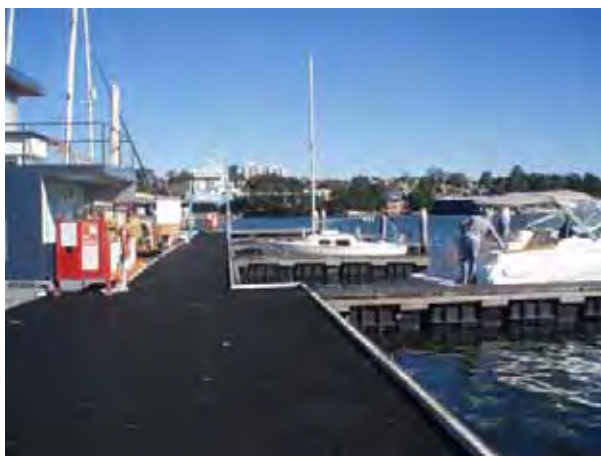
Low recreational and commercial charter fleet wharf

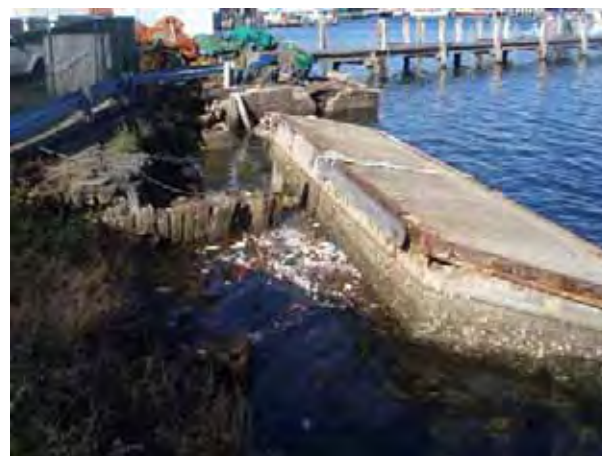
Concrete seawall in disrepair with relic timber structures behind

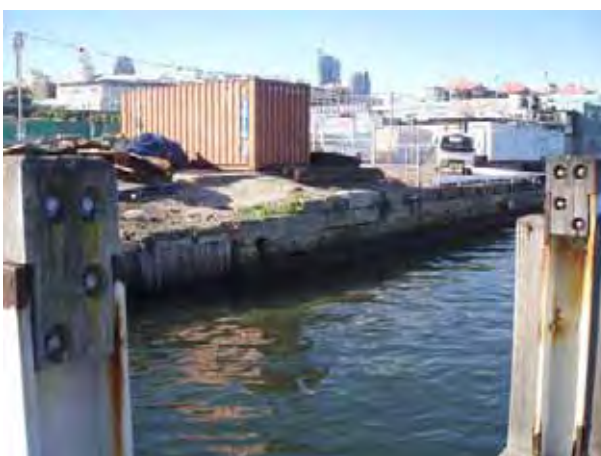
Sandstone seawall demarcating the original shoreline with seawall partially collapsed and subsided

North of the concrete main jetty (directly north of the Main Fish Market Building), is an embankment with rip-rap extending about 6m to the north of the jetty and sloping about 30° towards the Bay. Directly north of this embankment is a sandstone block seawall, in poor condition, between 1.2m and 1.8m in height.

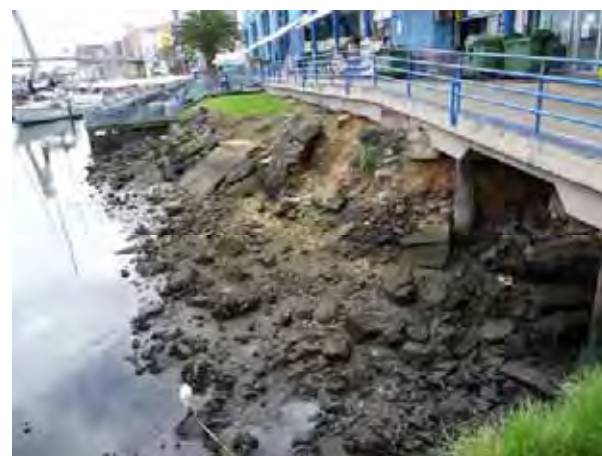
Rock edge seawall eroded from stormwater outlet with eroded rock bank stabilization required

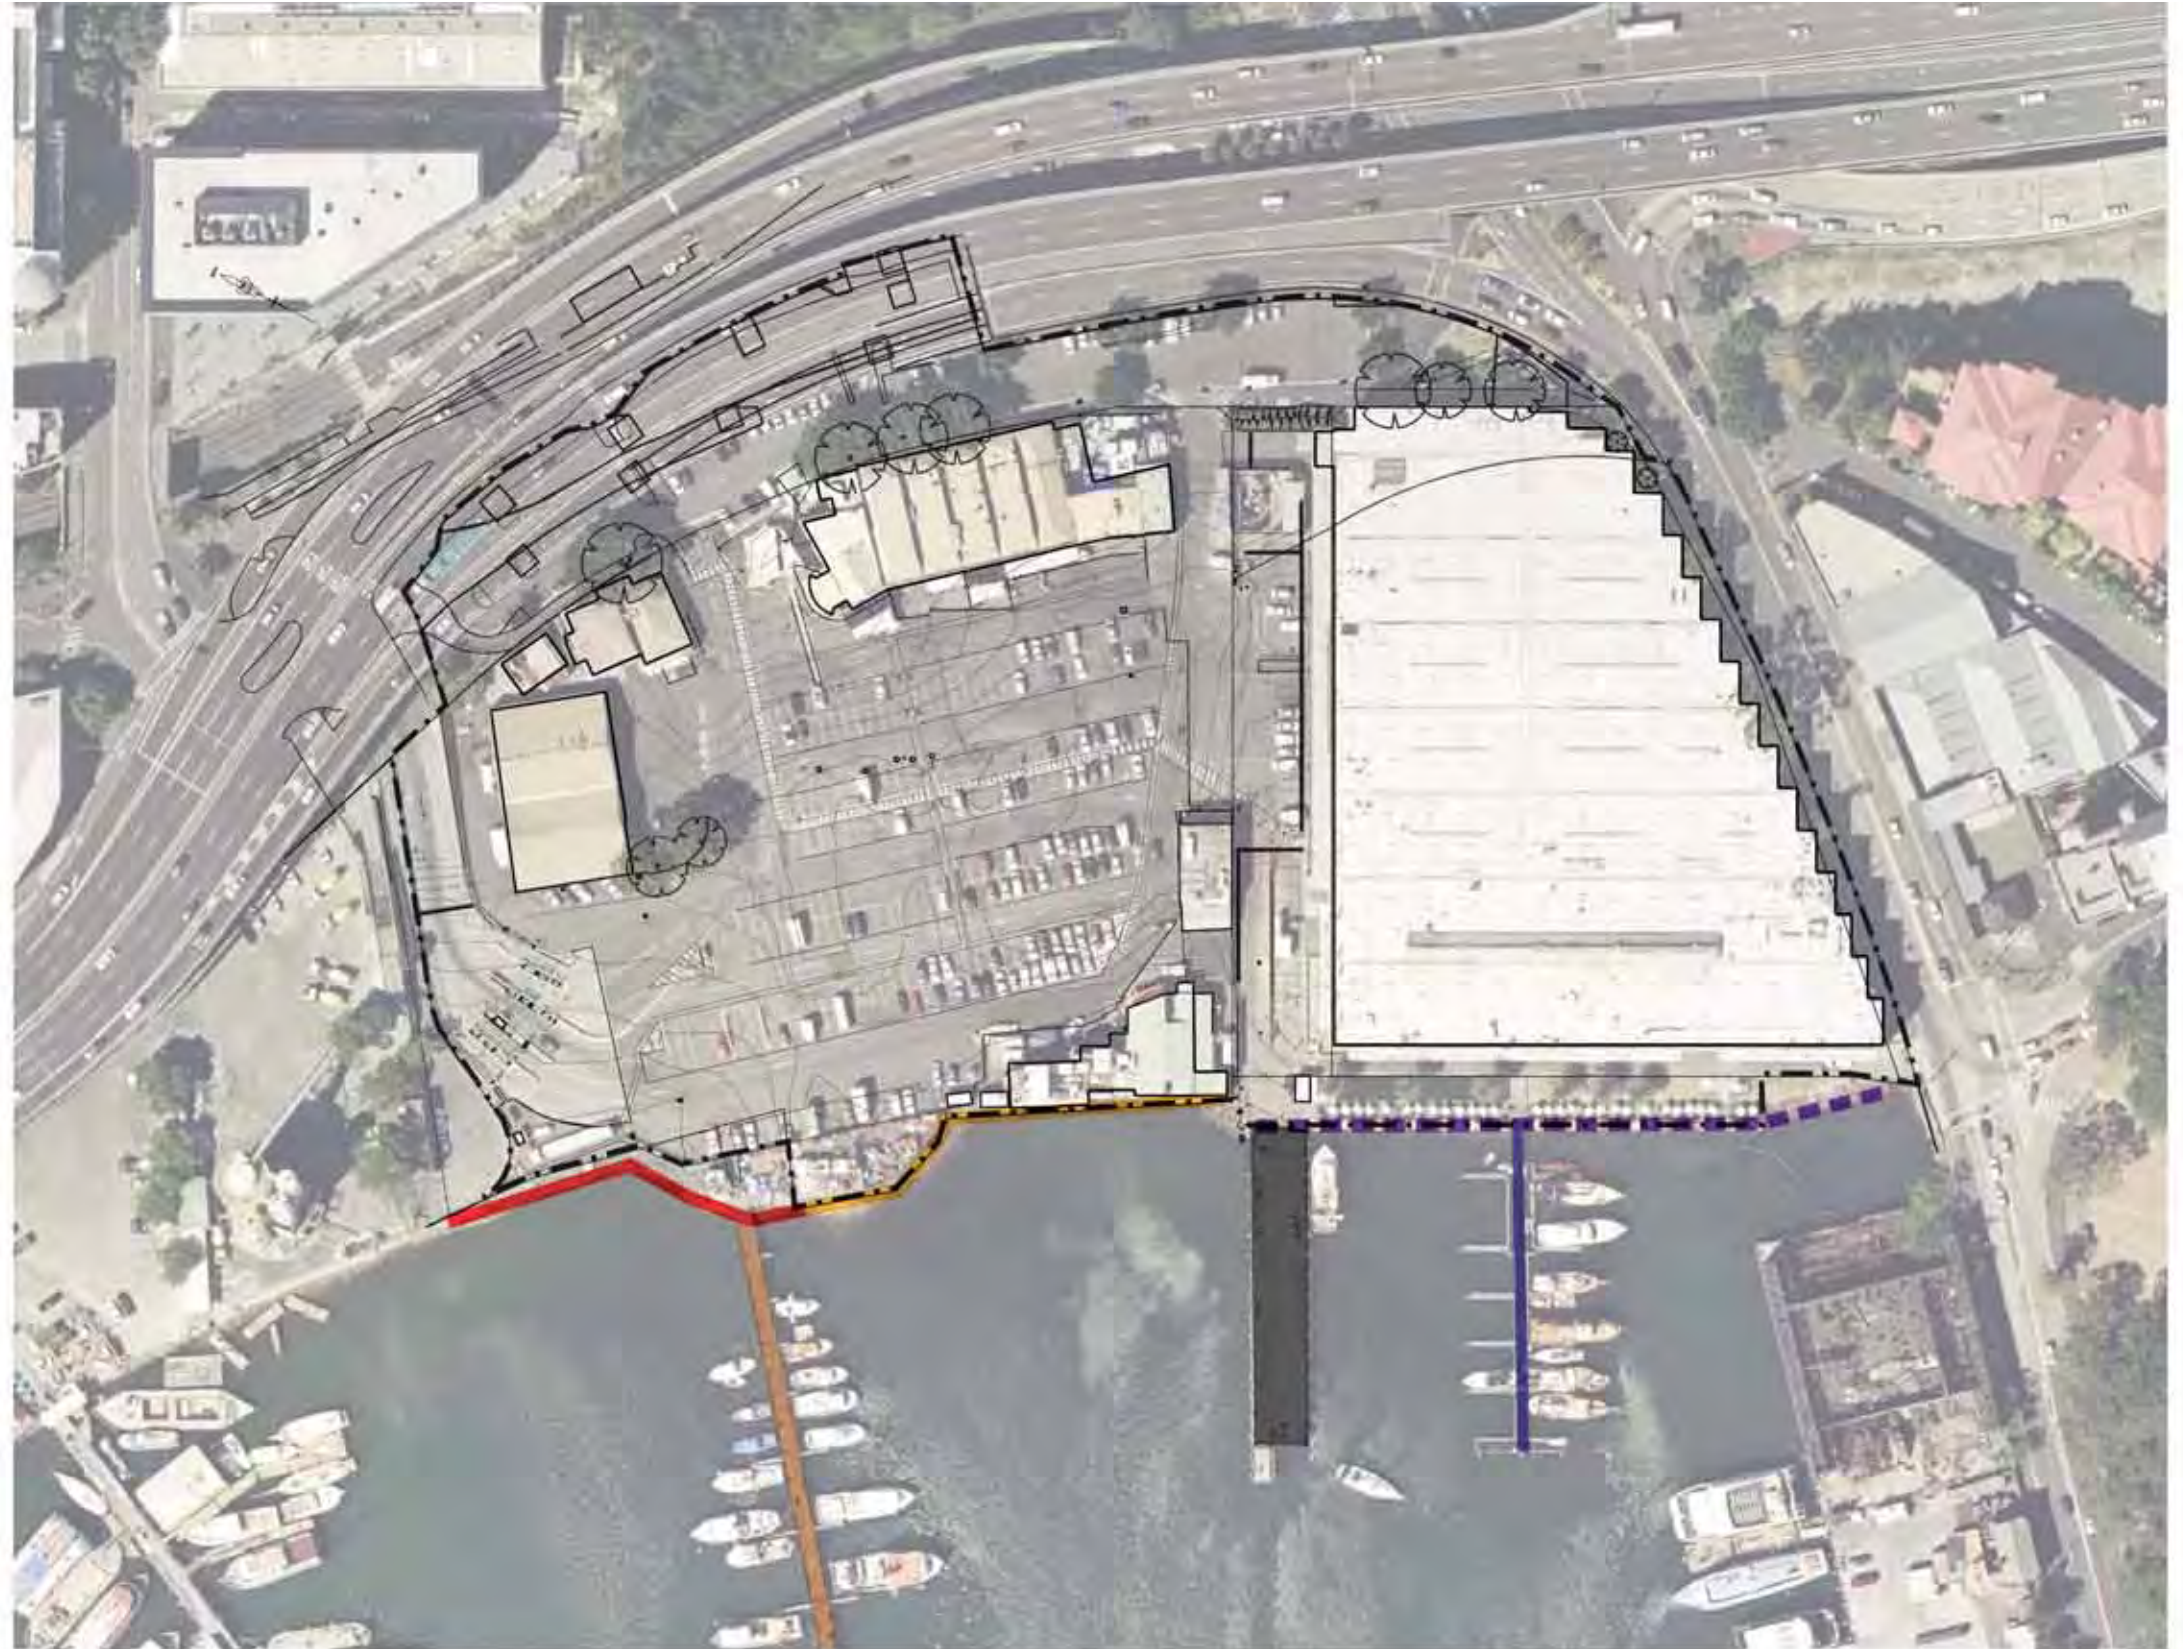
Refer to Figure 14: Marine and seawall structures plan.
