Report on  
Phase 2 Contamination Assessment  
With Limited Sampling

Proposed Wollongong Hospital Redevelopment  
Loftus Street, Wollongong

Prepared for  
Health Infrastructure

Project 48773.05  
July 2011

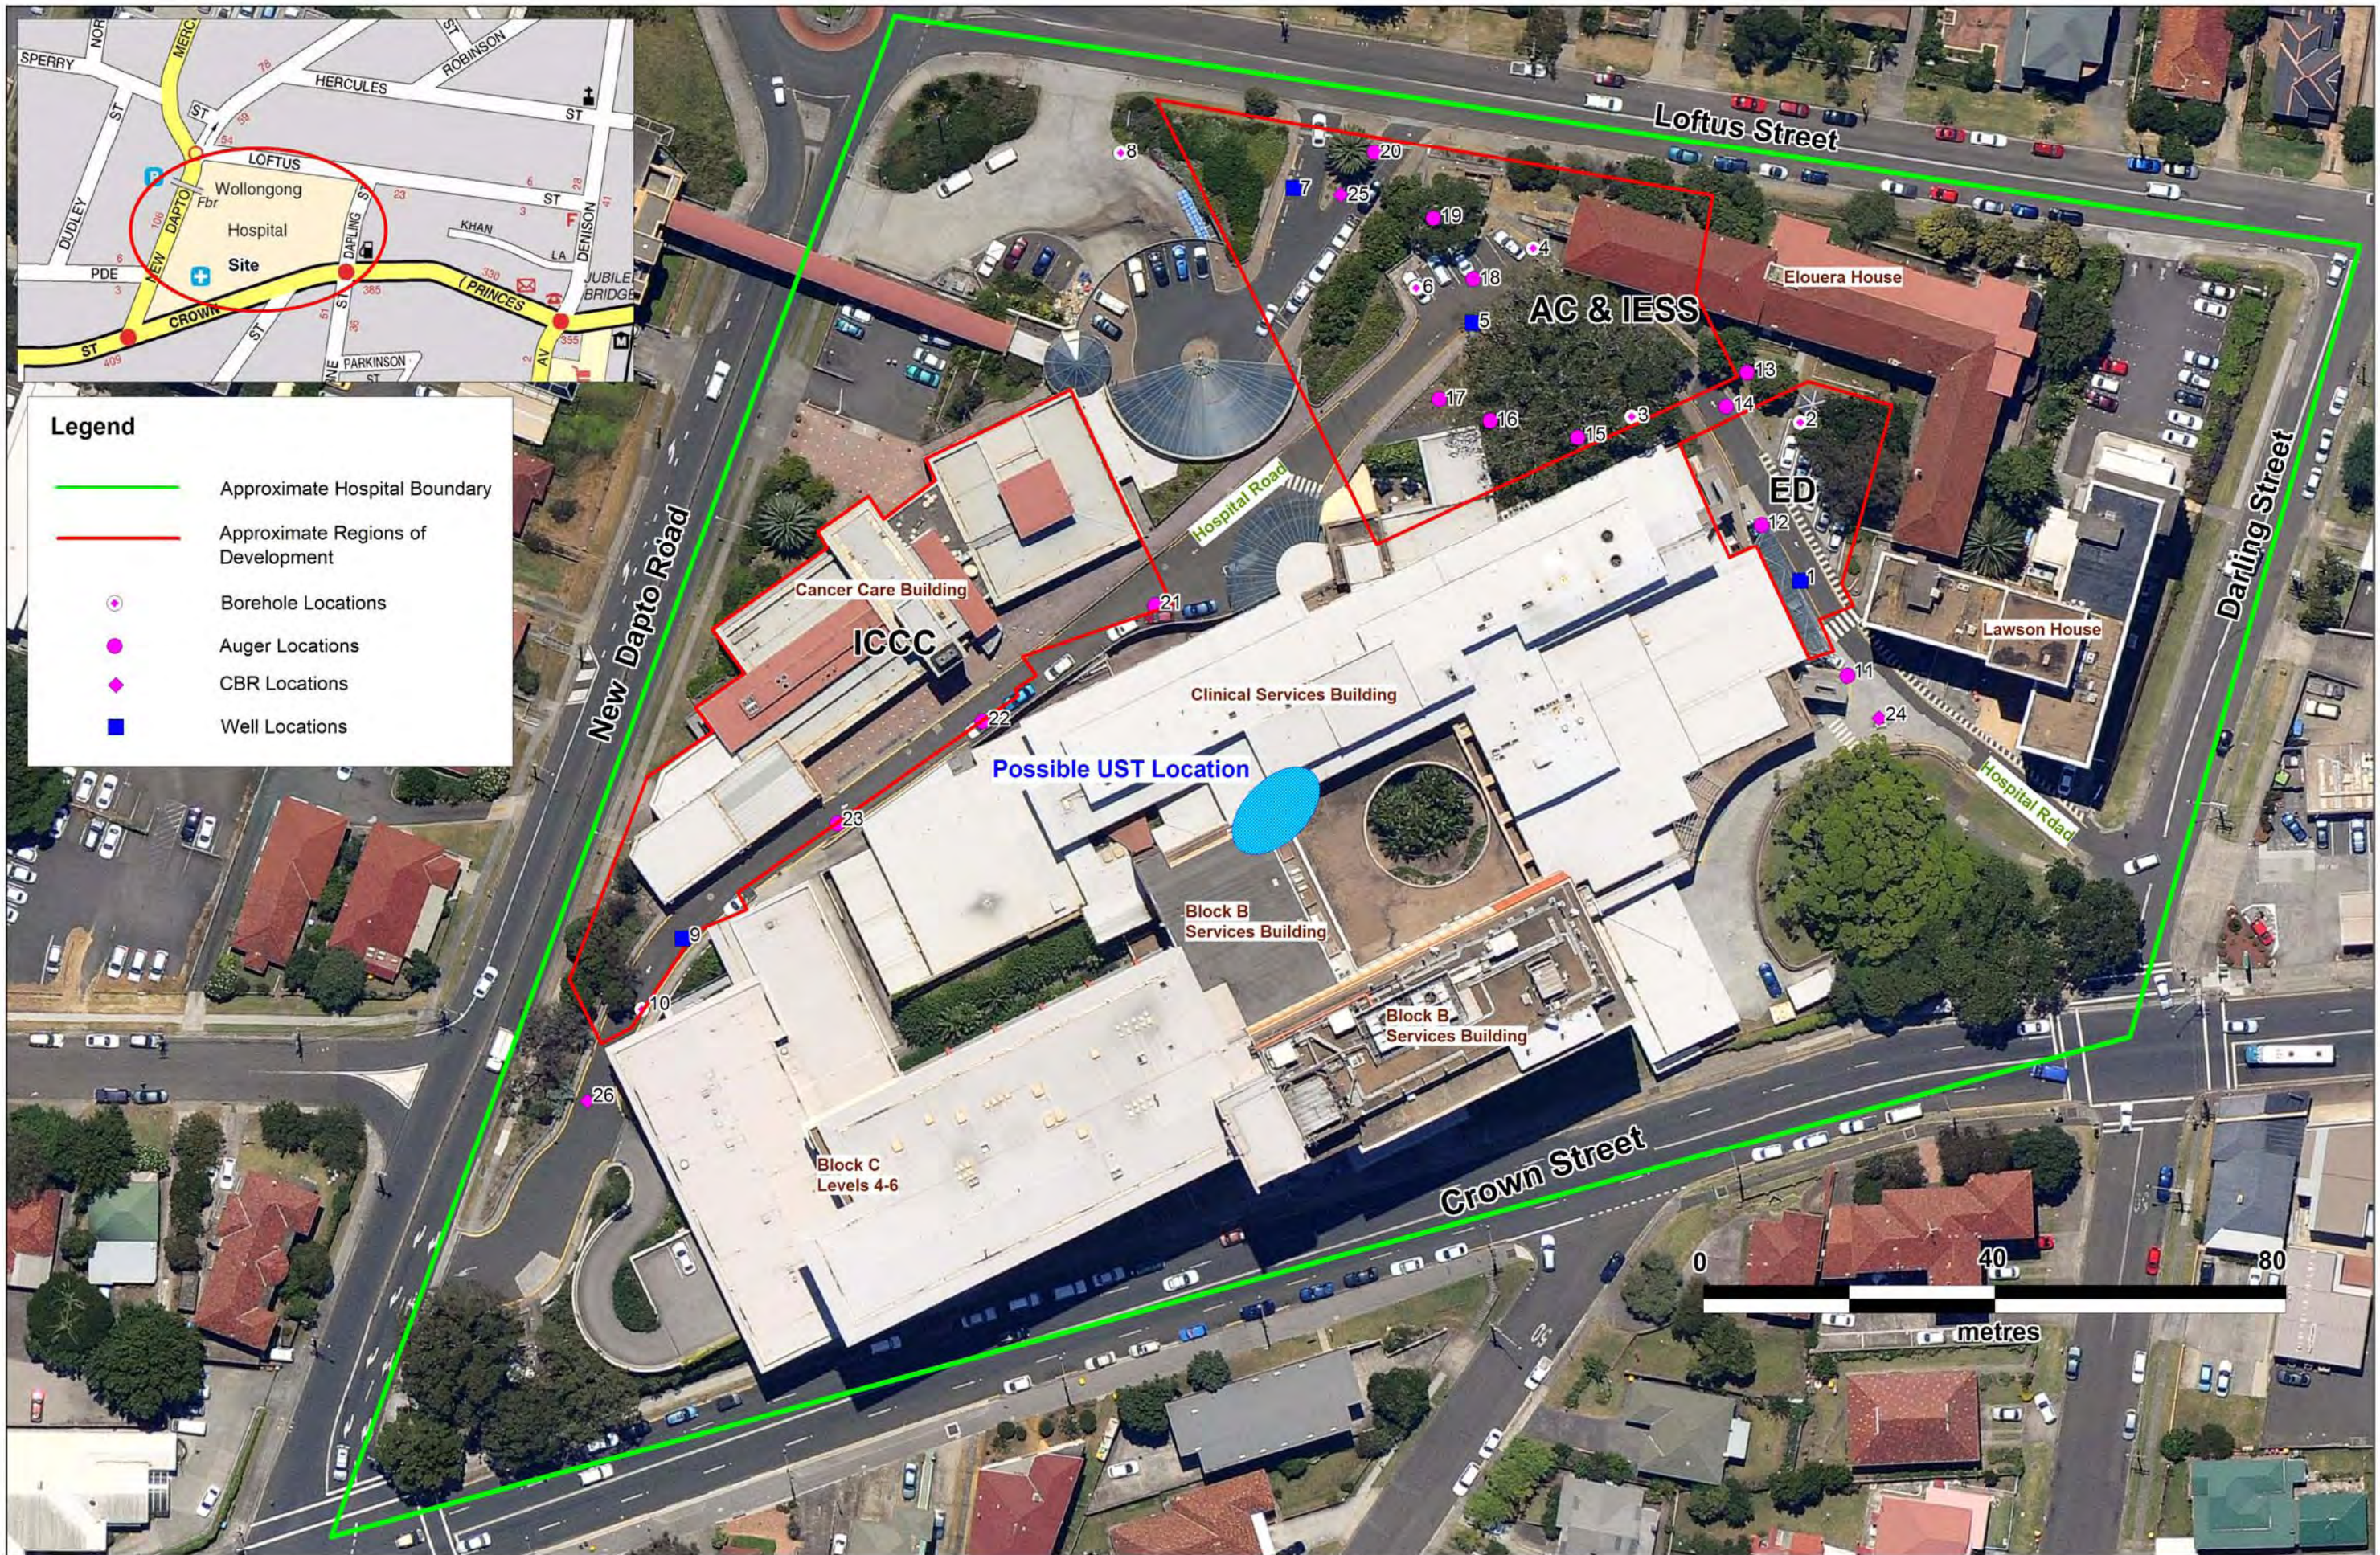
Drawing 1

- Approximate Hospital Boundary
- Approximate Regions of Development
- Borehole Locations
- Auger Locations
- ◆ CBR Locations
- Well Locations

Further review of the information pertaining to the petrol tank indicated that it was to be installed to service hospital vehicles and a sketch drawing showed the proposed location of the tank (refer to Drawing 1, Appendix B). No other information was available to indicate whether the tank was actually installed, if it was above or below ground, decommissioned or removed during building demolition and renovations. It is noted, however, that the proposed location of the tank was in the middle of a car park, hence it may be assumed that the tank was most likely an underground storage tank, if it was ever actually installed. The proposed location of the tank is outside and up-gradient of the three regions under consideration in this assessment.
