Remedial Action Plan, Proposed Rozelle Village Site

DKO Architects

18 December, 2009

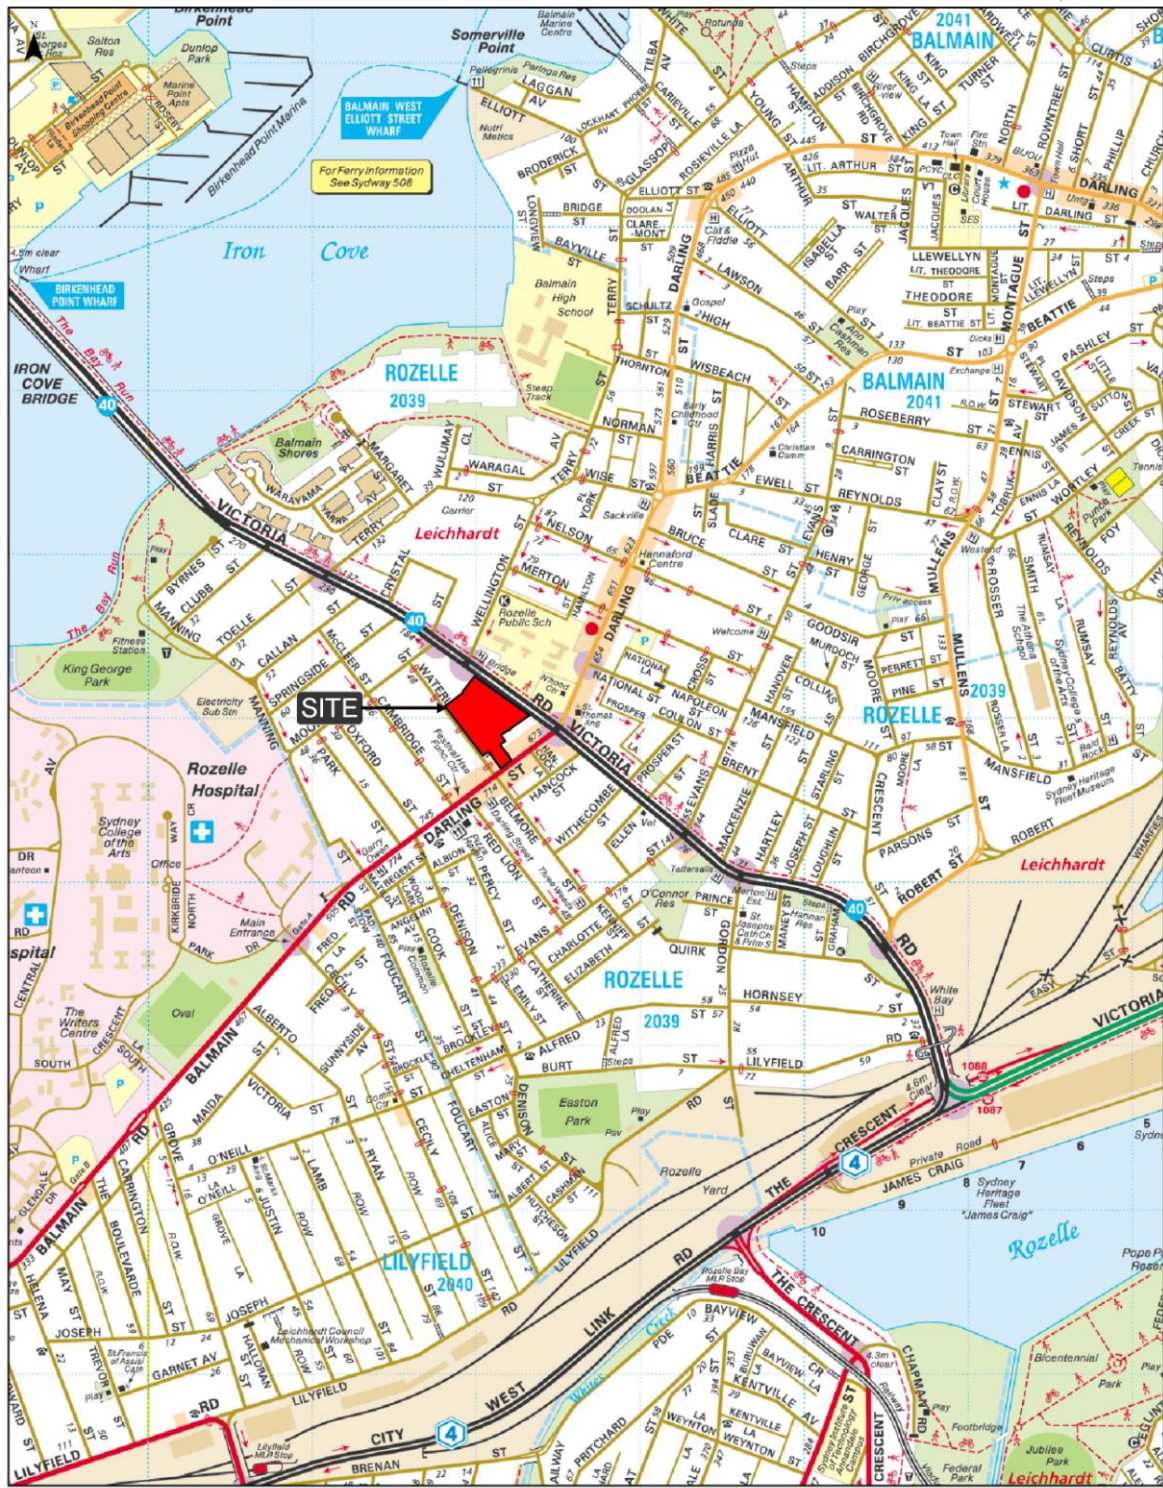
Figure 1: Site Location Plan

ROZELLE VILLAGE DEVELOPMENT
 SITE LOCATION PLAN
 Source: Sydways (2008)
 SEP 2009
 6000000
 Fig 1

AECOM Australia Pty Limited (AECOM) was engaged by DKO Architects to prepare a Remedial Action Plan (RAP) for the Proposed Rozelle Village Site, located near the corner of Victoria Road and Darling Street, Rozelle, NSW (the Site). The location of the Site is shown on Figure 1 and detail of the property layout is shown on Figure 2.

Proposed Land Use	Mixed club, commercial, retail and residential
Geographical Coordinates (AMG)	330500 E 6251250 N
Site Elevation (mAHD)	Approximately RL32 to RL41m AHD on Victoria Road and Waterloo Streets
Site Area (Approximate)	7,400m ²
Site Location	Figure 1
Site Layout	Figure 2
