CPP Project 6029

Subject: Wind Engineering – Building C3, Barangaroo South

Please find herein comments regarding the impact of the architectural changes to the Barangaroo South development on the pedestrian level wind conditions. The drawings prepared for this Planning Application No. MP11\_0044 S75W Mod 2 dated 13 September 2013 have been reviewed and assessed from an environmental wind perspective at ground level. The only relevant geometric changes are the re-orientation of Globe Street, with the corresponding change in plan form of Buildings R11, R2, R3, C1, C3, and C8, Figure 1, and the removal of mid-rise building C7, Figure 2. The heights of the amended buildings are similar.

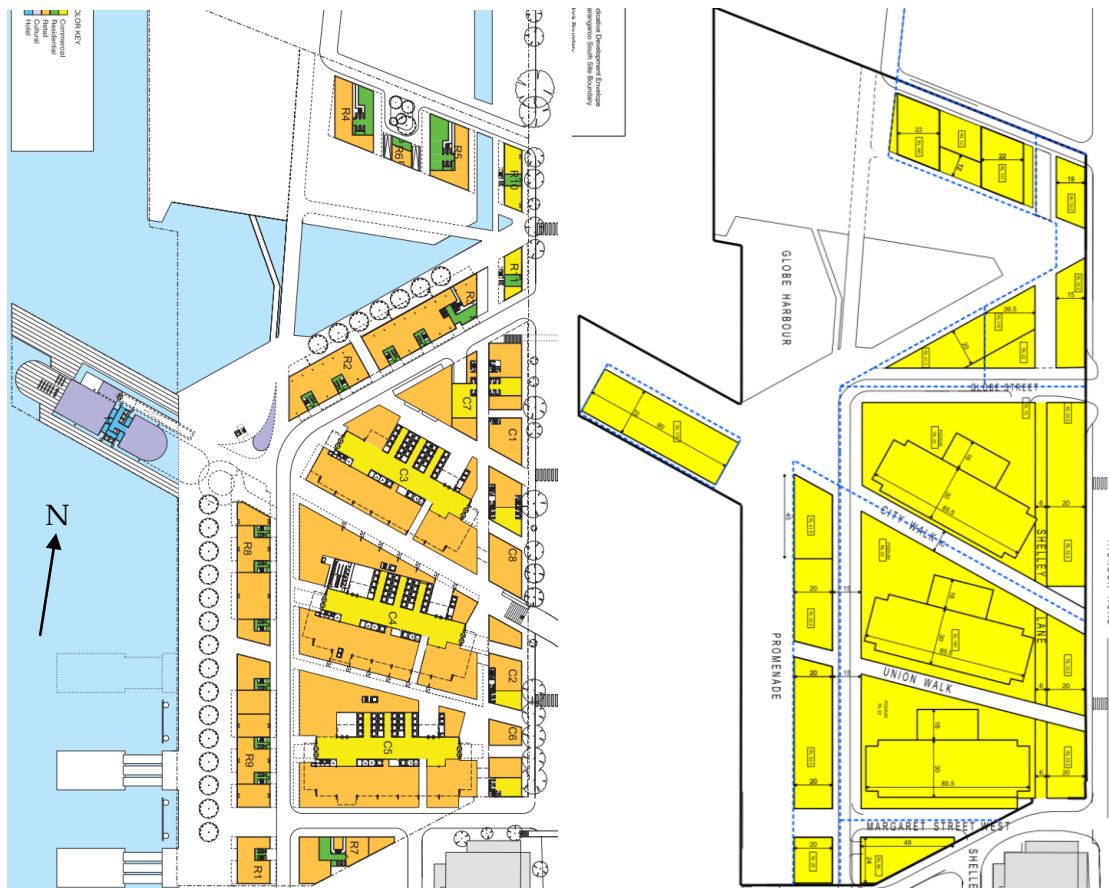
Figure 1: Ground plan of existing Mod 4 (L) and proposed Mod 6 (R) configurations

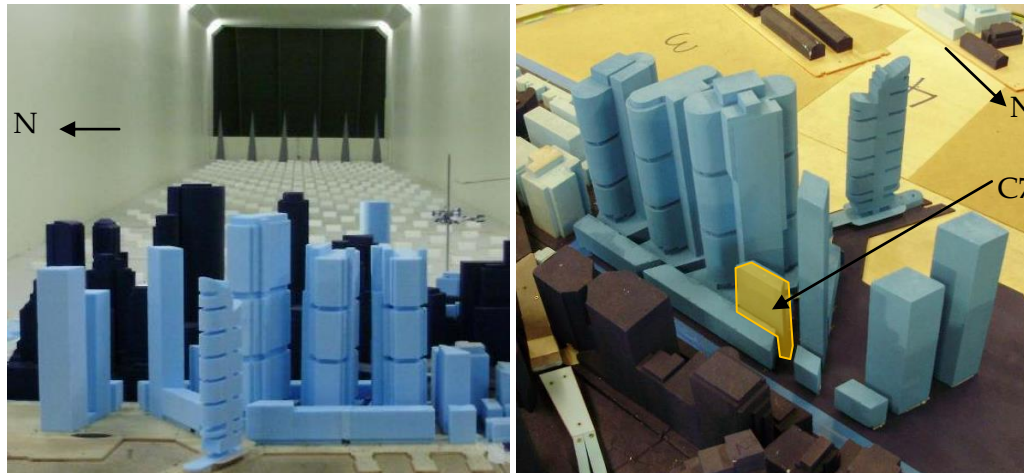
Figure 2: Photograph of the existing Mod 4 configuration (L) and existing Mod 4 configuration with revised tower geometry (R) wind tunnel models

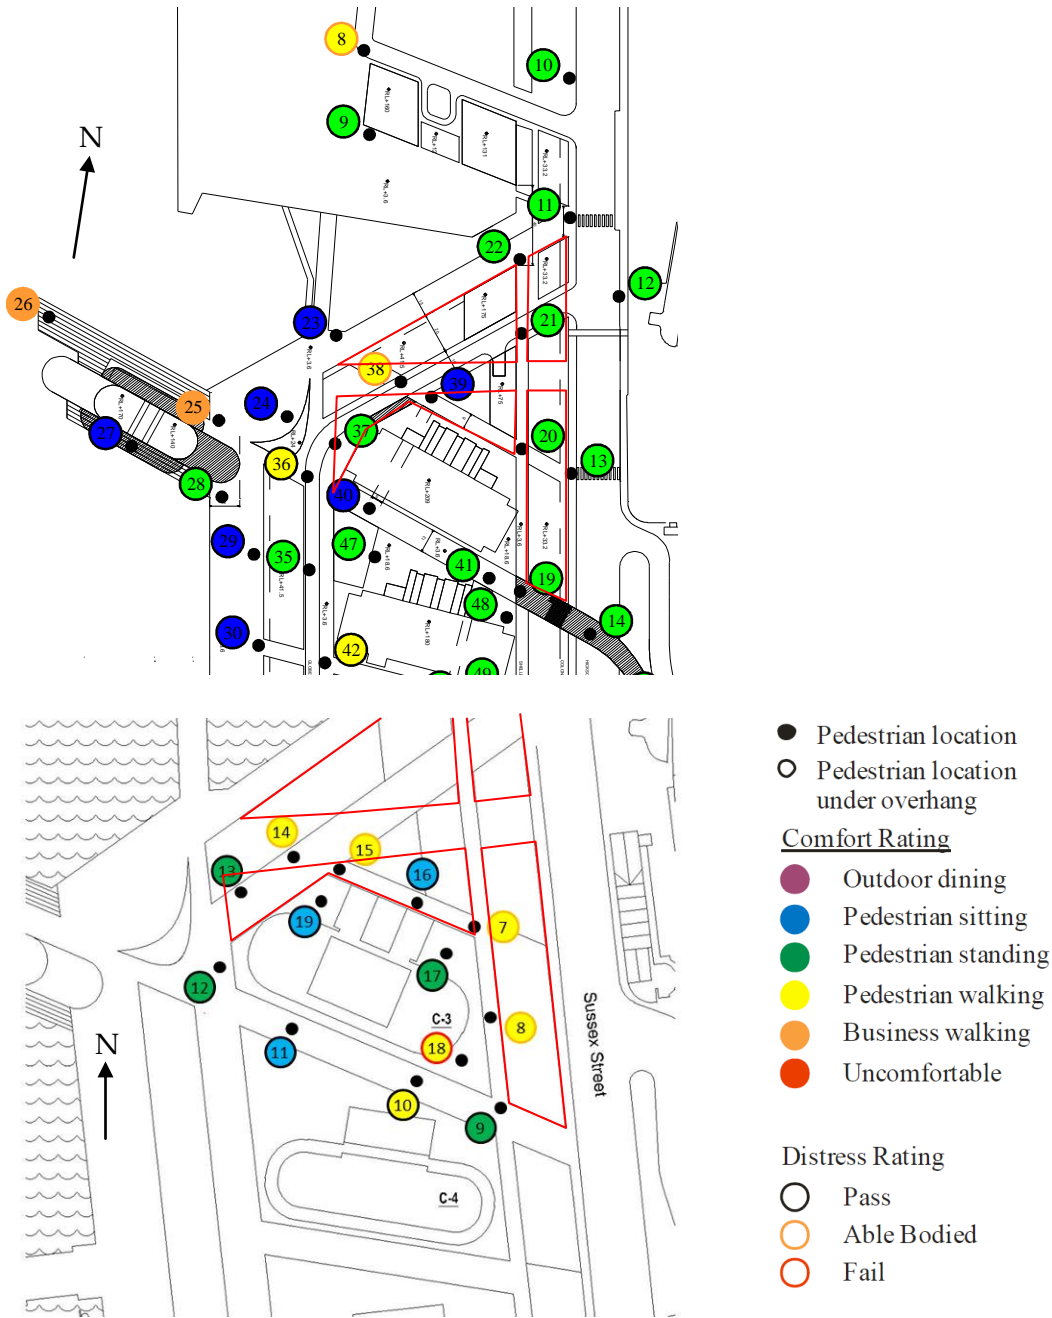
Figure 3: Wind climate results for the Mod 4 configuration (T) and curved towers and realignment of Globe Street(B)

The directional wind flow pattern around the site is complex. The classification of wind conditions at various locations around the site in the Mod 4 configuration is summarised in Figure 3, with directional results presented in Figure 4 and Figure 5. Classification of the comfort and distress criteria is determined by the integration of the measured wind speed with the local wind climate. The wind conditions between the two wind tunnel tested Mod 4 configurations are generally slight with any differences due to the precise measurement location, the proximity of the results to a step in the criterion level as well as the change in geometry of the towers.

From a comfort criterion perspective the wind conditions around the site all met the pedestrian walking criterion, Figure 3, except around the base of the hotel protruding into the harbour. From a pedestrian level wind comfort perspective, the most important change from the Mod 4 to Mod 6 geometry is the increase in size of the Building C3 podium, marked in red in Figure 3. This increase in size is expected to improve wind conditions to the north of Building C3 and along Shelley Lane and Globe Street, by redirecting downwash from reaching ground level. The forming of a regular street grid pattern, particularly opening Globe Street to the west, will increase the ground level wind speed and the channelling of wind. Winds from the west will be channelled along Globe Street to the north of Building C3 causing windy conditions across Hickson Road. The rising topography to the east of the site and the lack of a continuation of the flow path across Hickson Road will ameliorate this condition and wind conditions are expected to remain suitable for pedestrian walking hence acceptable for the intended use of the space.

From a pedestrian distress perspective, apart from in the vicinity of the exposed hotel, there were five locations around the site that were classified as acceptable for 'able-bodied' pedestrians only; to the north-west of Building 4 (Location 8, Figure 3(T)), on Globe Street to the north of Building C3 (Location 38, Figure 3(T), and Locations 14 and 15, Figure 3(B)), and on Shelley Lane to the east of Building C3 (Locations 7 and 8, Figure 3(B)). Exceedances were marginal, with a twice per annum mean wind speed about 15.5 m/s compared with the criterion level of 15 m/s, Figure 5, except Locations 8

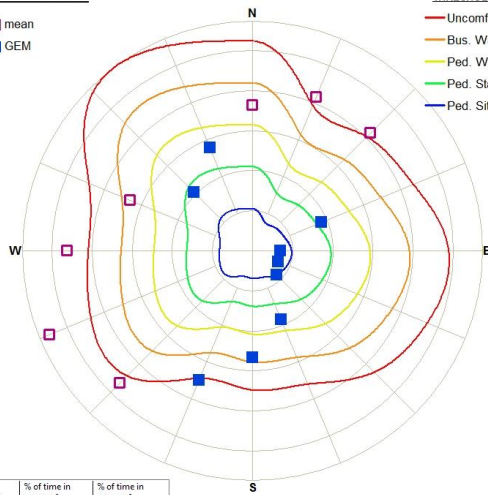
**LOCATION 8**

Wind Speed (m/s)	% of time in excess of Mean	% of time in excess of GEM
2.0	52.0	55.1
4.0	27.7	29.5
6.0	14.9	13.8
8.0	7.5	5.0
10.0	3.0	1.4
8.9	5.0	Bus Walking
18.4	0.022	Able Body
7.9	Ped Walking	5.0
15.5	Able Body	0.022

Figure 4: Directional results in the Mod 4 configuration with sharp-edged tower

It is evident from Figure 4 that the locations are impacted by winds from the south-west and to a lesser extent from the north-east. The wind conditions at Location 8 are governed by downwash from Building R4 and the proposed changes to the buildings to the south will have negligible impact on the wind climate in this area being governed by the geometry and orientation of Building R4. Winds conditions at Location 38 are expected to improve with the increase in Building C3 podium size by redirecting

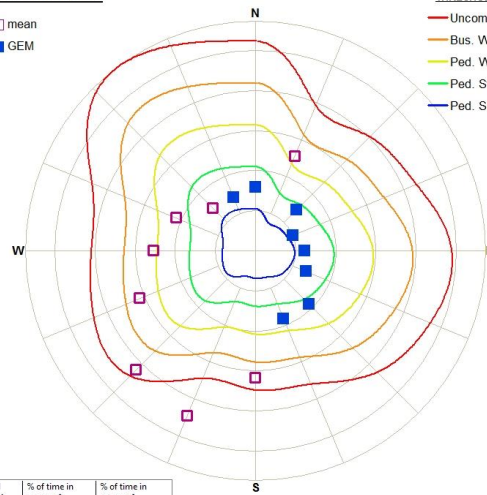
**LOCATION 38**

Wind Speed (m/s)	% of time in excess of Mean	% of time in excess of GEM
2.0	42.6	44.6
4.0	19.9	18.7
6.0	9.3	7.1
8.0	3.6	2.0
10.0	1.3	0.5
7.2	5.0	Ped Walking
18.0	0.022	Able Body
6.5	Ped Walking	5.0
14.6	Pass	0.022

downwash away from reaching ground level for critical winds from the south-south-west.

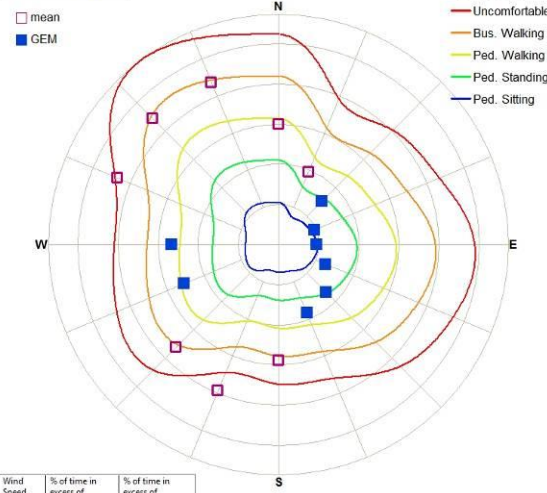
**LOCATION 7.2**

Wind Speed (m/s)	% of time in excess of Mean	% of time in excess of GEM
2.0	51.4	52.5
4.0	22.4	20.0
6.0	8.9	6.2
8.0	3.5	1.5
10.0	1.3	0.3
7.2	<b>5.0</b>	Ped Walking
17.5	<b>0.022</b>	Able Body
6.3	Ped Walking	<b>5.0</b>
13.4	Pass	<b>0.022</b>

Figure 5: Directional results in the Mod 4 configuration with curved towers

It is evident from Figure 5 that Location 7, on Shelley Lane, was impacted by winds from the south-west and north-west quadrants. Both these wind directions induce downwash from Building C3 at this location. Winds from the south-west are channelled between Buildings C3, C4, and the hotel on the peninsula and brought to ground level by the massing of the tall buildings. Winds from the north-west are brought to ground level by the massing of Building C3. With the increase in podium size to the north of Building C3, a portion of this downwash will be redirected away from reaching ground level and will pass over the roofs of Building C1/C8. The re-direction of flow is expected to improve the wind conditions in this area.

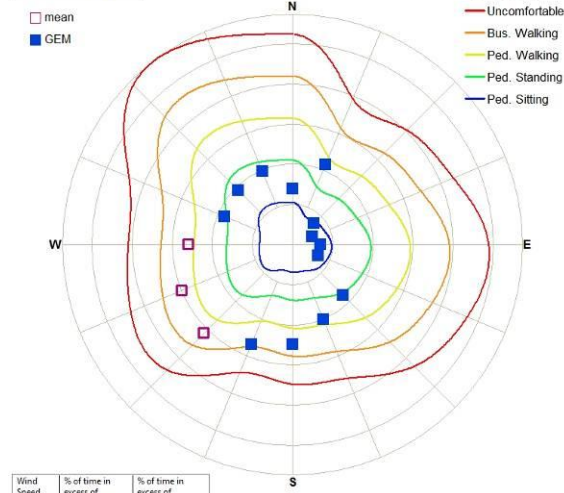
**LOCATION 10**

Wind Speed (m/s)	% of time in excess of Mean	% of time in excess of GEM
2.0	33.0	40.4
4.0	13.7	16.7
6.0	3.9	4.2
8.0	0.7	0.7
10.0	0.1	0.1
5.6	<b>5.0</b>	Ped Standing
11.7	<b>0.022</b>	Pass
5.7	Ped Standing	<b>5.0</b>
11.5	Pass	<b>0.022</b>

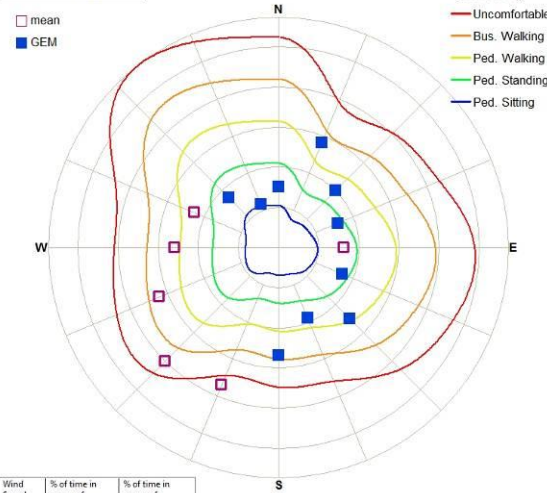
**LOCATION 14.2**

Wind Speed (m/s)	% of time in excess of Mean	% of time in excess of GEM
2.0	47.1	48.9
4.0	20.1	20.3
6.0	6.9	6.0
8.0	1.9	1.2
10.0	0.5	0.2
6.5	<b>5.0</b>	Ped Walking
15.2	<b>0.022</b>	Able Body
6.2	Ped Walking	<b>5.0</b>
12.7	Pass	<b>0.022</b>

Locations 14 and 15 marginally exceed the distress criterion and are classified as suitable for 'able bodied' pedestrians. The conditions are caused by strong winds from the south-south-west, Figure 5. These conditions are calmer than Location 38 in Figure 4 caused to a large extent by the curved ends of the towers, but the flow is still accelerated between the hotel and the Building C3 and C4. The increase in size of podium to the north-west of Building C3 and to the south of R3, is expected to improve the wind conditions in this area.

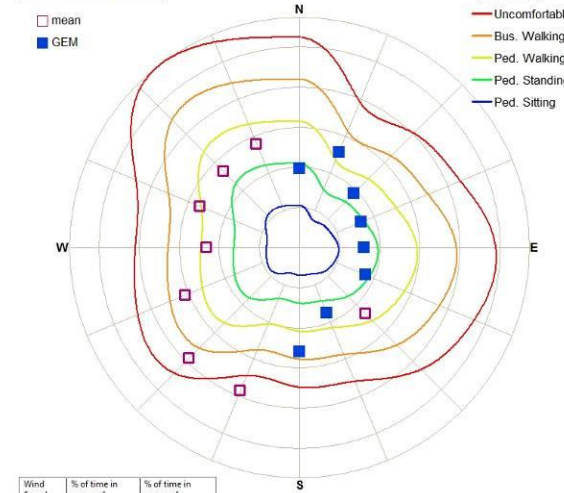
**LOCATION 15.2**

Wind Speed (m/s)	% of time in excess of Mean	% of time in excess of GEM
2.0	51.0	52.2
4.0	18.2	19.7
6.0	5.7	5.8
8.0	1.8	1.3
10.0	0.6	0.3
6.1	<b>5.0</b>	Ped Walking
15.6	<b>0.022</b>	Able Body
6.2	Ped Walking	<b>5.0</b>
13.7	Pass	<b>0.022</b>
