**Hunter Transmission
Project**

Preliminary Site
Investigation

May 2024

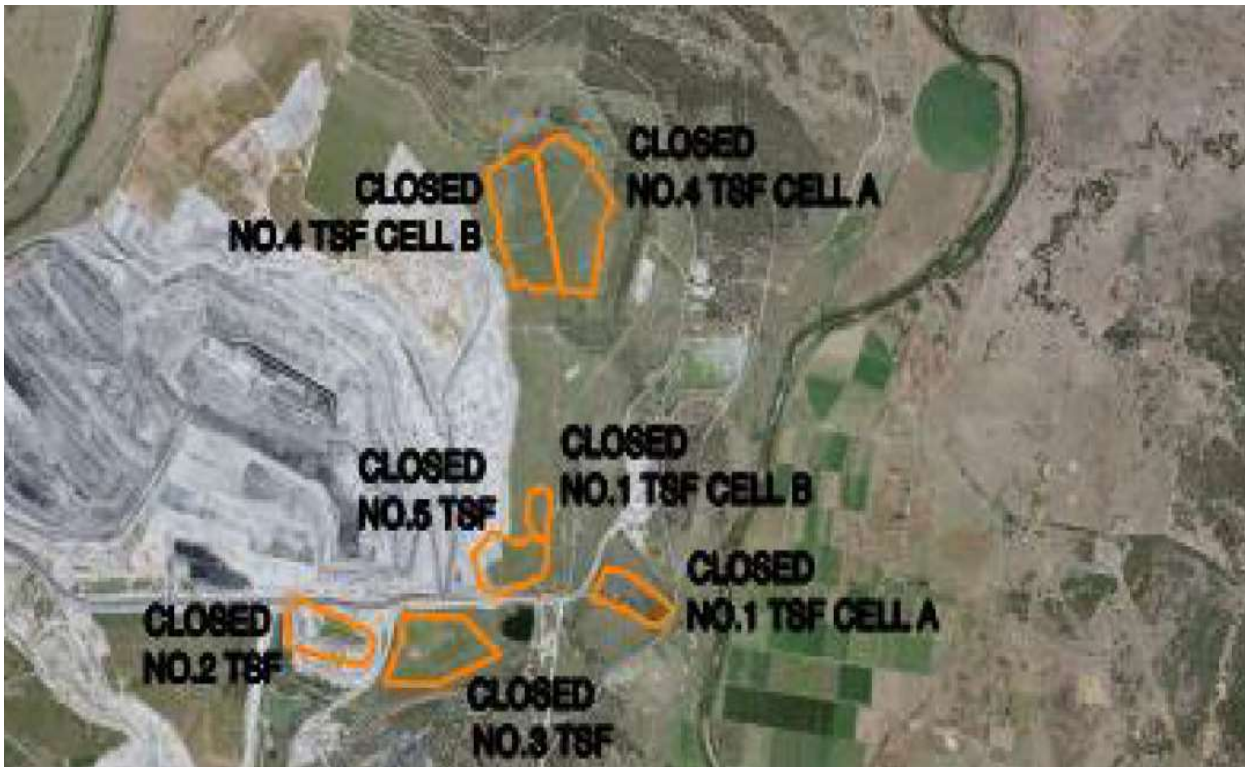
Figure 5.1 Closed No1. TSF Cell A (sourced from HVO Fine Reject Management Strategy, dated: 01/08/2023, version: 4)

Further south, there are also several closed TSF that fall within the HTP corridor (HVO Fine Reject Management Strategy, dated: 01/08/2023, version: 4), see Figure 5.1.
