# MANGOOLA OPEN CUT

## Rehabilitation Management Plan

**Number:** MANOC-1276546935-5

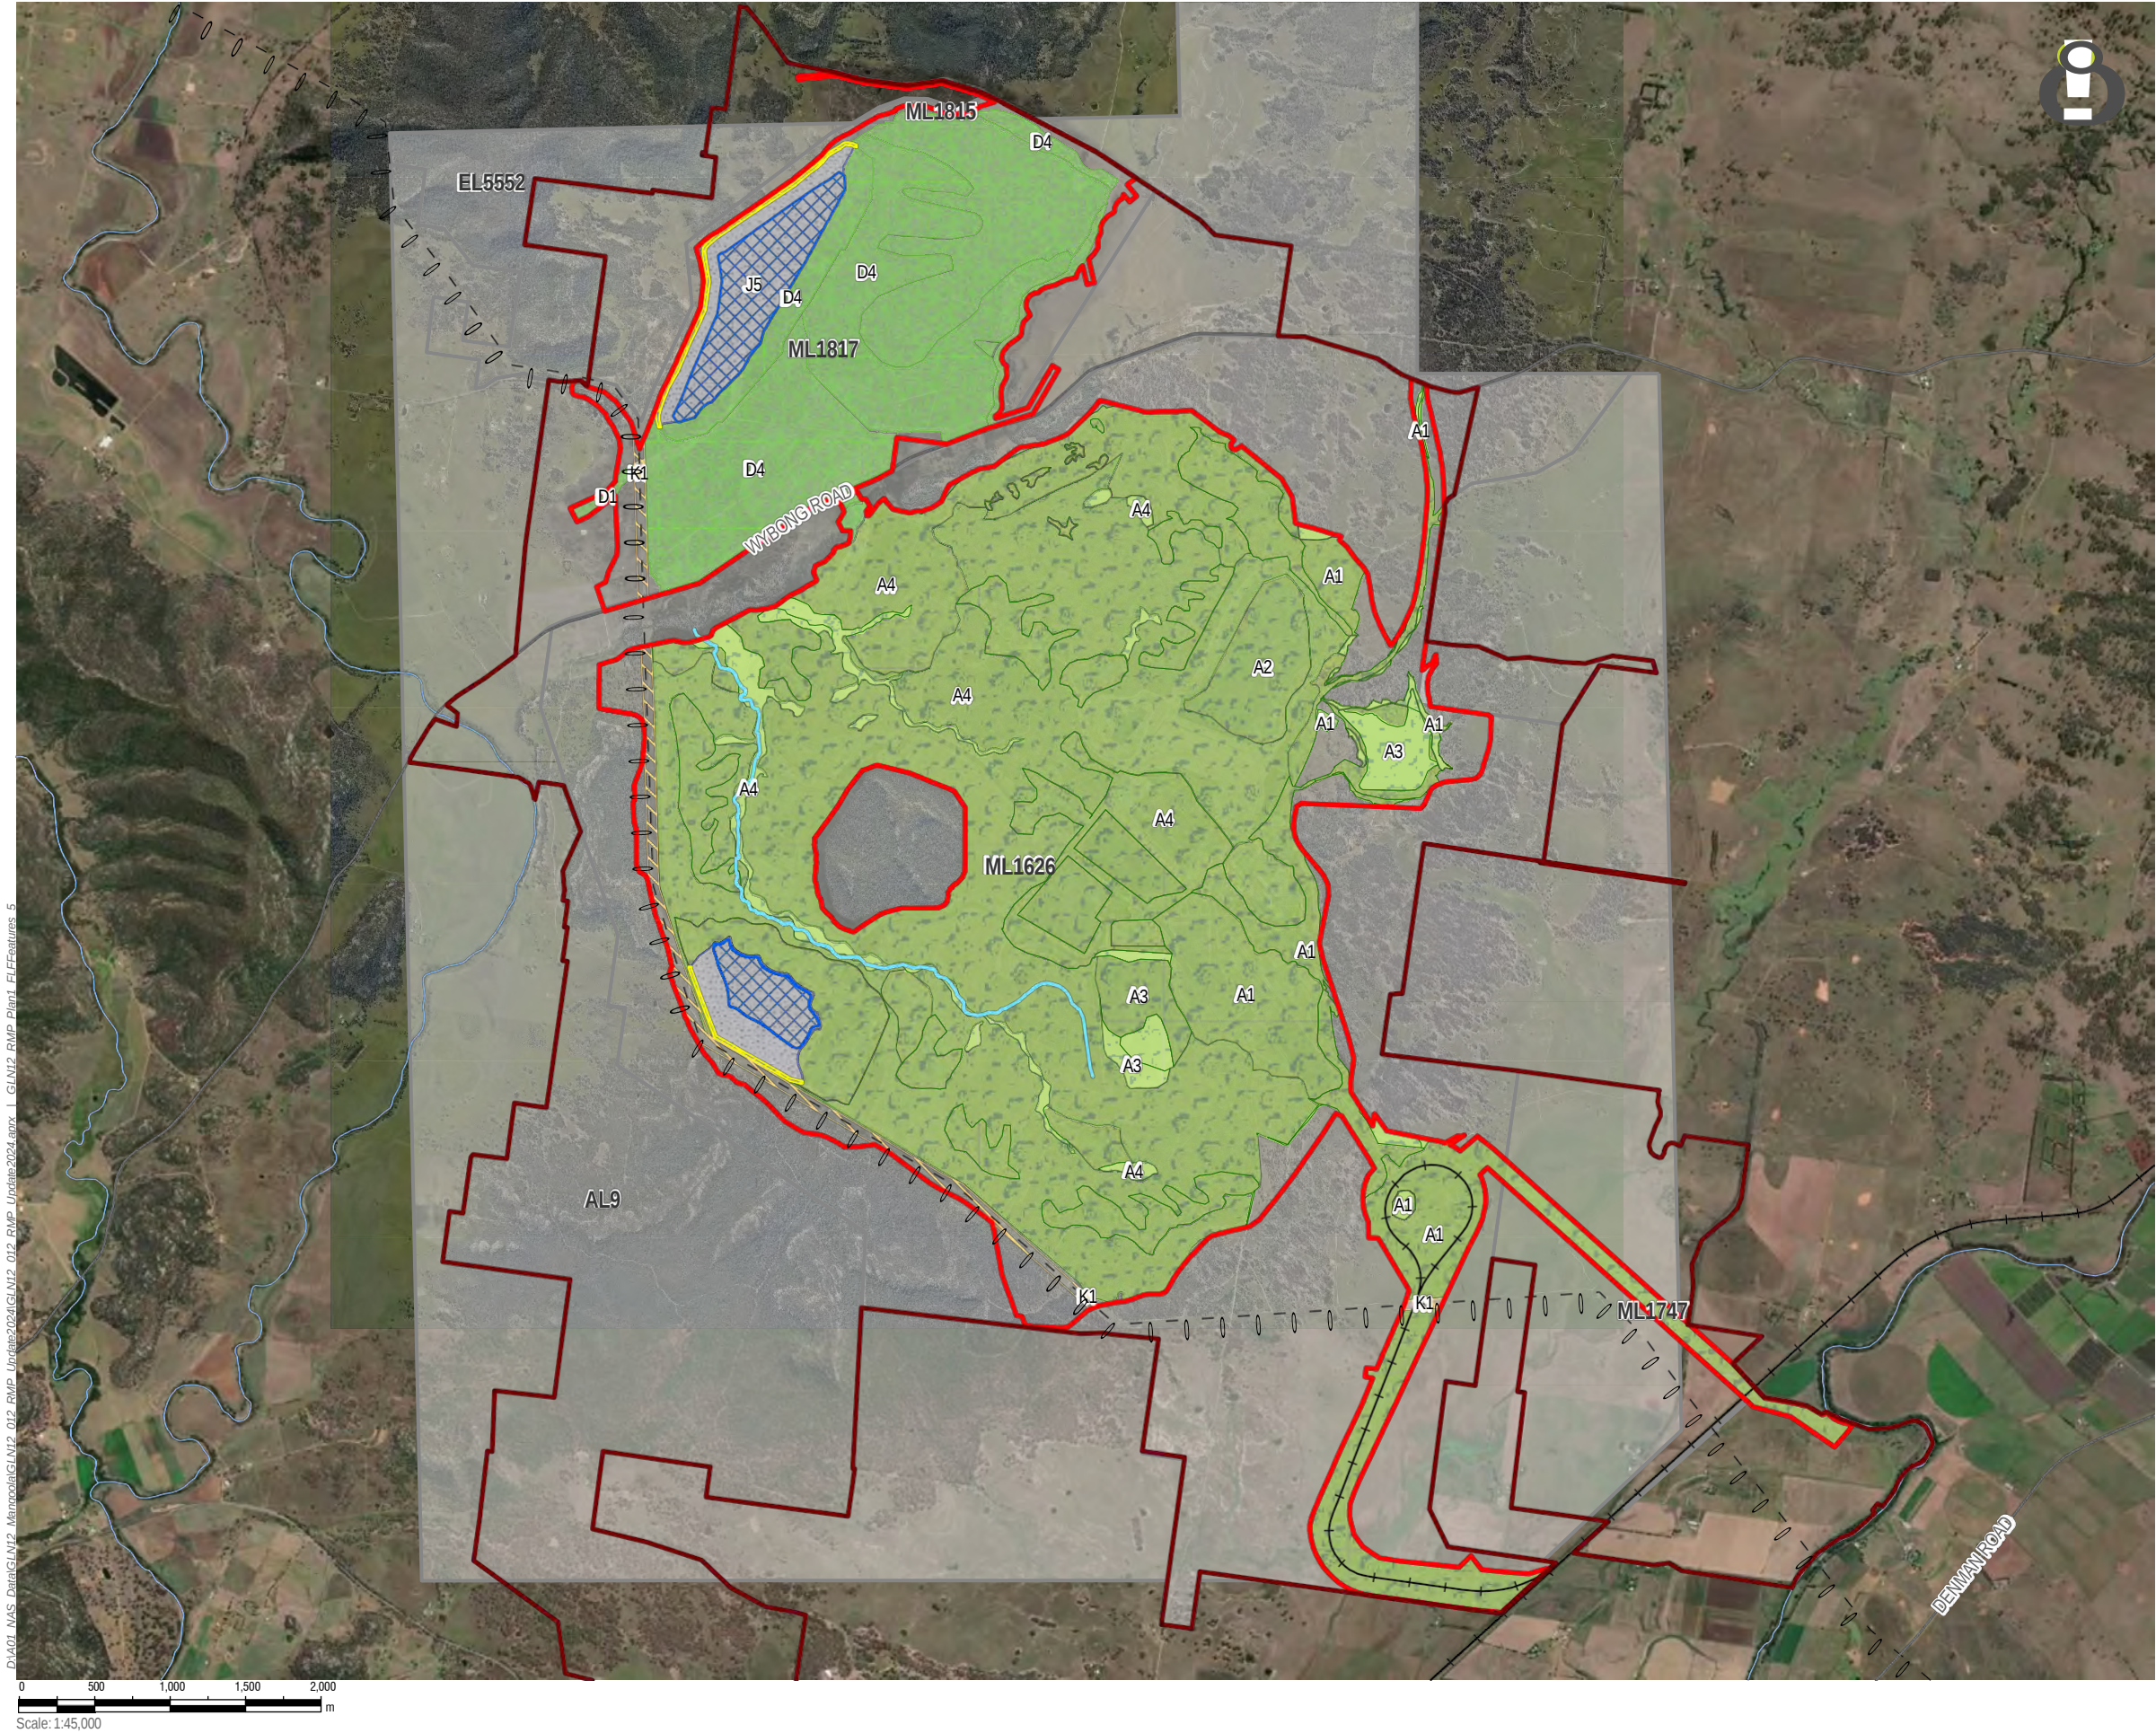
- LEGEND**
- Project Approval Boundary
  - Approved Disturbance Boundary
  - Road
  - Railway
  - Electricity Transmission Line
  - Watercourse
- Final Landform Feature**
- Drainage Network
  - Final Void Safety Bund
  - Final Void Water Level
  - 500kV Powerline Easement
- Final Landuse Domain**
- Domain A: Native Ecosystem
  - Domain D: Rehabilitation Biodiversity Offset Area
  - Domain J: Final Void
  - Domain K: Other
- Current Authorisations**
- Coal - Current Titles

In accordance with the requirements of the RMP guidelines, a Final Land Use and Rehabilitation Plan (FLRP) (**FLRP Plan 1** and **FLRP Plan 2**) has been prepared to show the proposed final land use and final landform at the end of mine life.

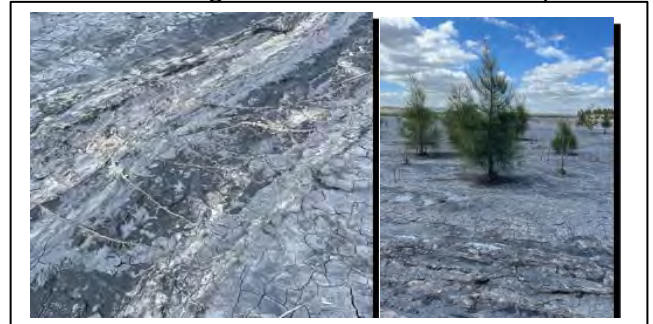
The research team continue to find plant roots in trap to support potential soil microbial growth. most holes dug into the tailings whilst planting, up to more than 5m from the nearest tree. We assume them to be of *M. quinquenervia* but probably also of *Casuarina glauca* (photos – here a natural drain in the foreground of the photo on the right shows roots exposed after erosion – detail on the left). It is not unusual for wetland plants to grow horizontal roots, especially where cracking and aeration opportunities exist as depth causes anoxia (M. Cole 2024, unpublished).
