RE: ROYAL HALL OF INDUSTRIES, MOORE PARK - RESPONSE TO SUBMISSIONS

A State Significant Development (SSD) Application has been submitted for the proposed adaptive reuse of the Royal Hall of Industries (RHI) for a high-performance sport and community facility. The development will maintain the structural integrity and façade of the RHI, whilst re-purposing the interior of the building to support a number of compatible uses and utilise the space effectively. GTA Consultants (GTA) completed a transport assessment dated 8 May 2019 to support the SSD Application.

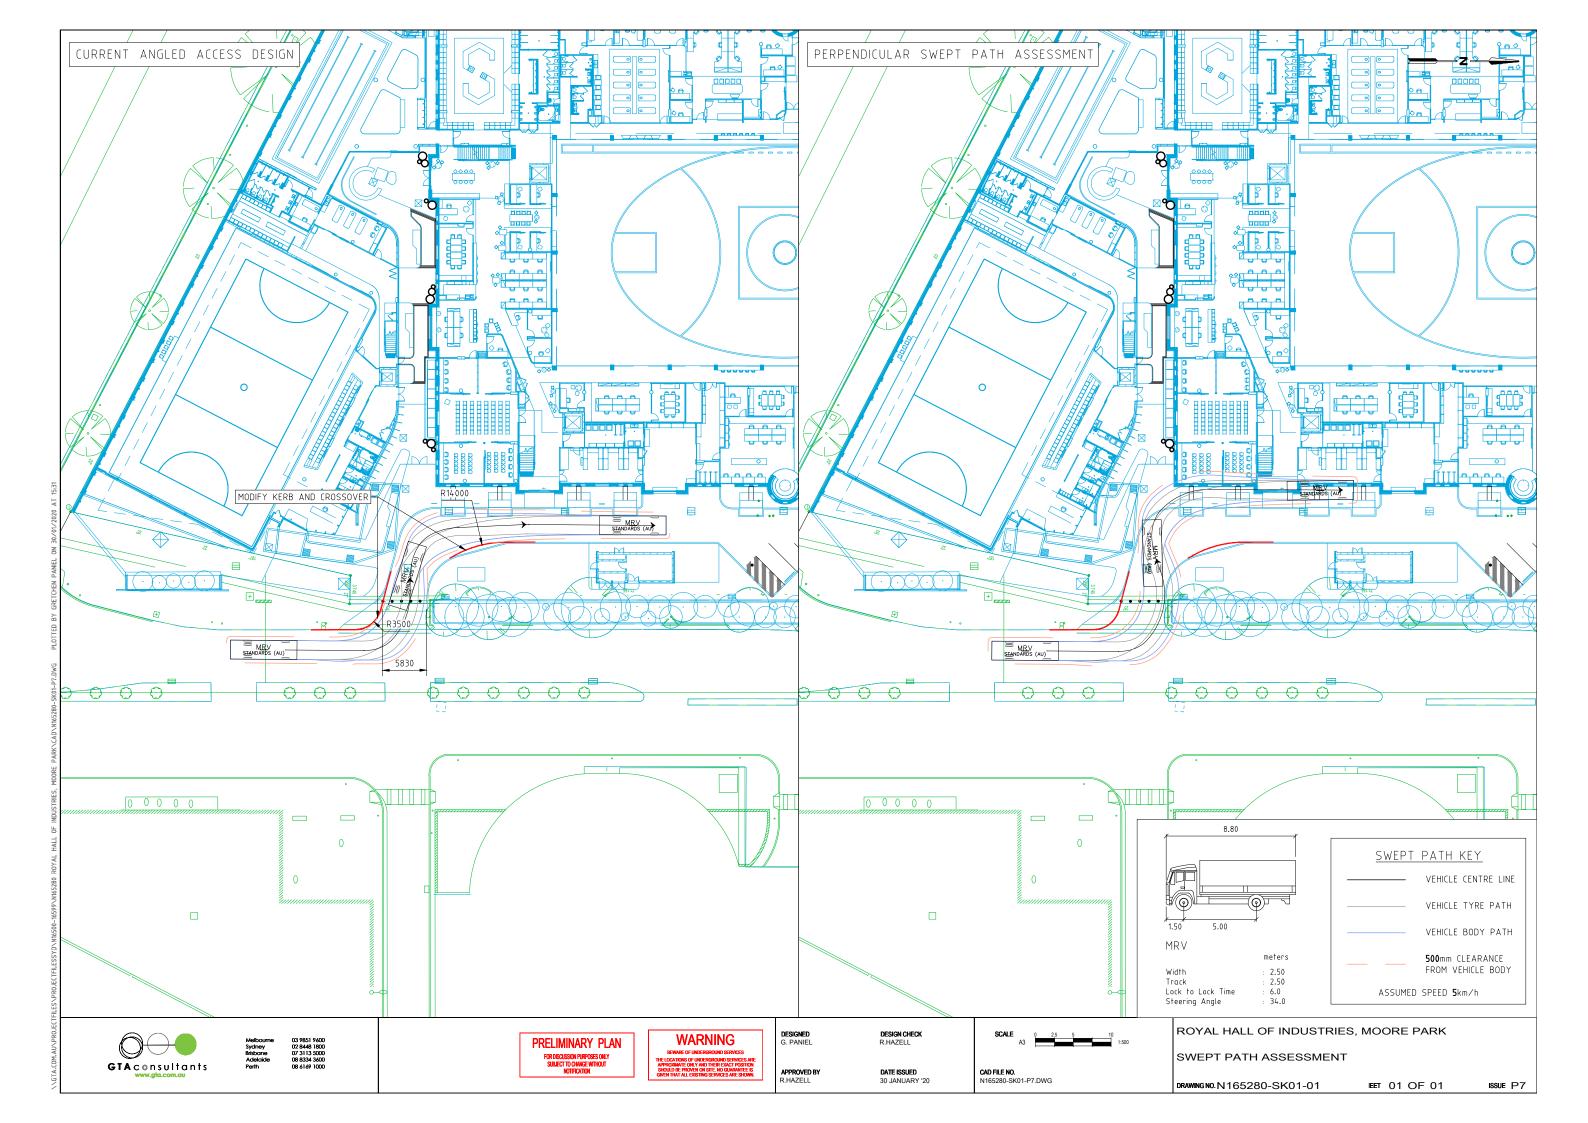
Swept path diagrams for the service vehicle access (relied upon to justify the proposed angled driveway from Errol Flynn Boulevard).
