TEMPORARY HERITAGE PROTECTION PLAN

Atlassian Central

Prepared for
BUILT
6 June 2022

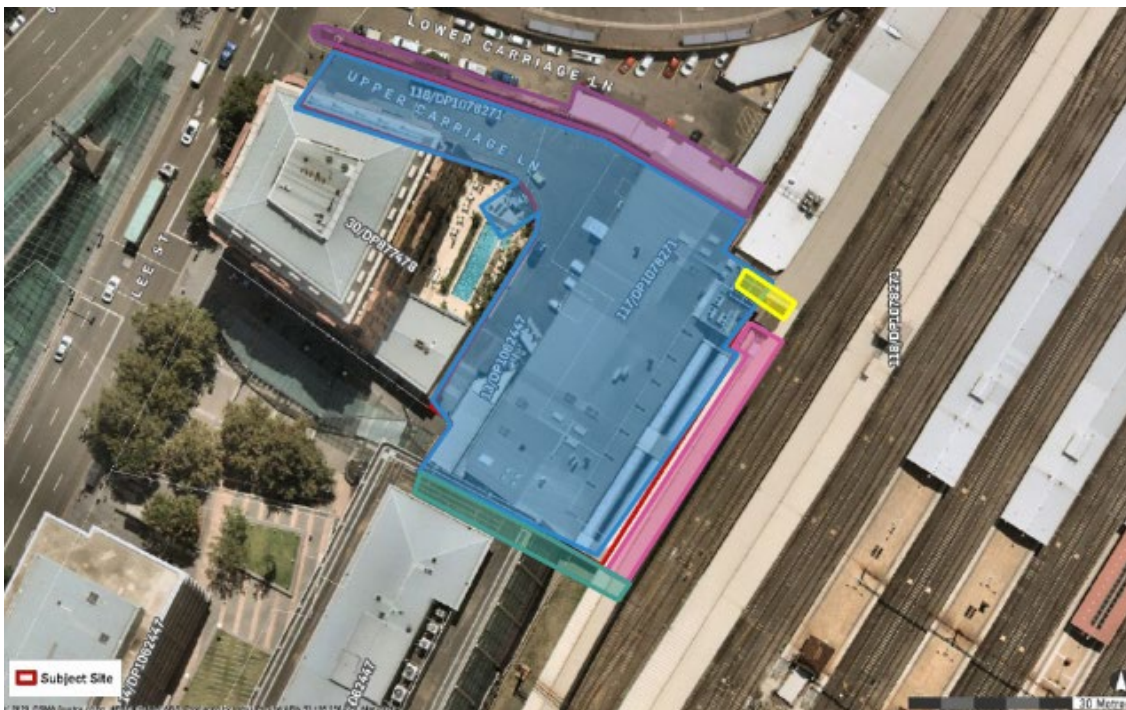
The five components of the site are identified (and mapped in the image below). However, this report is primarily concerned with protecting significant fabric surrounding the subject site as identified in Section 2.

Figure 1 – Aerial image with the subject site outlined in red.

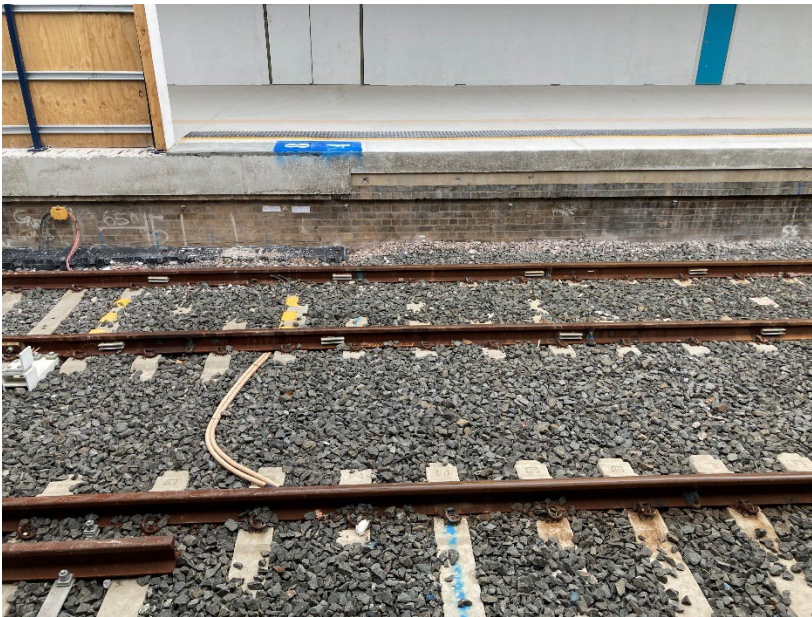
Figure 6 – Existing track monitors adjacent to platform.

Note that monitors are required to be installed to the surrounding heritage structures in accordance with the accompanying Construction Management Plans which are required as a condition of the approval. These monitors are necessary to ensure the integrity of the buildings in the context of the approved works. The monitors will be installed in the same manner as existing vibration monitors around the Station (mechanical fixings for buildings and adhesive for track monitoring). There is no heritage impact because of the mechanically fixed monitors, any penetrations can be easily patched, and monitors are generally to be attached to structure rather than decorative elements. Track monitoring devices would be fixed using adhesive and are designed to have no permanent impact on the tracks.

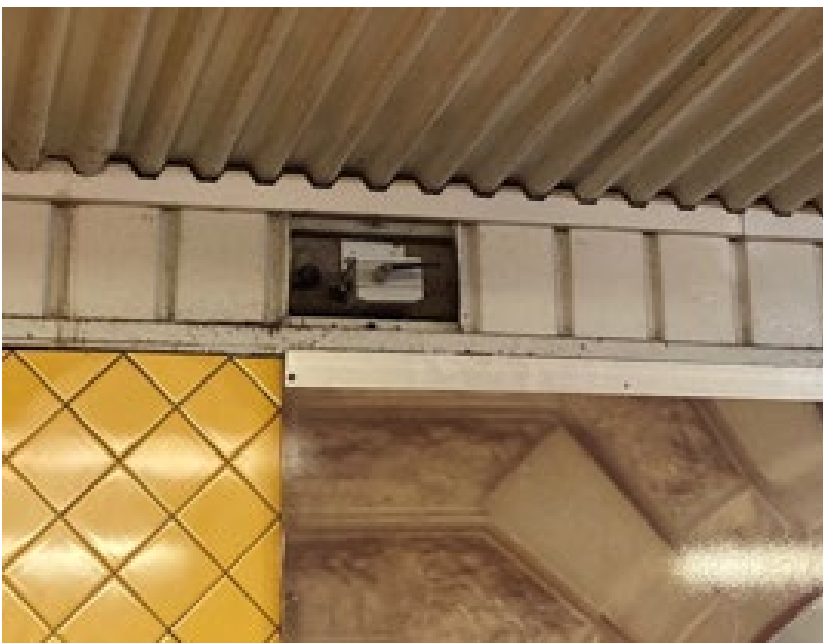
Figure 7 – Existing vibration monitors within Central Station.

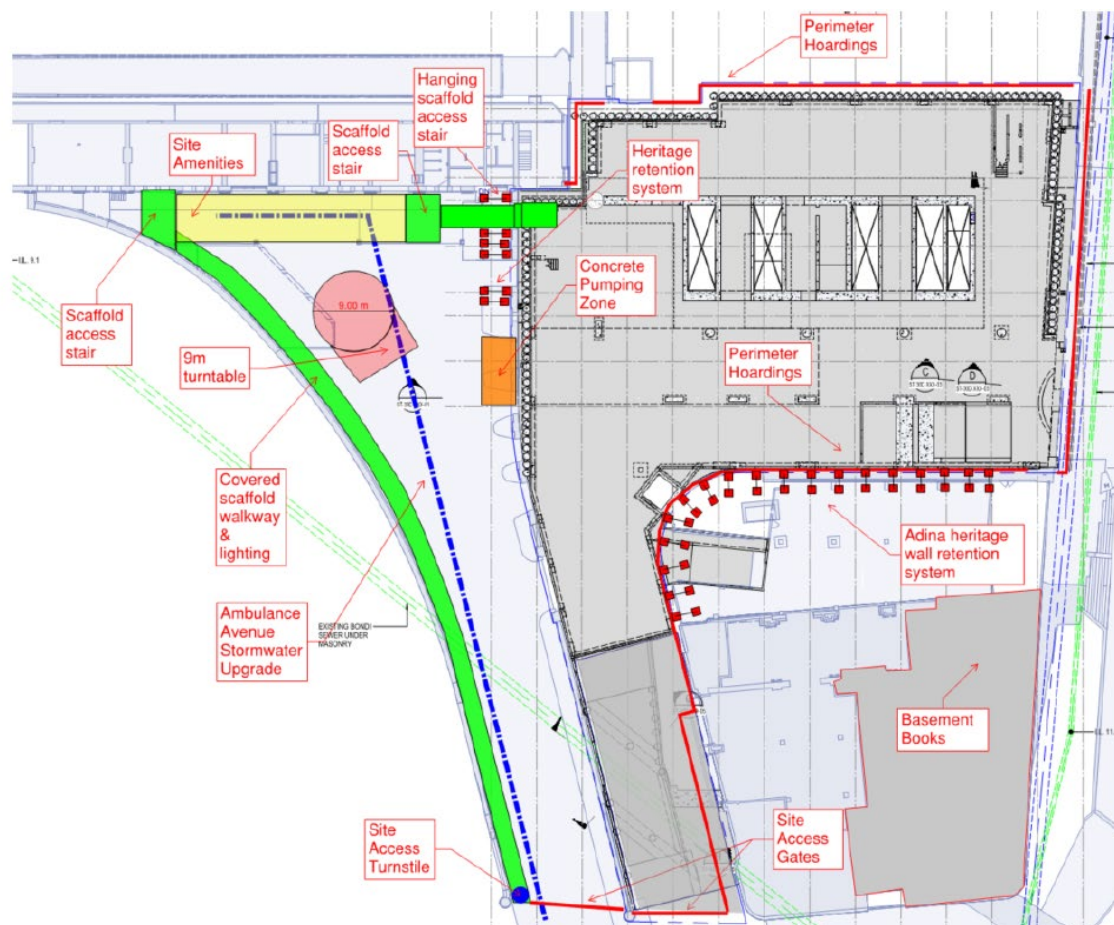
Figure 8 – Site plan showing locations of hoarding and scaffolding.

- For heritage buildings, the preference is for scaffold, hoardings and the temporary protective “boarding-up” of openings, to be free standing or only stabilised by using bracing through the existing or proposed facade openings.
- Where this cannot be achieved then any proposed temporary fixings into masonry or woodwork will be documented and approved by the HC prior to implementation. Where bracing into masonry is unavoidable (e.g. no existing or planned openings available in the external wall), then whole stones or brick areas will be temporarily removed by hand and stored for reinstatement on removal of the scaffold.
- Do not saw cut stones or brickwork for temporary stabilisation or other construction activity. Ensure steel scaffold members and hoarding materials are not in direct contact with masonry or timber heritage fabric avoiding vibration impacts and staining.

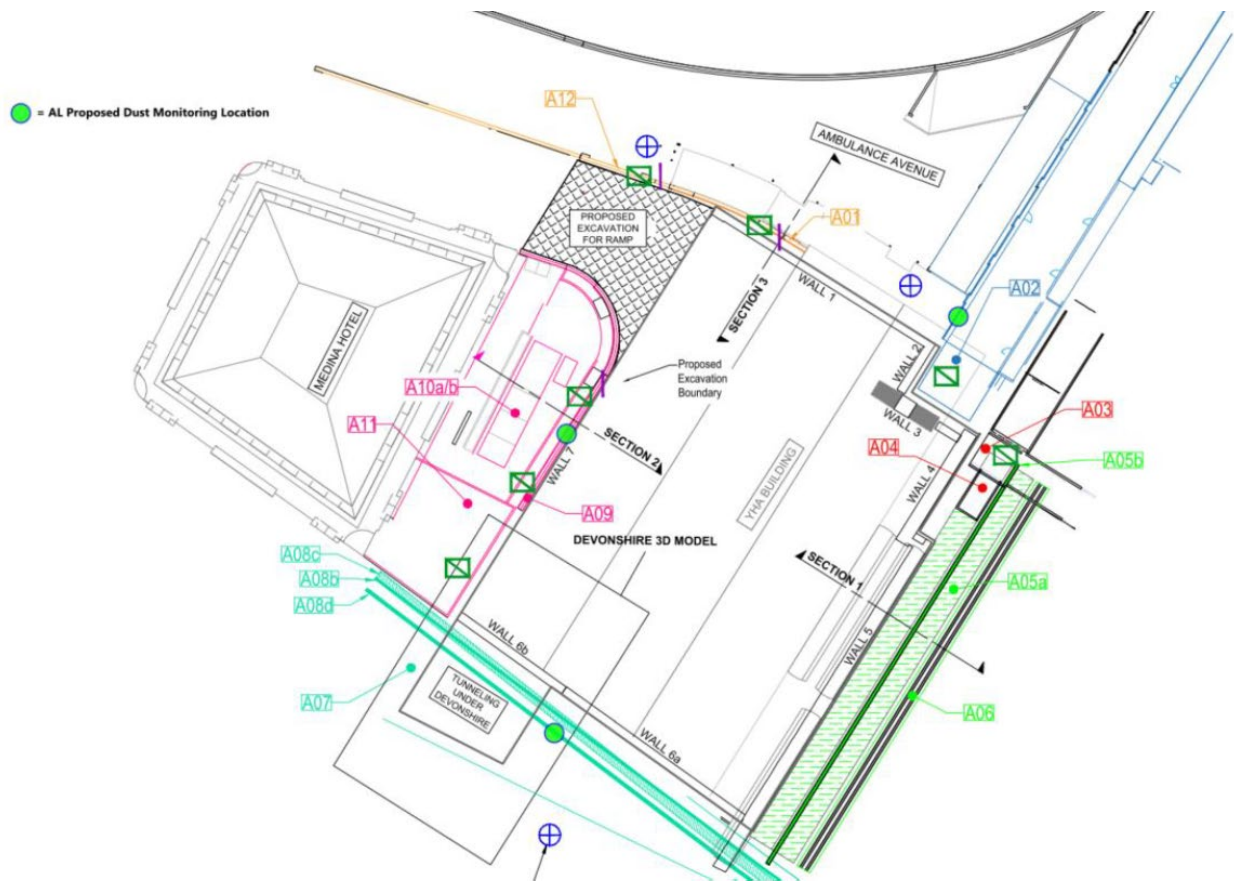
Figure 10 – Recommended dust monitoring locations

The report establishes that demolition, excavation and piling works all have potential to produce significant ground vibration. It also states that at this stage it is not possible to predict the vibrations generated by the works and therefore a recommendation is made that vibration monitoring is undertaken in a series of locations throughout the construction of the project.

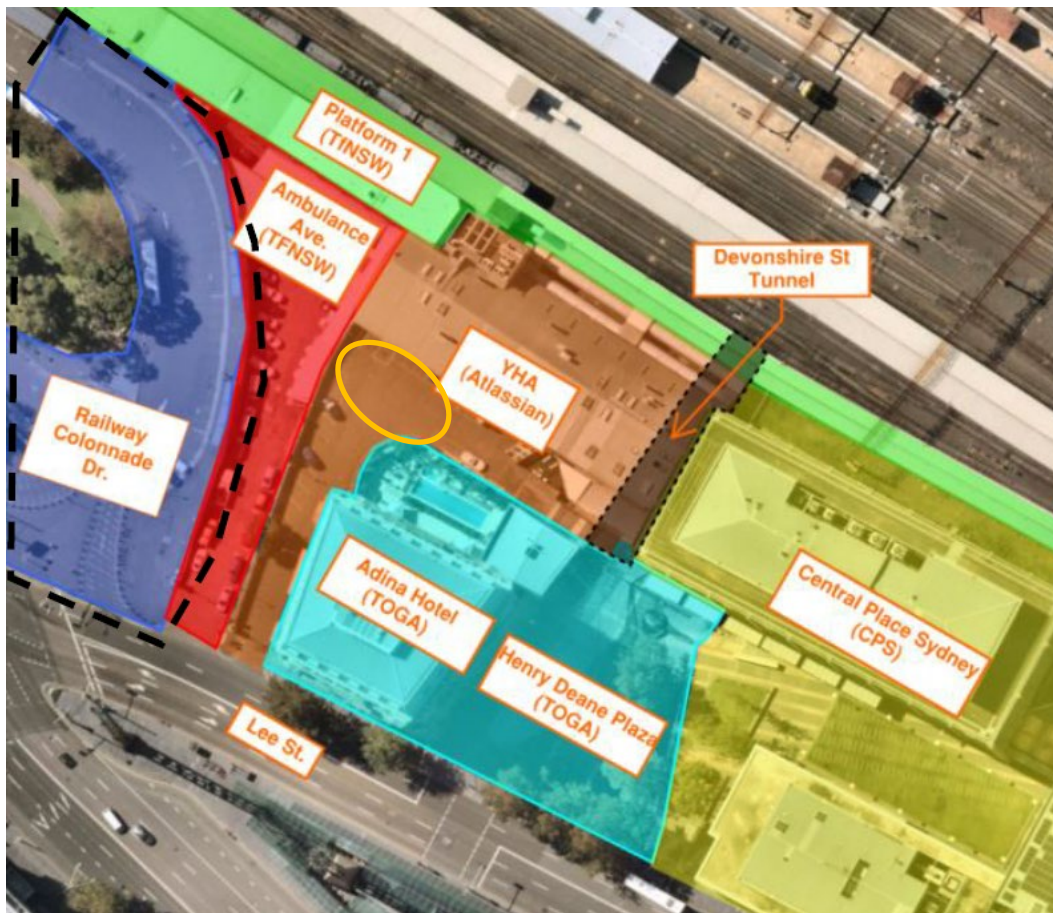
Figure 11 – Aerial image showing areas requiring traffic management in and around the subject site.

It is understood that prior to construction works commencing, a detailed CTPMP will be developed by an authorised traffic consultant (JMT). This document should appropriately acknowledge the location of significant fabric in the area of vehicle movement as demonstrated in this report and be in accordance with the heritage recommendations set out in this report.

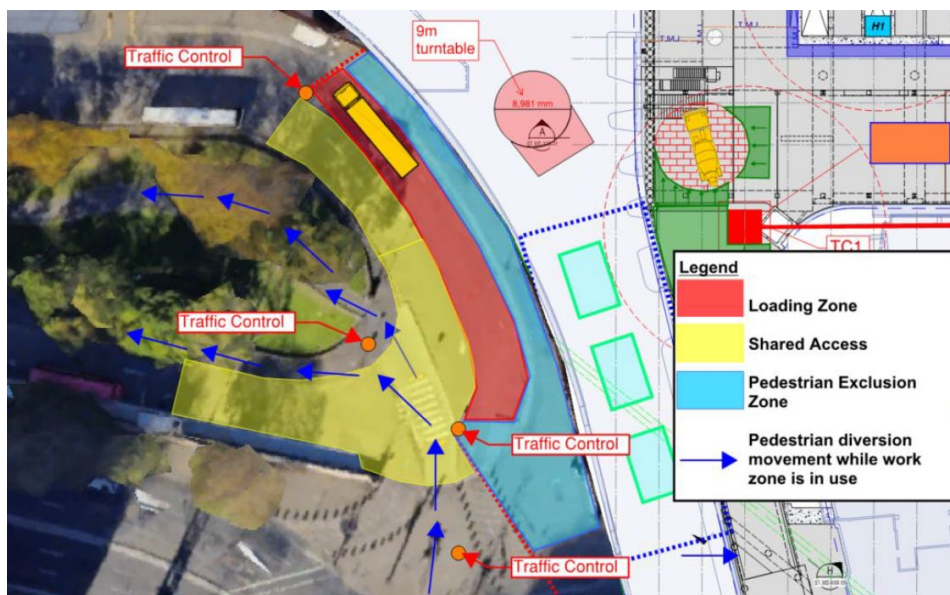
The below is the configuration for most activities within the RCD.

Figure 12 – Aerial image showing traffic management in the RCD per loading zone configuration 1.

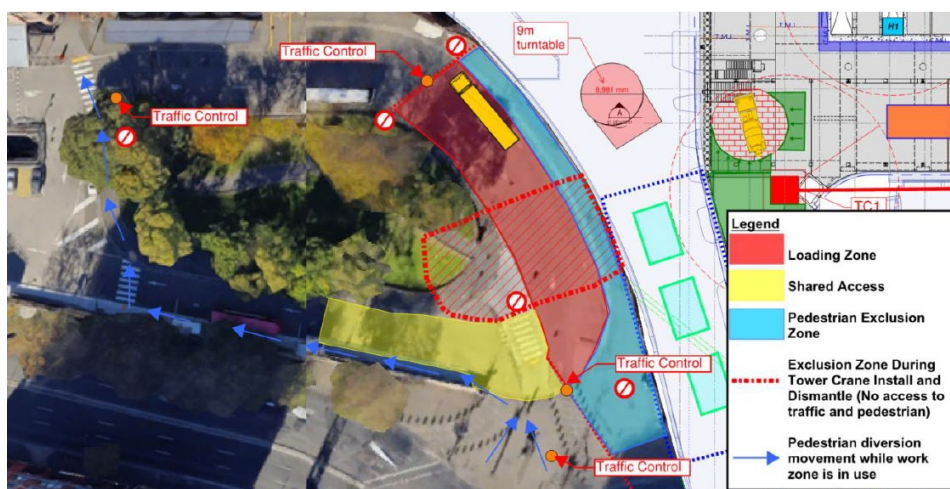
Configuration for crane install and dismantle

Figure 13 – Aerial image showing traffic management in the RCD per loading zone configuration 2.

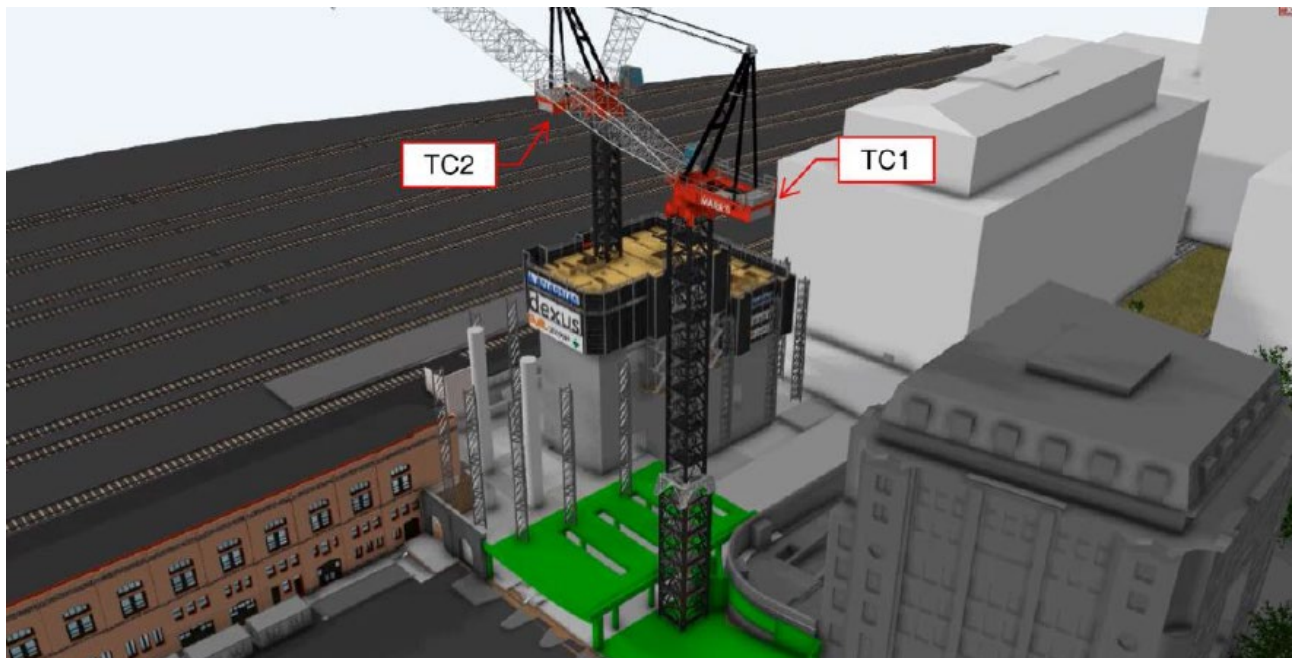
Figure 14 – Tower Crane Overview – note TC1 adjacent to heritage brick wall.

The use of cranes (x3) is identified in the Tower Construction Management Plan with one crane (TC1) being installed on a pad footing within the existing Upper Carriageway Lane zone adjacent to the Adina brick retaining wall. TC1 is to be installed using a mobile crane established in Ambulance Avenue and utilising the RCD in accordance with the methodologies set out in the RCD Management Plan.

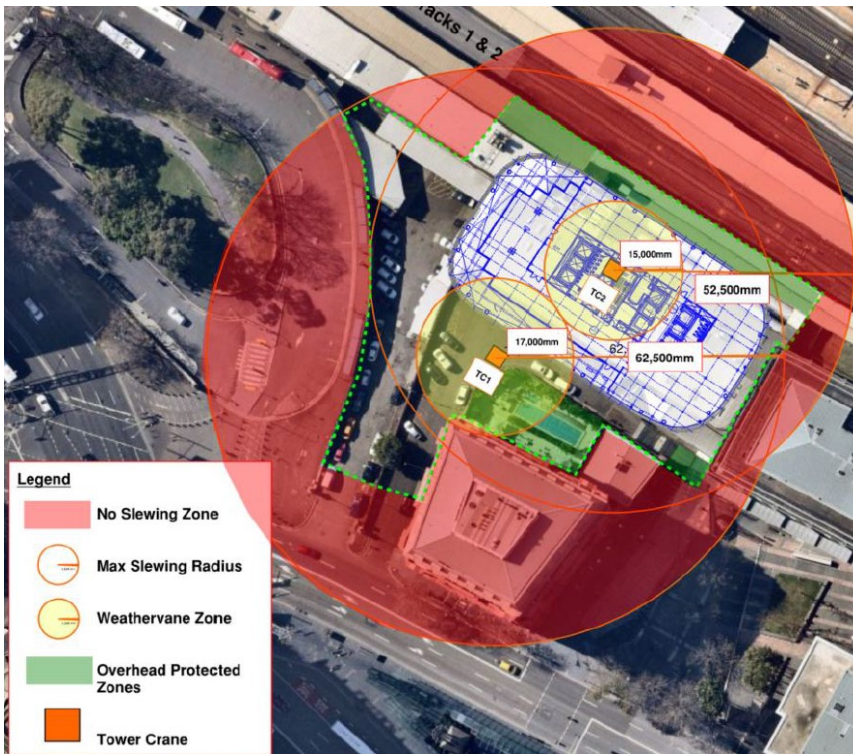
Figure 15 – Tower crane no slewing zone diagram.

The Tower Construction Management Plan establishes non slewing zones for the cranes (diagram reproduced below) which minimises slewing over significant fabric. The non slewing zones will be established by slew restriction systems to the tower cranes.

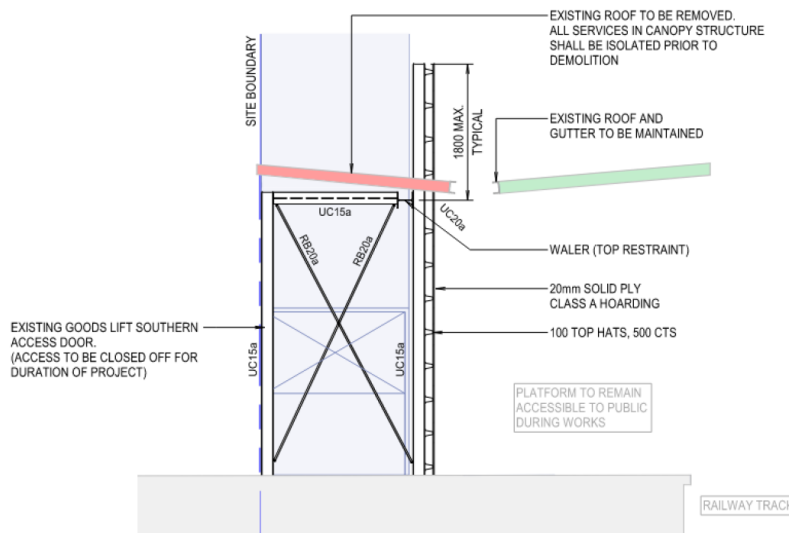
Figure 16 – Construction detail for Partial Removal of Platform 1 awning.

The construction methodology for the partial removal of the Platform 1 awning and the remnant section of awning allows for the current stormwater and downpipe system to remain operational. There are therefore no anticipated impacts on heritage fabric as a result of the partial removal of the Platform 1 Awning.

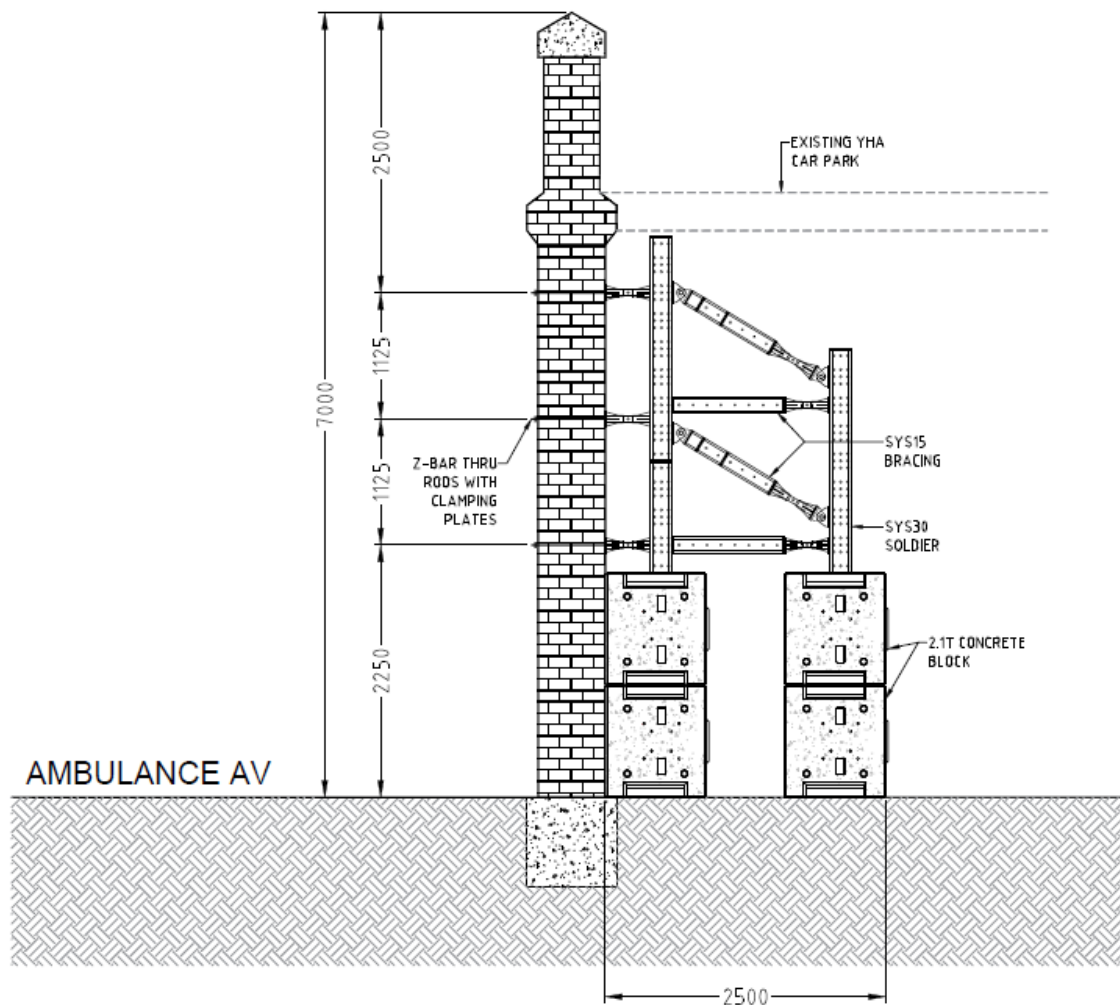
Figure 17 – Section showing propping of Ambulance Avenue masonry facade.

In order to avoid the above risks, the below shoring plan has been developed in conjunction with TTW. Any change to this plan must be reported to Urbis for comment.

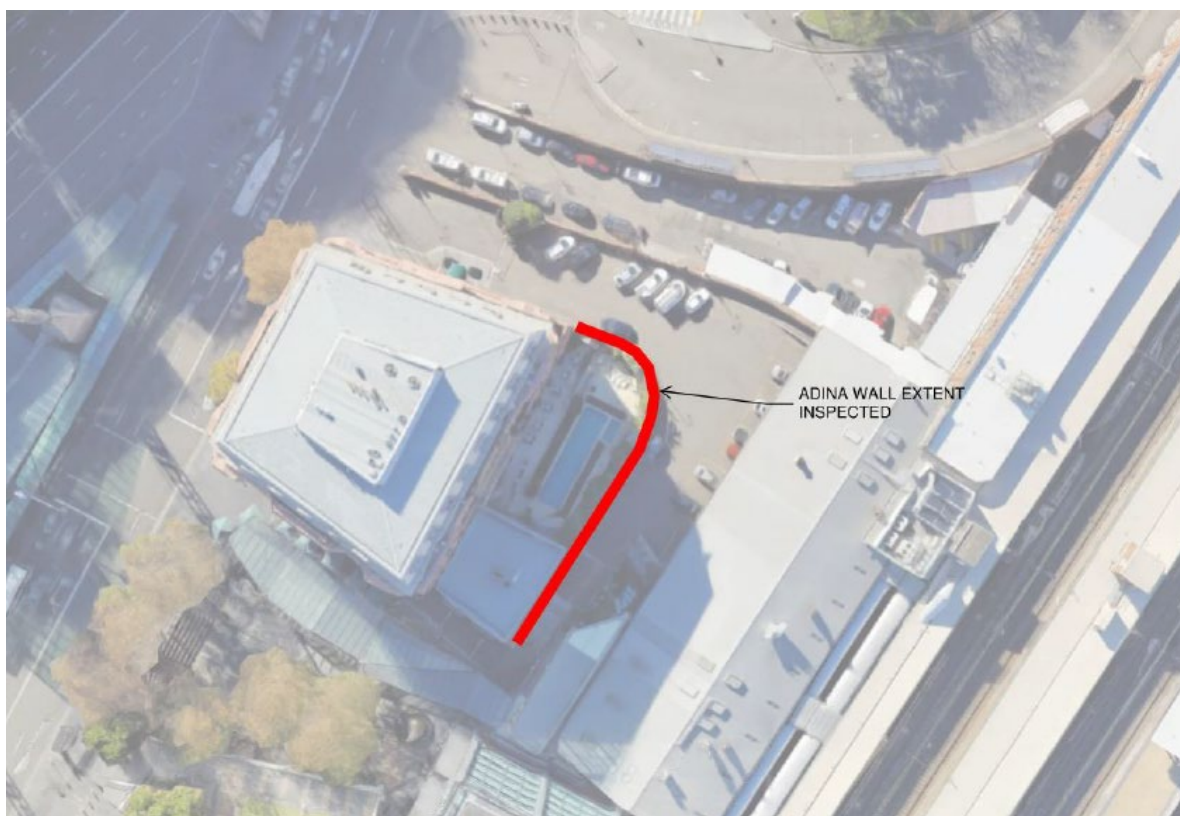
Figure 18 – Extent of Adina Wall inspected by TTW in September 2021.

Significant elements of the Adina Hotel, including the masonry wall are located adjacent to the access ramp to the existing YHA. The wall was visually inspected by TTW in September 2021 to inform a due diligence inspection which concluded the following:

- *From visual inspection the wall appears to be in reasonable condition for age with no obvious signs of deterioration or cracking.*
- *The Wall appears to have been previously repaired from a suspected truck impact along the northeast corner of the wall as indicated in Figure 8 and 9 below.*
- *The sandstone coping is in a poor condition with several mortar repairs noted along the surface.*

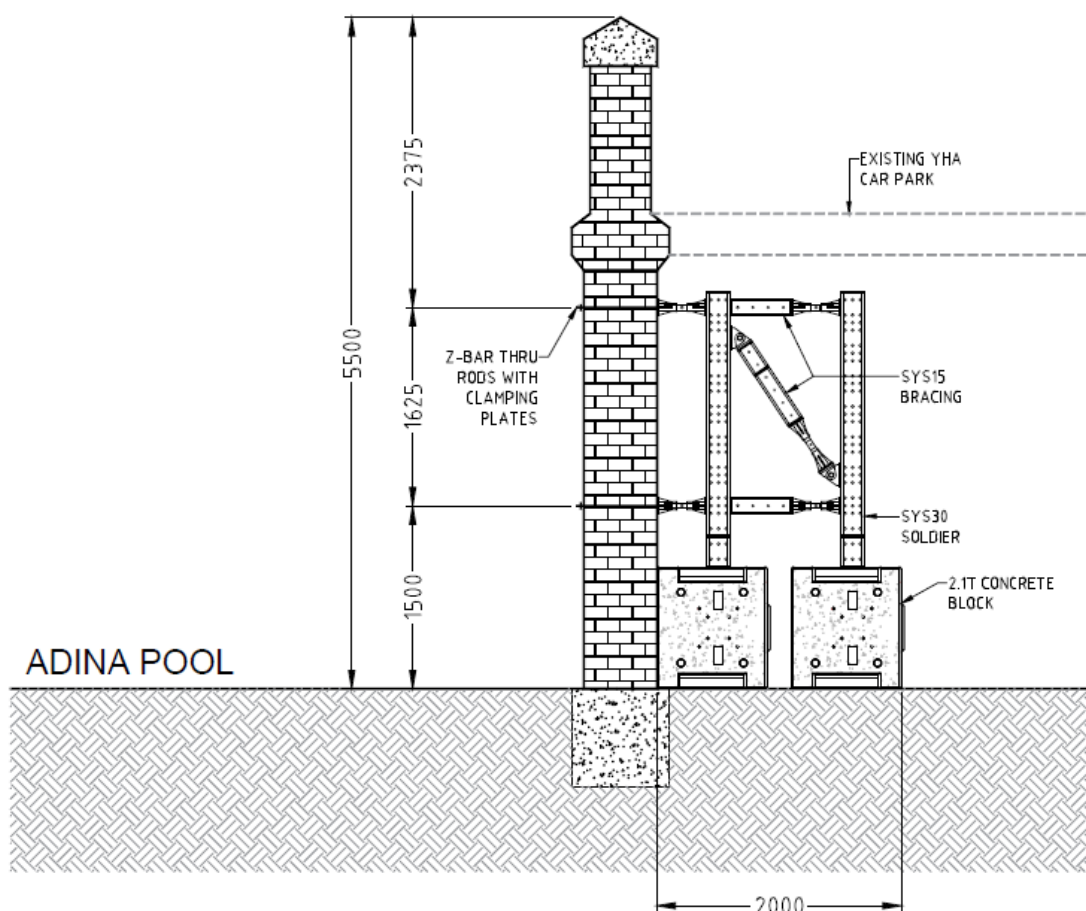
Figure 19 – Section showing propping of Adina Wall.

As set out in the Monitoring and Alert Plan, the unreinforced masonry makes the Adina hotel susceptible to slight ground movement and ground borne vibrations from excavation. Of particular risk is the toppling of masonry at the top of the arch structure/in part of arch structure and complete out of plan failure of arch structure.

In order to avoid the above risks, the below shoring plan has been developed in conjunction with TTW. Any change to this plan must be reported to Urbis for comment.

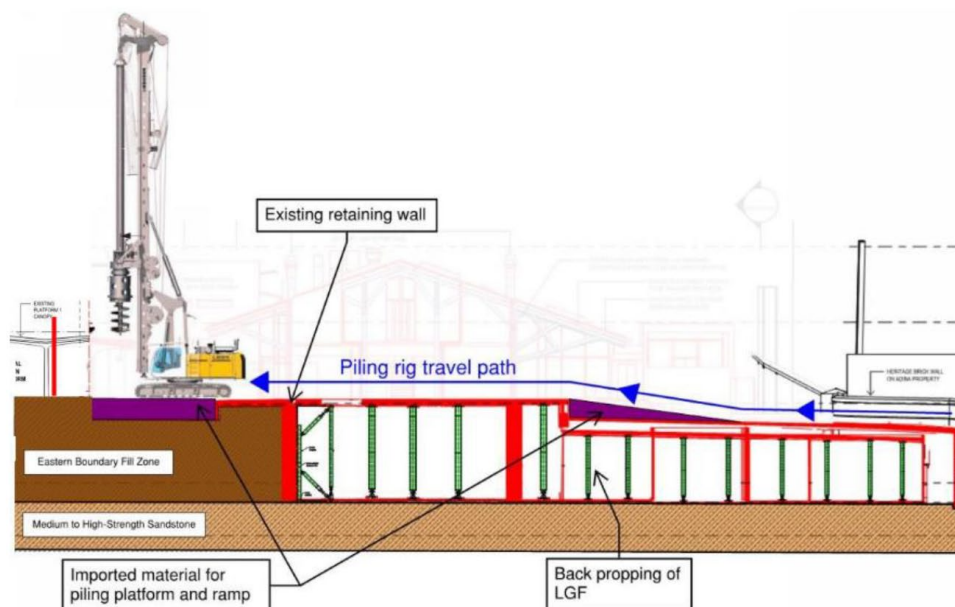
Figure 20 – Sectional view of piling operations on Eastern boundary.

Section 2.3 of the Tower Eastern Elevation Management Plan establishes risk mitigation measures that have been put in place to manage the piling works. Mitigation measures relevant to heritage are based around monitoring strategies for vibration, noise and dust. These strategies are reproduced in Section 6 of this report. Mitigation measures also relate to monitoring of movement during piling operations and subsequent bulk excavation on site by AEO certified structural advice including periodic review of monitoring data to ensure the retention structures is performing as expected (in line with the Structural Monitoring Alert and Response Plan – appended).

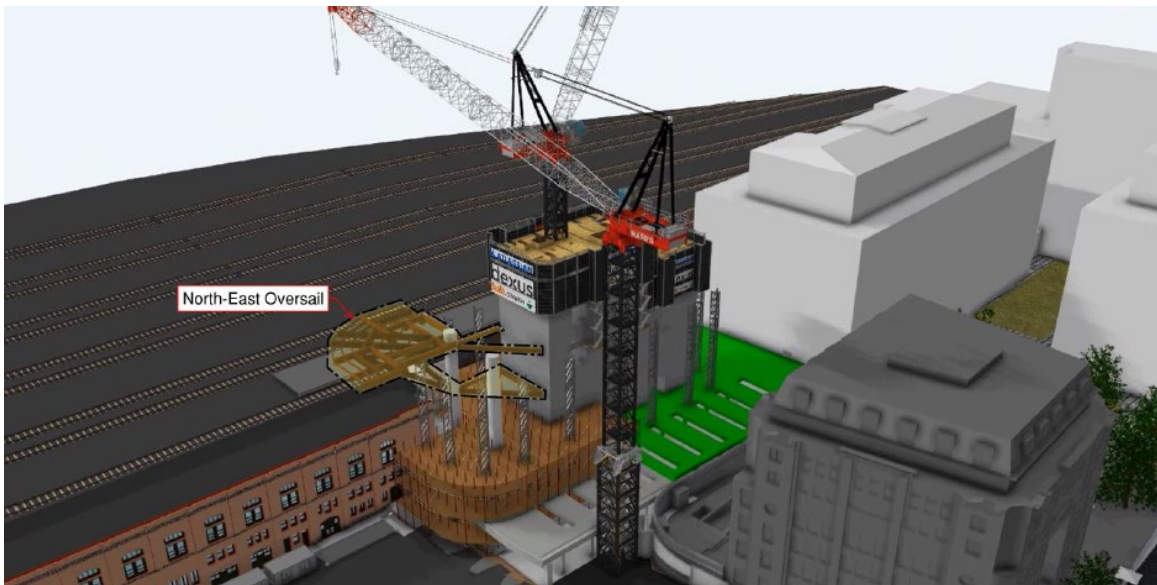
Figure 22 – North east over sail structure protecting the significant Western Extension.

During bulk excavation, existing fill over the Baggage Tunnel will be removed and the section of the tunnel within the Atlassian site boundary (which is of no significance) will be demolished and removed from the site. the below images (included at Figure 2 – 22 of the Tower Eastern Elevation Management Plan) demonstrate the temporary retention system for the remaining structure of the Baggage Tunnel, train platforms and surrounding heritage items (specifically the West Wing Extension) which are located outside the subject site.

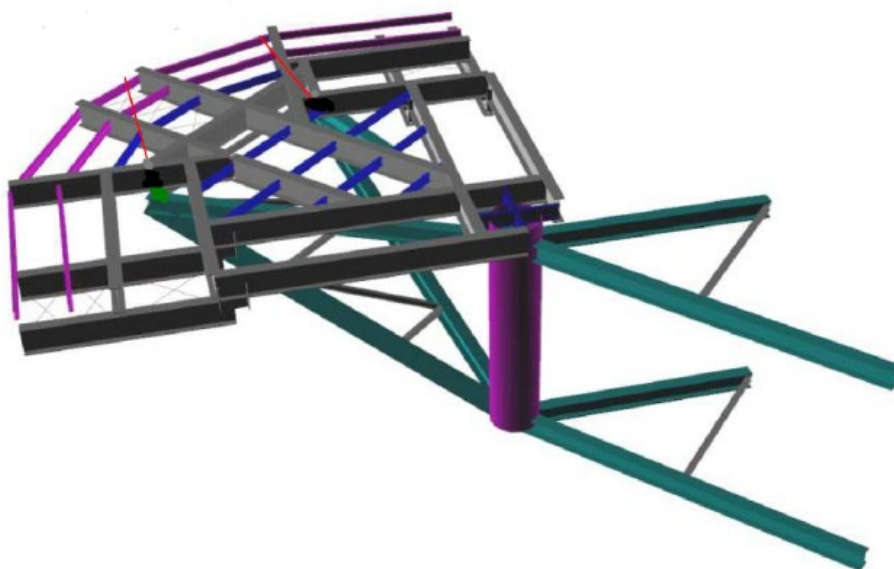
Figure 23 – Detail of north east sail structure protecting the significant Western Extension.

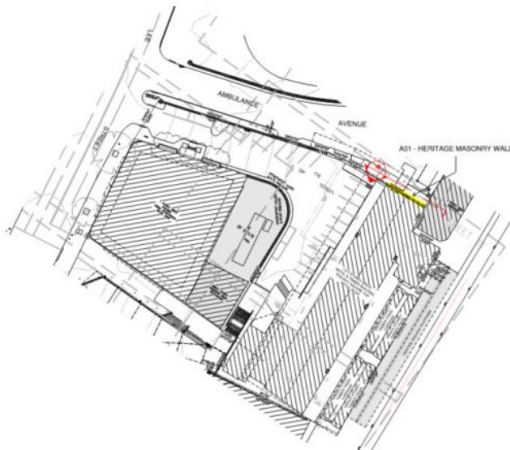
Figure 26 – Location of Ambulance Masonry Wall

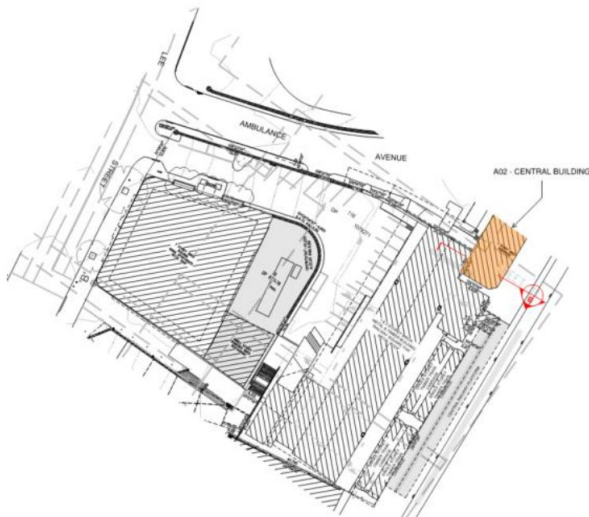
Figure 29 – Location of North East Building.

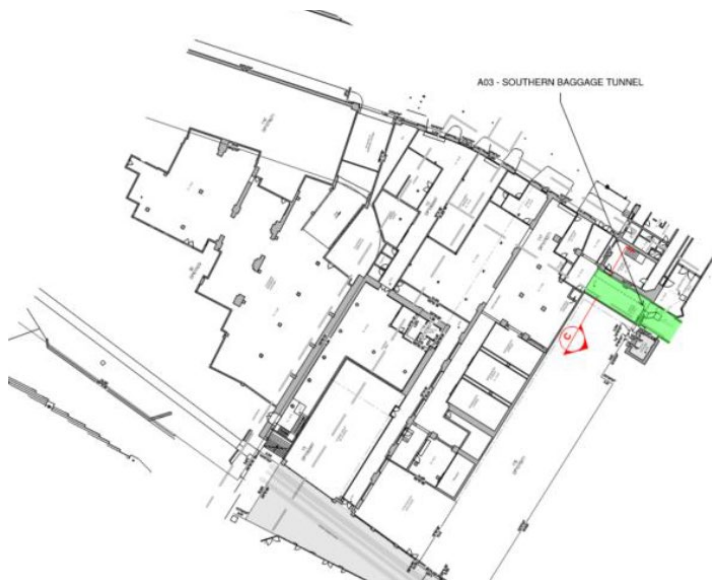
Figure 32 – Location of the Baggage Tunnel.

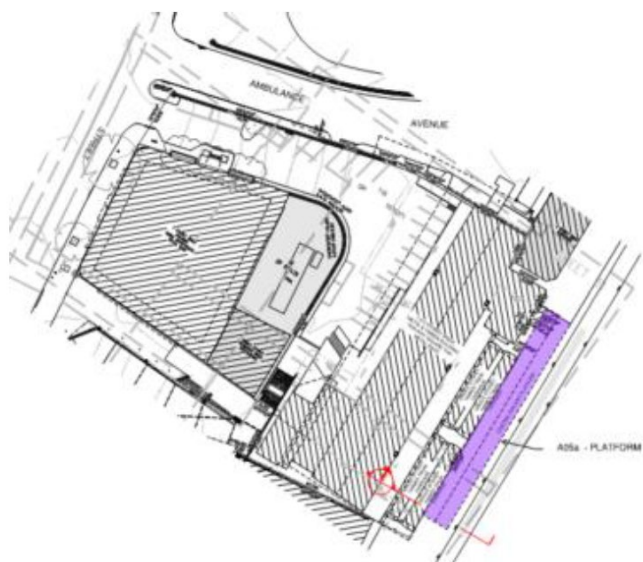
Figure 35 – Location of Platform 1.

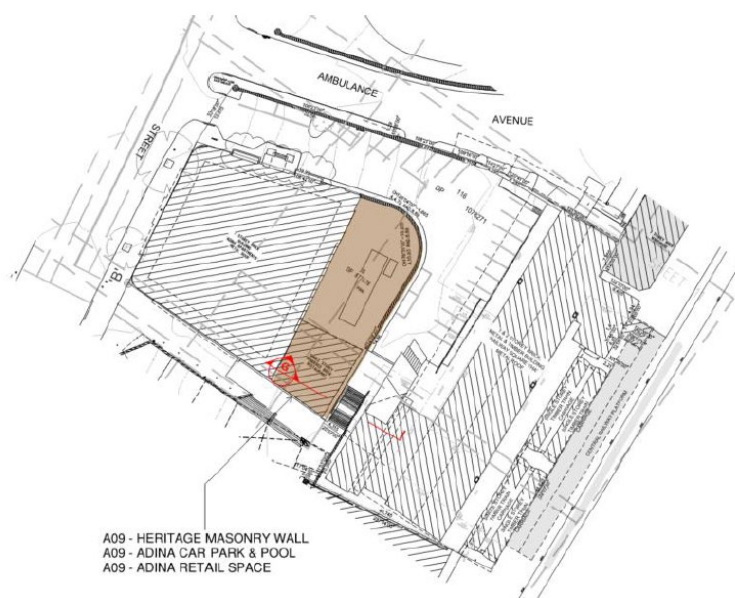
Figure 38 – Location of Adina Heritage Masonry Wall etc.

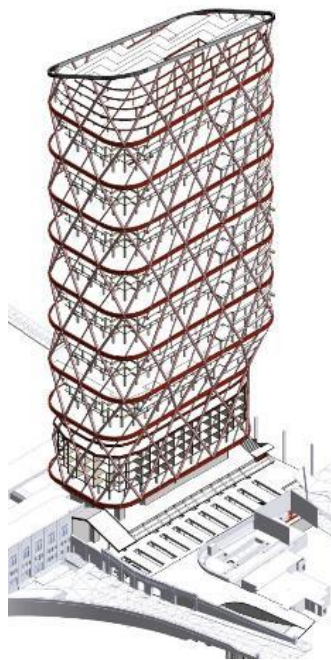
Figure 2: Proposed Development

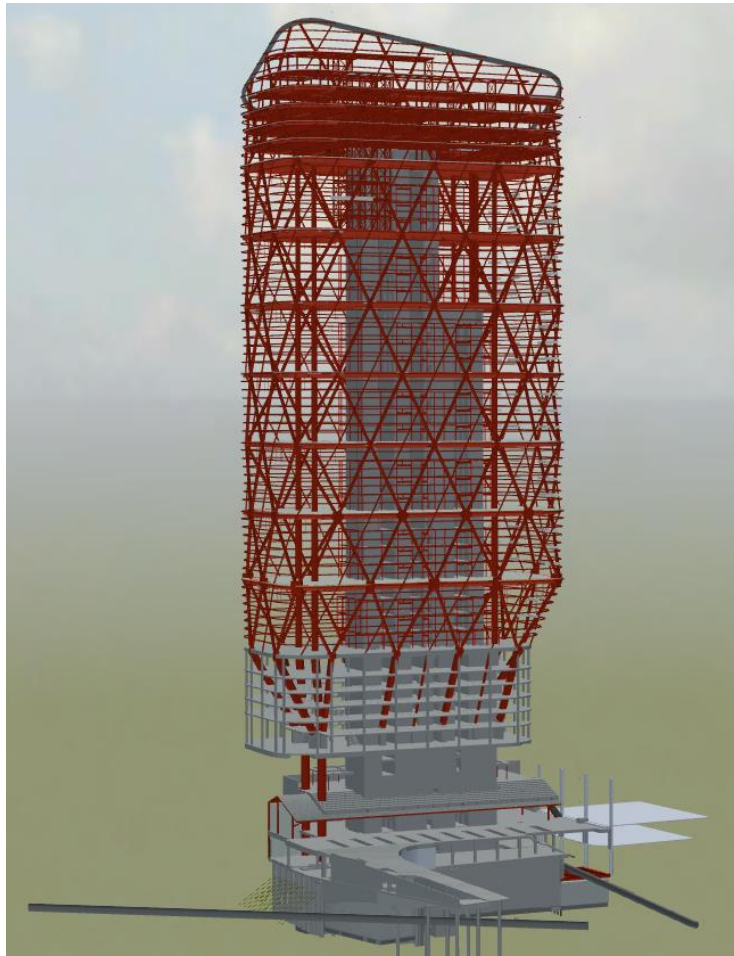
Figure 3: Tower Structure

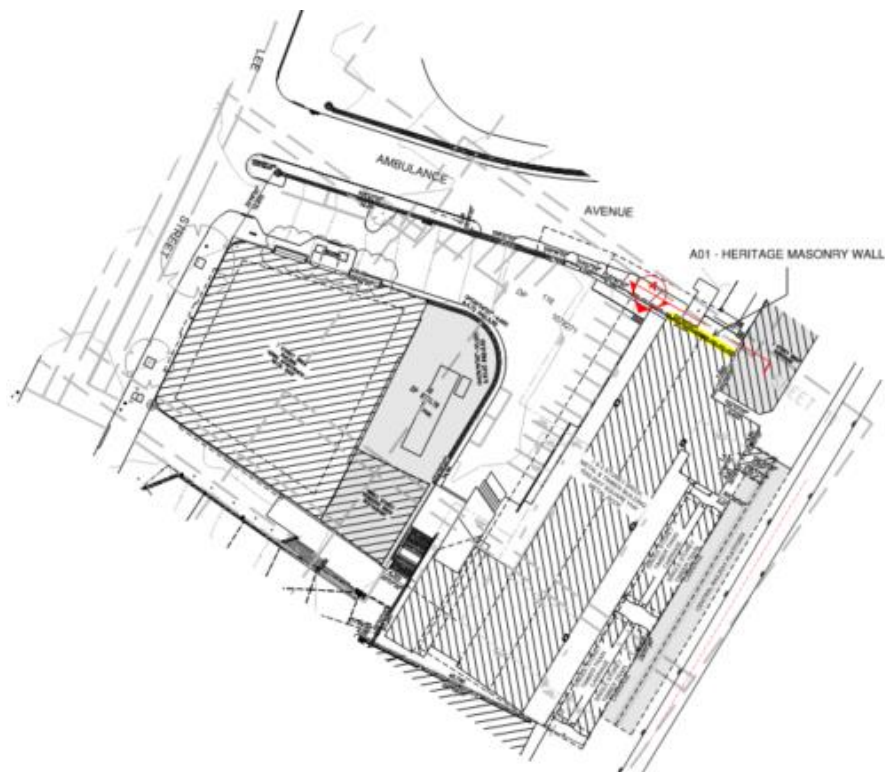
Figure 5: Plan View of Heritage Masonry Wall on Ambulance Ave

- The heritage facade is of unreinforced masonry construction with brickwork and sandstone feature arches. The façade is generally in a poor condition
- The unreinforced masonry construction makes the masonry facade susceptible to slight ground movements and ground borne vibrations from excavation.

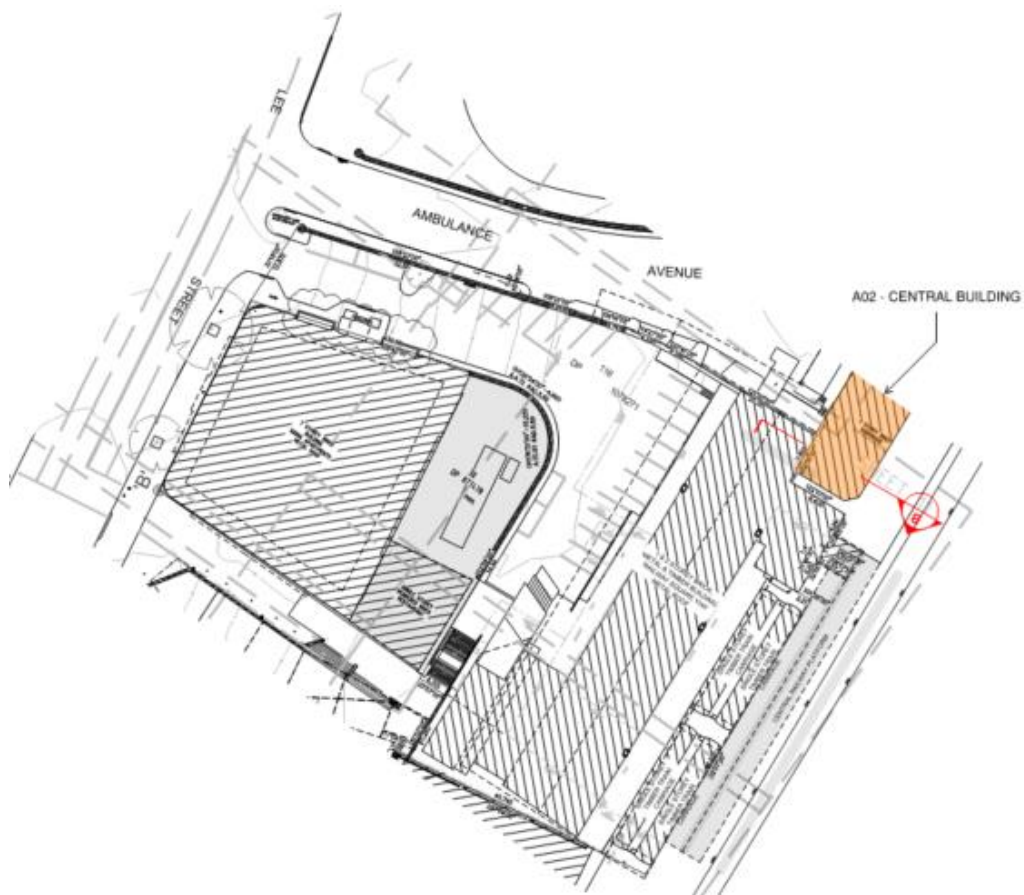
Figure 7: Plan View of Central Building

- The heritage façade of the central building is of unreinforced masonry construction with brickwork and sandstone feature arches. The façade is generally in a reasonable condition for age.
- The unreinforced masonry construction makes the masonry facade susceptible to slight ground movements and ground borne vibrations from excavation.

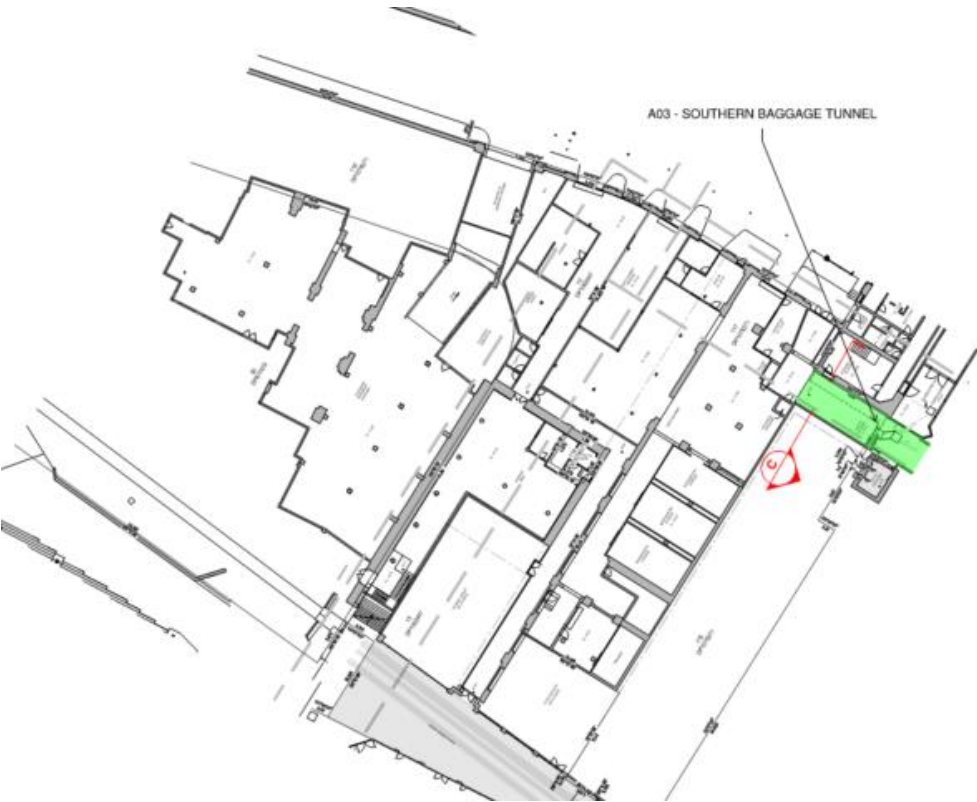
Figure 9: Plan View of Baggage Tunnel

- The baggage tunnel is of unreinforced arched concrete construction. The tunnel structure is generally in a reasonable condition for age.
- The unreinforced concrete construction makes the baggage tunnel susceptible to slight ground movements and ground borne vibrations from excavation.

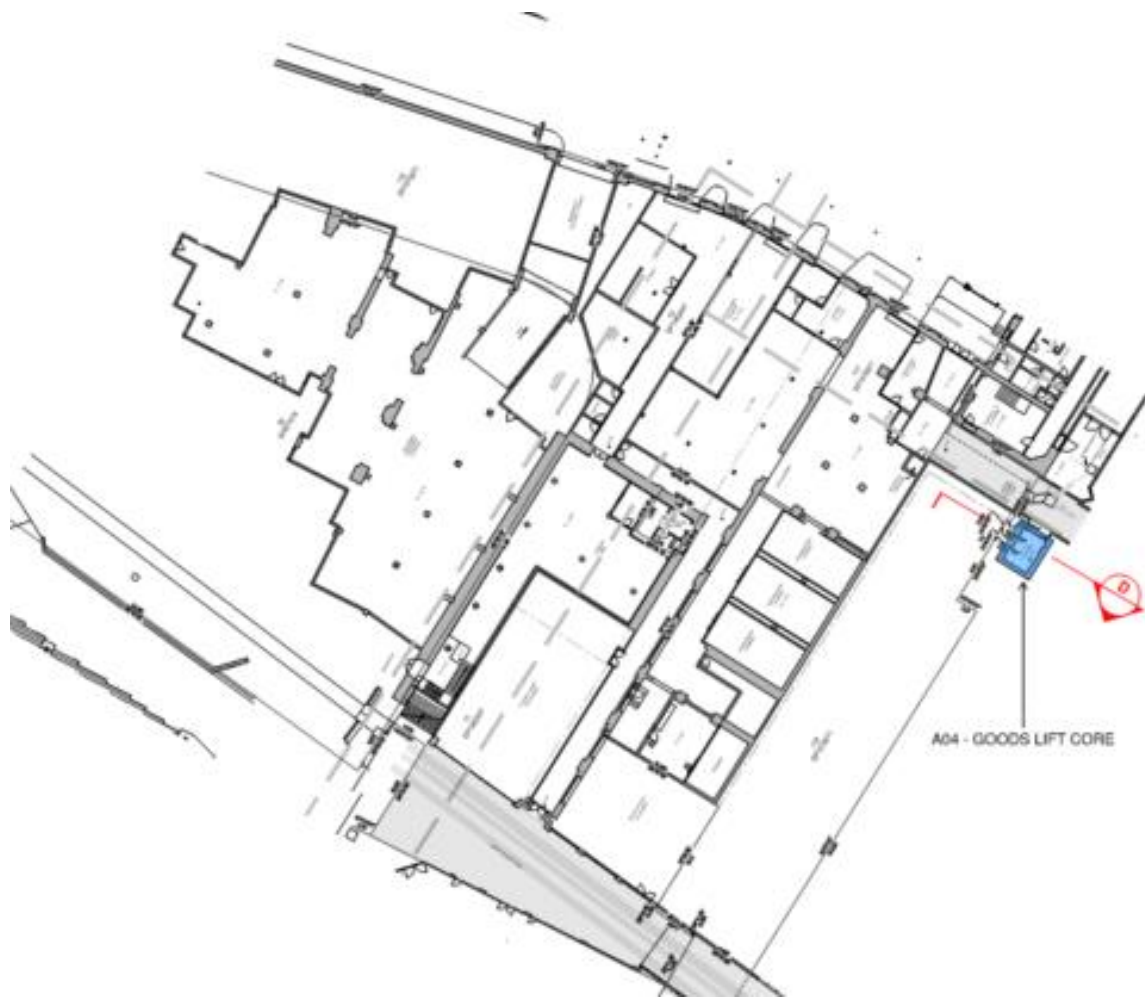
Figure 11: Plan View of Goods Lift Core

- The baggage tunnel is understood to be of unreinforced concrete construction. The lift structure is awaiting investigations to confirm however appears to generally be in a reasonable condition for age.
- The unreinforced concrete construction makes the goods lift susceptible to slight ground movements and ground borne vibrations from excavation.

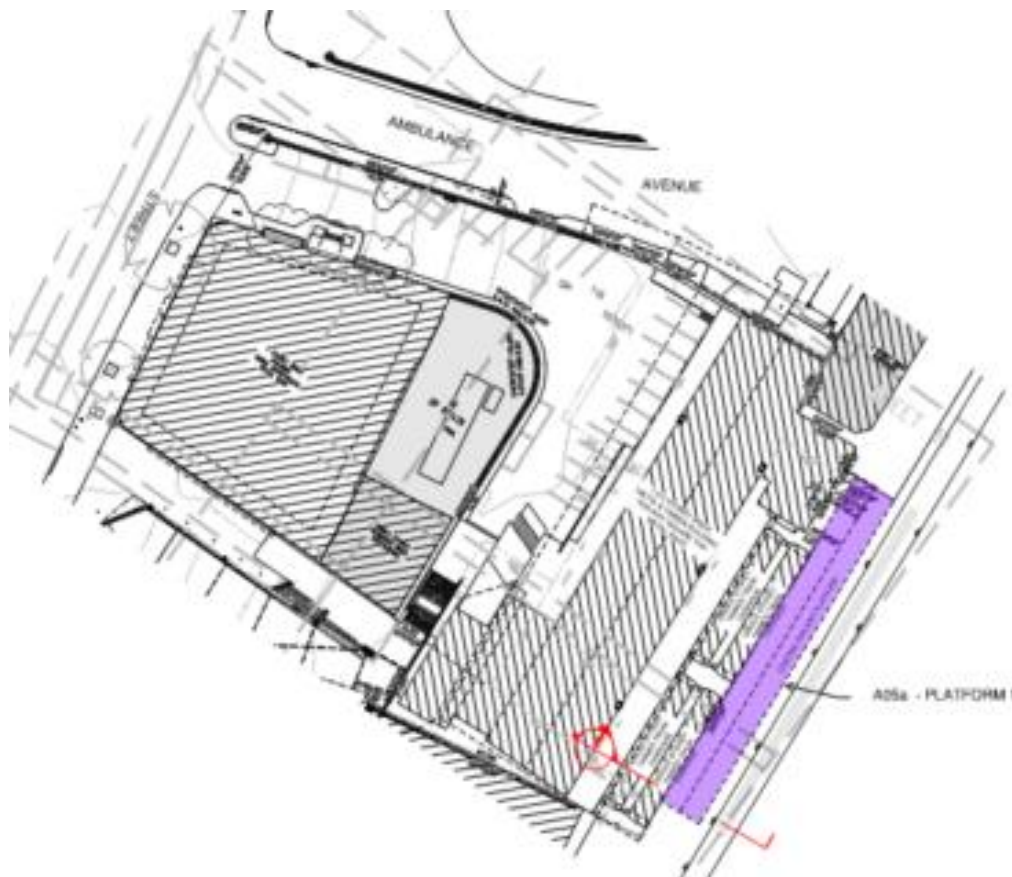
Figure 13: Plan View of Platform 1

- Platform 1 is understood to consist of a reinforced concrete slab bearing onto unreinforced masonry walls with unreinforced concrete footings. The platform structure appears to be in reasonable condition for age.
- The unreinforced masonry construction makes the platform susceptible to slight ground movements and ground borne vibrations from excavation.
