TEMPORARY HERITAGE PROTECTION PLAN

Atlassian Central

Prepared for
BUILT
6 June 2022

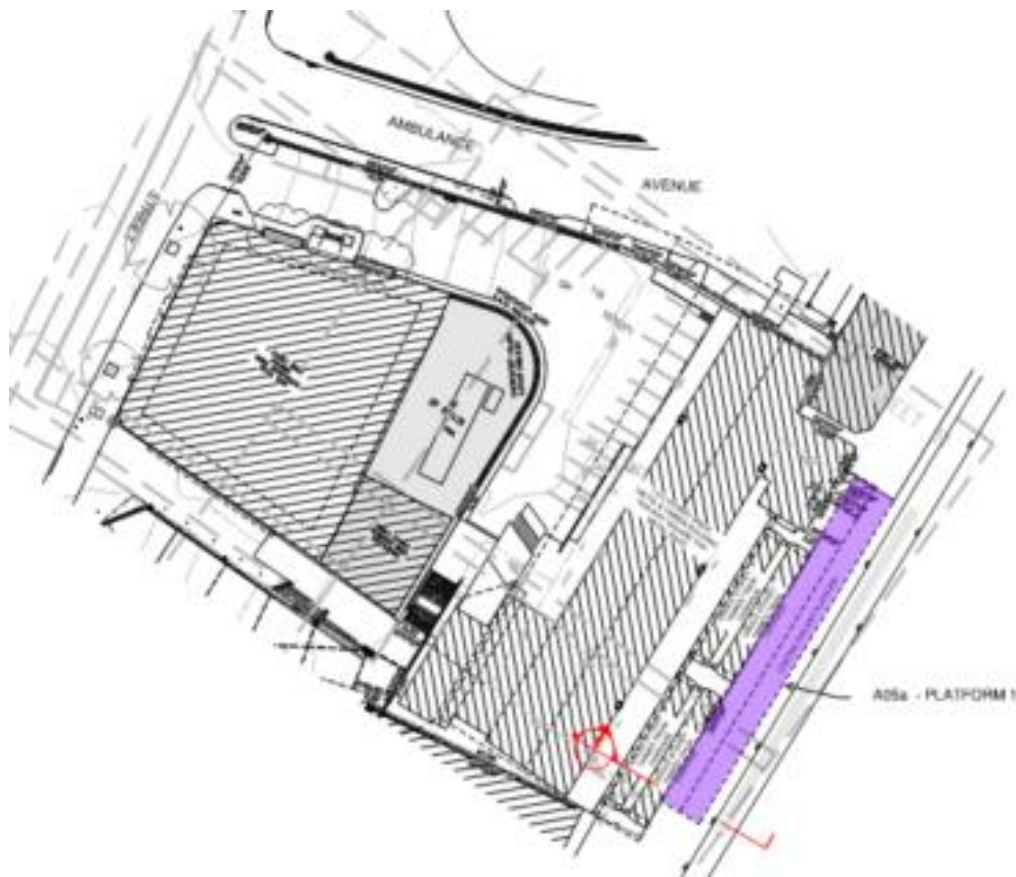
Figure 15: Plan View of Platform 1

- Platform 1 stormwater pipe is assumed to be constructed of unreinforced concrete
- The unreinforced concrete construction makes the pipe susceptible to slight ground movements and ground borne vibrations from excavation.
- Based on the underground location, it is recommended that monitoring for this asset is based on platform movement / vibration or a similar rigid adjacent structure

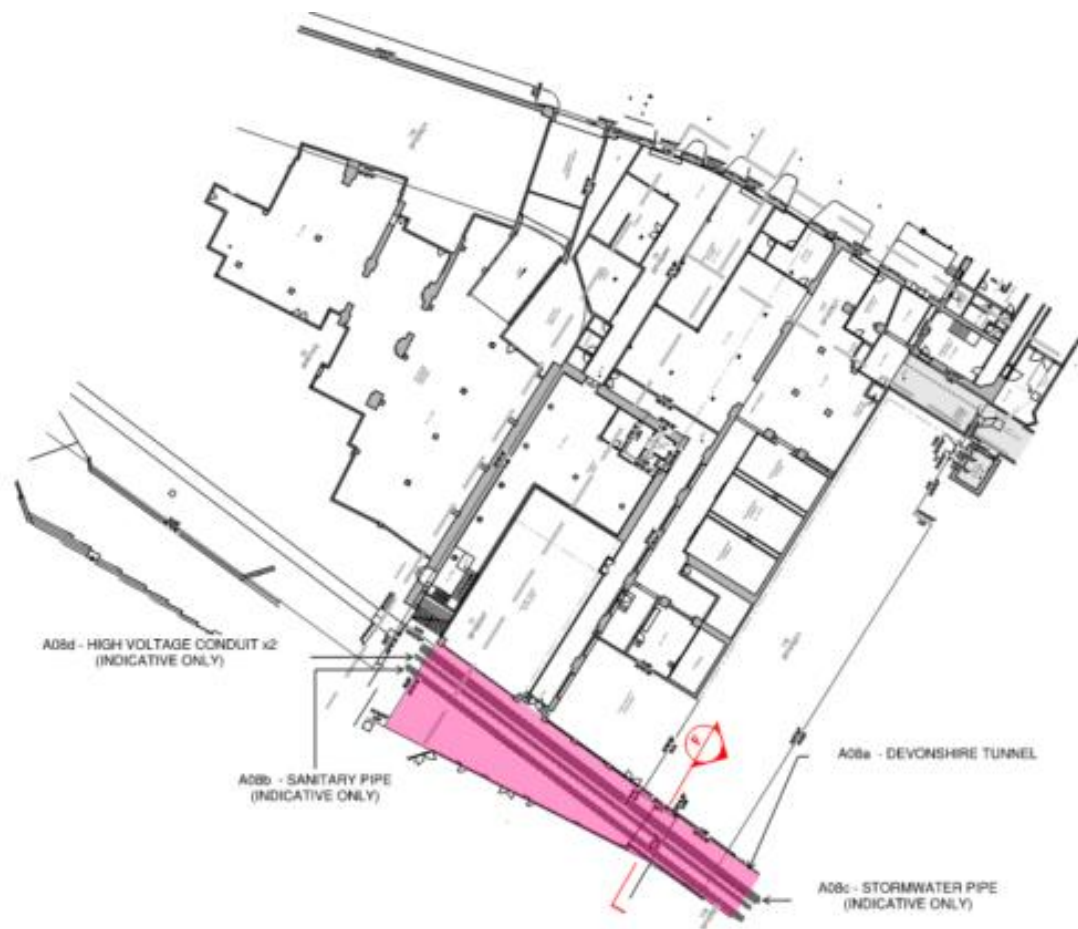
Figure 21: Plan View of Devonshire Street Tunnel and Sewer Pipes Below

- Existing drawings for the 400 mm sewer pipe (Clisdell St Carrier) show it is vitrified clay pipe laid in a trench and cast completely in concrete with a minimum thickness of 150 mm.
- A CCTV condition assessment of the sewer pipe was undertaken by SureSearch. The results of which show that the sewer pipe has been relined and is in generally good condition.
- The vitrified clay construction makes the pipe susceptible to slight ground movements and ground borne vibrations from excavation and piling.
- Based on the underground location, it is recommended that monitoring for this asset is based on movement / vibration from an adjacent rigid structure

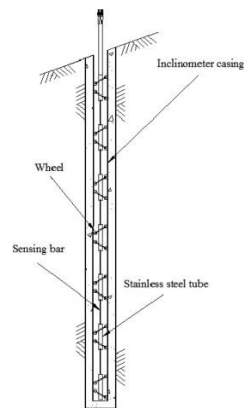
Inclinometer

Installed within grouted boreholes, within piled foundations or piled walls

Measures lateral movement (displacement) with depth

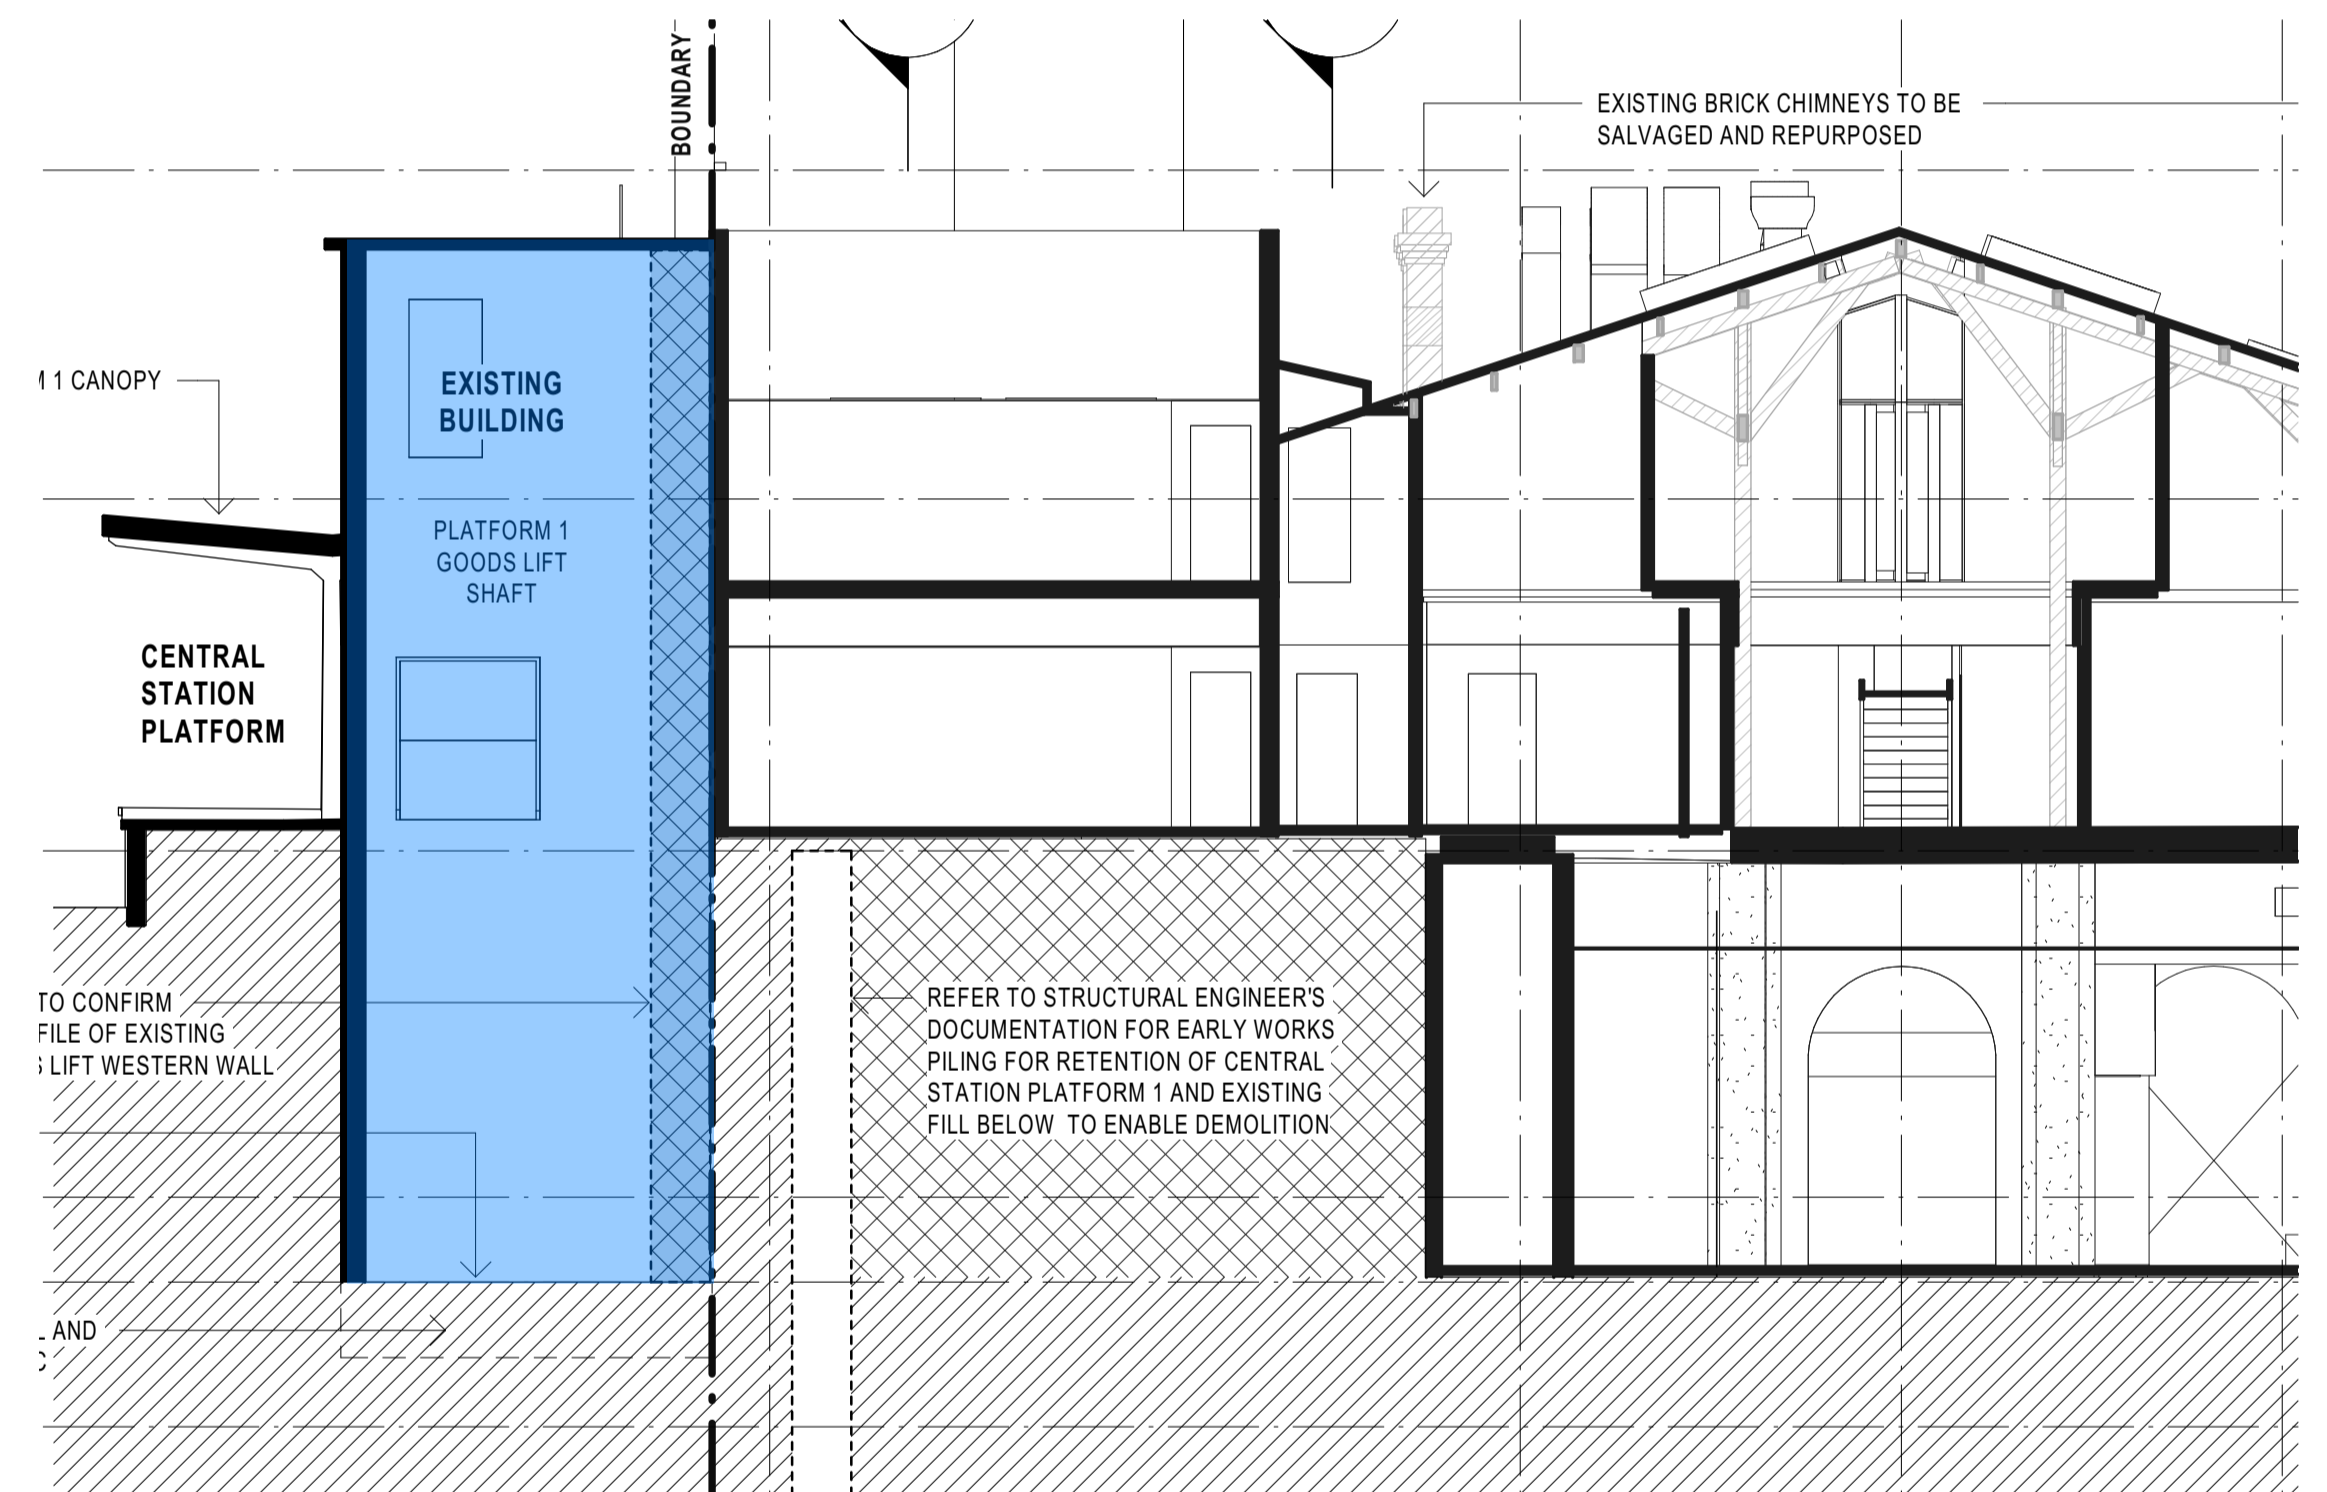
**SECTION D: CROSS-SECTION ELEVATION VIEW OF GOODS LIFT CORE
(BVN DRG AR-23D-GXX-01[5])**

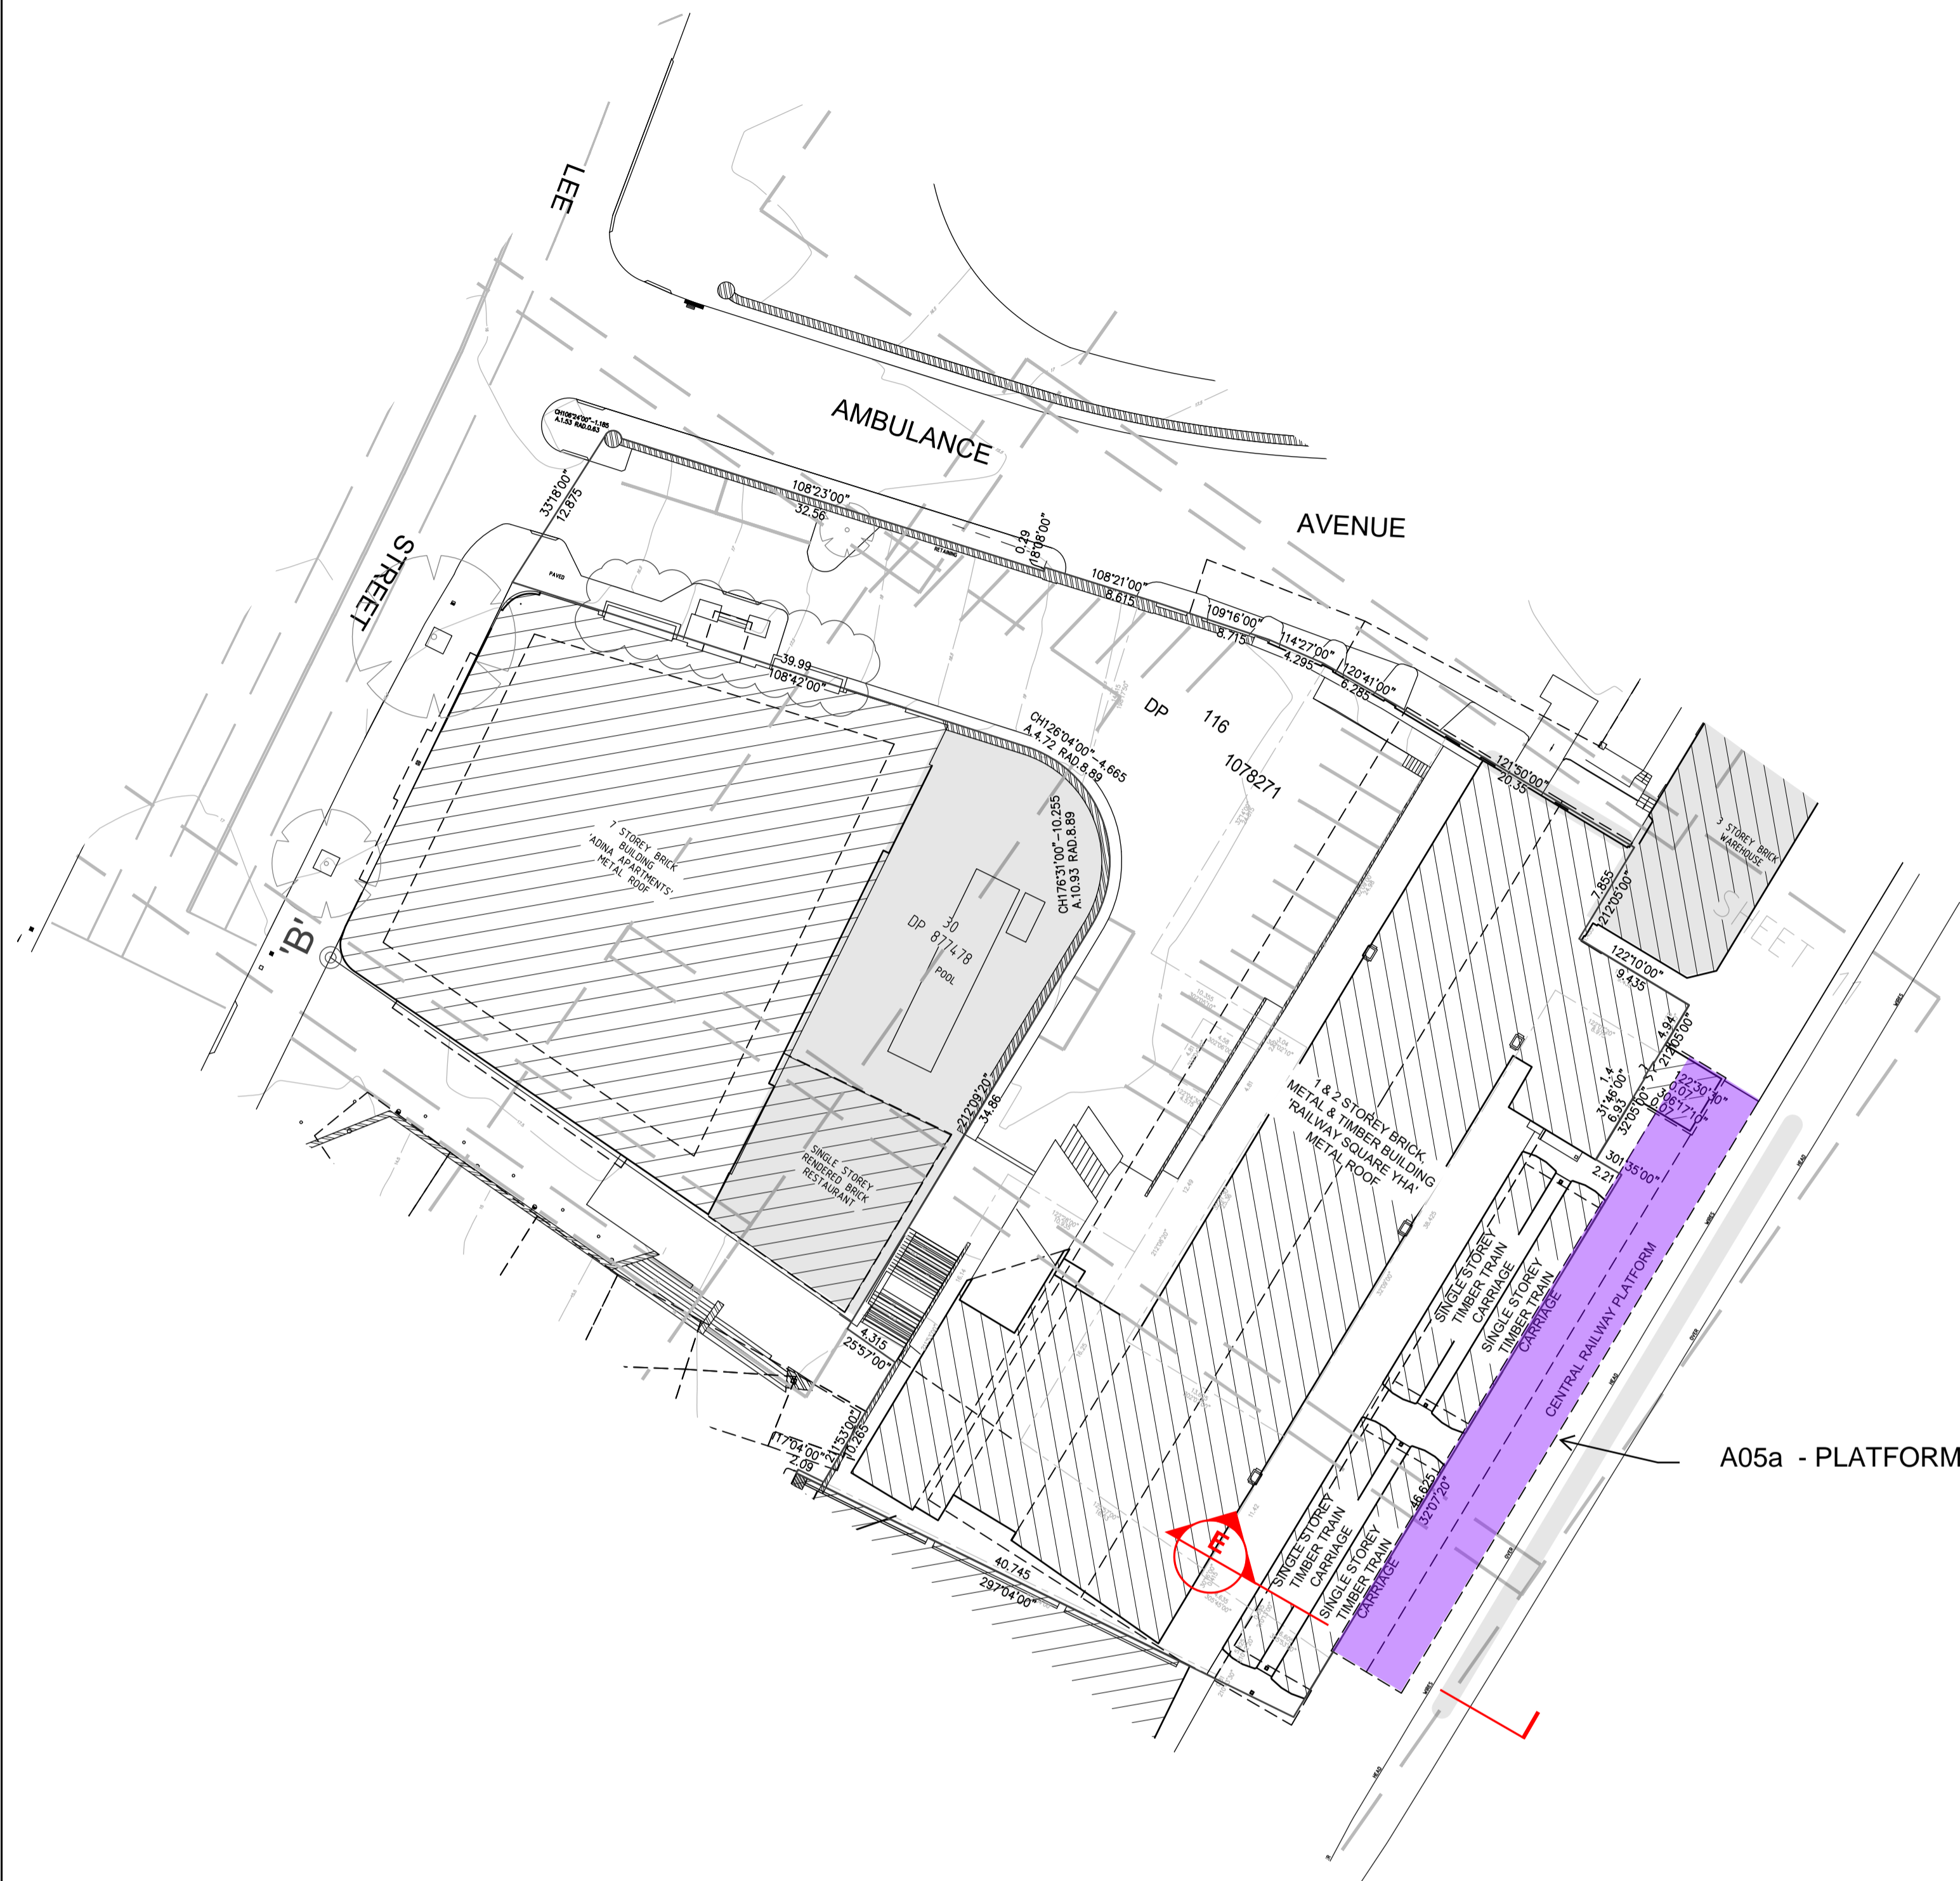
PLAN VIEW OF PLATFORM 1
(LTS LOCKLEY DRG 50176 001DT[T])

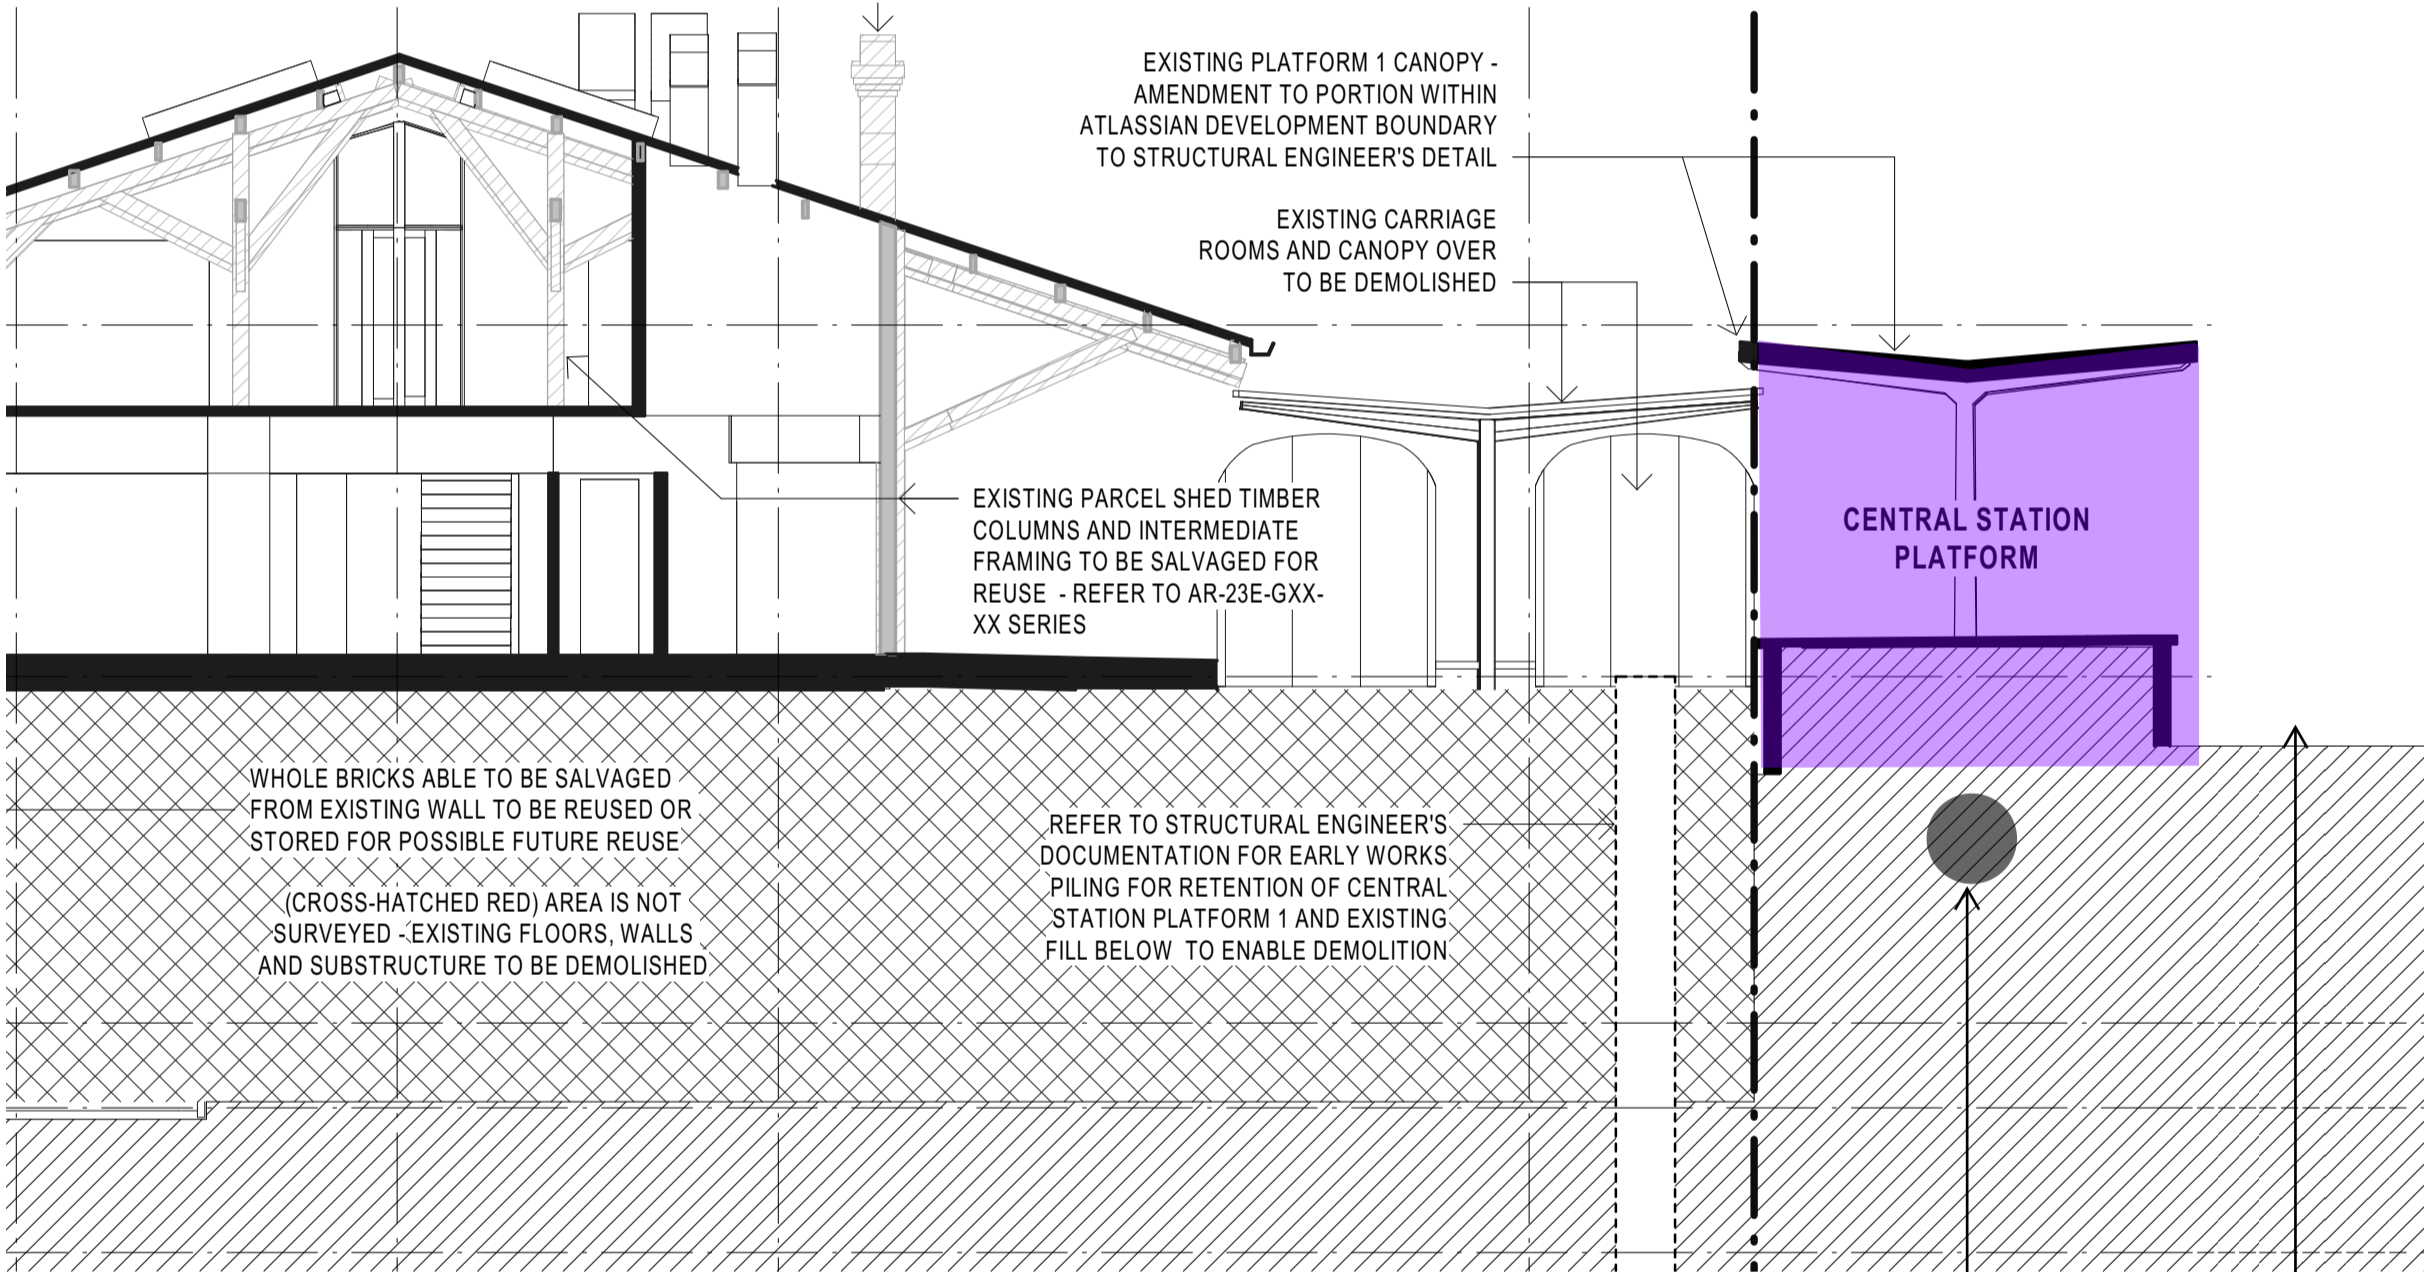
SECTION E: CROSS-SECTION ELEVATION VIEW OF PLATFORM 1
INCLUDING A05b (PLATFORM 1 STORMWATER PIPE) AND A06 (UP MAIN)
(BVN DRG AR-23D-GXX-02[5])

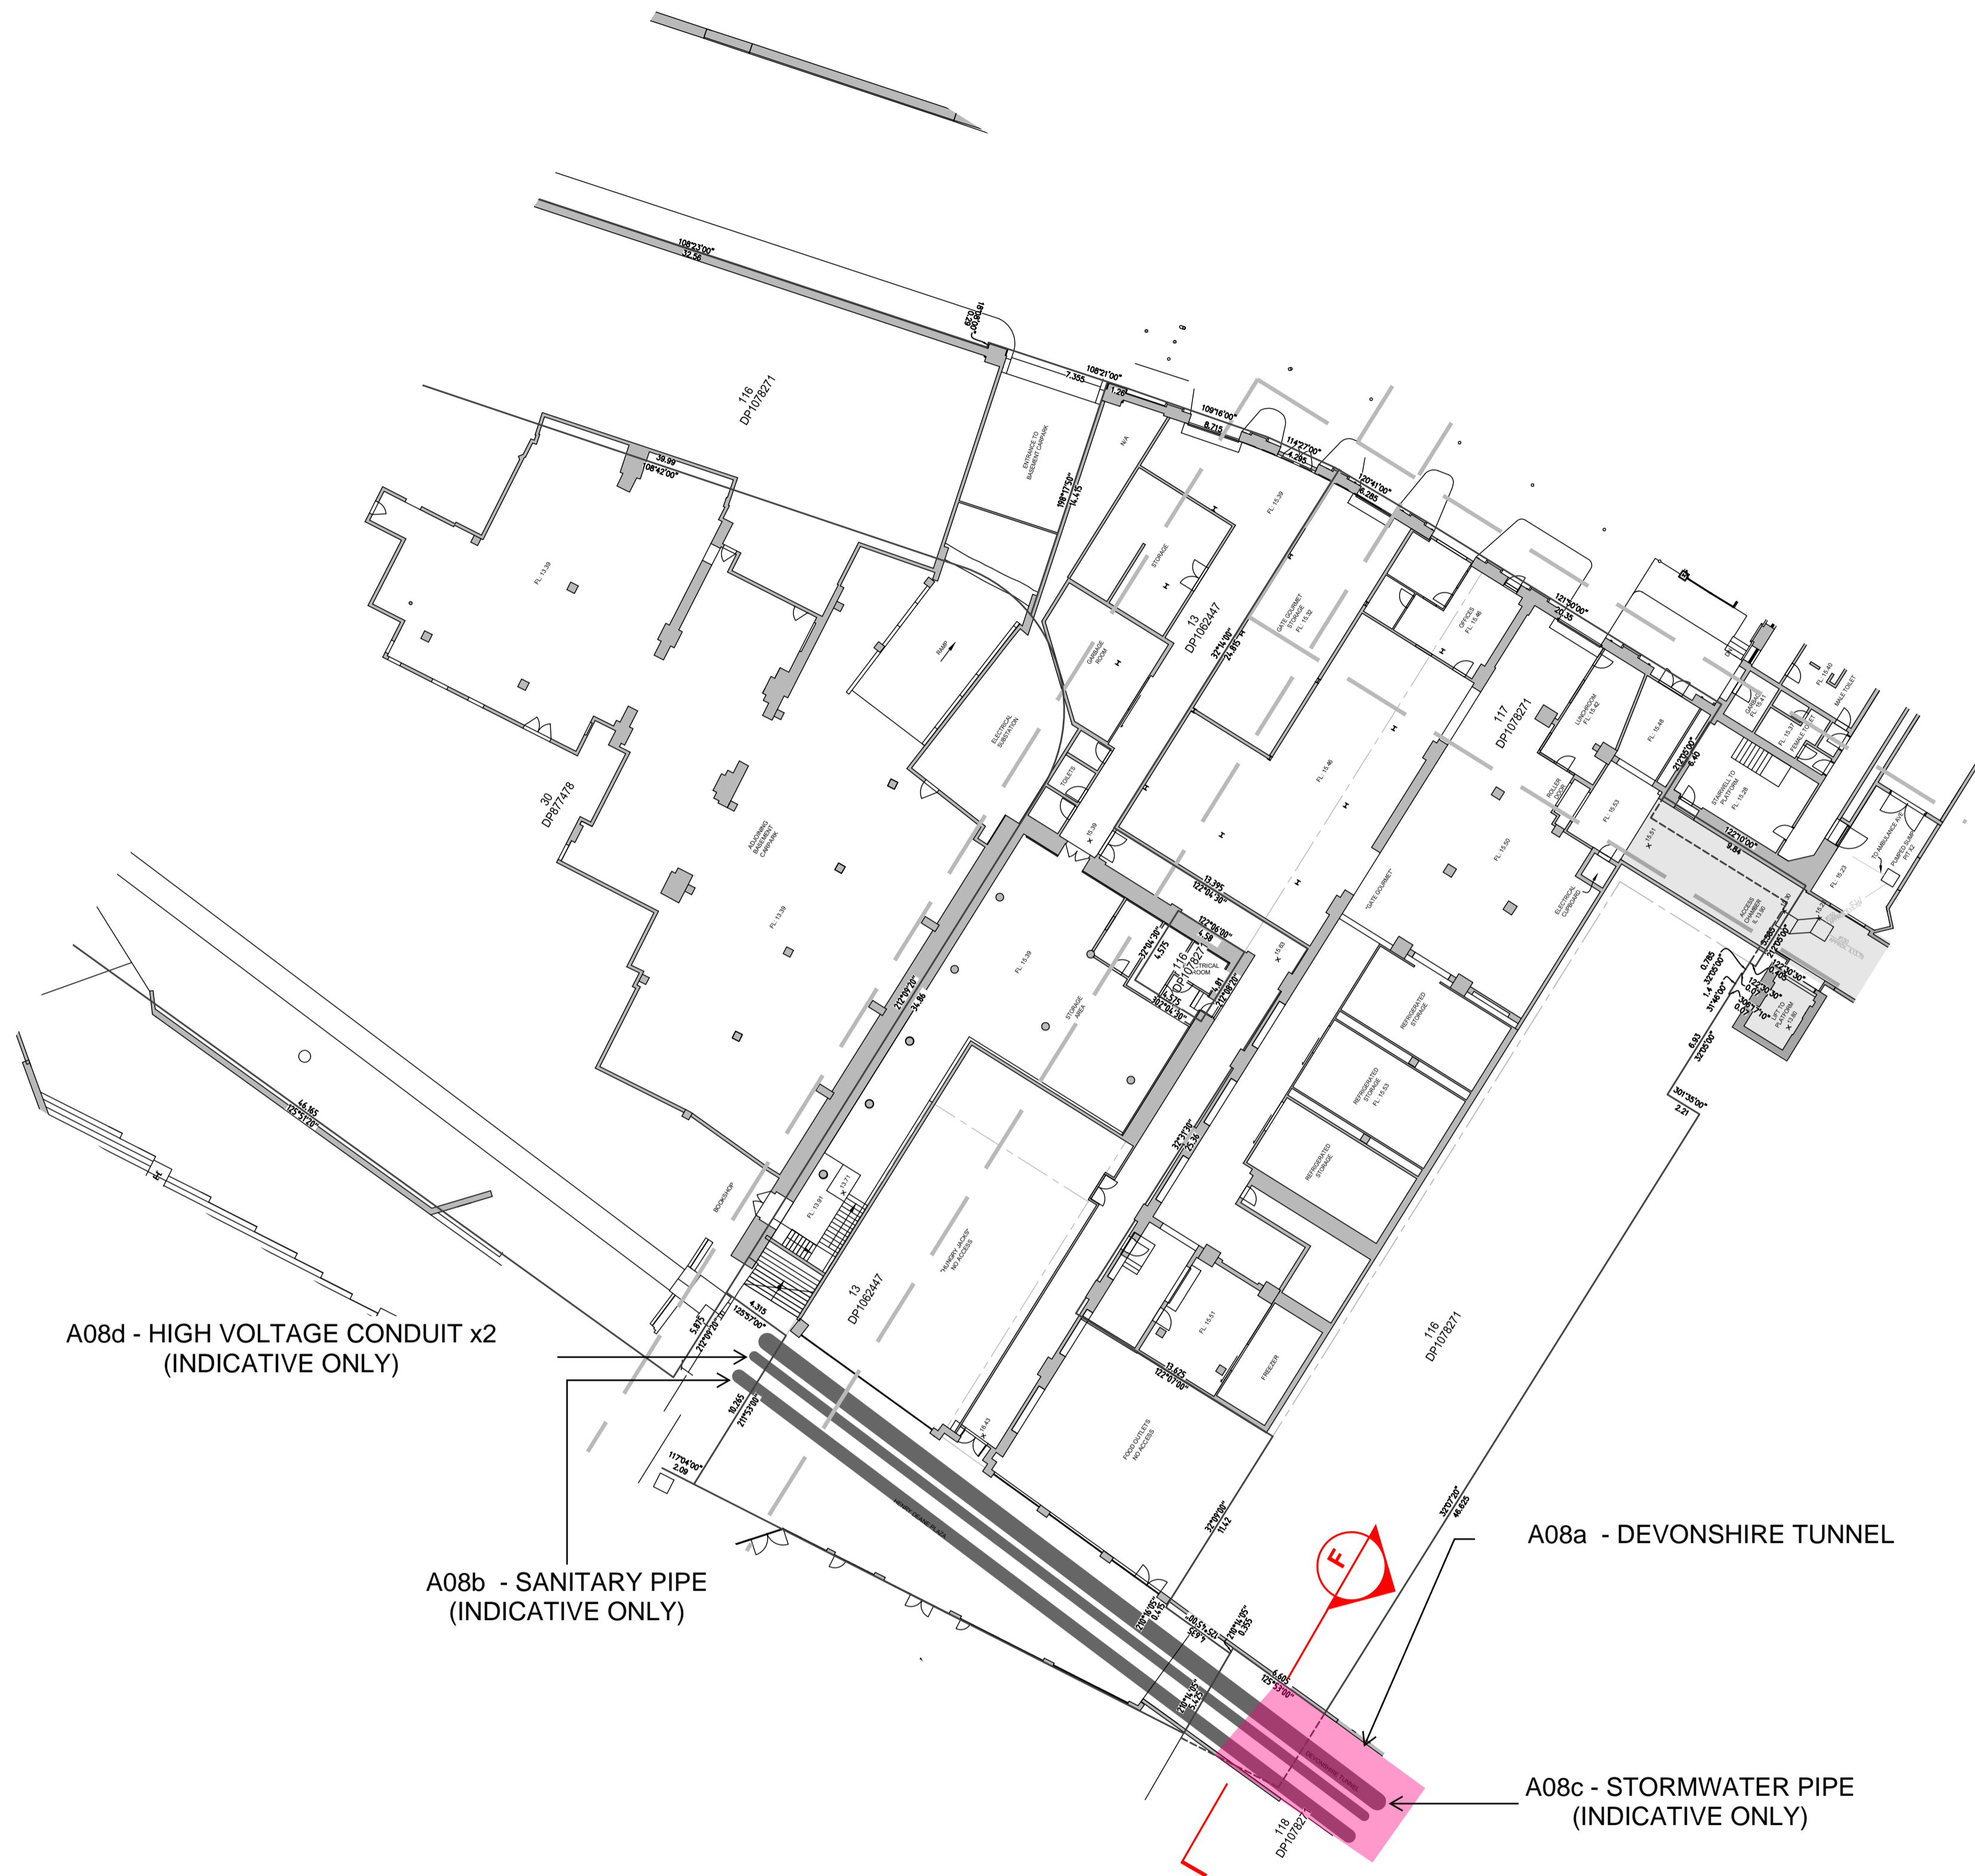
PLAN VIEW OF DEVONSHIRE STREET TUNNEL AND INDICATIVE LOCATION OF SERVICES
(LTS LOCKLEY DRG 50176 001DT[T])

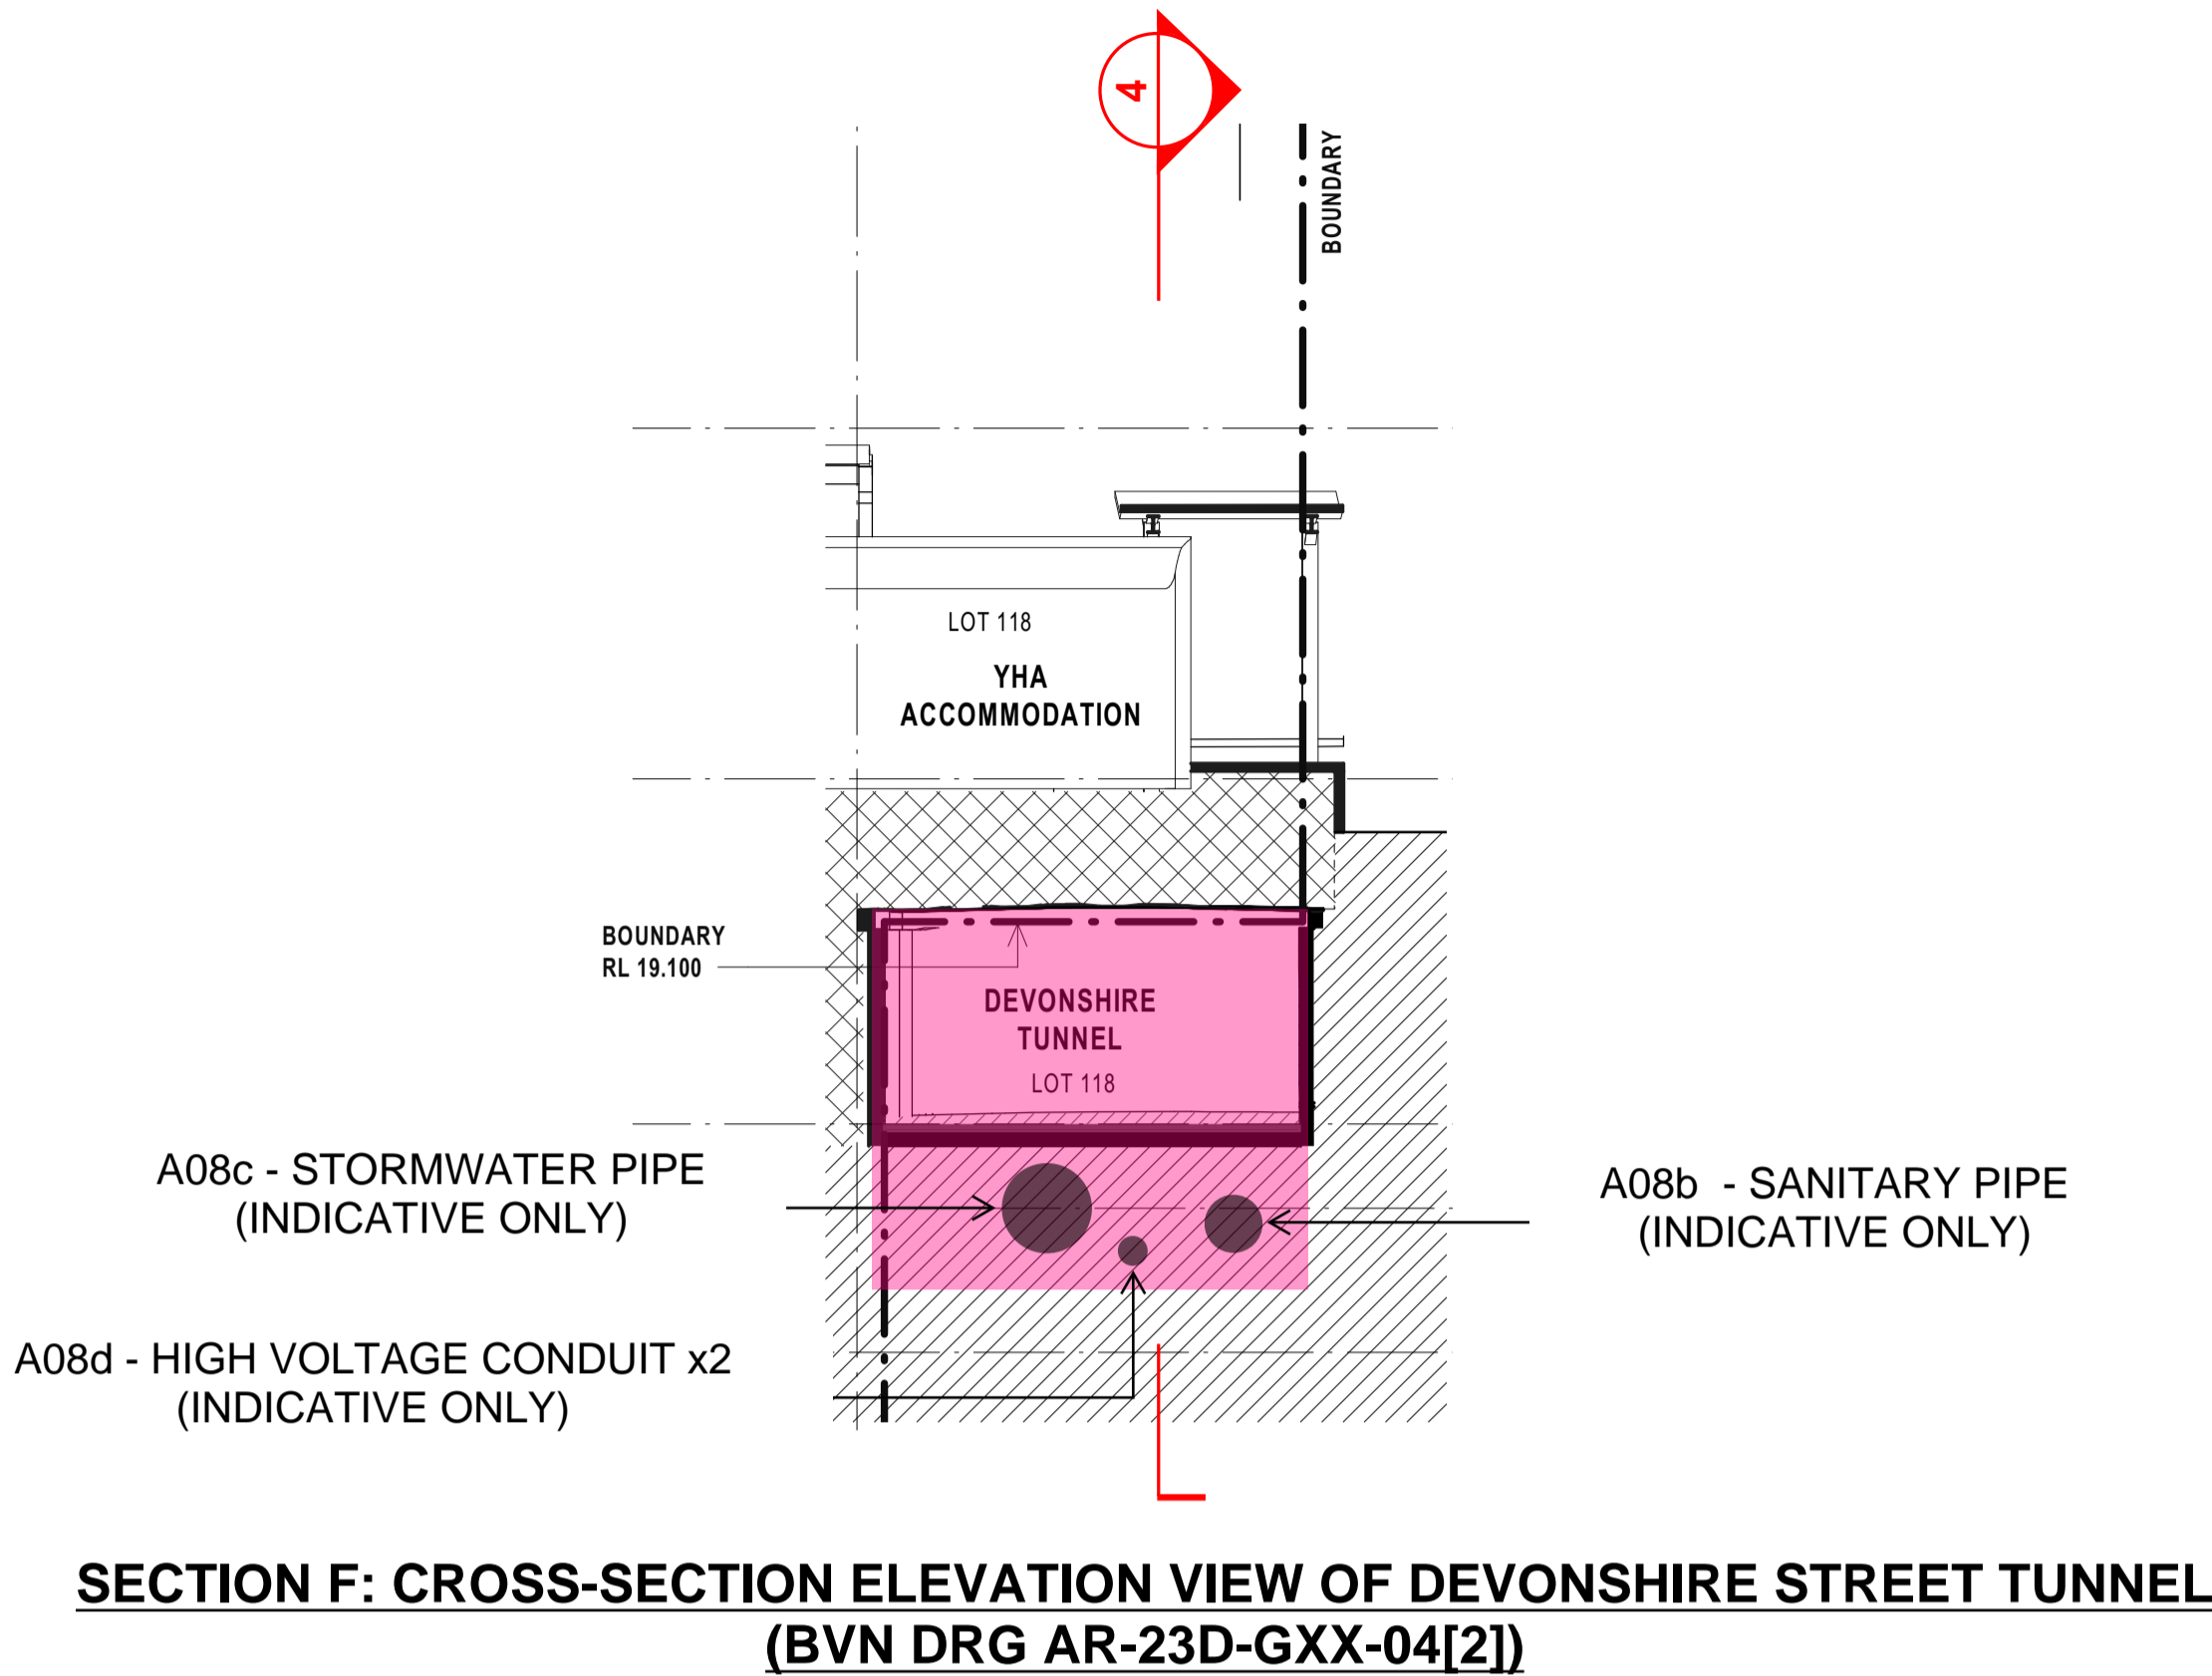
SECTION F: CROSS-SECTION ELEVATION VIEW OF DEVONSHIRE STREET TUNNEL
(BVN DRG AR-23D-GXX-04[2])

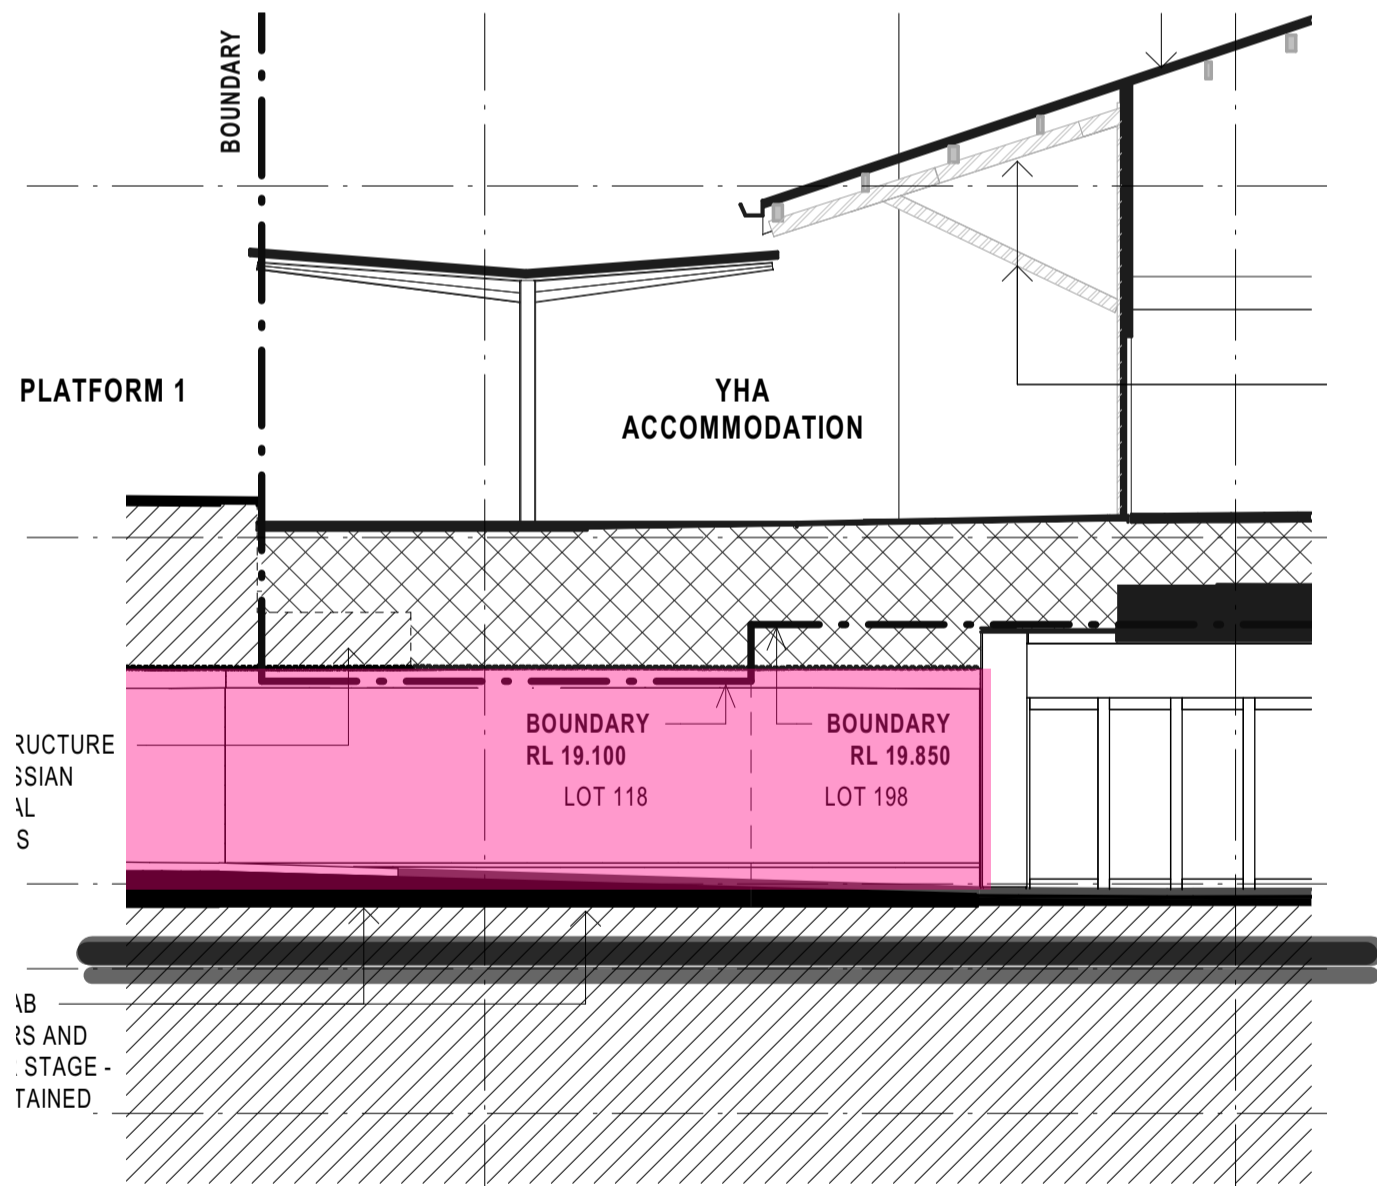
SECTION 4: CROSS-SECTION ELEVATION VIEW OF DEVONSHIRE STREET TUNNEL
(BVN DRG AR-23D-GXX-04[2])
