**UG4 LONGWALLS 401 TO 408  
BUILT FEATURES  
MANAGEMENT PLAN  
ULAN COAL MINES PTY  
LIMITED**

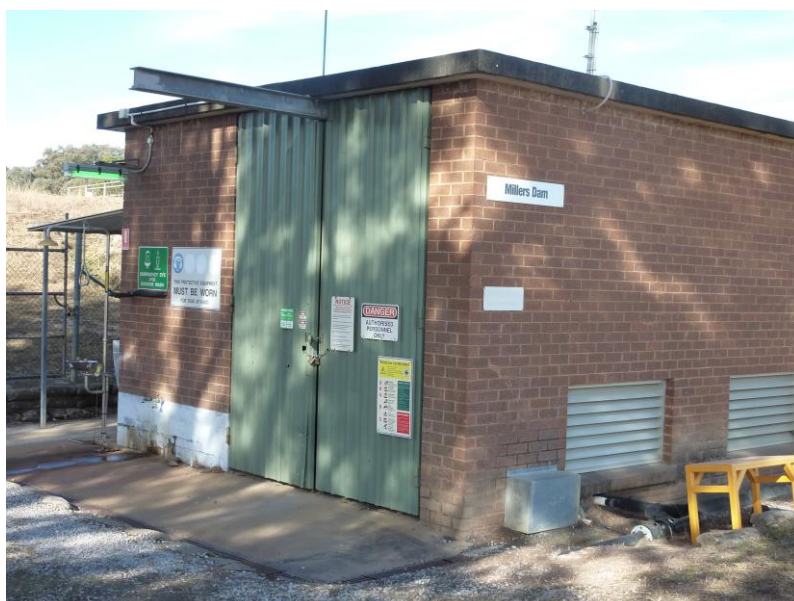
Figure 3 Millers Dam Plant

The Millers Dam Compound is located to the west of Longwalls 406 and 407. There are three dams 200 m to 310 m from the longwalls. Two of the dams have plan dimensions of approximately 70 m x 30 m and one larger dam has plan dimensions of approximately 85 m x 130 m. Embankments surrounding the dams are up to approximately 2 m height. Other features located 320 m to 350 m from the longwalls include a reverse osmosis plant, two above ground concrete storage tanks, telecommunications tower, cyclone fencing, and pipes and power lines. The detailed features at the Millers Dam Compound are shown in Figure 2 and photographs are shown in Figure 3 to Figure 5. The overhead powerlines are supported on timber poles and are located on the western side of Ulan Road at approximately 400 m from the longwalls.

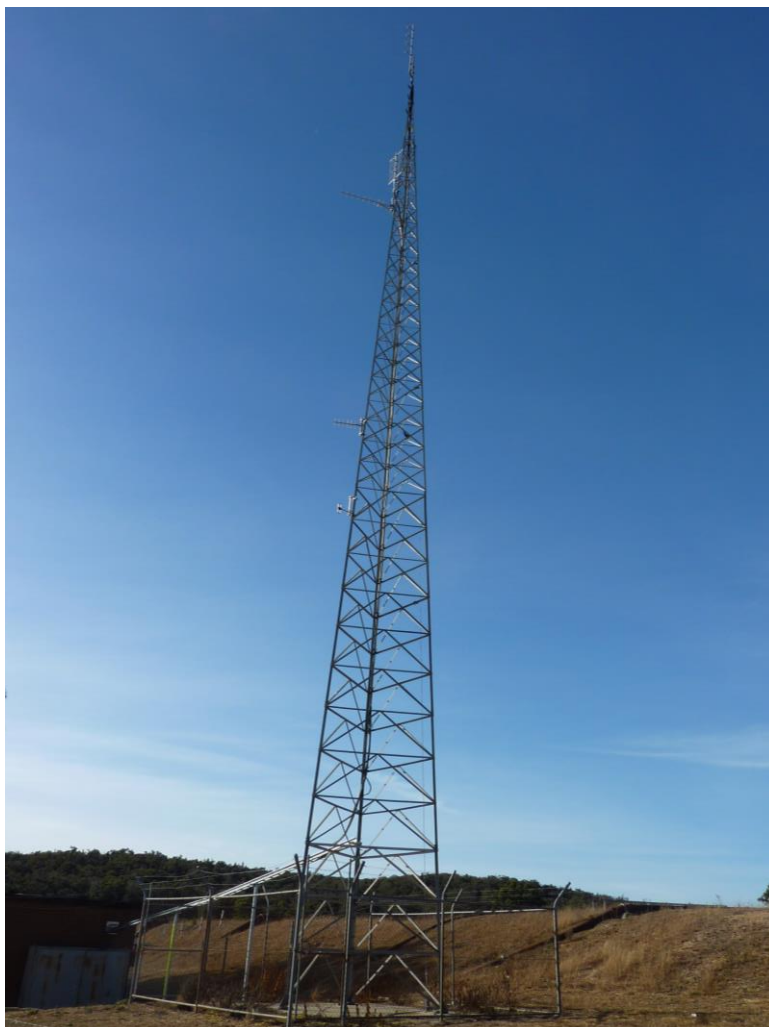
**Figure 4 telecommunications tower and dam embankment**

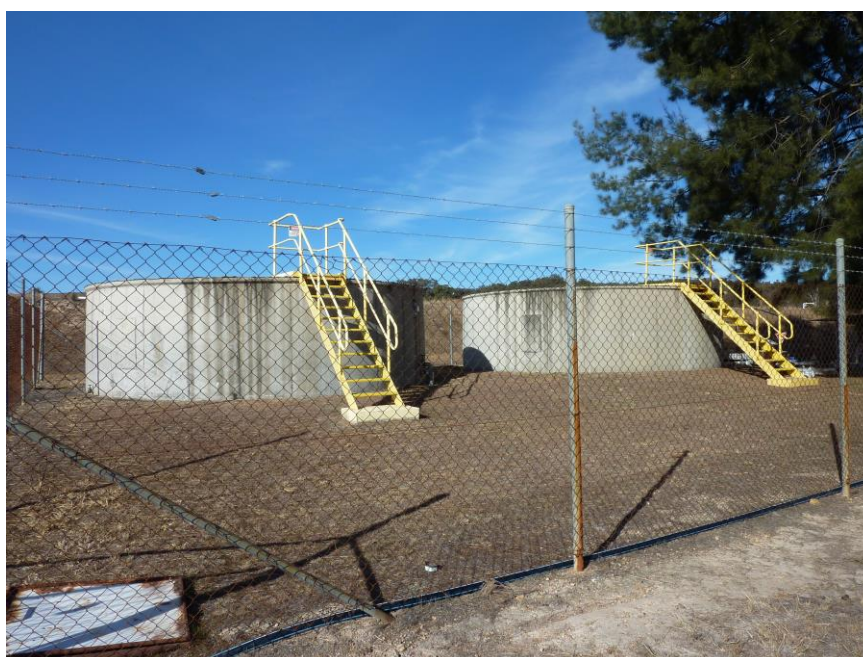
**Figure 5 concrete tanks**
