WOLLONGONG COAL LTD

Russell Vale Colliery: Subsidence Assessment for PC07-08 and PC21-25 Extraction Plan

WCRV5285

Mining Research and Consulting Group

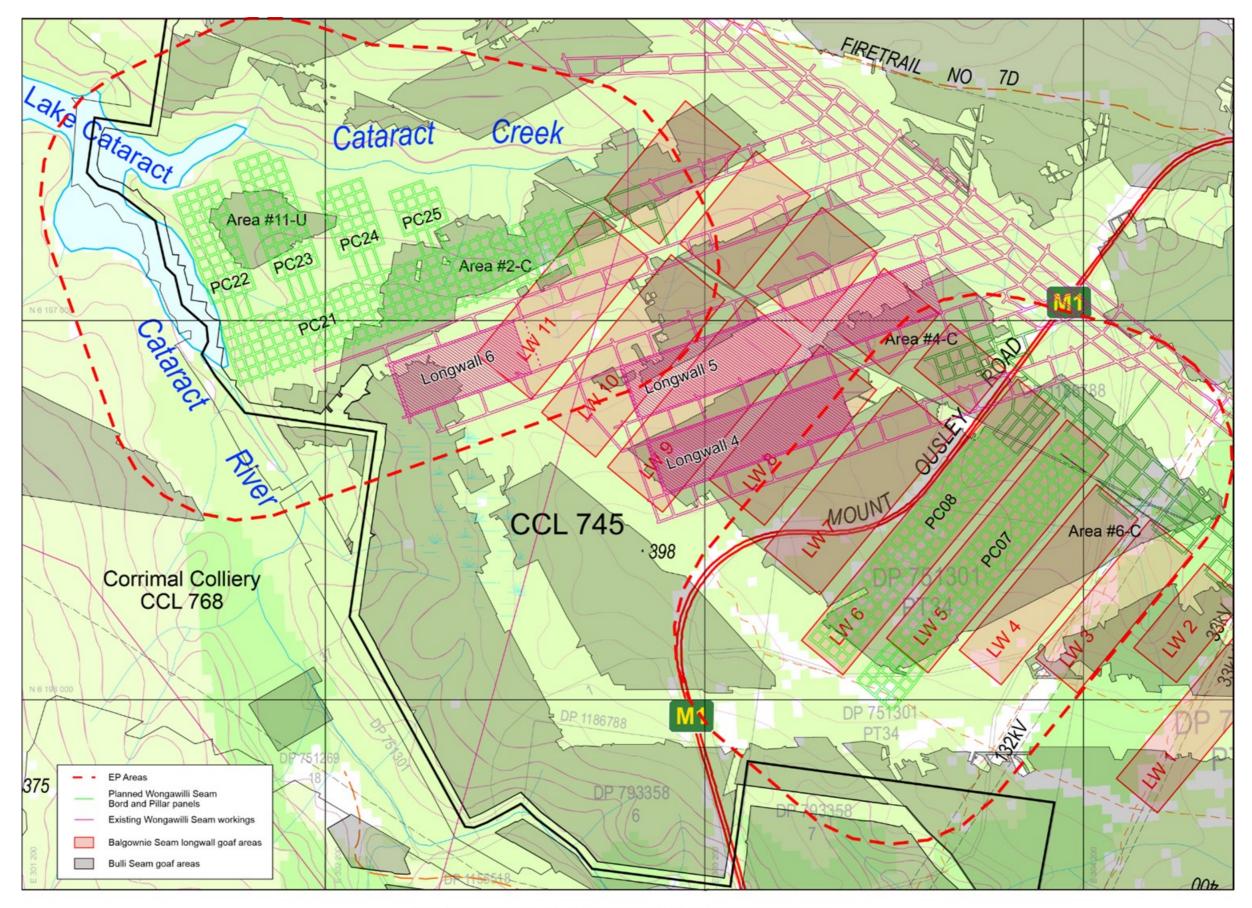
Figure 1 shows a site plan of the existing and planned mining in the Wongawilli Seam and the EP Areas superimposed onto a 1:25,000 topographic map of the area. Secondary extraction areas of the overlying Balgownie and Bulli Seams are also shown. The subsidence assessment presented in this document is based on this plan. Variations to this plan would require reassessment of the subsidence potential.

Figure 1: Site plan superimposed on 1:25,000 topographic map.

We recommend subsidence monitoring for the planned bord and pillar mining shown in Figure 1 includes:

The management plans required by an EP under Condition C10 of MPO9_0013 are expected to be suitable to manage the potential risks and impacts from subsidence effects expected for the planned bord and pillar mining shown in Figure 1.

The EP Areas for PC07-08 and PC21-25 shown in Figure 1 are considered conservative zones where all impacts from the planned mining would be expected to occur and are focus of the assessment of potential subsidence impacts.

As shown in Figure 1, most of PC21 and all of PC22-25 bord and pillar panels are located in areas where there is previous extraction in one seam only, mainly the Bulli Seam. Only a small area of PC21 is below Balgownie Seam Longwall 11 and in this area, the Bulli Seam has only been mined as first workings. Area #11 is the Bulli Seam goaf area located over PC22-24 and is yet to be confirmed as having subsided. Area #2 is located over the eastern area of PC21 and is confirmed as having subsided. Details of the pillar extraction areas on the mine working plans and copies of the recording tracings indicate the dates of mining in these two areas are similar. Dates of mining were 1942-1945 in Area #11 and 1943-1949 in Area #2.

In this section, the maximum subsidence effects for the primary subsidence parameters are estimated for the planned geometry shown in Figure 1.

The mining plan layout and mining sequence for this EP has been revised from that approved by development consent MPO9_0013. This subsidence assessment is for the mining layout shown in Figure 1 and described in detail in Section 3.5.2.

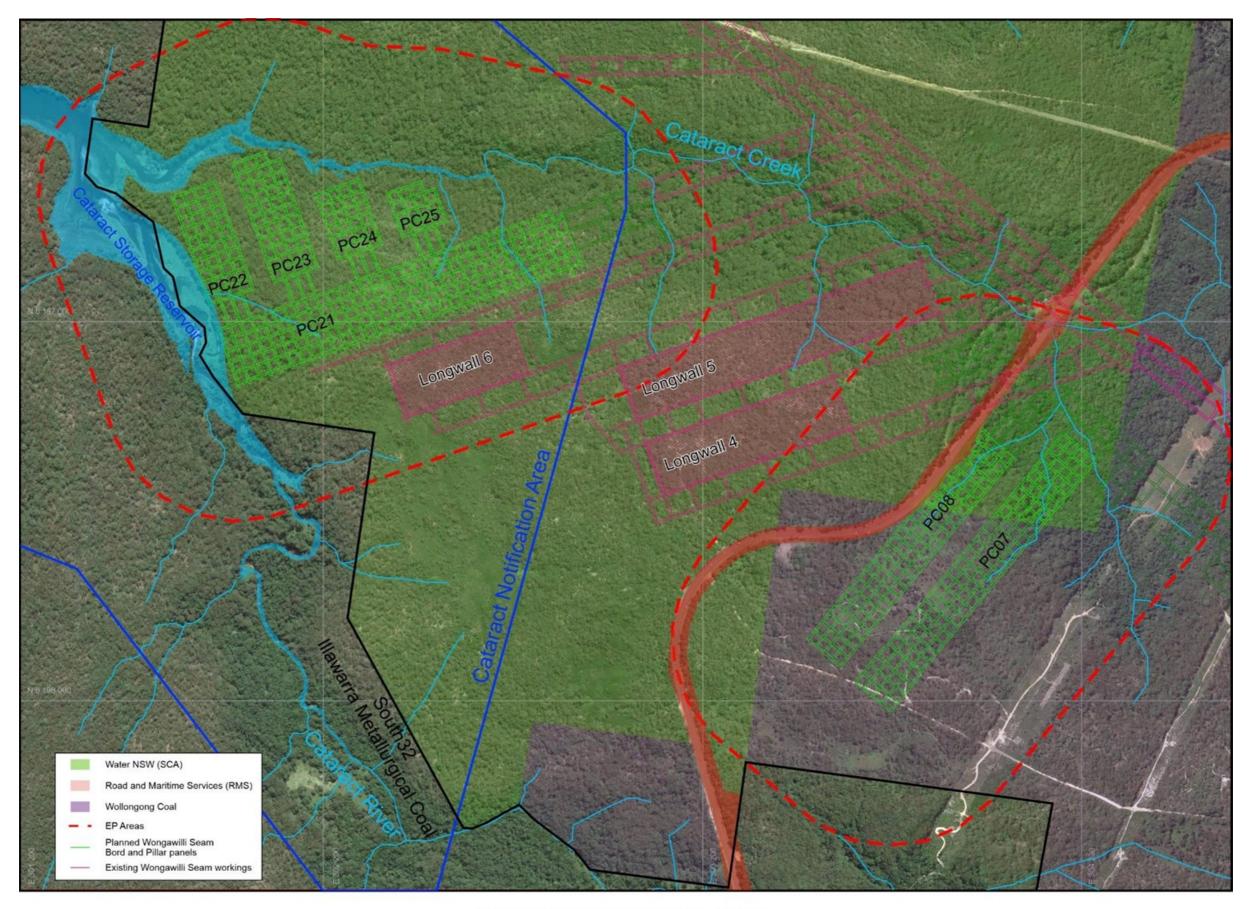
Figure 2 shows the existing and planned workings in the Wongawilli Seam superimposed onto an aerial photograph with vegetation, watercourses, and land ownership details.

Figure 2: Site plan showing land ownership.

Figure 2 shows details of the land ownership within the EP Areas.

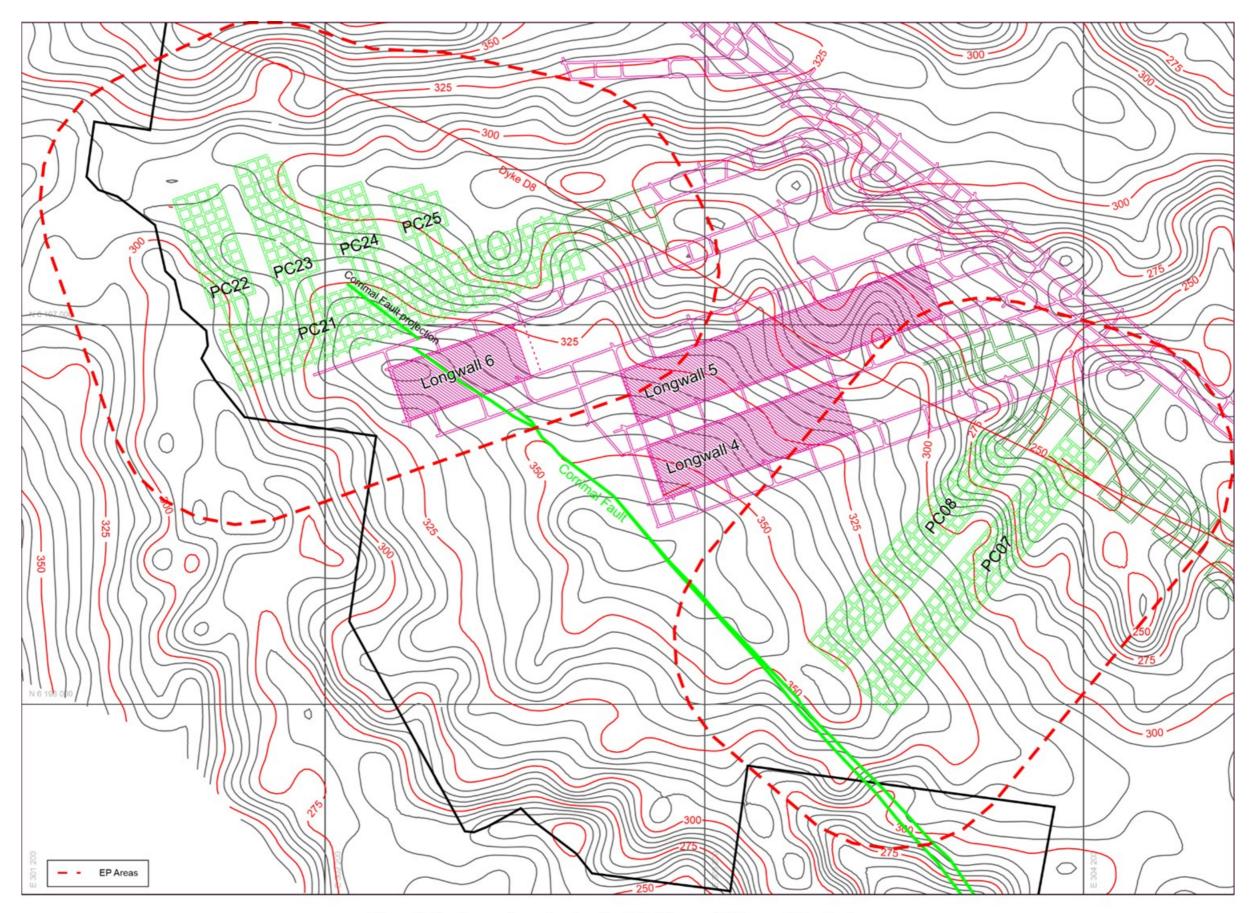
Figure 3 shows the planned mining layout and contours of overburden depth to the mining horizon in the Wongawilli Seam assessed in this report.

Figure 3: Contours of overburden depth to Wongawilli Seam mining horizon.

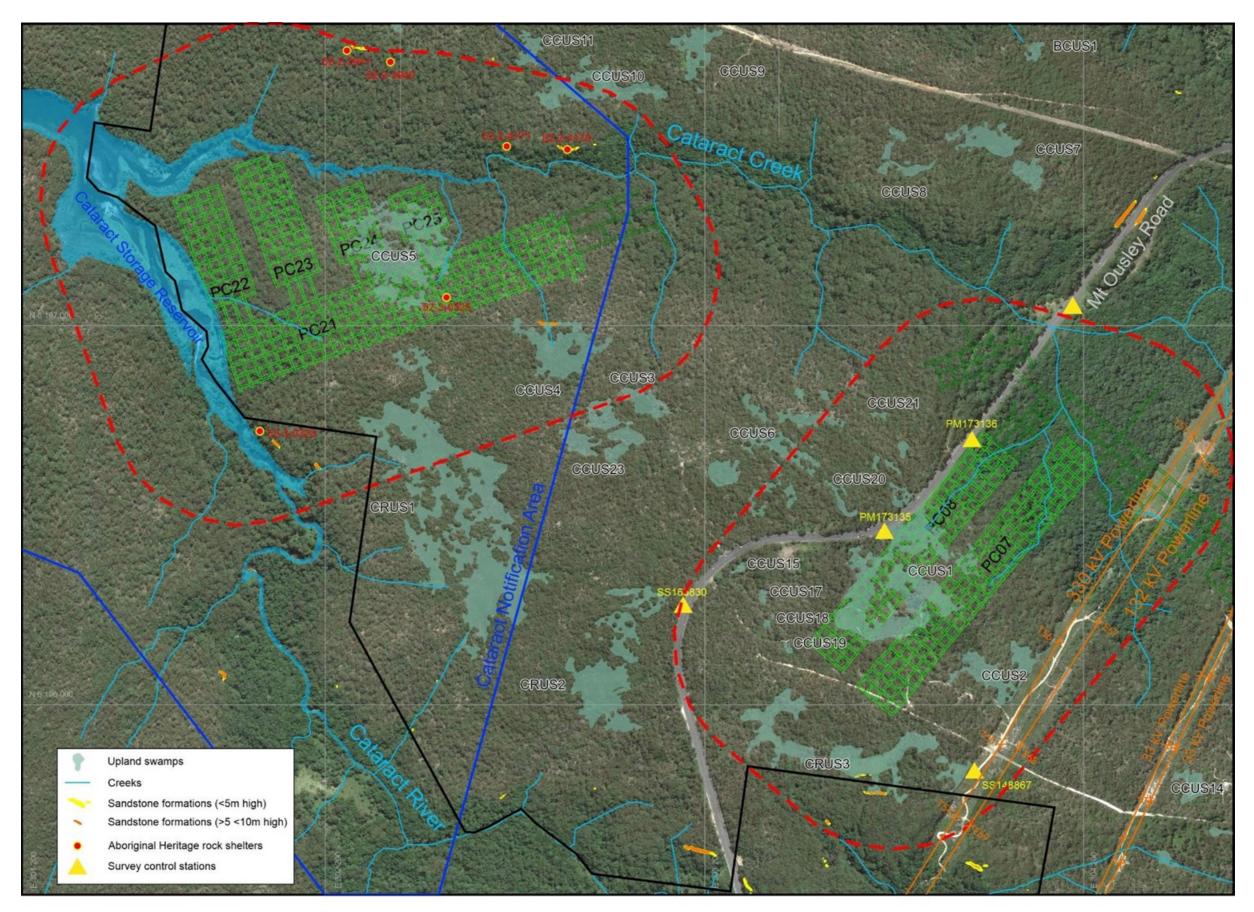
Figure 4 shows the locations of surface features identified within the EP Areas for PC07-08 and PC21-25 during a risk assessment conducted on 10 March 2021. These features are described in this section.

Figure 4: Surface features.

Appendix 6 of MP09_0013 shows two Aboriginal heritage rock shelter sites located (52-3-0323 and 52-3-0325) within EP Area for PC21-25. The positions shown on this plan are inconsistent with previously assessments and recent ground-truthing field work confirms this plan is incorrect. Figure 4 shows the locations of six rock shelter sites (52-3-0323, 52-3-0325, 52-2-4170, 52-24171, 52-2-3940 and 52-2-3941) within the EP Area for PC21-25. Only one site (52-3-0325) located above Bulli Seam goaf Area #2 (confirmed as collapsed) is over the planned bord and pillar panels. No aboriginal heritage sites are located above the EP area for PC07-08.

Natural features considered in this section comprise upland swamps, watercourses, sandstone formations and steep slopes, surface landform and groundwater more generally. Figure 4 shows the locations of these surface features.

Figure 4 shows the locations of six rock shelter sites (52-3-0323, 52-3-0325, 52-2-4170, 52-24171, 52-2-3940 and 52-2-3941) within the EP Area for PC21-25. No aboriginal heritage sites are located above the EP Area for PC07-08.

Built features are shown in Figure 4. Public utilities identified within the EP Areas or in positions with potential to be affected include: Mount Ousley Road, the Cataract Storage Reservoir and overhead electricity transmission lines. Minor infrastructure is limited to unsealed access road/four-wheel drive tracks and survey control stations. There are no public amenities, farmland and facilities, industrial, commercial and business establishments, residential establishments, or items of architectural significance.

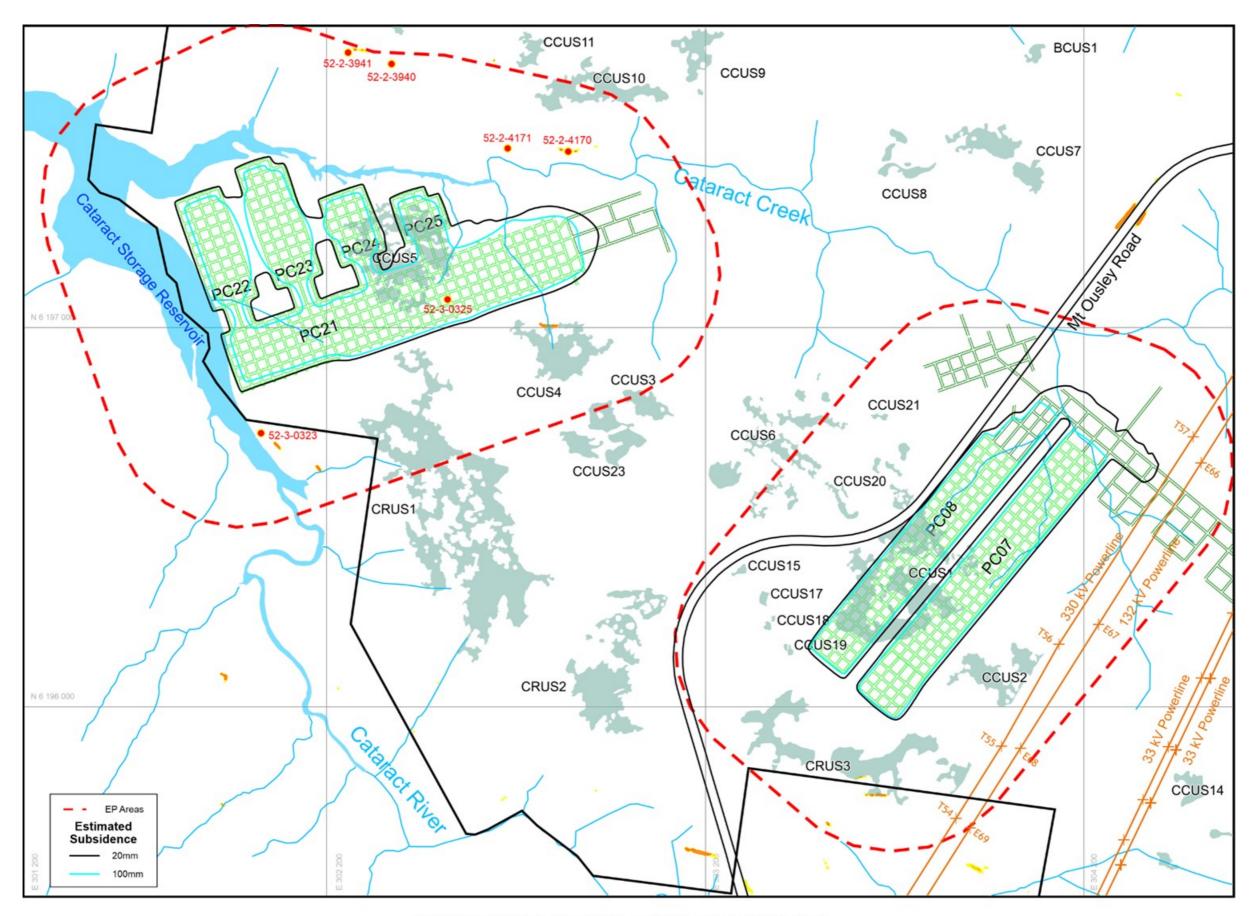
Figure 6 shows contours for the estimated vertical subsidence expected at the completion of the planned bord and pillar panels in the EP Areas. Vertical subsidence from the mining of the planned bord and pillar panels is expected to be less than 100mm and generally less than 30mm within the EP Areas. These levels of subsidence are expected to be imperceptible for all practical purposes.

Figure 6: Estimated subsidence contours and surface features.

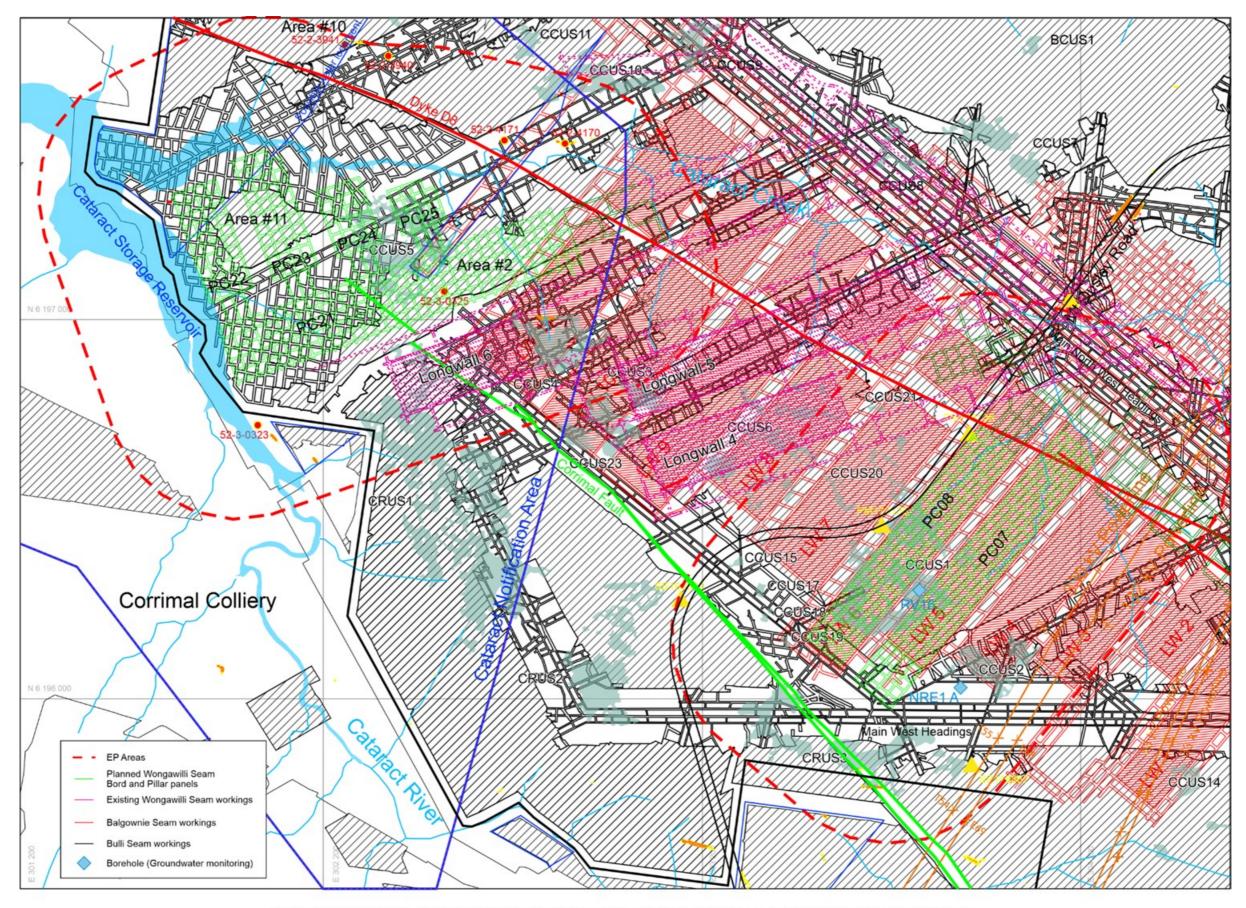
Figure 7 shows the details of the existing Bulli and Balgownie Seam workings and the existing and planned mining in the Wongawilli Seam relative to the EP Areas.

RV16 shown on Figure 7, was drilled down through the collapsed Bulli Seam goaf, through the Balgownie Seam chain pillar between Longwall 5 and 6 and down the Wongawilli Seam floor at approximately 320m depth. Fragments of timber were encountered at the Bulli Seam mining horizon indicating the presence of previous mining activity, but the Bulli Seam mining horizon was observed to be completely compressed. This borehole was not cased through the strata above the chain pillar but was observed to support more than 300m of water head indicating the Bulli Seam mining horizon was tightly compressed.

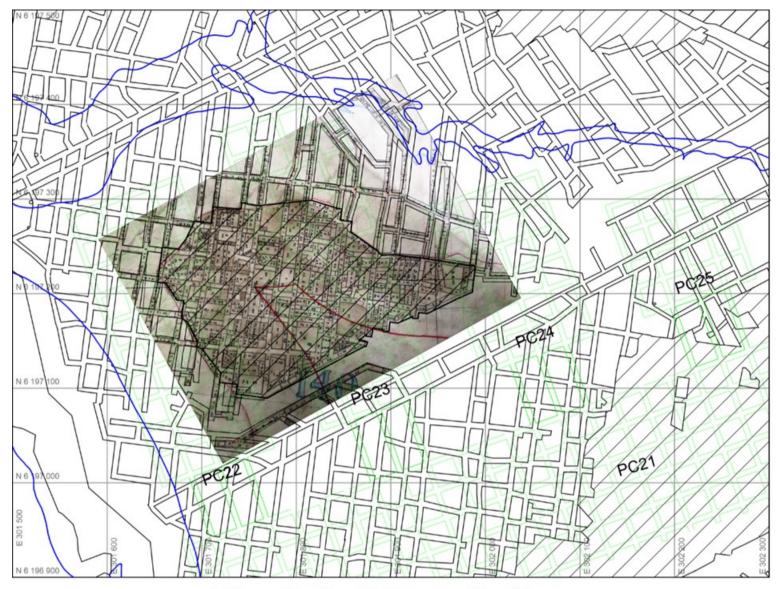
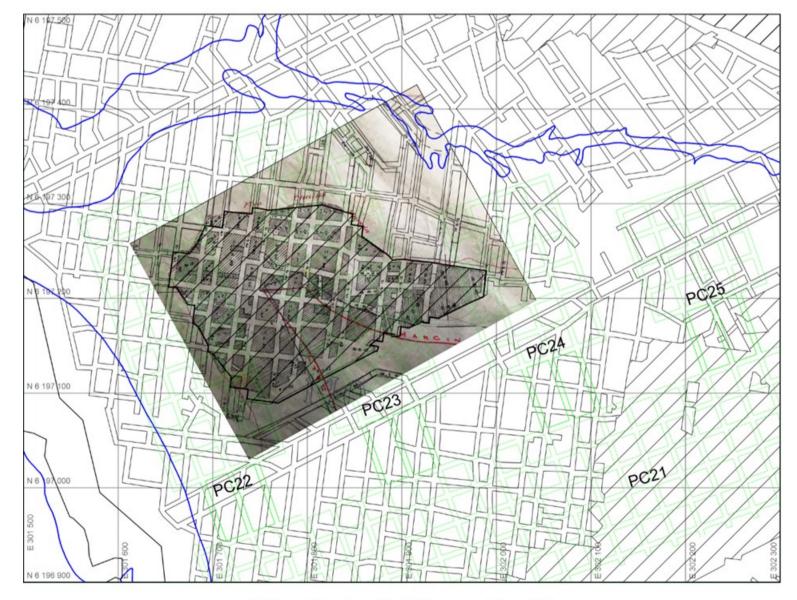
a) Mine working plan of Bulli Seam goaf Area #11.

b) Record tracing of Bulli Seam goaf Area #11.

Figure 8: Example of Bulli Seam mine plan records.

In Area #11, the original mine working plan and record tracing copy indicate the secondary extraction of the first workings pillars was undertaken from 1942 to 1945. Care was taken to show the extraction of pillars and sections of pillars to the limit for secondary extraction around the FSL of Cataract Reservoir allowed at that time. Only two small remnant pillars are shown as not mined, but these are likely to have collapsed at the time of secondary extraction because they are less than 8m wide and 10m long and surrounded by secondary extraction at a depth of 280m. Figure 8 shows sections of the mine working plan and the record tracing copy for Area # 11 demonstrating the reliability of the Bulli Seam records. These are two hand-drawn plans drafted at different times, updated at different intervals, and using different depictions for secondary extraction. Similar records are available for Area #2.

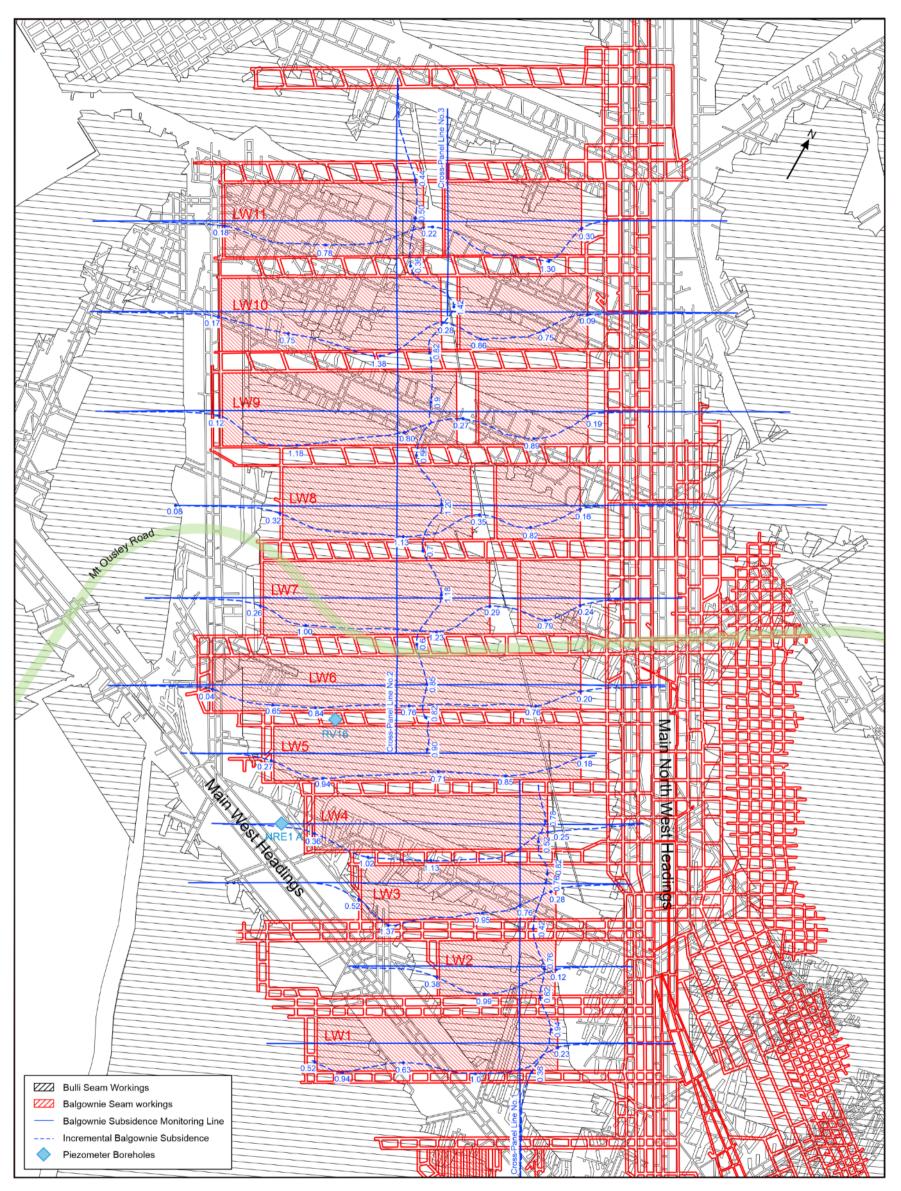
Figure A3.1: Incremental Subsidence measured for Balgownie Seam Longwalls.

For Longwalls 1-6, individual panels are subcritical in a single seam context. The average overburden depth ranges 250-280m. The panel width to depth ratio is 0.51-0.58. In a single seam context, maximum subsidence of 30-40% of the mining height or up to approximately 0.5m would be expected over these early longwalls. However, in the multi-seam environment up to 75% of the mining height or approximately 1.0m would be expected with any latent subsidence being additional. These estimates exclude natural variation for single and multi-seam subsidence.

For the wider Longwalls 7-11, the mining geometry is also subcritical in single seam terms. The average overburden depth ranges 275-280m. The panel width to depth ratio is 0.67-0.69. In a single seam context, maximum subsidence of about 45% of the mining height or approximately 0.7m would be expected over these later longwalls. However, in the multi-seam environment up to around 75% of the mining height or up to 1.2m could be expected excluding any latent subsidence. These estimates exclude natural variation.

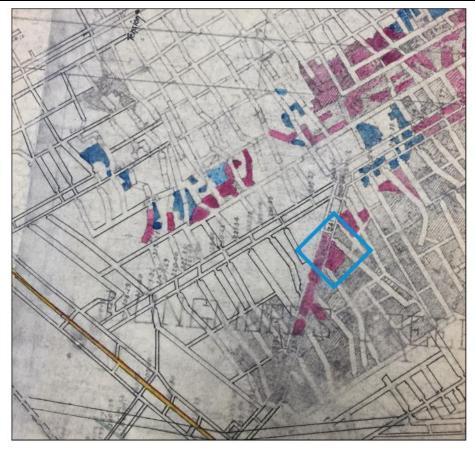
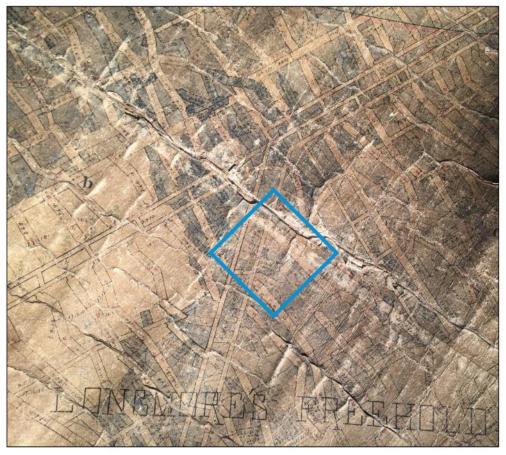
Figure A3.2 shows the extent of mining in the Bulli Seam in the vicinity of location of RV16 from the 1916 yearly plan and the mine working plan for this area. A later mine working plan which also includes this area shows that additional pillar extraction to the west was undertaken in 1944.

a) Position of Borehole RV16 relative to Bulli Seam workings on plan from 1916.

b) Position of Borehole RV16 relative to Bulli Seam workings on mine working plan to 1932.

Figure A3.2: Position of Borehole RV16 relative to Bulli Seam records.

The collapsed status of the Bulli Seam at the location of RV16 is consistent with the mining detailed in the recently discovered mine working plan and in the annual production plans from 1913, 1916 and 1917. These plans indicate the Bulli Seam was extracted at this location within the larger area that is now depicted as 'goaf' on other mine workings plans and record tracings. Extraction of the Bulli Seam and collapse of the strata above the Bulli Seam is also consistent with the subsidence profiles from the Balgownie Seam mining along the cross-panel monitoring line that traverses the longwalls panels adjacent to this location.
