Marulan South Limestone Mine | SSD 7009

REHABILITATION STRATEGY

Prepared for Boral Cement Limited | 30 August 2022

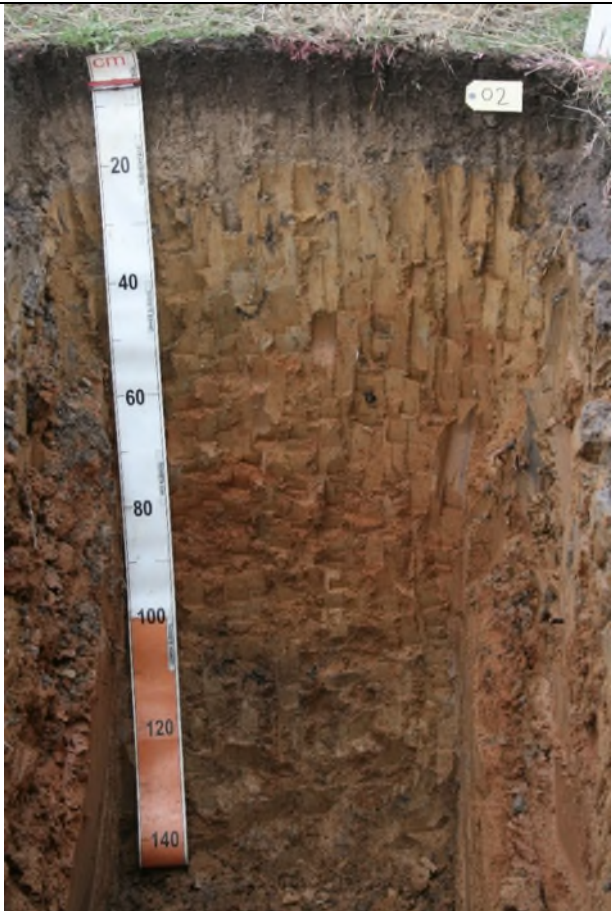
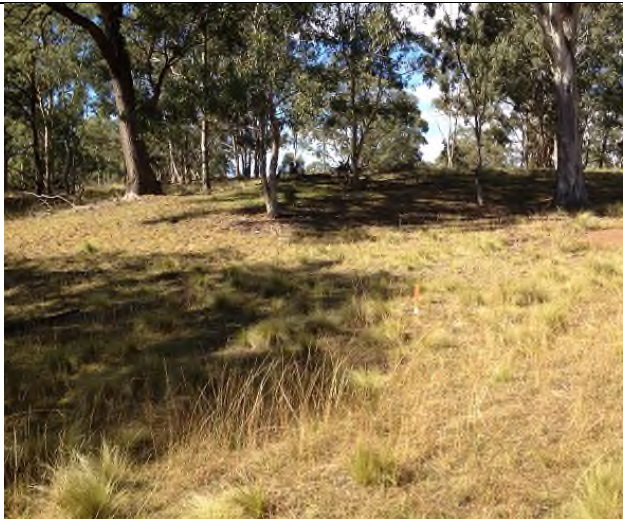
Soil Unit: Sodosol, Red/ Brown		
Representative Dominant Sites:	1 & 7 (Red) 2, 4, 8 and 12 (Brown)

Minor Sites	9 & 11 (Brown Chromosol)	
Typical Soil Profile	A1: 0-11 – Very dark grey loam, very weak angular-blocky, rough-faced, peds 30-40mm, moist, nil gravel	
	A2: 11-21 – Yellowish brown, sandy loam, weak polyhedral, rough faced peds, 20-40mm, moist, nil gravel	
	B2: 21-95 – Light olive brown heavy clay, apedal massive, moist, increasing weathered bedrock fragments	
	B/C: 95- >140 – weathered bedrock	
Roots:	Fine, few to 44cm

Landscape Association:	Mid to upper slopes	
Landuse:	Low density sheep grazing	
BSAL Status and limiting factors: Not BSAL. Fertility <i>Moderately Low</i> at all sites except 9 and 11. Indicators of poor drainage (such as distinct mottling) at all sites except Sites 1 and 2. Site 4 has pH (CaCl ₂) of 4.4 at < 600mm depth which also represents a chemical barrier at <750 mm depth. Site 9 has pH of 4.3 at <600mm depth and Ca:Mg ratio < 0.1 at < 750mm depth.

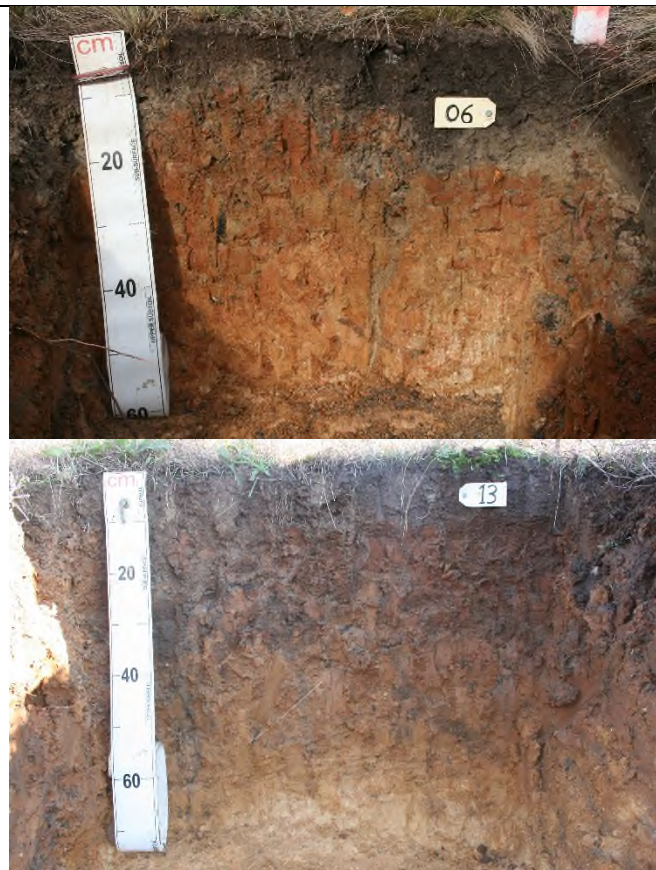
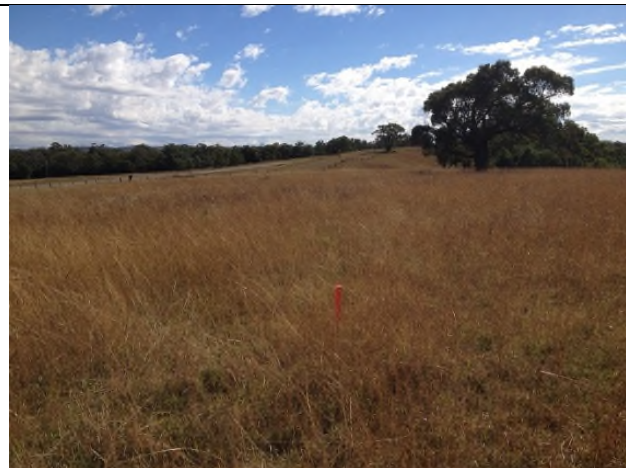
Soil Unit: Tenosol, Bleached-Orthic / Brown-Orthic		
Representative Dominant Sites:	3 & 6 (Bleached-Orthic)

Co-dominant Sites:	5 & 13 (Brown-Orthic)	
Typical Soil Profile	A1: 0-11 – Dark brown sandy loam, weak angular-blocky, rough-faced, peds 10-30mm, moist, 0-10% gravel	
	B2: 11-60 – Yellowish brown heavy clay, apedal massive	
	B/C: 60- >95 – weathered bedrock	Soil Profile Sites: 6 & 13
Roots:	Fine, few to 58cm

Landscape Association:	Crests and steep slopes	
Landuse:	Mine buffer land	
BSAL status and limiting factors: Not BSAL. Fertility <i>Moderately Low</i> at all sites. Physical barrier (typically high proportion of weathered bedrock fragments) at <750 mm depth at all sites; Site 3 has pH (CaCl ₂) of 4.3 at < 600mm depth, which also represents a chemical barrier at <750 mm depth. Indicators of poor drainage at Sites 3 and 6.

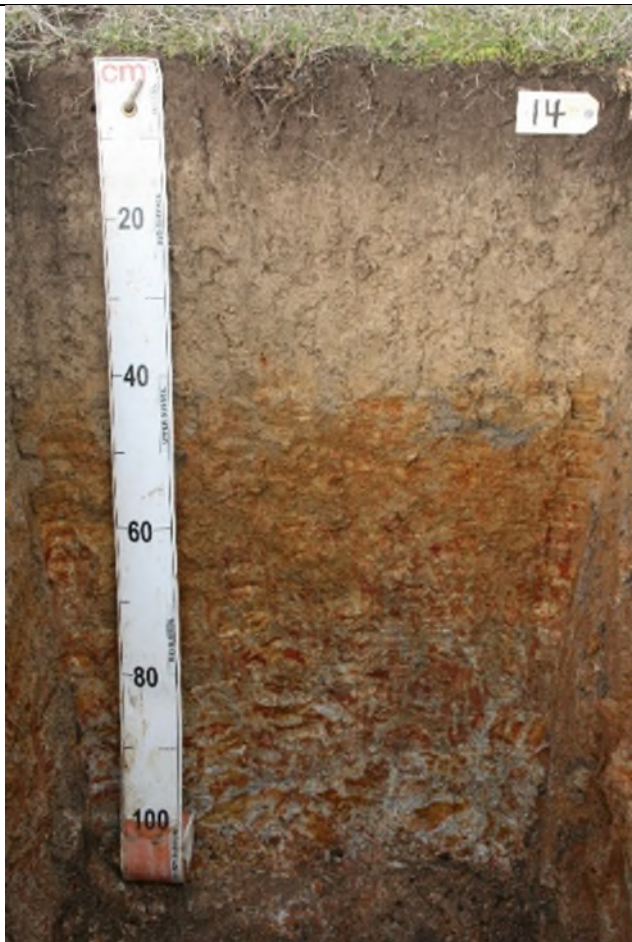
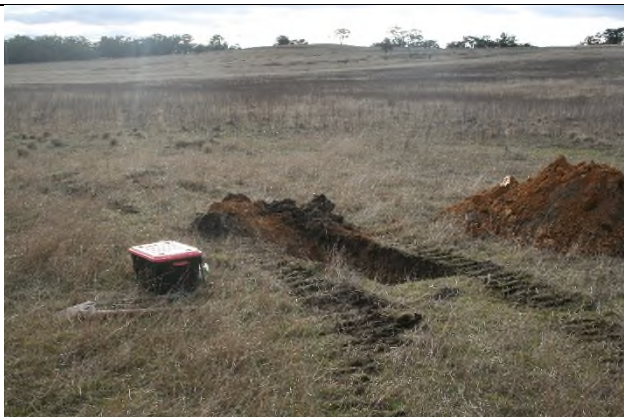
Soil Unit: Kurosol, Brown		
Representative Sites:	14

Typical Soil Profile	A1: 0-12 – Dark greyish brown sandy loam, weak polyhedral, rough-faced, peds 10-20mm, moist, nil gravel	
	A2: 12-44 – Light yellowish brown, sandy clay loam, weak polyhedral, rough faced peds, 20-30mm, moist, 20% ironstone nodules	
	B2: 44-65 – Yellowish brown medium clay, weak polyhedral to platy peds, 5-10mm, moist, 5% weathered bedrock fragments	
	B/C: 65- >110 – weathered bedrock	
Roots:	Fine, few to 57cm

Landscape Association:	Flats and drainage depressions	
Landuse:	Low density sheep grazing	
BSAL status and limiting factors: Not BSAL. Fertility ranking <i>Moderate</i> . Site 14 has pH (CaCl ₂) of 4.4 at < 600 mm depth, which also represents a chemical barrier at <750 mm depth. Indicators of poor drainage (bleached A2 horizon) at Site 14.

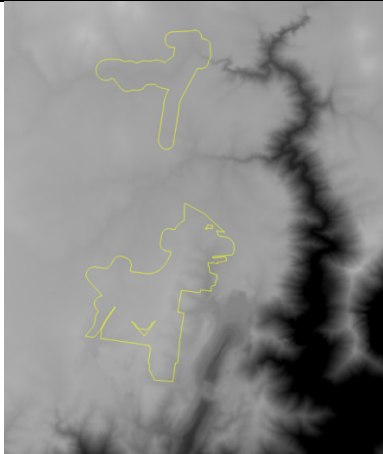
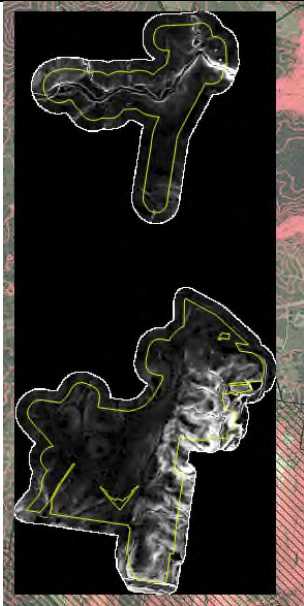
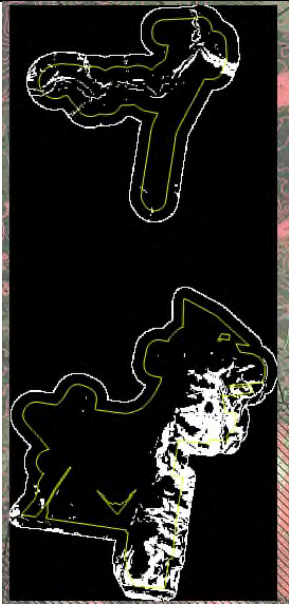
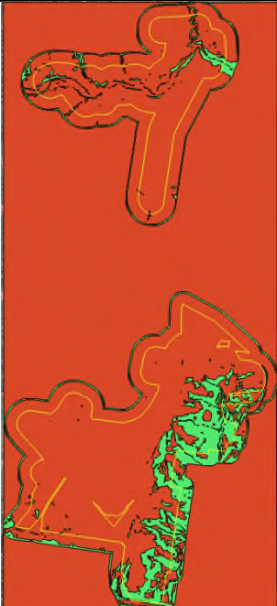
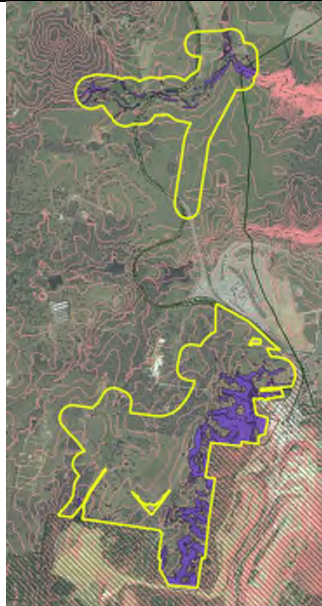
Step 1	Step 2	Step 3	Step 4	Step 5

LIDAR imagery of Project area displayed as raster layer in QGIS, with vector polygons of BSAL assessment areas shown in yellow.	LIDAR image clipped to 100m buffer around BSAL assessment areas and analysed for slope using QGIS <i>Terrain Analysis</i> , giving a range of 0-25% slope within the area.	QGIS <i>Raster Calculator</i> used to identify areas of slope greater than 10% (white areas).	Raster image converted to vector polygons, with brown areas representing slope less than 10%, and green showing areas greater than 10% slope.	Polygons clipped to BSAL assessment areas, with purple polygons representing those areas with slope greater than 10%.

An analysis of terrain within the BSAL assessment areas was undertaken to identify slope gradient greater than ten percent (10%), and exclude those areas from further assessment. LIDAR imagery of the assessment areas was collected in November 2014, and processed using QGIS as described below.
