Our Reference: NSW201629

**Re: Northside West Clinic, 23-27 Lytton Street, Wentworthville – Response to SES letter**

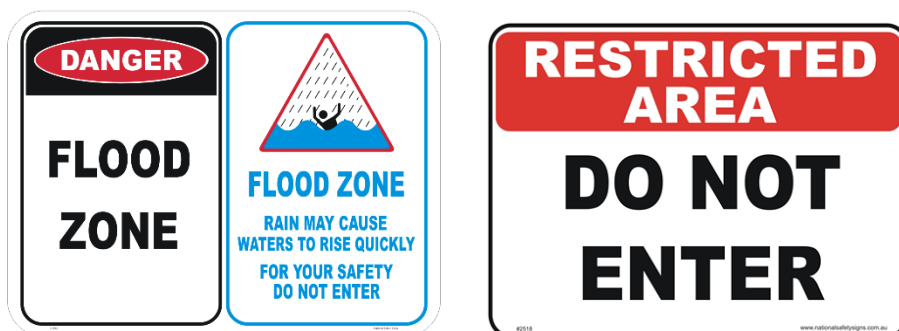
Figure 1 Flood Warning signs at lower ground floor doors to external areas, and in landscaped areas

The existing driveway near the south-eastern corner of the site that led to the existing open carpark area experiences a hazard up to the H4 category during the pre-developed (existing) scenario, which is rendered unsafe for vehicles and people. However, the high hazard area is confined within the existing driveway area, which was anticipated to have higher velocity due to a slope of approximately 7.8%. The hazard classification remains consistent during the post-developed scenario. A flood hazard category up to H5 (rendering unsafe for vehicles and people) was noticeable during the post-developed scenario within the proposed landscaping at the southwest corner of the site. As a flood risk management strategy, the landscaping area and the driveway entrance to the southern carpark will be sign-posted with flood warning signs shown below in Figure 1.

To further minimize the flood risks, the lower ground level should be designed with a suitably designed structural element with rubber seals to the threshold. Portals can also be provided in lieu of a proprietary item if the seal can be certified against the water pressure up to the PMF flood level. In that regard, all doors in the lower ground level (to external areas) shall be sign-posted (facing the inside of the building) with the signs as shown below.

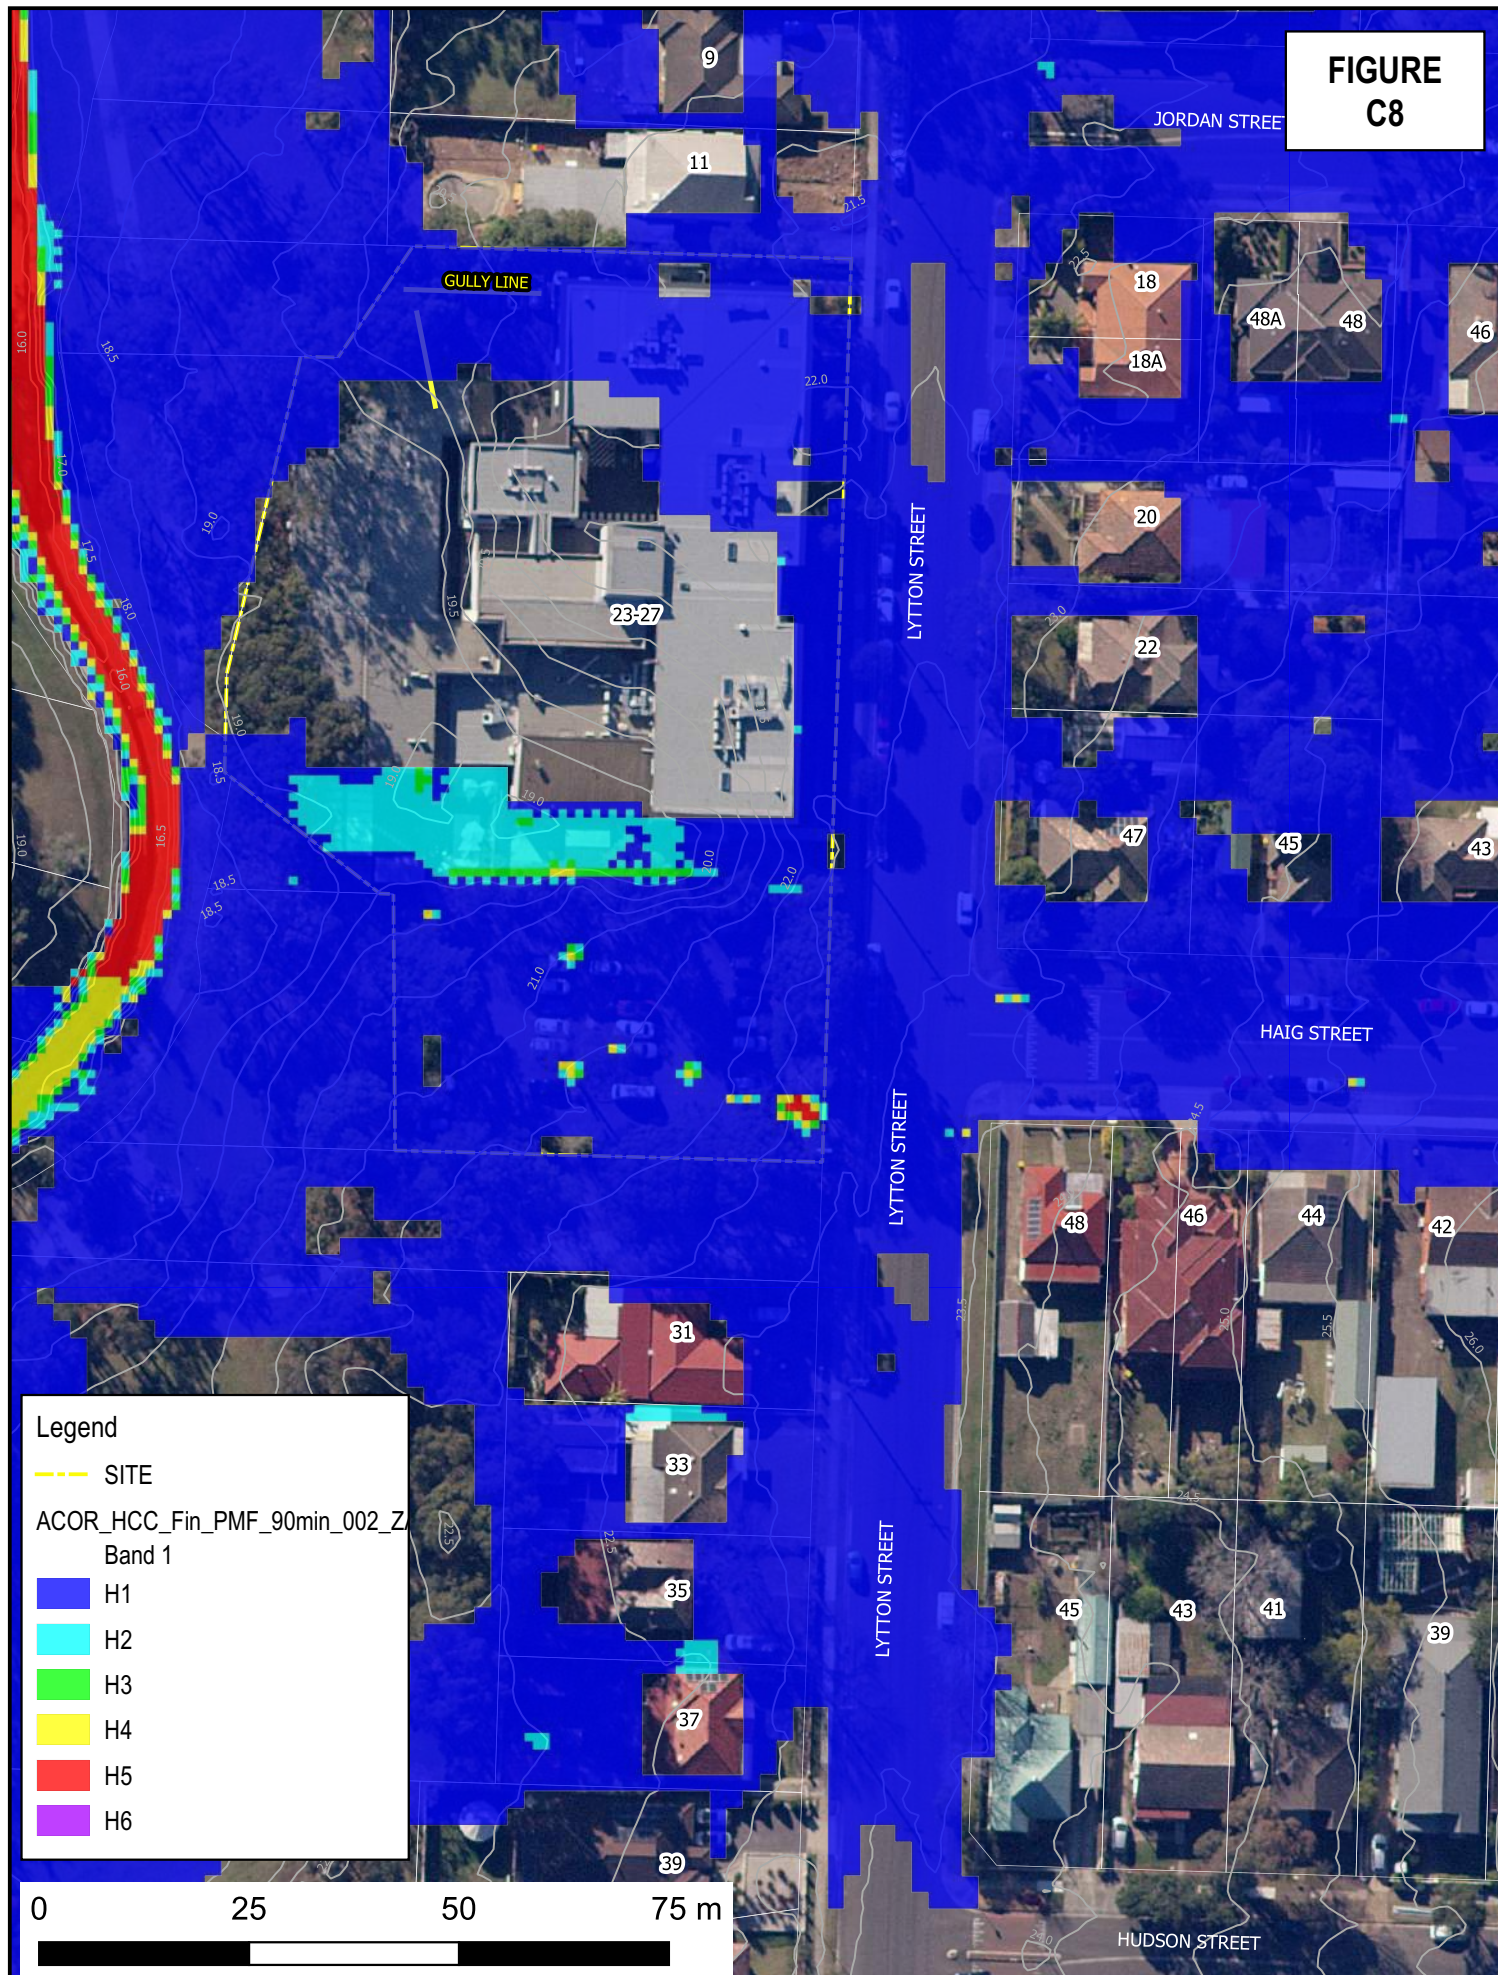
**FIGURE  
C8**

PROJECT: NORTHSIDE WEST CLINIC FLOOD STUDY - NSW201629  
LOCATION: 23-27 LYTON STREET, WENTWORTHVILLE

Flood hazard analyses were carried out during the PMF events during both the pre-developed (existing) and the post-developed (proposed) scenario in accordance with the Australian Disaster Resilience Guideline 7-3 Flood Hazard (AIDR 2017). Refer to the attached map showing the PMF flood hazard.

The post-development flood hazard exposure within the site generally remains consistent with the existing scenario. The associated flood hazard within the northern carpark area can be classified within the H1 category, which is considered generally safe for vehicles, people and buildings.

The existing driveway to the south of the building, which is mainly used by service vehicles and has no associated permanent carparking facilities, would be exposed to H2 to H3 category of flooding. The H2 category is classified as unsafe for small vehicles, while H3 is classified as unsafe for vehicles, children, and the elderly. The flood hazard category does not change during the post-developed scenario as no modification to the existing driveway has been proposed.
