**RE: INTERIM AUDIT ADVICE LETTER NO. 1 - REVIEW OF COCKLE BAY  
PARK DEVELOPMENT PRELIMINARY REMEDIATION ACTION PLAN**

Audit Number: TO-111

As a NSW Environment Protection Authority (EPA) accredited Contaminated Sites Auditor, on behalf of DPT Operator Pty Ltd and DPPT Operator Pty Ltd, I am conducting an Audit (TO-111) under the NSW *Contaminated Land Management Act 1997* (CLM Act) in relation to the Cockle Bay Park Development.

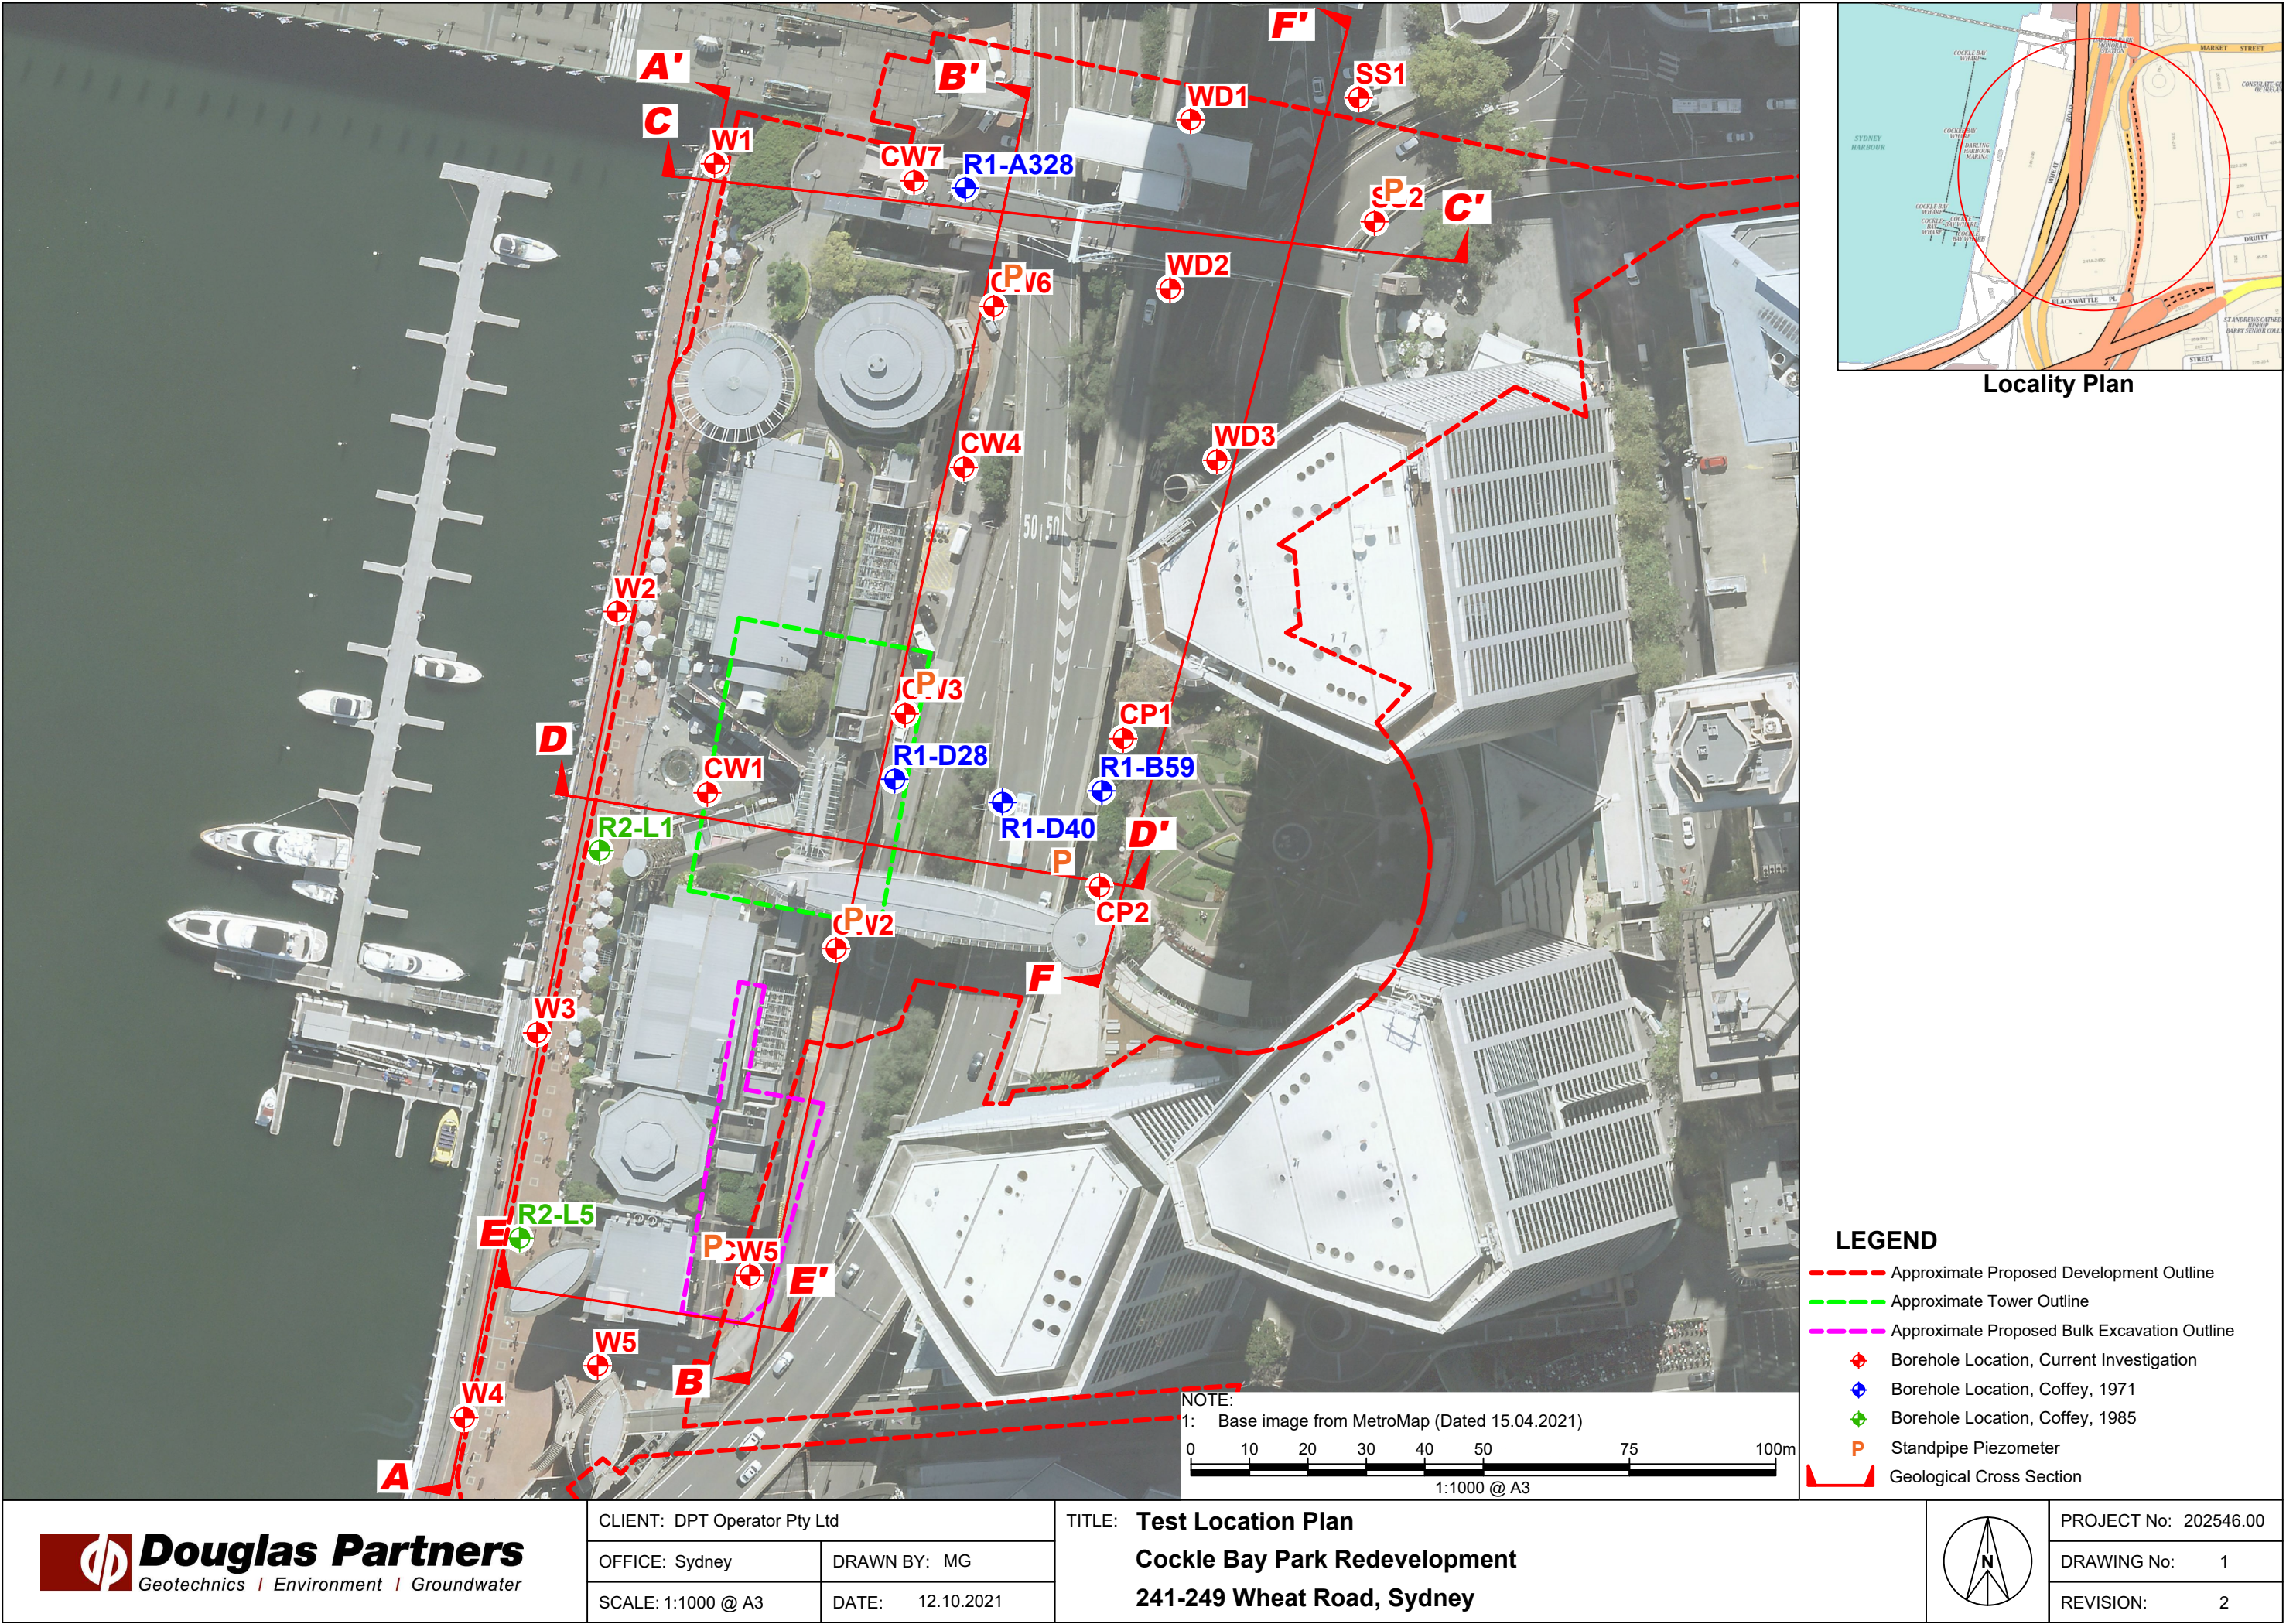
Attachment 1: Site Layout, Site Location and CI Sample Locations

The site layout is shown on Attachment 1 and the site details are as follows:
