# **Environmental Management Plan** (EMP)

12 Grand Avenue, Rosehill, NSW

Prepared for: ACE Rosehill Pty Ltd

A101024.0518.00 | EMP.V3f | Date: 7 March 2025

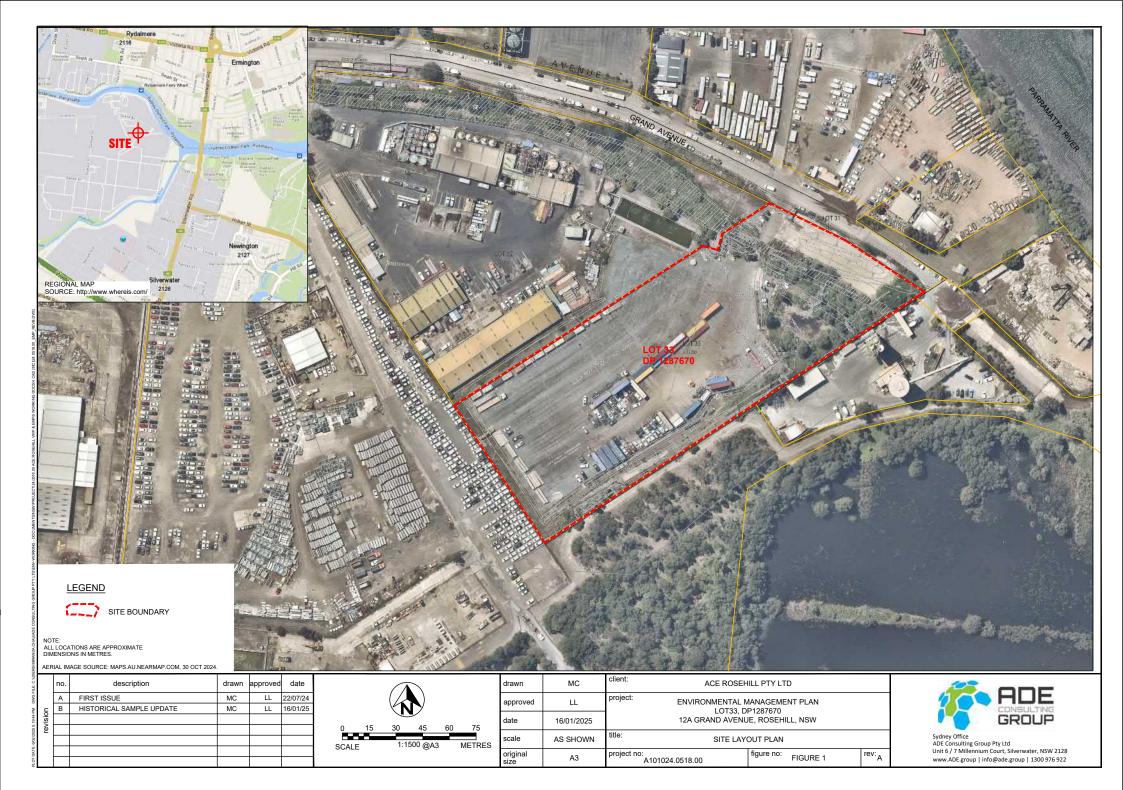
This EMP applies to Lot 33 (**Appendix A – Figure 1**) and is intended to be in effect for the duration of the site's operation under its current heavy industrial land use. However, the EMP should be updated if significant changes to environmental conditions are identified or if a change in land use is proposed.

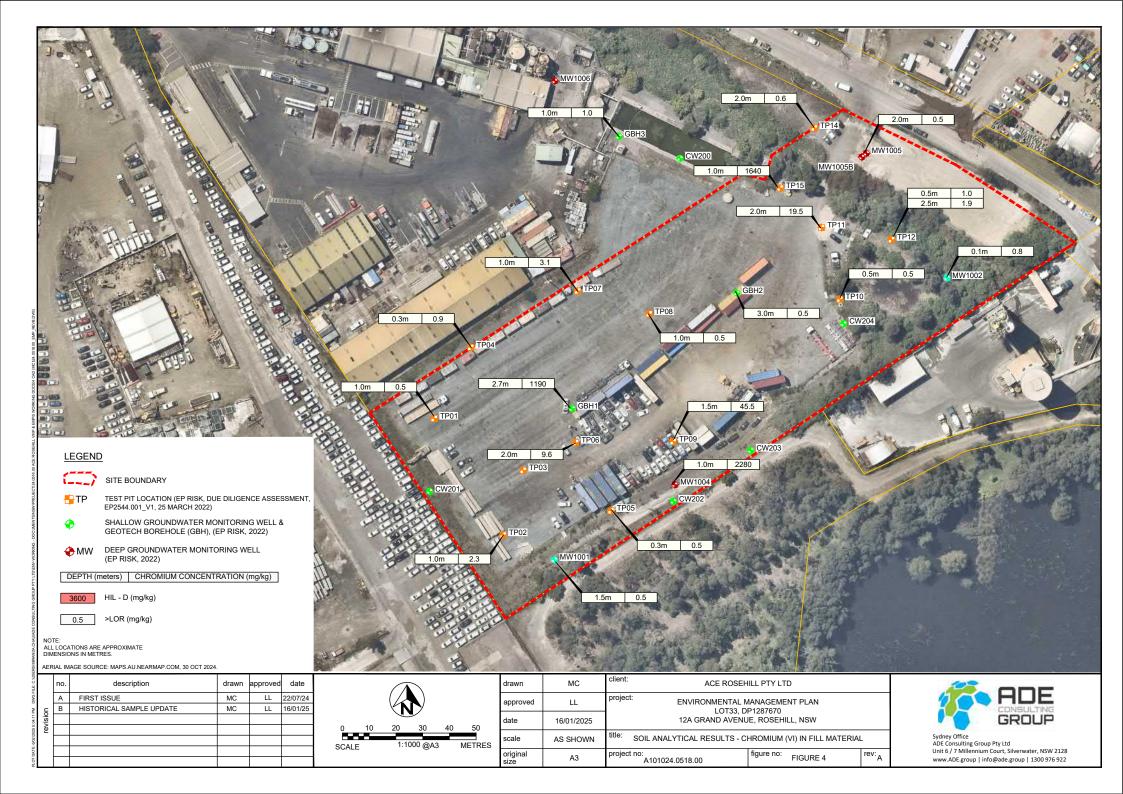
Suspected COPR was observed in the fill layer generally observed at depths up to 3.0 m BGL across the southeast and northern portions of the site (see **Table 2** and **Appendix A– Figure 4**). This was characterised by lime green / yellow-coloured precipitates observed within Fill. Sources of COPR historically used in backfill across the Peninsula and originating as by-product from the chromium chemical factory at 6 Grand Avenue (former ICI/AKZO–currently remediated by horizontal and vertical cap & contain). The results of the investigation had indicated chromium in the 6+ oxidation state exists within the natural material at the site primarily in areas where suspected historically placed COPR waste had been identified. As shown in **Table 3** below and **Appendix A– Figure 5**, no exceedance of the investigation NEPM HIL-D for Cr (VI) was detected in both fill and natural soil at the site. See Also Figure 9 Appendix A for locations where suspected COPR was observed within test pits.
