**REPORT TO
HAMMONDCARE**

**ON
HAZARDOUS BUILDING MATERIALS SURVEY**

**FOR
PROPOSED DEMOLITION WORKS**

**AT
GREENWICH HOSPITAL, 97-115 RIVER ROAD,
GREENWICH, NSW**

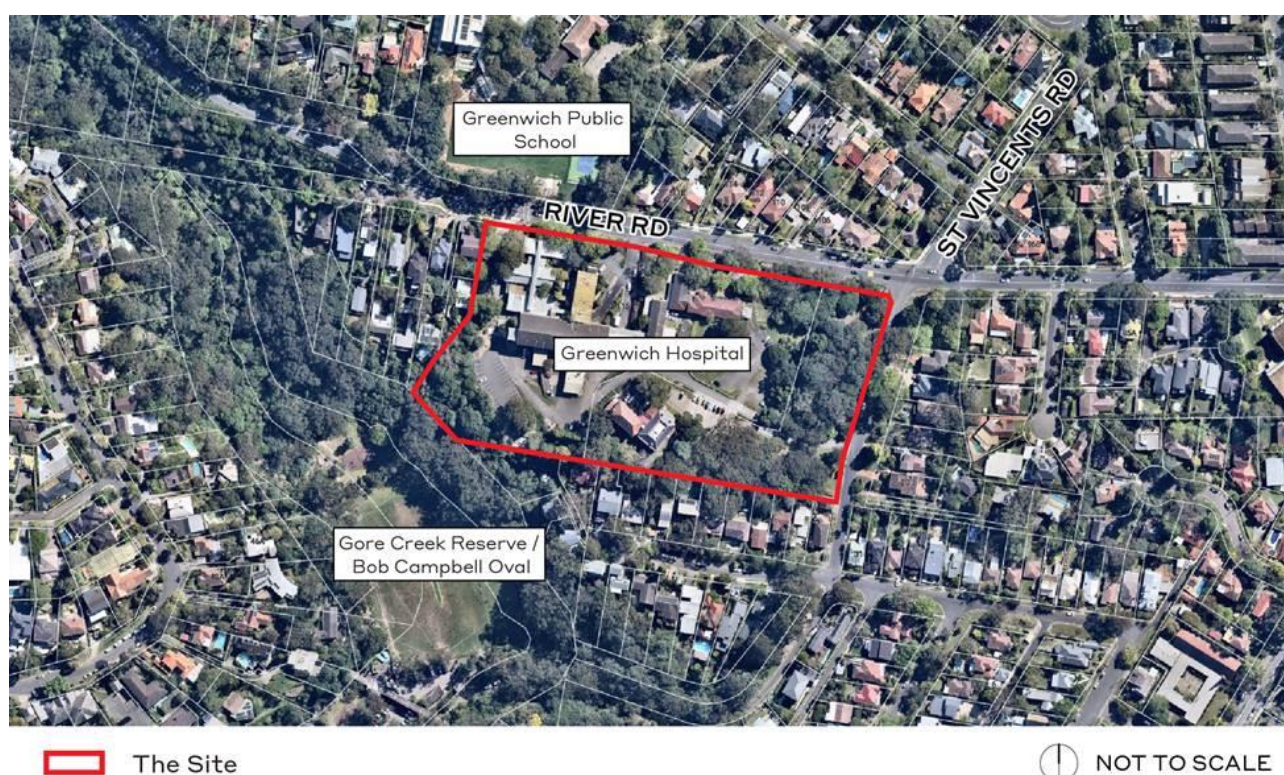
This report is to be submitted to the Department of Planning, Environment (DPE) in support of a State Significant Development Application (SSD-13619238) for the redevelopment of Greenwich Hospital into an integrated hospital and seniors living facility on land identified as 97-115 River Road, Greenwich, NSW (the site). The extent of the site is shown below.
