DEICORP PROJECTS SHOWGROUND PTY LTD

Geotechnical Investigation

2 Mandala Parade, Castle Hill, NSW

Report No: E24724.G03_Rev2

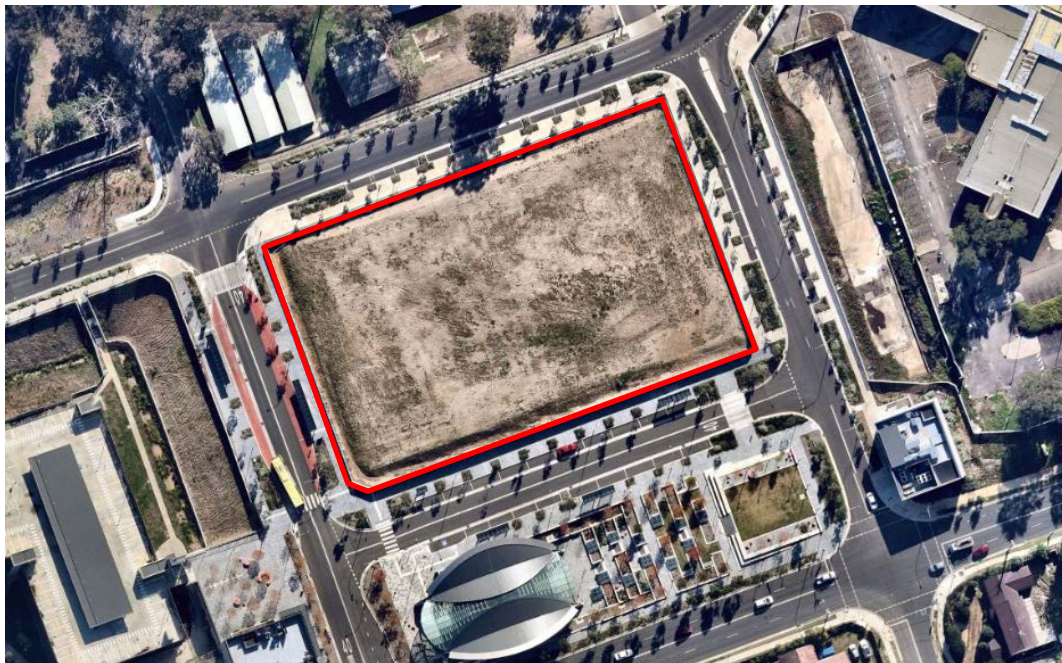
Plate 1: Aerial photograph of the site (source: Six Maps, accessed 5/8/20)

The site identification details and associated information are presented in **Table 2-1** below while the site locality is shown on **Figure 1**. An aerial photograph of the site is presented in **Plate 1** below.

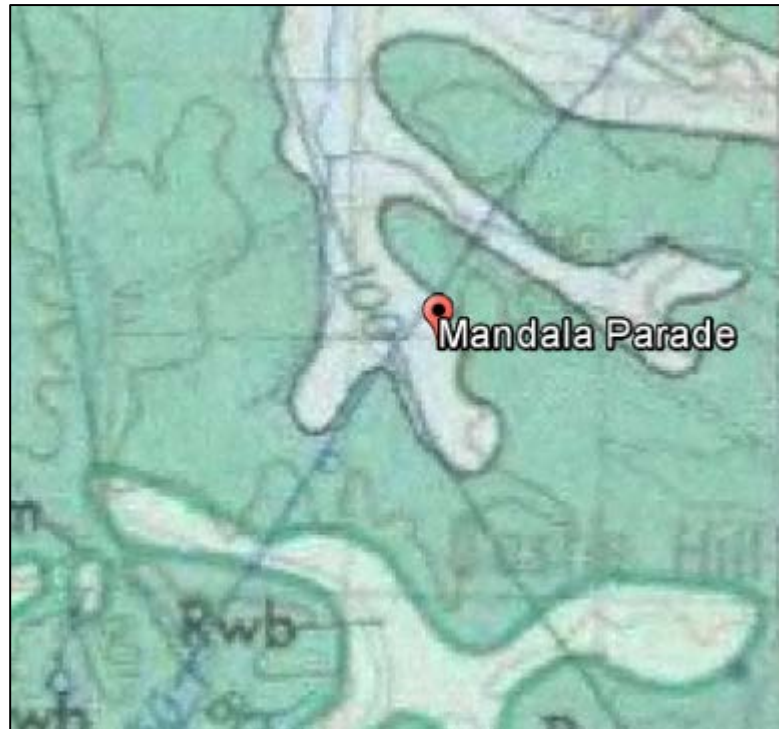
Plate 2: Excerpt of geological map showing location of site.

Attribute	Description
Topography	The site is located on the high north side of Mandala Parade within gently (0° to 5°), west dipping topography with site levels varying from R.L. 98.20m at the north eastern site corner to R.L. 80.80m at the south western site corner. Around the site boundary is a channel approximately 1m deep.
Regional Geology	Information on regional sub-surface conditions, referenced from the Department of Mineral Resources Geological Map Penrith 1:100,000 Geological Series Sheet 9030 (DMR 1991) indicates the site is underlain by Hawkesbury Sandstone, which typically comprises medium to very coarse-grained quartz sandstone, minor laminated mudstone and siltstone lenses .

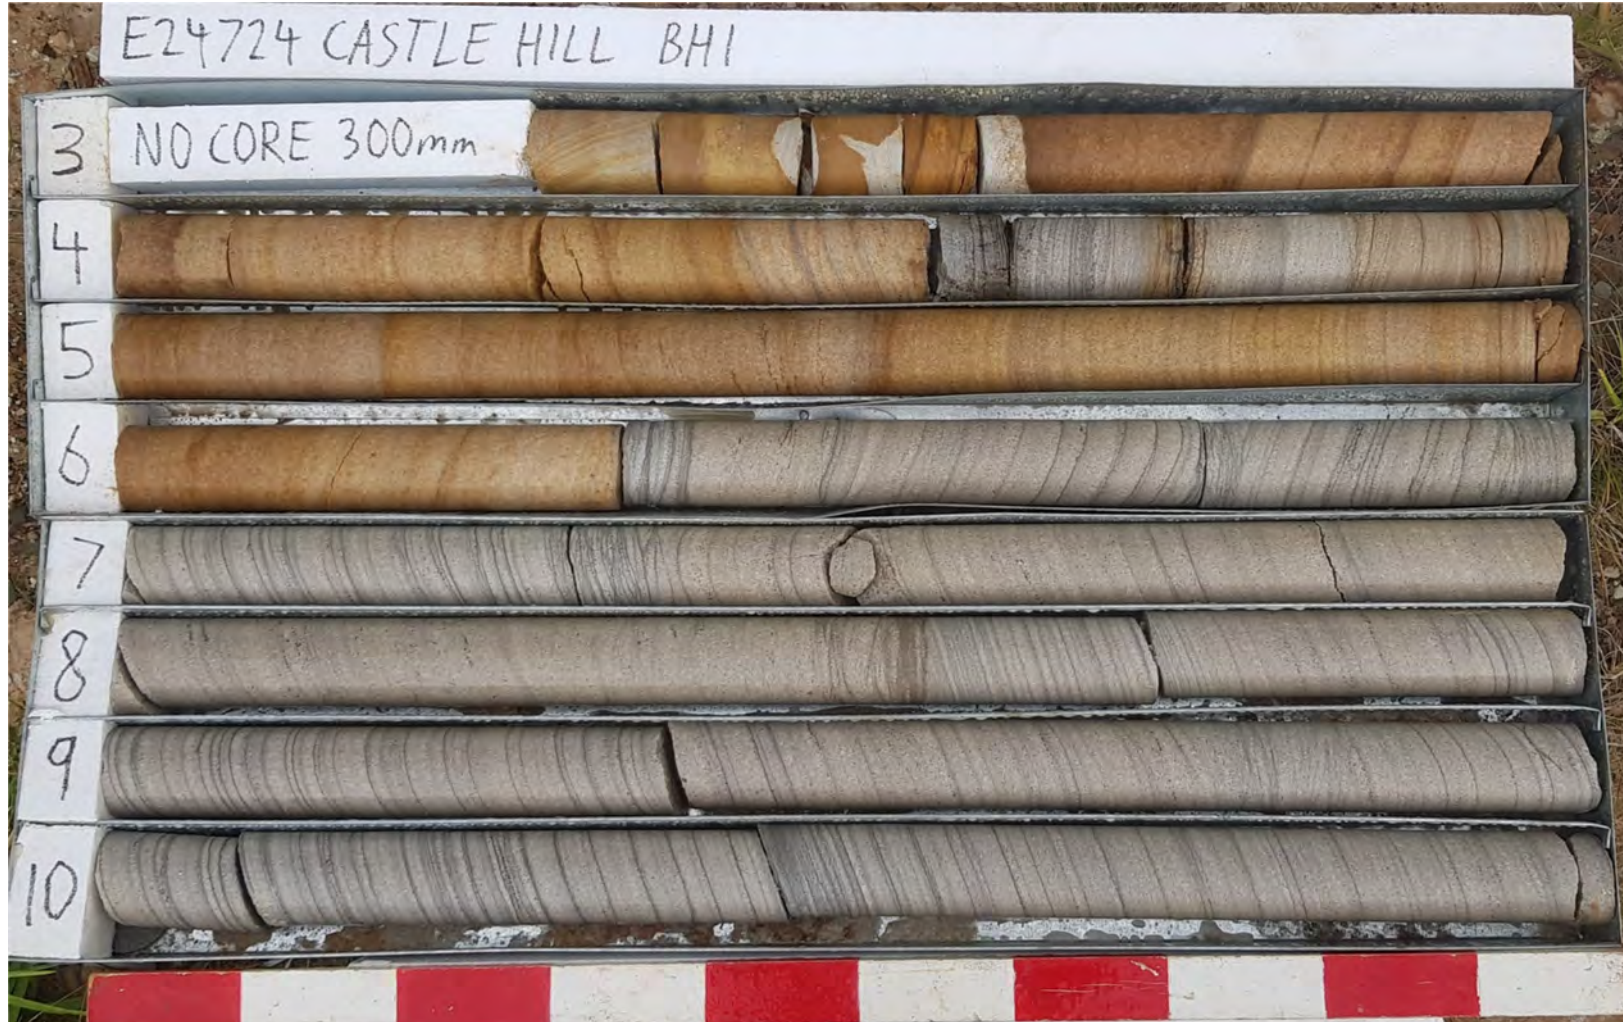
CORE PHOTOGRAPH OF BOREHOLE: BH1

Project	Proposed Development	Depth Range	3.0m to 11.0m BEGL	
Location	2 Mandala Parade, Castle Hill NSW	Contractor	Hagstrom	
Position	See Figure 2	Drill Rig	Hydrapower Scout V (DR011)	
Job No.	E24724.G03_Rev1	Logged	DS	Date 09 / 07 / 2020
Client	Deicorp Projects Showground P/L	Inclination	-90°	Date 24 / 08 / 2020
		Box	1-2 of 11

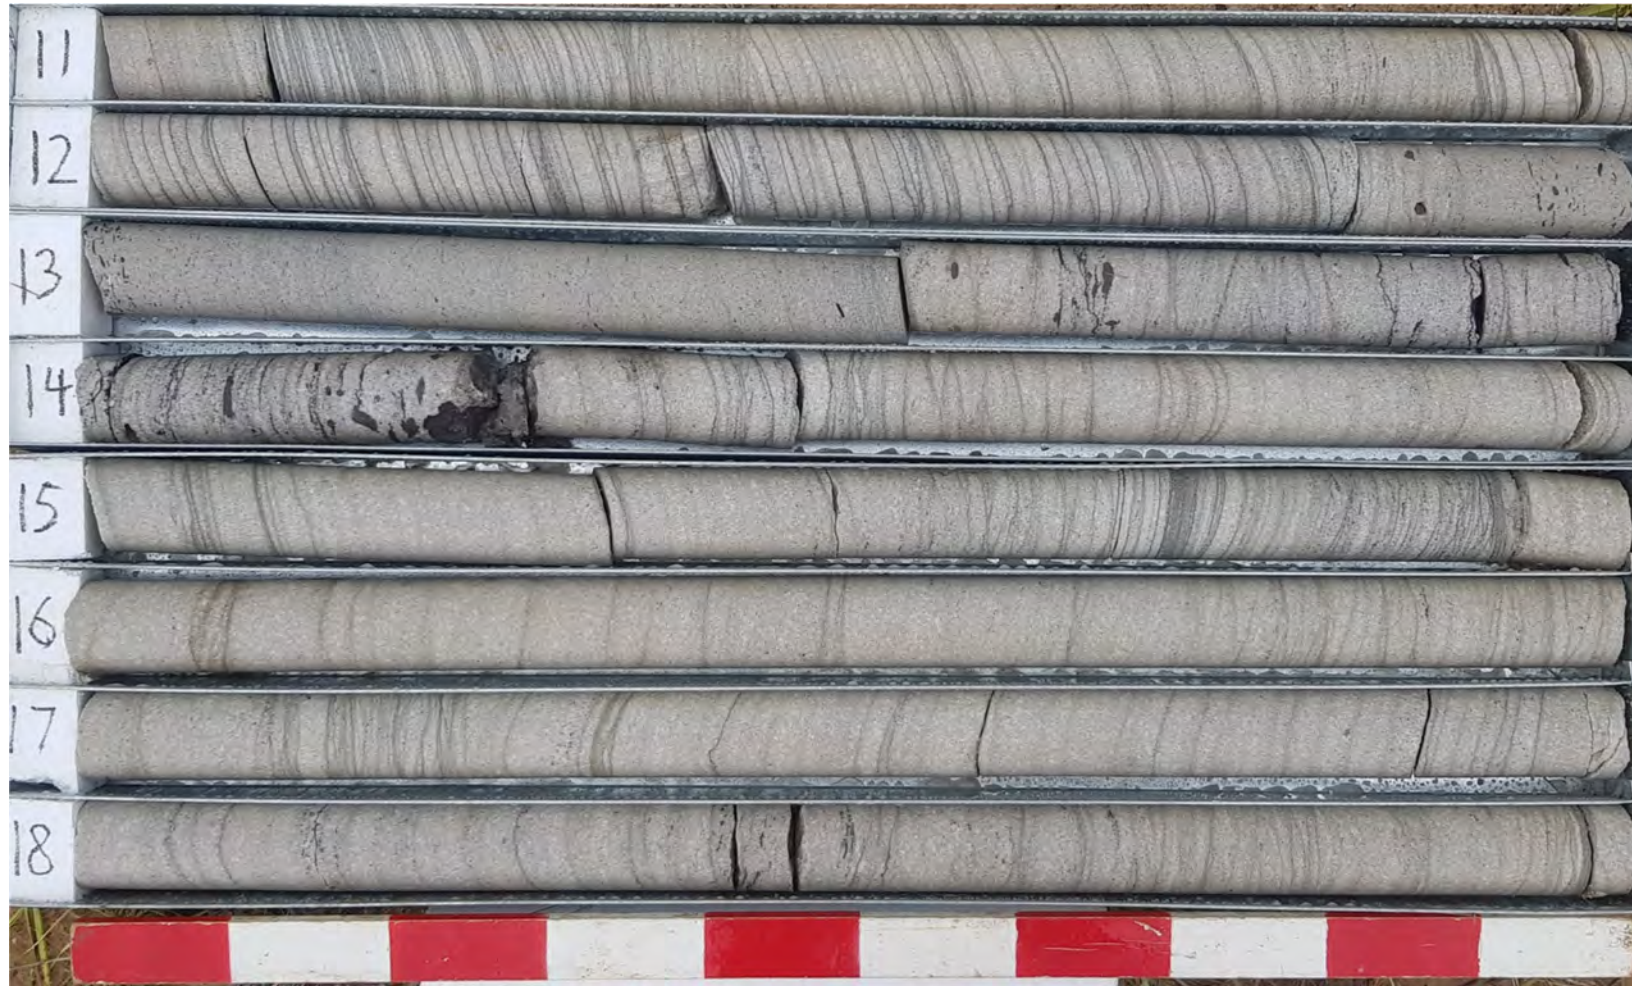
CORE PHOTOGRAPH OF BOREHOLE: BH1

Project	Proposed Development	Depth Range	11.0m to 19.0m BEGL	
Location	2 Mandala Parade, Castle Hill NSW	Contractor	Hagstrom	
Position	See Figure 2	Drill Rig	Hydrapower Scout V (DR011)	
Job No.	E24724.G03_Rev1	Logged	DS	Date 09 / 07 / 2020
Client	Deicorp Projects Showground P/L	Inclination	-90°	Date 24 / 08 / 2020
		Box	3-4 of 11	
		Checked	SR

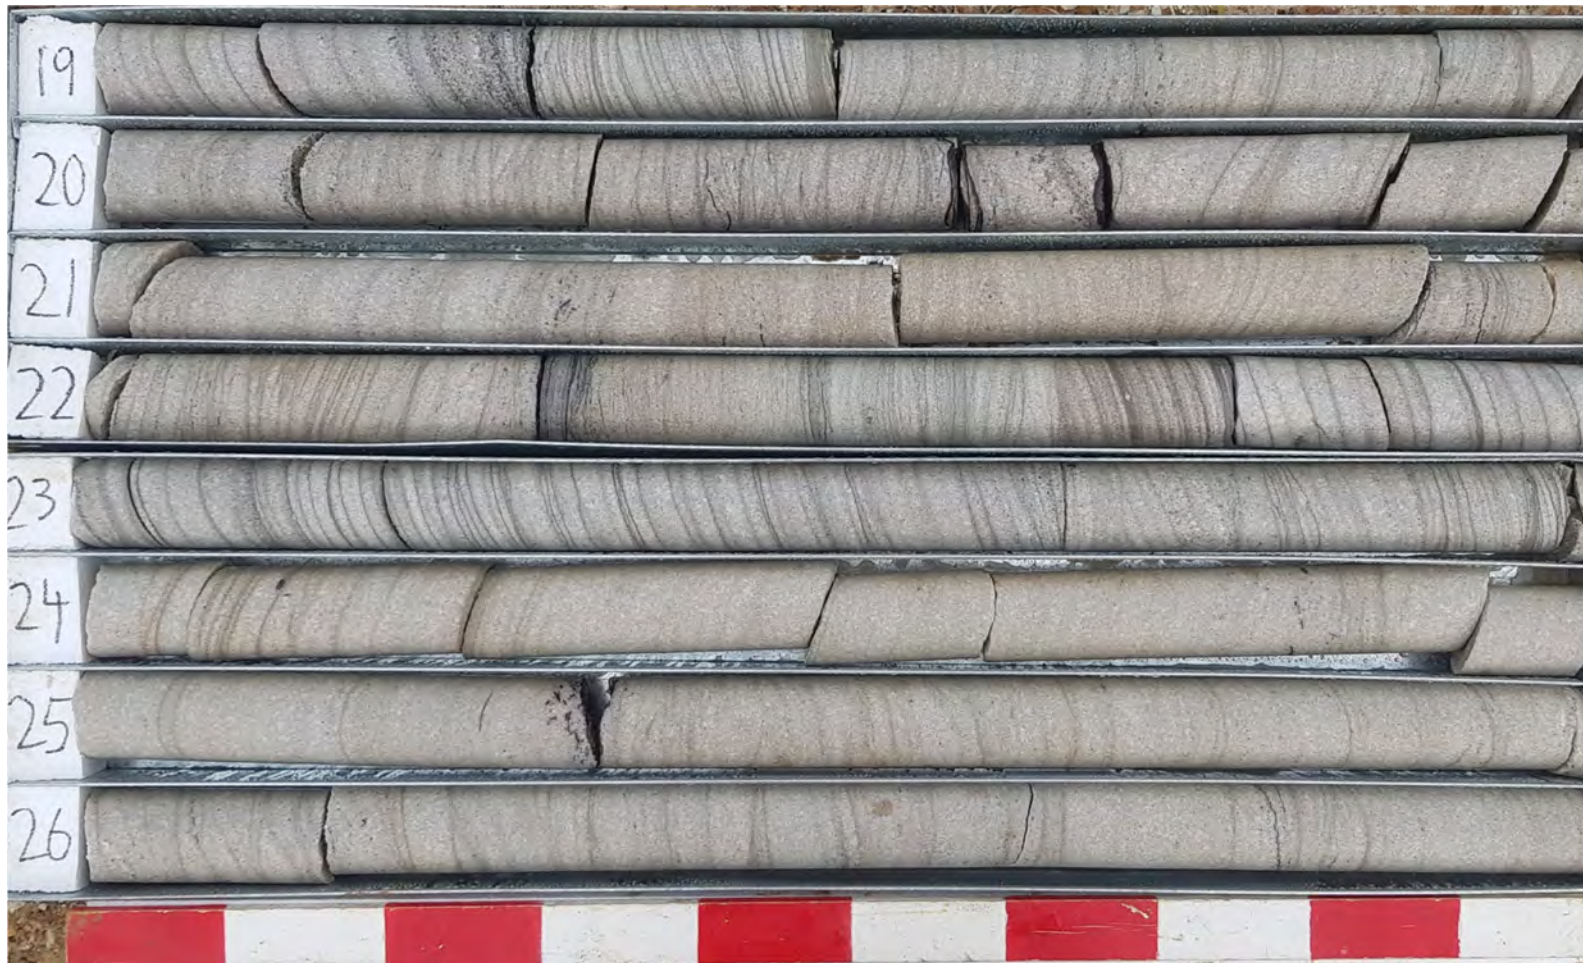
CORE PHOTOGRAPH OF BOREHOLE: BH1

Project	Proposed Development	Depth Range	19.0m to 27.0m BEGL	
Location	2 Mandala Parade, Castle Hill NSW	Contractor	Hagstrom	
Position	See Figure 2	Drill Rig	Hydrapower Scout V (DR011)	
Job No.	E24724.G03_Rev1	Logged	DS	Date 09 / 07 / 2020
Client	Deicorp Projects Showground P/L	Inclination	-90°	Date 24 / 08 / 2020
		Box	5-6 of 11	
		Checked	SR

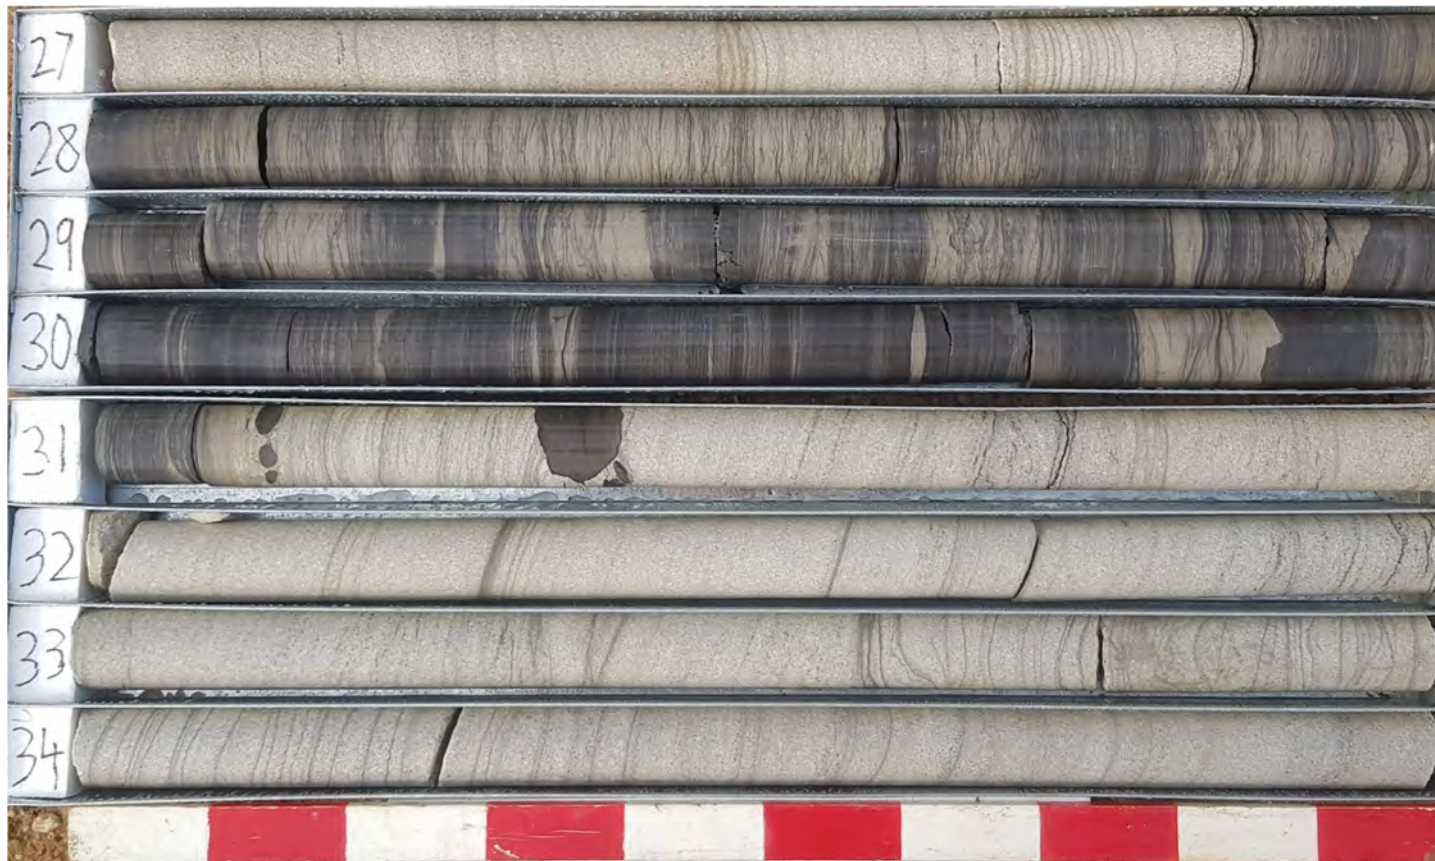
CORE PHOTOGRAPH OF BOREHOLE: BH1

Project	Proposed Development	Depth Range	27.0m to 35.0m BEGL	
Location	2 Mandala Parade, Castle Hill NSW	Contractor	Hagstrom	
Position	See Figure 2	Drill Rig	Hydrapower Scout V (DR011)	
Job No.	E24724.G03_Rev1	Logged	DS	Date 09 / 07 / 2020
Client	Deicorp Projects Showground P/L	Inclination	-90°	Date 24 / 08 / 2020
		Box	7-8 of 11

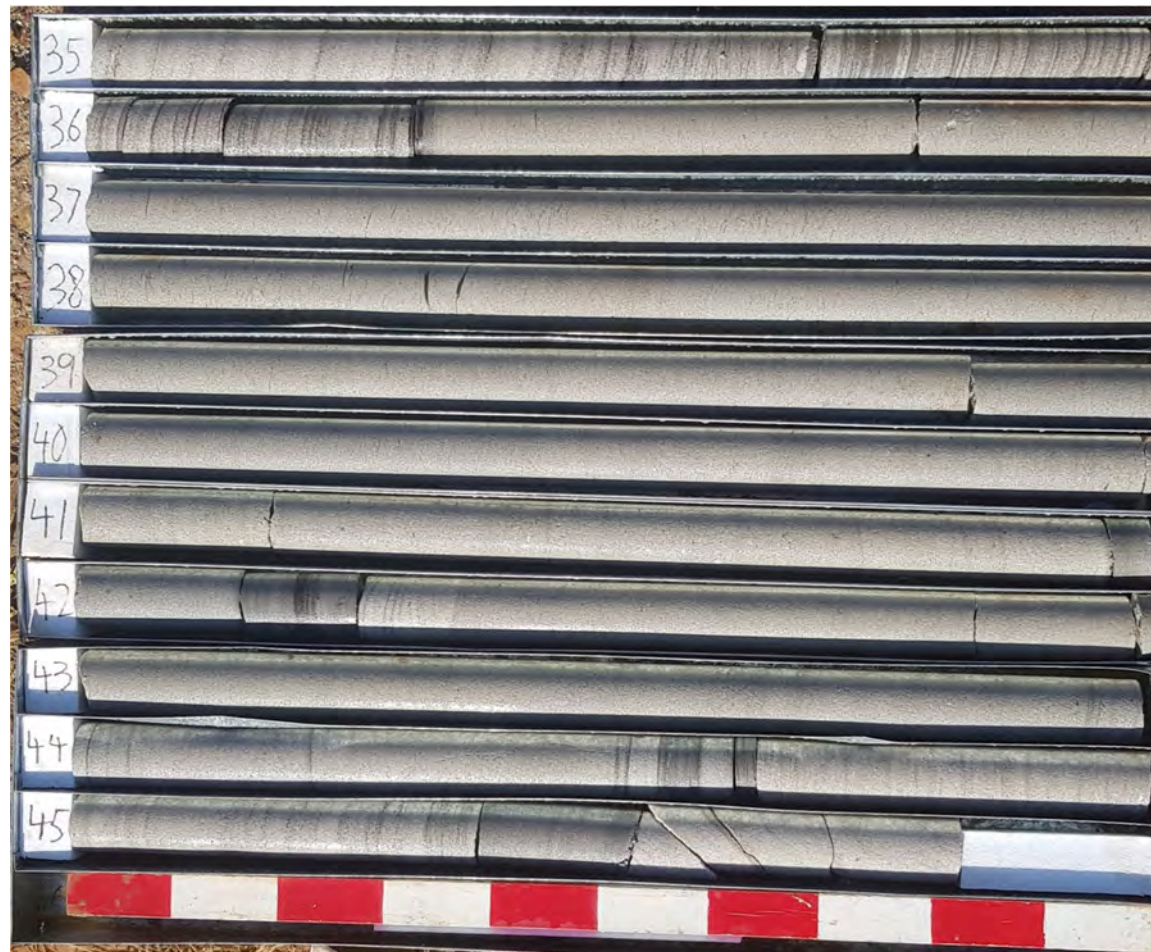
CORE PHOTOGRAPH OF BOREHOLE: BH1

Project	Proposed Development	Depth Range	35.0m to 45.84m BEGL	
Location	2 Mandala Parade, Castle Hill NSW	Contractor	Hagstrom	
Position	See Figure 2	Drill Rig	Hydrapower Scout V (DR011)	
Job No.	E24724.G03_Rev1	Logged	DS	Date 09 / 07 / 2020
Client	Deicorp Projects Showground P/L	Inclination	-90°	Date 24 / 08 / 2020
		Box	9-11 of 11	
		Checked	SR

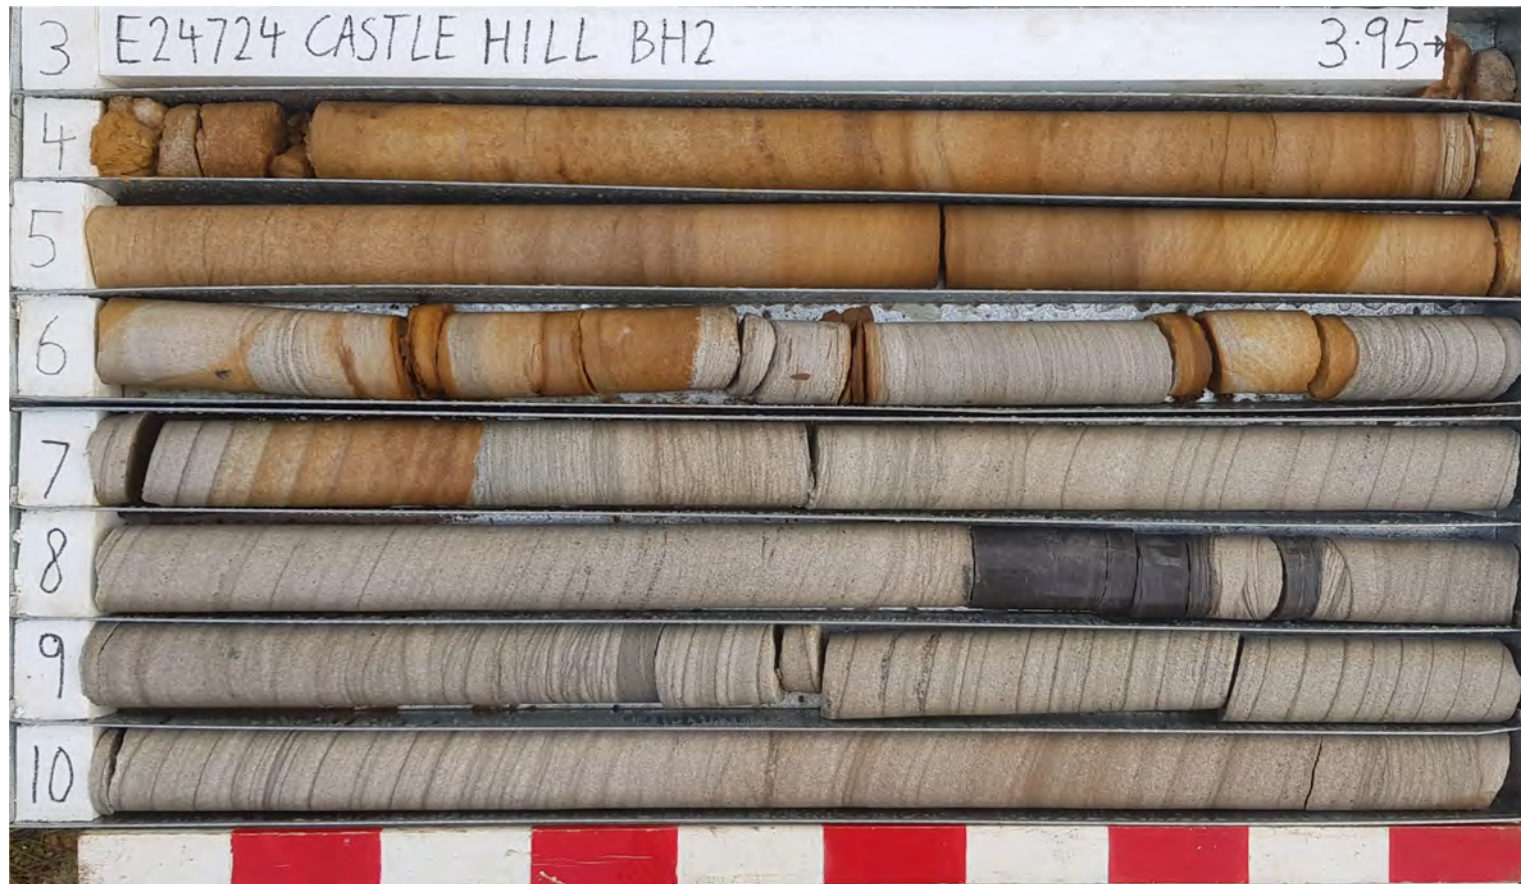
CORE PHOTOGRAPH OF BOREHOLE: BH2

Project	Proposed Development	Depth Range	3.95m to 11.0m BEGL	
Location	2 Mandala Parade, Castle Hill NSW	Contractor	Hagstrom	
Position	See Figure 2	Drill Rig	Hydrapower Scout V (DR011)	
Job No.	E24724.G03_Rev1	Logged	DS	Date 10 / 07 / 2020
Client	Deicorp Projects Showground P/L	Inclination	-90°	Date 24 / 08 / 2020
		Box	1-2 of 11

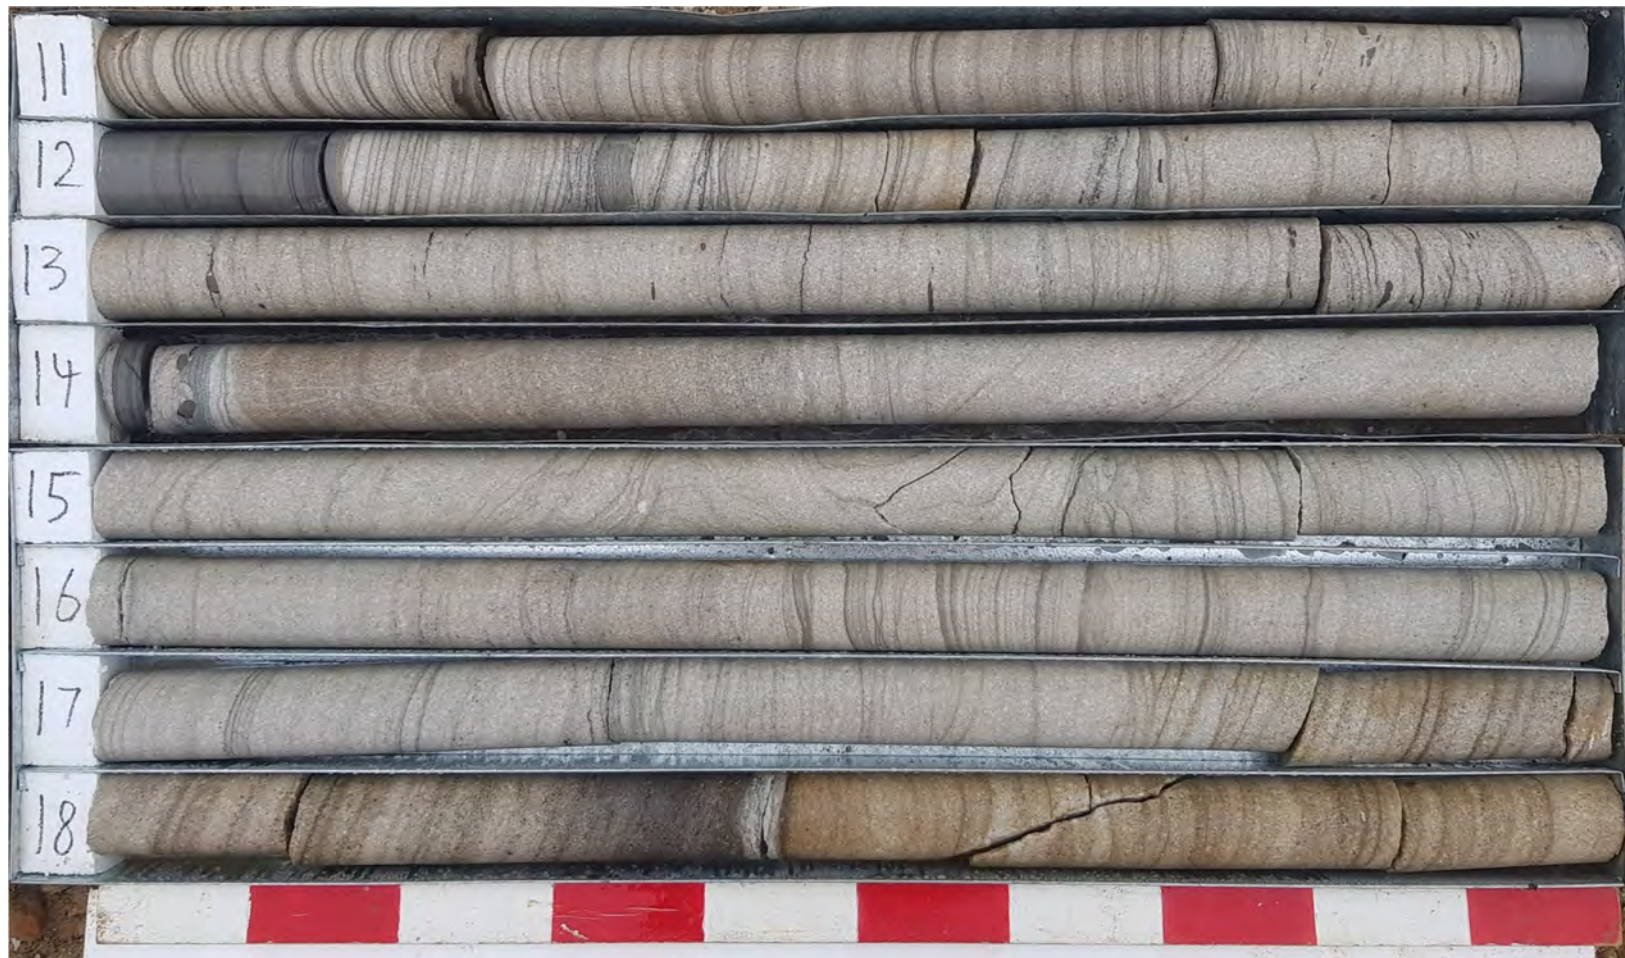
CORE PHOTOGRAPH OF BOREHOLE: BH2

Project	Proposed Development	Depth Range	11.0m to 19.0m BEGL	
Location	2 Mandala Parade, Castle Hill NSW	Contractor	Hagstrom	
Position	See Figure 2	Drill Rig	Hydrapower Scout V (DR011)	
Job No.	E24724.G03_Rev1	Logged	DS	Date 10 / 07 / 2020
Client	Deicorp Projects Showground P/L	Inclination	-90°	Date 24 / 08 / 2020
		Box	3-4 of 11	
		Checked	SR

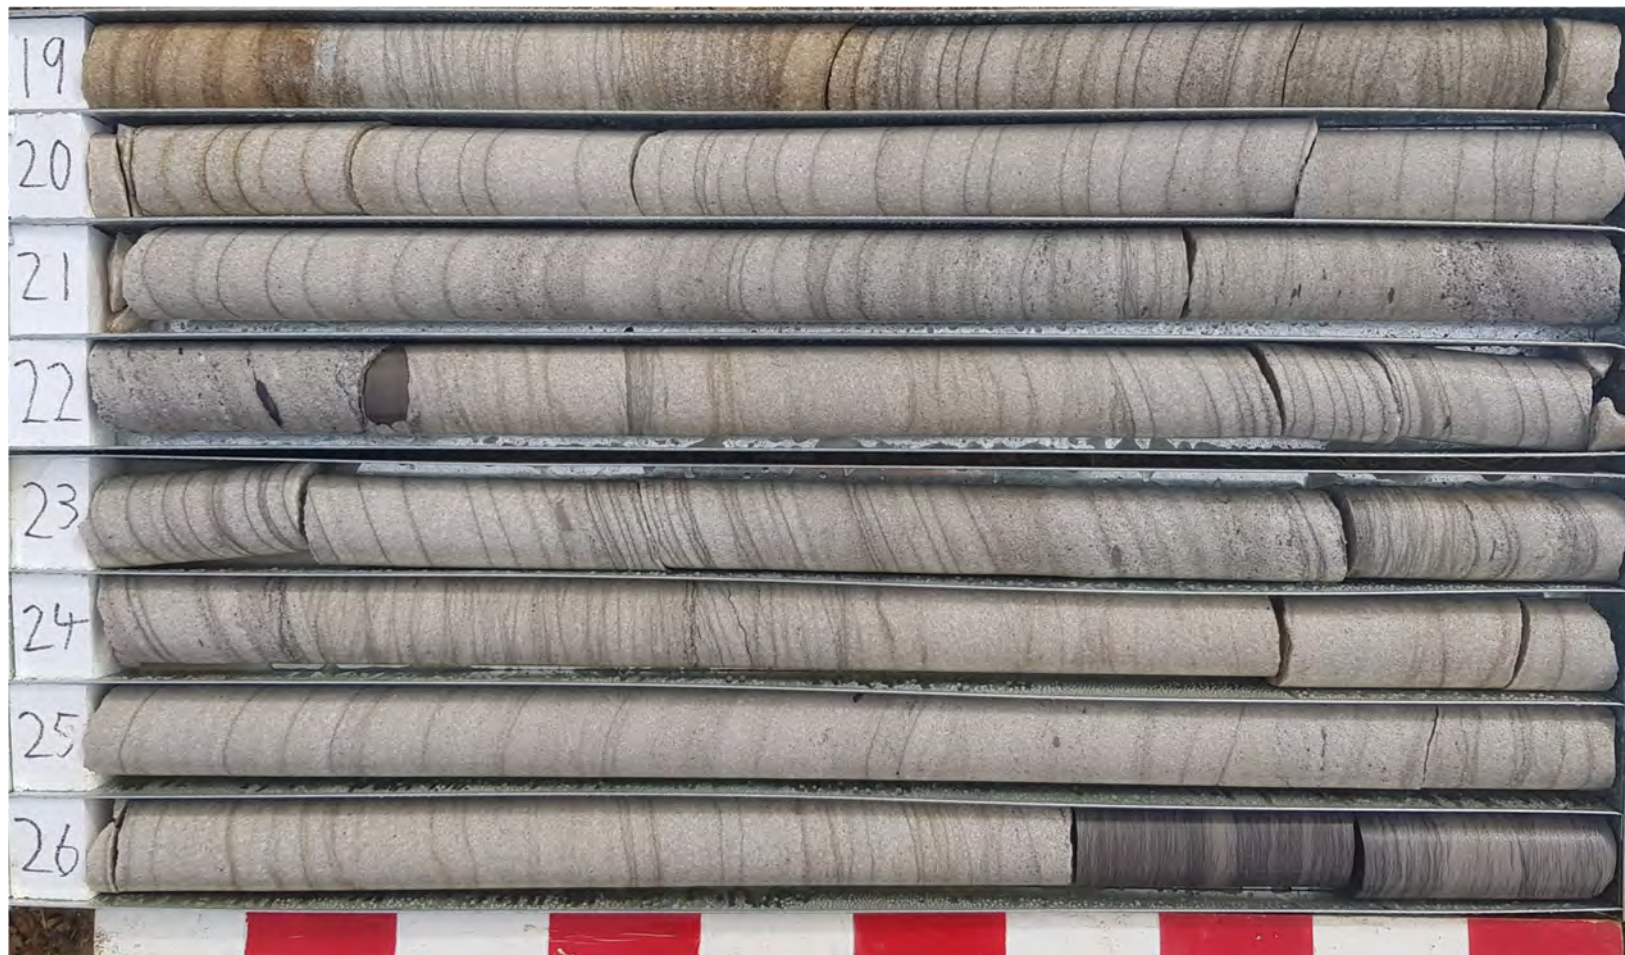
CORE PHOTOGRAPH OF BOREHOLE: BH2

Project	Proposed Development	Depth Range	19.0m to 27.0m BEGL	
Location	2 Mandala Parade, Castle Hill NSW	Contractor	Hagstrom	
Position	See Figure 2	Drill Rig	Hydrapower Scout V (DR011)	
Job No.	E24724.G03_Rev1	Logged	DS	Date 10 / 07 / 2020
Client	Deicorp Projects Showground P/L	Inclination	-90°	Date 24 / 08 / 2020
		Box	5-6 of 11	
		Checked	SR

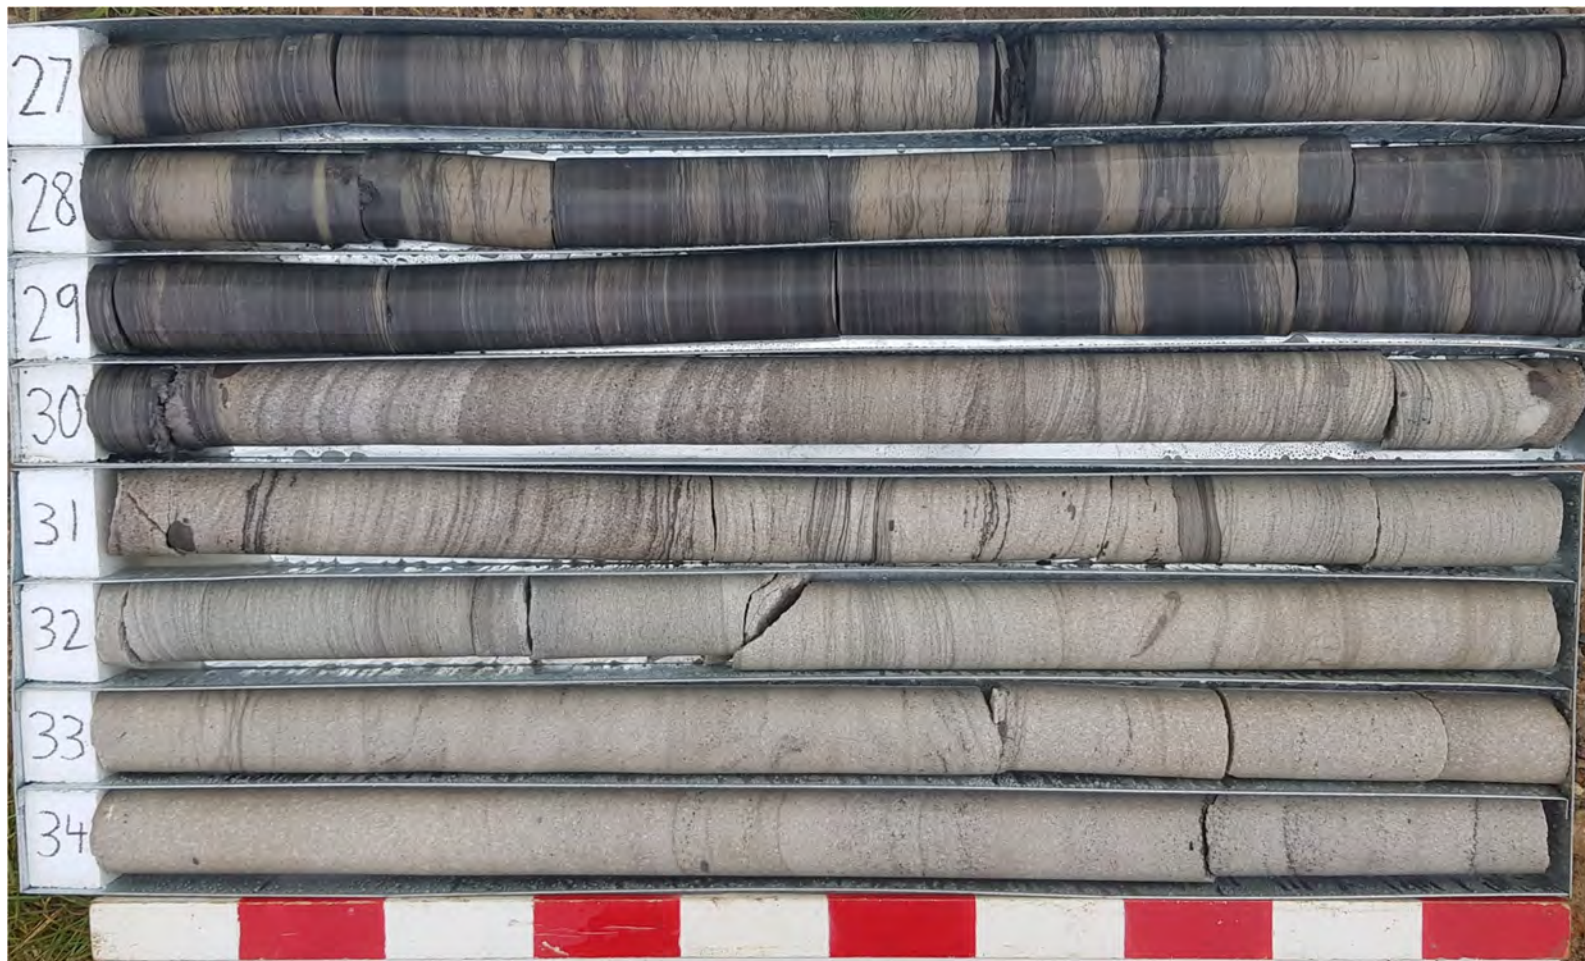
CORE PHOTOGRAPH OF BOREHOLE: BH2

Project	Proposed Development	Depth Range	27.0m to 35.0m BEGL	
Location	2 Mandala Parade, Castle Hill NSW	Contractor	Hagstrom	
Position	See Figure 2	Drill Rig	Hydrapower Scout V (DR011)	
Job No.	E24724.G03_Rev1	Logged	DS	Date 10 / 07 / 2020
Client	Deicorp Projects Showground P/L	Inclination	-90°	Date 24 / 08 / 2020
		Box	7-8 of 11

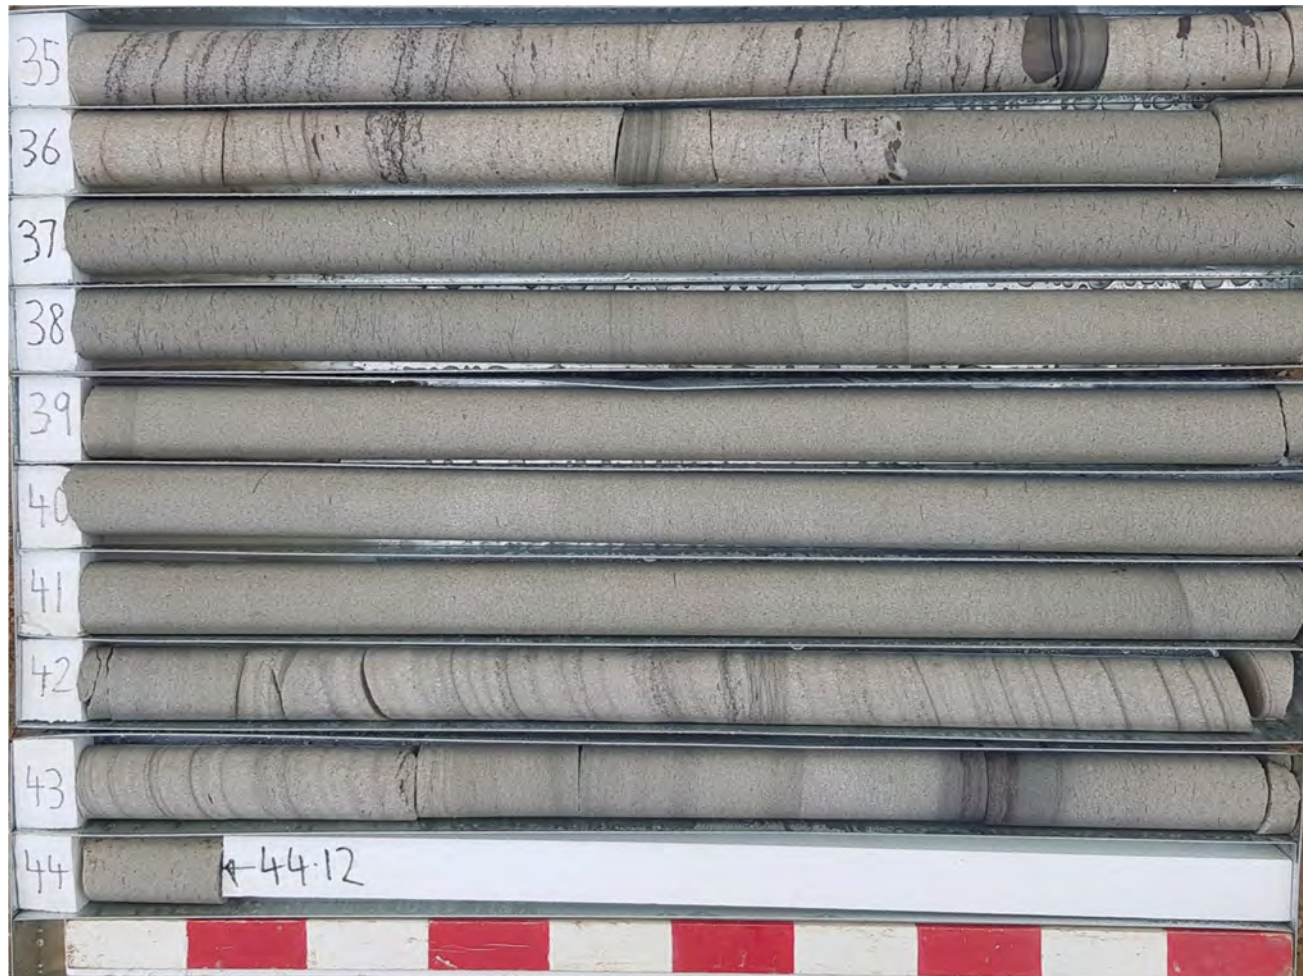
CORE PHOTOGRAPH OF BOREHOLE: BH2

Project	Proposed Development	Depth Range	35.0m to 44.12m BEGL	
Location	2 Mandala Parade, Castle Hill NSW	Contractor	Hagstrom	
Position	See Figure 2	Drill Rig	Hydrapower Scout V (DR011)	
Job No.	E24724.G03_Rev1	Logged	DS	Date 10 / 07 / 2020
Client	Deicorp Projects Showground P/L	Inclination	-90°	Date 24 / 08 / 2020
		Box	9-11 of 11	
		Checked	SR

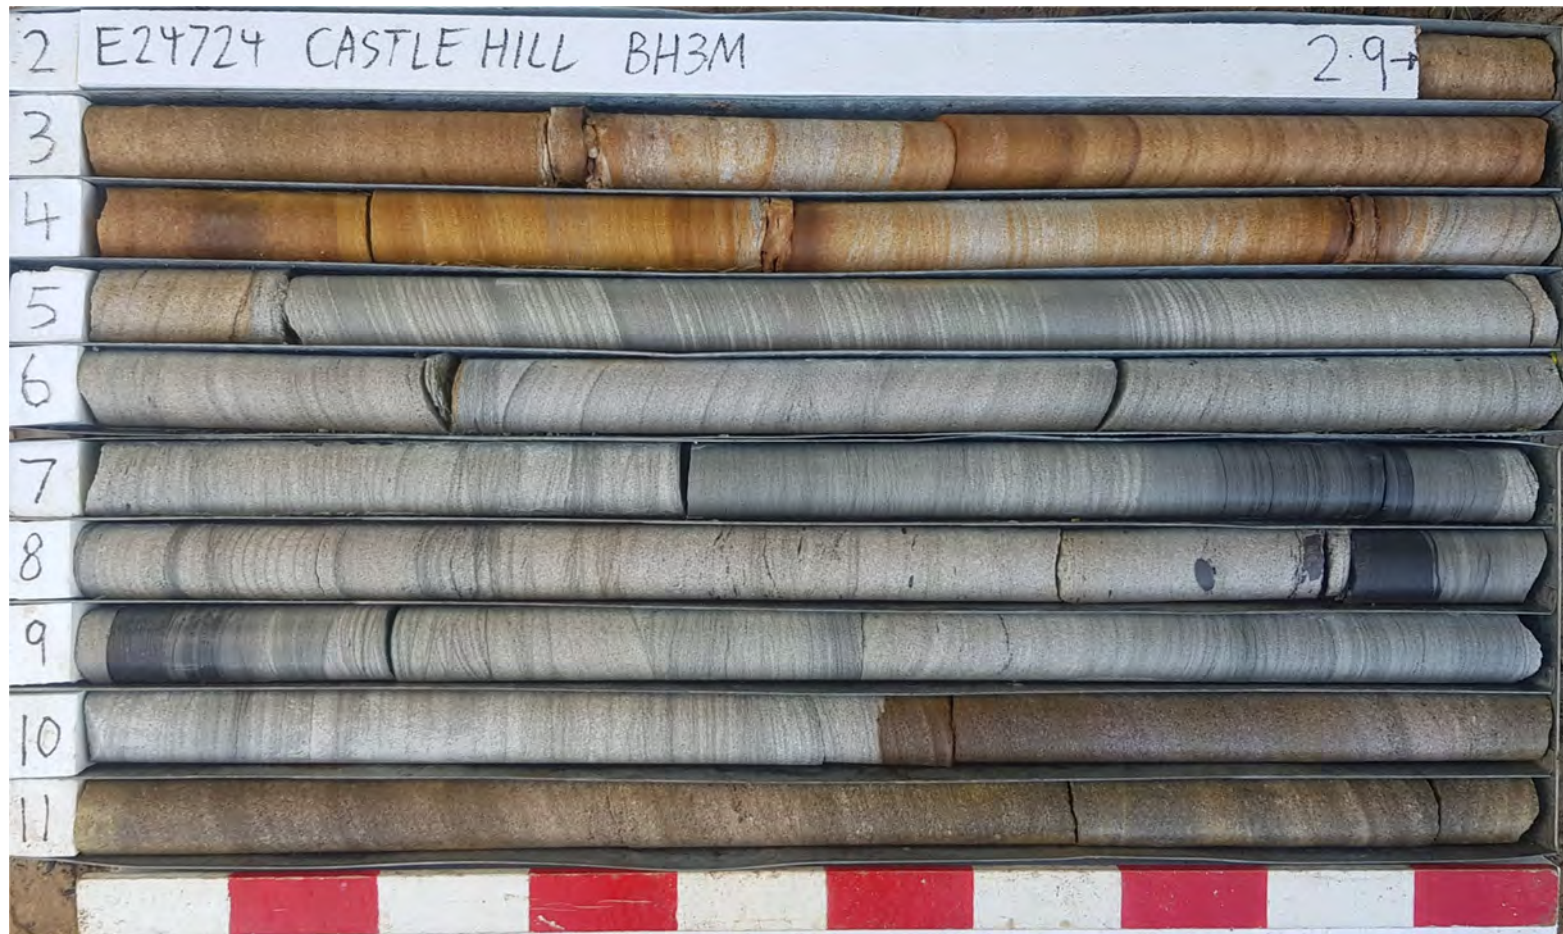
CORE PHOTOGRAPH OF BOREHOLE: BH3M

Project	Proposed Development	Depth Range	2.9m to 12.0m BEGL	
Location	2 Mandala Parade, Castle Hill NSW	Contractor	Hagstrom	
Position	See Figure 2	Drill Rig	Hydrapower Scout V (DR011)	
Job No.	E24724.G03_Rev1	Logged	DS	Date 14 / 07 / 2020
Client	Deicorp Projects Showground P/L	Box	1-2 of 8	Date 24 / 08 / 2020

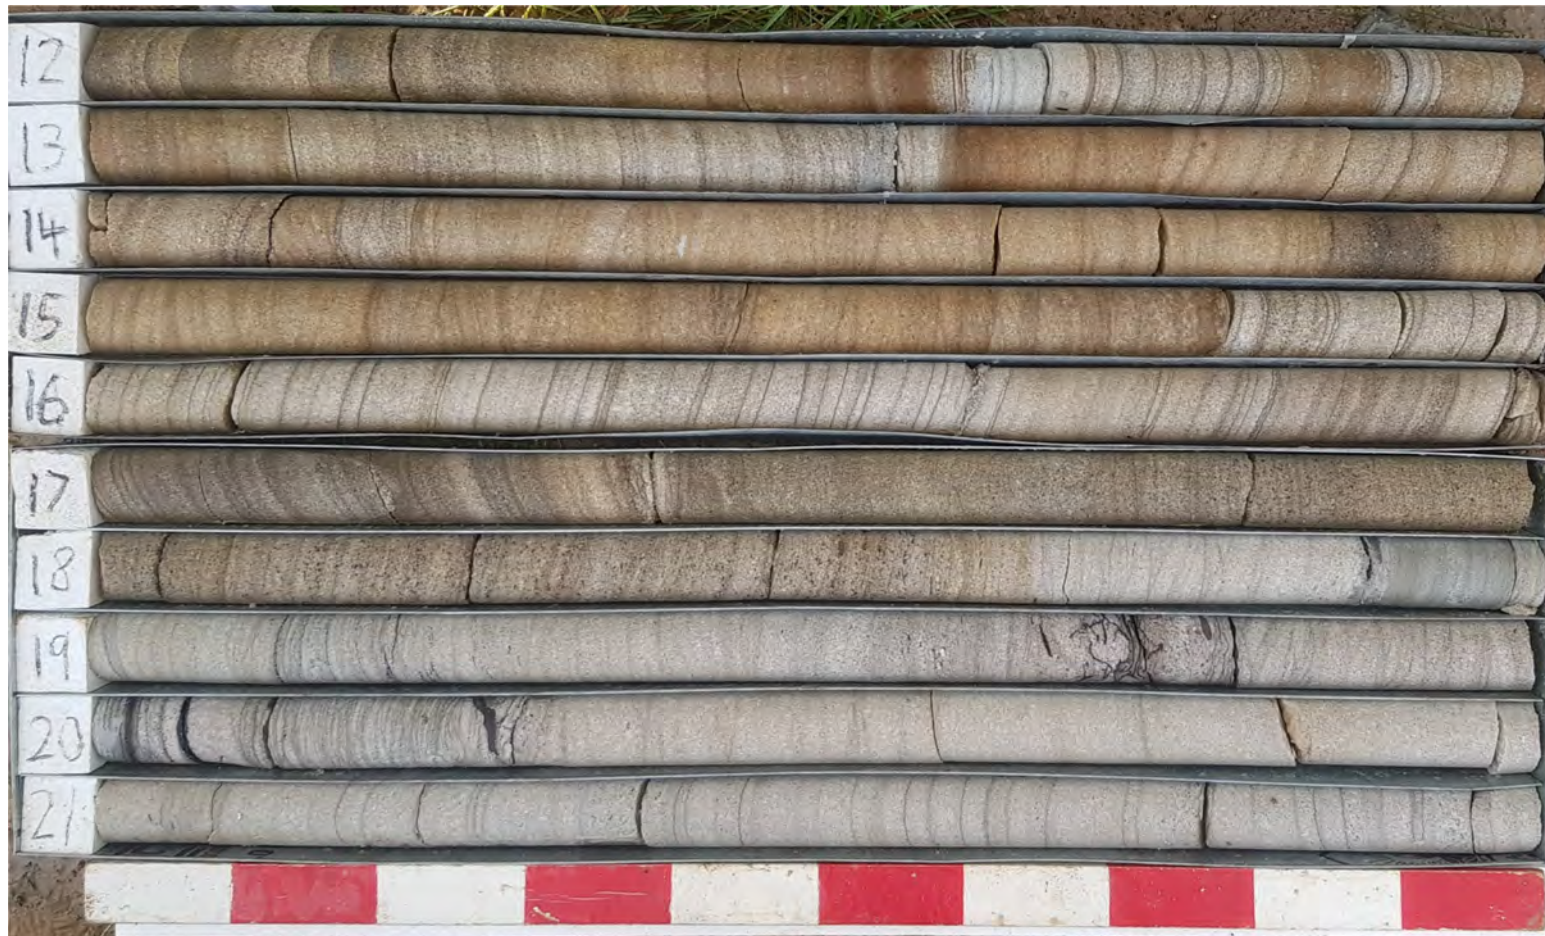
CORE PHOTOGRAPH OF BOREHOLE: BH3M

Project	Proposed Development	Depth Range	12.0m to 22.0m BEGL	
Location	2 Mandala Parade, Castle Hill NSW	Contractor	Hagstrom	
Position	See Figure 2	Drill Rig	Hydrapower Scout V (DR011)	
Job No.	E24724.G03_Rev1	Logged	DS	Date 14 / 07 / 2020
Client	Deicorp Projects Showground P/L	Box	3-4 of 8	Checked SR Date 24 / 08 / 2020

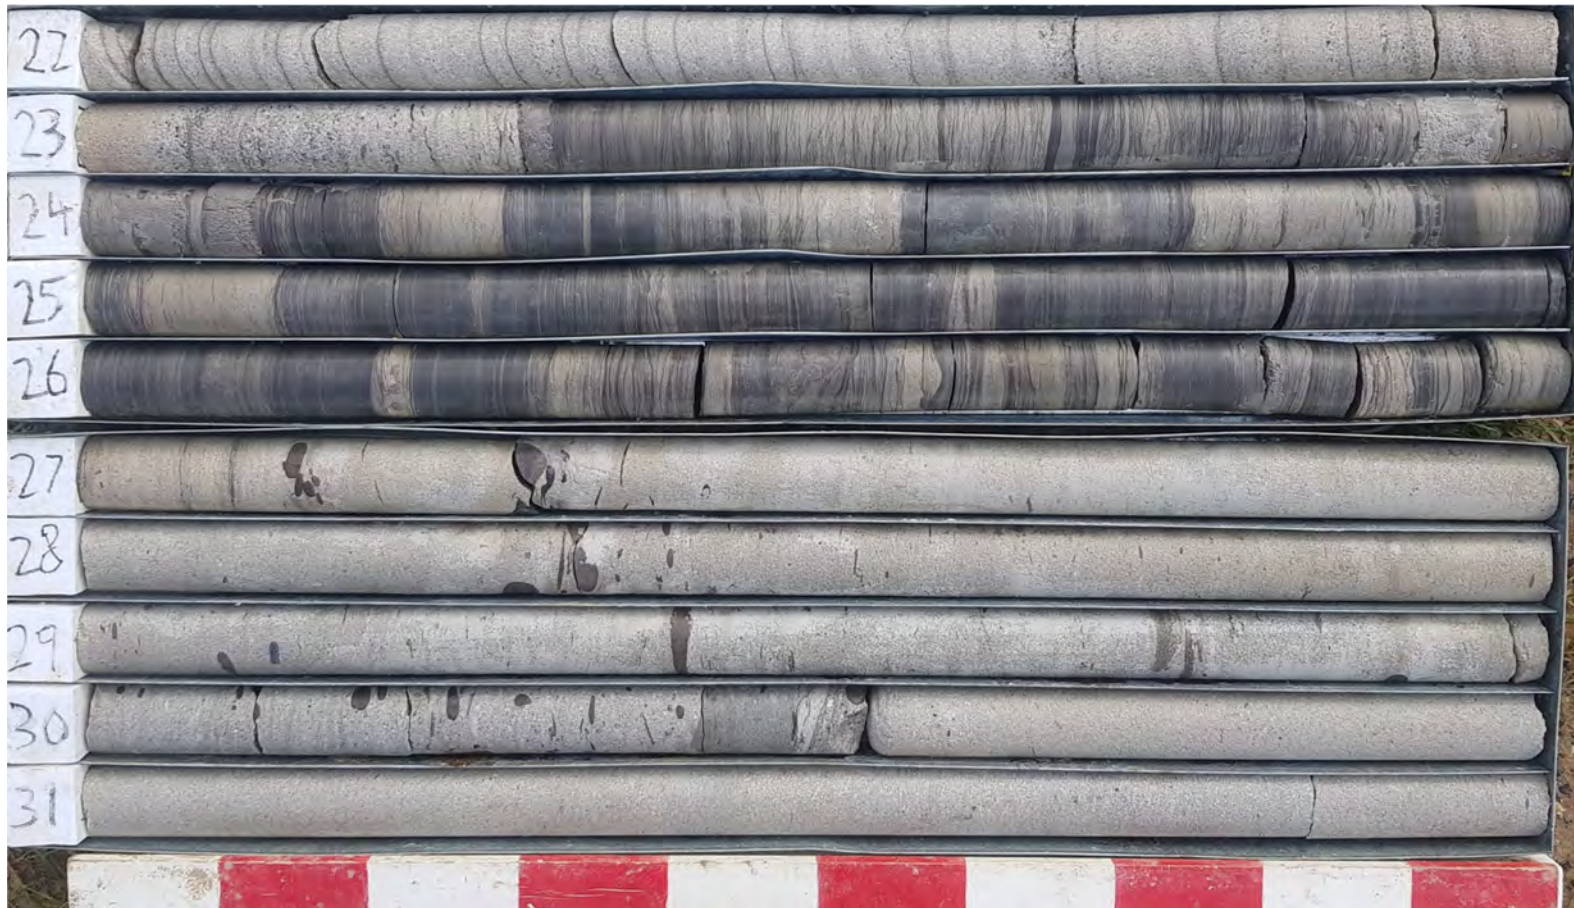
CORE PHOTOGRAPH OF BOREHOLE: BH3M

Project	Proposed Development	Depth Range	22.0m to 32.0m BEGL	
Location	2 Mandala Parade, Castle Hill NSW	Contractor	Hagstrom	
Position	See Figure 2	Drill Rig	Hydrapower Scout V (DR011)	
Job No.	E24724.G03_Rev1	Logged	DS	Date 14 / 07 / 2020
Client	Deicorp Projects Showground P/L	Inclination	-90°	Date 24 / 08 / 2020
		Box	5-6 of 8	
		Checked	SR

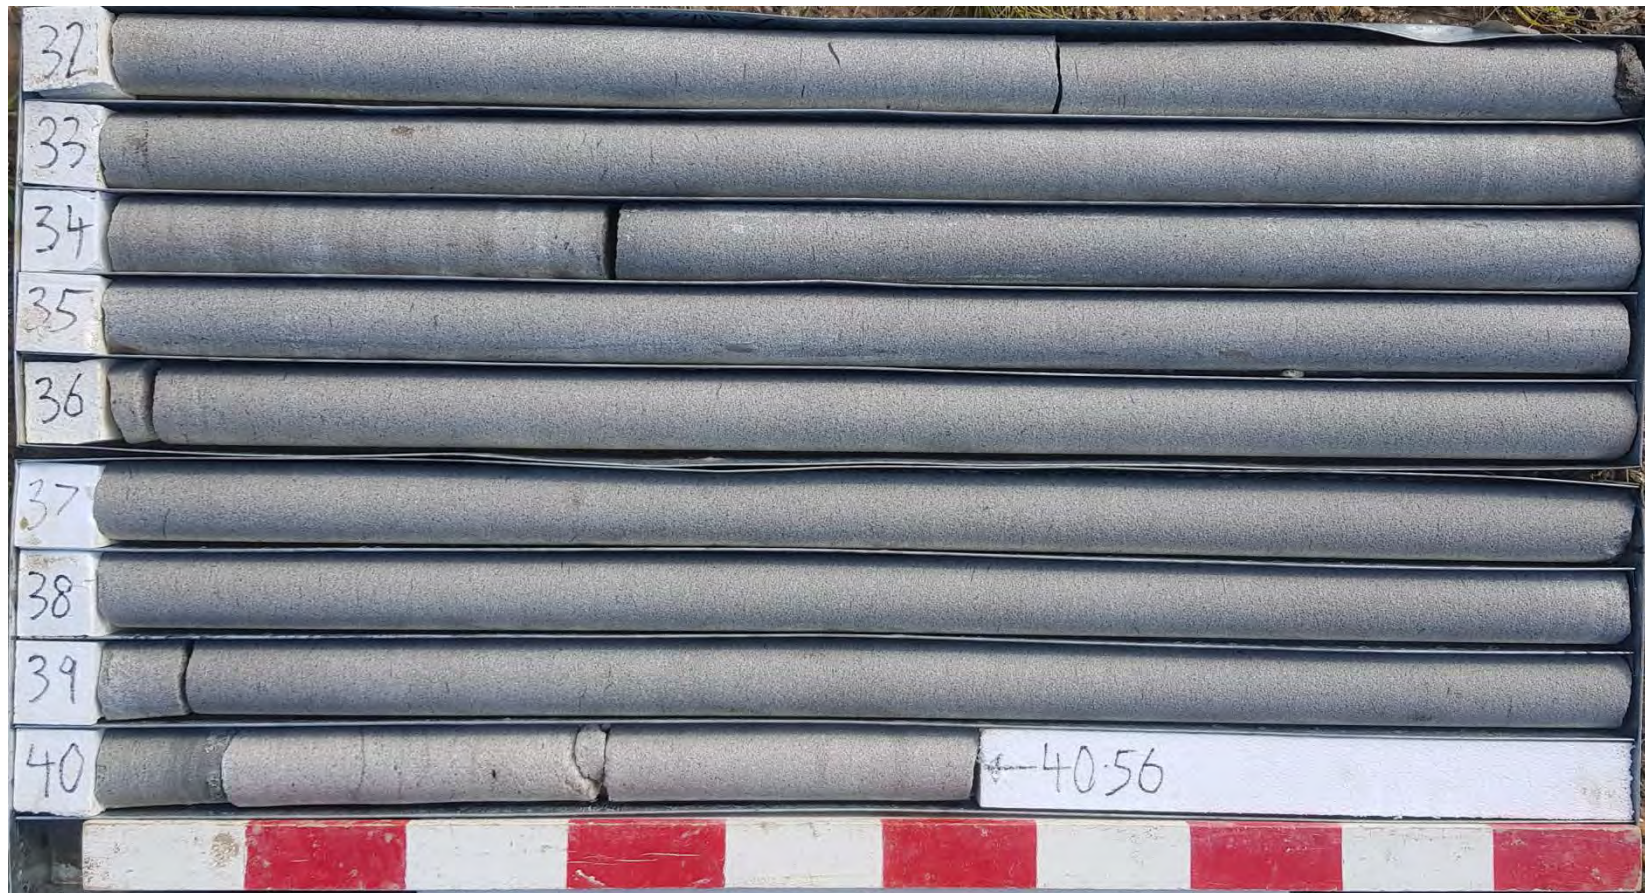
CORE PHOTOGRAPH OF BOREHOLE: BH3M

Project	Proposed Development	Depth Range	22.0m to 32.0m BEGL	
Location	2 Mandala Parade, Castle Hill NSW	Contractor	Hagstrom	
Position	See Figure 2	Drill Rig	Hydrapower Scout V (DR011)	
Job No.	E24724.G03_Rev1	Logged	DS	Date 14 / 07 / 2020
Client	Deicorp Projects Showground P/L	Box	7-8 of 8	Checked SR Date 24 / 08 / 2020
