DEICORP PROJECTS SHOWGROUND PTY LTD

Geotechnical Investigation

2 Mandala Parade, Castle Hill, NSW

Report No: E24724.G03_Rev2

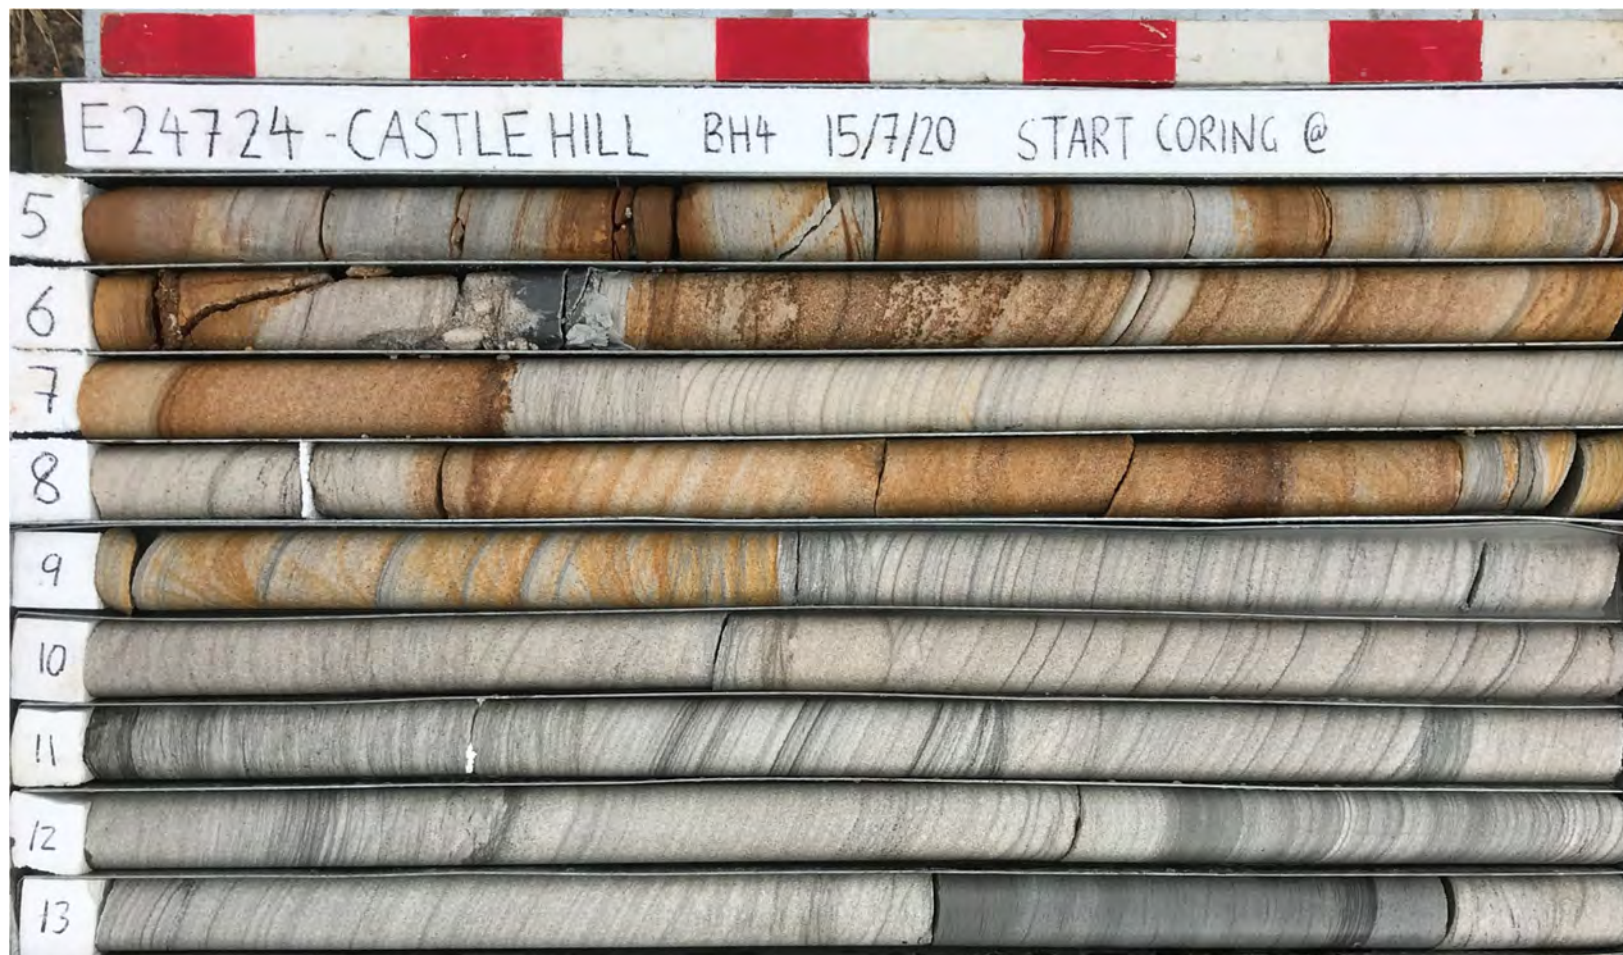
CORE PHOTOGRAPH OF BOREHOLE: BH4M

Project	Proposed Development	Depth Range	5.0m to 14.0m BEGL	
Location	2 Mandala Parade, Castle Hill NSW	Contractor	Geosense Drilling	
Position	See Figure 2	Drill Rig	Hanjin DB8	
Job No.	E24724.G03_Rev1	Logged	SL	Date 14 / 07 / 2020
Client	Deicorp Projects Showground P/L	Box	1-2 of 9	Checked SR Date 24 / 08 / 2020
		Surface RL	≈ 98.0m	
		Inclination	-90°

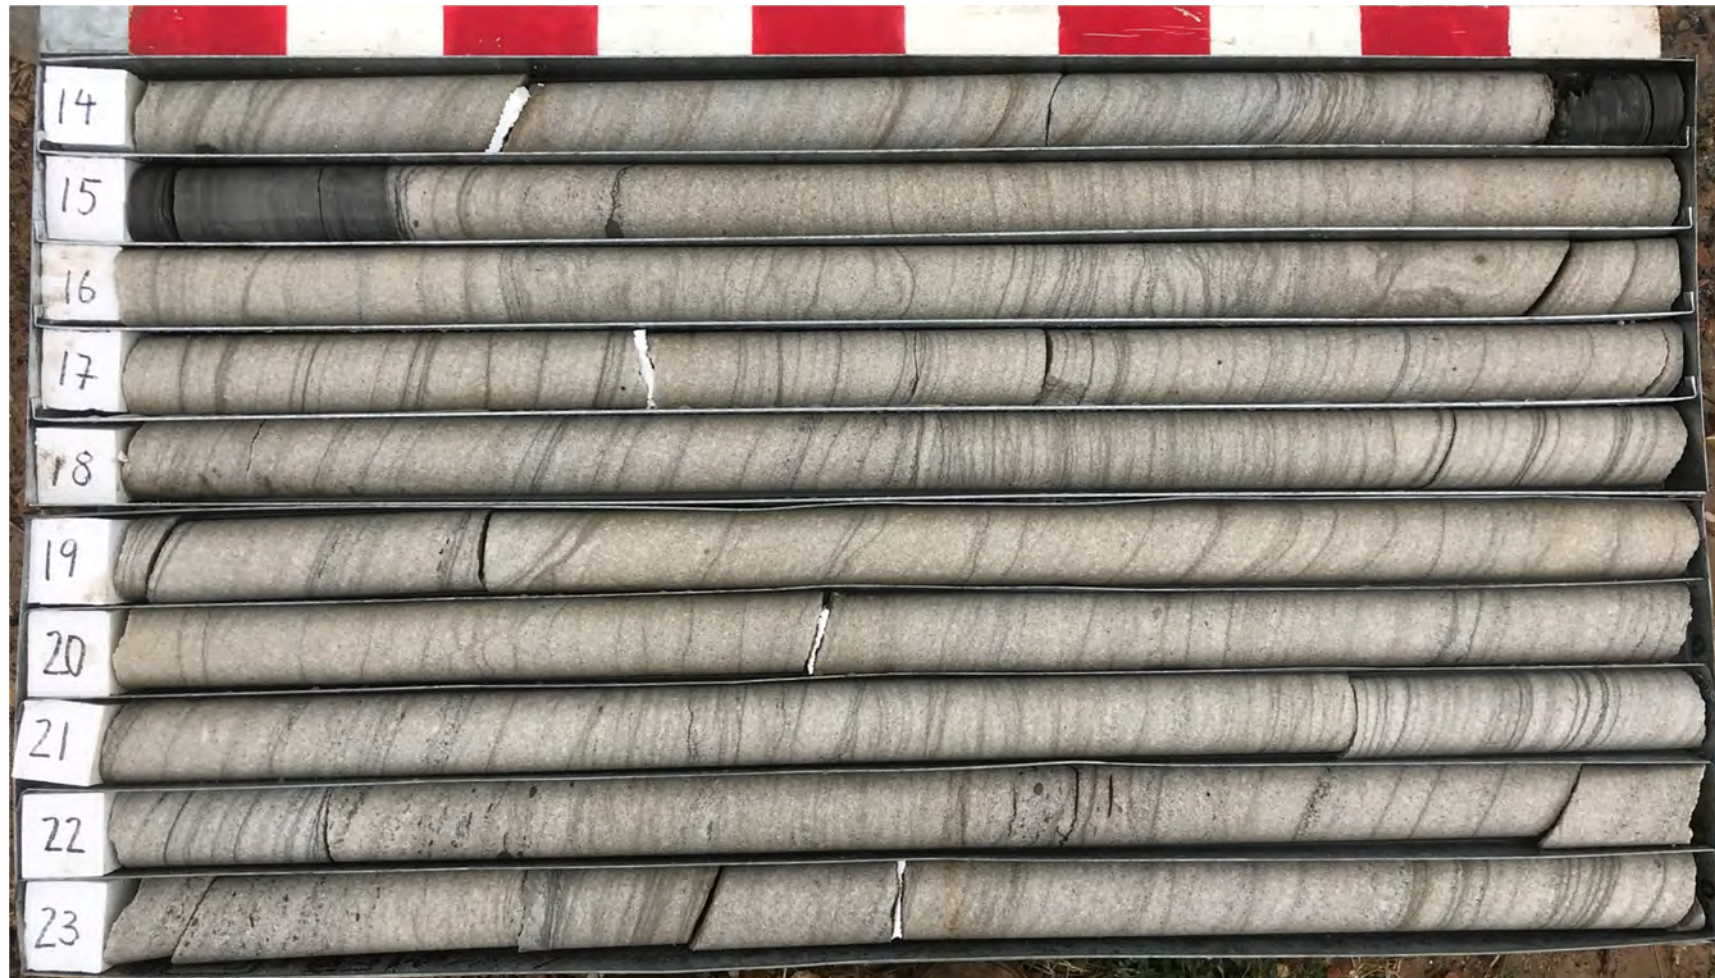
CORE PHOTOGRAPH OF BOREHOLE: BH4M

Project	Proposed Development	Depth Range	14.0m to 24.0m BEGL	
Location	2 Mandala Parade, Castle Hill NSW	Contractor	Geosense Drilling	
Position	See Figure 2	Drill Rig	Hanjin DB8	
Job No.	E24724.G03_Rev1	Logged	SL	Date 14 / 07 / 2020
Client	Deicorp Projects Showground P/L	Inclination	-90°	Date 24 / 08 / 2020
		Box	3-4 of 9

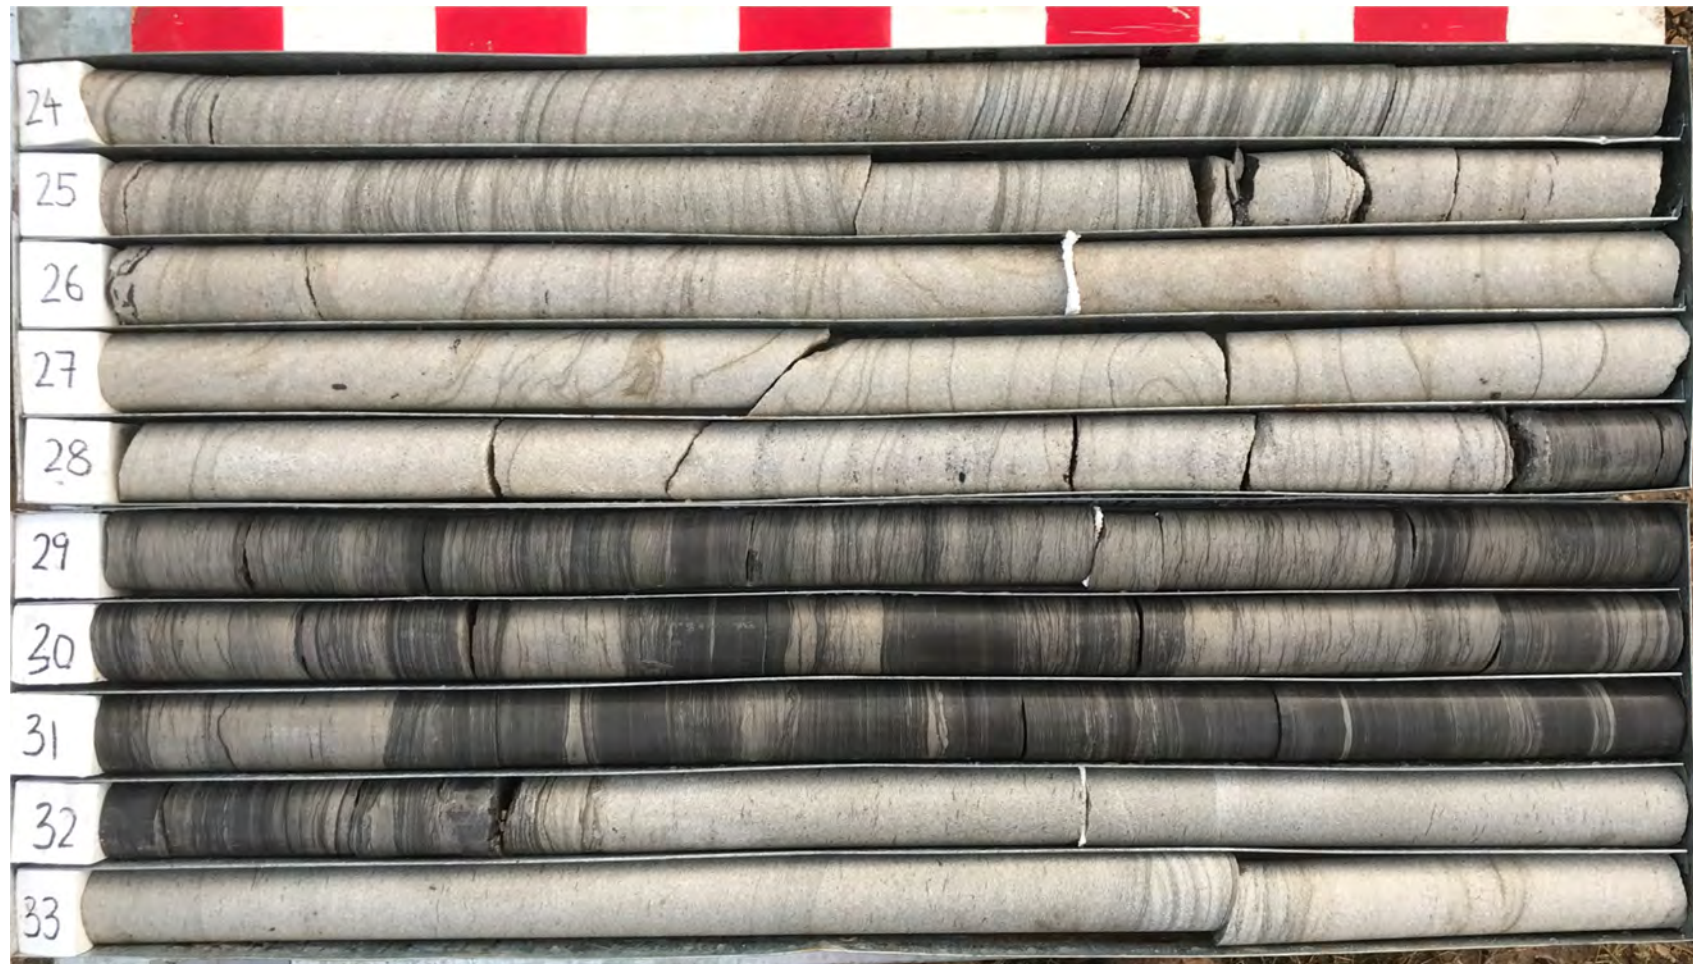
CORE PHOTOGRAPH OF BOREHOLE: BH4M

Project	Proposed Development	Depth Range	24.0m to 34.0m BEGL	
Location	2 Mandala Parade, Castle Hill NSW	Contractor	Geosense Drilling	
Position	See Figure 2	Drill Rig	Hanjin DB8	
Job No.	E24724.G03_Rev1	Logged	SL	Date 14 / 07 / 2020
Client	Deicorp Projects Showground P/L	Inclination	-90°	Date 24 / 08 / 2020
		Box	5-6 of 9

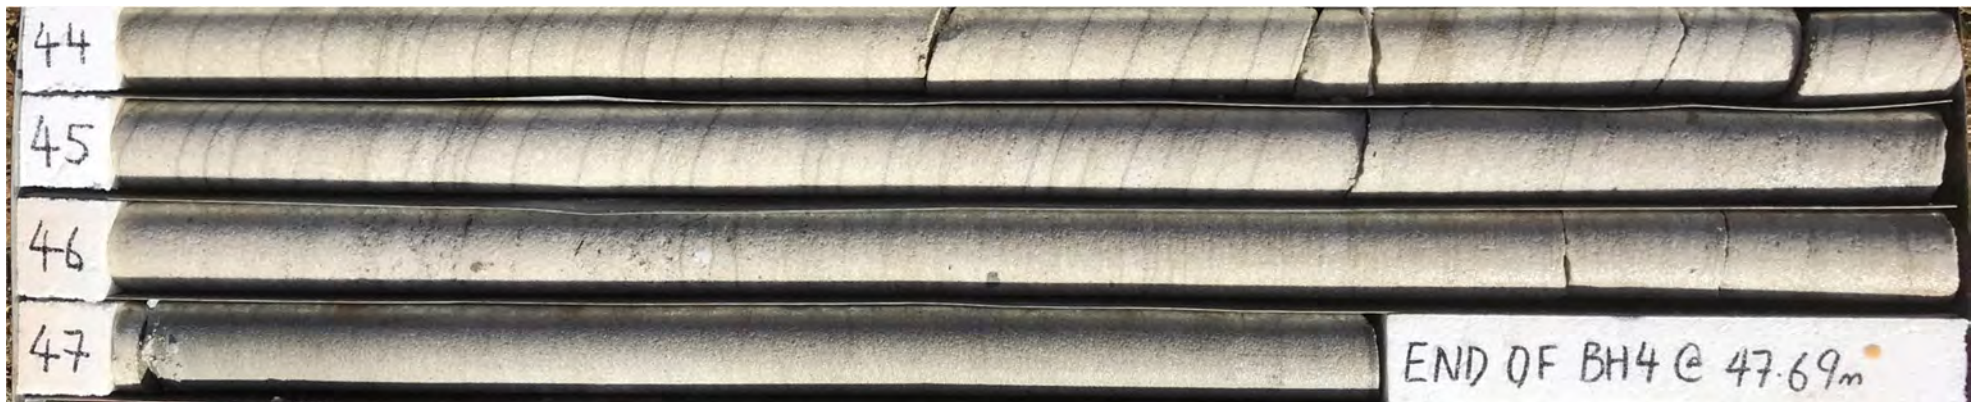
CORE PHOTOGRAPH OF BOREHOLE: BH4M

Project	Proposed Development	Depth Range	44.0m to 47.69m BEGL	
Location	2 Mandala Parade, Castle Hill NSW	Contractor	Geosense Drilling	
Position	See Figure 2	Drill Rig	Hanjin DB8	
Job No.	E24724.G03_Rev1	Logged	SL	Date 14 / 07 / 2020
Client	Deicorp Projects Showground P/L	Inclination	-90°	
		Box	9 of 9	
		Checked	SR	Date 24 / 08 / 2020

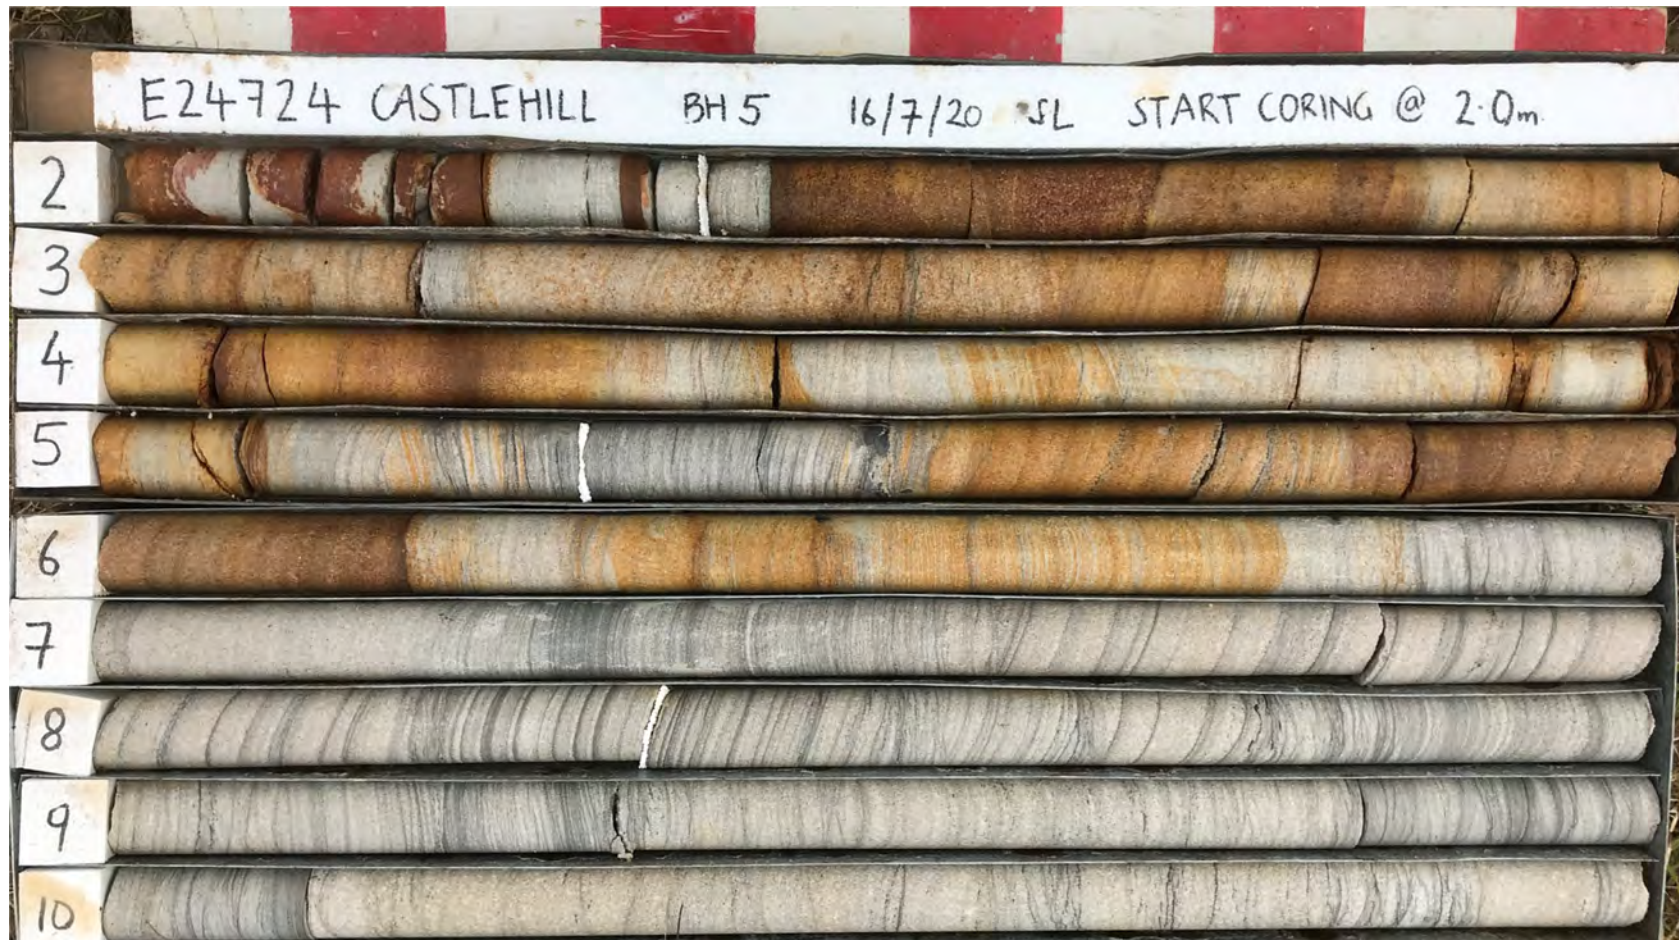
CORE PHOTOGRAPH OF BOREHOLE: BH5M

Project	Proposed Development	Depth Range	2.0m to 11.0m BEGL	
Location	2 Mandala Parade, Castle Hill NSW	Contractor	Geosense Drilling	
Position	See Figure 2	Drill Rig	Hanjin DB8	
Job No.	E24724.G03_Rev1	Logged	SL	Date 16 / 07 / 2020
Client	Deicorp Projects Showground P/L	Inclination	-90°	Date 24 / 08 / 2020
		Box	1-2 of 9

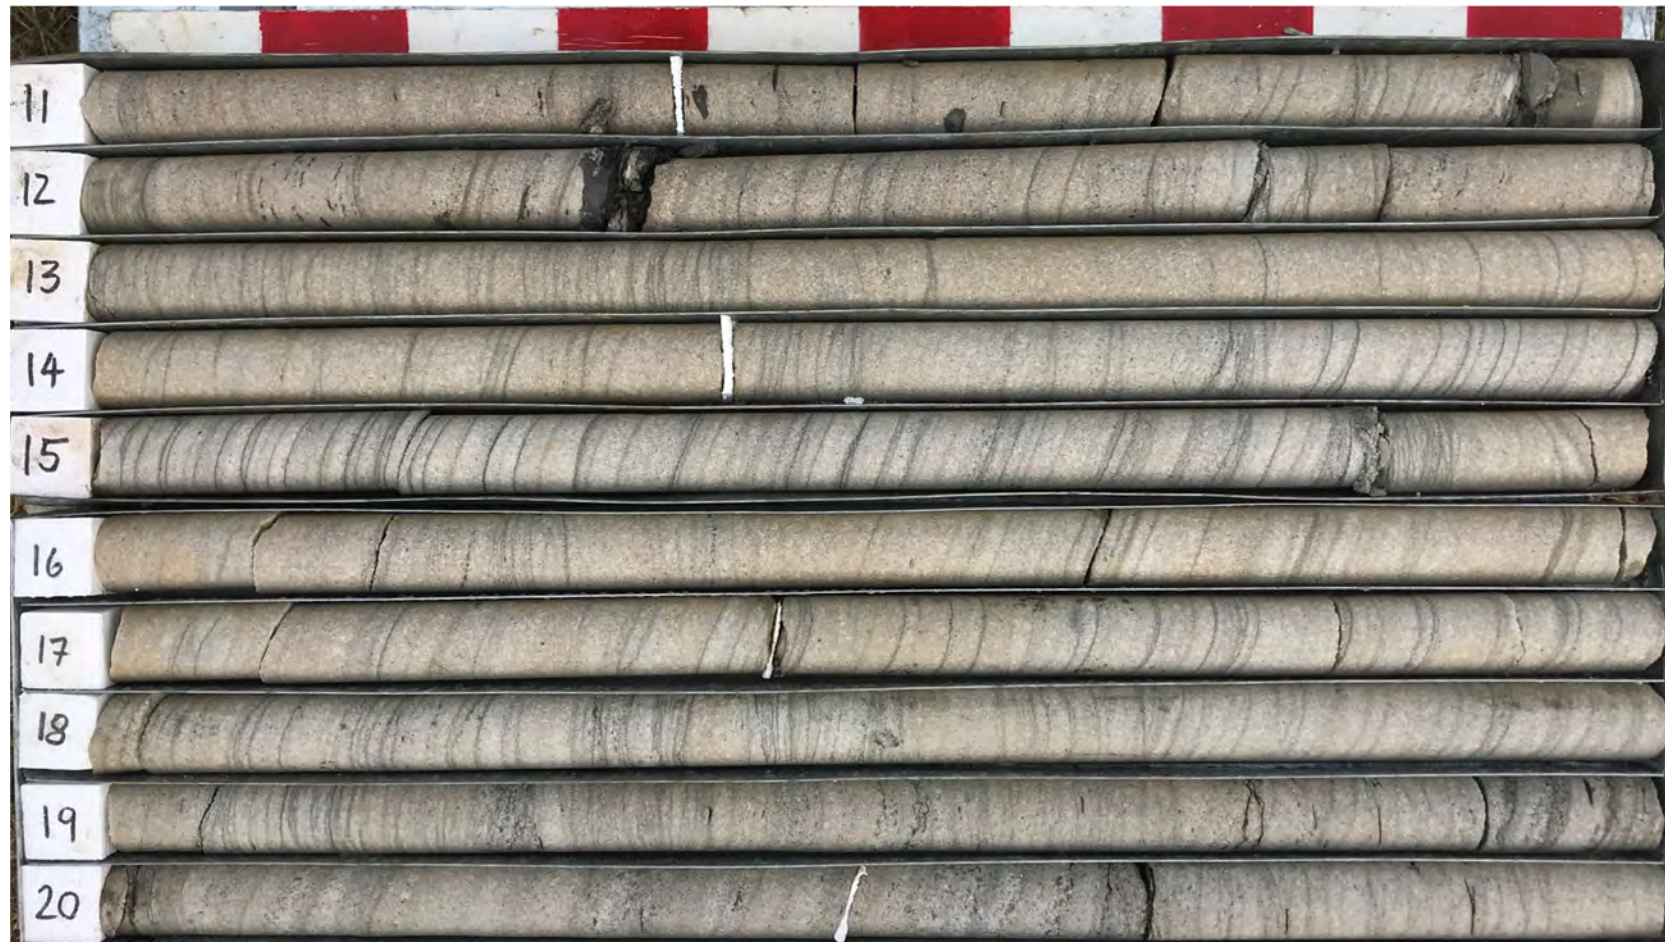
CORE PHOTOGRAPH OF BOREHOLE: BH5M

Project	Proposed Development	Depth Range	11.0m to 21.0m BEGL	
Location	2 Mandala Parade, Castle Hill NSW	Contractor	Geosense Drilling	
Position	See Figure 2	Drill Rig	Hanjin DB8	
Job No.	E24724.G03_Rev1	Logged	SL	Date 16 / 07 / 2020
Client	Deicorp Projects Showground P/L	Inclination	-90°	Date 24 / 08 / 2020
		Box	3-4 of 9

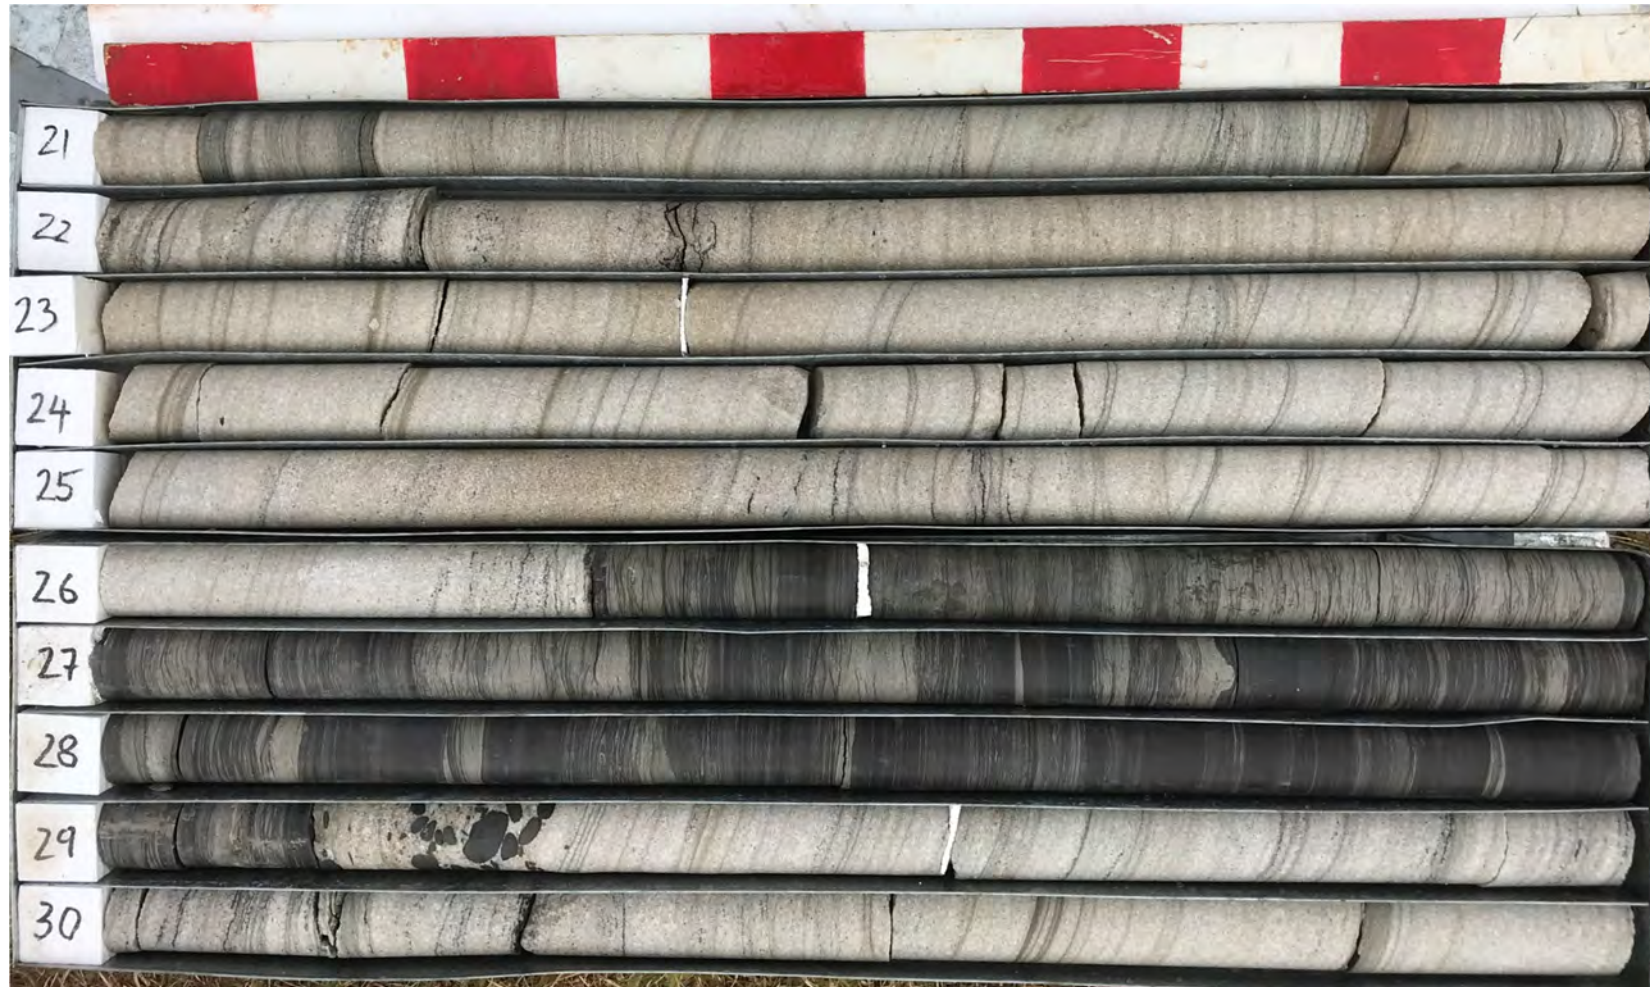
CORE PHOTOGRAPH OF BOREHOLE: BH5M

Project	Proposed Development	Depth Range	21.0m to 31.0m BEGL	
Location	2 Mandala Parade, Castle Hill NSW	Contractor	Geosense Drilling	
Position	See Figure 2	Drill Rig	Hanjin DB8	
Job No.	E24724.G03_Rev1	Logged	SL	Date 16 / 07 / 2020
Client	Deicorp Projects Showground P/L	Inclination	-90°	Date 24 / 08 / 2020
		Box	5-6 of 9

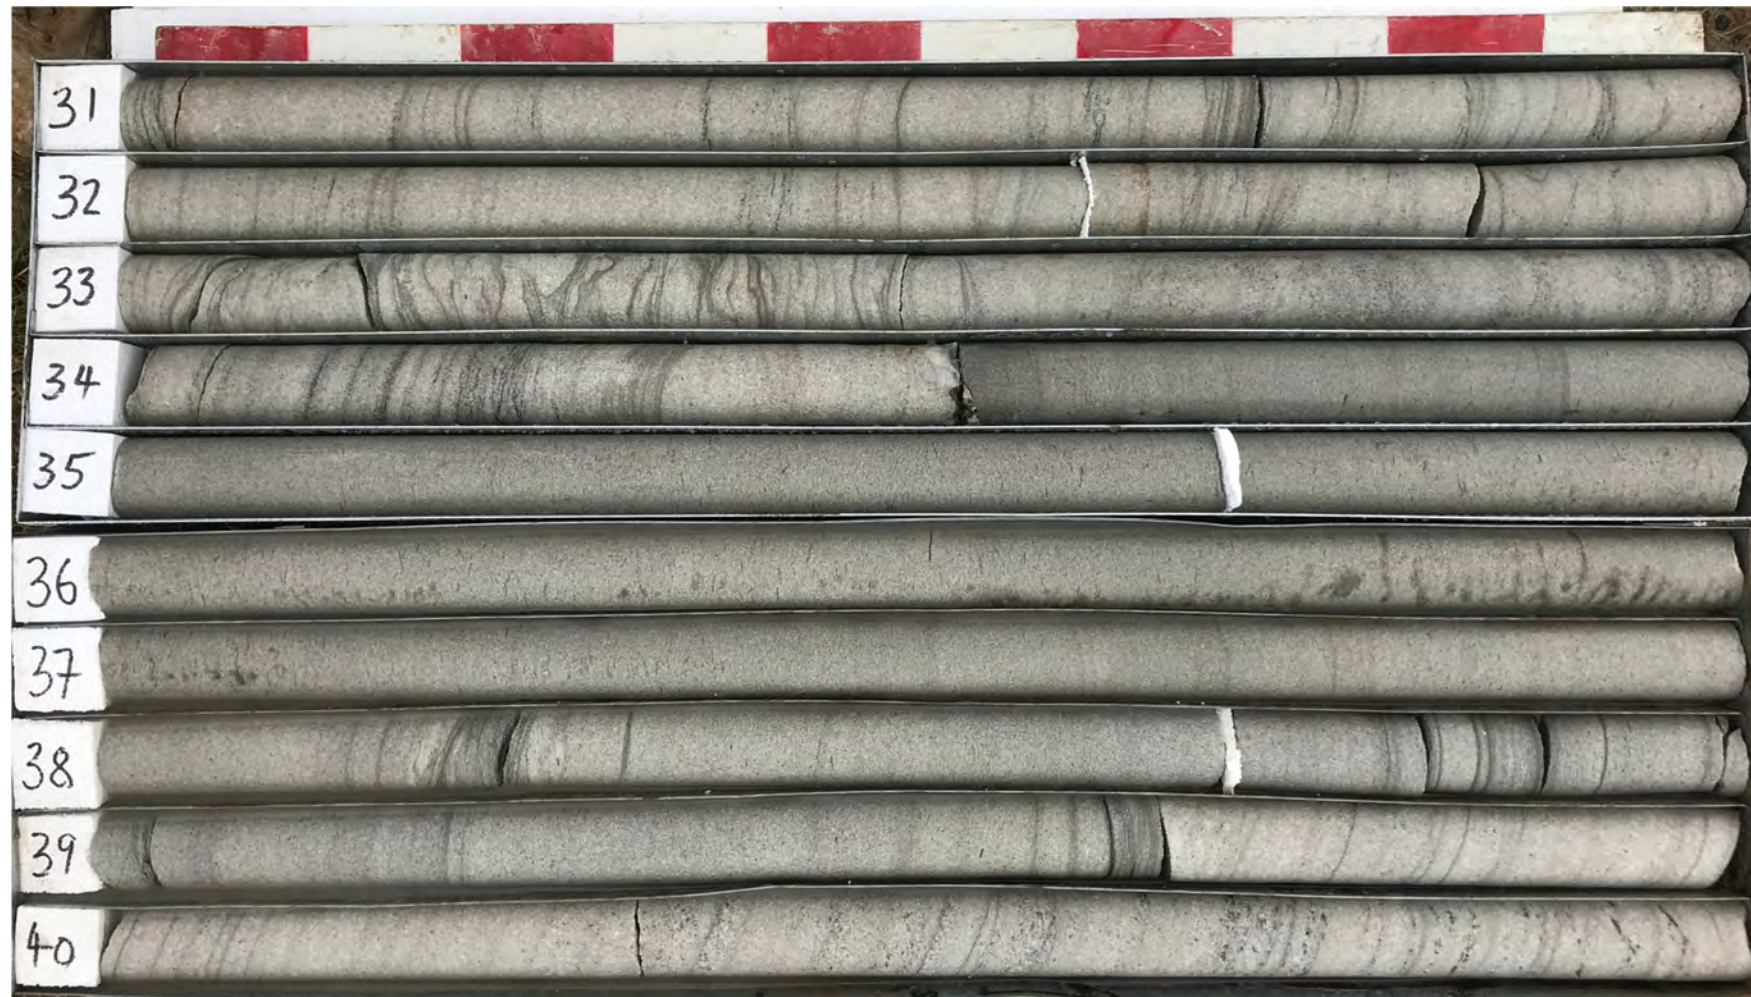
CORE PHOTOGRAPH OF BOREHOLE: BH5M

Project	Proposed Development	Depth Range	31.0m to 41.0m BEGL	
Location	2 Mandala Parade, Castle Hill NSW	Contractor	Geosense Drilling	
Position	See Figure 2	Drill Rig	Hanjin DB8	
Job No.	E24724.G03_Rev1	Logged	SL	Date 16 / 07 / 2020
Client	Deicorp Projects Showground P/L	Box	7-8 of 9	Date 24 / 08 / 2020
		Inclination	-90°	
		Surface RL	≈ 94.1m

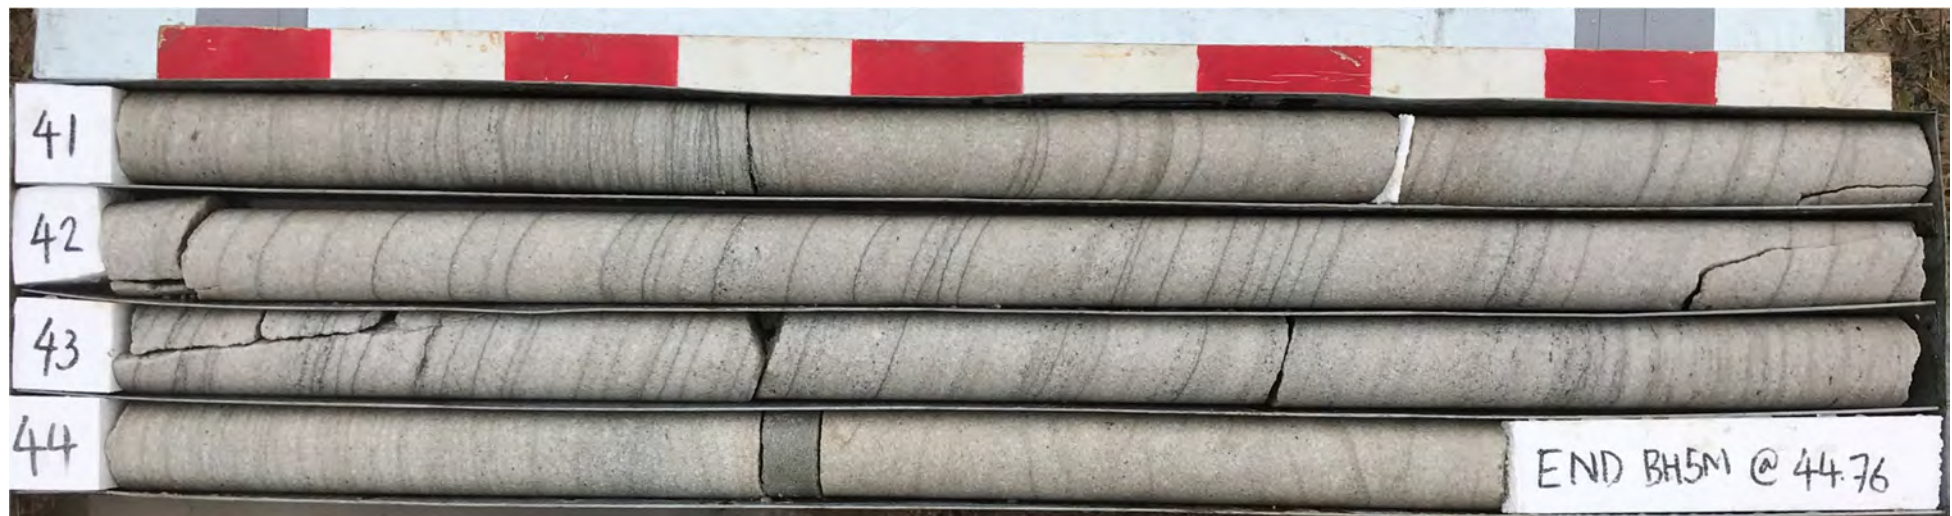
CORE PHOTOGRAPH OF BOREHOLE: BH5M

Project	Proposed Development	Depth Range	41.0m to 44.76m BEGL	
Location	2 Mandala Parade, Castle Hill NSW	Contractor	Geosense Drilling	
Position	See Figure 2	Drill Rig	Hanjin DB8	
Job No.	E24724.G03_Rev1	Logged	SL	Date 16 / 07 / 2020
Client	Deicorp Projects Showground P/L	Inclination	-90°	Date 24 / 08 / 2020
		Box	9 of 9

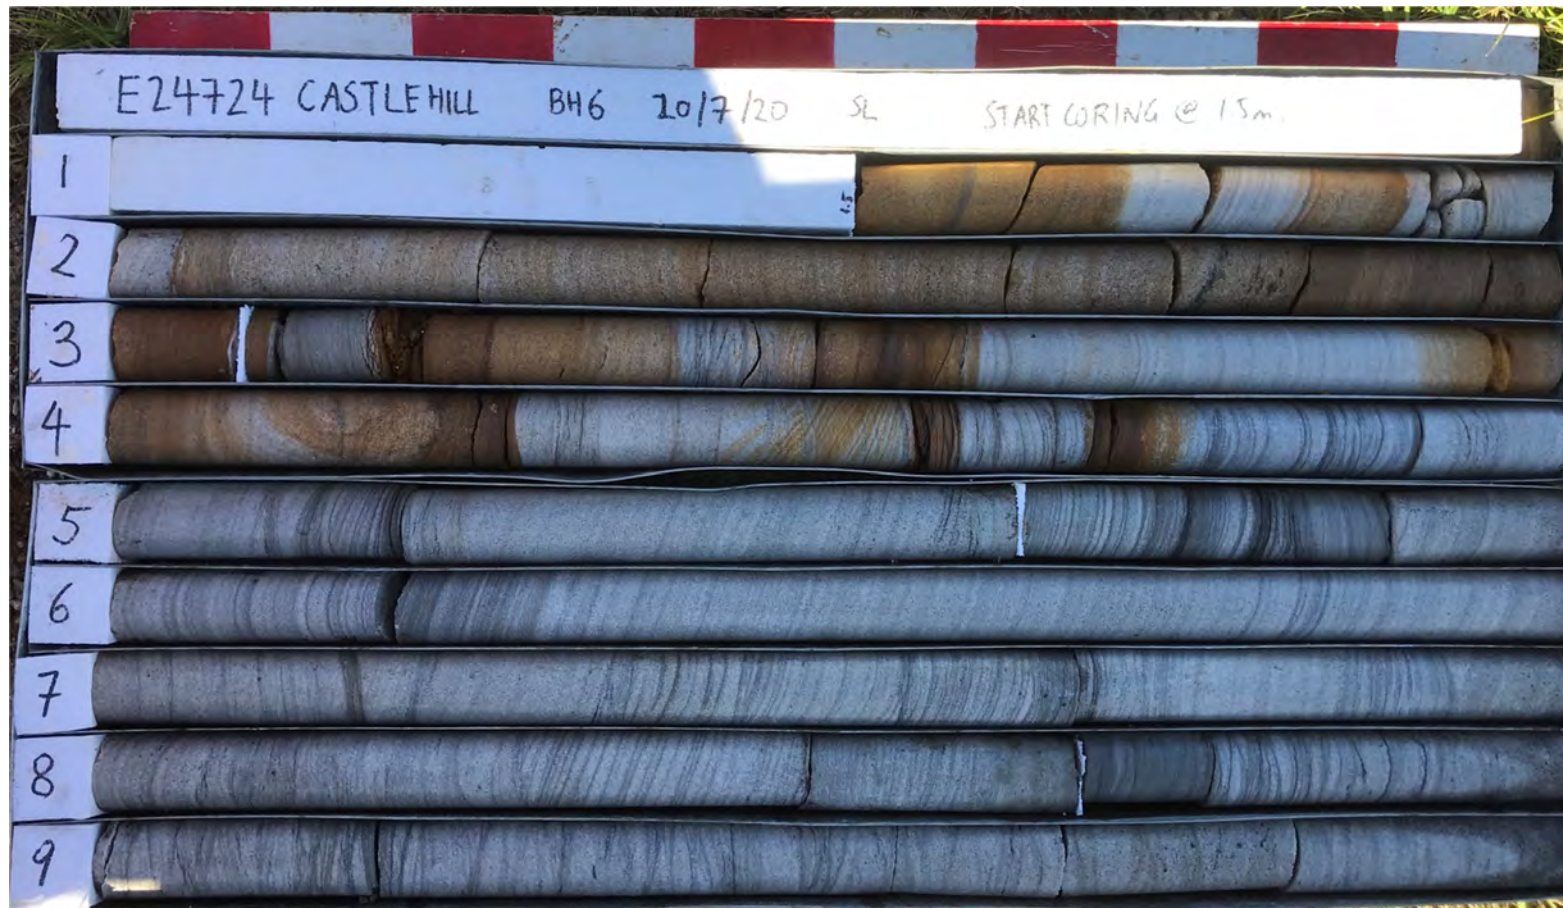
CORE PHOTOGRAPH OF BOREHOLE: BH6

Project	Proposed Development	Depth Range	1.5m to 10.0m BEGL	
Location	2 Mandala Parade, Castle Hill NSW	Contractor	Geosense Drilling	
Position	See Figure 2	Drill Rig	Hanjin DB8	
Job No.	E24724.G03_Rev1	Logged	SL	Date 20 / 07 / 2020
Client	Deicorp Projects Showground P/L	Box	1-2 of 7	Checked SR Date 24 / 08 / 2020
		Surface RL	≈ 90.8m	
		Inclination	-90°

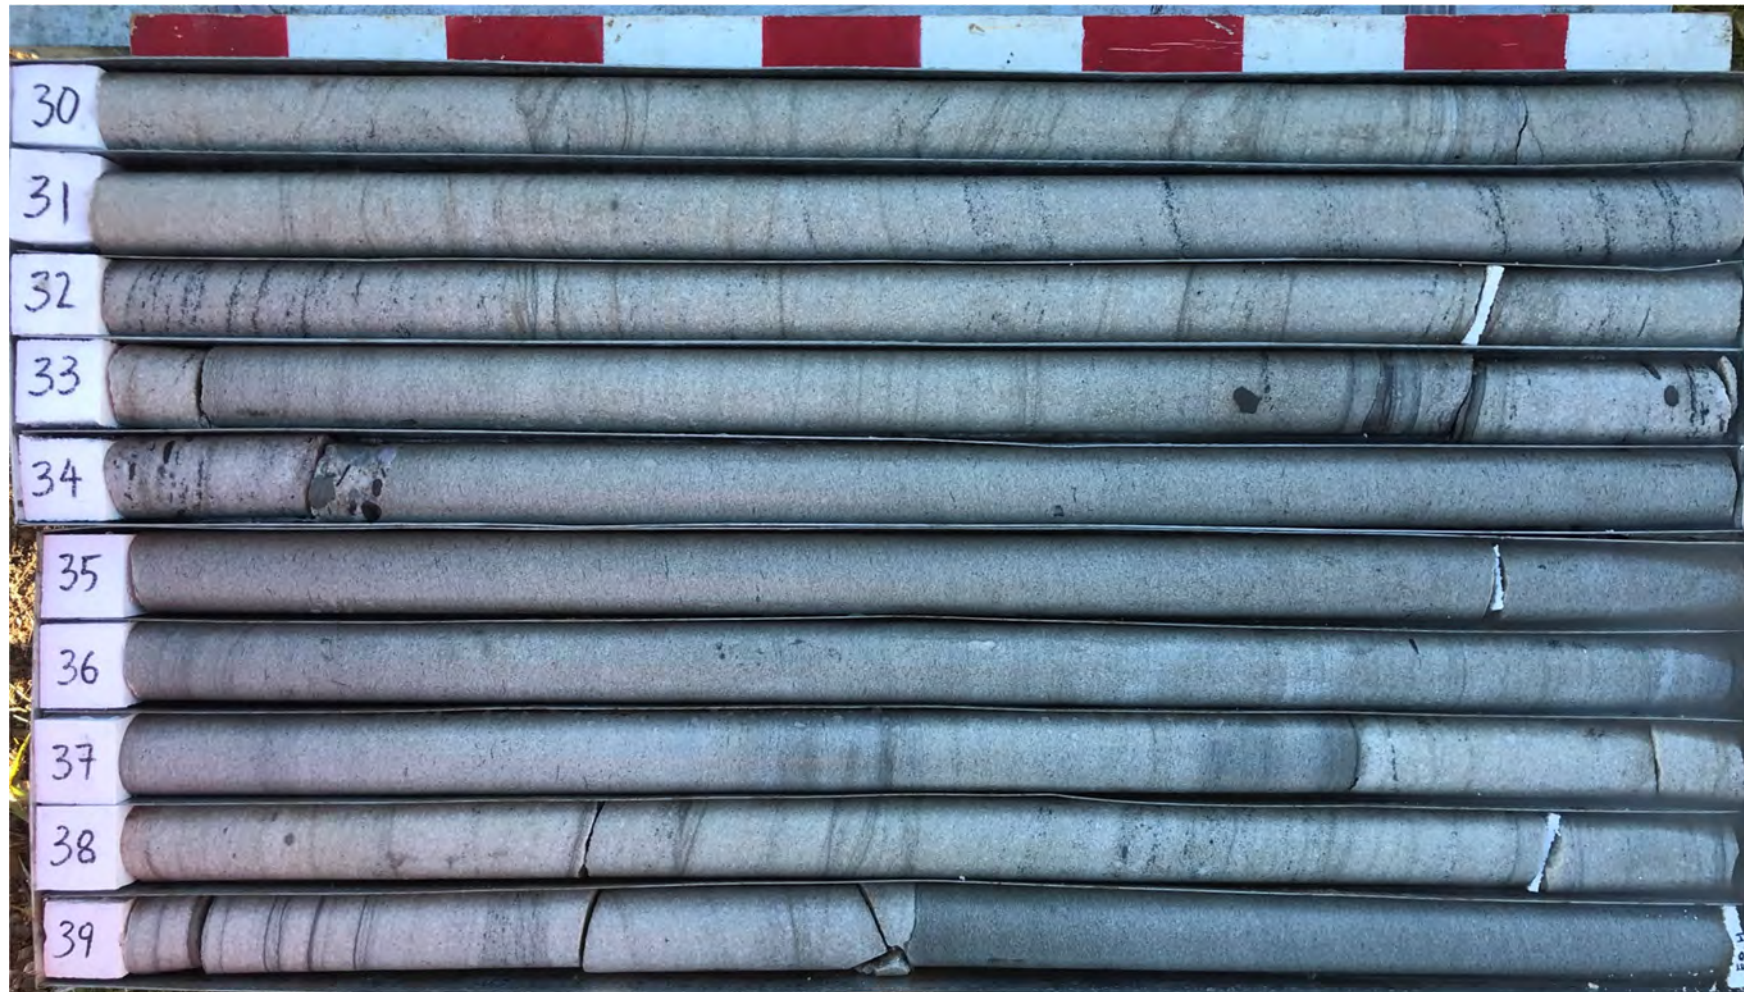
CORE PHOTOGRAPH OF BOREHOLE: BH6

Project	Proposed Development	Depth Range	30.0m to 40.0m BEGL	
Location	2 Mandala Parade, Castle Hill NSW	Contractor	Geosense Drilling	
Position	See Figure 2	Drill Rig	Hanjin DB8	
Job No.	E24724.G03 _Rev1	Logged	SL	Date 20 / 07 / 2020
Client	Deicorp Projects Showground P/L	Inclination	-90°	Date 24 / 08 / 2020
		Box	6-7 of 7
