Sampling, Analysis and Quality Plan  
Supplementary Contamination Assessment

Proposed School  
Lot 100 DP1261496, Maitland Street, Muswellbrook  
NSW

Prepared for  
Pacific Brook Christian School Ltd

Project 91601.03  
September 2021

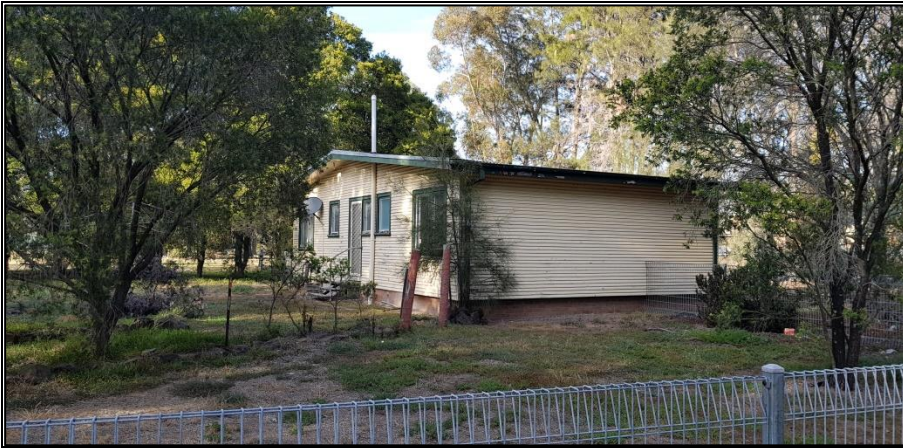
**Figure 1: Residential building in the central portion of the site, looking south east**

- The site was vacant and contained several site structures as follows:
  - o A residential property in the central northern portion of the site (Figure 1);
  - o Administration buildings in the south central portion of the site;
  - o A glasshouse in the south eastern portion of the site (Figure 2);
  - o Two Hazchem sheds in the south eastern portion of the site (Figures 3); and
  - o Several awning and shed structures and a large water tank were also located across the site (Figures 3 and 4).

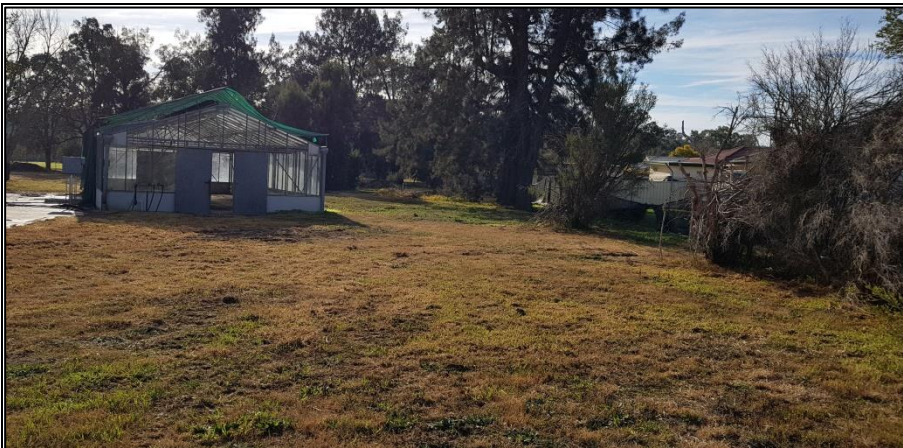
**Figure 2: Glasshouse in the south eastern portion of the site, looking north**

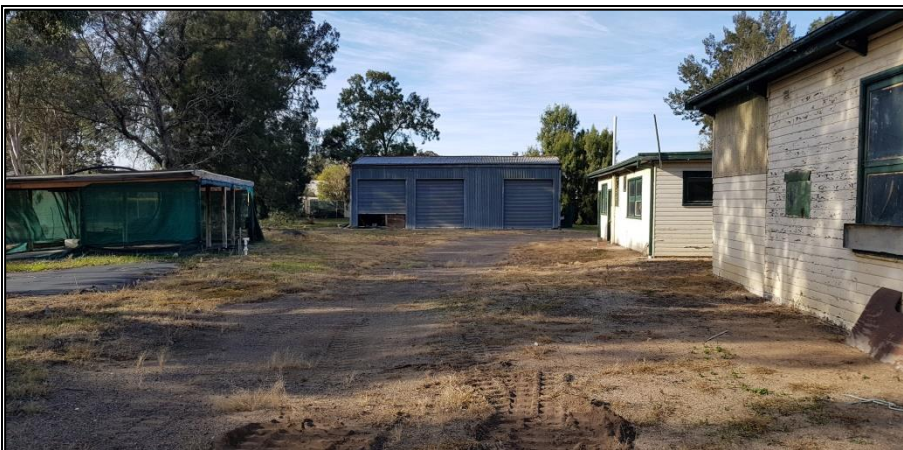
**Figure 3: Hazchem buildings in the background and on the right and awning / shed on the left, looking south east**

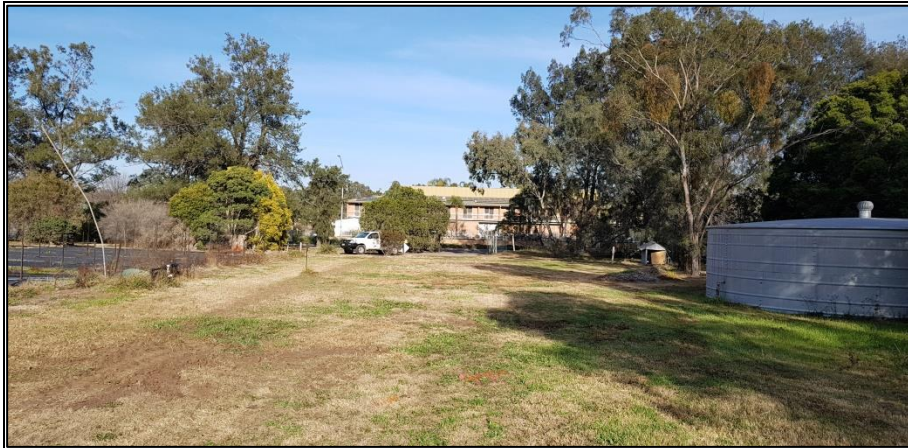
**Figure 4: Large water tank on the right and gravel beds lined with weed matting on left, looking south west**

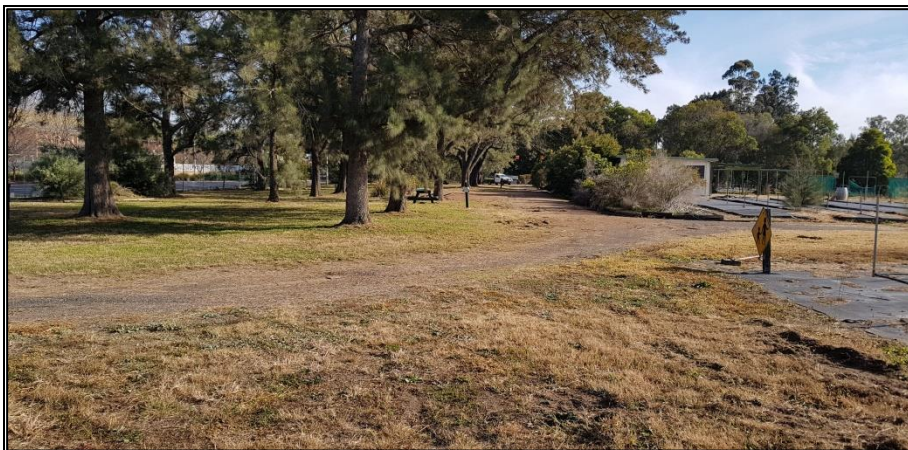
**Figure 5: Grassed covered areas, internal gravel paths and gravel / weed matting areas, looking north west**

The south eastern portion of the site was fenced and housed the majority of the buildings which were made of weatherboard cladding or metal sheeting along with metal sheet roofing. The south eastern areas also comprised several mature trees along and adjacent to the site boundaries and internal gravel paths and gravel areas covered in weed matting presumably used as display beds when the previous nursery was in operation. The undeveloped areas in the south eastern portion were grassed (Figure 5).

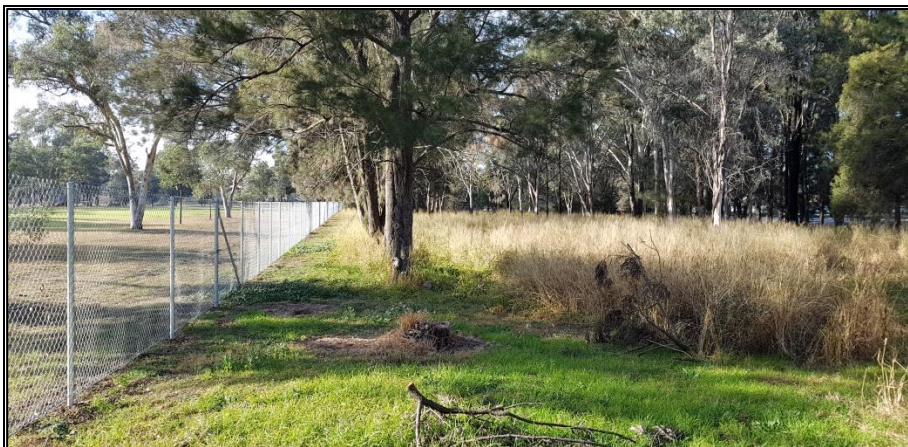
**Figure 6: Dense grass covered area with abundant mature trees in the undeveloped north western portion of the site, looking south**

The north western portion of the site was unfenced and appeared to be undeveloped comprising abundant mature trees and vegetative ground cover (Figure 6).

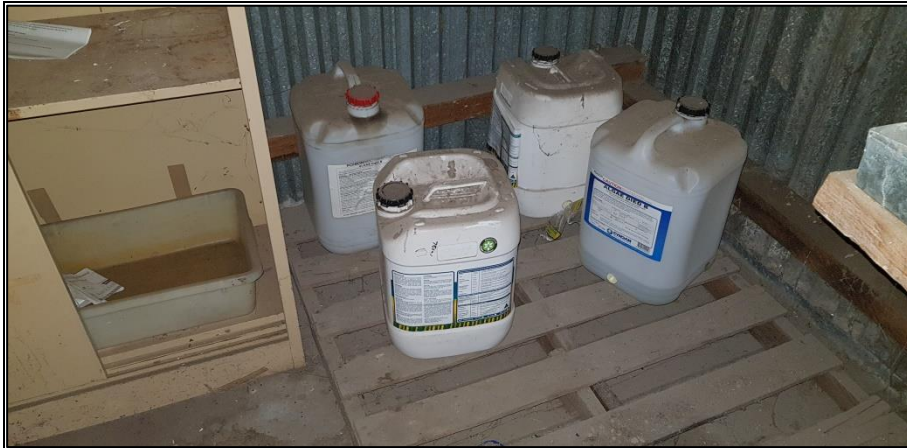
**Figure 7: Stored chemical containers within the Hazchem building**

At the time of the inspection the majority of the accessible buildings (sheds, Hazchem and glasshouse) were mostly vacant. The two Hazchem buildings contained remnants of previous chemical storage (ie containers of pesticides etc) (Figure 7).

The concrete flooring and concrete surrounds within the Hazchem buildings did not comprise gross staining or evidence of chemicals leaking from the buildings.

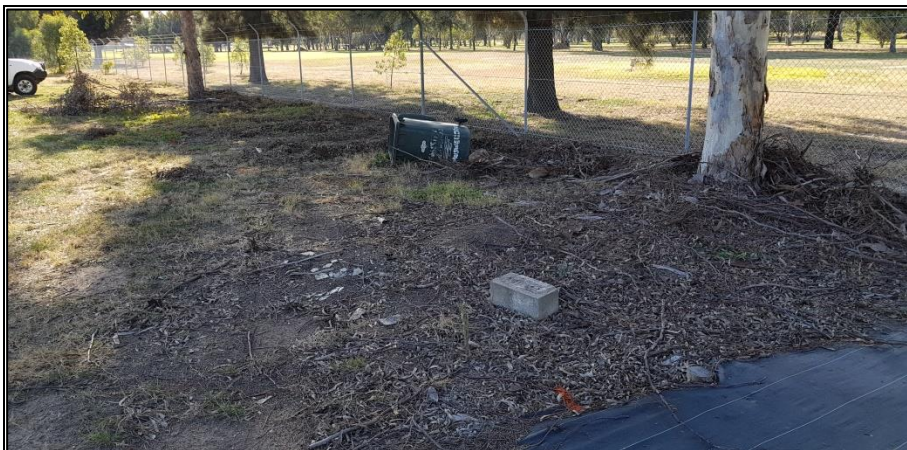
**Figure 8: Fibrous cement fragments encountered adjacent to the northern boundary in the south eastern portion of the site, looking north**

Fibrous cement fragments were also encountered in south eastern portion of the site adjacent to the northern boundary (Figure 8).

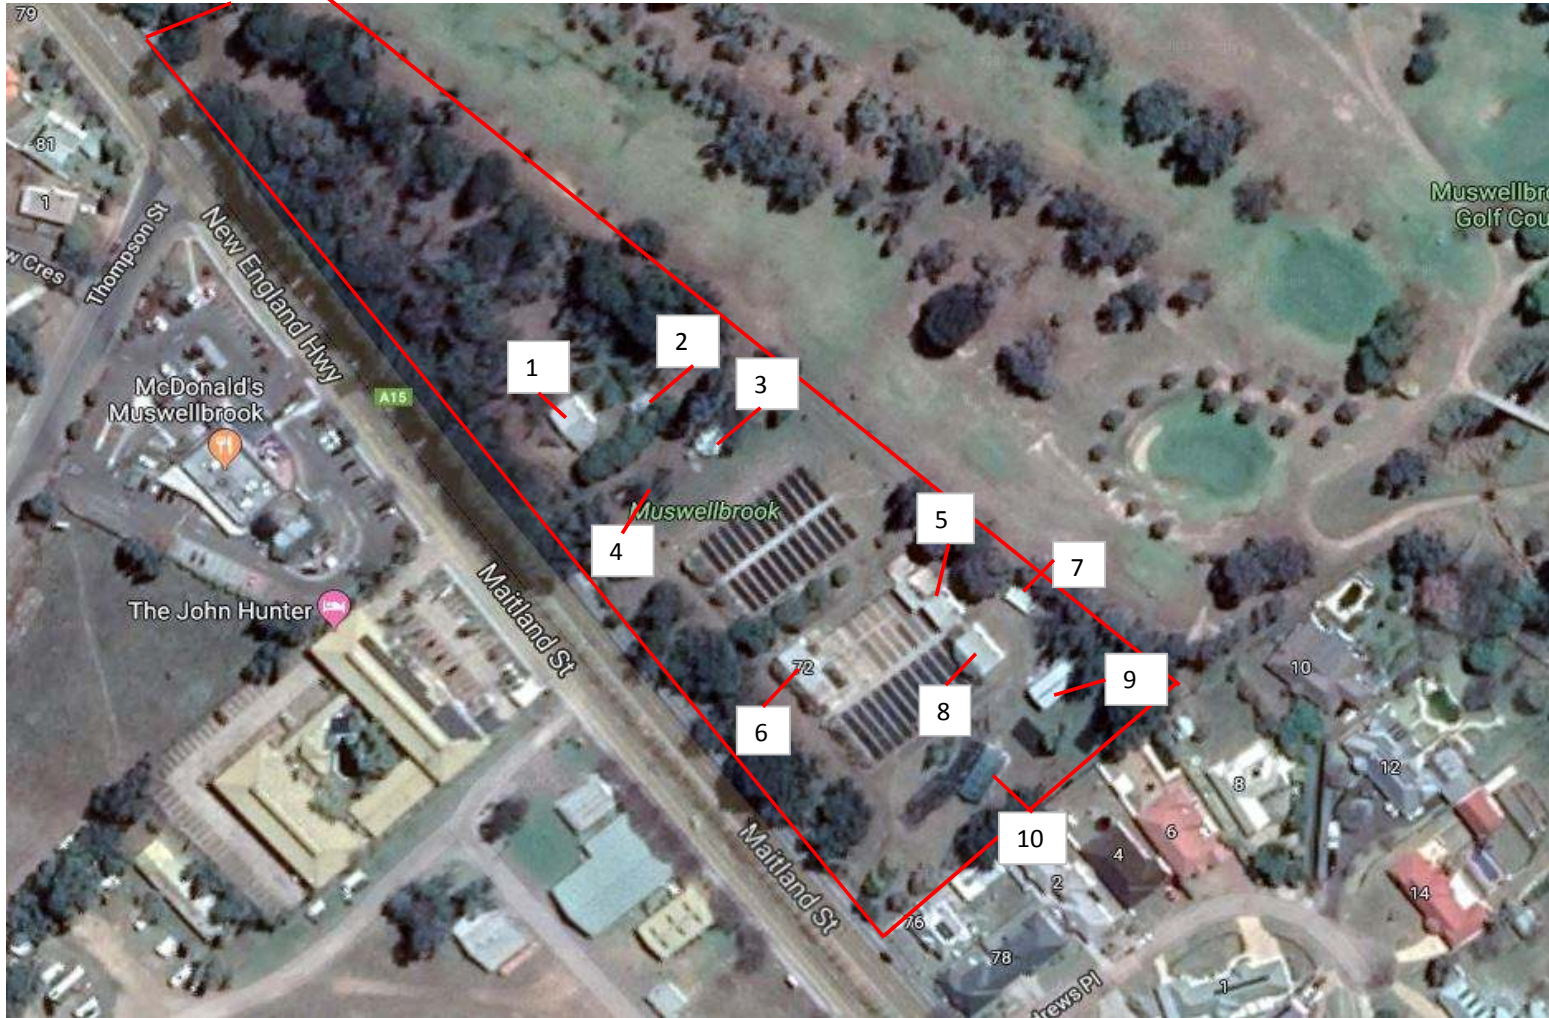
PROJECT No: 91601.01  
 DWG No: 1  
 REVISION: 0

**Site Locations**  
**Lot 100 DP1261496, Maitland Street**  
**Muswellbrook NSW**

- Most buildings were in a dilapidated state with peeling paint and fragments of fibre board visible on the ground around the buildings;
  - The hazardous material assessment report (DP, 2019b) identified lead paint and ACM in buildings 1, 5, 6, 8 and 9, hence assessment of the potential contamination of near surface soils around these buildings for lead and asbestos is required (refer to Appendix B plans for building IDs);
