Manildra – Port Kembla  
Bulk Liquid Terminal

# Acid Sulfate Soils Management Plan

Client Reference No. 30013038-R03  
Prepared for: Manildra Group Pty Ltd  
6 May 2022

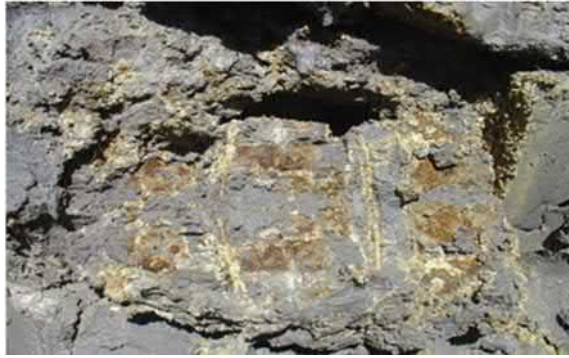
Actual ASS (pH <4.0)

Typically, AASS and PASS would appear as indicated in the photos below from eastern Australian estuarine fine-grained soils. Selected actual site photographs from previous test pit investigations are also included in Photo 3-1 to Photo 3-6.

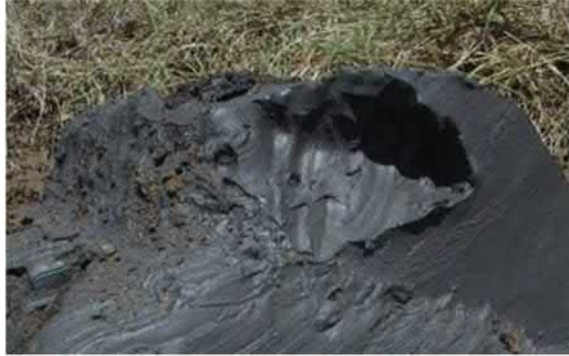
Potential PASS (pH >4.0)

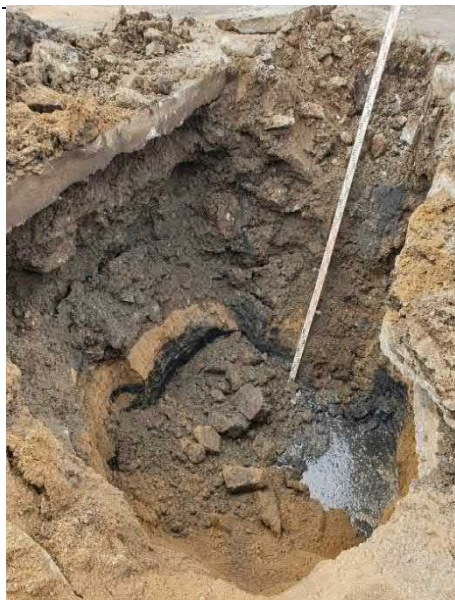
Photo 3-1 TP13 – Dark grey sandy clay Unit 3 (Estuarine) layer observed at 2.0-2.2m

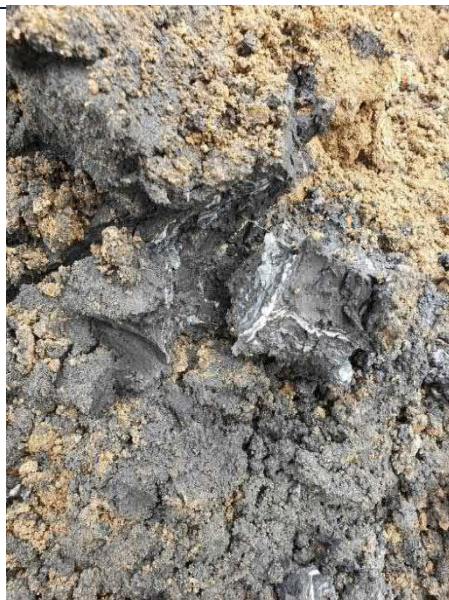
Photo 3-2 TP13 – Dark grey sandy clay Unit 3 (Estuarine) layer observed at 2.0-2.2m

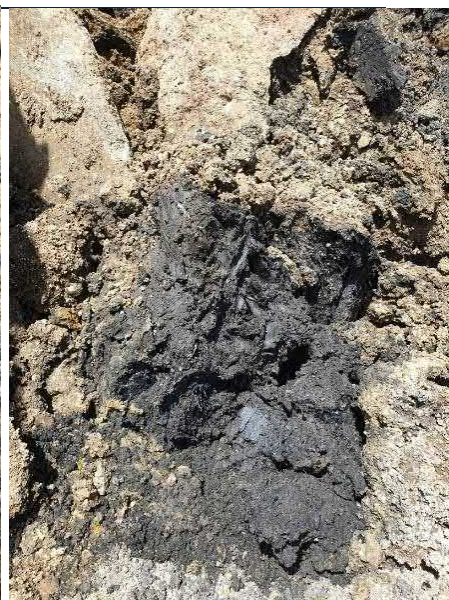
Photo 3-3 TP14 – Dark grey sandy clay Unit 3 (Estuarine) layer observed at 1.2-1.4m

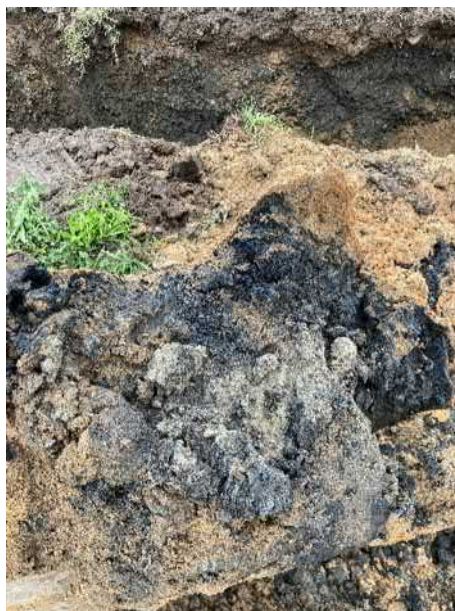
Photo 3-4 Example of dark grey clayey sand Unit 3 (Estuarine soils) approximately greater than 2.2 m bgl.

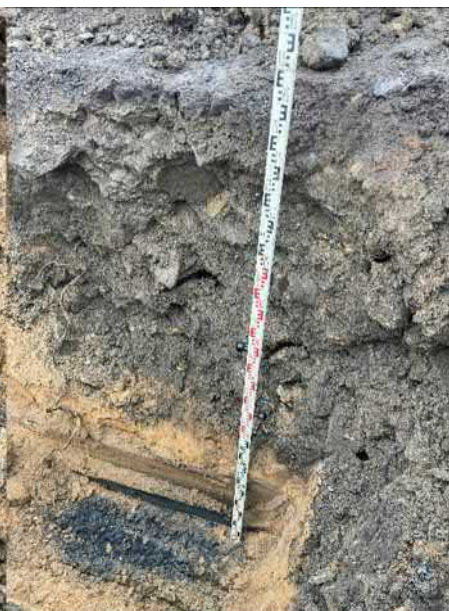
Photo 3-5 Example of dark grey clayey sand Unit 3 (Estuarine soils) approximately greater than Unit 1 (fill) and Unit 2 (Aeolian) layers sand

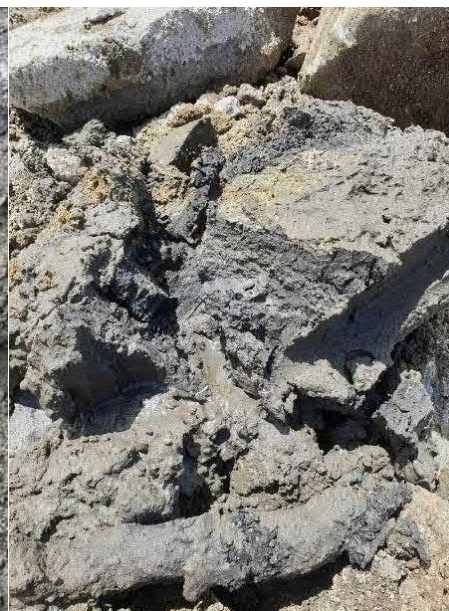
Photo 3-6 TP14 Clayey sand, pale grey Unit 3 (Estuarine soils) approximately greater than 2.4 m bgl.

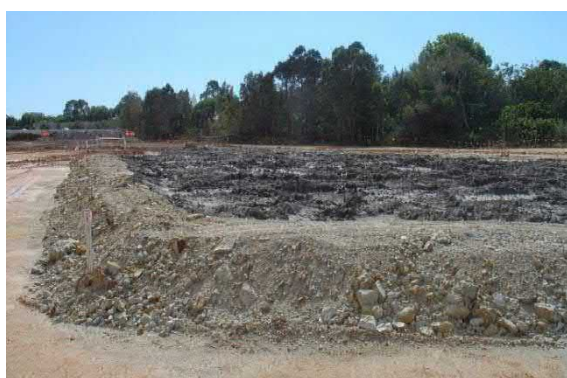
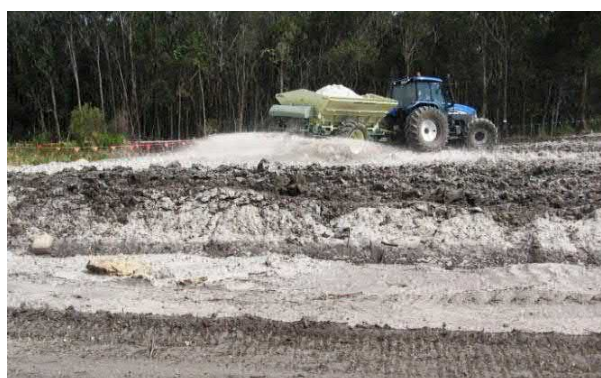
Examples of banded treatment area for ASS and lime application Ref: Dear et al (2014)
