Remediation Action Plan

Proposed Commercial Development 2-8a Lee Street, Haymarket

Project 86884.05 July 2022

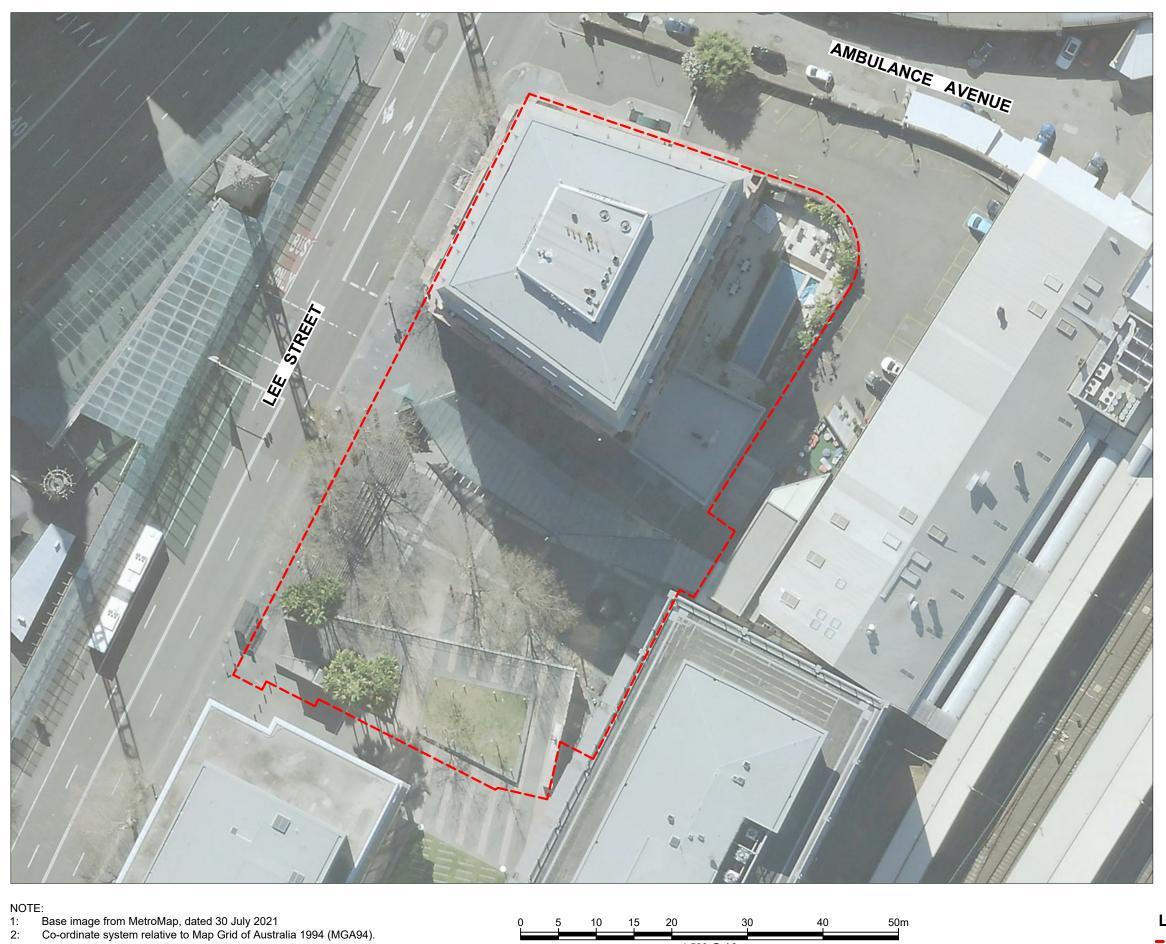
PROJECT No:	86884.05
DRAWING No:	1
REVISION:	0

Site Boundary

**Locality Plan**
