RE: GEOTECHNICAL INVESTIGATION FOR THE RYDE HOSPITAL REDEVELOPMENT (CONCEPT AND STAGE 1)

The attached report (Ref. PSM3828-002R REV 2 dated 13 June 2019) to this letter presents the results of the geotechnical investigation undertaken by Pells Sullivan Meynink (PSM) in 2019 for the proposed Ryde Hospital Redevelopment (Concept and Stage 1).

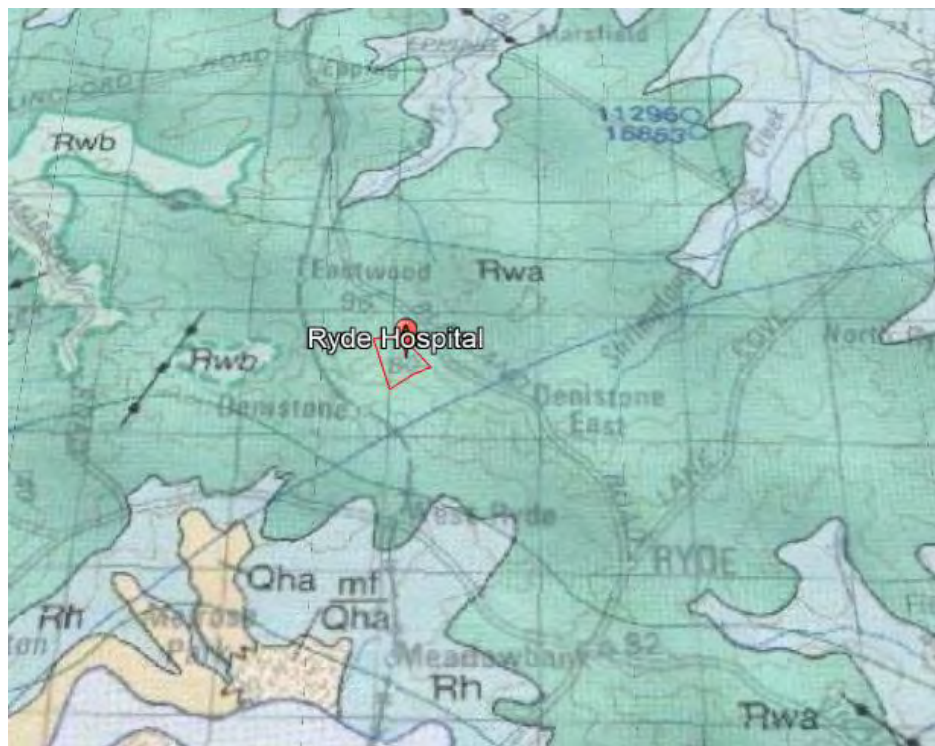
Inset 1: Sydney geological map indicating approximate site location

Inset 1 presents an indicative site locality on the geological map.

The 1:100,000 Sydney Geological Map indicates the site is underlain by Ashfield Shale of the Wianamatta group (Rwa) which consist of black to dark-grey Shale and Laminite. The published information is consistent with the subsurface conditions encountered in the field investigation.

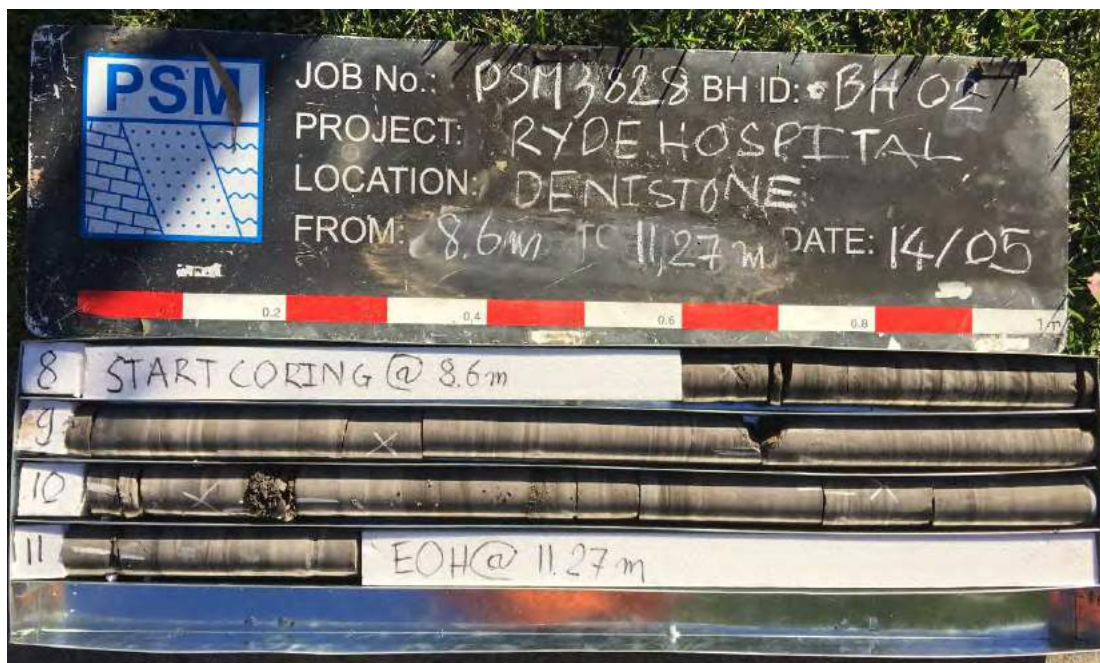
JBS&G
Ryde Hospital
Eastwood, NSW
GEOTECHNICAL INVESTIGATION
CORE PHOTOGRAPHY - BH02

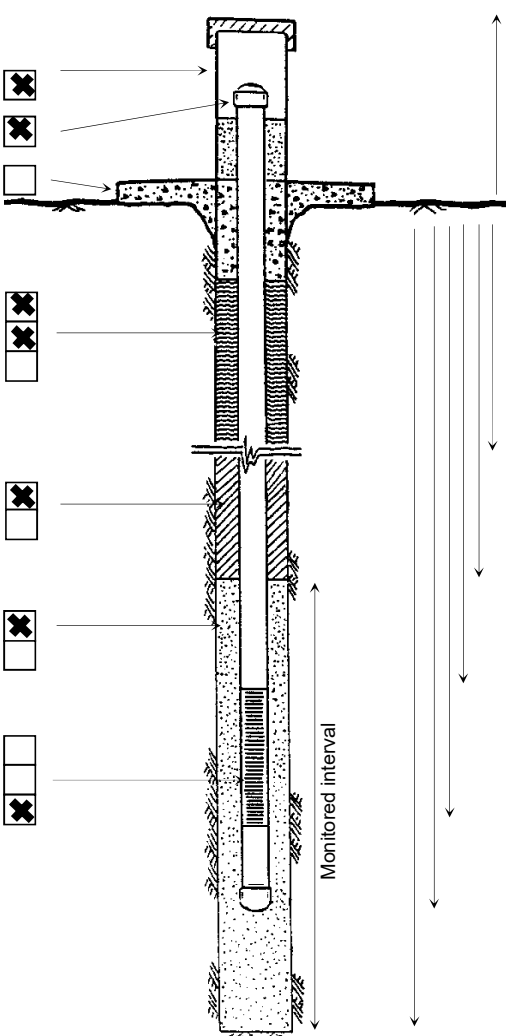
Height of stickup (m)	<u>NONE</u>
PVC cap	<input checked="" type="checkbox"/>		Diameter of PVC (mm)	<u>60 mm</u>
Concrete collar	<input type="checkbox"/>			
Back fill type: Cement bentonite	<input checked="" type="checkbox"/>			
Soil	<input checked="" type="checkbox"/>			
None	<input type="checkbox"/>			
Seal: Bentonite pellets	<input checked="" type="checkbox"/>		Depth to top of seal	<u>3.1m</u>
Other	<input type="checkbox"/>			
Gravel type: 2-5mm gravel	<input checked="" type="checkbox"/>		Depth to top of gravel pack	<u>5.1m</u>
Other	<input type="checkbox"/>			
Perforation type: Drill holes	<input type="checkbox"/>	Depth to top of screen	<u>5.2m</u>	
Hack saw cuts	<input type="checkbox"/>			
40um machine slots	<input checked="" type="checkbox"/>	Depth to base of screen	<u>8.2m</u>	
		Depth to base of piezo	<u>8.3m</u>	
		Depth to base of gravel	<u>8.3m</u>

COMMENTS: Water level after installation 15/05/2019- depth 3.01m BLG
