REPORT TO
HAMMONDCARE

ON
HAZARDOUS BUILDING MATERIALS SURVEY

FOR
PROPOSED HOSPITAL REDEVELOPMENT

AT
**NERINGAH HOSPITAL, 4-12 NERINGAH AVENUE
SOUTH, WAHROONGA, NSW**

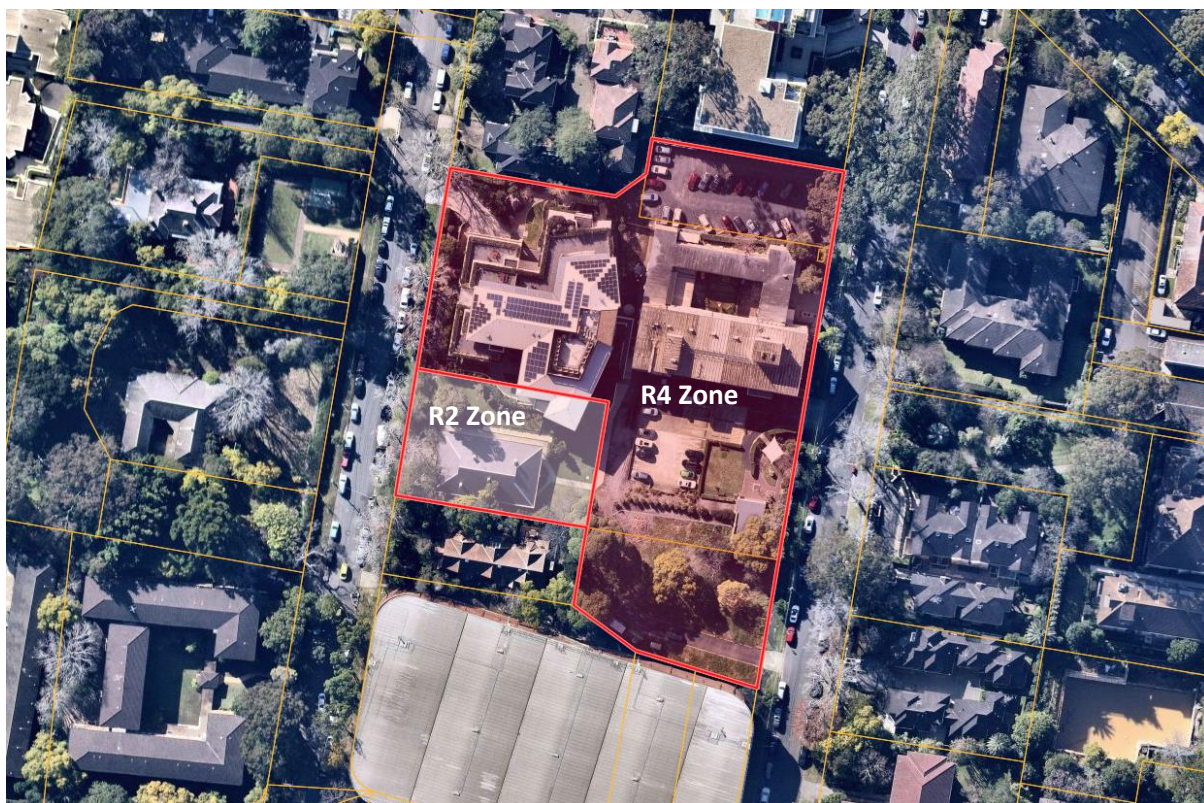
Figure A – Outline of the site, with the portion of the site subject to the SCC shaded dark red (R4 zone)

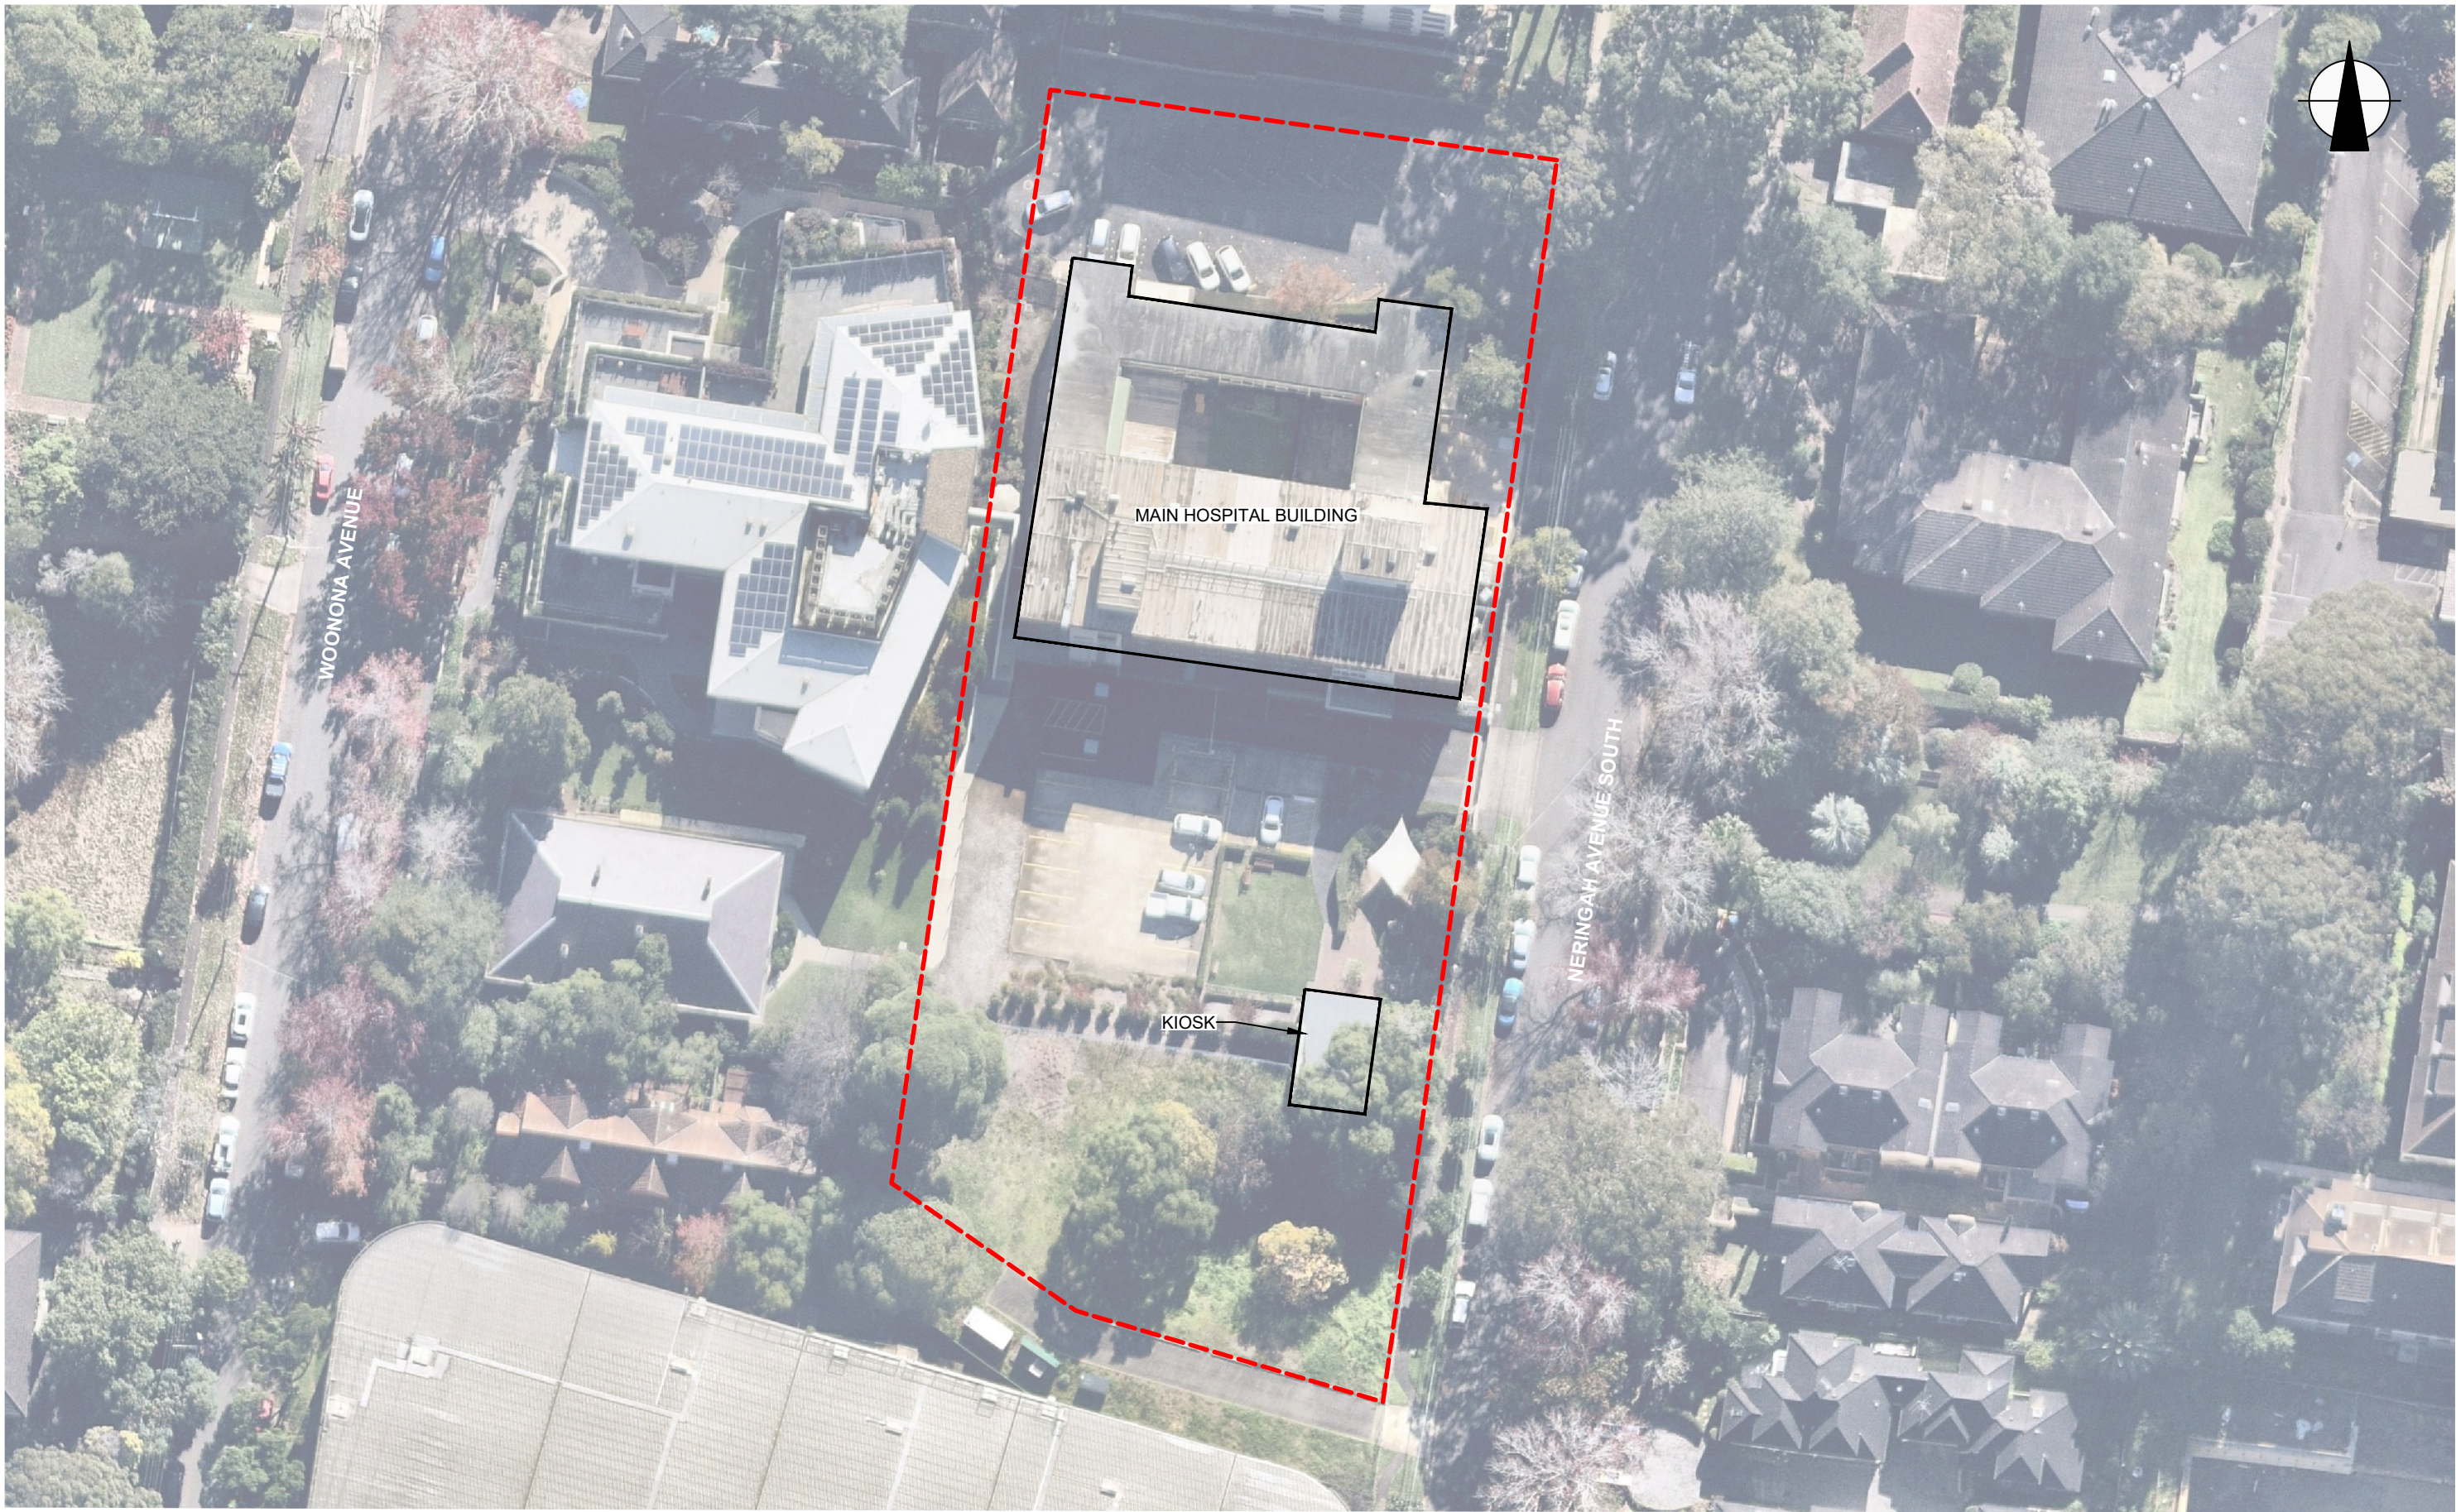
- APPROXIMATE SITE BOUNDARY
- BUILDINGS INCLUDED IN THE SURVEY

HammondCare ('the client') commissioned JK Environments (JKE) to undertake a hazardous building materials survey for the proposed hospital redevelopment at Neringah Hospital, 4-12 Neringah Avenue South, Wahroonga, NSW. The site location is shown on Figure 1 and the survey was confined to the development area as shown on Figure 2 attached in the appendices.

Field work for this investigation was confined to the development area and undertaken between the 3rd and 5th August 2022. The site description at the time of the field work is outlined below. The site location is shown on Figure 1 and the general site layout is shown on Figure 2.
