# Taronga Zoo Sky Safari

Appendix DD  
Infrastructure Delivery,  
Management and Staging Plan

## Infrastructure Report

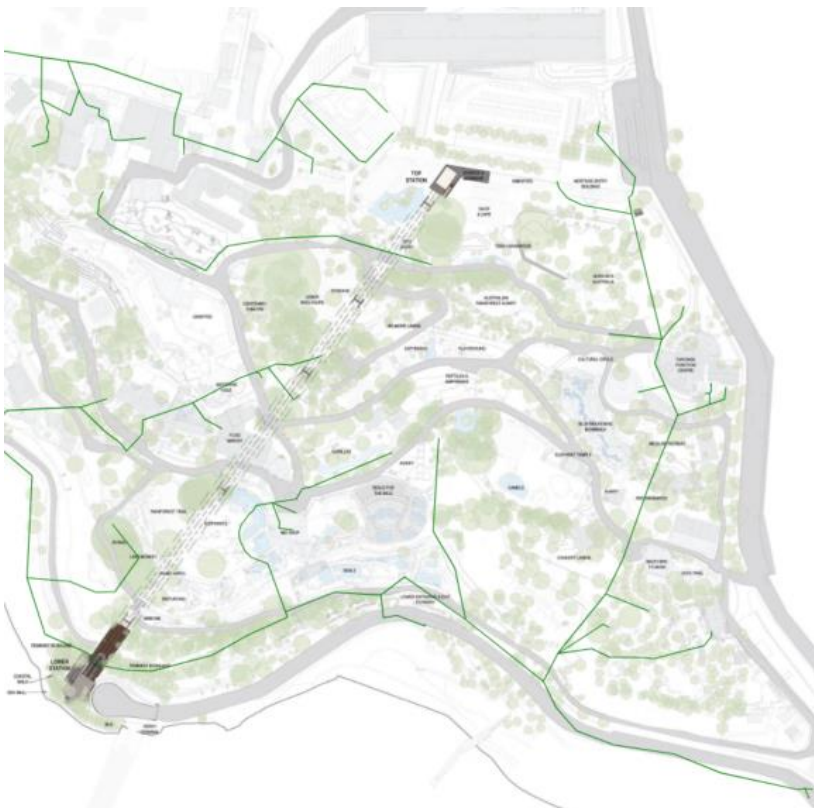
- > An existing sewer main network is located throughout the site.
- > See Figure 13 below for sewer main location:

Figure 13 Existing Sewer Infrastructure

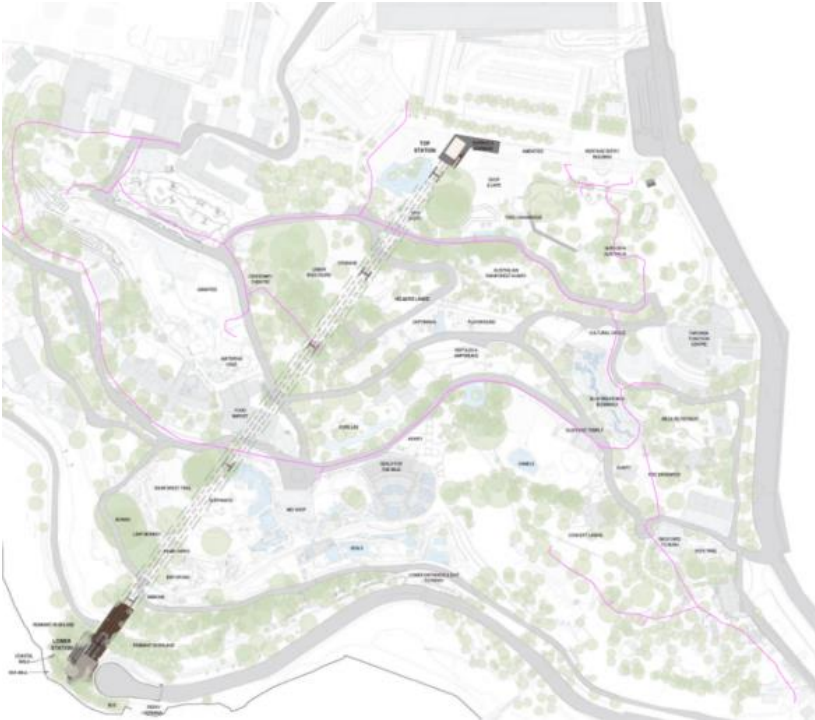
- > An existing recycled water main network is located throughout the site
- > See Figure 15 below for water main location:

Figure 15 Existing Recycled Water Infrastructure

There are existing recycled water main connection points for the top station, however, there is no indication of a recycled water main available to the lower station.

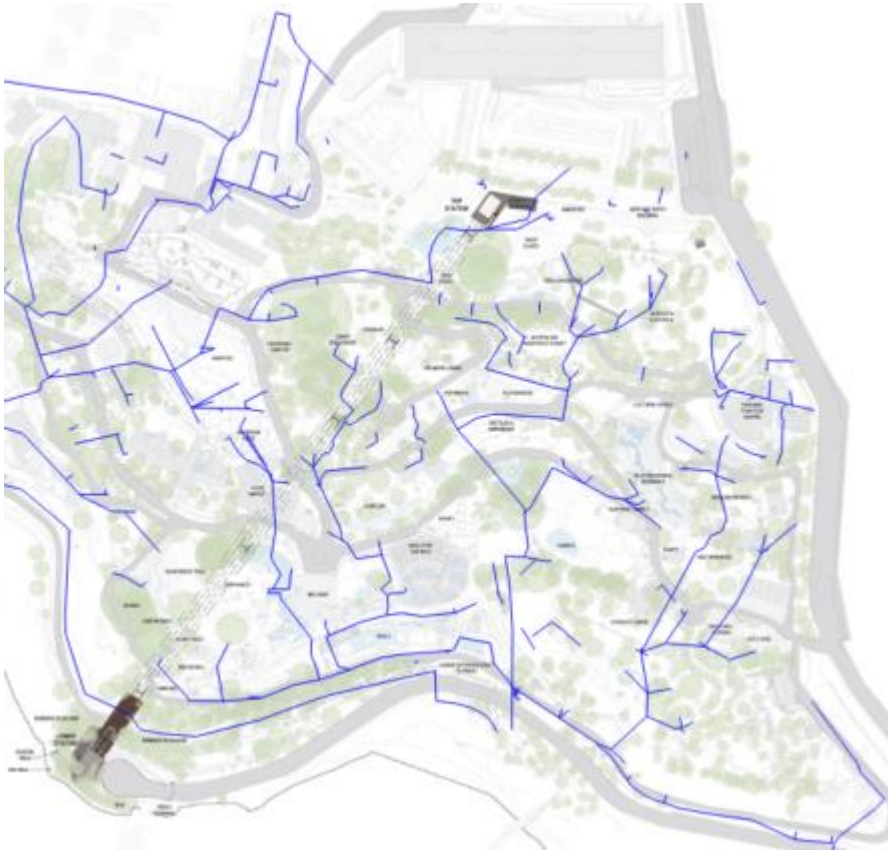
- > An existing stormwater main network is located throughout the site
- > See Figure 16 below for water main location:

Figure 16 Existing Stormwater Infrastructure

The size and depths of the water, recycled water, sewer and stormwater mains are to be confirmed prior to any works being conducted to ensure that they have adequate capacity to serve the proposed pylon structure. Should any excavation works be required, it is necessary to confirm the invert levels (IL's) of the existing services to appropriate relocate or protect them.

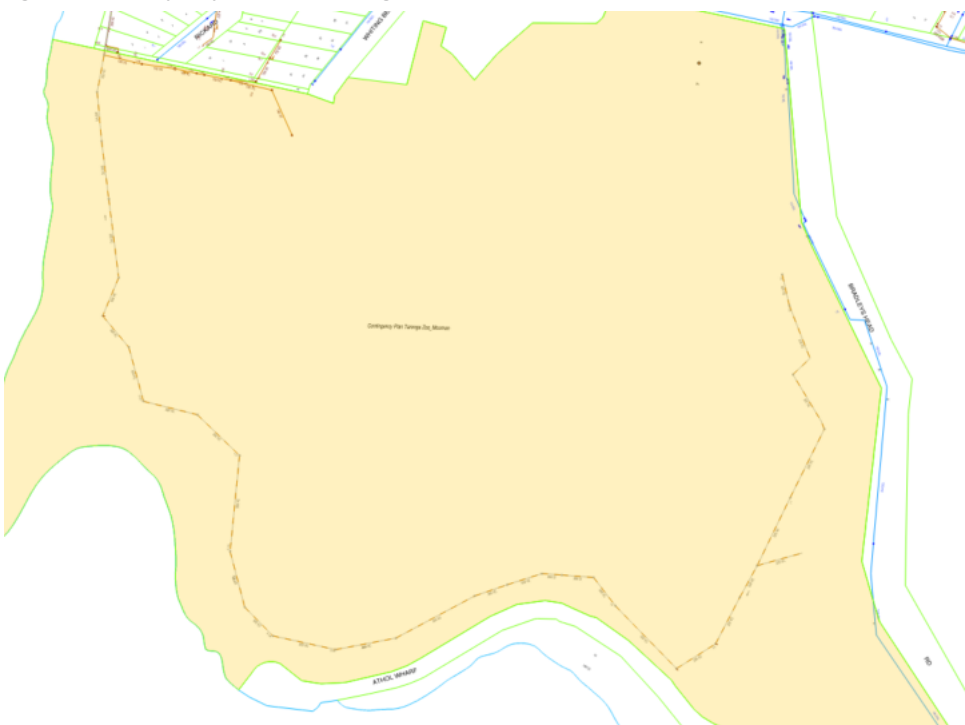
The lower station sewer connection will be directly into the Sydney Water Ø300mm VC sewer main. The top nature station does not have a direct sewer connection point as seen above. A sewer main extension may be required to serve the station. The exact location of sewer connection is subjected to a Section 73 Notice of Requirements Advice. The BYDA Sydney Water sewer and water diagram is shown below:

Figure 3 Sydney Water BYDA Diagram

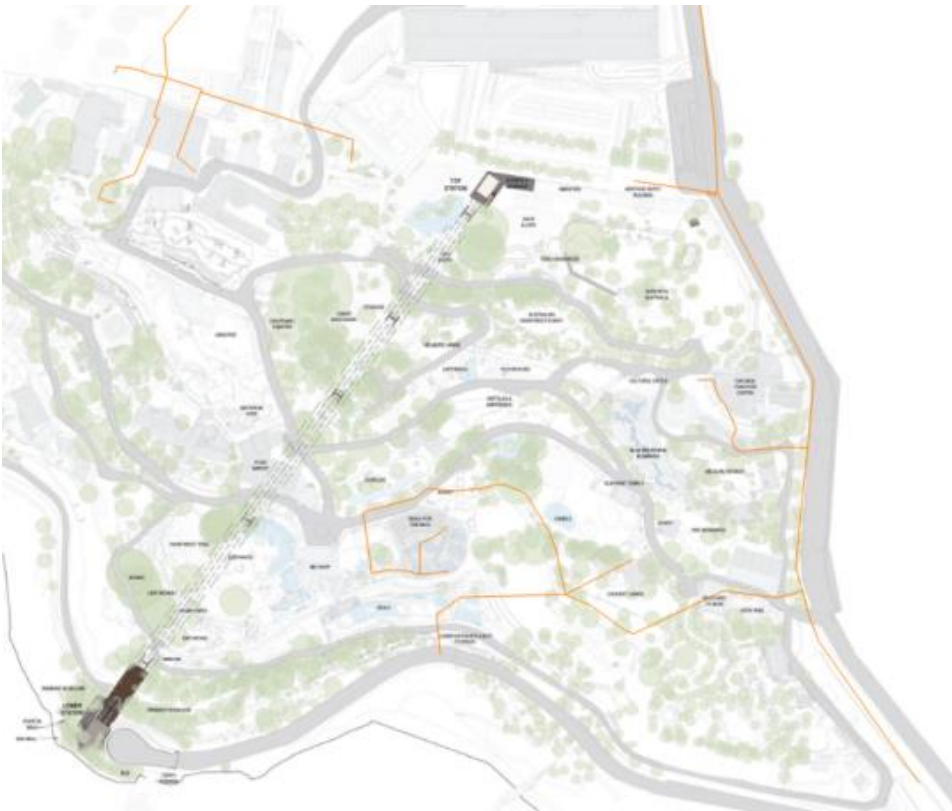
The existing size and rating of the internal infrastructure is unknown. Figure 3 below highlights the internal gas infrastructure network. It is anticipated that the gas main running along the eastern boundary of the site is Jemena's gas main.

Figure 5 Existing Gas Infrastructure

- > A 75mm Nylon 210 kPa medium pressure gas main is located along Bradleys Head Rd
