BULGA SURFACE OPERATIONS EASTERN EMPLACEMENT AREA MODIFICATION

Response to Submissions

Prepared by
Umwelt (Australia) Pty Limited
on behalf of
Bulga Coal Management Pty Ltd

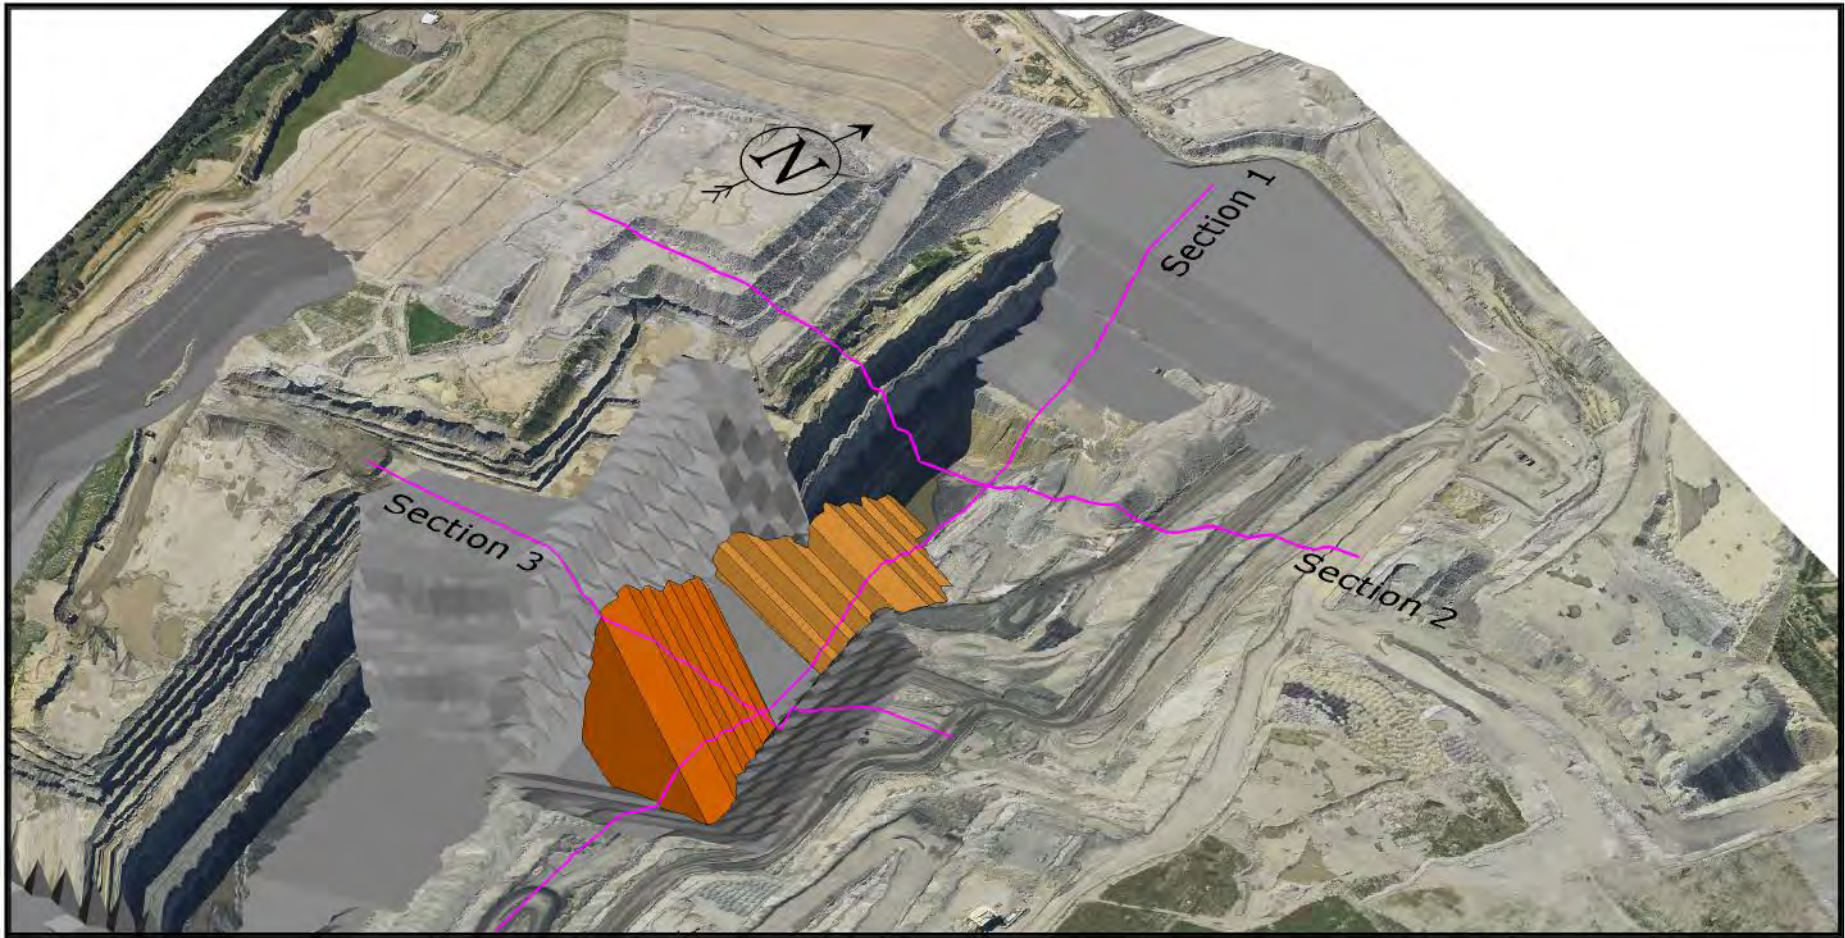
Figure 2.1 Revised Tailings Emplacement Location

Orange areas indicate proposed tailings dams

The proposed revised tailings emplacement location is shown on **Figures 2.1** and **2.2**. Tailings are planned to be deposited into a series of cells at the base of the Main Pit, from approximately -60 mRL up to an approximate elevation of 0 mRL. The total volume of tailings to be emplaced is estimated as 7.5 GL. The tailings emplaced will be in conjunction with other mining waste materials such as overburden / interburden and coarse reject or thickened tailings which are currently co-disposed during backfilling operations.

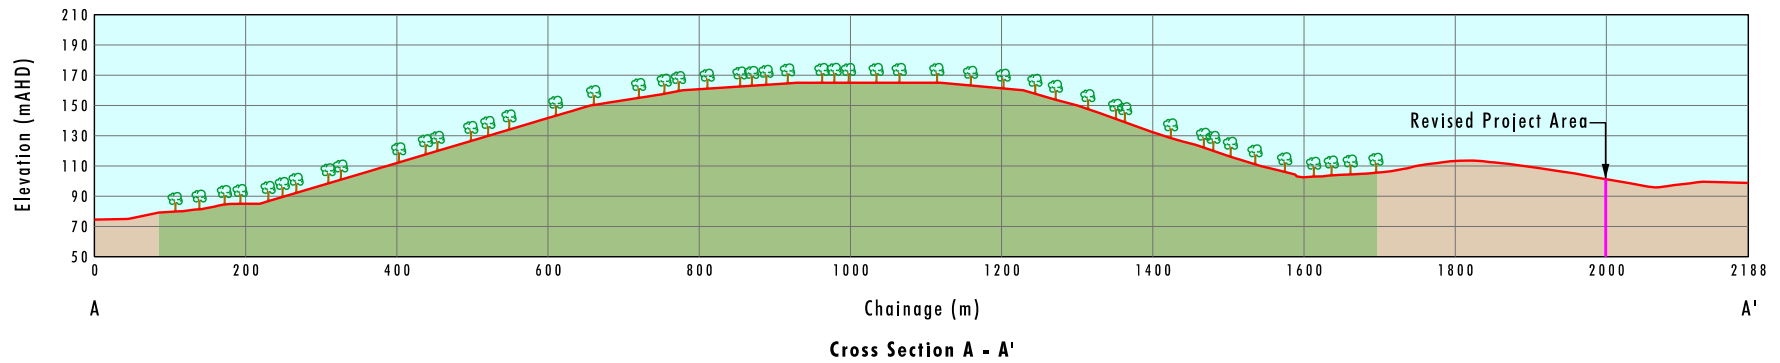
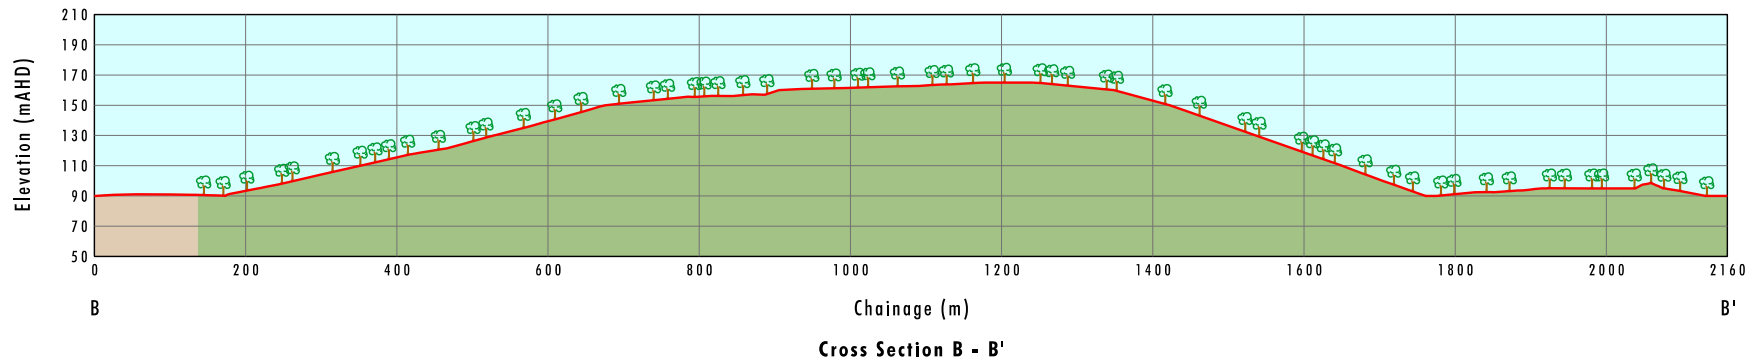
FIGURE 2.6
Eastern Emplacement Area
Cross Sections

Legend
 — Conceptual Final Landform
 ■ Woodland

Rehabilitation and closure activities will be implemented progressively throughout the life of mine to maximise any opportunities for the development of other potentially viable land use options. Further, the details of the landform, land use and associated rehabilitation from the BOP EIS have been included into the currently approved Mining Operations Plan (MOP). It is proposed that should the modification be approved, the MOP would be updated to include the modified EEA including more detailed landform plans in accordance with DREs guidelines for MOPs. **Figures 2.5 and 2.6** provide further detail on the proposed final land form and land use for the EEA including cross sections.

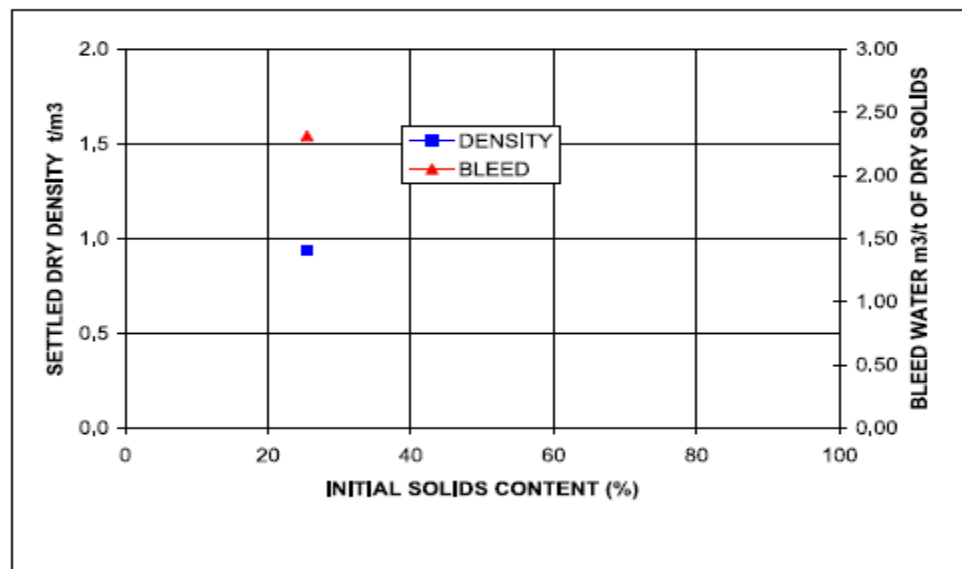
**SUMMARY OF RESULTS
Drained Tray Settlement Tests
(10 kPa Vacuum)**

Sample No. 27808 Flocculated Tailings Sample

SOLIDS CONTENT %		SAMPLE DEPTH mm			(H _F /H ₀)x100	SETTLED DRY DENSITY t/m ³	BLEED WATER	
INITIAL*	FINAL	INITIAL H ₀	FINAL H _F	DH			% OF INITIAL WATER	m ³ /t OF DRY SOLIDS
25.46	62.03	59.40	18.70	40.70	31.48	0.940	79.09	2.316
